Expertise

Protocol number: 46449008  
Order No. / Reference: 25933883  
Inspection date: 8 Jul 2026

Model: Vito 116 CDI Tourer Extralang Aut. PRO

VIN: W1VVLGFZ1T4567996

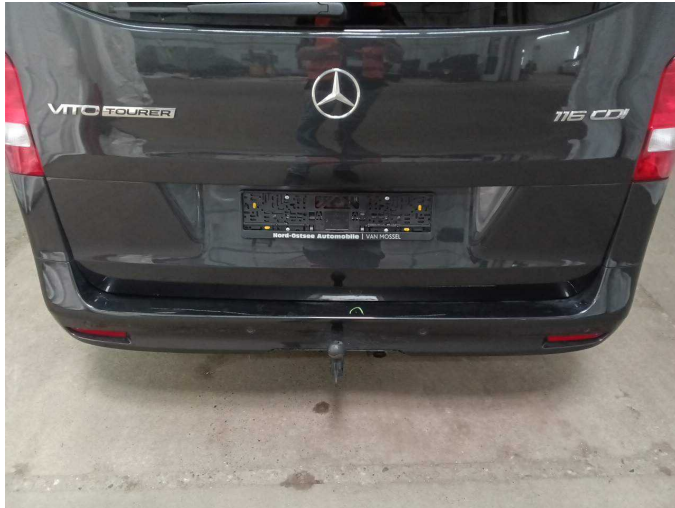
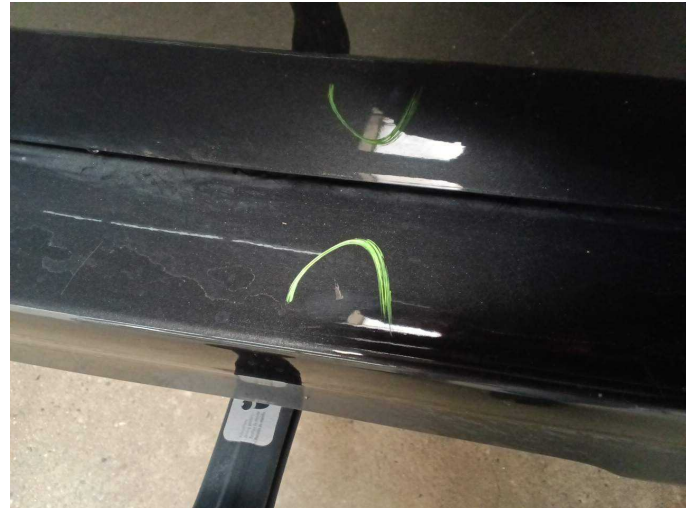
| No. | Component group | Description |
|---|---|---|
| 1 | Rear bumper | Rear bumper - Scratch(es) - Smart repair |

**Damage 1:** Rear bumper: Rear bumper - Scratch(es) - Smart repair

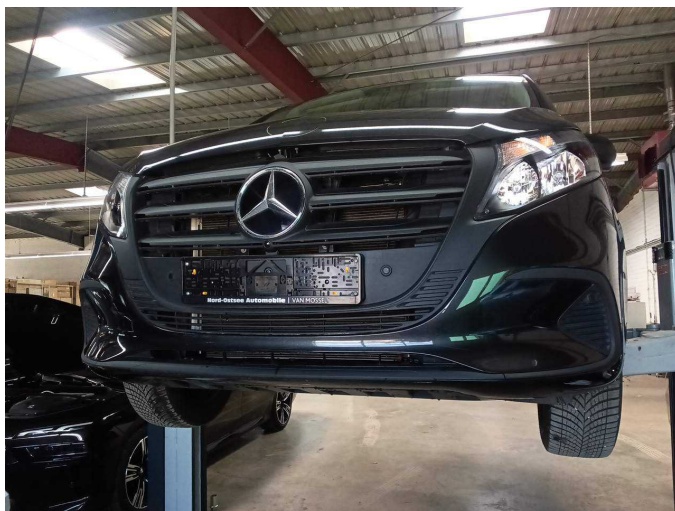
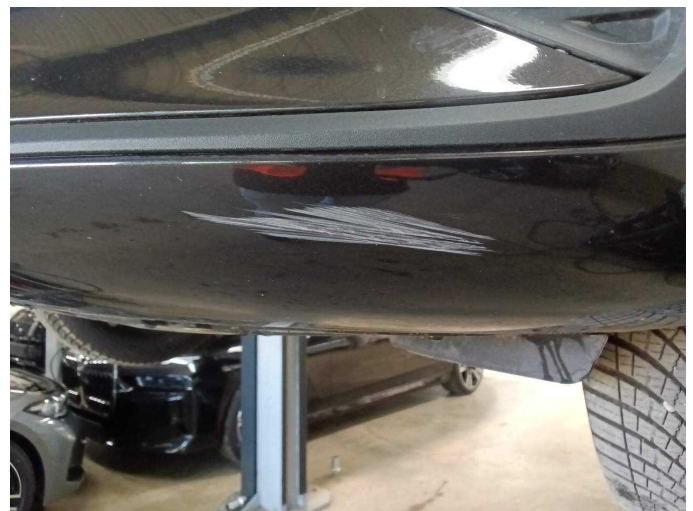
| No. | Component group | Description |
|---|---|---|
| 2 | Front bumper | Front bumper - Scratch(es) - Paint |

**Damage 2:** Front bumper: Front bumper - Scratch(es) - Paint

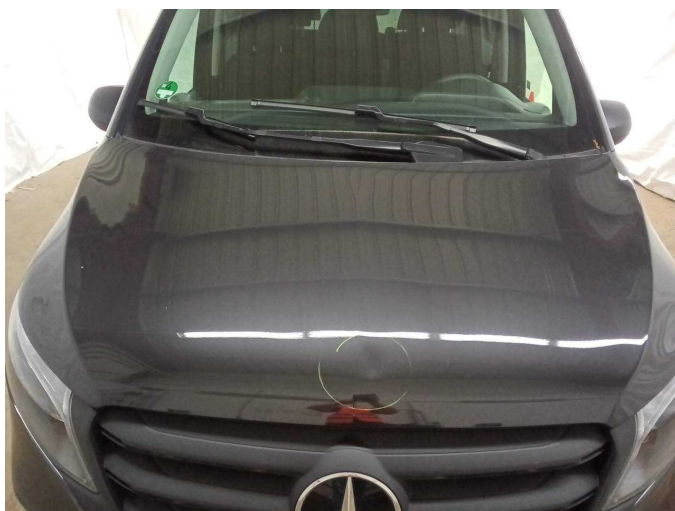
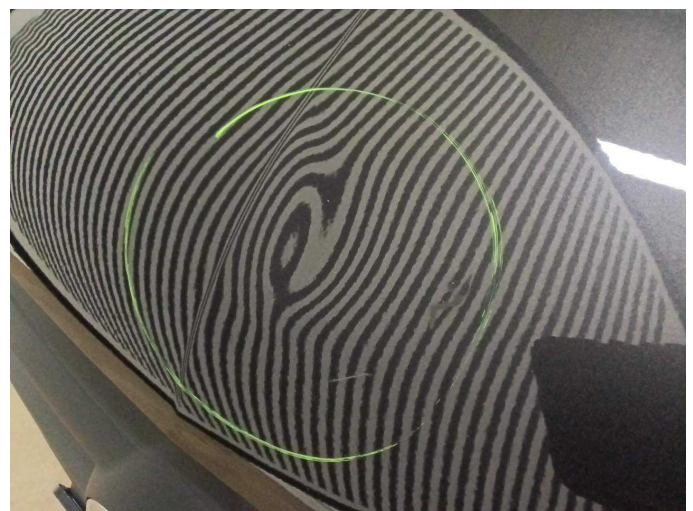
| No. | Component group | Description |
|---|---|---|
| 3 | Bonnet | Bonnet - dent(s) - Repair and paint |

**Damage 3:** Bonnet: Bonnet - dent(s) - Repair and paint
