## Expertise

Protocol number: 45517102  
Order No. / Reference: 26366638  
Inspection date: 7 May 2026

Manufacturer: Opel

Model: Astra Sports Tourer 1.5 D Automatik Business Elegance

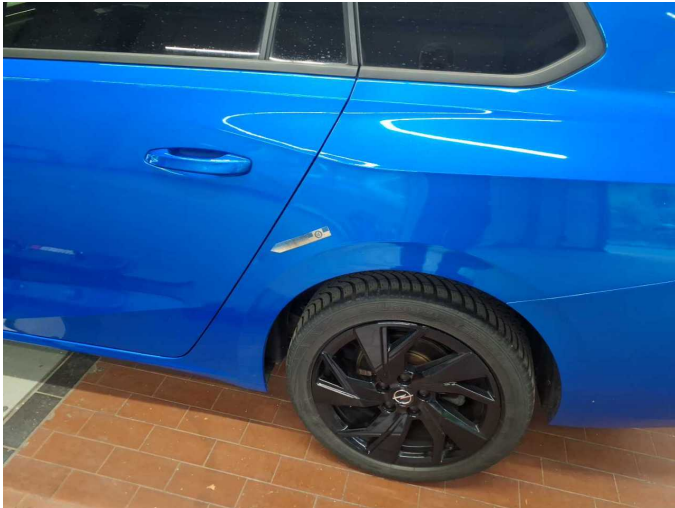
**Damage 2:** Side panel - rear left side: Side panel - dent(s) - Smart repair

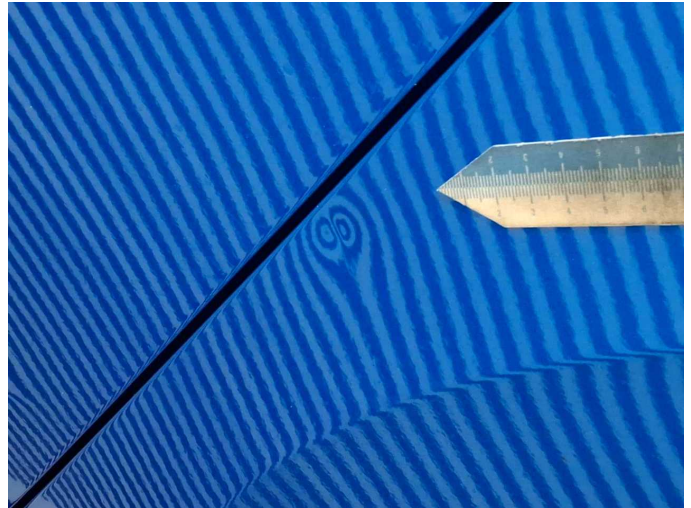
**Damage 2:** Side panel - rear left side: Side panel - dent(s) - Smart repair

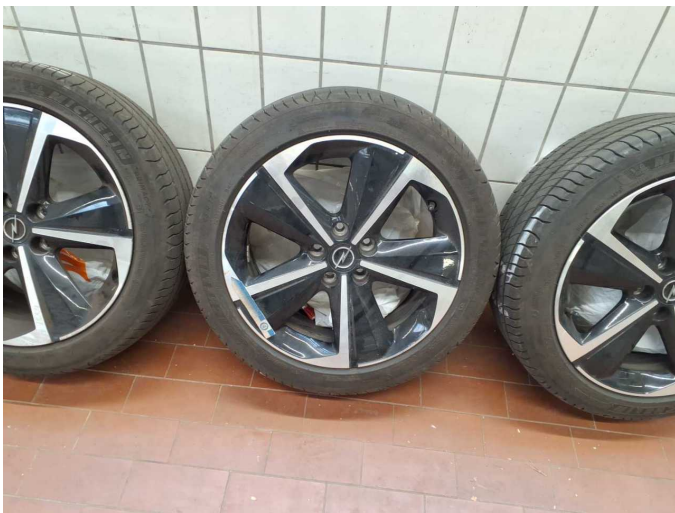
**Damage 3:** 2nd wheel set: 1 alloy rim - Scratch(es) - Loss in value

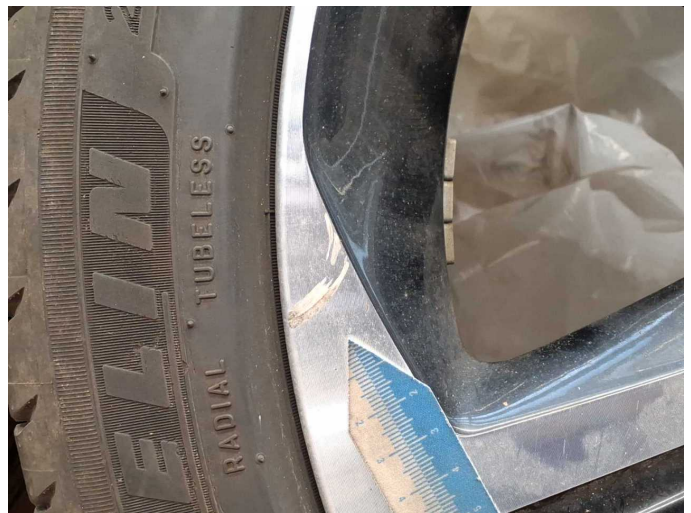
**Damage 3:** 2nd wheel set: 1 alloy rim - Scratch(es) - Loss in value

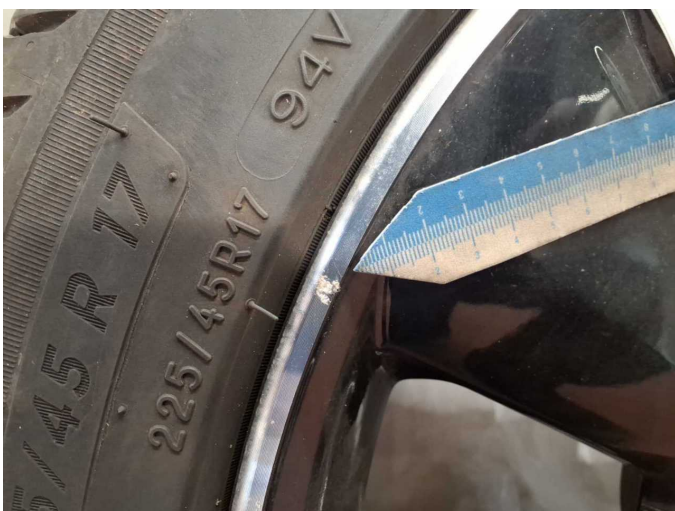
**Damage 3:** 2nd wheel set: 1 alloy rim - Scratch(es) - Loss in value

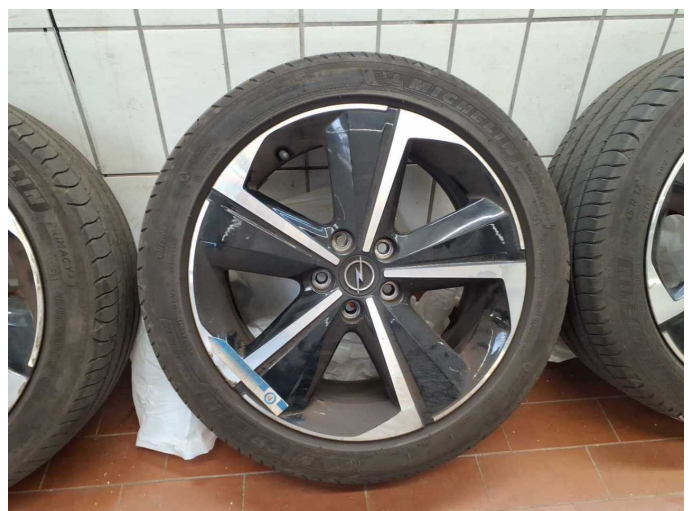
**Damage 4:** 2nd wheel set: 1 alloy rim - Scratched - Loss in value

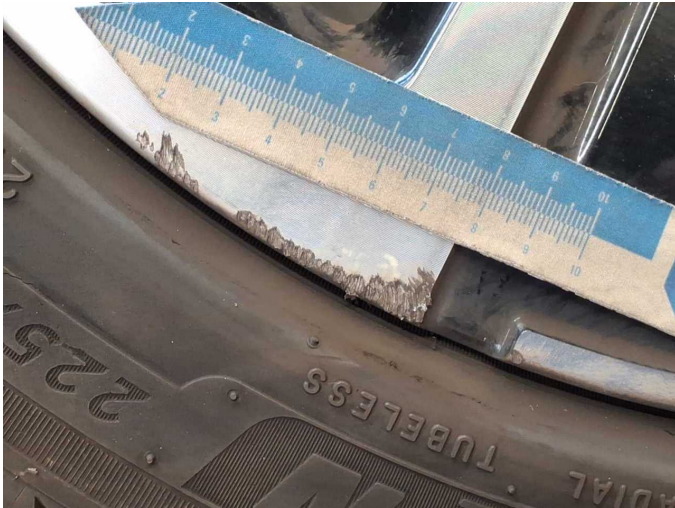
**Damage 4:** 2nd wheel set: 1 alloy rim - Scratched - Loss in value

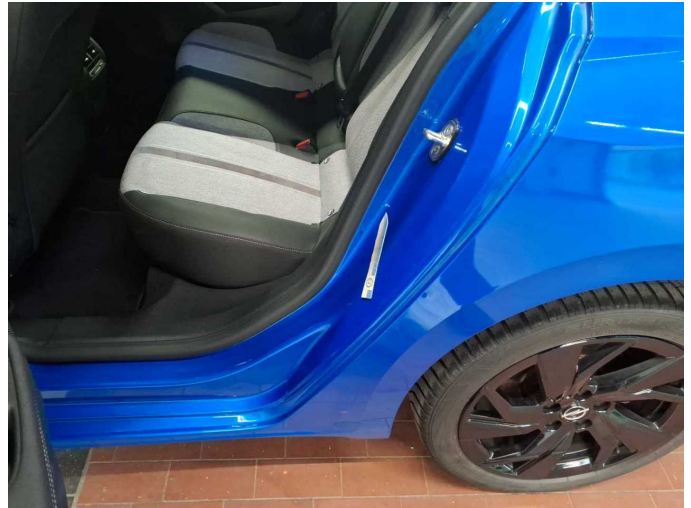
**Damage 5:** Side panel - rear left side: Sill - Scratch(es) - Smart repair

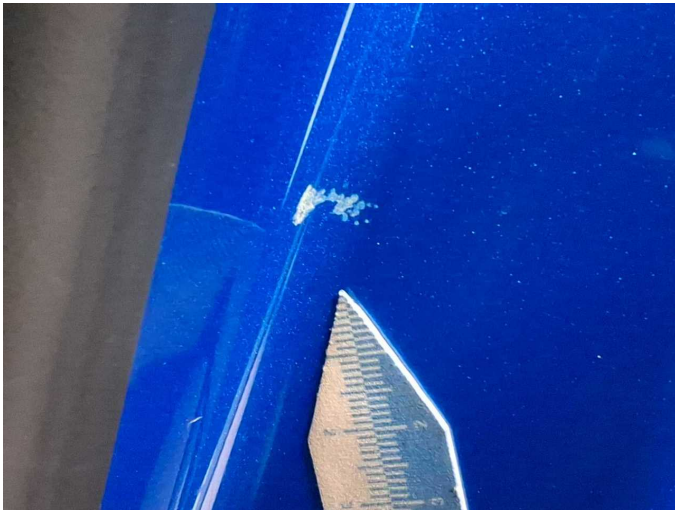
**Damage 5:** Side panel - rear left side: Sill - Scratch(es) - Smart repair

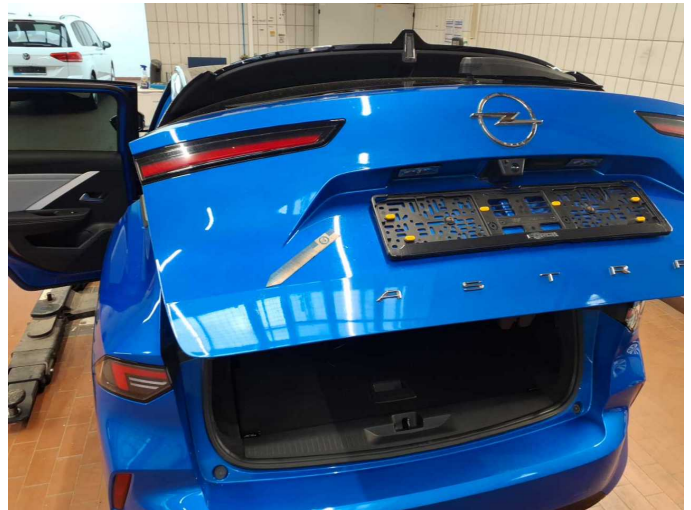
**Damage 6:** Boot lid / rear door: Boot lid - Scratch(es) - Smart repair

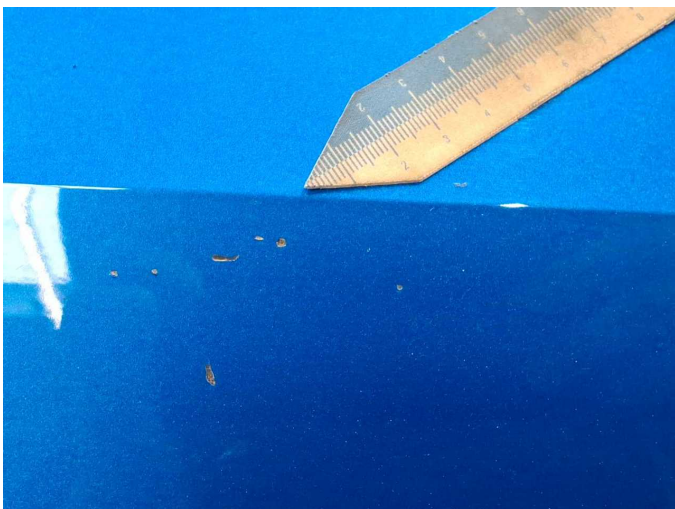
**Damage 6:** Boot lid / rear door: Boot lid - Scratch(es) - Smart repair

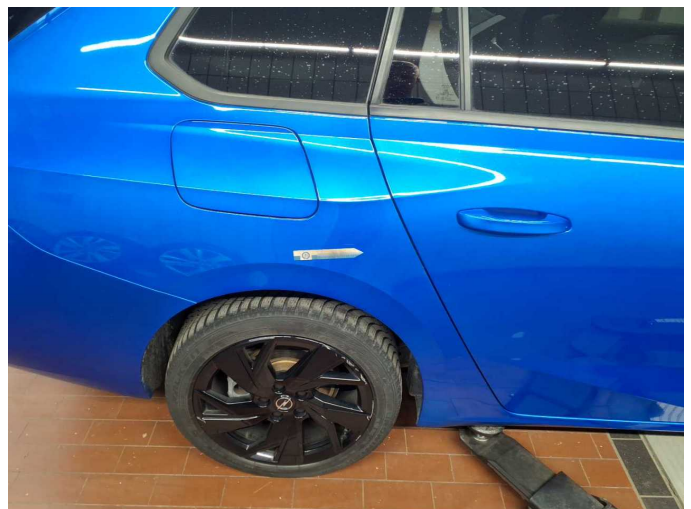
**Damage 7:** Side panel - rear right side: Side panel - Scratch(es) - Smart repair

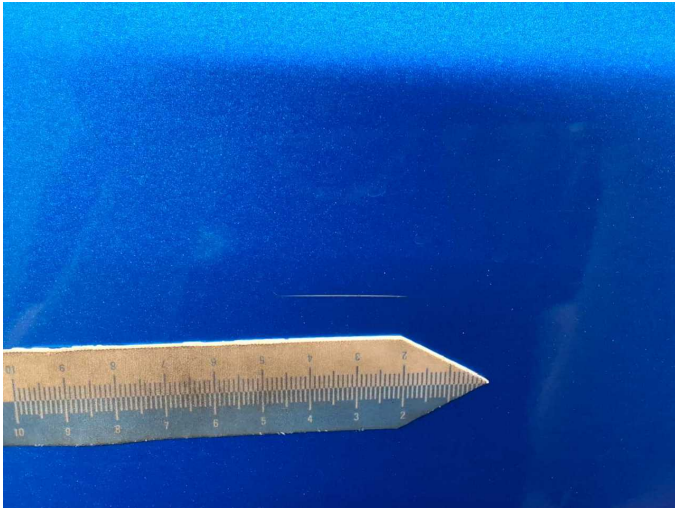
**Damage 7:** Side panel - rear right side: Side panel - Scratch(es) - Smart repair

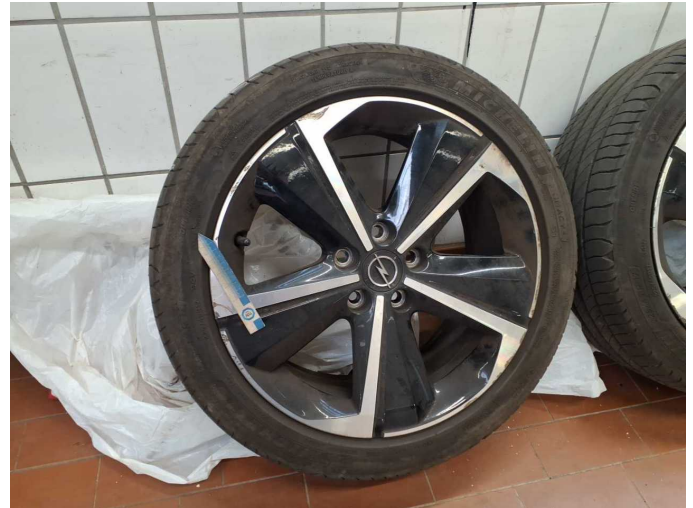
**Damage 8:** 2nd wheel set: 1 tyre - Broken / torn - Replace

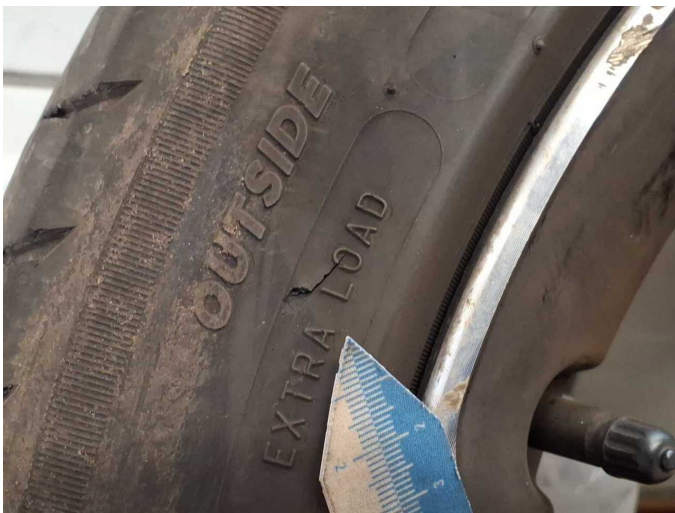
**Damage 8:** 2nd wheel set: 1 tyre - Broken / torn - Replace

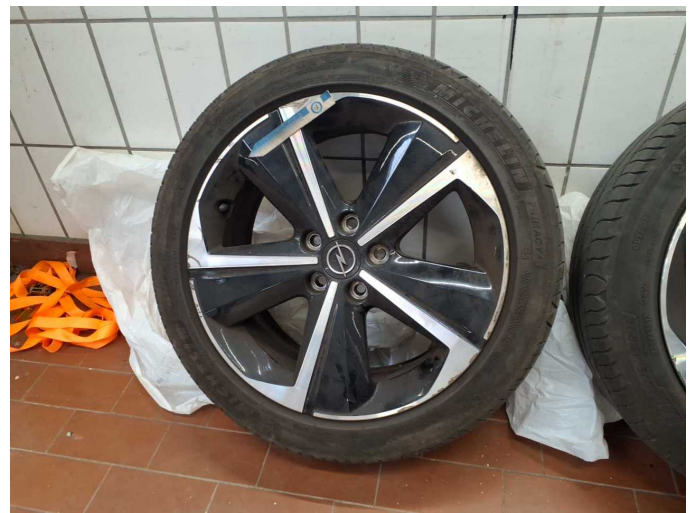
**Damage 9:** 2nd wheel set: 1 alloy rim - Scratched - Replace

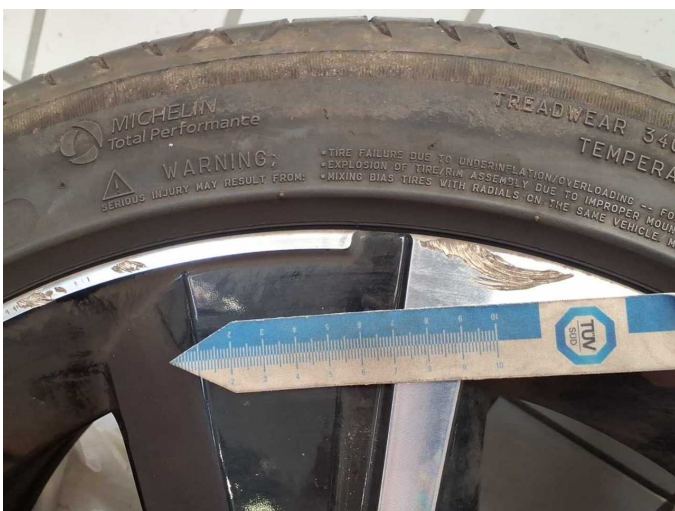
**Damage 9:** 2nd wheel set: 1 alloy rim - Scratched - Replace

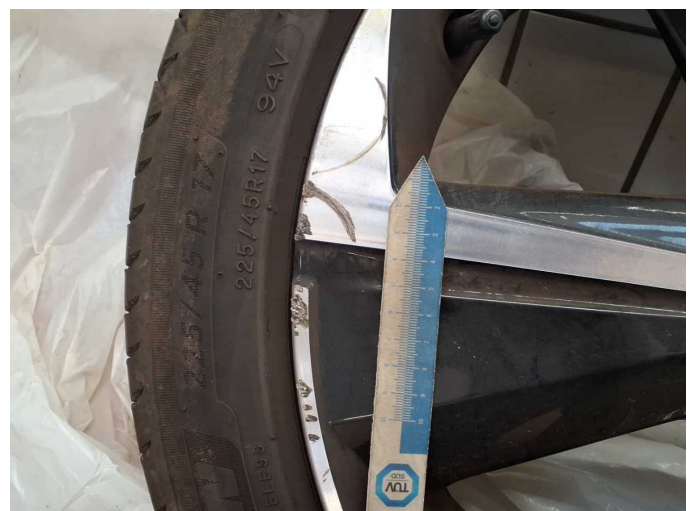
**Damage 9:** 2nd wheel set: 1 alloy rim - Scratched - Replace

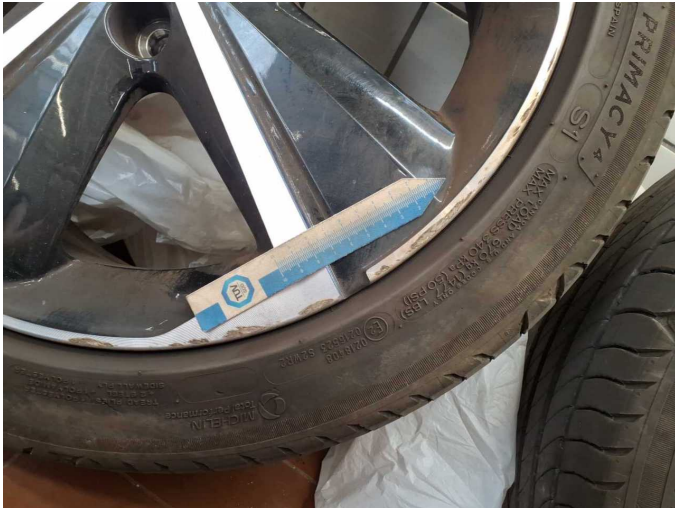
**Damage 9:** 2nd wheel set: 1 alloy rim - Scratched - Replace

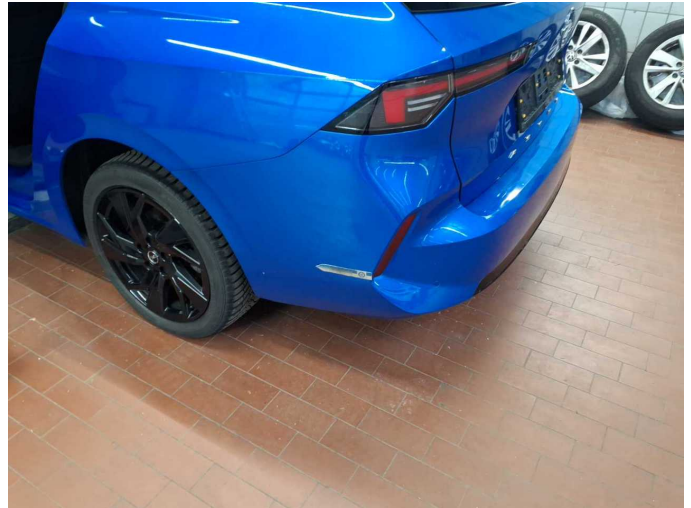
**Damage 10:** Rear bumper: Rear bumper - Scratch(es) - Paint

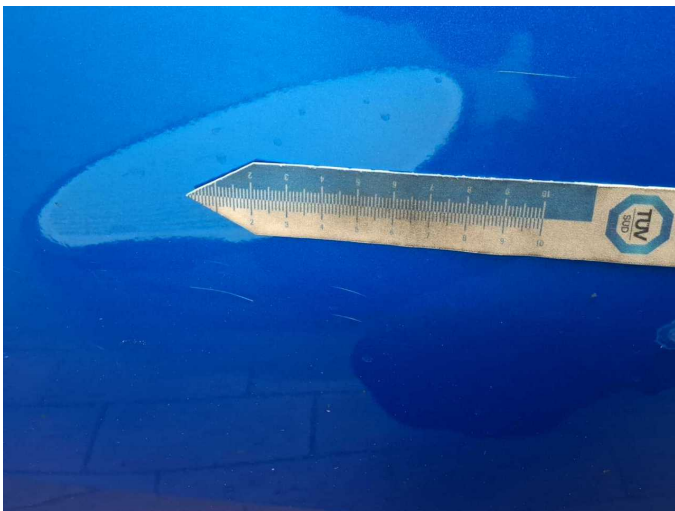
**Damage 10:** Rear bumper: Rear bumper - Scratch(es) - Paint

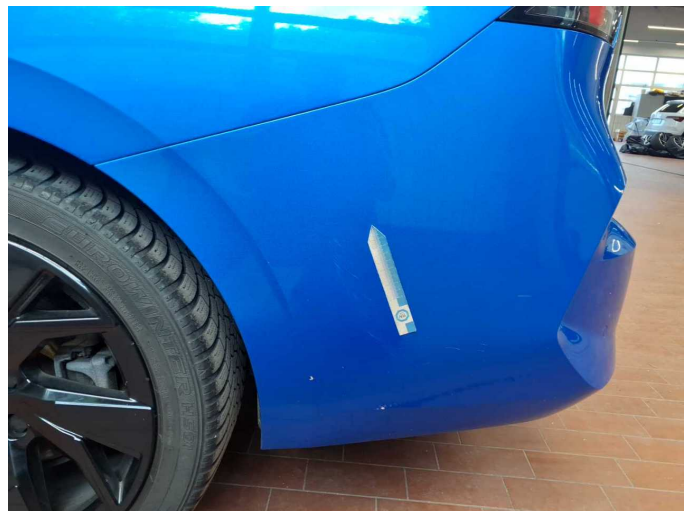
**Damage 10:** Rear bumper: Rear bumper - Scratch(es) - Paint

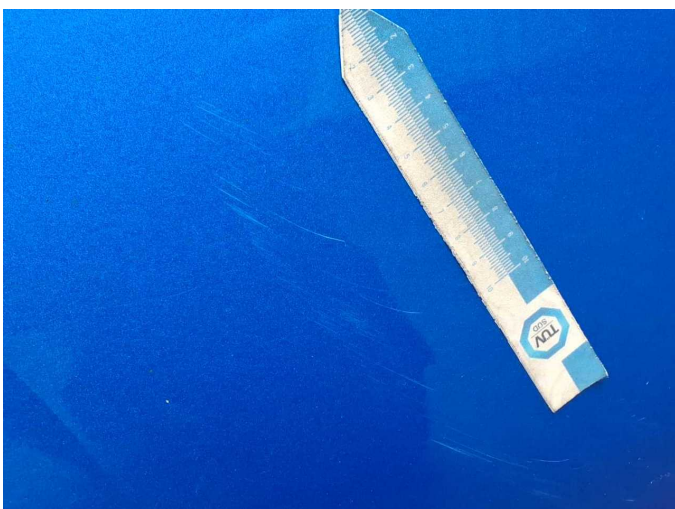
**Damage 10:** Rear bumper: Rear bumper - Scratch(es) - Paint

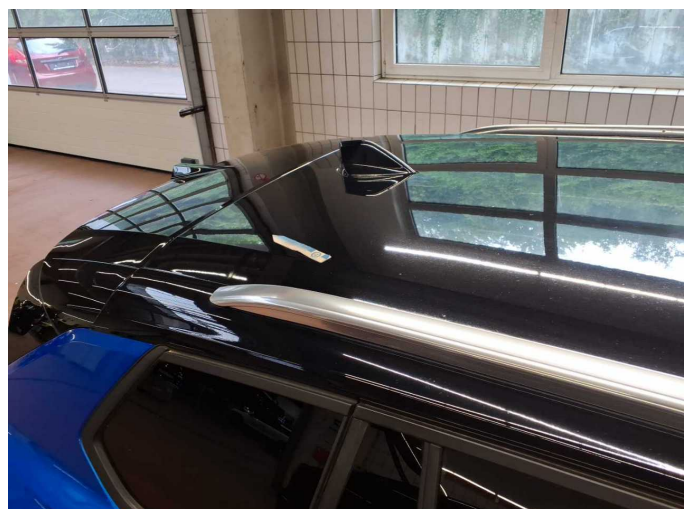
**Wear and tear 6:** Roof: Roof - dent(s) - No deduction

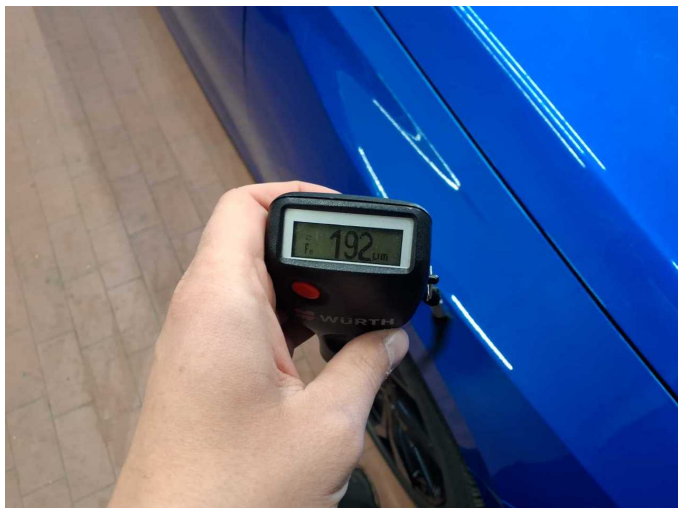
**Repainting 1:** Mudguard - right side

- 1 Mudguard - right side, Professionally carried out, Invoice of repair done Non-existent
- 2 Door - front right side, Professionally carried out, Invoice of repair done Non-existent

Mudguard - right side 192 µm | Door - front right side 187 µm
