Expertise

Protocol number: 46860871  
Order No. / Reference: 26763492  
Inspection date: 4 Aug 2026

Manufacturer: Opel

Model: Insignia Sports Tourer 1.5 Diesel Elegance

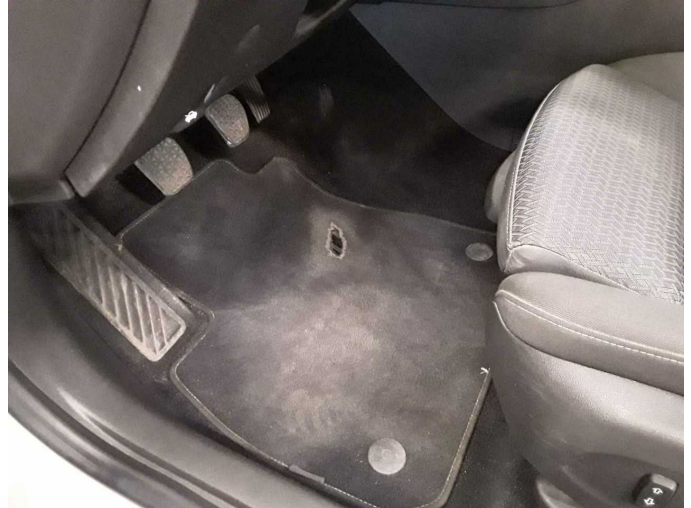
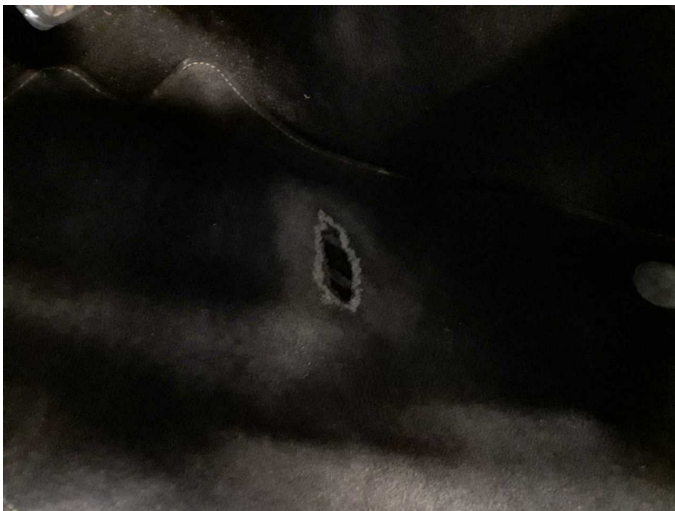
| No. | Component group | Description |
|---|---|---|
| 1 | Trim / covers | Floor mats - Broken / torn - Replace |

**Damage 1:** Trim / covers: Floor mats - Broken / torn - Replace

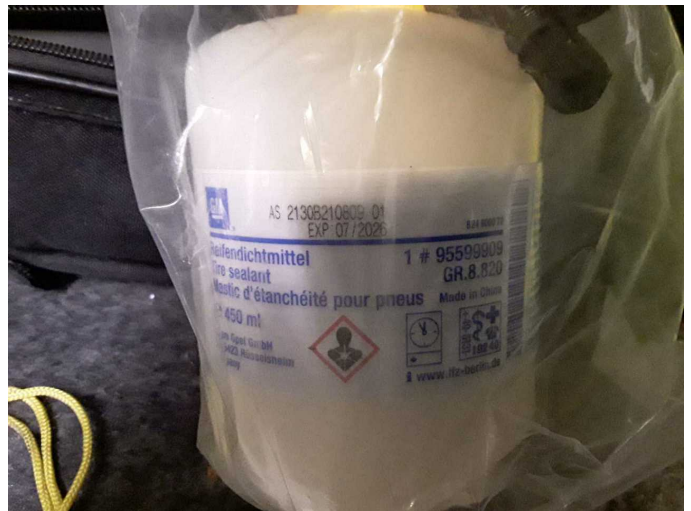
| No. | Component group | Description |
|---|---|---|
| 2 | Equipment | Tirefit filler - Expired - Replace |

**Damage 2:** Equipment: Tirefit filler - Expired - Replace

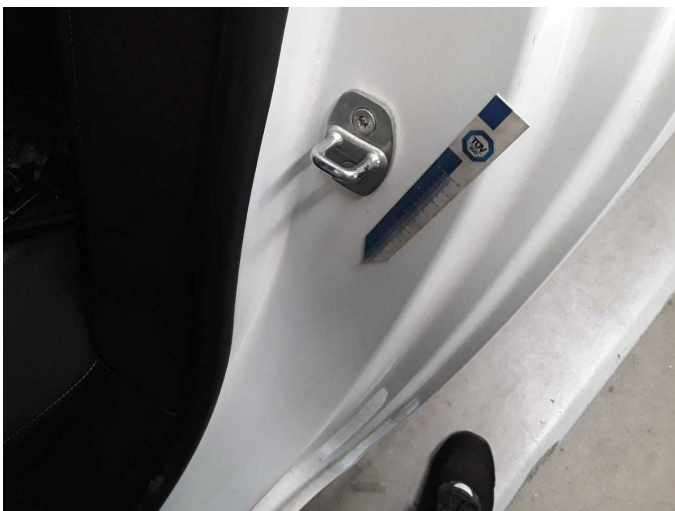
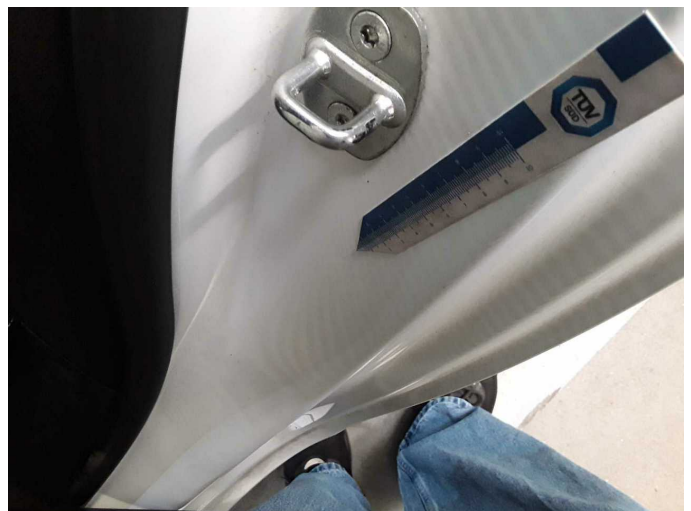
| No. | Component group | Description |
|---|---|---|
| 3 | Side panel - rear left side | Elbow - dent(s) - Smooth repair work |

**Damage 3:** Side panel - rear left side: Elbow - dent(s) - Smooth repair work

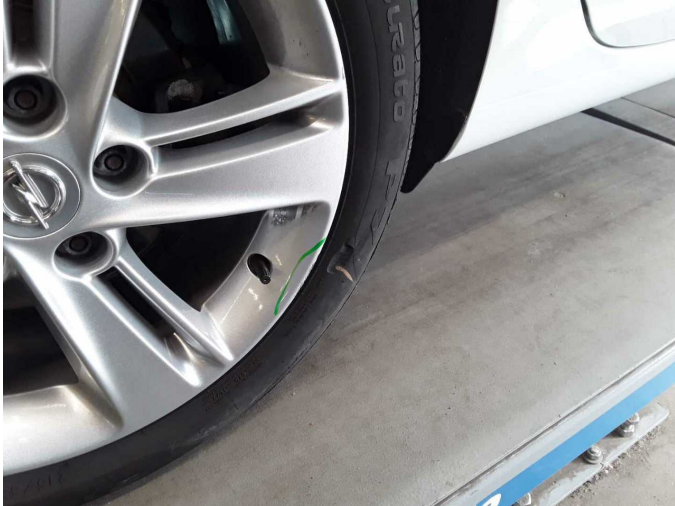
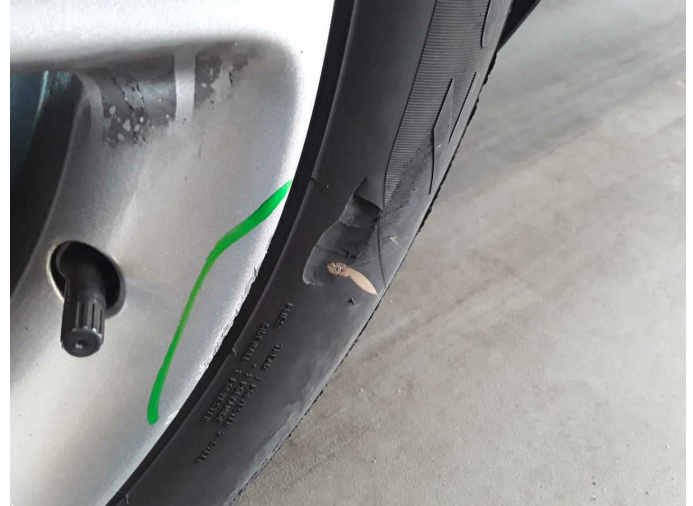
| No. | Component group | Description |
|---|---|---|
| 4 | Wheel / tyres | Tyre - rear right side - Damaged - Replace |

**Damage 4:** Wheel / tyres: Tyre - rear right side - Damaged - Replace

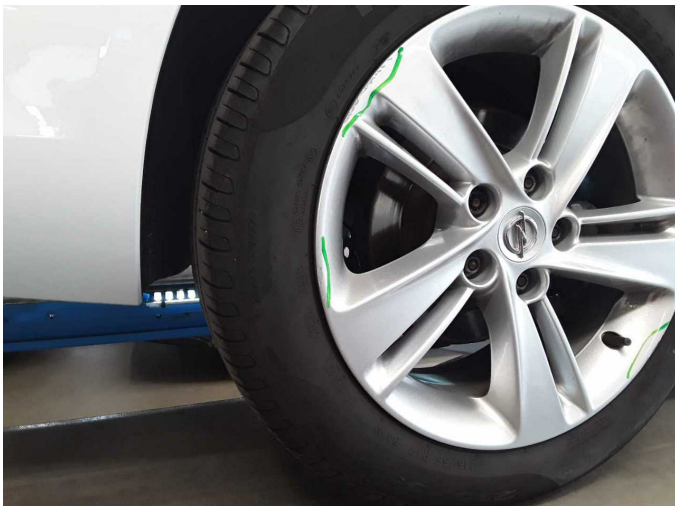
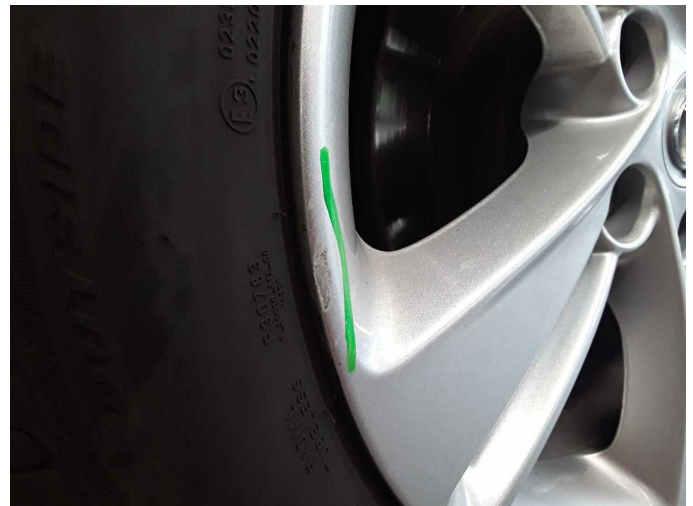
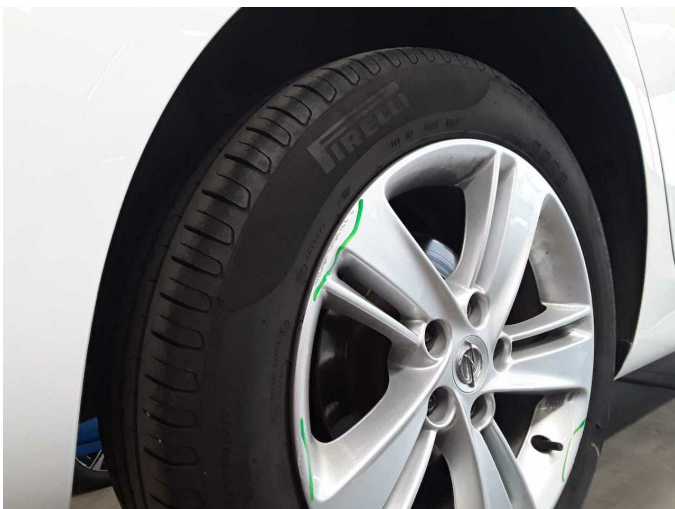
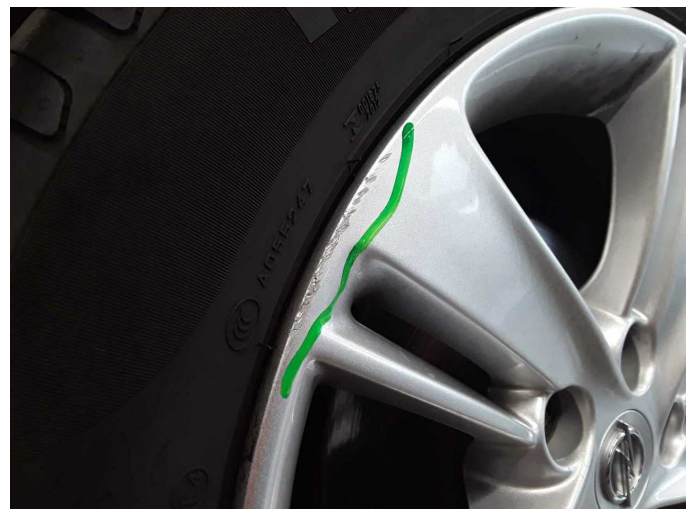
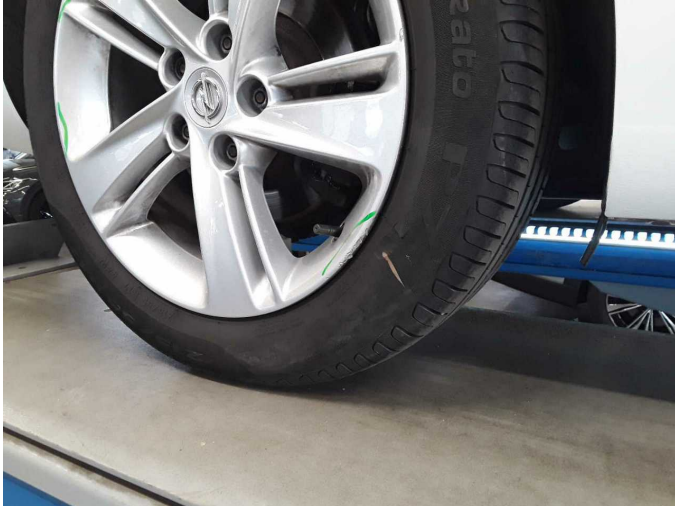
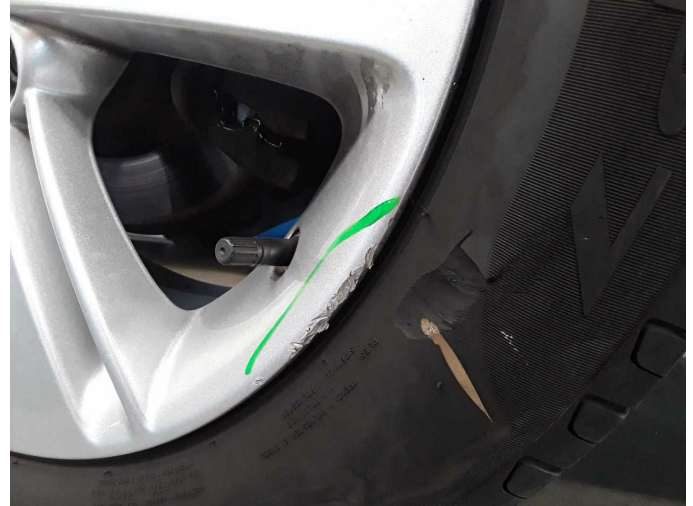
| No. | Component group | Description |
|---|---|---|
| 5 | Wheel / tyres | Alloy rim - rear right side - Scratched - Replace |

**Damage 5:** Wheel / tyres: Alloy rim - rear right side - Scratched - Replace

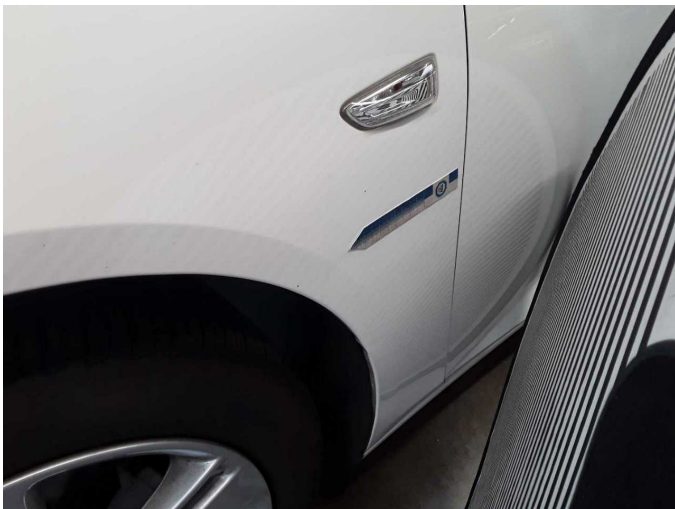
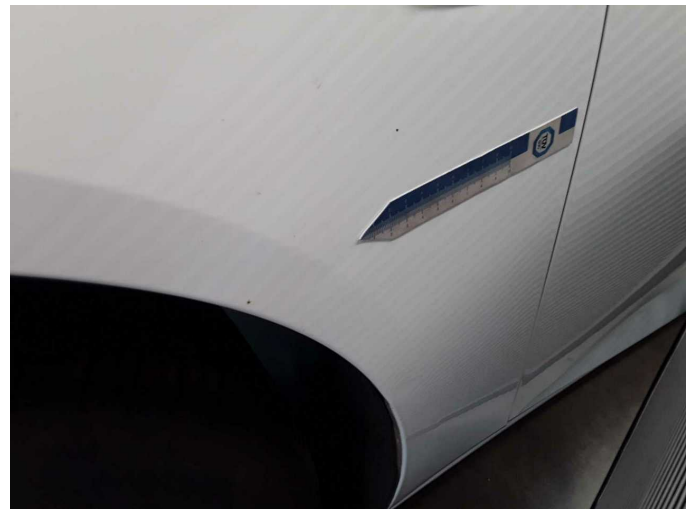
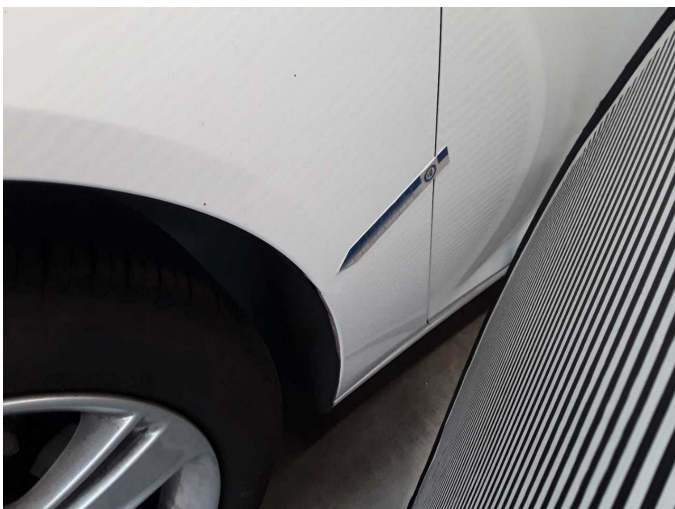
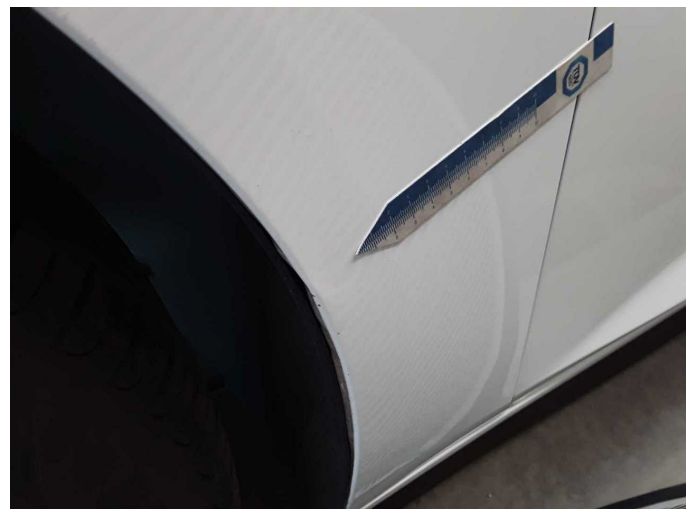
| No. | Component group | Description |
|---|---|---|
| 6 | Mudguard - left side | Mudguard - left side - dent(s) - Repair and paint |

**Damage 6:** Mudguard - left side: Mudguard - left side - dent(s) - Repair and paint

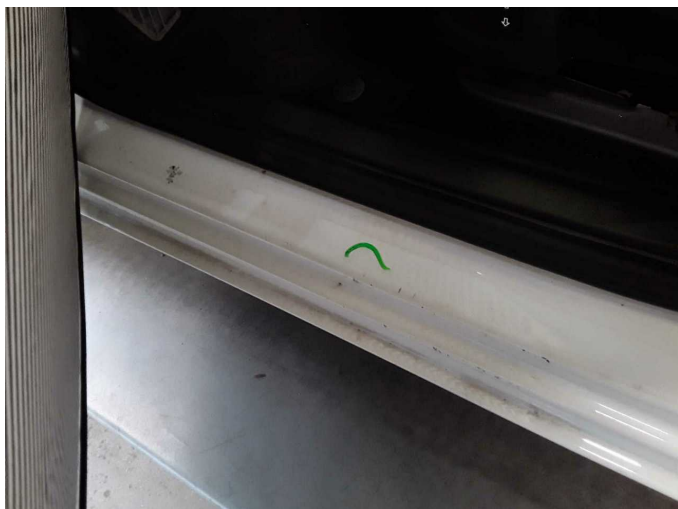
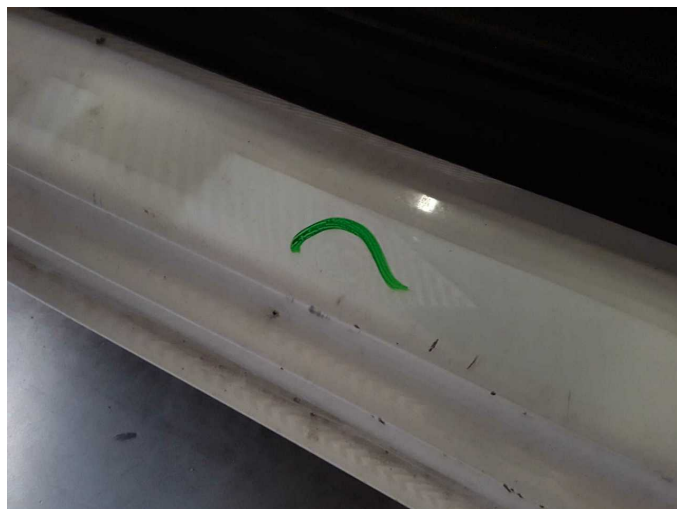
| No. | Component group | Description |
|---|---|---|
| 7 | Sill - left side | Sill - Dent / paintcoat damage - Repair and paint |

**Damage 7:** Sill - left side: Sill - Dent / paintcoat damage - Repair and paint

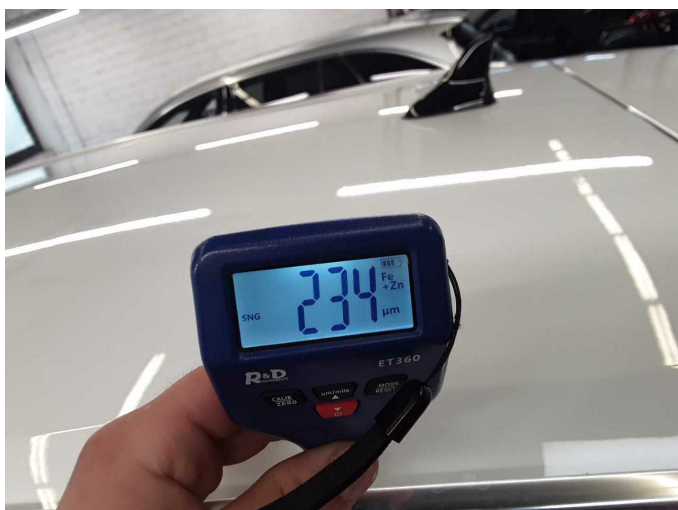
**Roof:** 234 µm

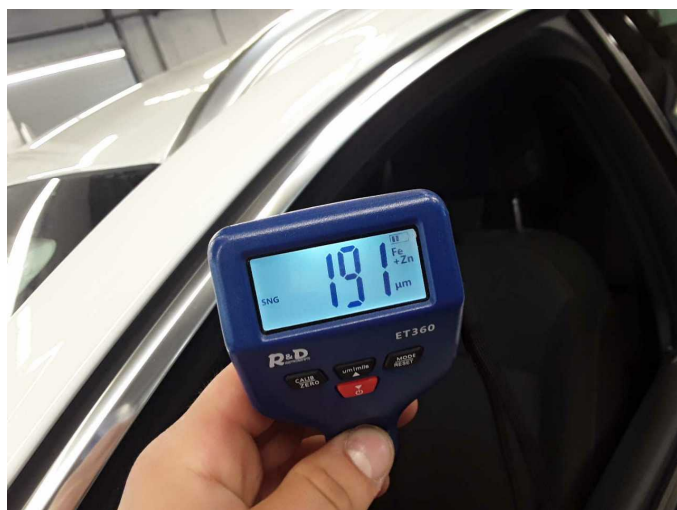
**Roof rail - left side:** 191 µm

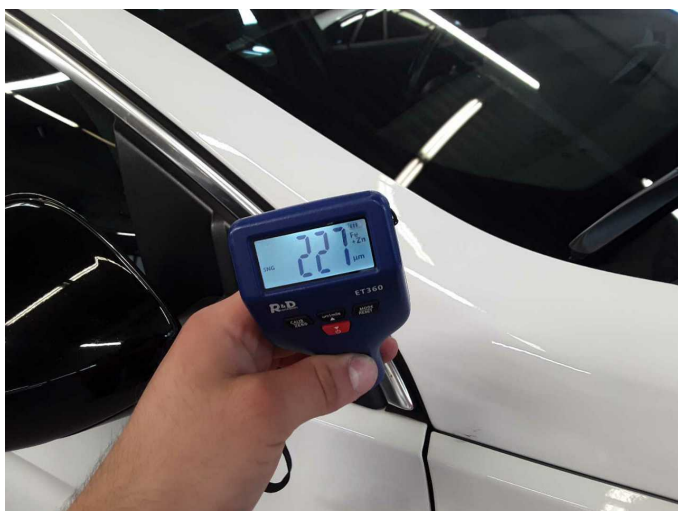
**Roof rail - right side:** 227 µm

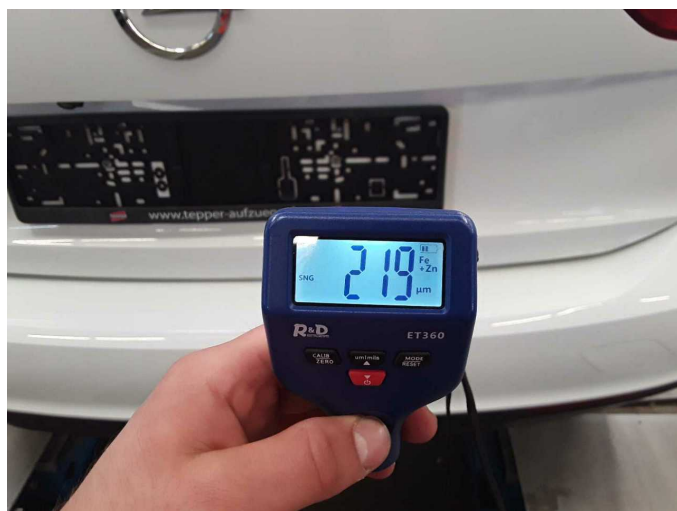
**Boot lid / rear door:** 219 µm

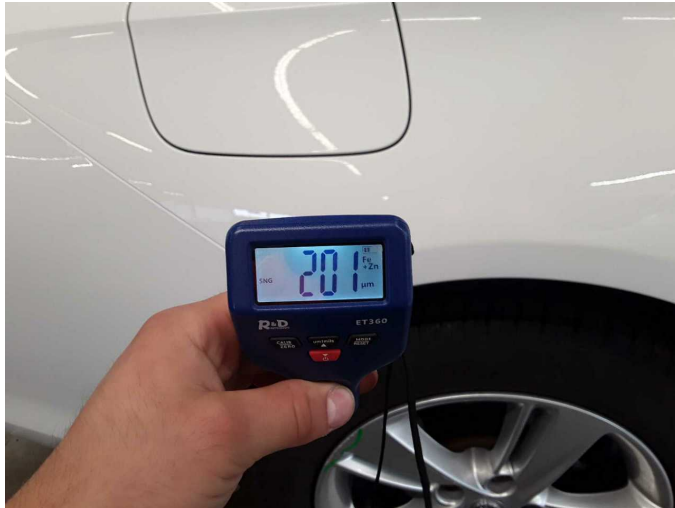
Side panel - rear right side: 201 µm

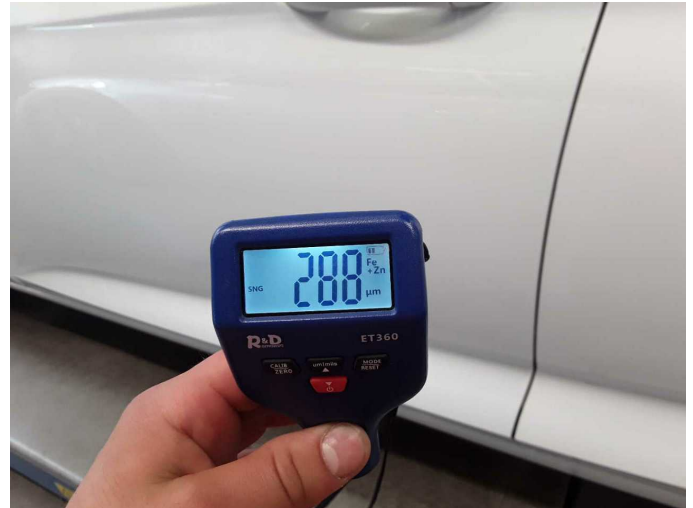
Door - front left side: 288 µm

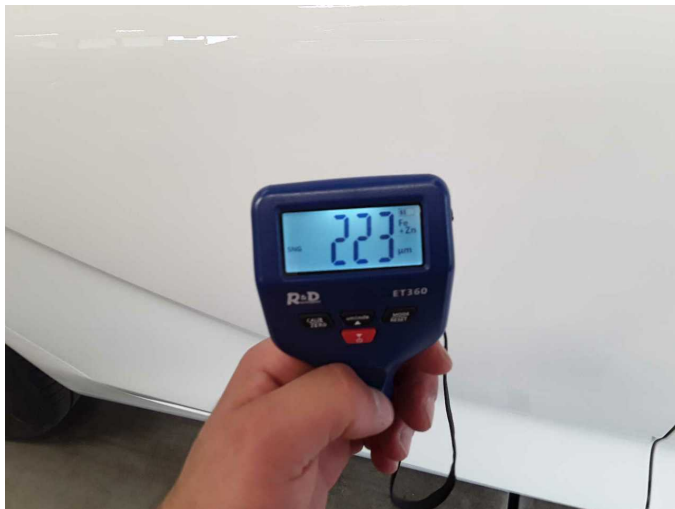
Door - front right side: 223 µm
