- Vehicle Inspection Report -

Number: 10215347
From: 12.03.2026

Order number: 1002361188
Order completed: 12.03.2026 14:32
Report number: 10215347
VIN: WVVZZZ3CZPE037991

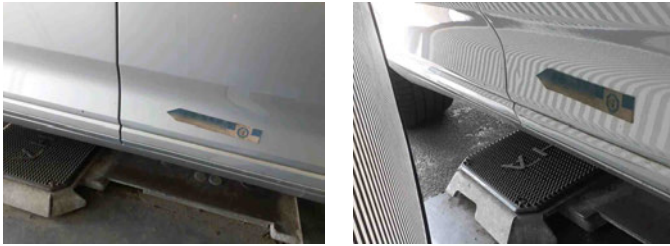
Nr	Location	Damage type	Repair type
1	Internal boot lining R	Scratch(es)	Acceptable
2	Boot lid covering R	Scratch(es)	Acceptable
3	Door FR	Dent(s)	Acceptable
4	Roof pillar R	Dent(s)	Acceptable

3 - Door FR - Dent(s) - Acceptable

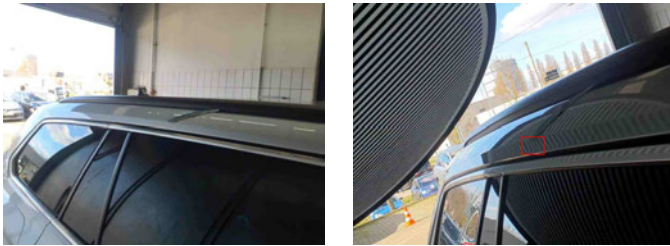
4 - Roof pillar R - Dent(s) - Acceptable
