IDENTIFICATION VEHICLE

| Make: | VOLVO |
| Model / version: | V90 DIESEL - 2016 |
| Vin: | YV1PW72TDK1105522 |

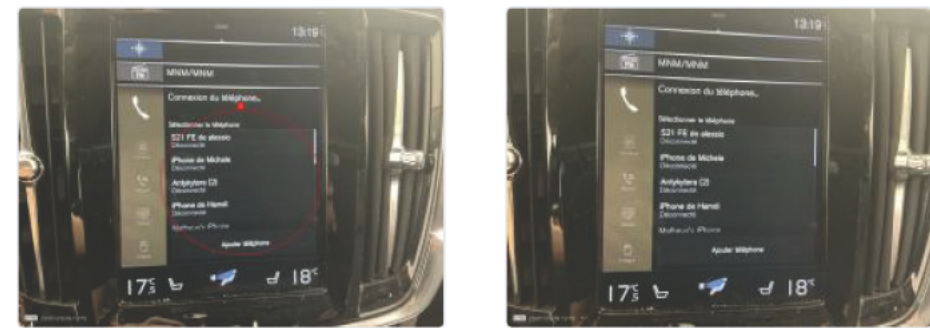
| # | Location | Damage type |
|---|---|---|
| 1 | Dashboard - Boordcomputer resetten | Not original part |

1 - Dashboard - Boordcomputer resetten - Not original part

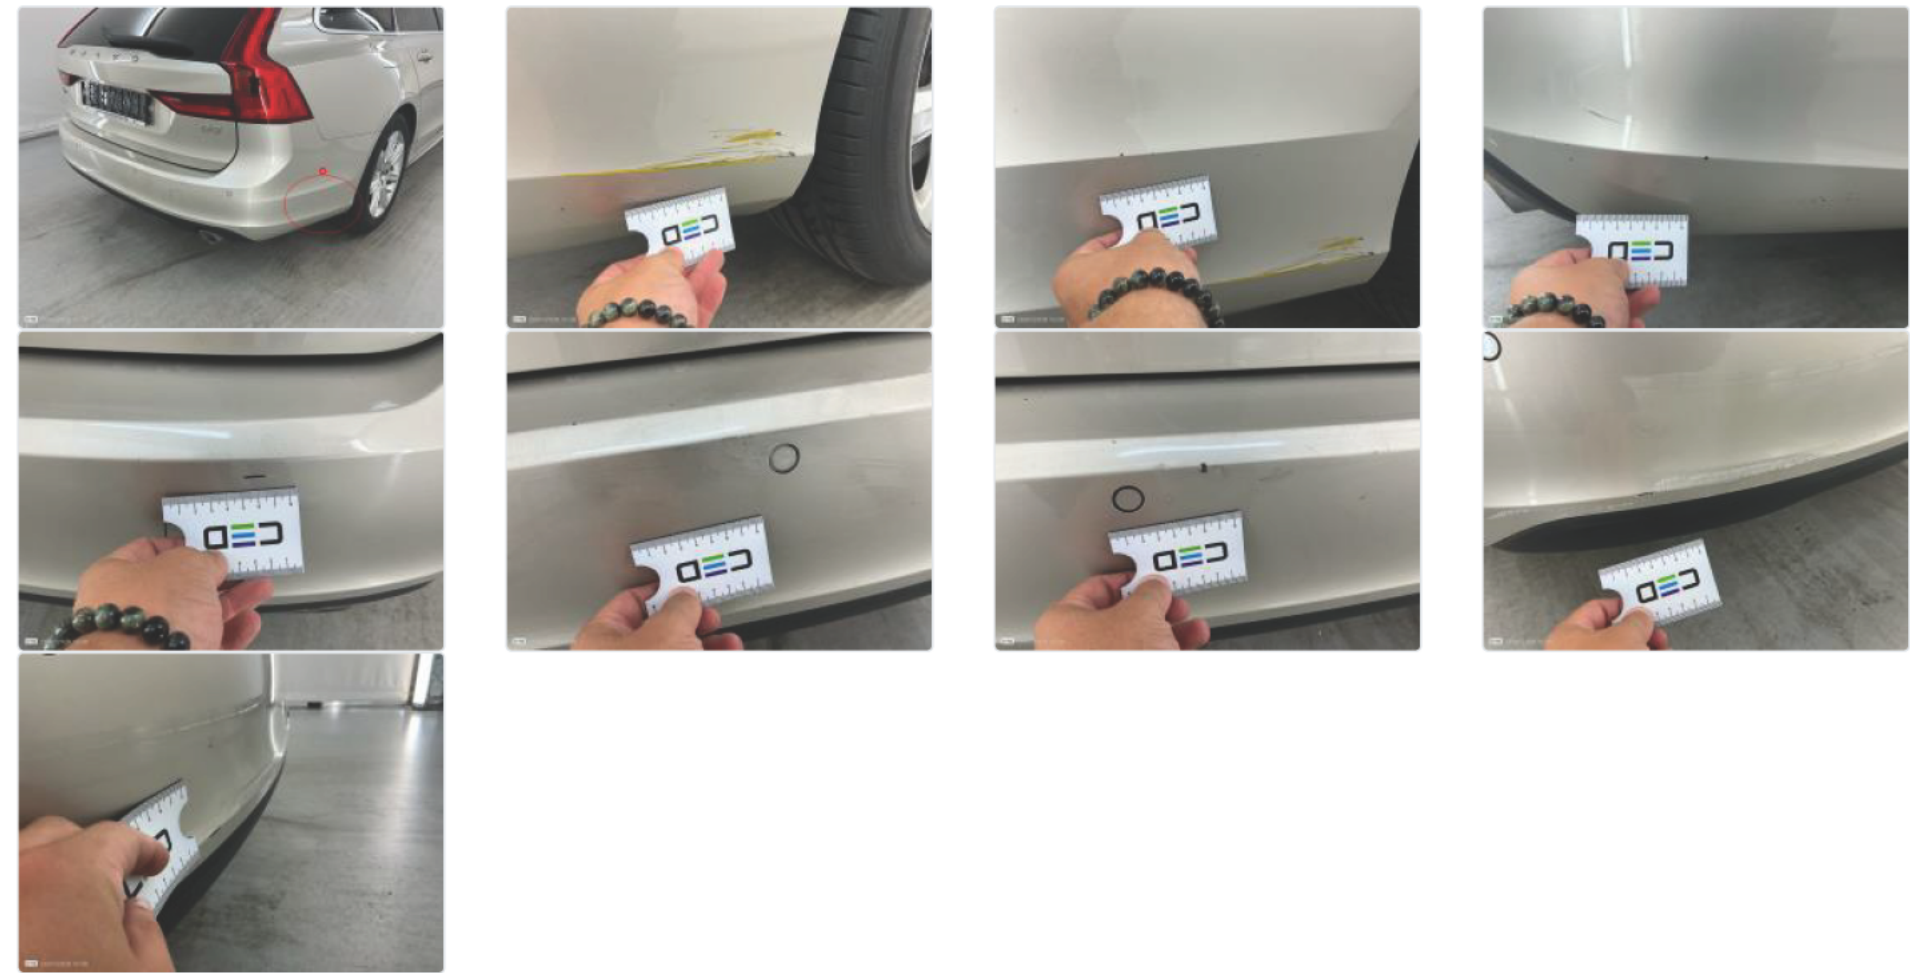
| # | Location | Damage type |
|---|---|---|
| 4 | Bumper R | Dent(s) and scratch(es) |

4 - Bumper R - Dent(s) and scratch(es)

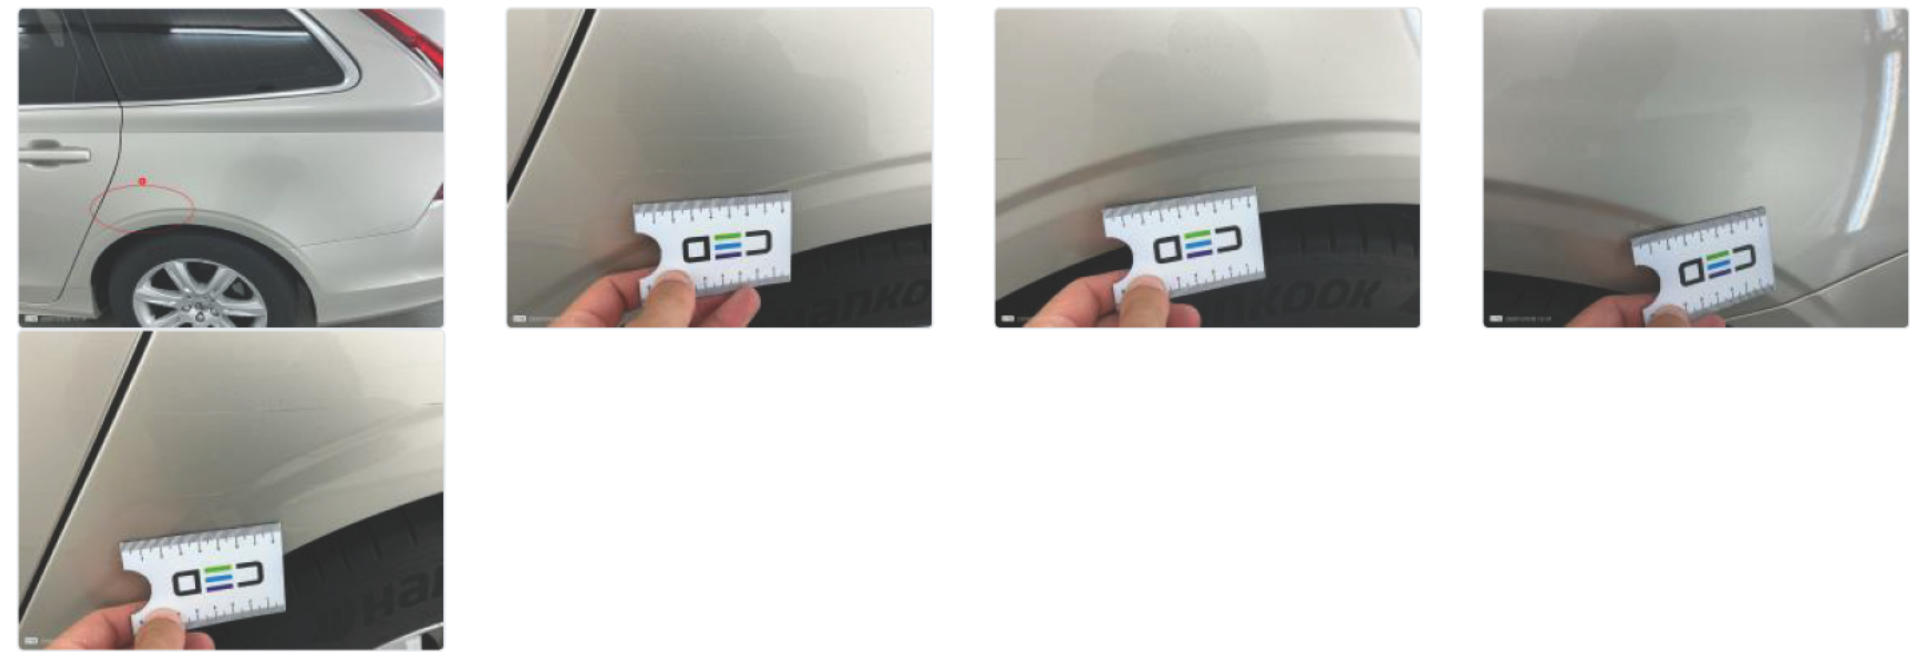
| # | Location | Damage type |
|---|---|---|
| 5 | Wing RL | Scratch(es) |

5 - Wing RL - Scratch(es)

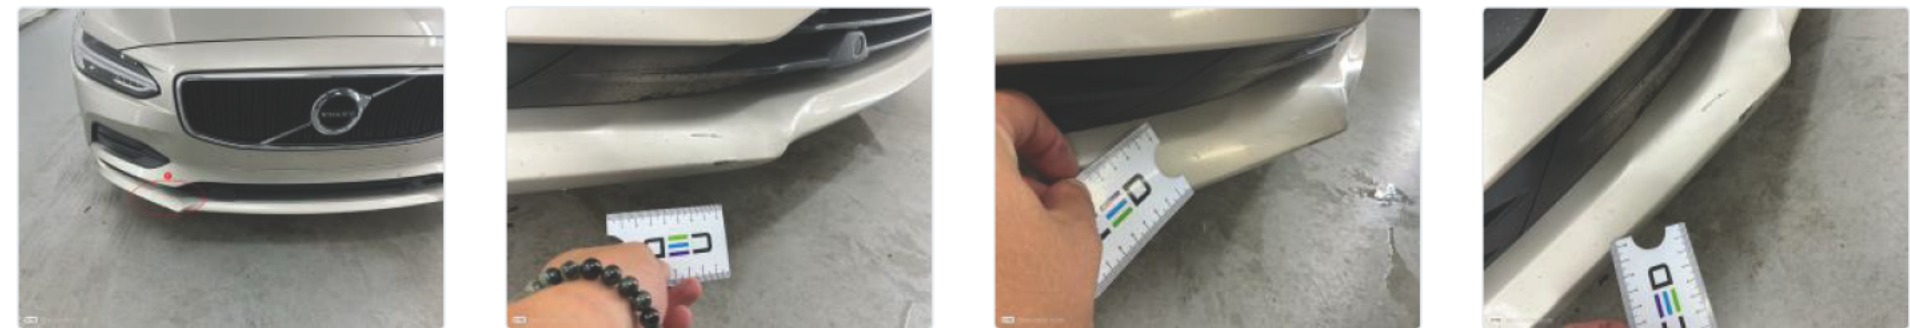
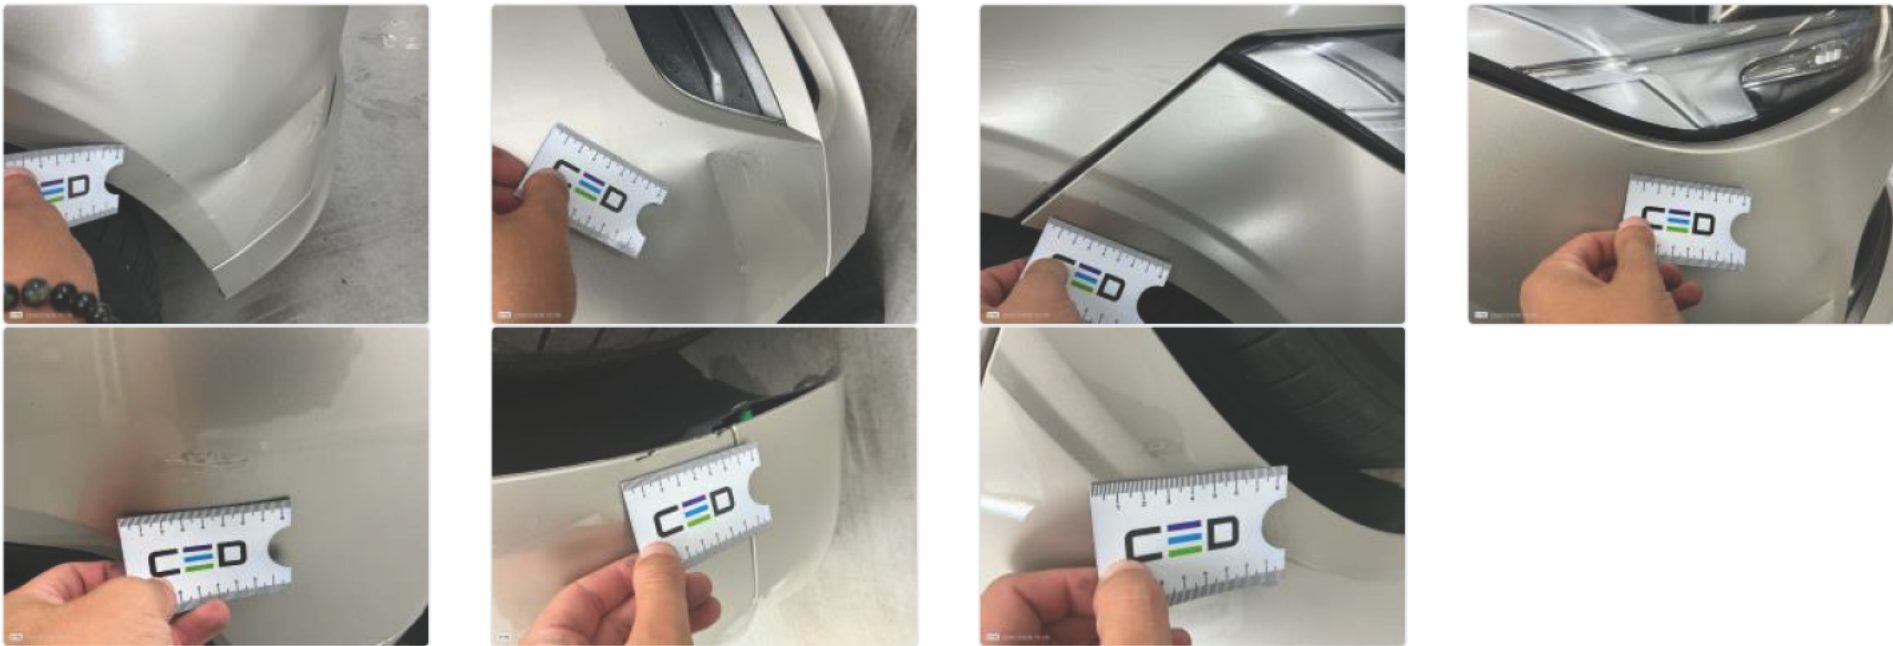
| # | Location | Damage type |
|---|---|---|
| 6 | Bumper F - + slecht hersteld | Dent(s) and scratch(es) |

6 - Bumper F - + slecht hersteld - Dent(s) and scratch(es)

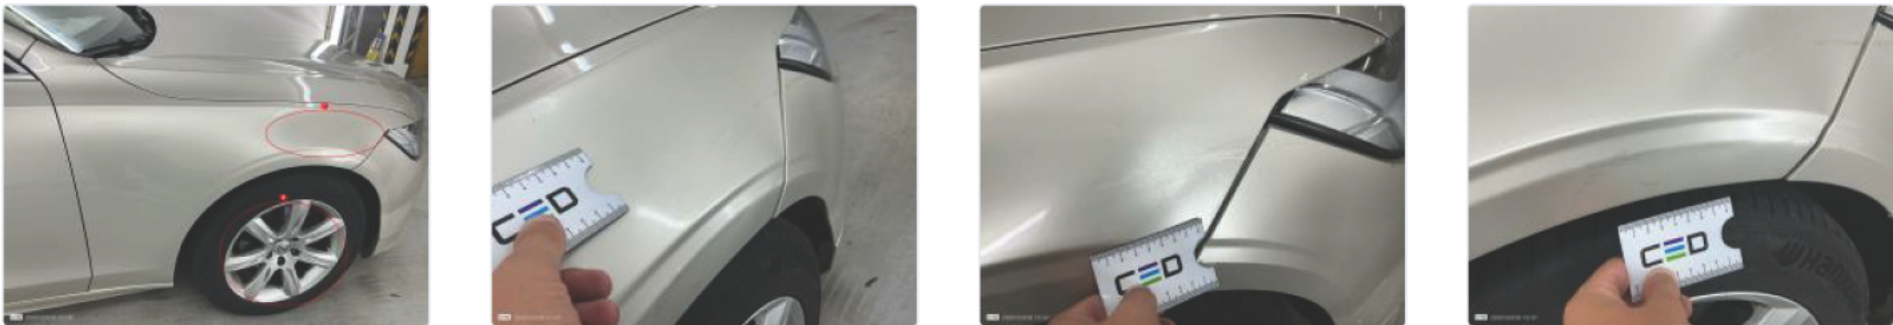
| # | Location | Damage type |
|---|---|---|
| 7 | Wing FR | Bad repair |

7 - Wing FR - Bad repair

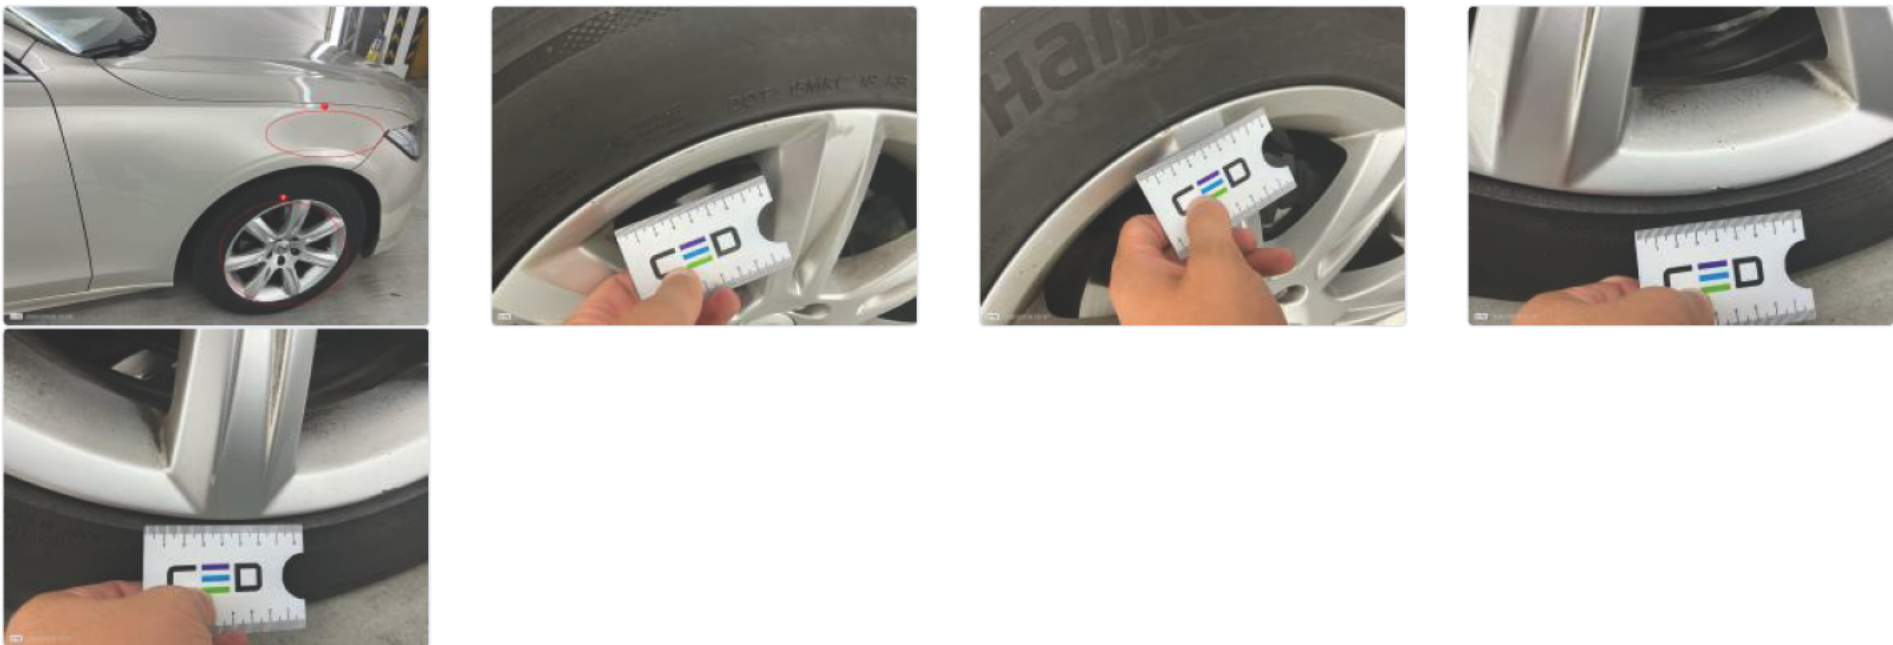
| # | Location | Damage type |
|---|---|---|
| 8 | Alloy rim FR | Grooved |

8 - Alloy rim FR - Grooved

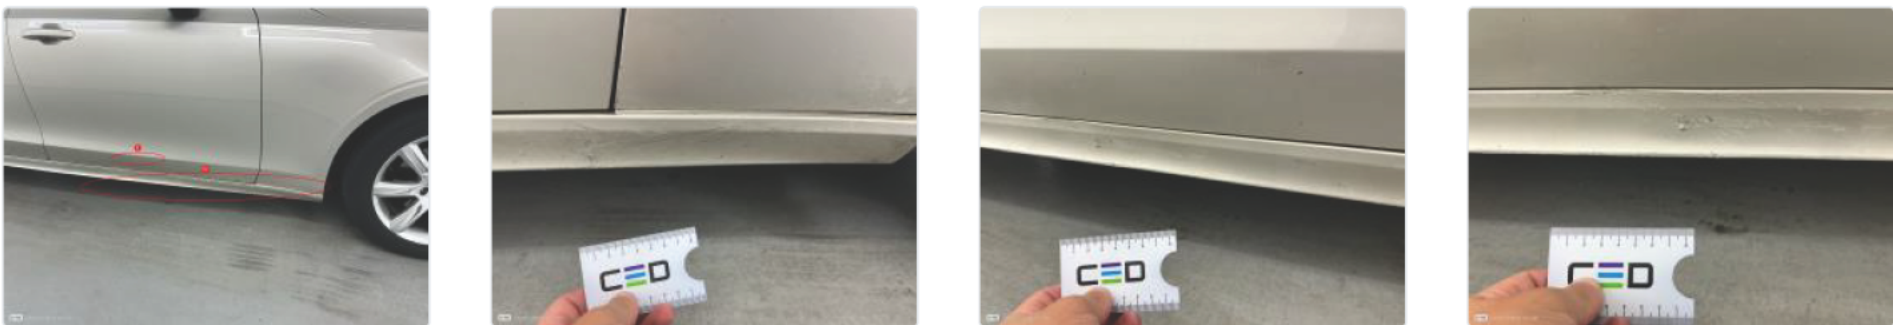
| # | Location | Damage type |
|---|---|---|
| 9 | Outer sill R | Scratch(es) |

9 - Outer sill R - Scratch(es)

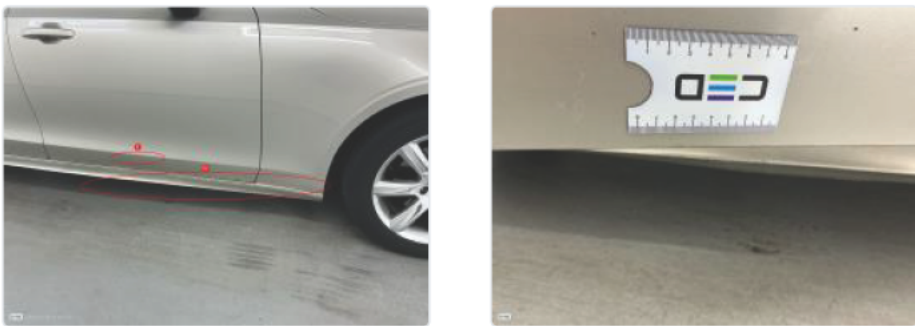
| # | Location | Damage type |
|---|---|---|
| 9 | Door FR | Scratch(es) |

9 - Door FR - Scratch(es)

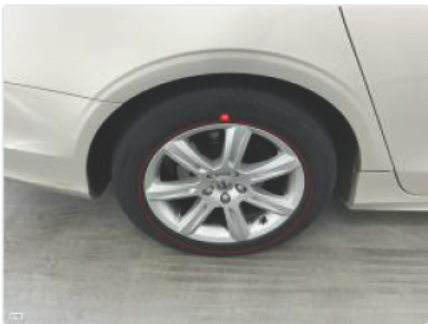
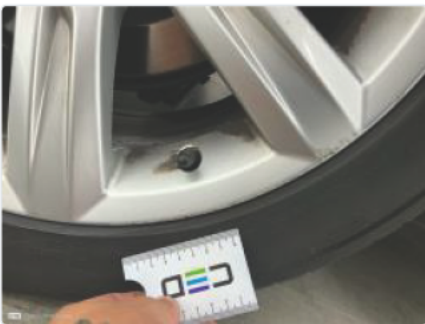
| # | Location | Damage type |
|---|---|---|
| 10 | Alloy rim RR | Grooved |

10 - Alloy rim RR - Grooved

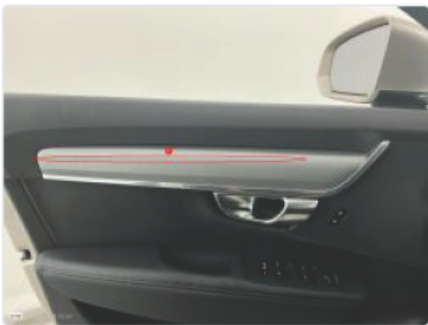
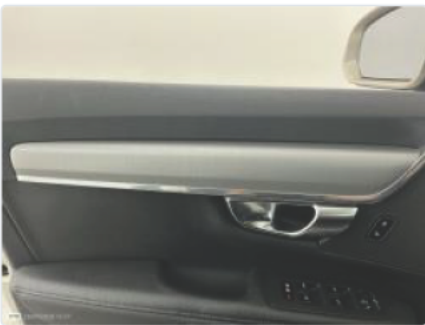
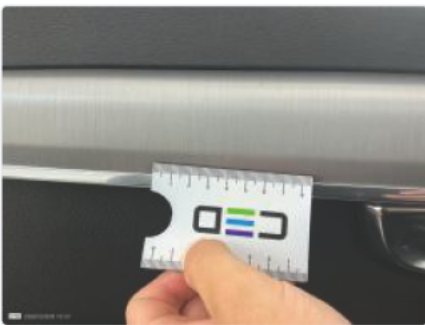
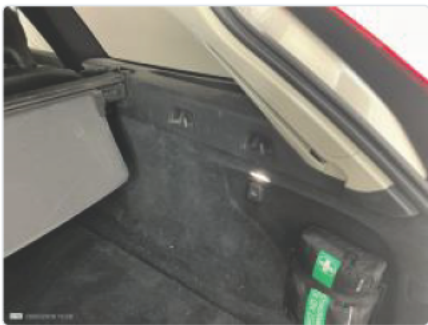
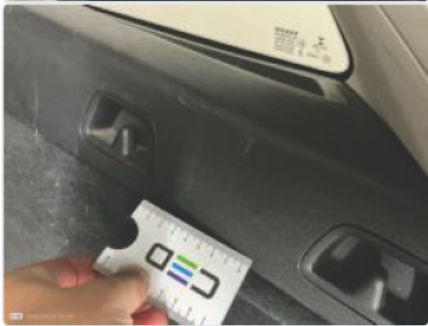
| # | Location | Damage type | Renta® | Repaired | Already invoiced |
|---|---|---|---|---|---|
| 2 | Interior | Damaged | | | |

2 - Interior - Damaged - Renta®

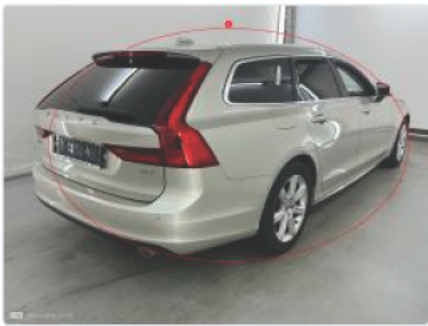
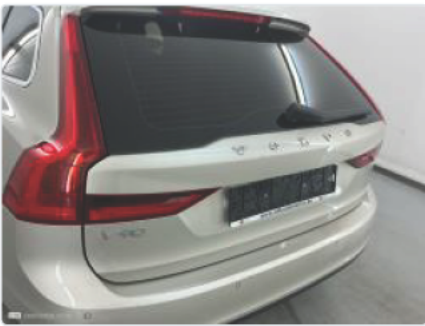
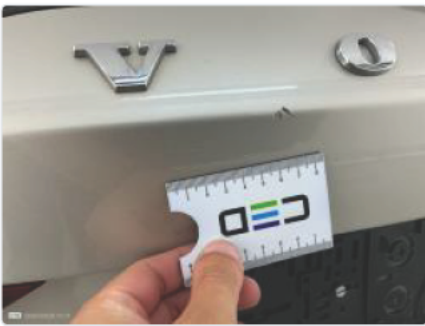
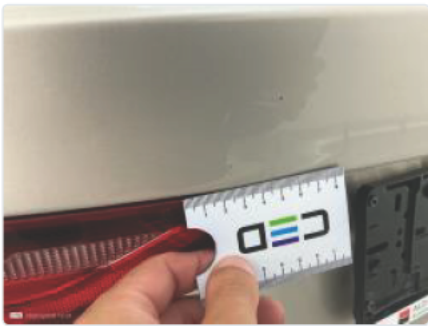
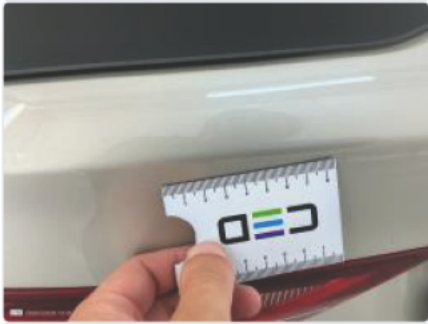
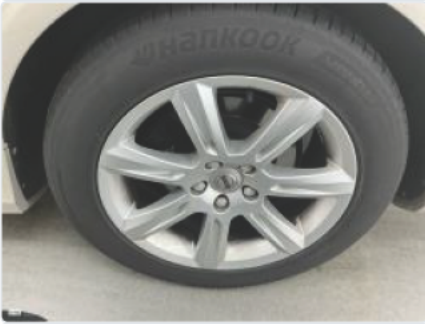
| # | Location | Damage type | Renta® | Repaired | Already invoiced |
|---|---|---|---|---|---|
| 3 | Bodywork | Dent(s) and scratch(es) | | | |

3 - Bodywork - Dent(s) and scratch(es) - Renta®
