Expertise

Protocol number: 46350867
Order No. / Reference: 26042958
Inspection date: 2 Jul 2026

Model: Vito 116 CDI Extralang HA Aut. PRO

VIN: W1VVLCEZ3T4564902

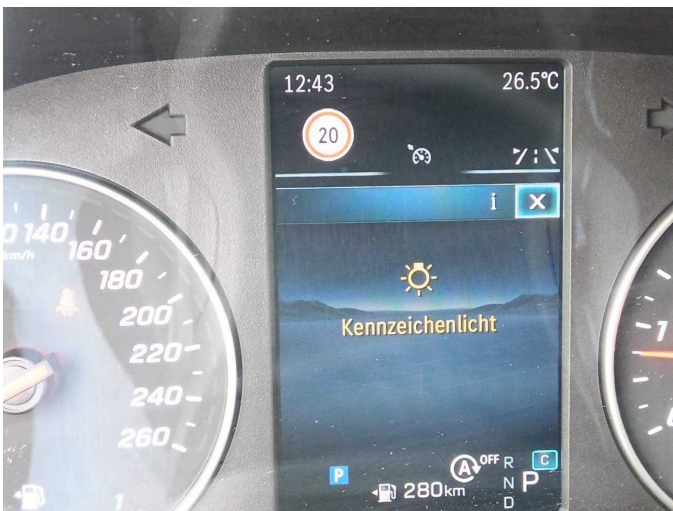
No.	Component group	Description
1	Tail light	License plate lamp - right side - Non-operational - Perform diagnosis
2	Rear bumper	Rear bumper - Scratch(es) - Paint

Damage 1: Tail light: License plate lamp - right side - Non-operational - Perform diagnosis

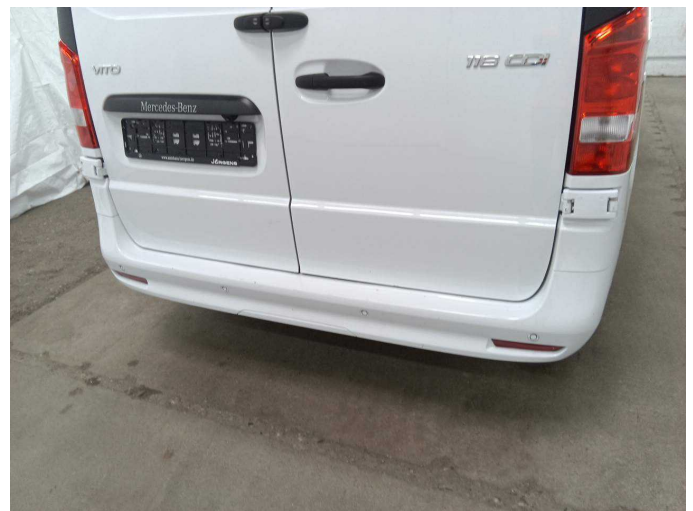
Damage 2: Rear bumper: Rear bumper - Scratch(es) - Paint

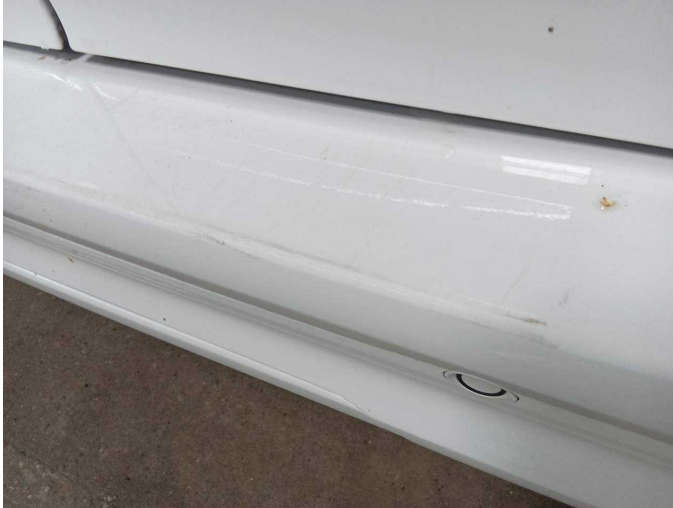
Damage 2: Rear bumper: Rear bumper - Scratch(es) - Paint

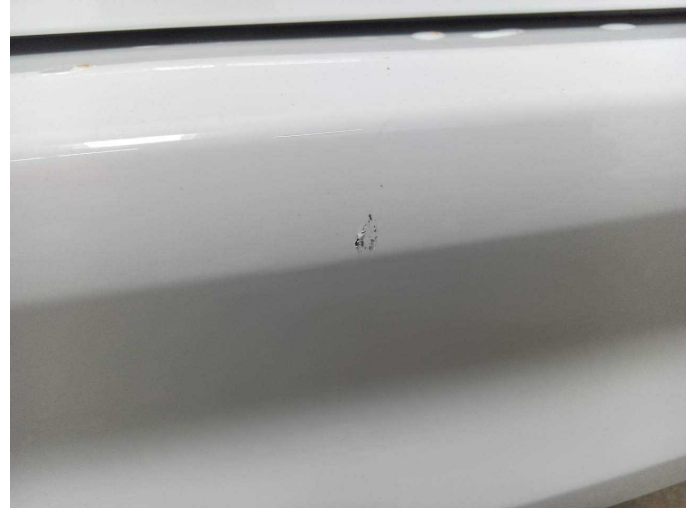
Damage 2: Rear bumper: Rear bumper - Scratch(es) - Paint

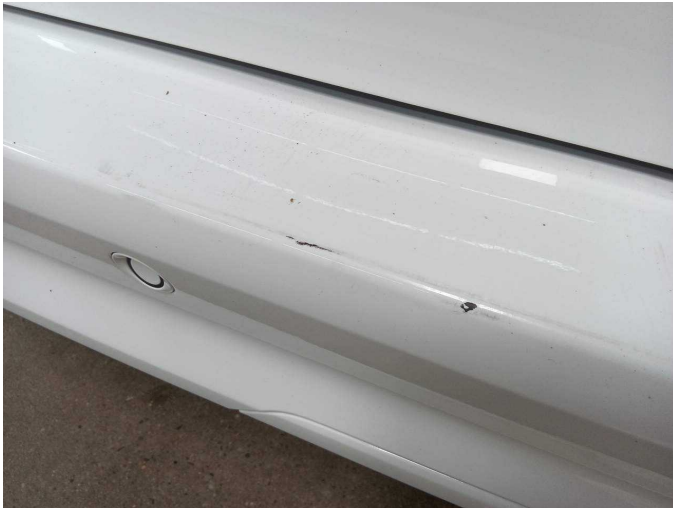
Damage 2: Rear bumper: Rear bumper - Scratch(es) - Paint

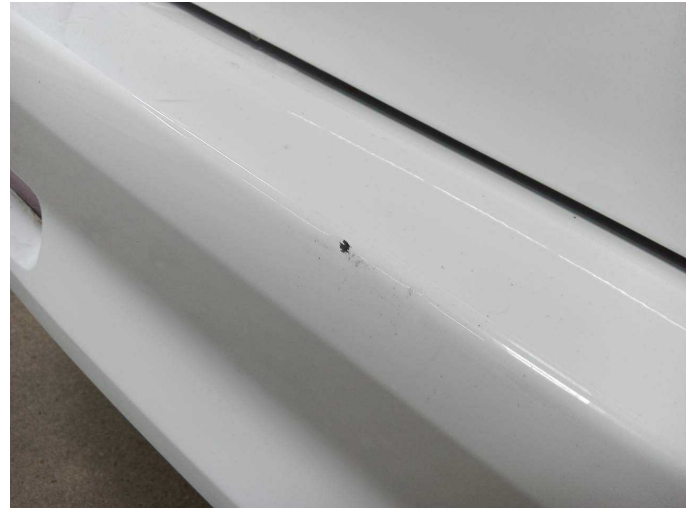
Damage 2: Rear bumper: Rear bumper - Scratch(es) - Paint

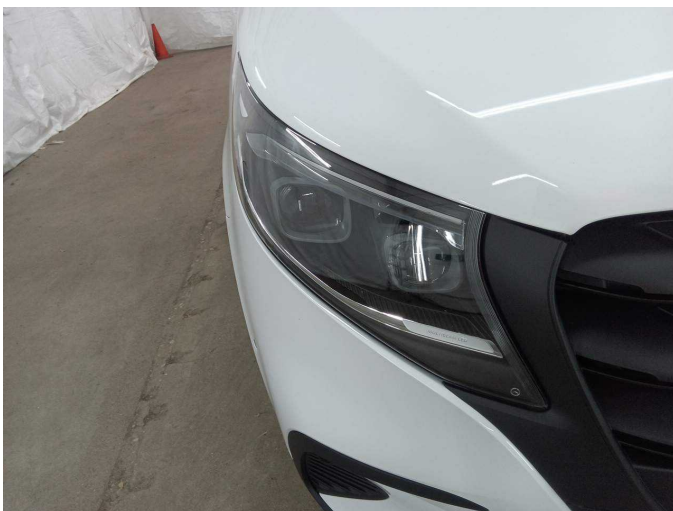
No.	Component group	Description
1	Headlight	Headlight - right side - Stone chips - No deduction
2	Front bumper	Front bumper - Stone chips - No deduction

Wear and tear 1: Headlight: Headlight - right side - Stone chips - No deduction

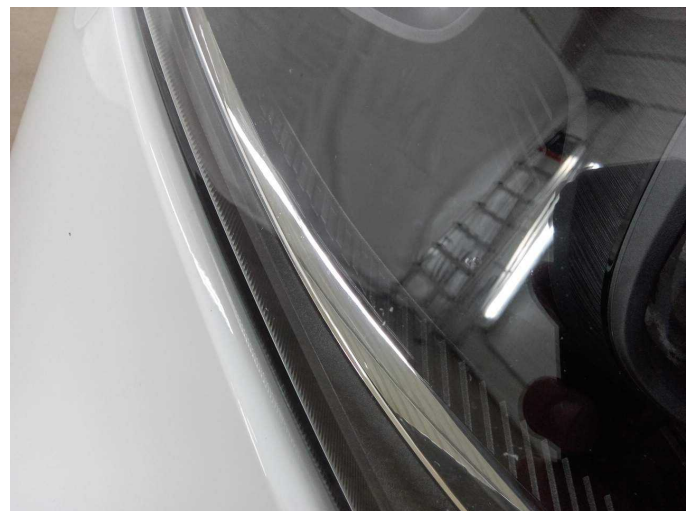
Wear and tear 1: Headlight: Headlight - right side - Stone chips - No deduction

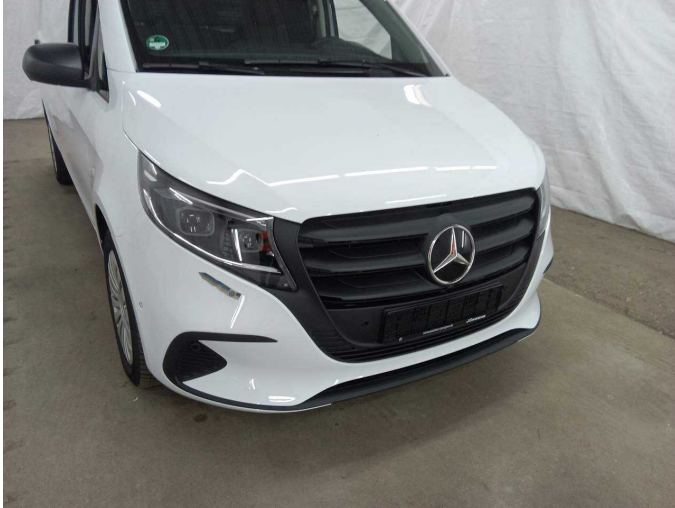
Wear and tear 2: Front bumper: Front bumper - Stone chips - No deduction

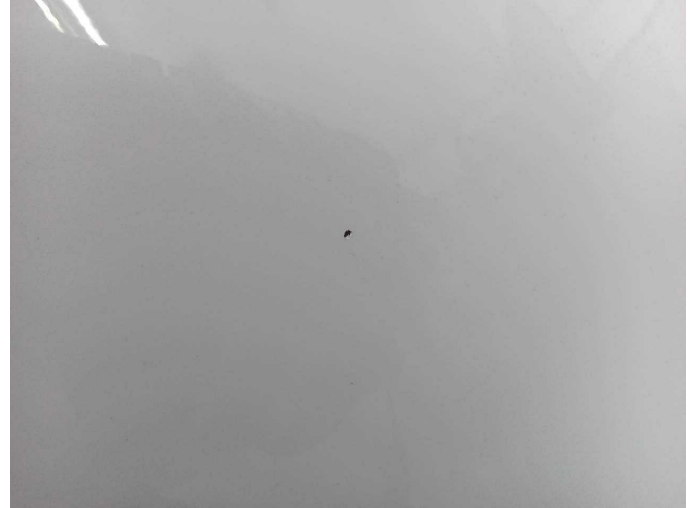
Wear and tear 2: Front bumper: Front bumper - Stone chips - No deduction
