## Expertise

Protocol number: 46149385  
Order No. / Reference: 26483798  
Inspection date: 22 Jun 2026

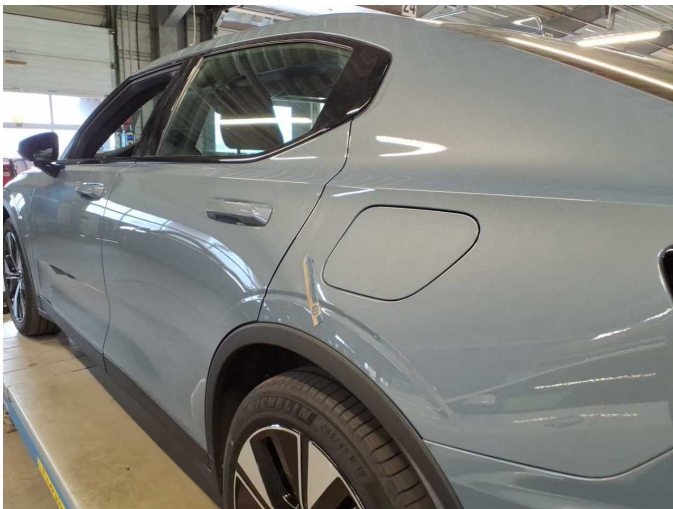
Damage 1: Side panel - rear left side: Side panel - dent(s) - Smooth repair work

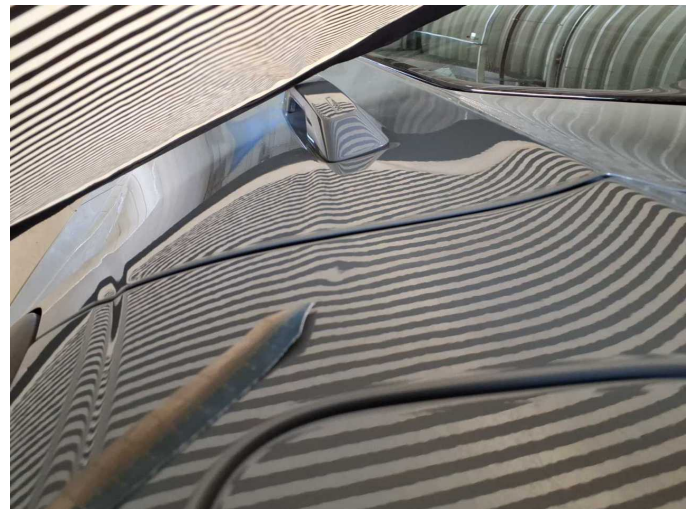
Damage 1: Side panel - rear left side: Side panel - dent(s) - Smooth repair work

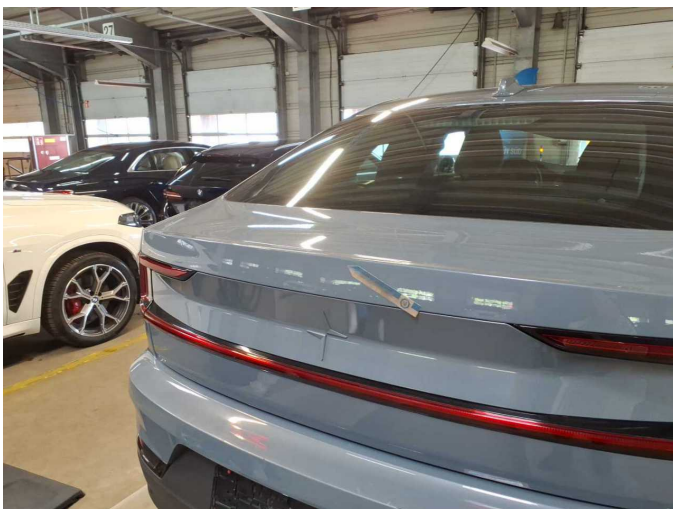
Damage 2: Boot lid / rear door: Boot lid - dent(s) - Smooth repair work

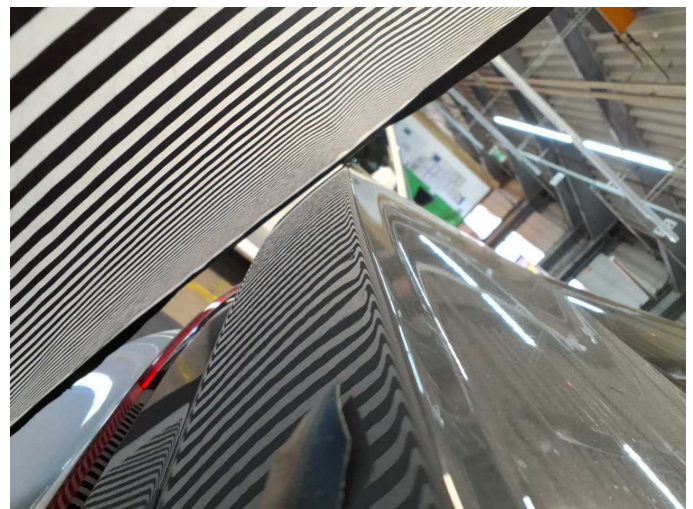
Damage 2: Boot lid / rear door: Boot lid - dent(s) - Smooth repair work

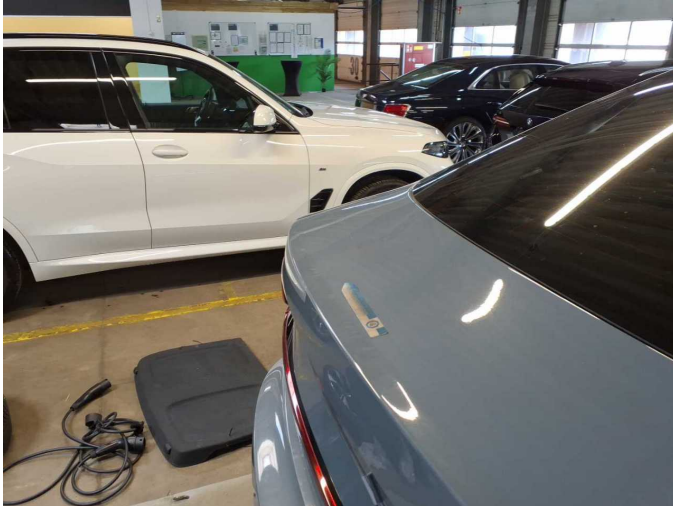
**Damage 2:** Boot lid / rear door: Boot lid - dent(s) - Smooth repair work

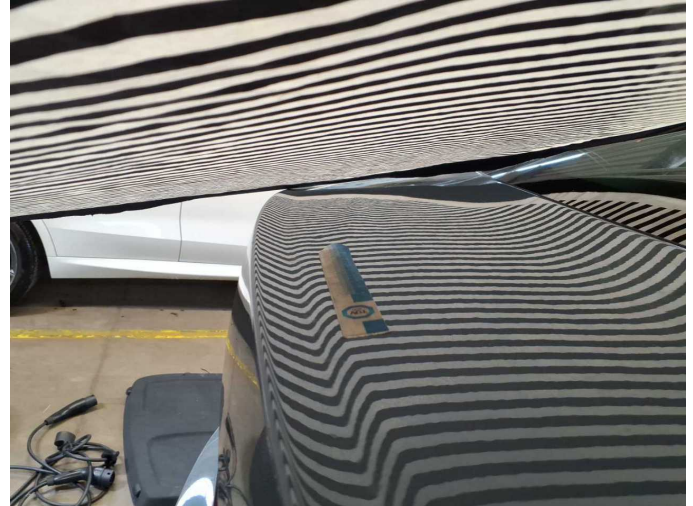
**Damage 2:** Boot lid / rear door: Boot lid - dent(s) - Smooth repair work

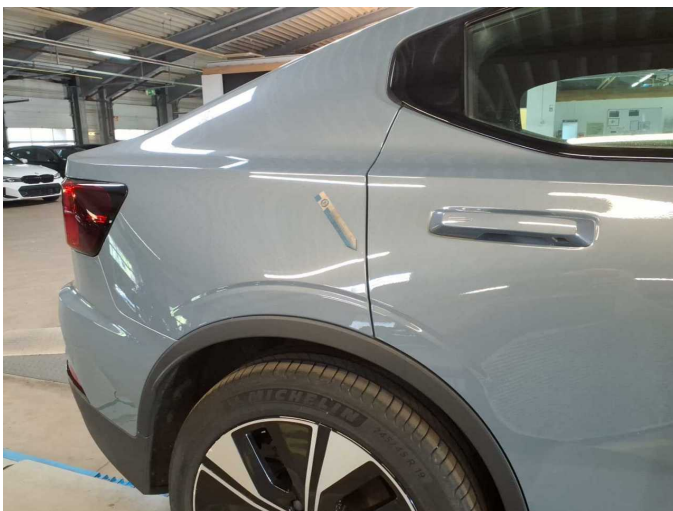
**Damage 3:** Side panel - rear right side: Side panel - dent(s) - Smooth repair work

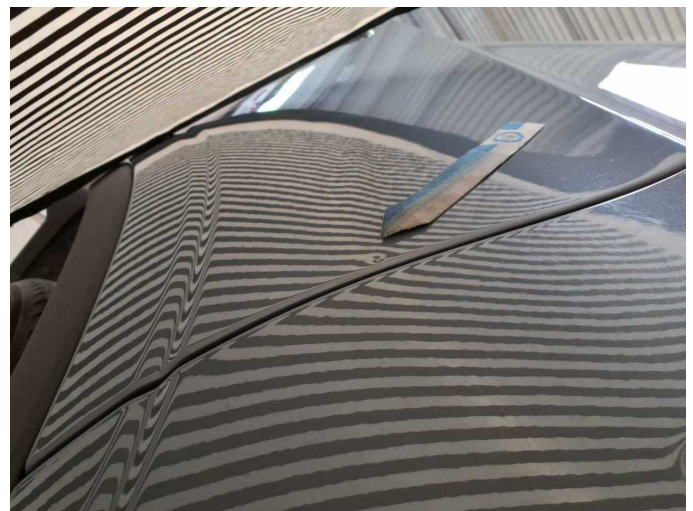
**Damage 3:** Side panel - rear right side: Side panel - dent(s) - Smooth repair work

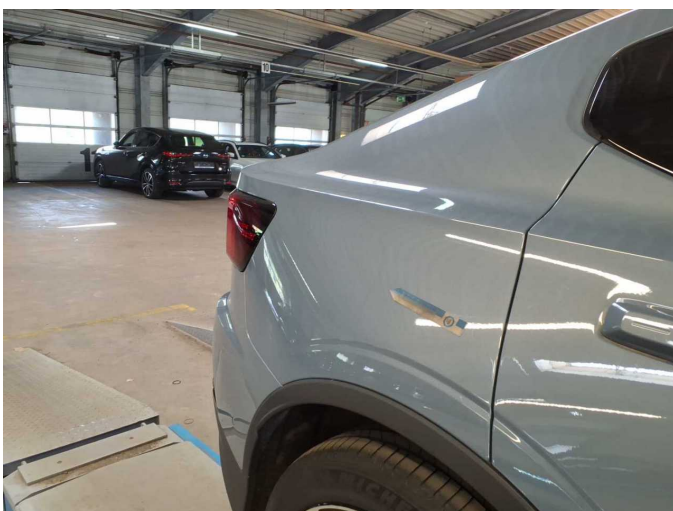
**Damage 3:** Side panel - rear right side: Side panel - dent(s) - Smooth repair work

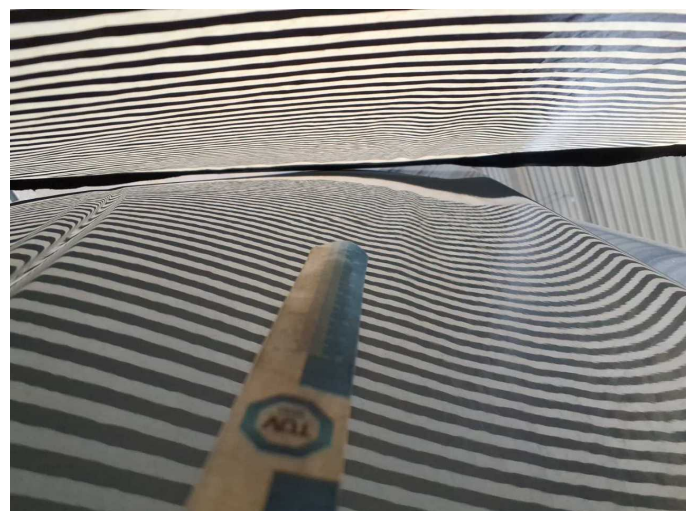
**Damage 3:** Side panel - rear right side: Side panel - dent(s) - Smooth repair work

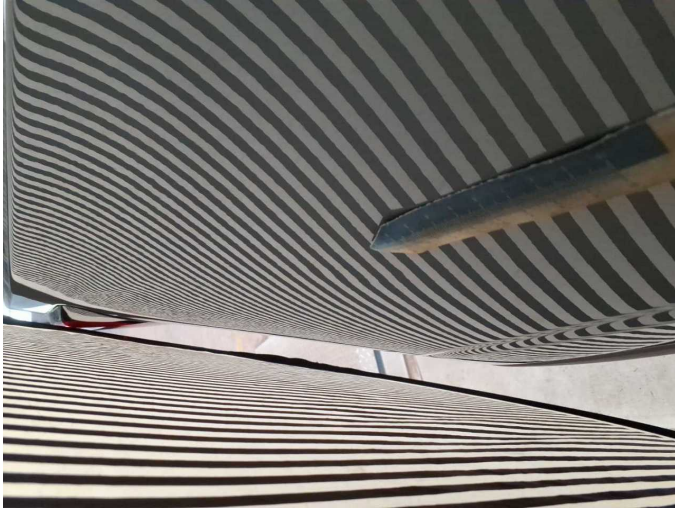
**Damage 3:** Side panel - rear right side: Side panel - dent(s) - Smooth repair work

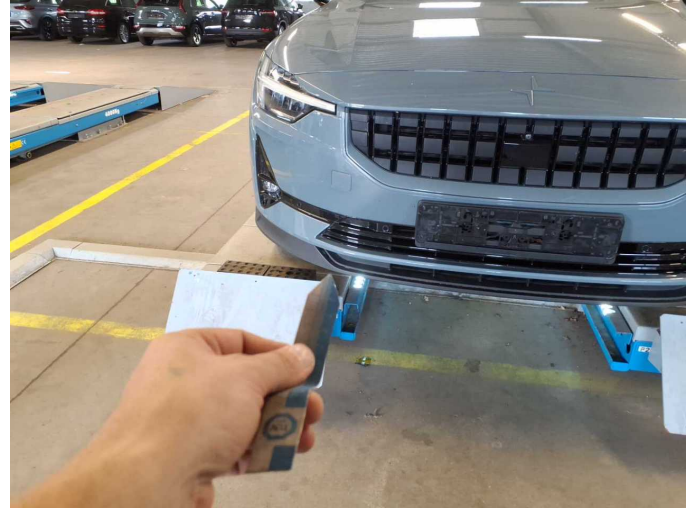
**Damage 5:** Front bumper: Air-inlet grille (Evtl. Mehrkosten) - Loose - Un- / install

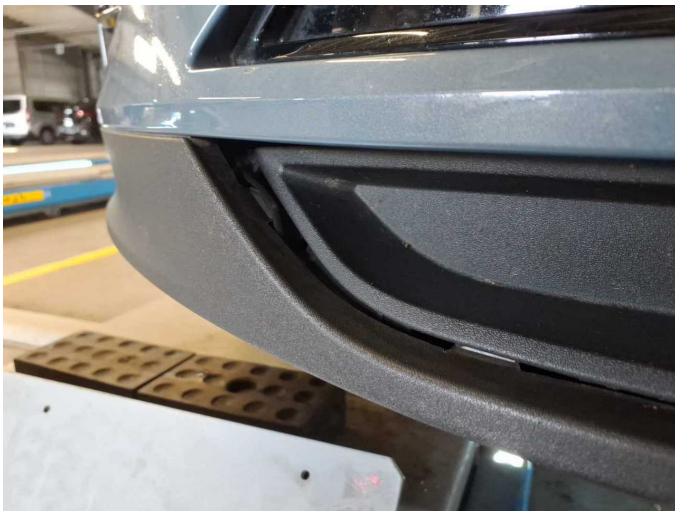
**Damage 5:** Front bumper: Air-inlet grille (Evtl. Mehrkosten) - Loose - Un- / install

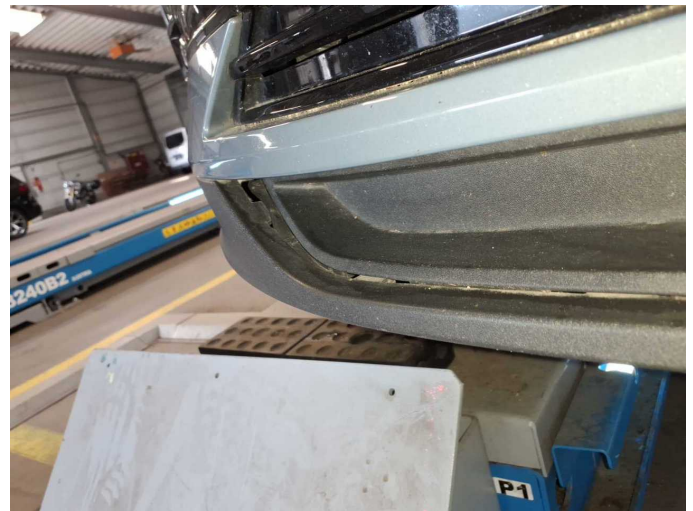
**Damage 5:** Front bumper: Air-inlet grille (Evtl. Mehrkosten) - Loose - Un- / install

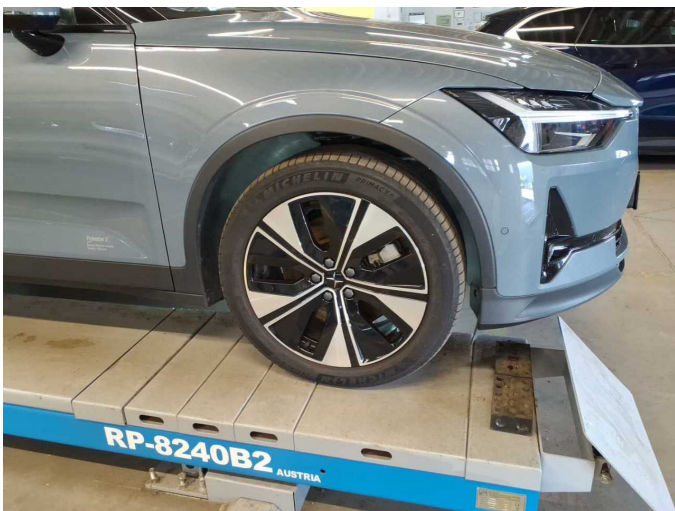
**Damage 6:** Wheel / tyres: Tyre - front right side (Flanke) - Damaged - Replace

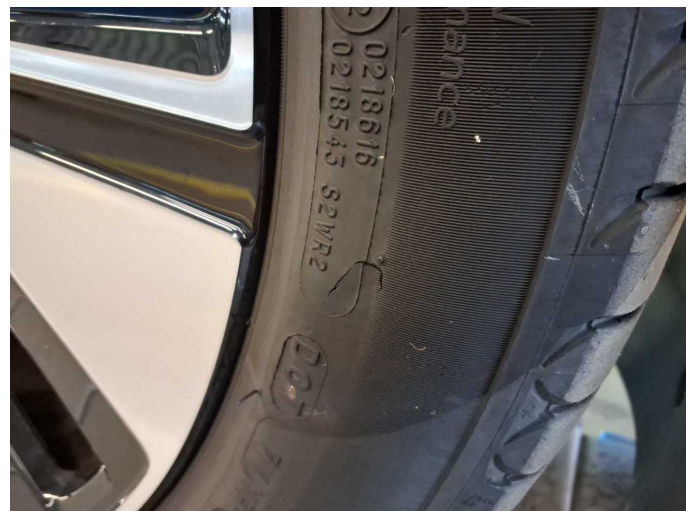
**Damage 6:** Wheel / tyres: Tyre - front right side (Flanke) - Damaged - Replace

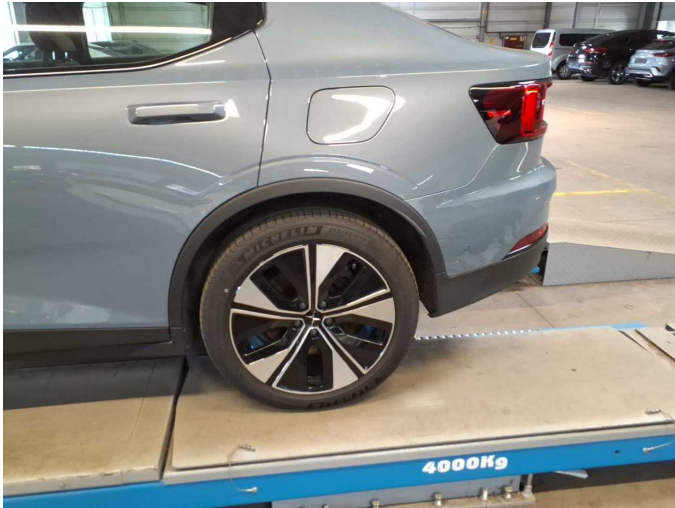
**Damage 7:** Wheel / tyres: Alloy rim - rear left side - Scratch(es) - Loss in value

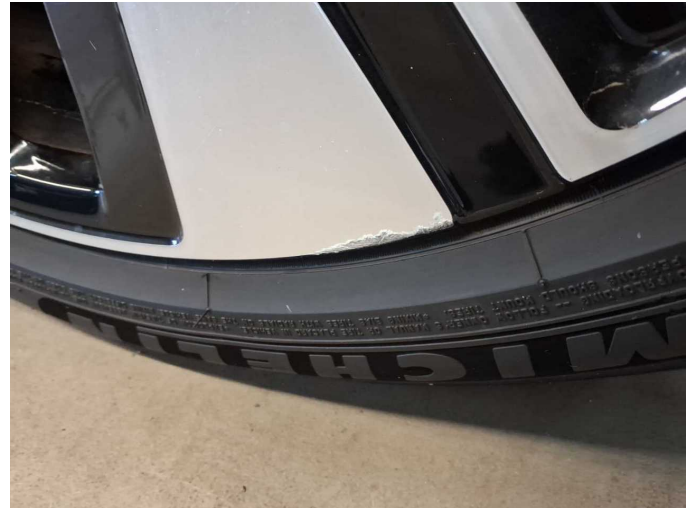
**Damage 7:** Wheel / tyres: Alloy rim - rear left side - Scratch(es) - Loss in value

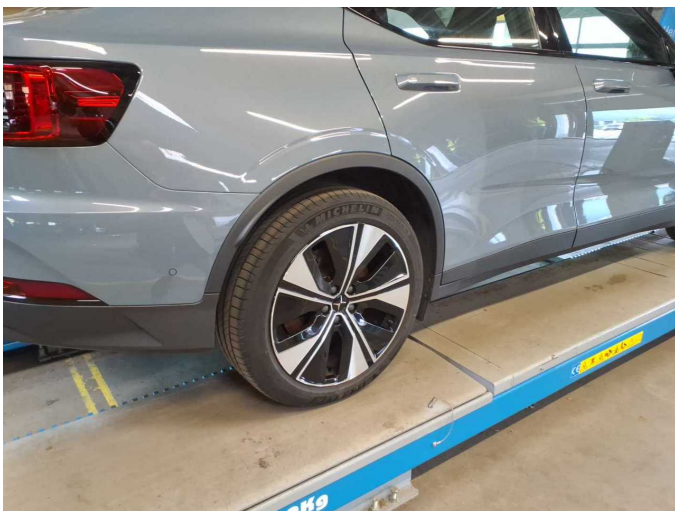
**Damage 8:** Wheel / tyres: Alloy rim - rear right side (Materialabtrag) - Scratched - Replace

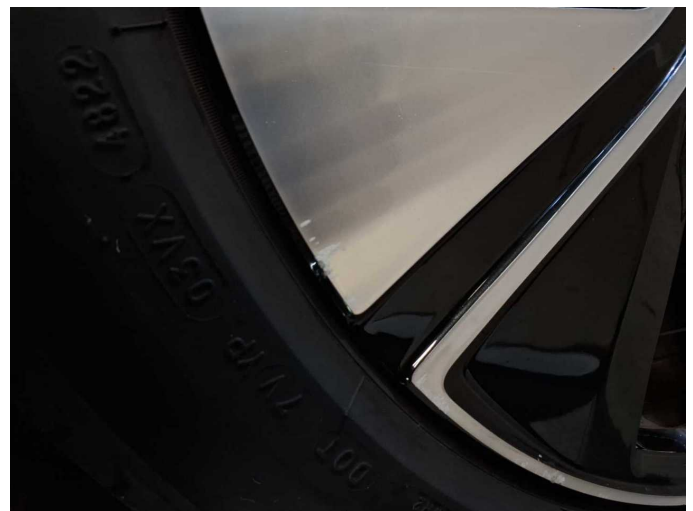
**Damage 8:** Wheel / tyres: Alloy rim - rear right side (Materialabtrag) - Scratched - Replace

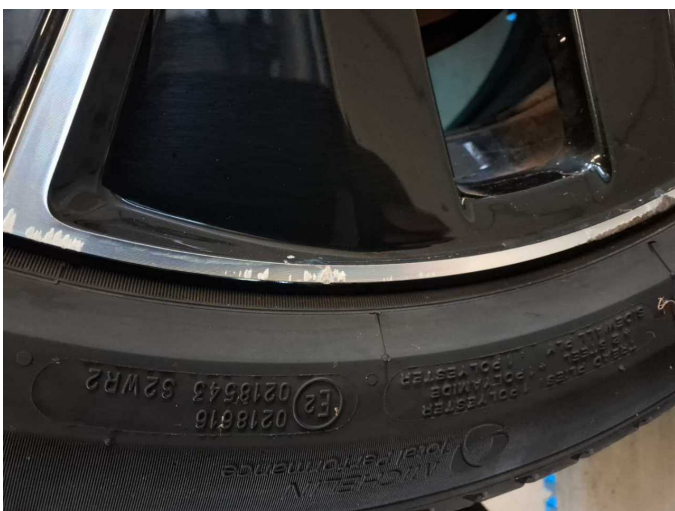
**Damage 8:** Wheel / tyres: Alloy rim - rear right side (Materialabtrag) - Scratched - Replace

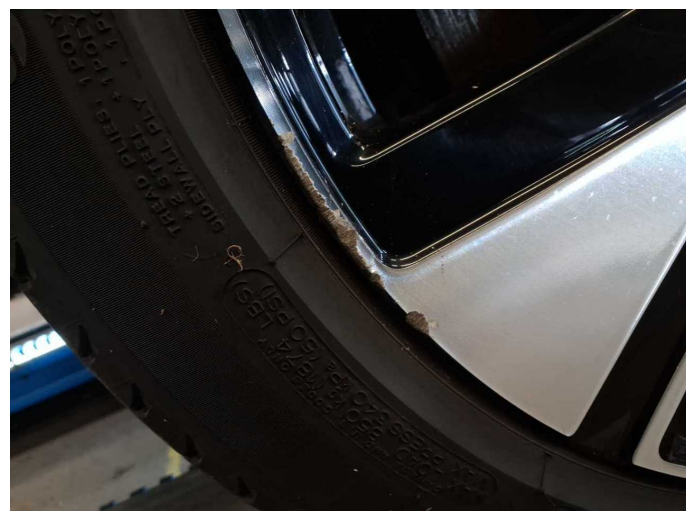
**Damage 8:** Wheel / tyres: Alloy rim - rear right side (Materialabtrag) - Scratched - Replace

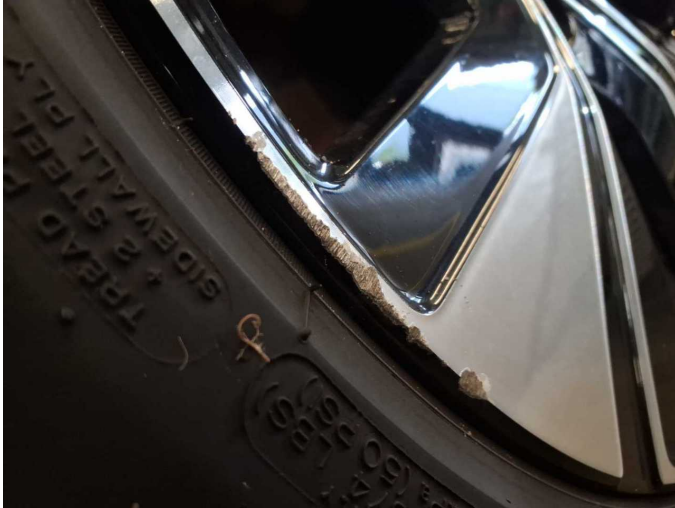
**Damage 8:** Wheel / tyres: Alloy rim - rear right side (Materialabtrag) - Scratched - Replace

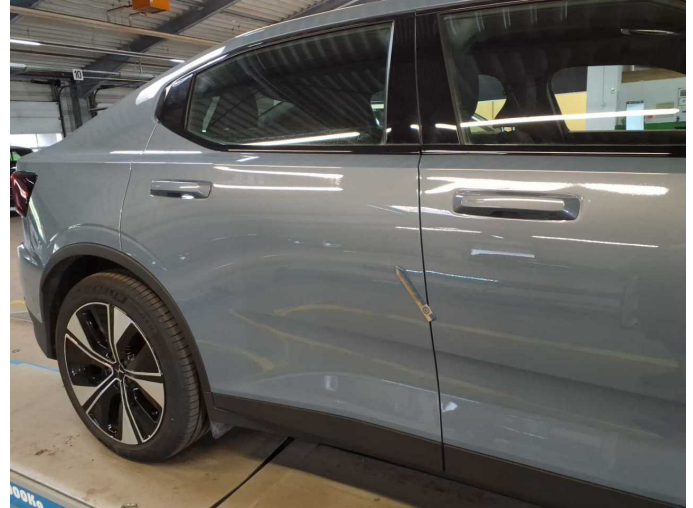
**Damage 9:** Door - rear right side: Door - Dent / paintcoat damage - Repair and paint

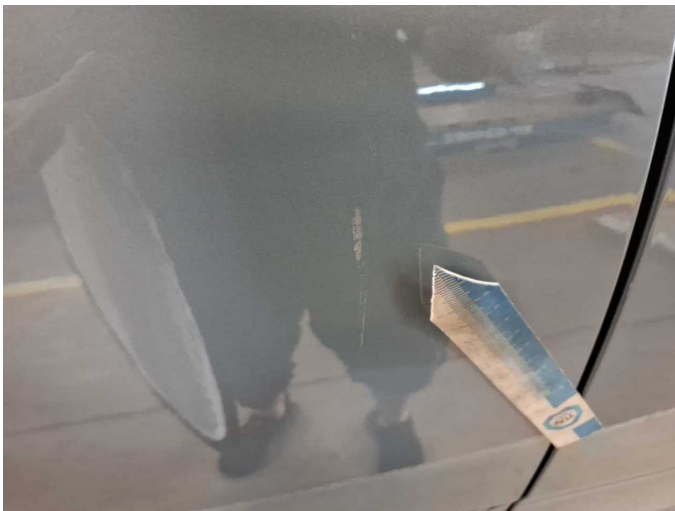
**Damage 9:** Door - rear right side: Door - Dent / paintcoat damage - Repair and paint

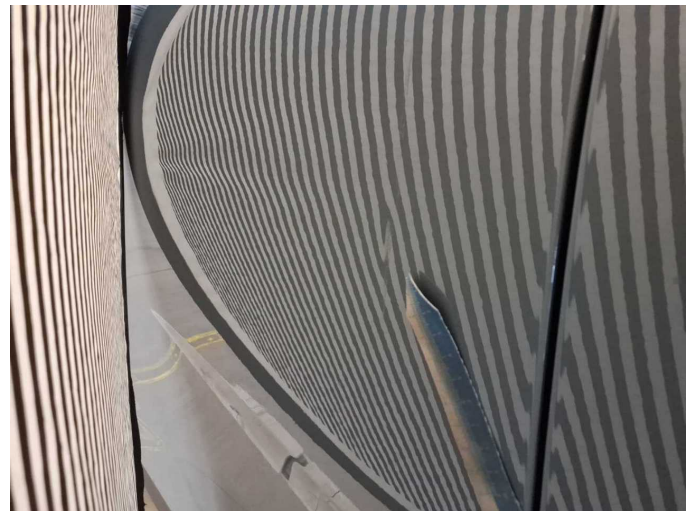
**Damage 9:** Door - rear right side: Door - Dent / paintcoat damage - Repair and paint

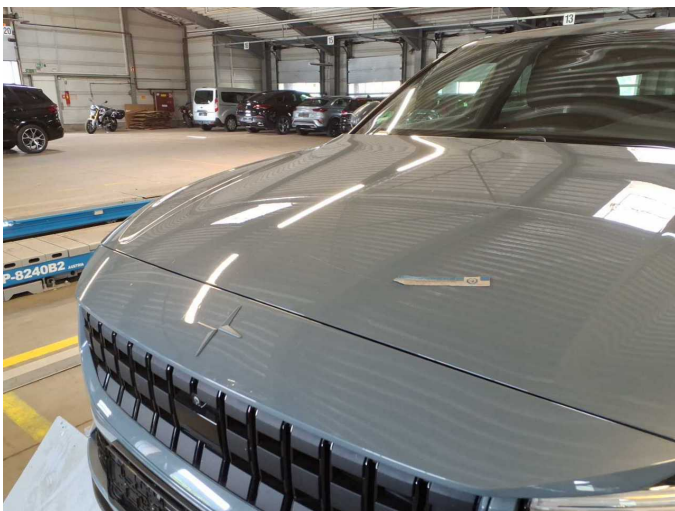
**Damage 10:** Bonnet: Bonnet - Scratch(es) - Paint

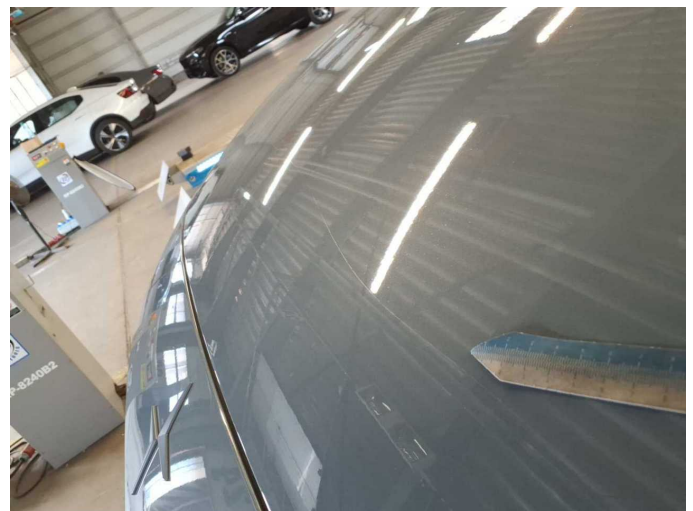
**Damage 10:** Bonnet: Bonnet - Scratch(es) - Paint

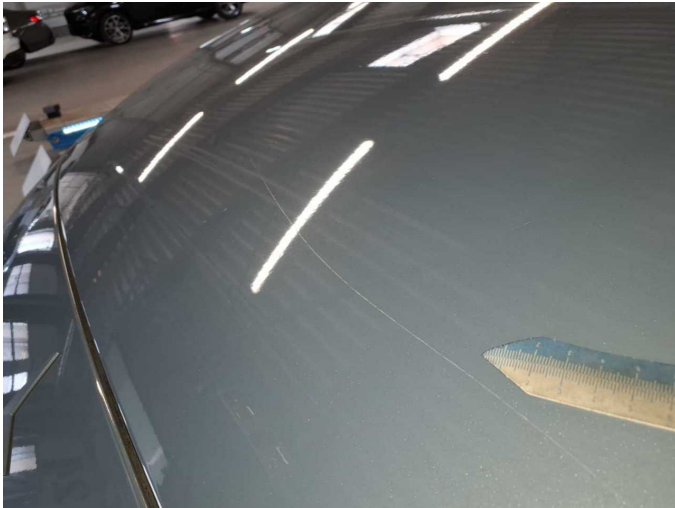
**Damage 10:** Bonnet: Bonnet - Scratch(es) - Paint

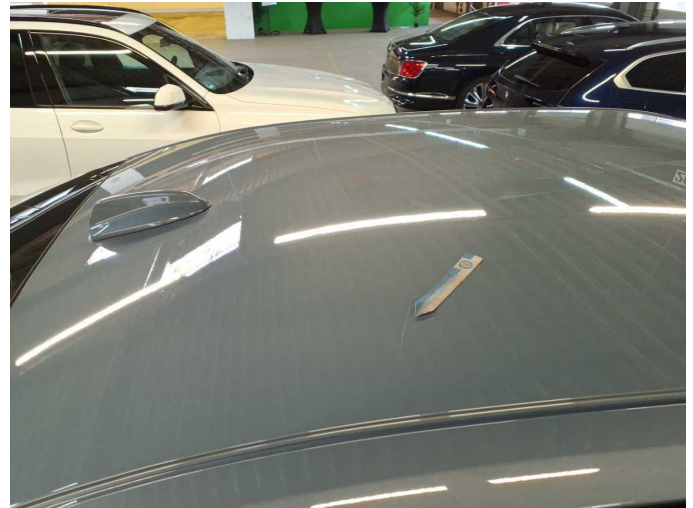
**Damage 11:** Roof: Roof - Dent / paintcoat damage - Repair and paint

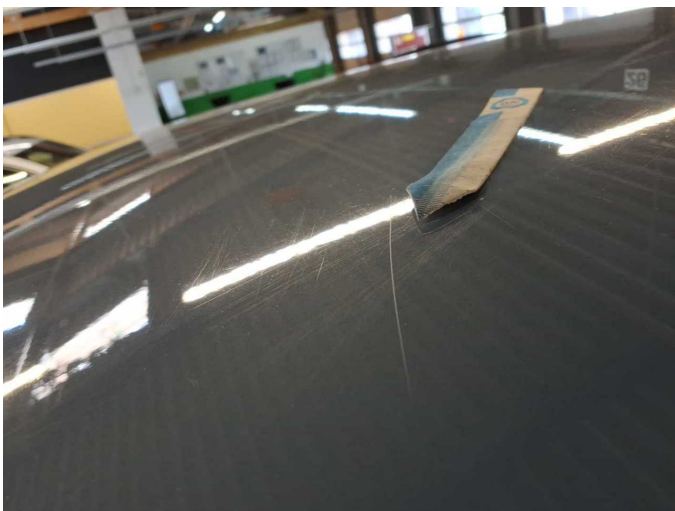
**Damage 11:** Roof: Roof - Dent / paintcoat damage - Repair and paint

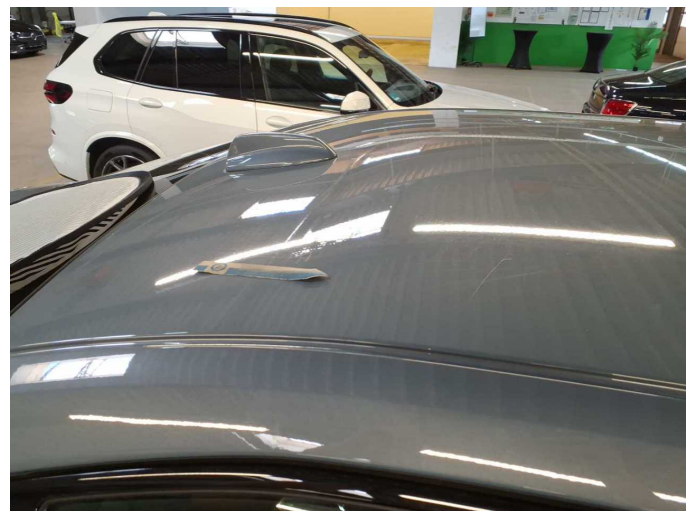
**Damage 11:** Roof: Roof - Dent / paintcoat damage - Repair and paint

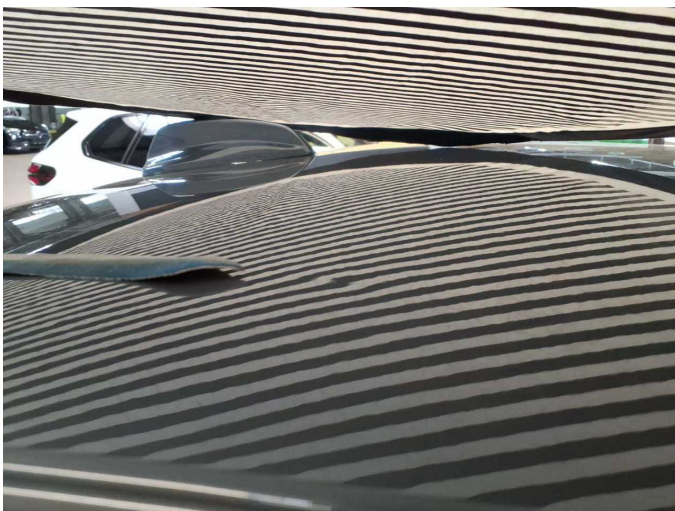
**Damage 11:** Roof: Roof - Dent / paintcoat damage - Repair and paint

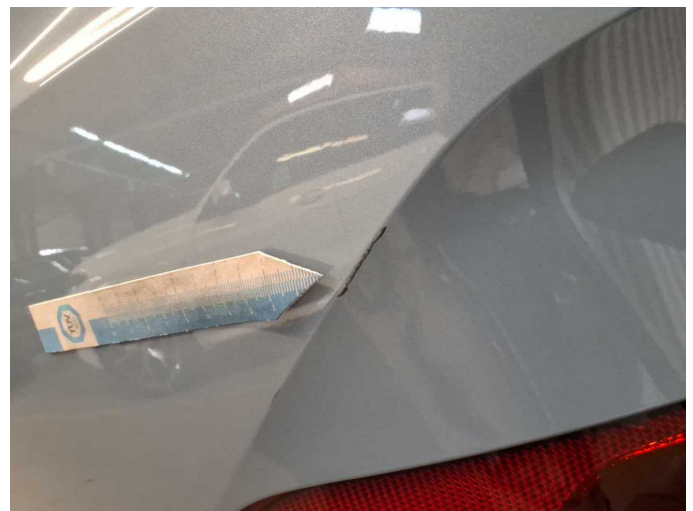
**Damage 12:** Rear bumper: Rear bumper - Scratched - repair according to calculation

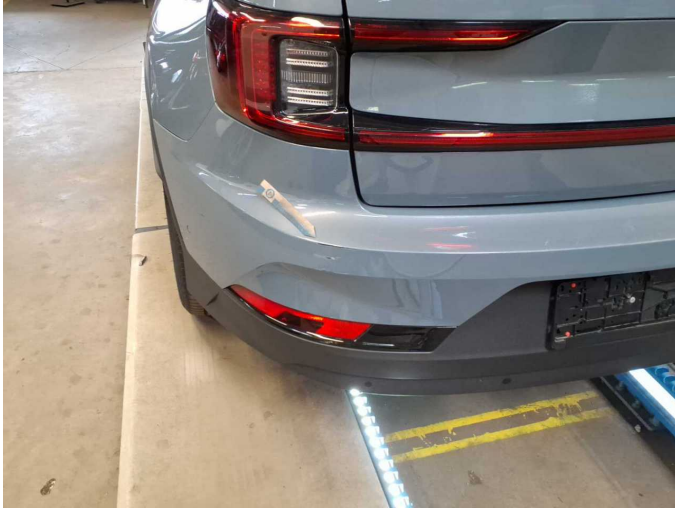
**Damage 12:** Rear bumper: Rear bumper - Scratched - repair according to calculation

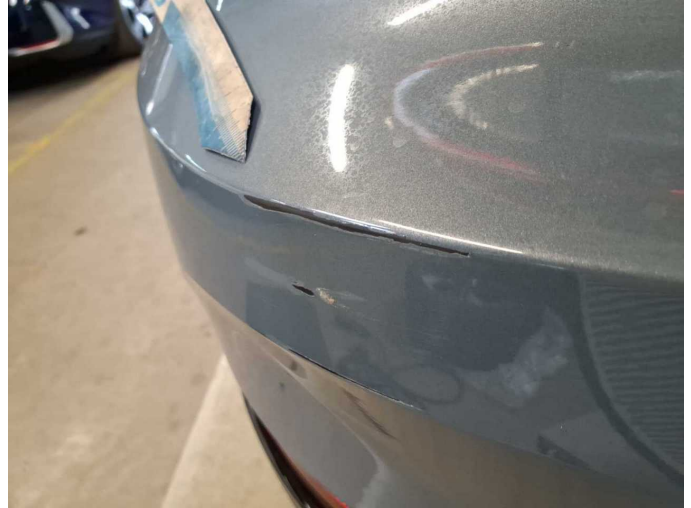
**Damage 12:** Rear bumper: Rear bumper - Scratched - repair according to calculation

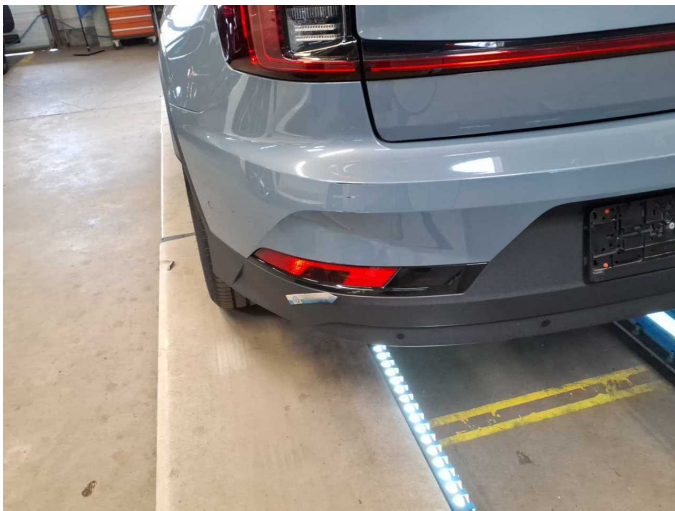
**Damage 12:** Rear bumper: Rear bumper - Scratched - repair according to calculation

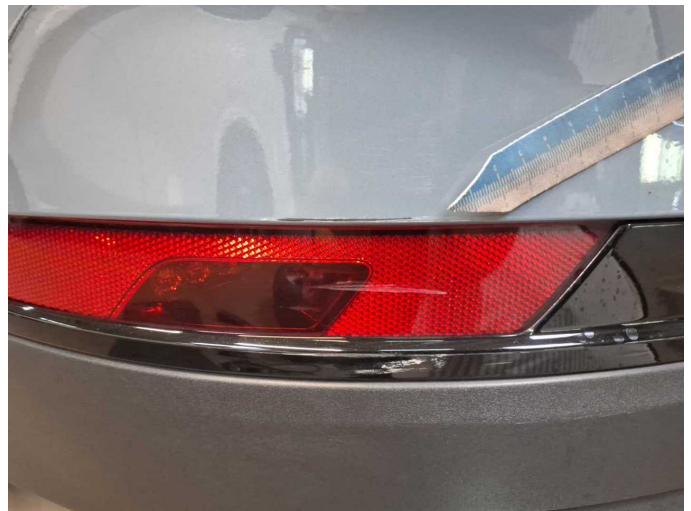
**Damage 12:** Rear bumper: Rear bumper - Scratched - repair according to calculation

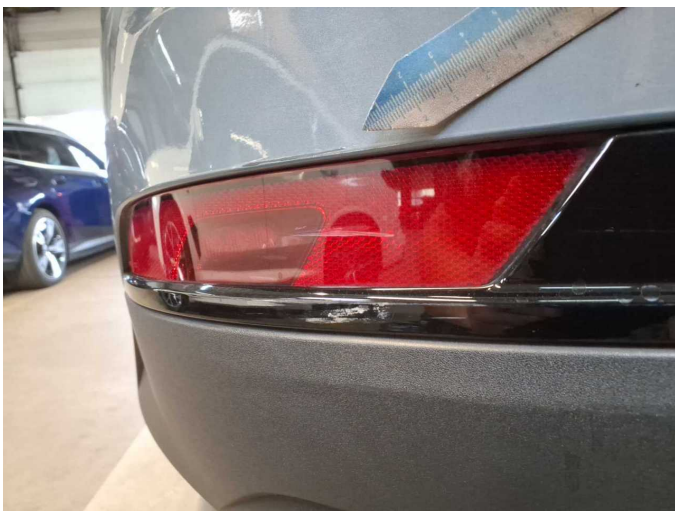
**Damage 12:** Rear bumper: Rear bumper - Scratched - repair according to calculation

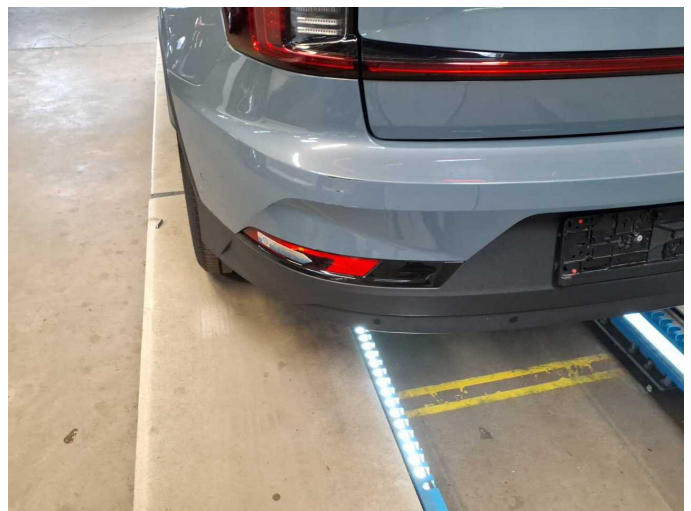
**Damage 12:** Rear bumper: Rear bumper - Scratched - repair according to calculation

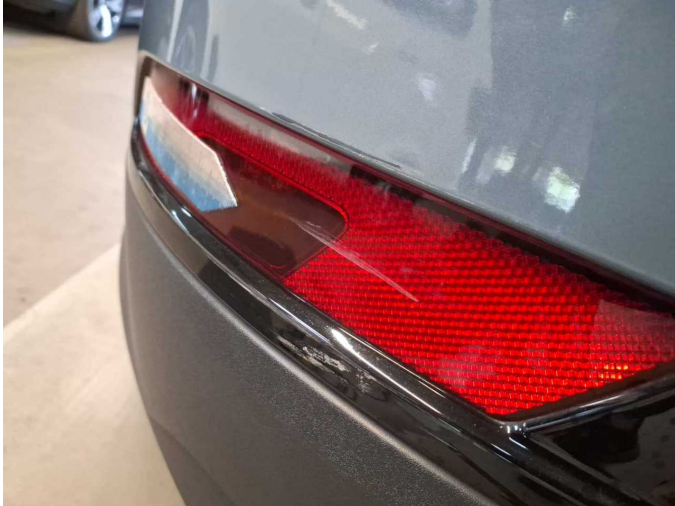
**Damage 12:** Rear bumper: Rear bumper - Scratched - repair according to calculation

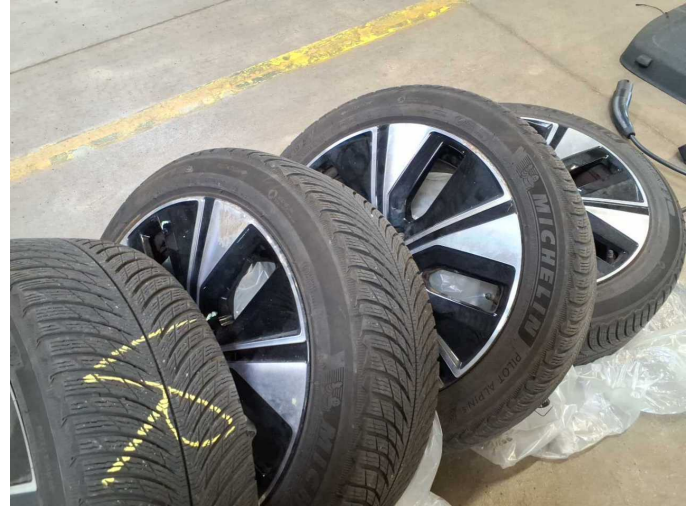
**Wear and tear 1:** 2nd wheel set: 2 alloy rims - Scratched - No deduction

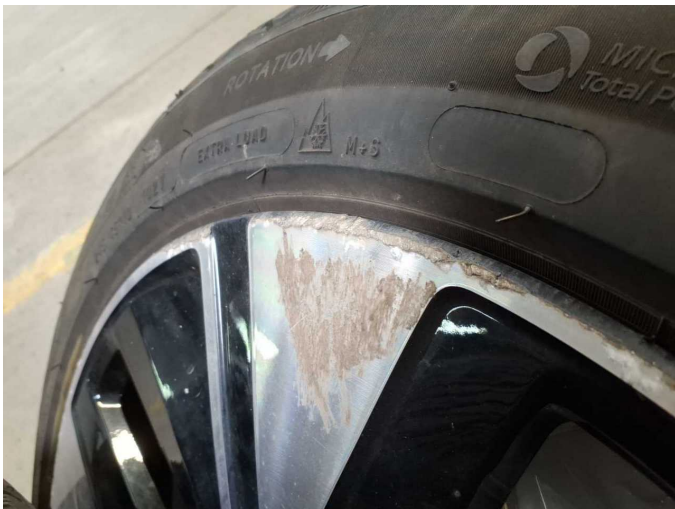
**Wear and tear 1:** 2nd wheel set: 2 alloy rims - Scratched - No deduction

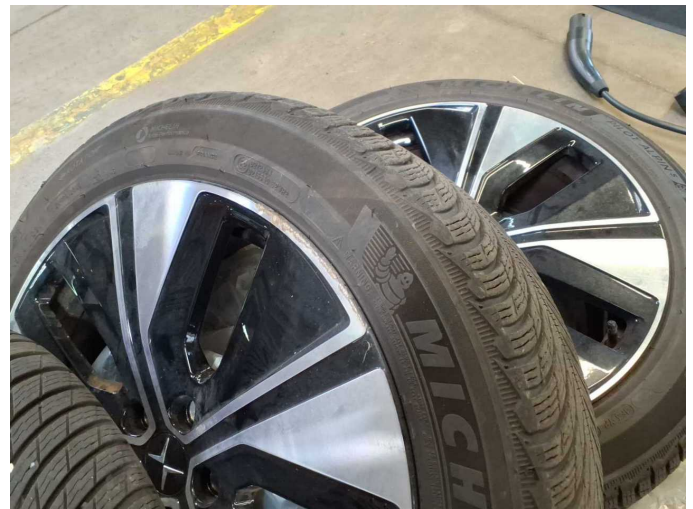
**Wear and tear 1:** 2nd wheel set: 2 alloy rims - Scratched - No deduction

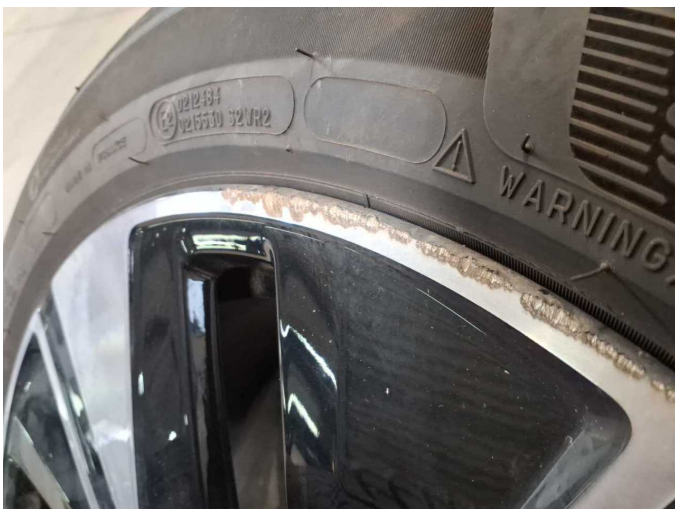
**Wear and tear 1:** 2nd wheel set: 2 alloy rims - Scratched - No deduction
