Expertise

Protocol number: 46916898  
Order No. / Reference: 26767057  
Inspection date: 6 Aug 2026

Manufacturer: Ford

Model: Kuga 1.5 EcoBlue Aut. TITANIUM

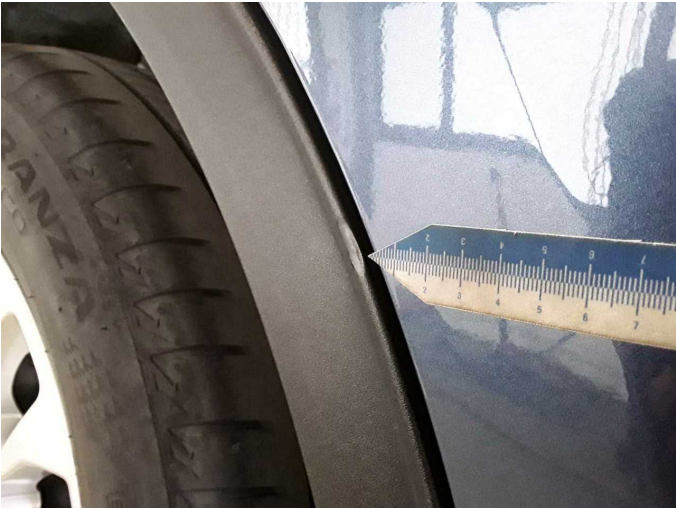
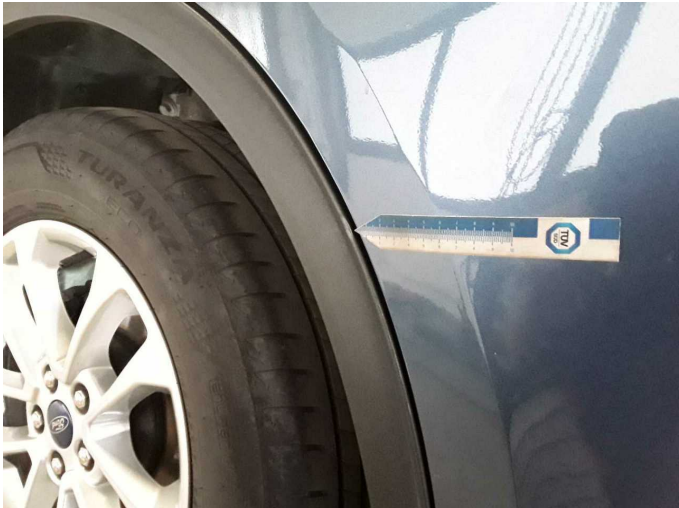
| No. | Component group | Description |
|---|---|---|
| 1 | Side panel - rear right side | Wheel arch - Scratch(es) - Loss in value |

Damage 1: Side panel - rear right side: Wheel arch - Scratch(es) - Loss in value

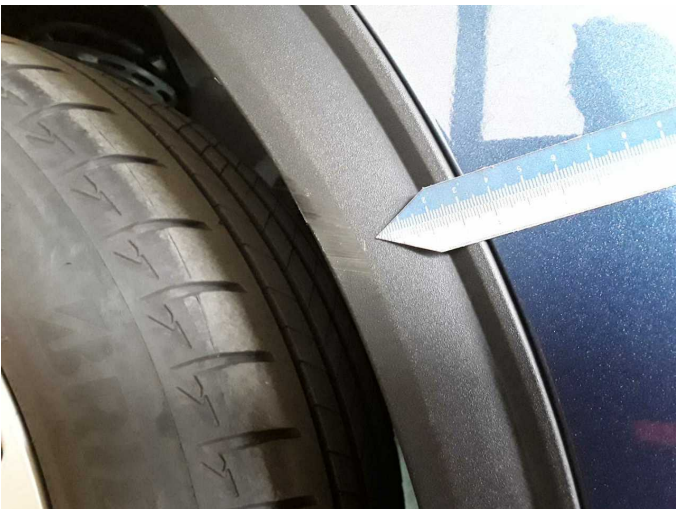
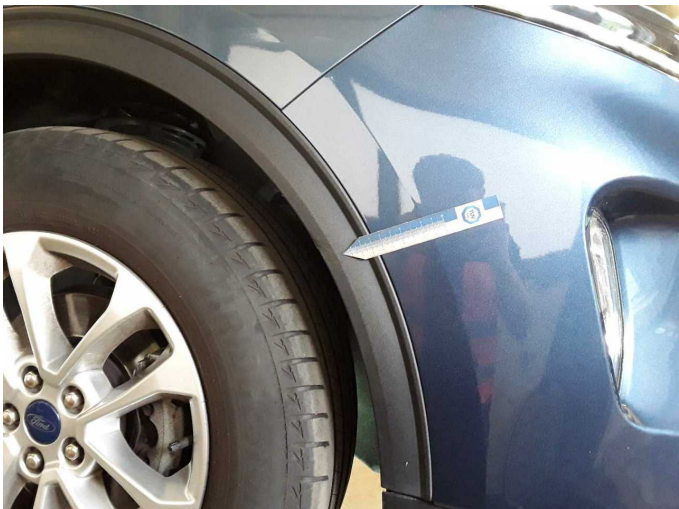
| No. | Component group | Description |
|---|---|---|
| 2 | Mudguard - right side | Wheel arch - Scratch(es) - Loss in value |

Damage 2: Mudguard - right side: Wheel arch - Scratch(es) - Loss in value

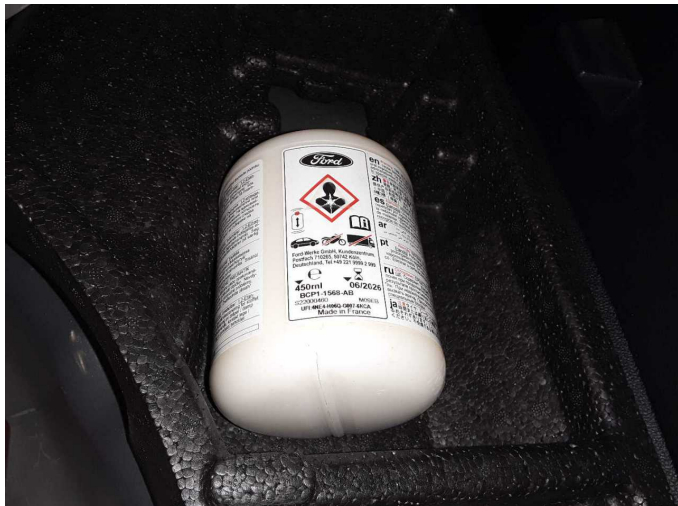
| No. | Component group | Description |
|---|---|---|
| 3 | Equipment | Tirefit filler - Expired - Replace |

**Damage 3:** Equipment: Tirefit filler - Expired - Replace

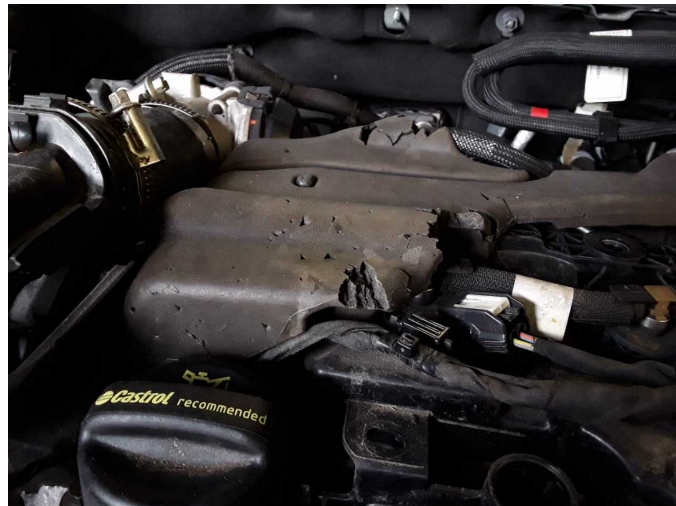
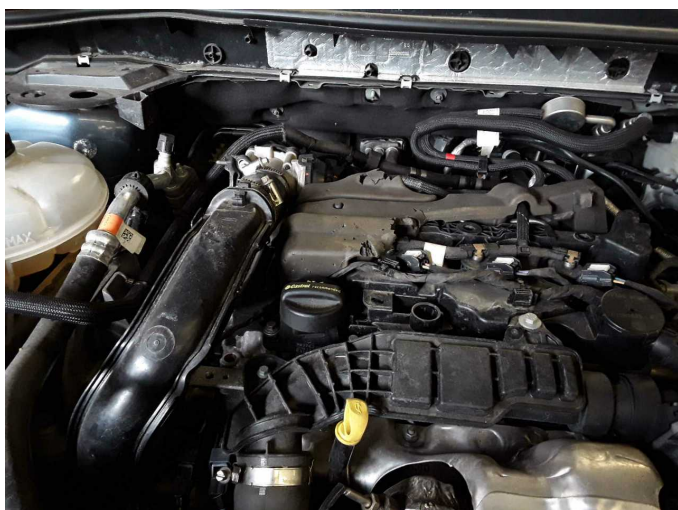
| No. | Component group | Description |
|---|---|---|
| 4 | Engine | Engine cover - top / cover - Damage caused by marten / rodent - Replace |

**Damage 4:** Engine: Engine cover - top / cover - Damage caused by marten / rodent - Replace

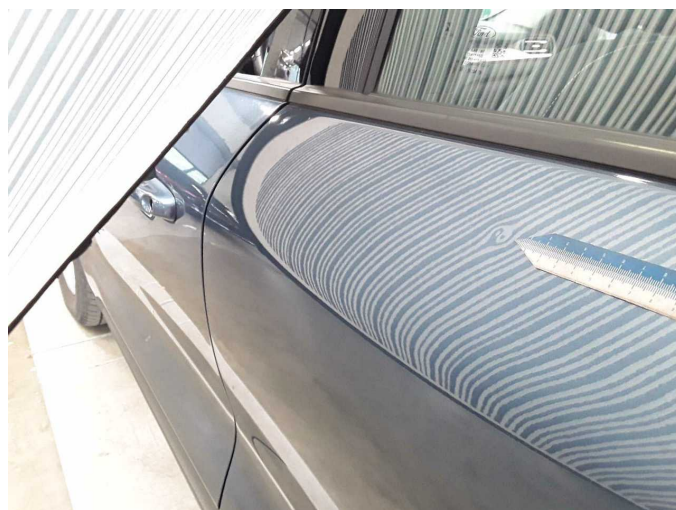
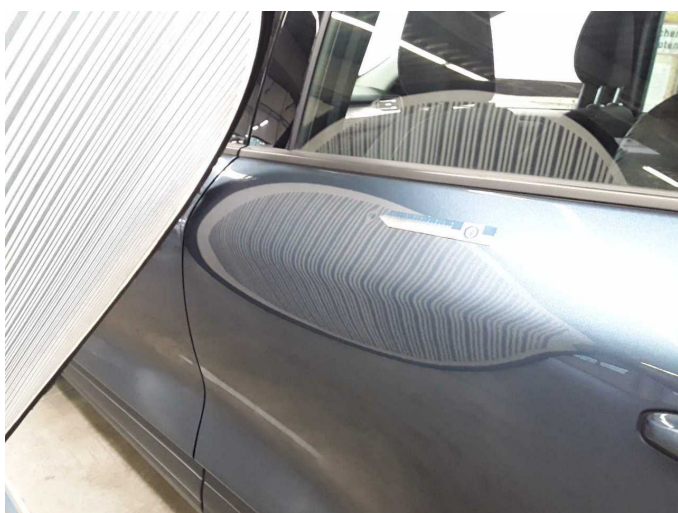
| No. | Component group | Description |
|---|---|---|
| 5 | Door - rear left side | Door - dent(s) - Smooth repair work |

**Damage 5:** Door - rear left side: Door - dent(s) - Smooth repair work

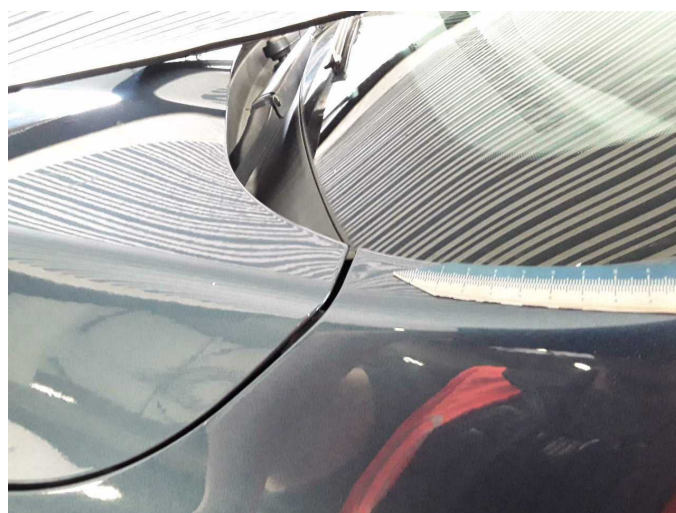
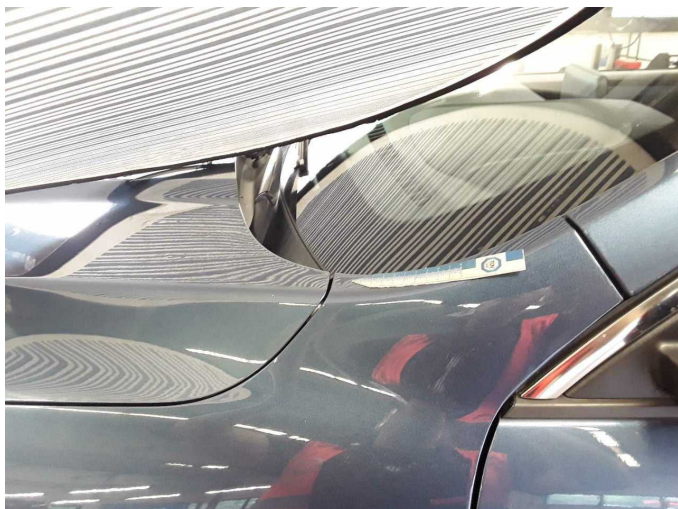
| No. | Component group | Description |
|---|---|---|
| 6 | Mudguard - left side | Mudguard - left side - dent(s) - Smooth repair work |

**Damage 6:** Mudguard - left side: Mudguard - left side - dent(s) - Smooth repair work

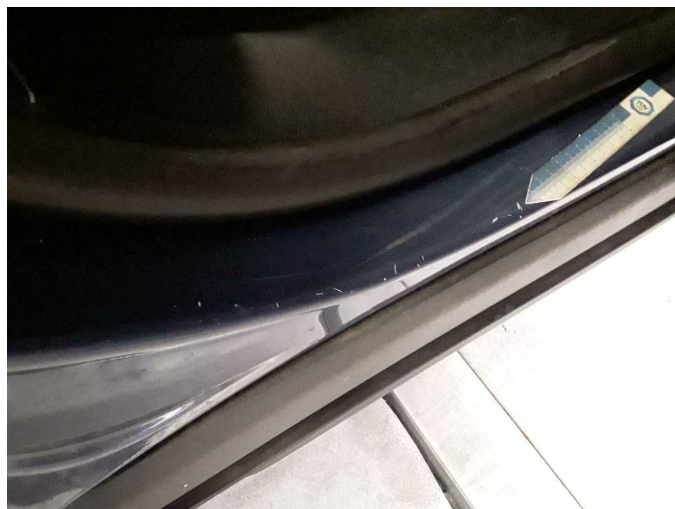
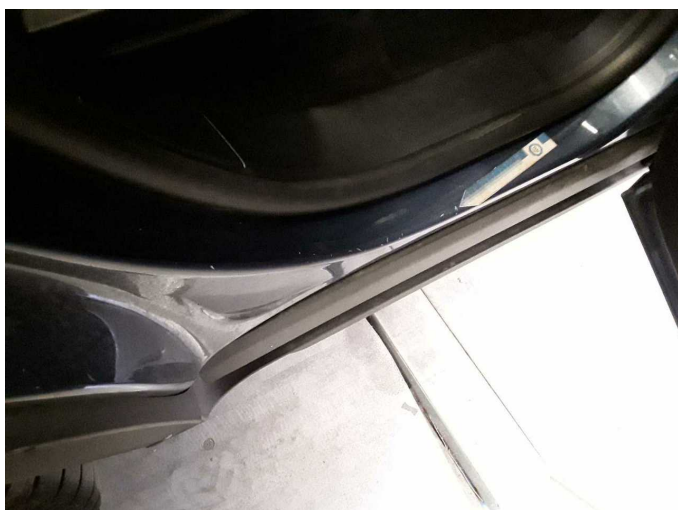
| No. | Component group | Description |
|---|---|---|
| 7 | Side panel - rear right side | Sill - Scratch(es) - Smart repair |

**Damage 7:** Side panel - rear right side: Sill - Scratch(es) - Smart repair

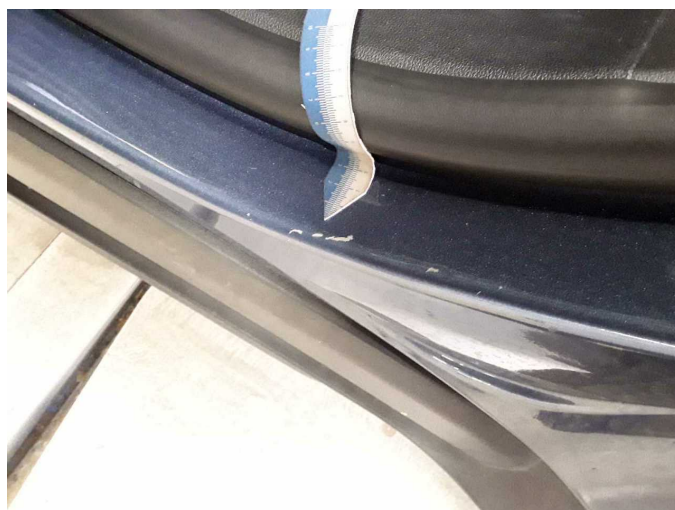
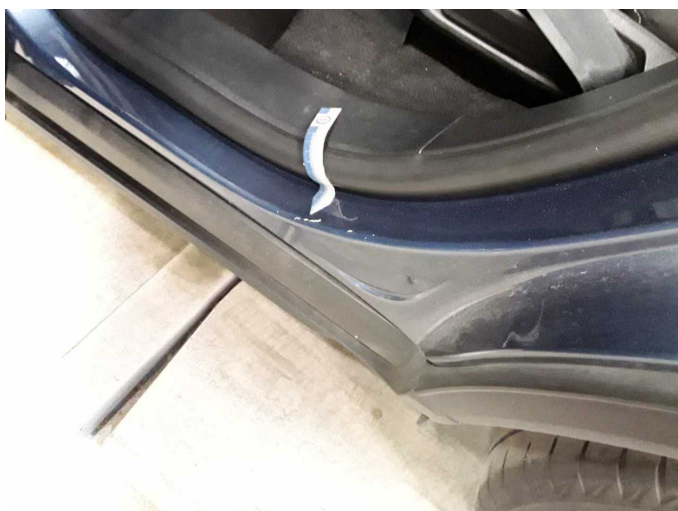
| No. | Component group | Description |
|---|---|---|
| 8 | Side panel - rear left side | Sill - Scratch(es) - Smart repair |

**Damage 8:** Side panel - rear left side: Sill - Scratch(es) - Smart repair

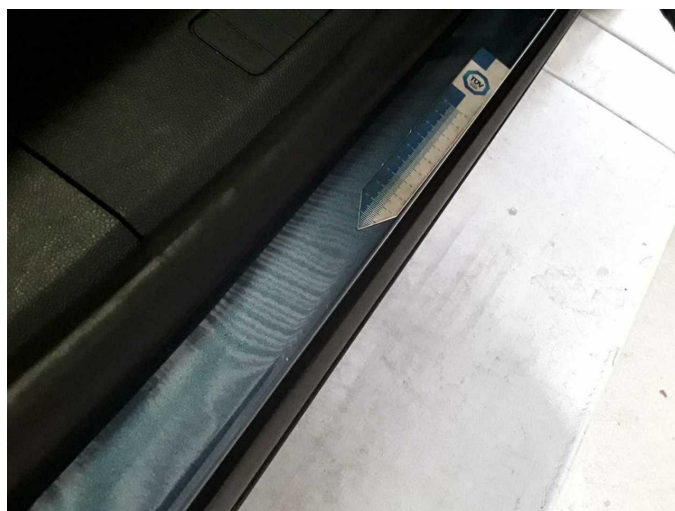
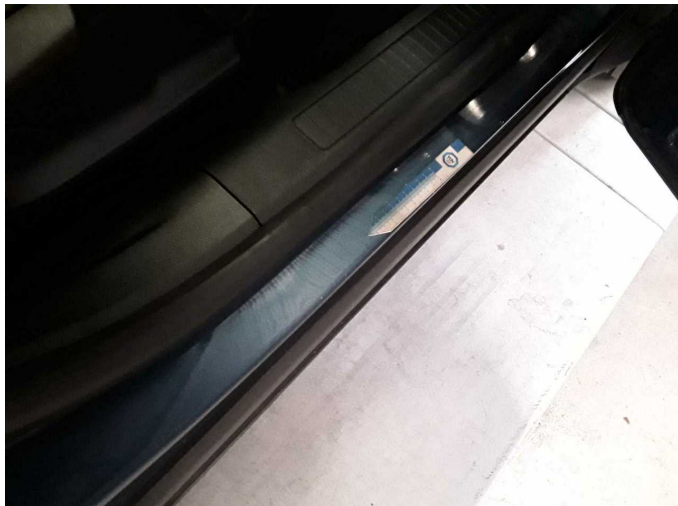
| No. | Component group | Description |
|---|---|---|
| 9 | Sill - right side | Sill - dent(s) - Smart repair |

**Damage 9:** Sill - right side: Sill - dent(s) - Smart repair

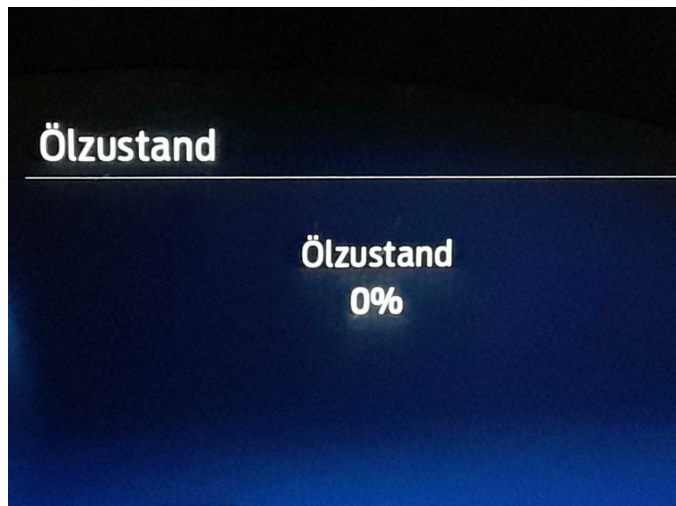
| No. | Component group | Description |
|---|---|---|
| 10 | Misc. | Inspection / maintenance - Due - Replace |

**Damage 10:** Misc.: Inspection / maintenance - Due - Replace

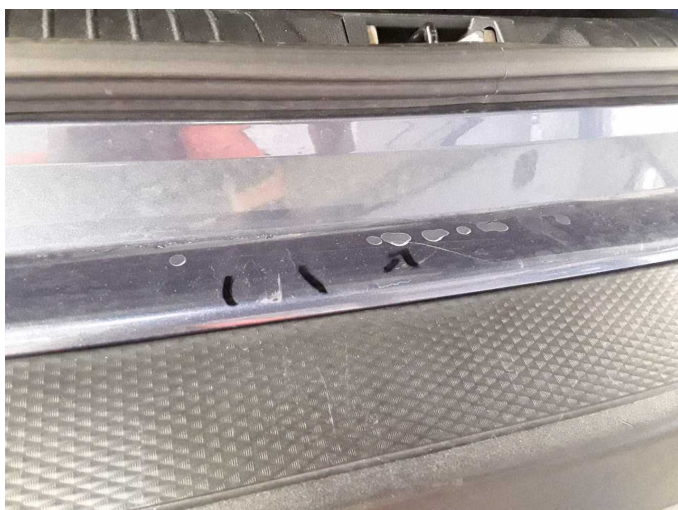
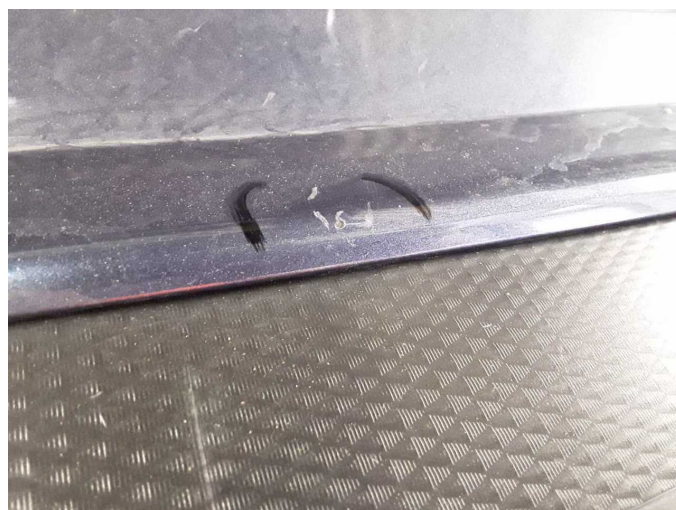
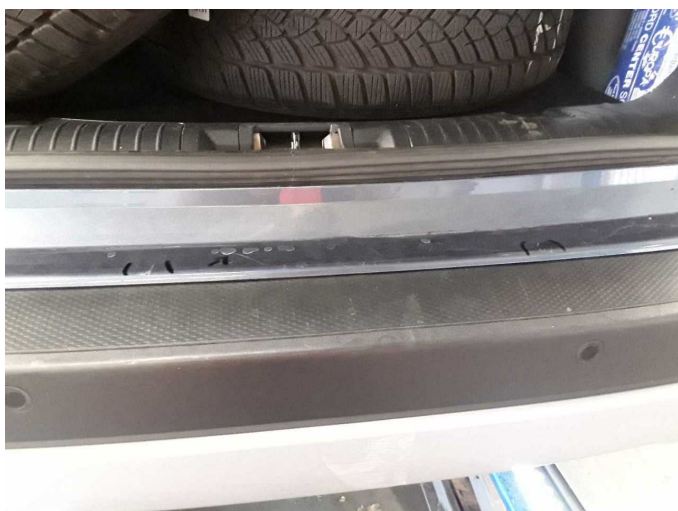
| No. | Component group | Description |
|---|---|---|
| 11 | Rear bumper | Rear bumper - Scratched - Paint |

**Damage 11:** Rear bumper: Rear bumper - Scratched - Paint

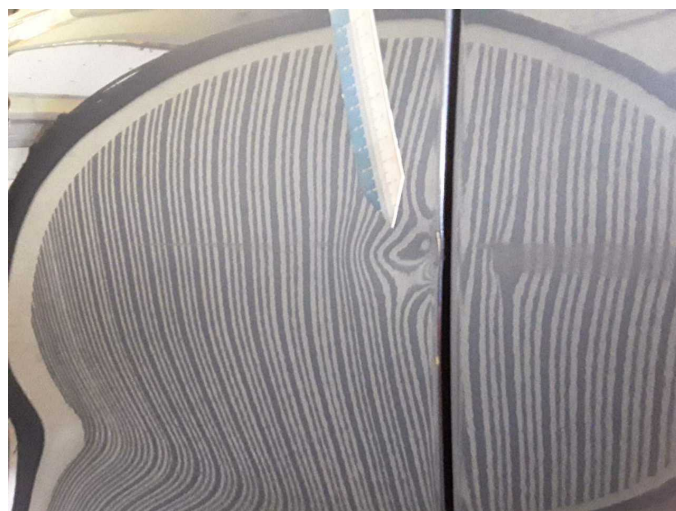
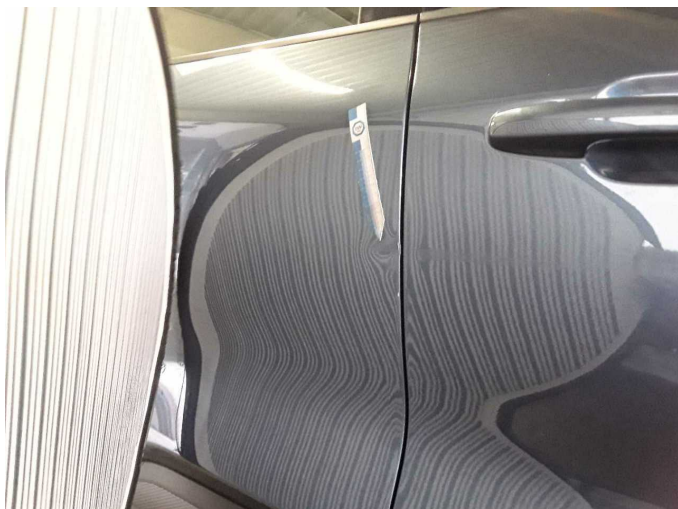
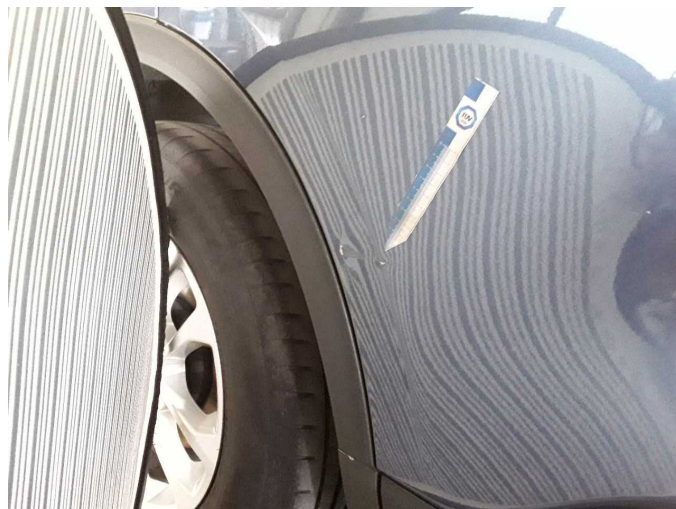
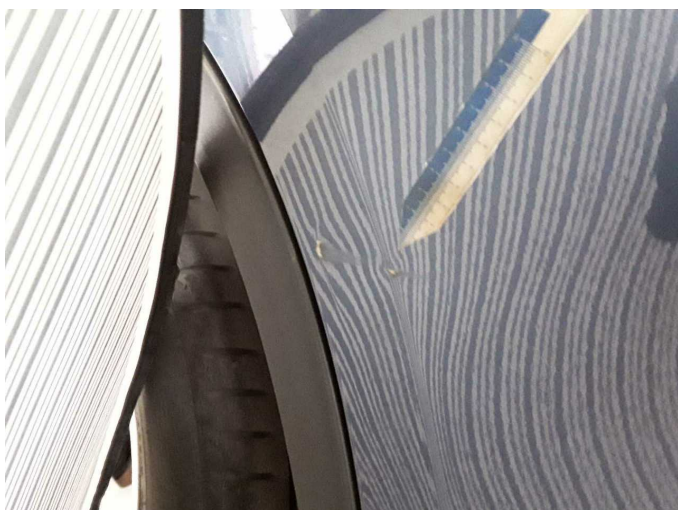
| No. | Component group | Description |
|---|---|---|
| 12 | Door - rear right side | Door - Dent / paintcoat damage - Repair and paint |

**Damage 12:** Door - rear right side: Door - Dent / paintcoat damage - Repair and paint

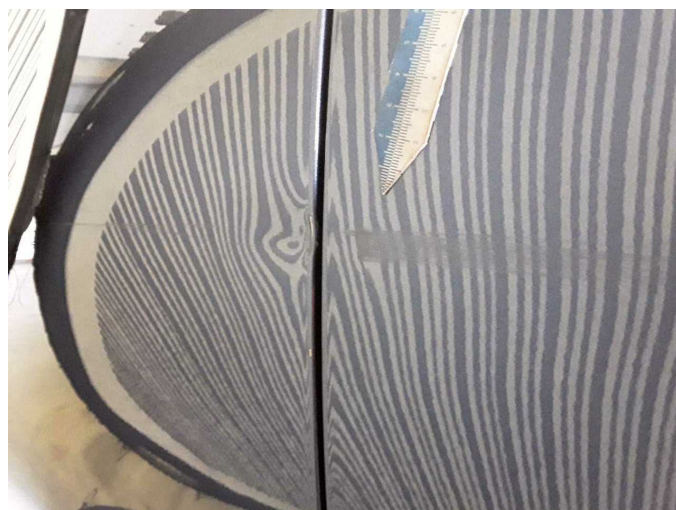
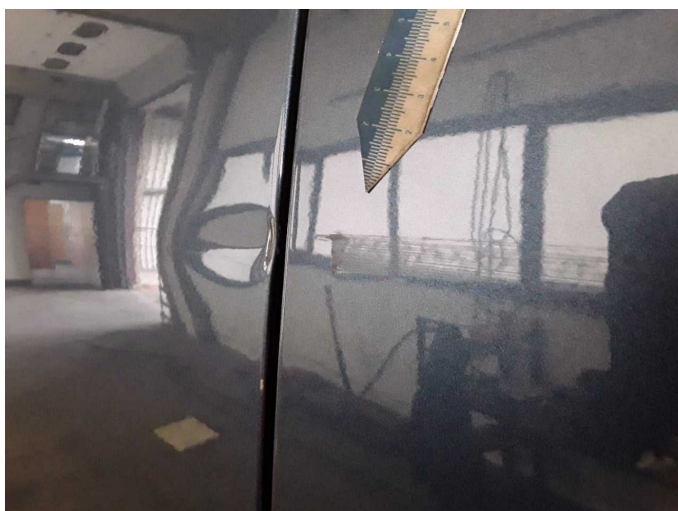
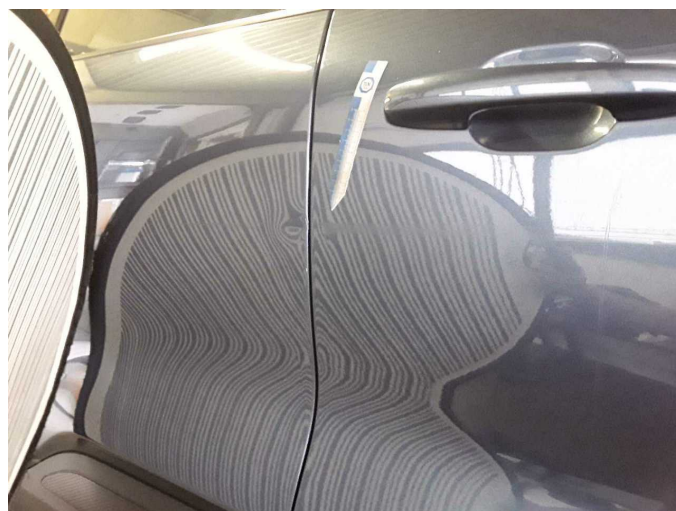
| No. | Component group | Description |
|---|---|---|
| 13 | Door - front right side | Door - Dent / paintcoat damage - Repair and paint |

**Damage 13:** Door - front right side: Door - Dent / paintcoat damage - Repair and paint

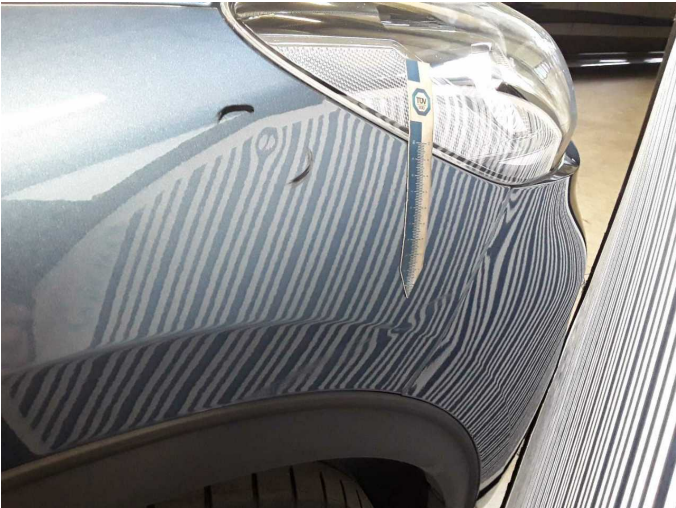
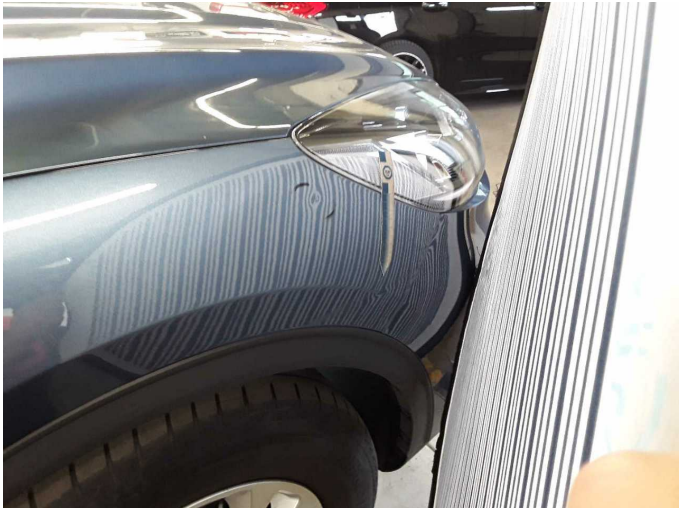
| No. | Component group | Description |
|---|---|---|
| 14 | Mudguard - right side | Mudguard - right side - Dent / paintcoat damage - Repair and paint |

**Damage 14:** Mudguard - right side: Mudguard - right side - Dent / paintcoat damage - Repair and paint

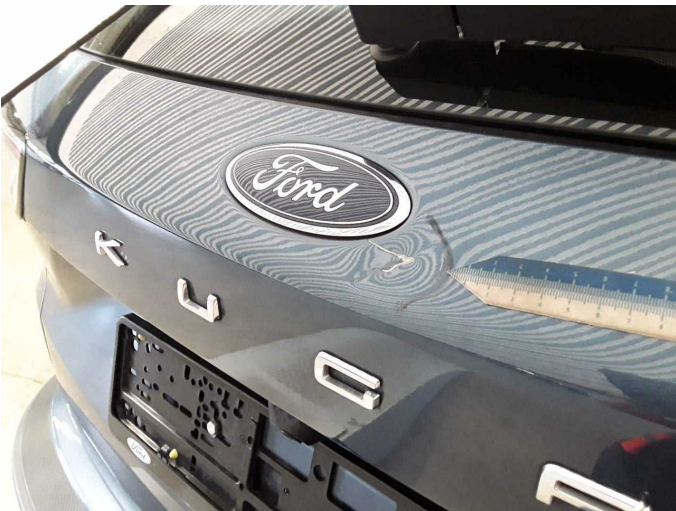
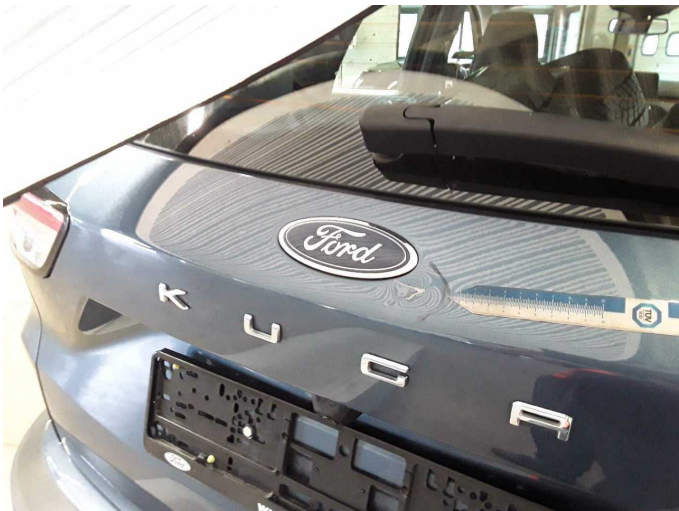
| No. | Component group | Description |
|---|---|---|
| 15 | Boot lid / rear door | Boot lid - Dent / paintcoat damage - Repair and paint |

**Damage 15:** Boot lid / rear door: Boot lid - Dent / paintcoat damage - Repair and paint

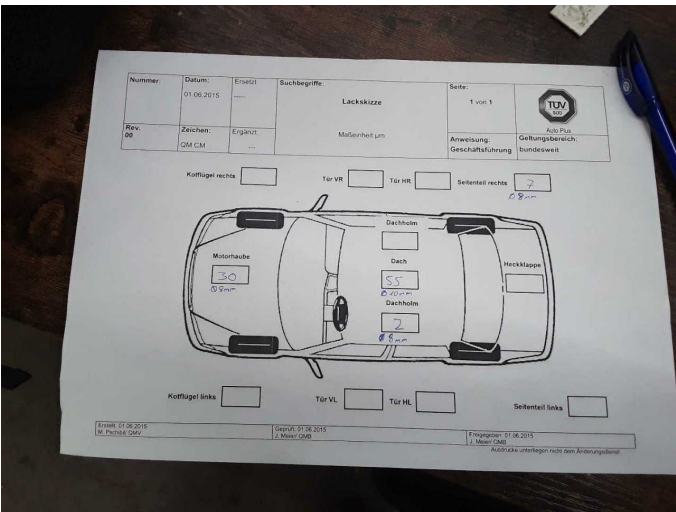
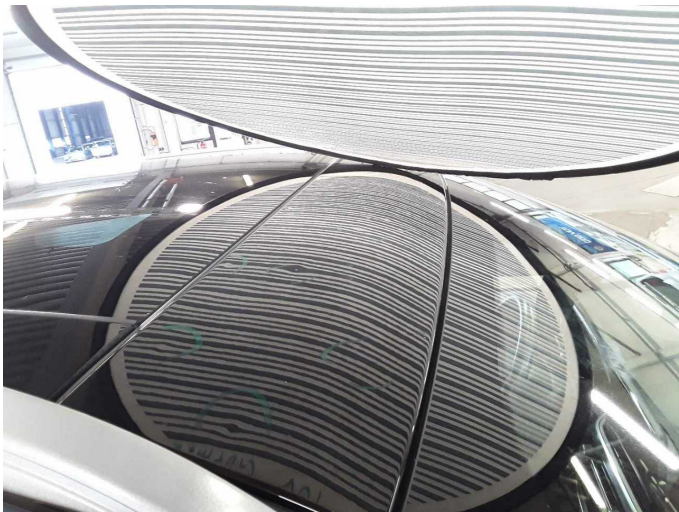
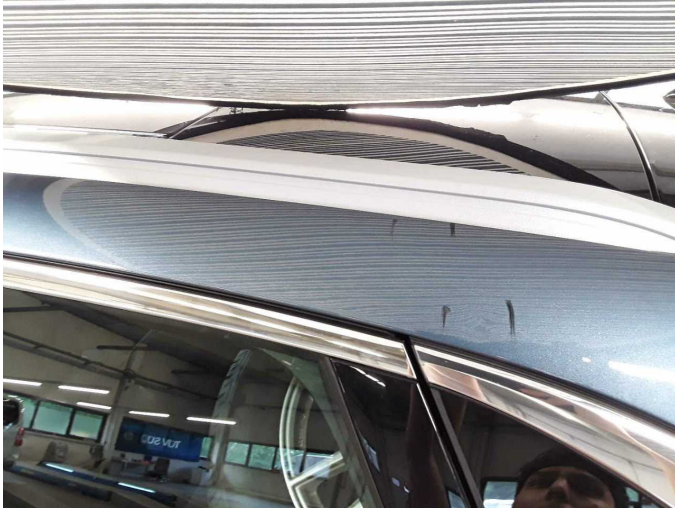
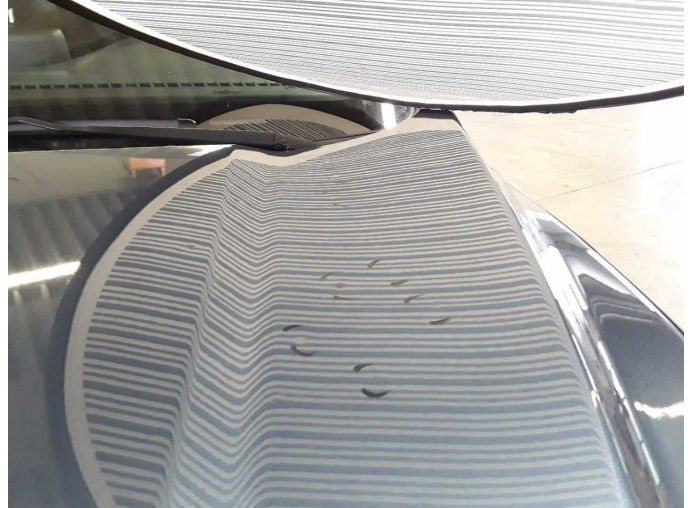
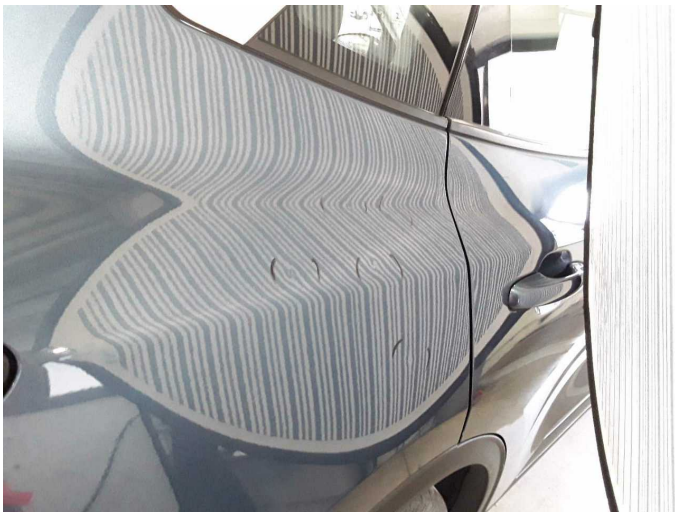
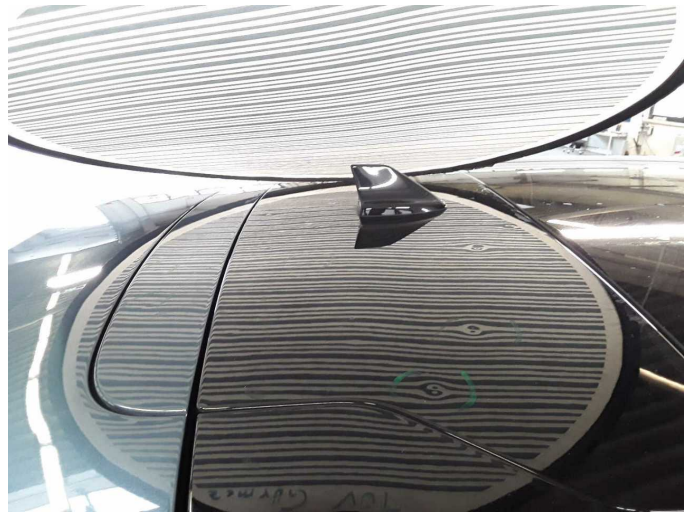
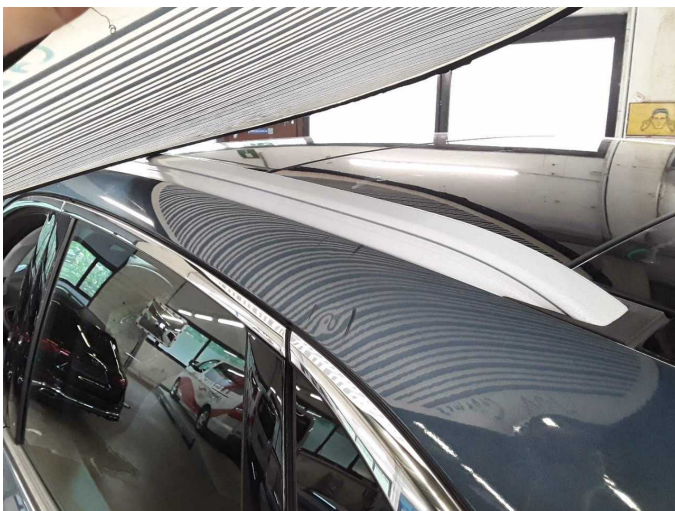
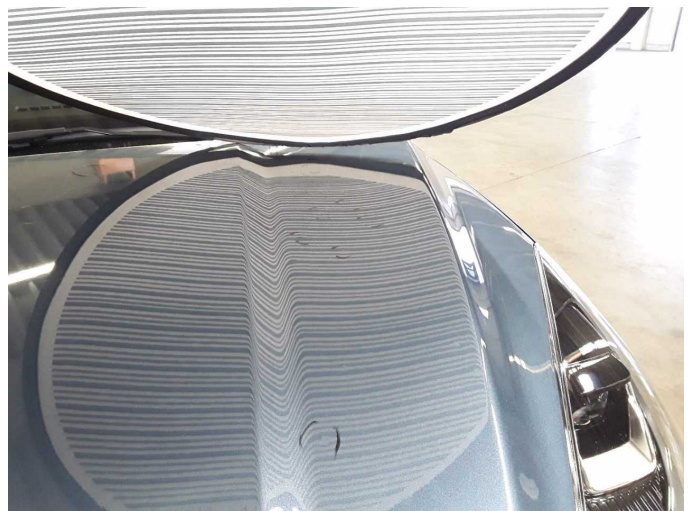
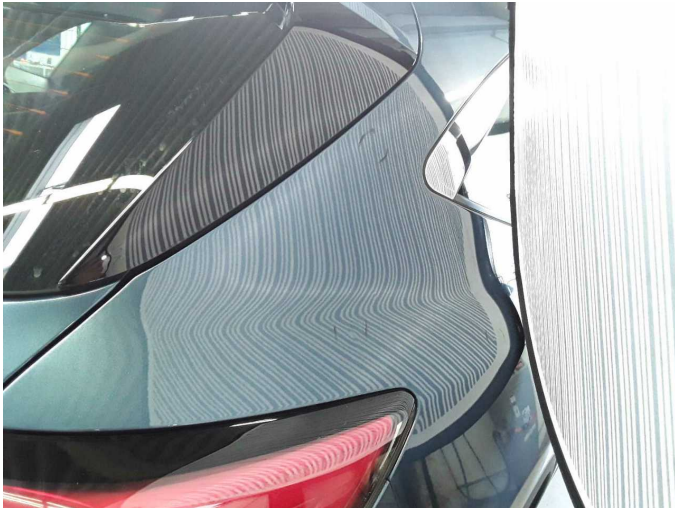
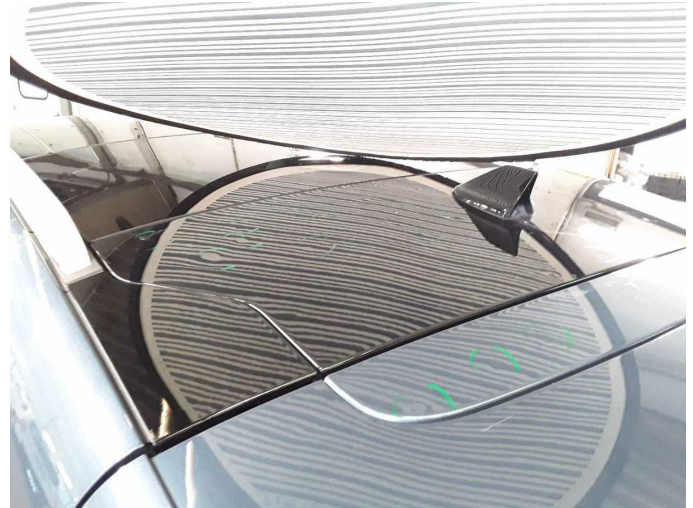
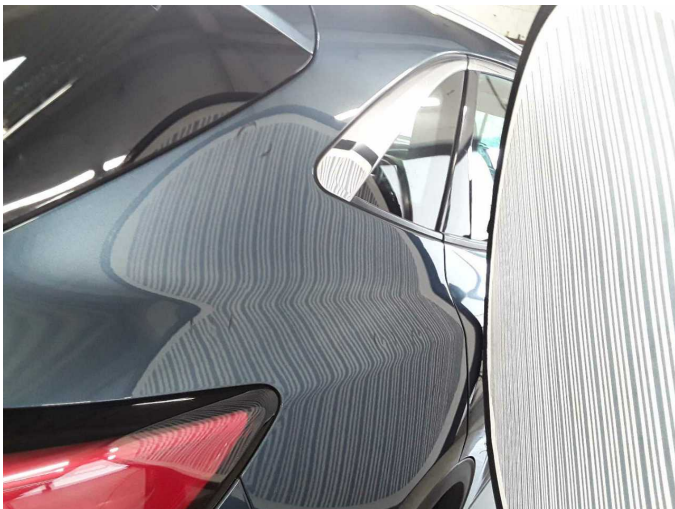
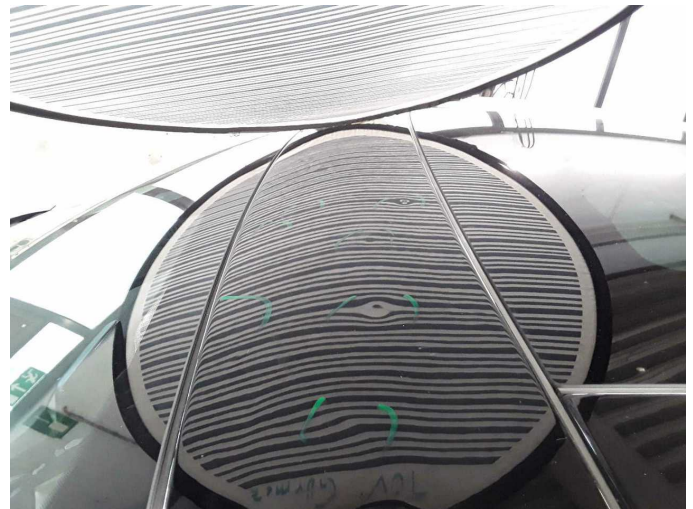
| No. | Component group | Description |
|---|---|---|
| 16 | Body | Body - Damage by hail - repair according to calculation |

**Damage 16:** Body: Body - Damage by hail - repair according to calculation
