Expertise

Protocol number: 46727947  
Order No. / Reference: 26663459  
Inspection date: 27 Jul 2026

| Manufacturer: Opel | Model: Astra 1.5 D Start/Stop Sports Tourer Automatik Edition |

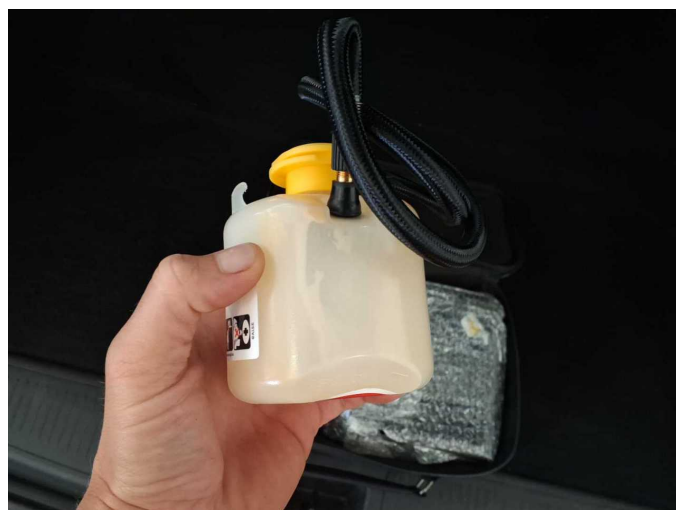
| No. | Component group | Description |
|---|---|---|
| 1 | Equipment | Tirefit filler - Empty - Replace |

**Damage 1:** Equipment: Tirefit filler - Empty - Replace

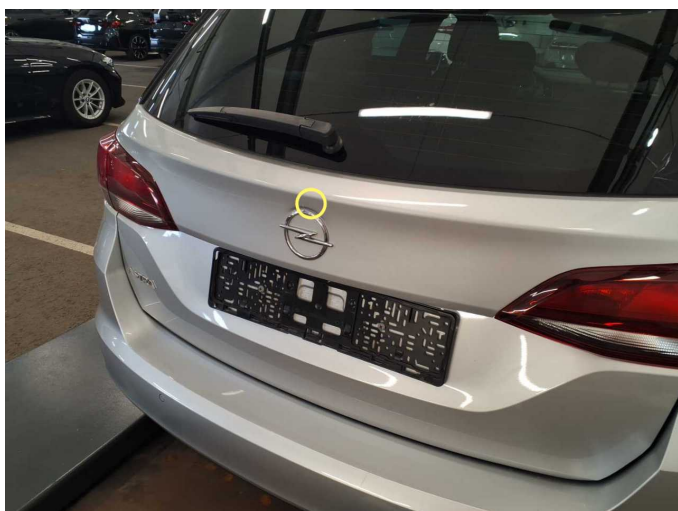
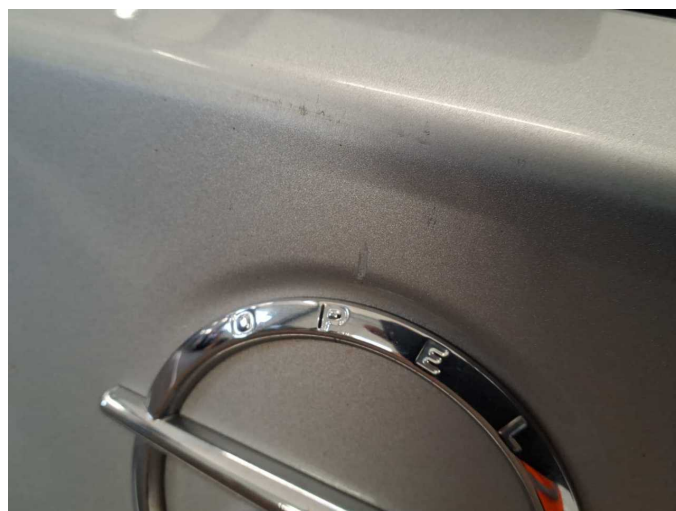
| No. | Component group | Description |
|---|---|---|
| 2 | Boot lid / rear door | Boot lid - Scratch(es) - Smart repair |

**Damage 2:** Boot lid / rear door: Boot lid - Scratch(es) - Smart repair

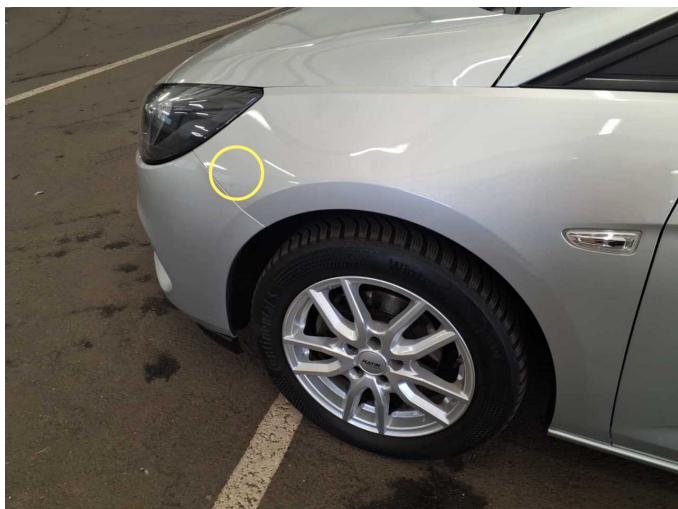
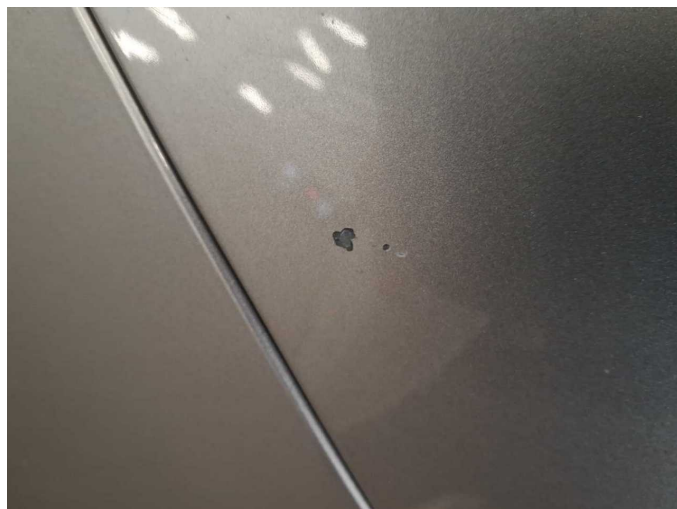
| No. | Component group | Description |
|---|---|---|
| 3 | Mudguard - left side | Mudguard - left side - Stone chips - Smart repair |

**Damage 3:** Mudguard - left side: Mudguard - left side - Stone chips - Smart repair

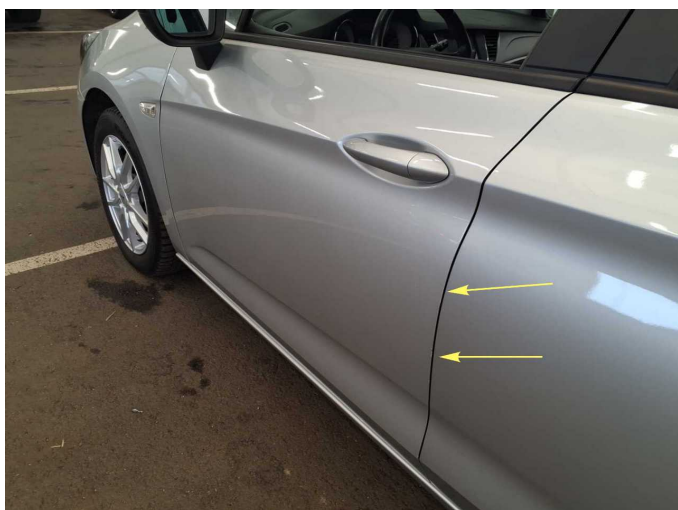
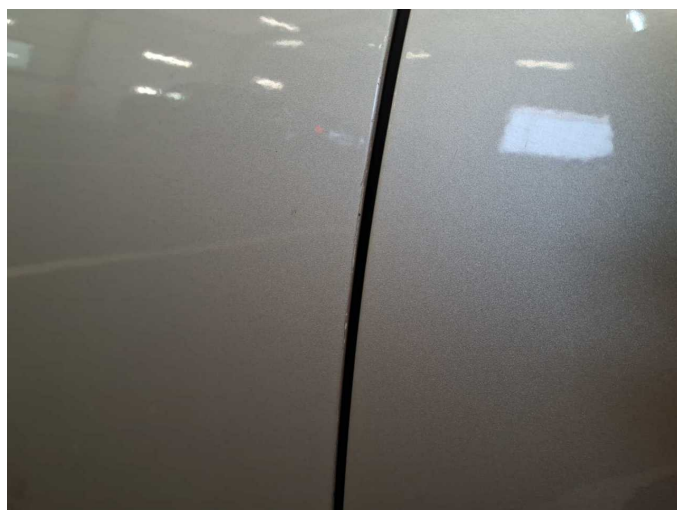
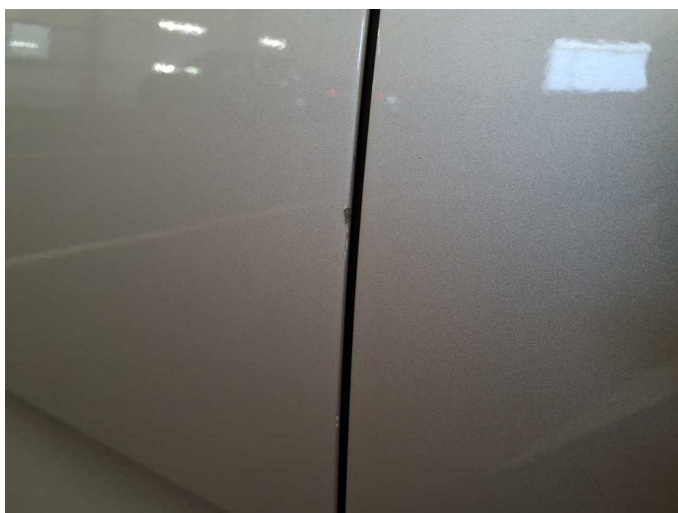
| No. | Component group | Description |
|---|---|---|
| 4 | Door - front left side | Door edge - Scratch(es) - Smart repair |

**Damage 4:** Door - front left side: Door edge - Scratch(es) - Smart repair

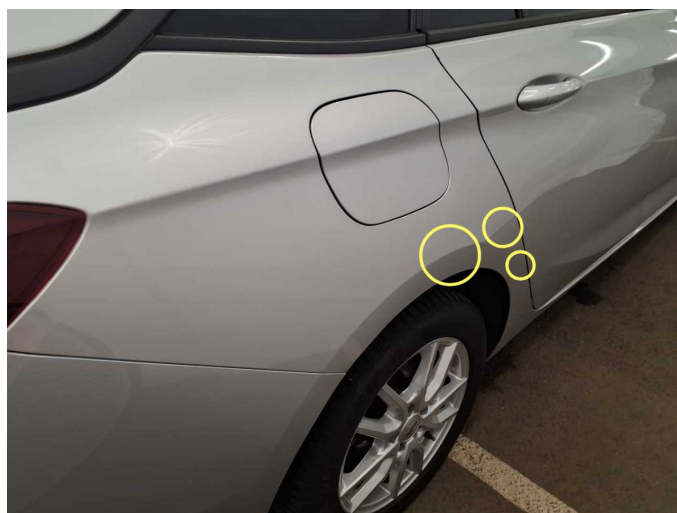
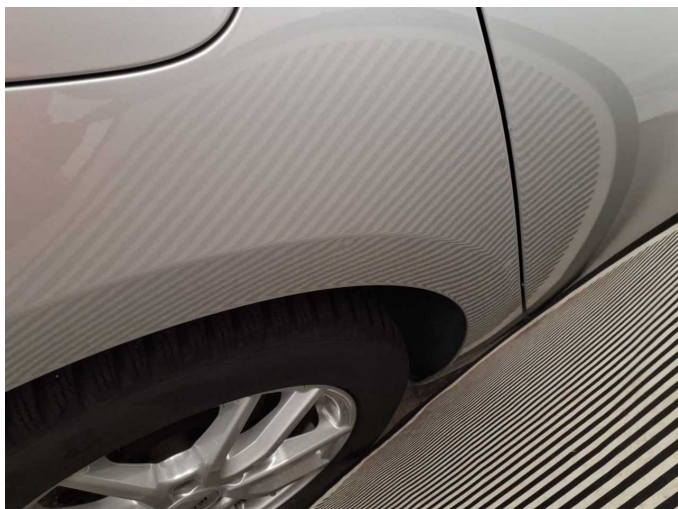
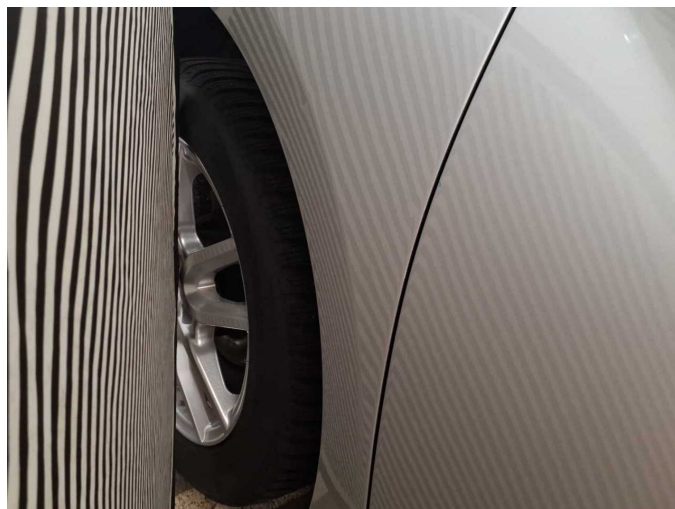
| No. | Component group | Description |
|---|---|---|
| 5 | Side panel - rear right side | Side panel (3x) - dent(s) - Smooth repair work |

**Damage 5:** Side panel - rear right side: Side panel (3x) - dent(s) - Smooth repair work

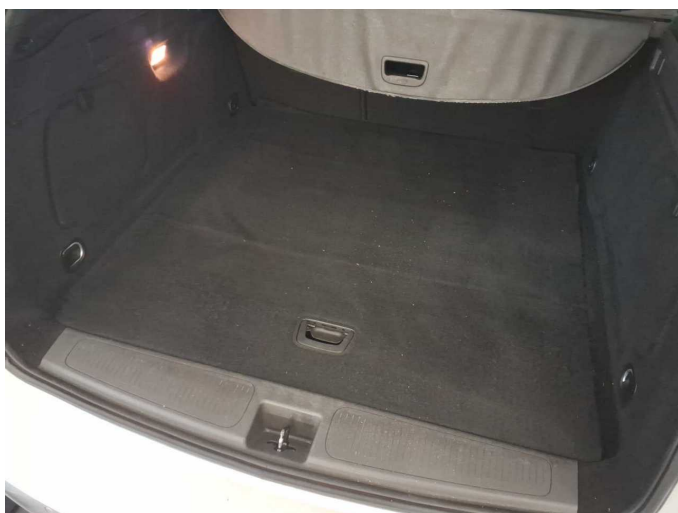
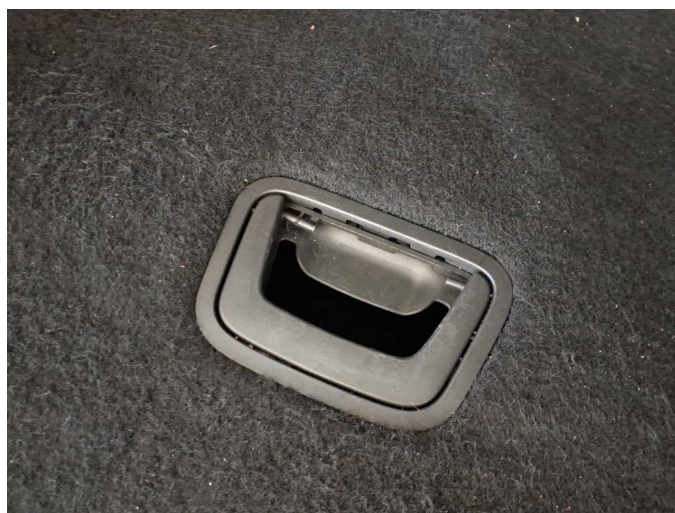
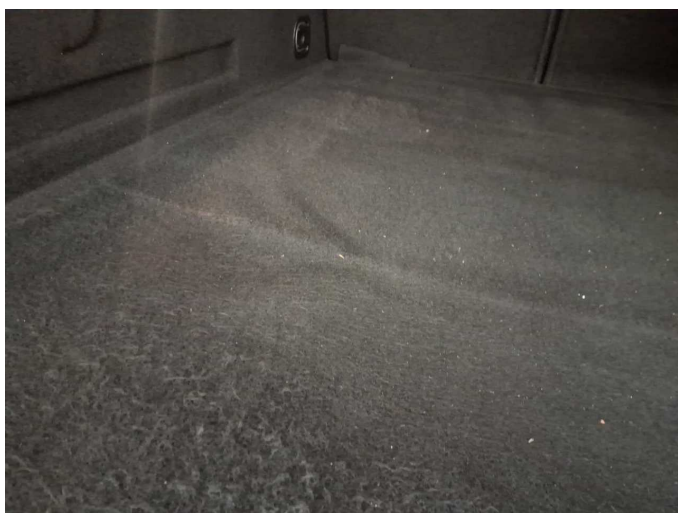
| No. | Component group | Description |
|---|---|---|
| 6 | Rear of vehicle | Boot floor - Damaged - Replace |

**Damage 6:** Rear of vehicle: Boot floor - Damaged - Replace

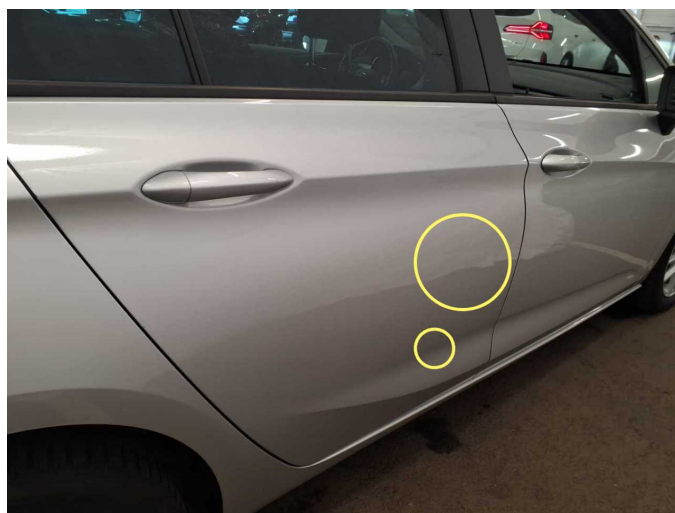
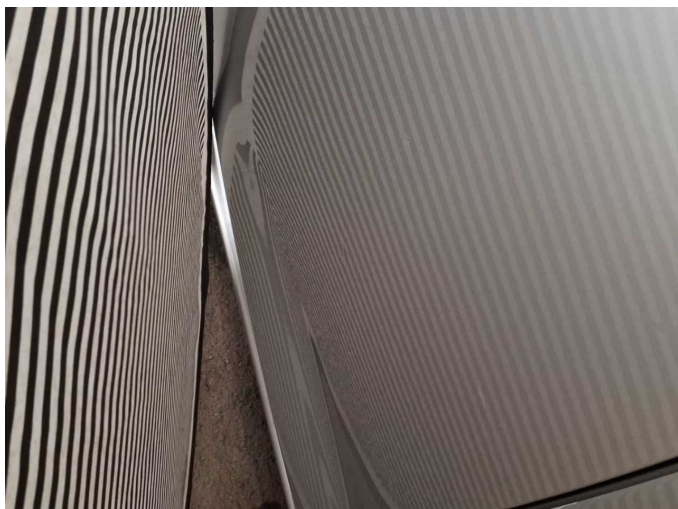
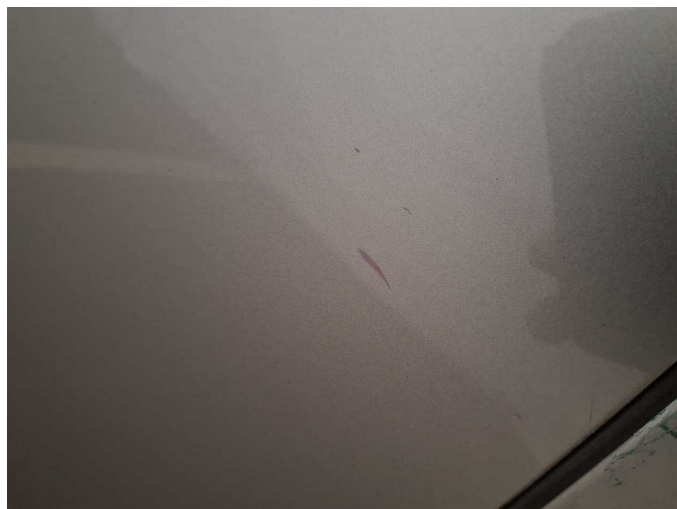
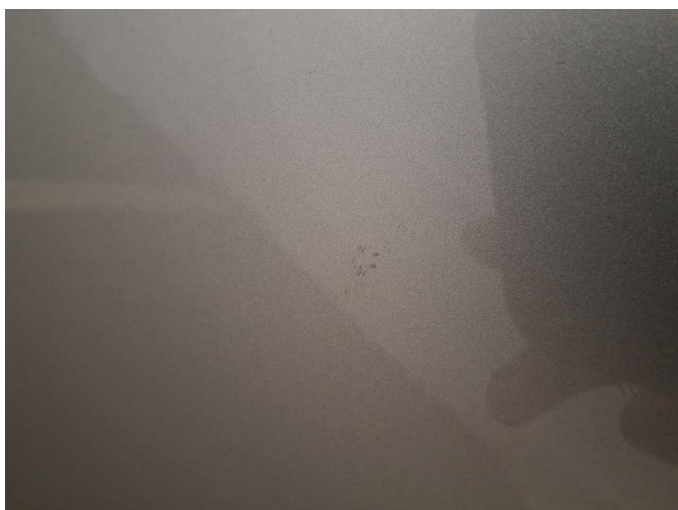
| No. | Component group | Description |
|---|---|---|
| 7 | Door - rear right side | Door - Dent / paintcoat damage - Repair and paint |

**Damage 7:** Door - rear right side: Door - Dent / paintcoat damage - Repair and paint

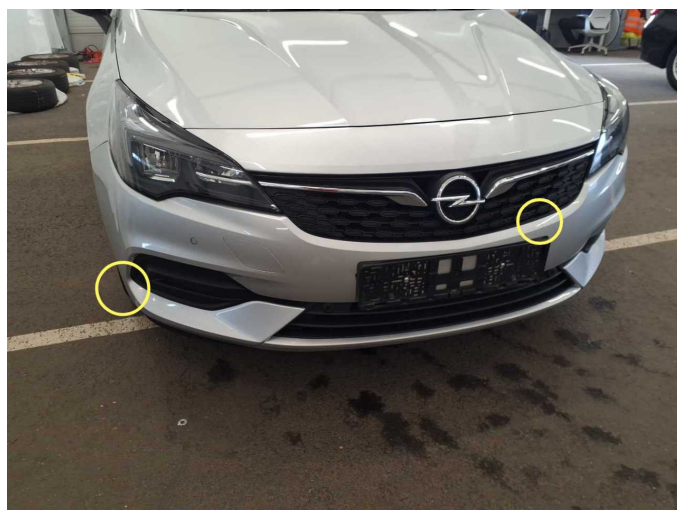
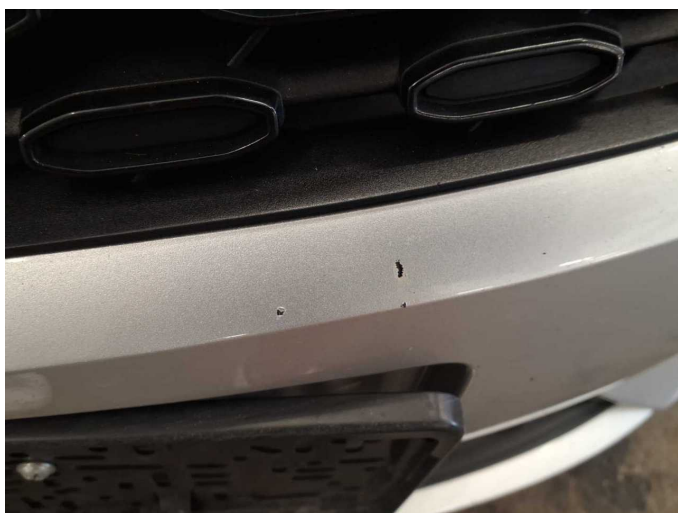
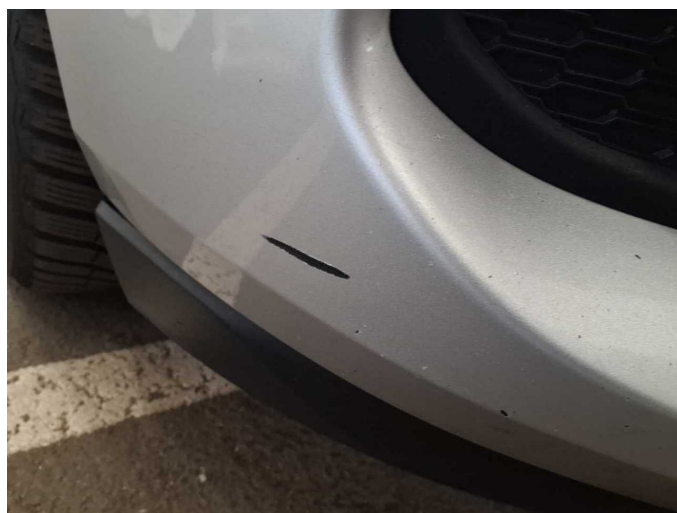
| No. | Component group | Description |
|---|---|---|
| 8 | Front bumper | Front bumper - Scratch(es) - Paint |

**Damage 8:** Front bumper: Front bumper - Scratch(es) - Paint

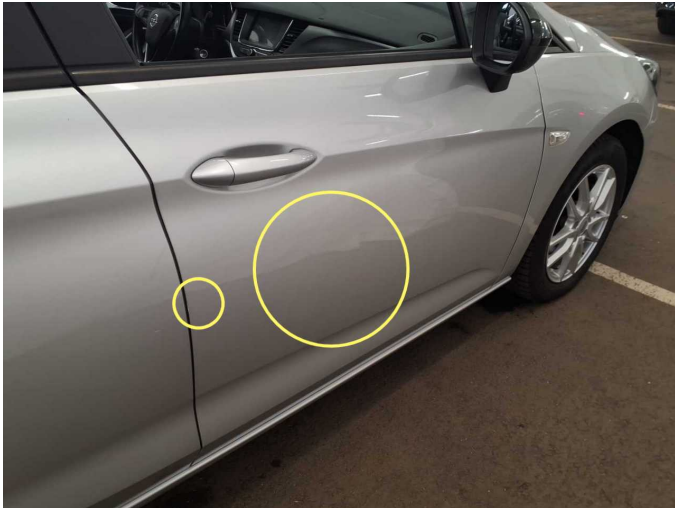
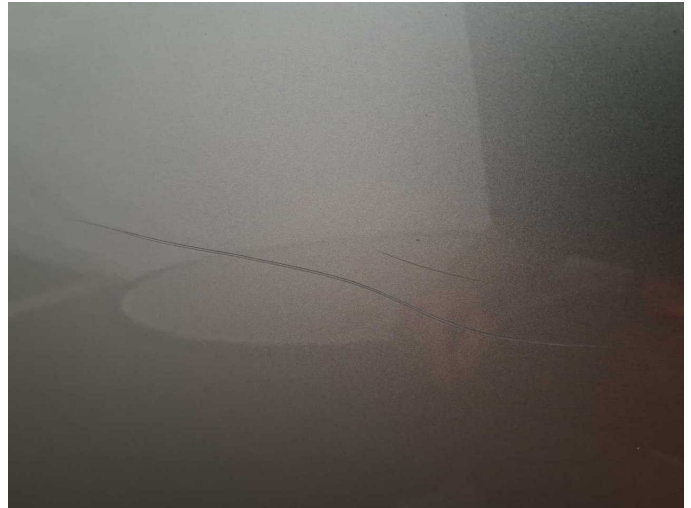
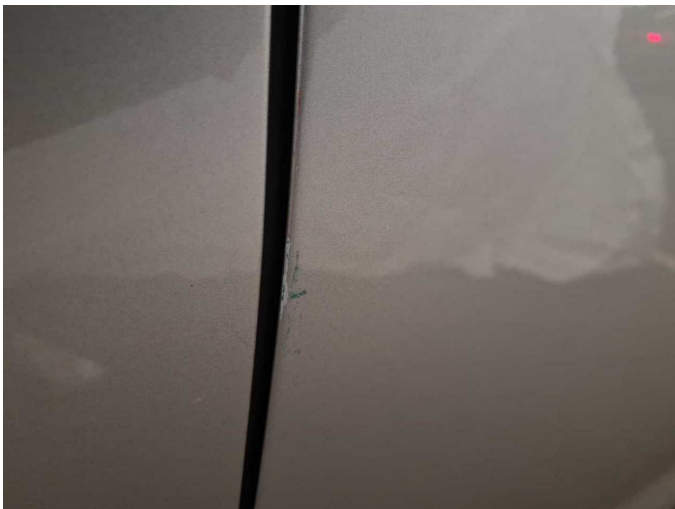
| No. | Component group | Description |
|---|---|---|
| 9 | Door - front right side | Door - Scratch(es) - Paint |

**Damage 9:** Door - front right side: Door - Scratch(es) - Paint

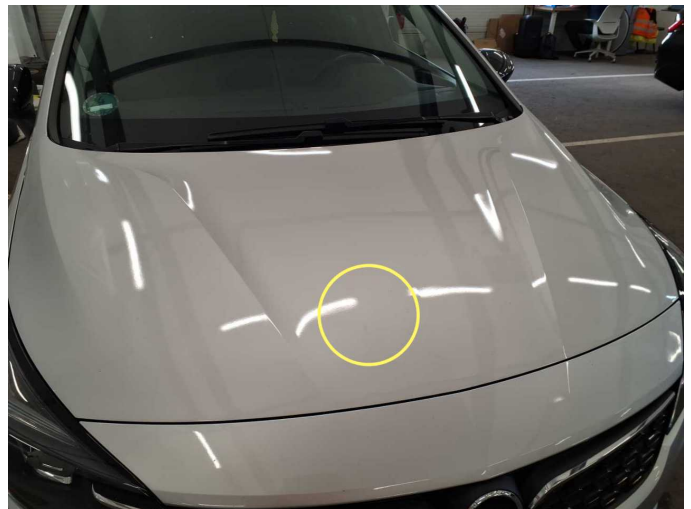
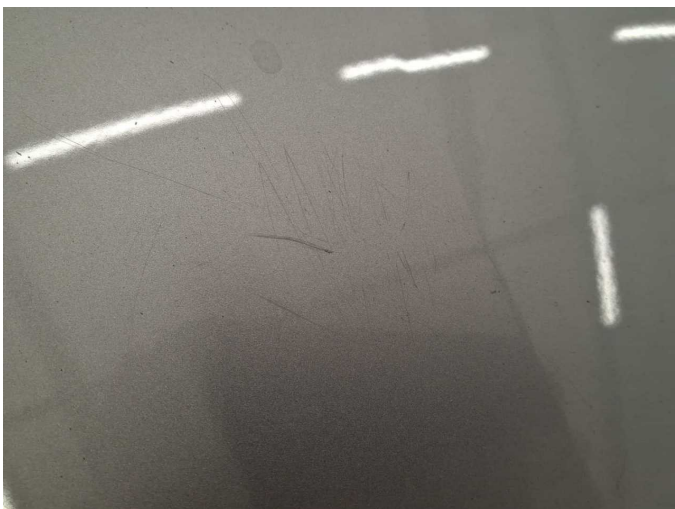
| No. | Component group | Description |
|---|---|---|
| 10 | Bonnet | Bonnet - Scratch(es) - Paint |

**Damage 10:** Bonnet: Bonnet - Scratch(es) - Paint
