Order number: 1002361776
Order completed: 12.03.2026 15:03
Report number: 10216079
VIN: TMBJJ7NS6M8503110

Vehicle category:	Passenger Car
Vehicle type:	SUV
Make:	Skoda
Model:	Kodiaq
Manufacturers and type code:	8004 / ART
Date of first registration:	14.12.2020
Mileage:	158,893 km
Proof of mileage:	ReadOff
Exterior colour:	Energy-Blau
Roof colour:	Energy-Blau
Propulsion:	Front
Fuel:	Diesel
Engine size (cc):	1,968 ccm
Performance:	110 kW (150 PS)
Length:	
Height:	
Width:	
Permitted total weight:	
Wheelbase:	
Number of powered axles:	2
Cylinders:	4
Euronorm:	Euro 6
Number of doors:	4
Number of seats:	5
Gearbox:	Automatic 7-speed
Upholstery type:	Lining fabrics
Interior colour:	Schwarz
Number of keys:	3

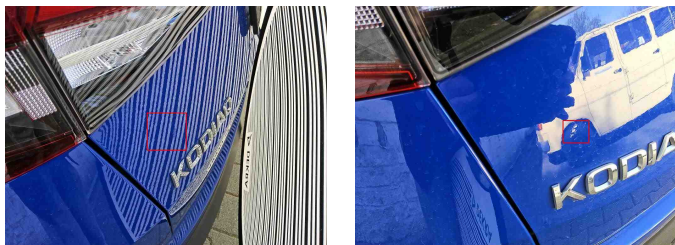
1 - Tailgate / Boot - Blistering - Paint

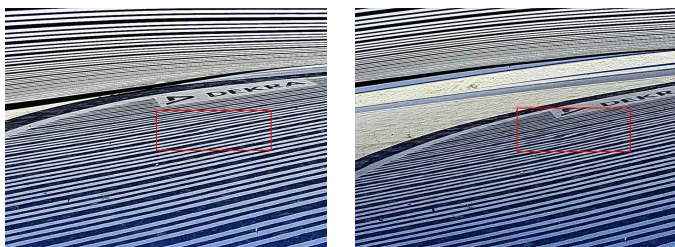
Part	Paint (µm)
Paint thickness Wing RR (µm)	204.0
Paint thickness Roof (µm)	218.0

3 - Roof - Dent(s) - Paintless dent repair

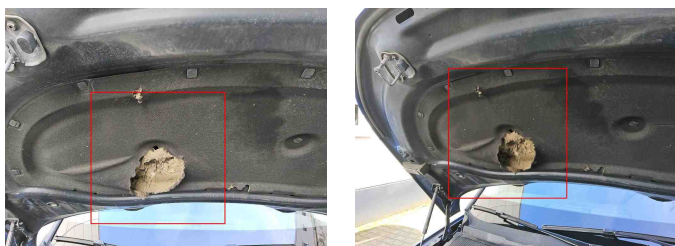
4 - Engine insulation - Damaged - Replace

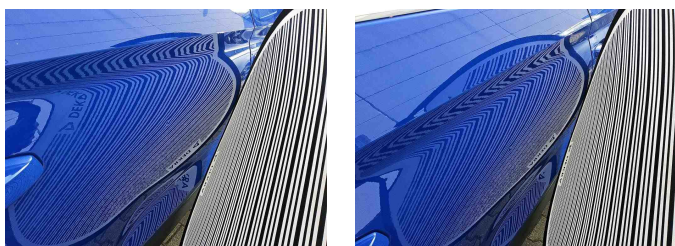
1 - Door RR - Dent(s) - Acceptable
