Expertise

Protocol number: 46907288  
Order No. / Reference: 26774990  
Inspection date: 5 Aug 2026

Manufacturer: Peugeot

Model: 508 SW BlueHdi 130 EAT8 Allure Pack

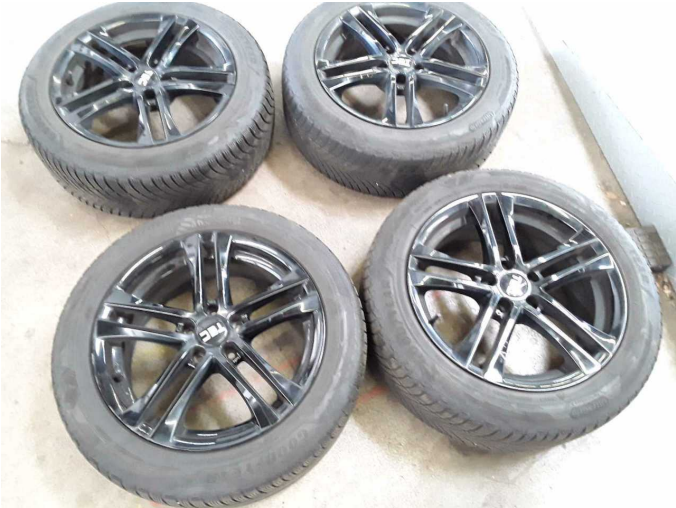
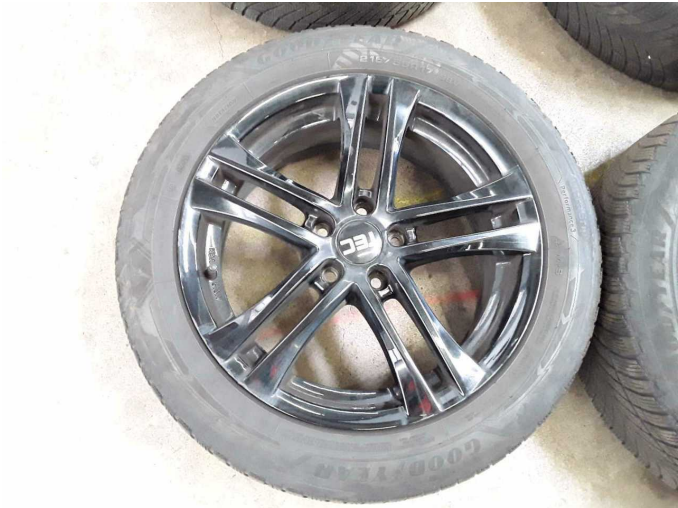
| No. | Component group | Description |
|---|---|---|
| 1 | 2nd wheel set | 2 tyres (2. Radsatz nicht in Ausstattungsliste) - Worn - No deduction |

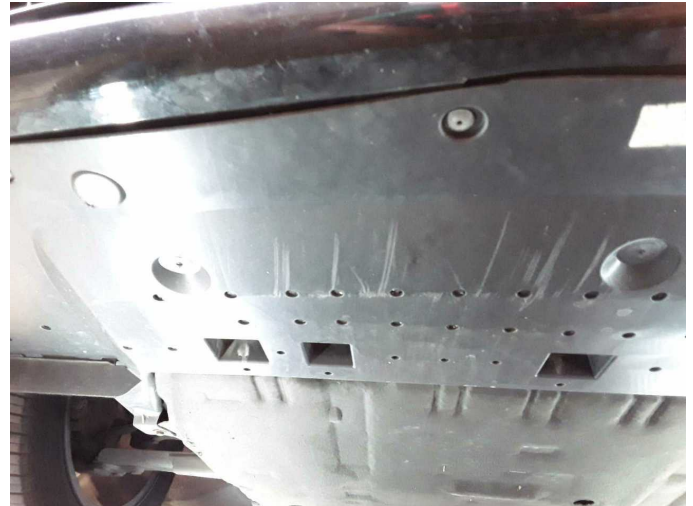
| No. | Component group | Description |
|---|---|---|
| 1 | Body | Underbody panelling - Scratched - Loss in value |

**Damage 1:** Body: Underbody panelling - Scratched - Loss in value

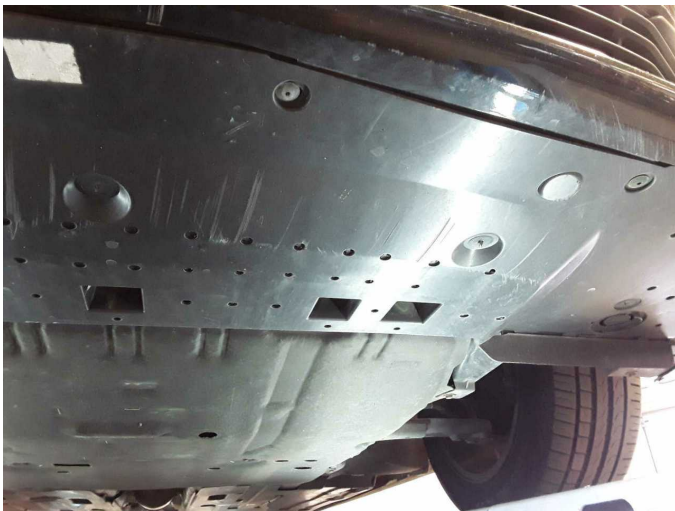
**Damage 1:** Body: Underbody panelling - Scratched - Loss in value

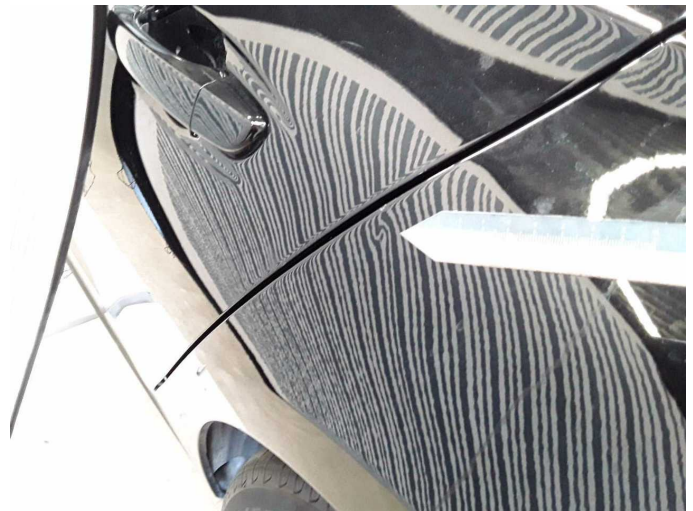
| No. | Component group | Description |
|---|---|---|
| 2 | Side panel - rear left side | Side panel - dent(s) - Smooth repair work |

**Damage 2:** Side panel - rear left side: Side panel - dent(s) - Smooth repair work

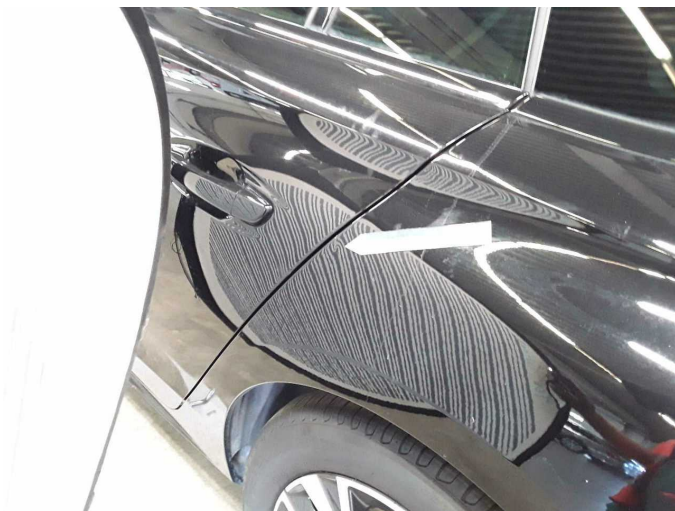
**Damage 2:** Side panel - rear left side: Side panel - dent(s) - Smooth repair work

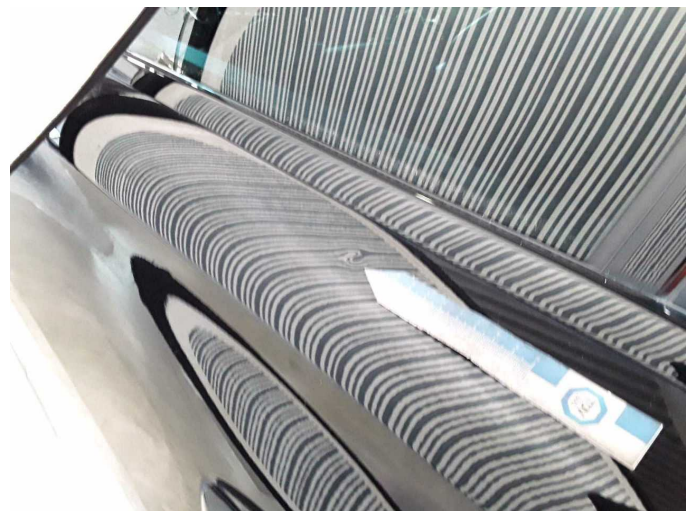
| No. | Component group | Description |
|---|---|---|
| 3 | Door - rear left side | Door - dent(s) - Smooth repair work |

**Damage 3:** Door - rear left side: Door - dent(s) - Smooth repair work

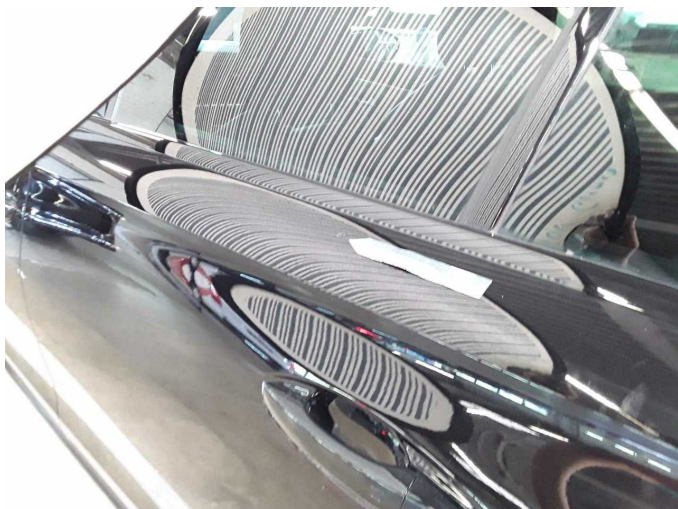
**Damage 3:** Door - rear left side: Door - dent(s) - Smooth repair work

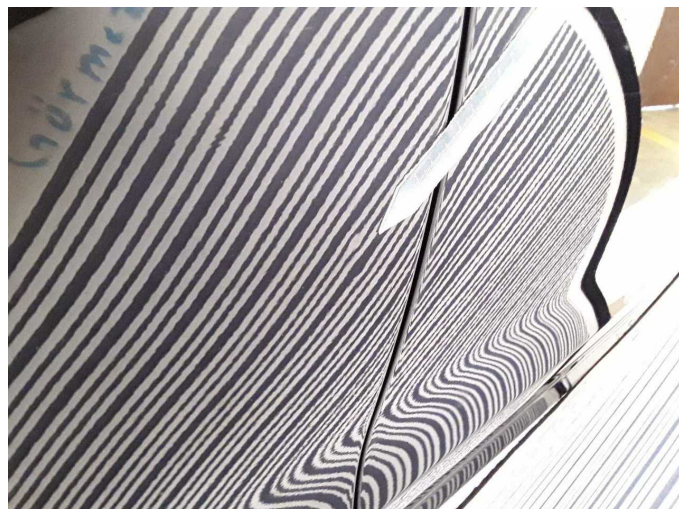
| No. | Component group | Description |
|---|---|---|
| 4 | Door - rear right side | Door (2 Dellen nebeneinander) - dent(s) - Smooth repair work |

**Damage 4:** Door - rear right side: Door (2 Dellen nebeneinander) - dent(s) - Smooth repair work

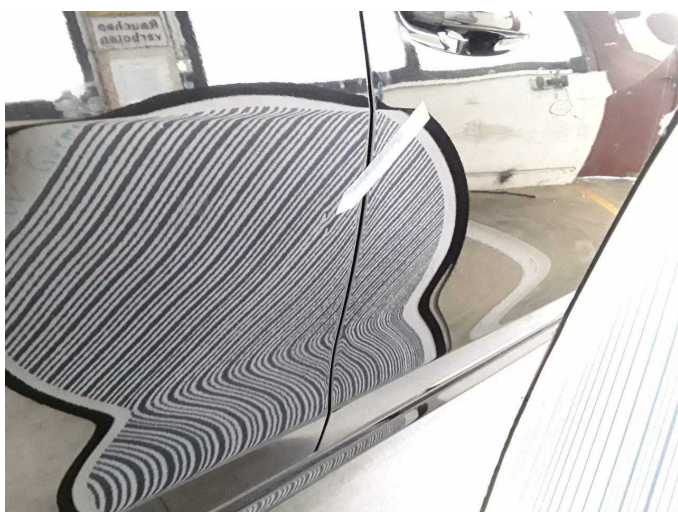
**Damage 4:** Door - rear right side: Door (2 Dellen nebeneinander) - dent(s) - Smooth repair work

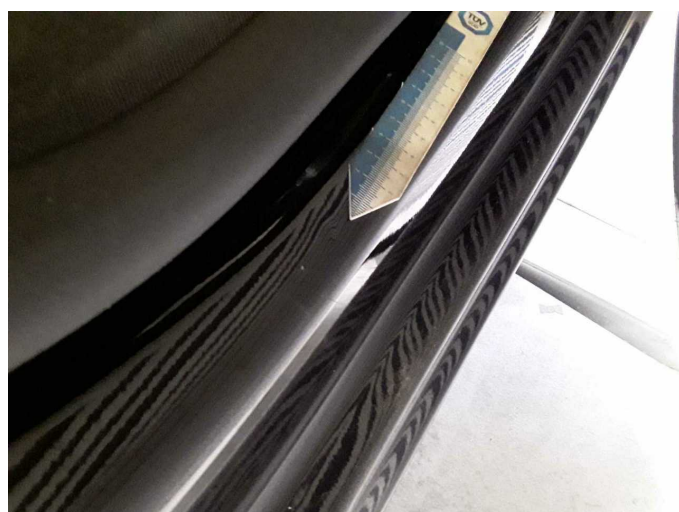
| No. | Component group | Description |
|---|---|---|
| 5 | Side panel - rear right side | Elbow - dent(s) - Smooth repair work |

**Damage 5:** Side panel - rear right side: Elbow - dent(s) - Smooth repair work

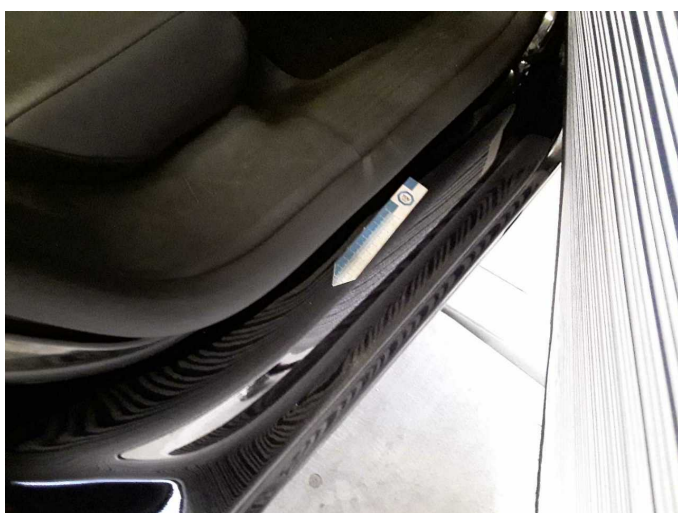
**Damage 5:** Side panel - rear right side: Elbow - dent(s) - Smooth repair work

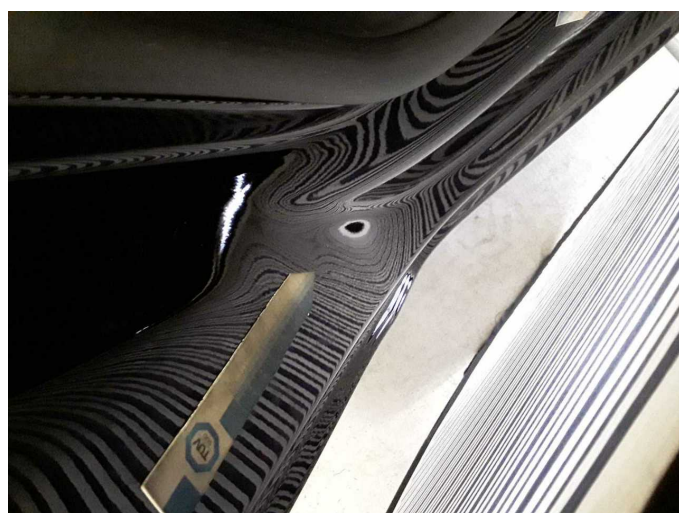
**Damage 5:** Side panel - rear right side: Elbow - dent(s) - Smooth repair work

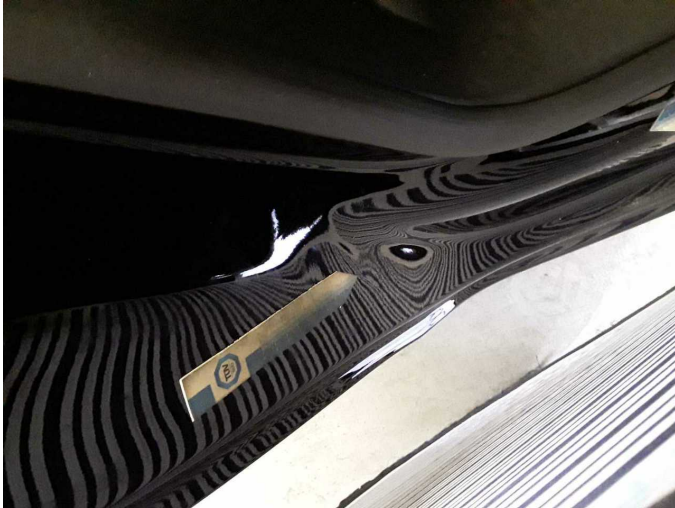
**Damage 5:** Side panel - rear right side: Elbow - dent(s) - Smooth repair work

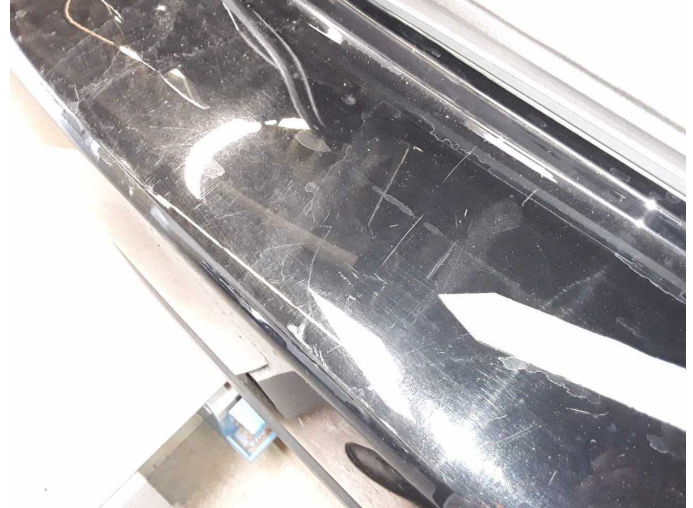
| No. | Component group | Description |
|---|---|---|
| 6 | Rear bumper | Rear bumper - Scratch(es) - Paint |

**Damage 6:** Rear bumper: Rear bumper - Scratch(es) - Paint

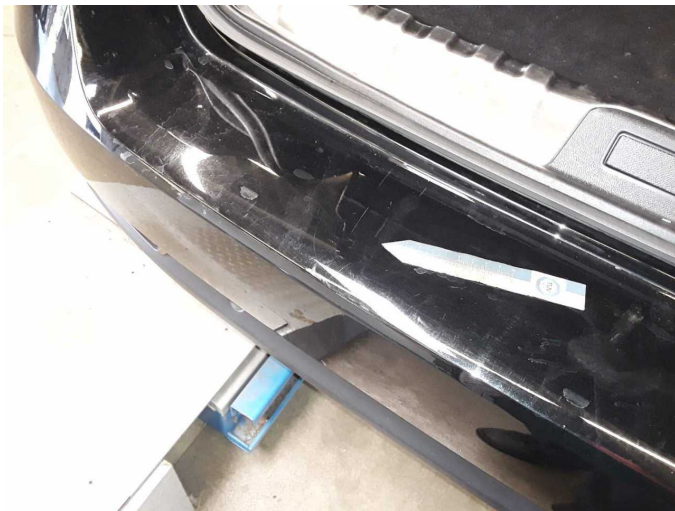
**Damage 6:** Rear bumper: Rear bumper - Scratch(es) - Paint

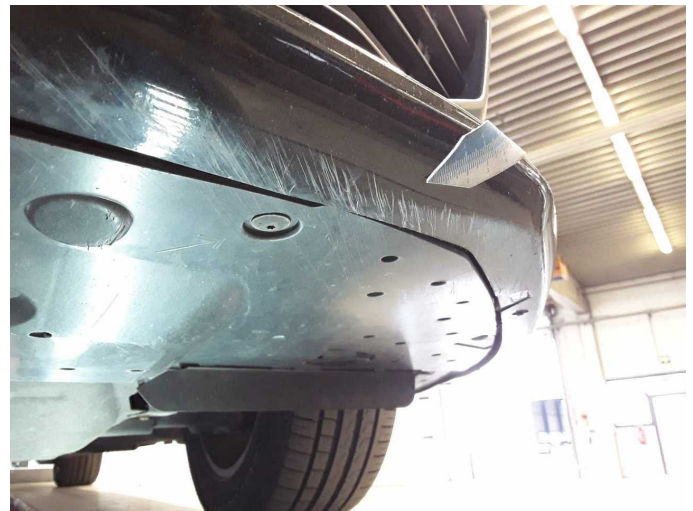
| No. | Component group | Description |
|---|---|---|
| 7 | Front bumper | Front bumper - Scratched - Paint |

**Damage 7:** Front bumper: Front bumper - Scratched - Paint

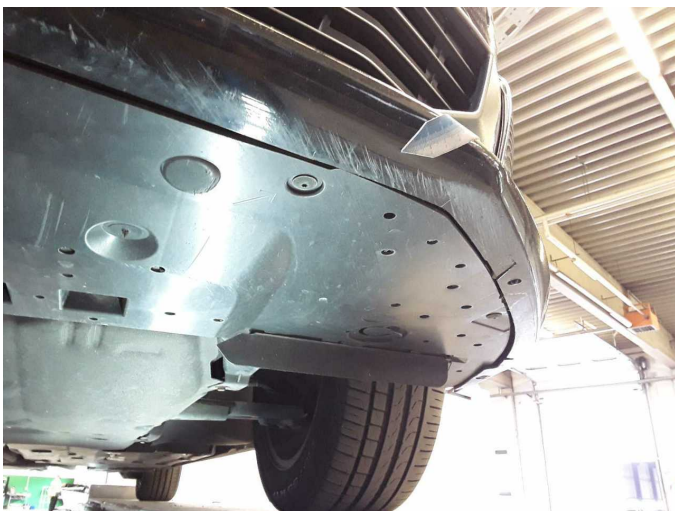
**Damage 7:** Front bumper: Front bumper - Scratched - Paint

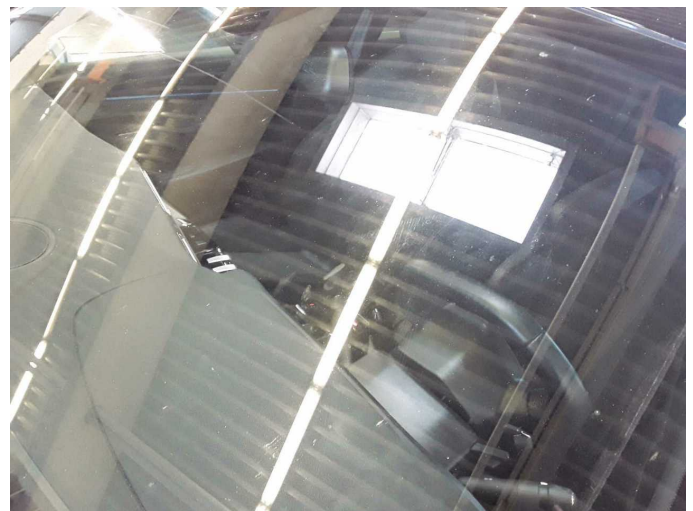
| No. | Component group | Description |
|---|---|---|
| 8 | Vehicle glazing | Windscreen (Zu viele Steinschläge) - Stone chips - Replace |

**Damage 8:** Vehicle glazing: Windscreen (Zu viele Steinschläge) - Stone chips - Replace

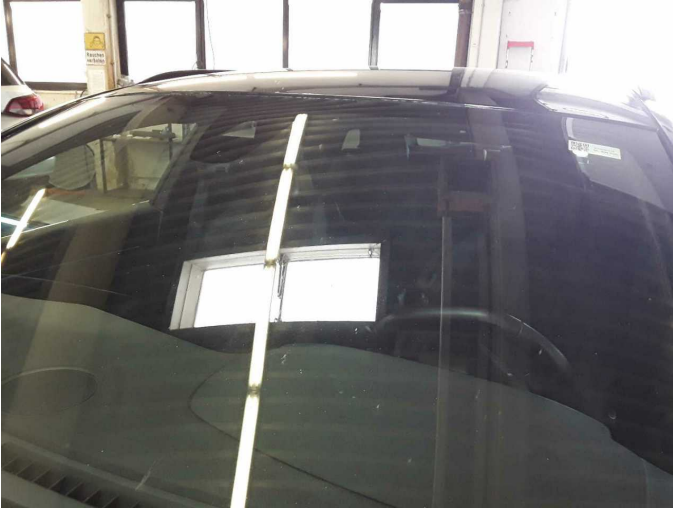
**Damage 8:** Vehicle glazing: Windscreen (Zu viele Steinschläge) - Stone chips - Replace
