Expertise

Protocol number: 45802676
Order No. / Reference: 26153469
Inspection date: 2 Jun 2026

Model: 319 CDI Sprinter 4x4 Standard 9G-TRONIC PRO

VIN: W1V3MBTZ7TP848968

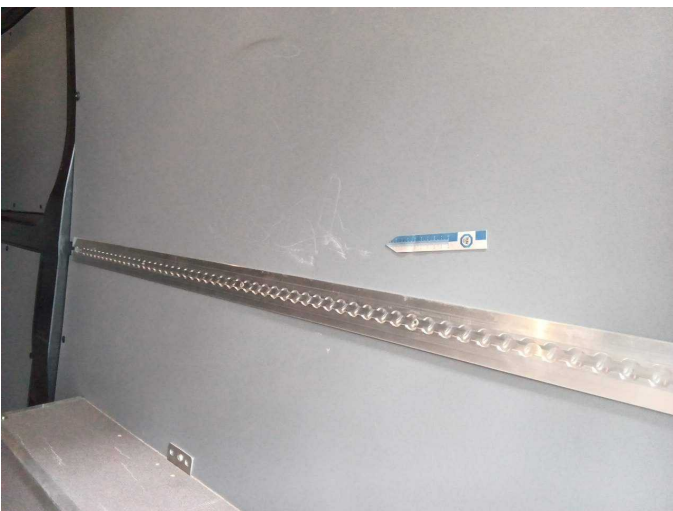
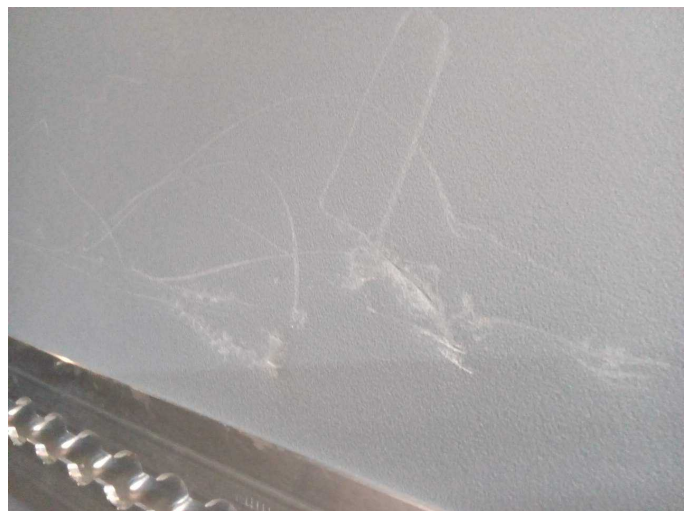
Damage 1: Side panel - rear right side: Interior trim - Scratched - Loss in value

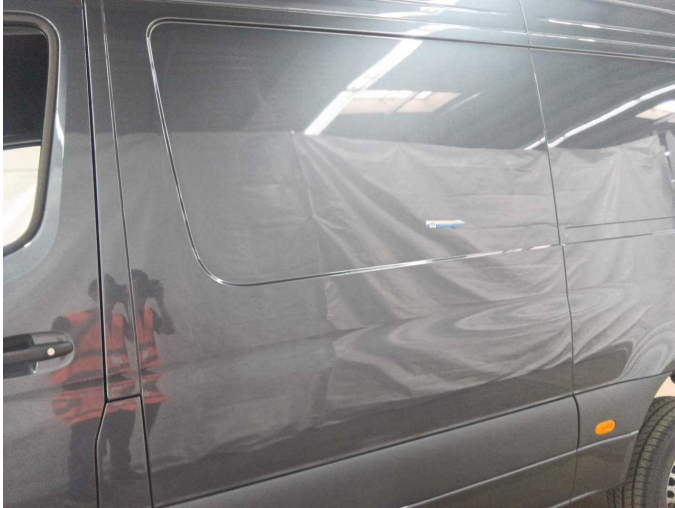
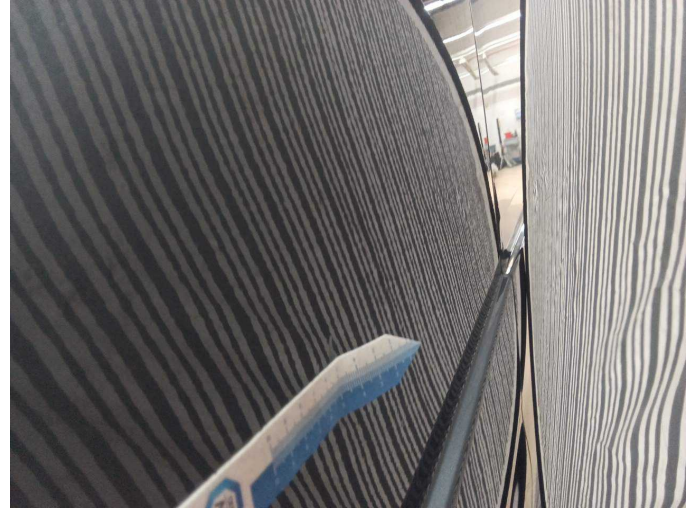
Damage 2: Side panel - rear left side: Side panel - dent(s) - Smooth repair work

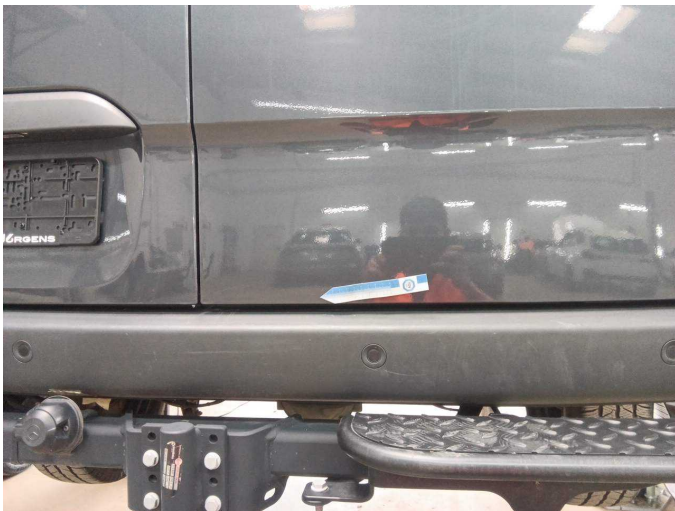
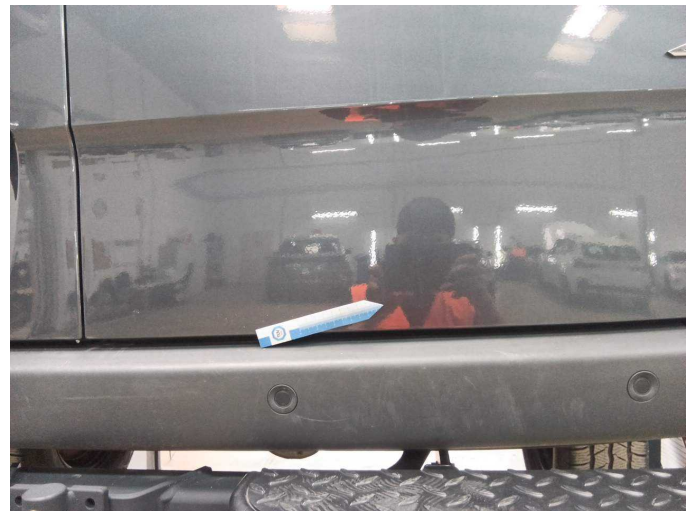
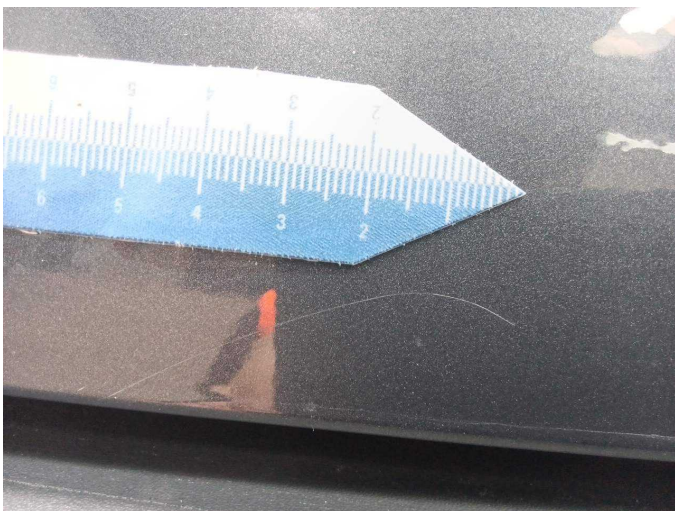
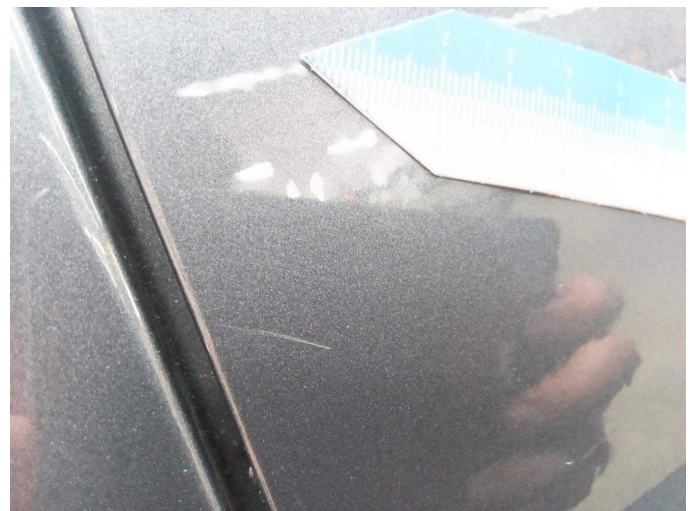
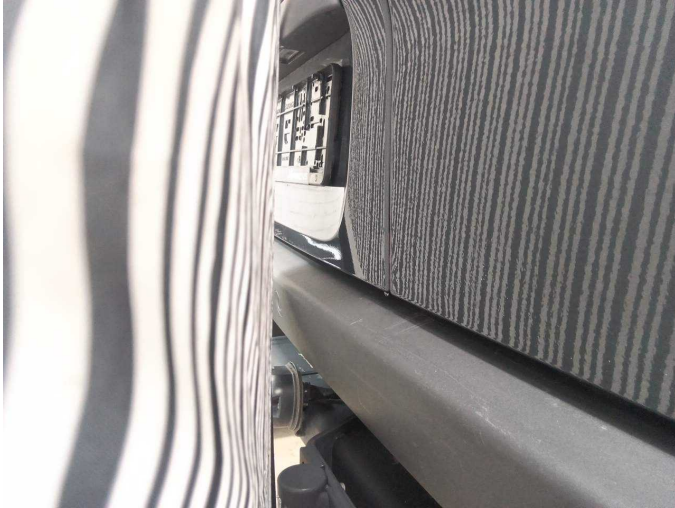
Damage 3: Boot lid / rear door: Rear door - right side - Scratch(es) - Smart repair

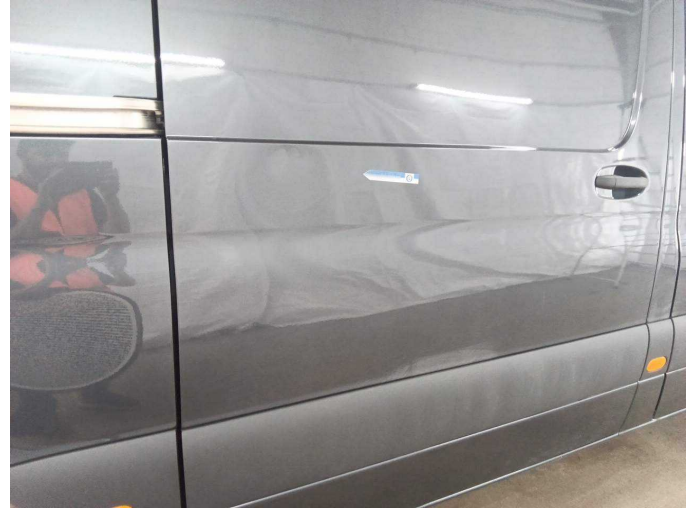
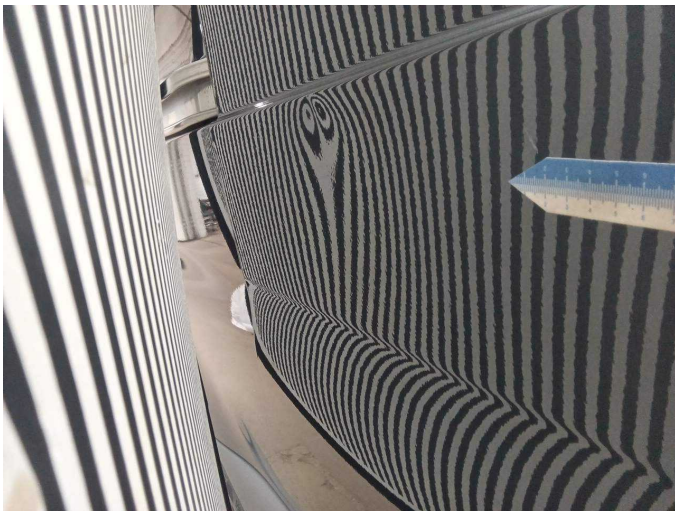
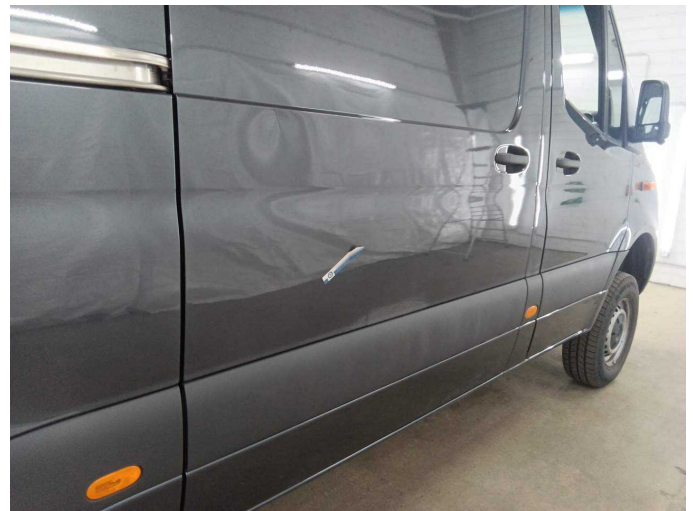
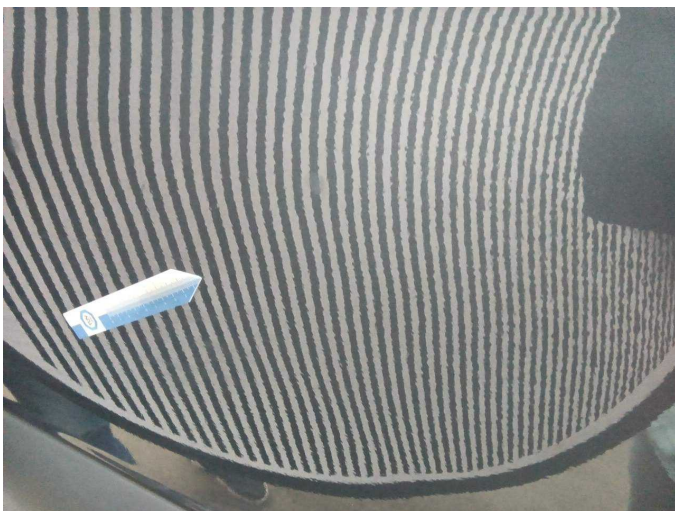
Damage 4: Sliding door, right: Sliding door - dent(s) - Smart repair

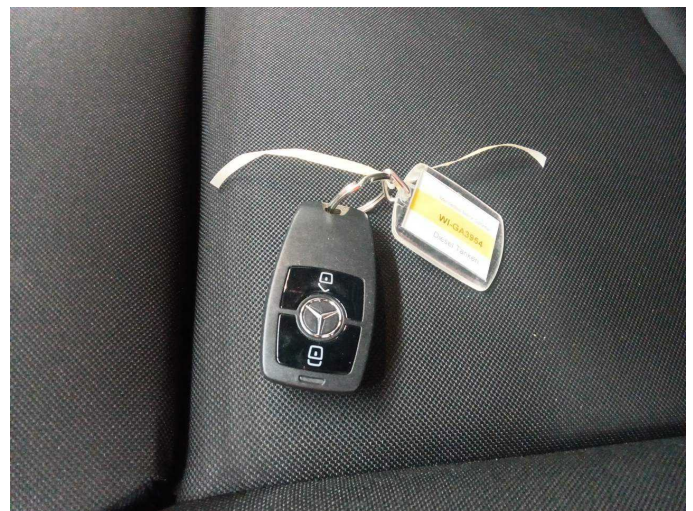
Missing part 1: Equipment: Vehicle key (1 Schlüssel vorhanden) - Missing - Perform
