**BMW X1:** [Redacted]

**Limited Technical Inspection**

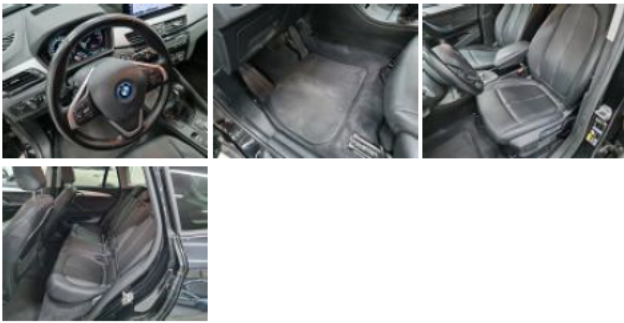
Total cost ex VAT	1164,74
Interior, Damaged, Acceptable	0,00

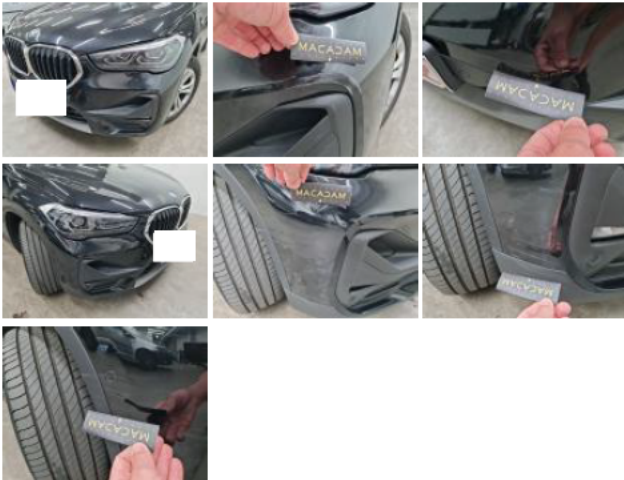
Bumper F, Scratch(es), Repair and paint (complete) 296,58
