Expertise

Protocol number: 46627503  
Order No. / Reference: 26685754  
Inspection date: 21 Jul 2026

Manufacturer: CUPRA

Model: Formentor 2.0 TDI

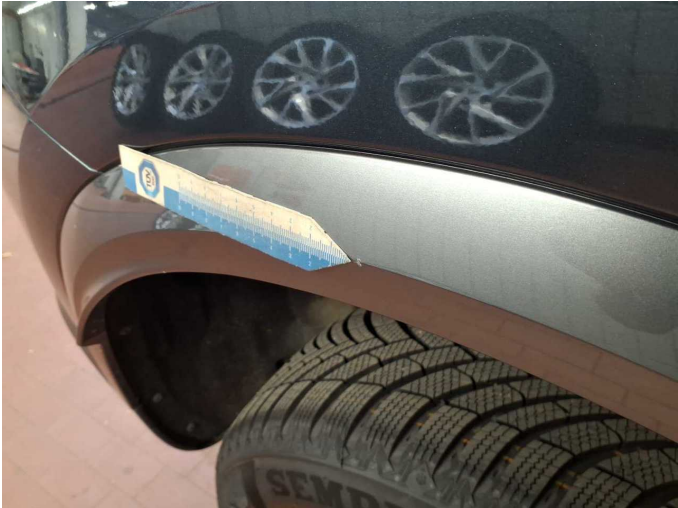
| No. | Component group | Description |
|---|---|---|
| 1 | Side panel - rear right side | Wheel well extension - Scratch(es) - Smart repair |

Damage 1: Side panel - rear right side: Wheel well extension - Scratch(es) - Smart repair

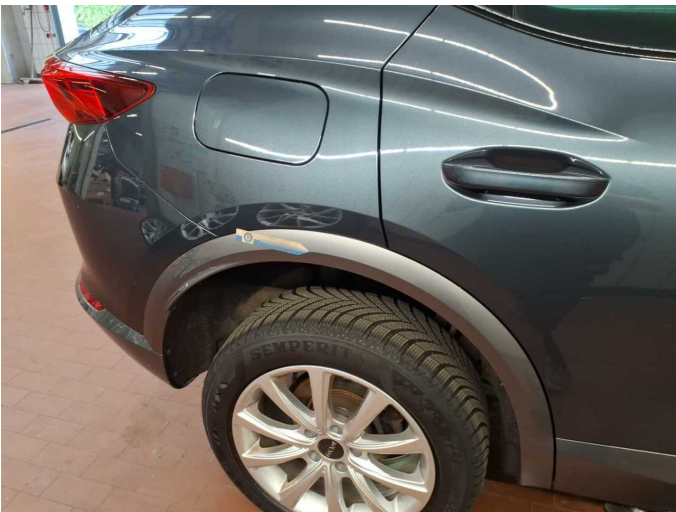
Damage 1: Side panel - rear right side: Wheel well extension - Scratch(es) - Smart repair

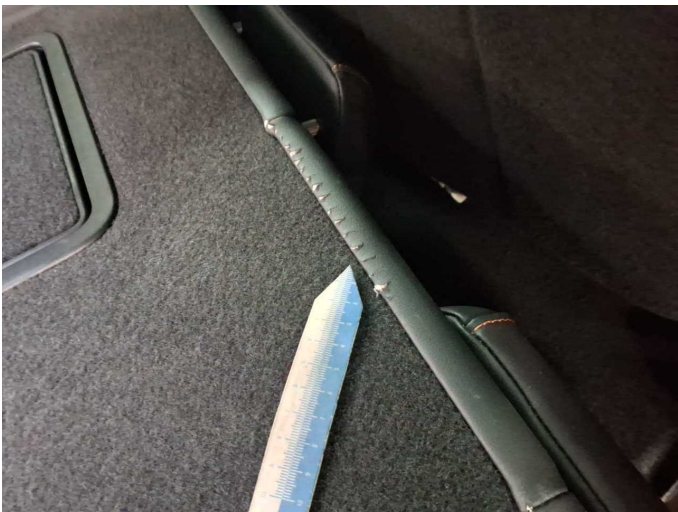
| No. | Component group | Description |
|---|---|---|
| 2 | Seat - rear | Backrest cover - Porous / cracked - Replace |

Damage 2: Seat - rear: Backrest cover - Porous / cracked - Replace

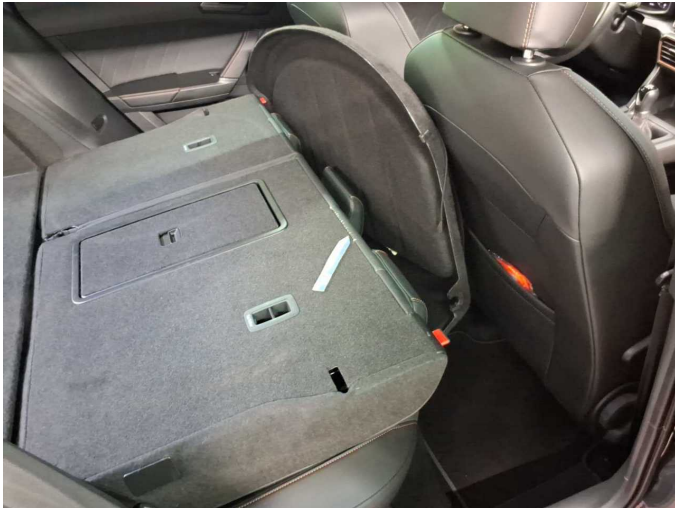
**Damage 2:** Seat - rear: Backrest cover - Porous / cracked - Replace

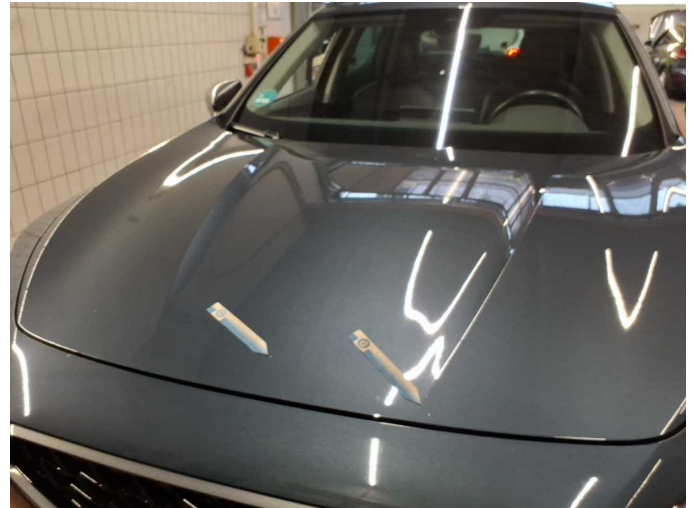
| No. | Component group | Description |
|---|---|---|
| 1 | Bonnet | Bonnet - Stone chips - No deduction |

**Wear and tear 1:** Bonnet: Bonnet - Stone chips - No deduction

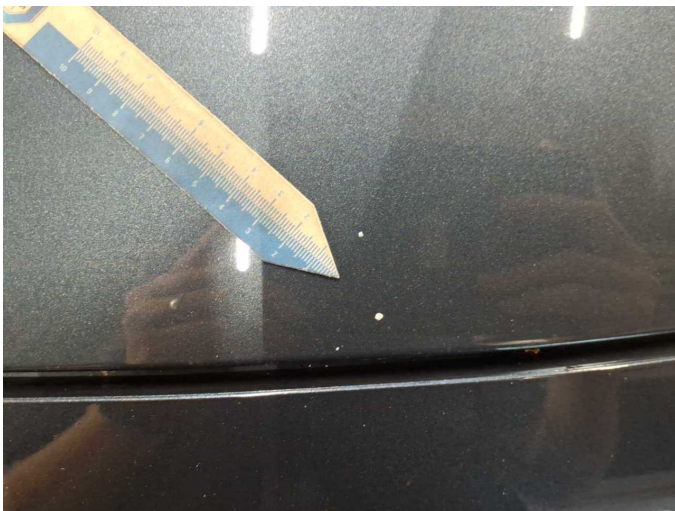
**Wear and tear 1:** Bonnet: Bonnet - Stone chips - No deduction

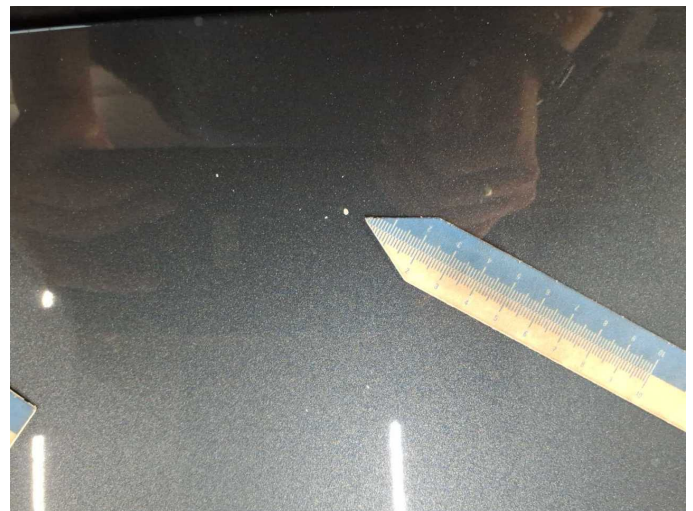
**Wear and tear 1:** Bonnet: Bonnet - Stone chips - No deduction

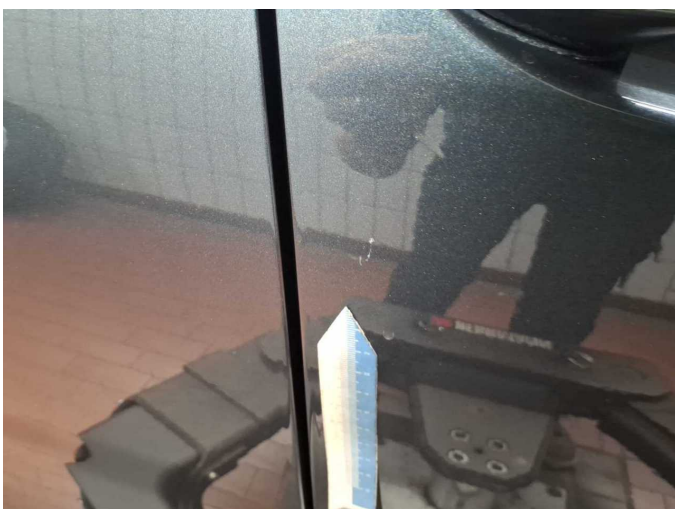
| No. | Component group | Description |
|---|---|---|
| 3 | Door - front right side | Door - Scratch(es) - No deduction |

**Wear and tear 3:** Door - front right side: Door - Scratch(es) - No deduction

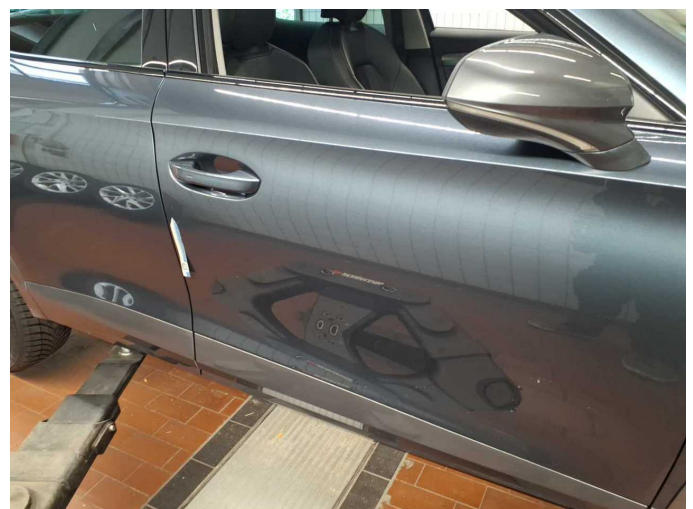
**Wear and tear 3:** Door - front right side: Door - Scratch(es) - No deduction

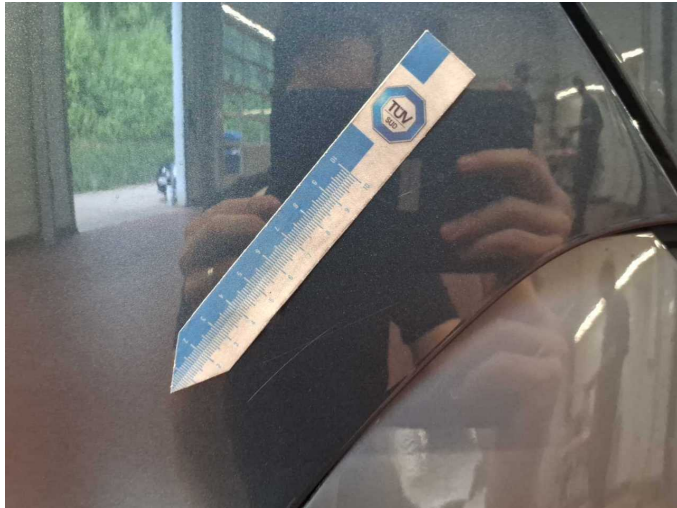
| No. | Component group | Description |
|---|---|---|
| 4 | Rear bumper | Rear bumper - Scratch(es) - No deduction |

**Wear and tear 4:** Rear bumper: Rear bumper - Scratch(es) - No deduction

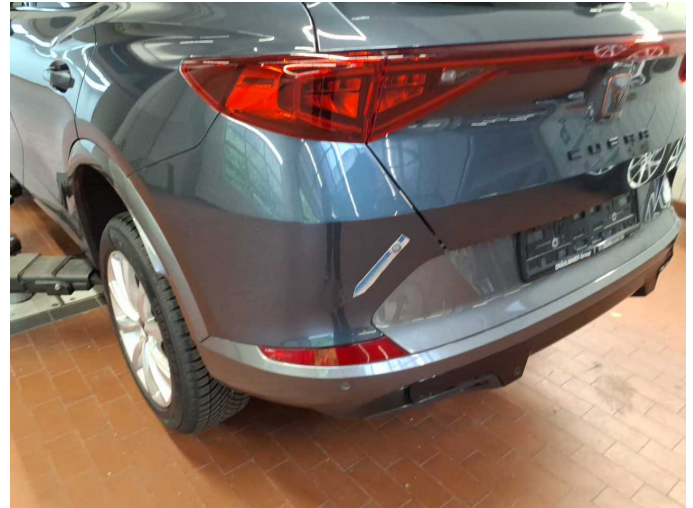
**Wear and tear 4:** Rear bumper: Rear bumper - Scratch(es) - No deduction

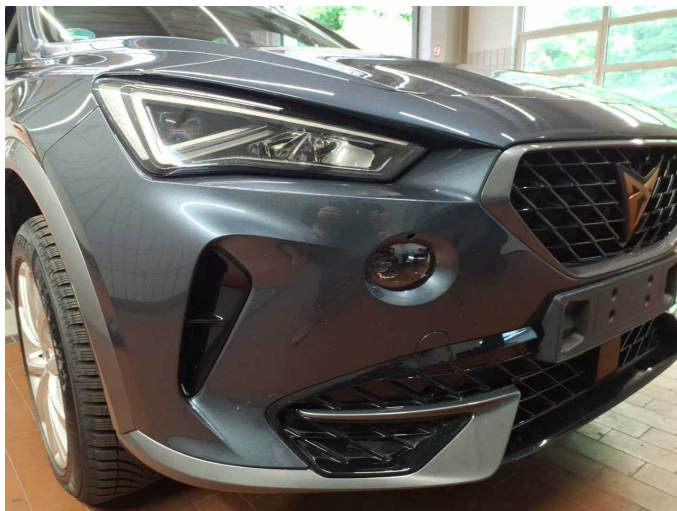
| No. | Component group | Description |
|---|---|---|
| 7 | Front bumper | Front bumper - Stone chips - No deduction |

**Wear and tear 7:** Front bumper: Front bumper - Stone chips - No deduction

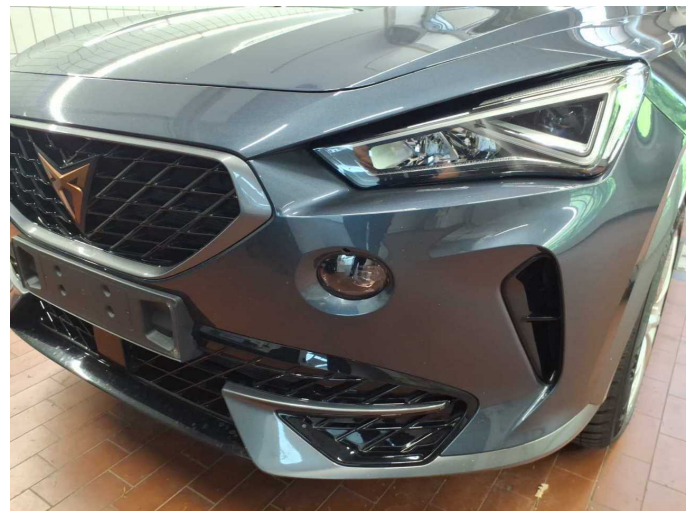
**Wear and tear 7:** Front bumper: Front bumper - Stone chips - No deduction
