Expertise

Protocol number: 46829658  
Order No. / Reference: 26566424-1  
Inspection date: 6 Jul 2026

Manufacturer: Opel

Model: Combo Life 1.2 Turbo Start/Stop Edition

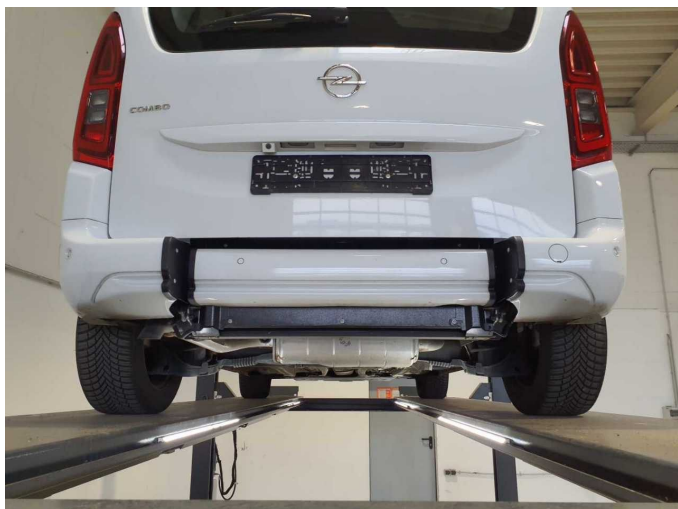
| No. | Component group | Description |
|---|---|---|
| 2 | Rear bumper | Rear bumper (Umbau Behindertentransport) - No deduction |

**Wear and tear 2:** Rear bumper: Rear bumper (Umbau Behindertentransport) - No deduction

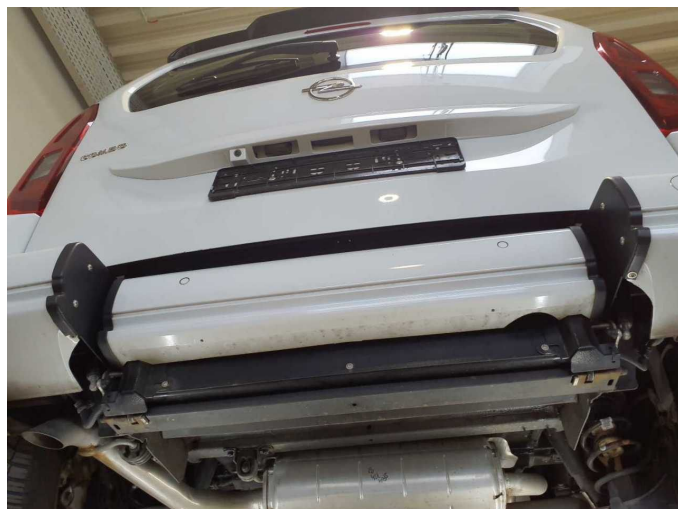
**Wear and tear 2:** Rear bumper: Rear bumper (Umbau Behindertentransport) - No deduction

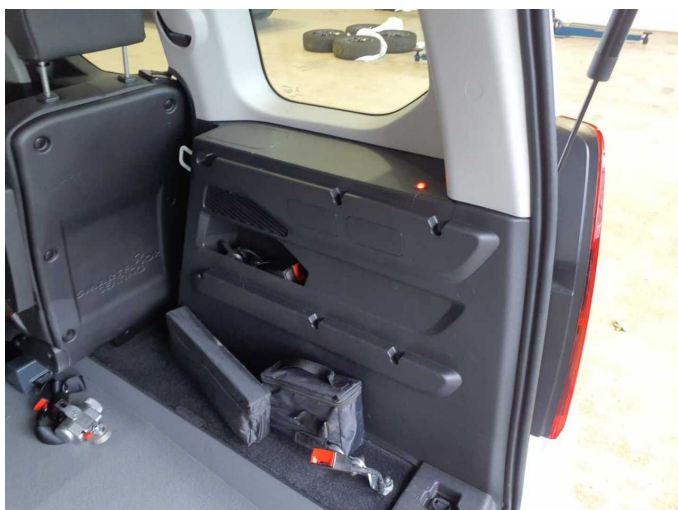
| No. | Component group | Description |
|---|---|---|
| 3 | Trim / covers | Cargo area - lining - right side (Schalter) - No deduction |

**Wear and tear 3:** Trim / covers: Cargo area - lining - right side (Schalter) - No deduction

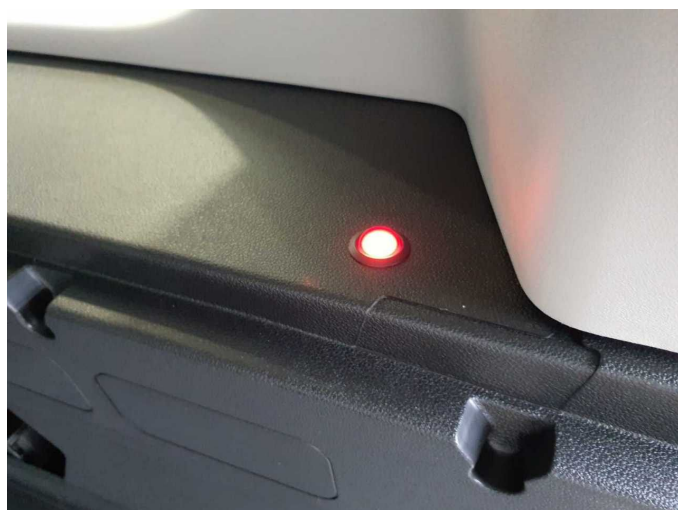
**Wear and tear 3:** Trim / covers: Cargo area - lining - right side (Schalter) - No deduction
