Expertise

Protocol number: 46307795
Order No. / Reference: 26646088
Inspection date: 2 Jul 2026

Manufacturer: Peugeot

Model: 308 SW BlueHDi 130 EAT8 Allure

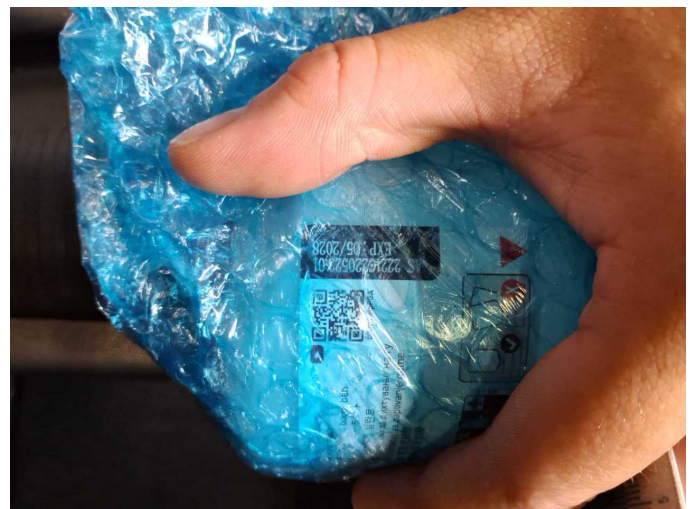
| No. | Component group | Description |
|---|---|---|
| 1 | Equipment | Tirefit filler - Empty - Replace |

Damage 1: Equipment: Tirefit filler - Empty - Replace

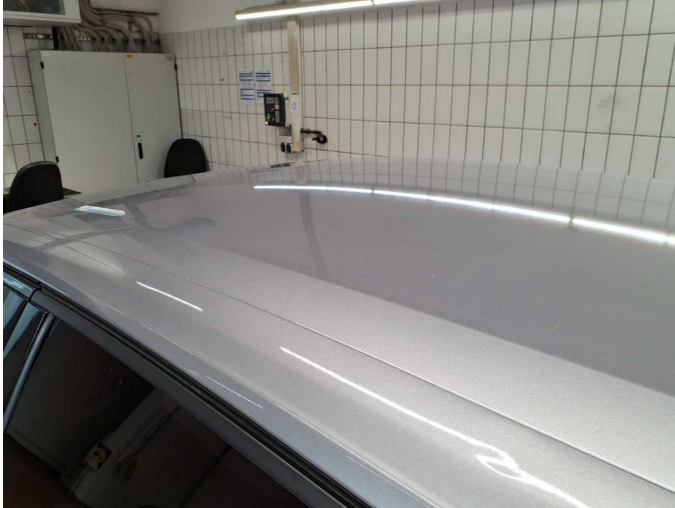
| No. | Component group | Description |
|---|---|---|
| 2 | Roof | Roof - dent(s) - Smooth repair work |

Damage 2: Roof: Roof - dent(s) - Smooth repair work

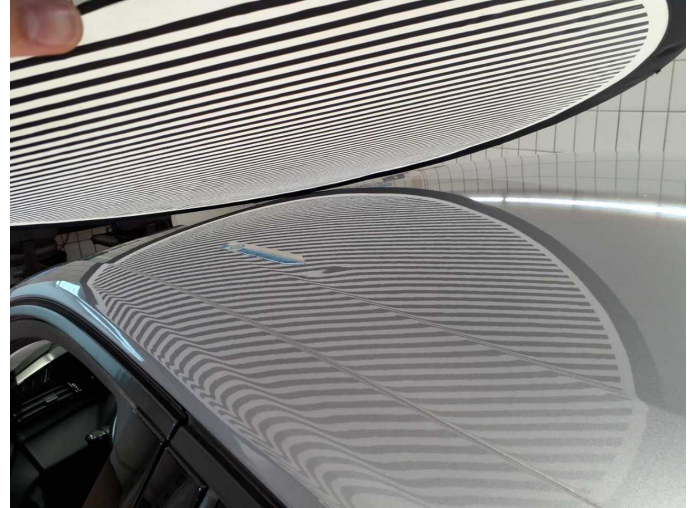
Damage 2: Roof: Roof - dent(s) - Smooth repair work

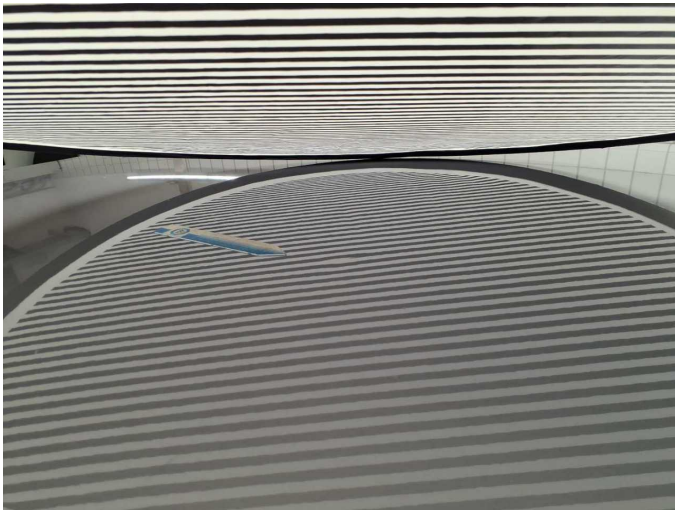
Damage 2: Roof: Roof - dent(s) - Smooth repair work

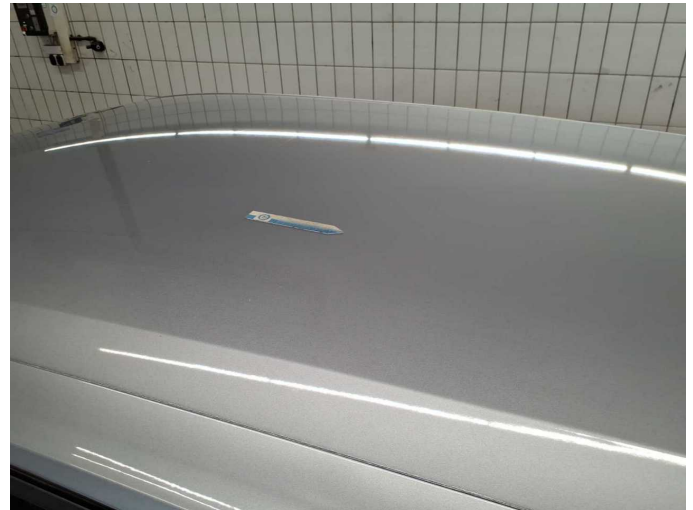
Damage 2: Roof: Roof - dent(s) - Smooth repair work

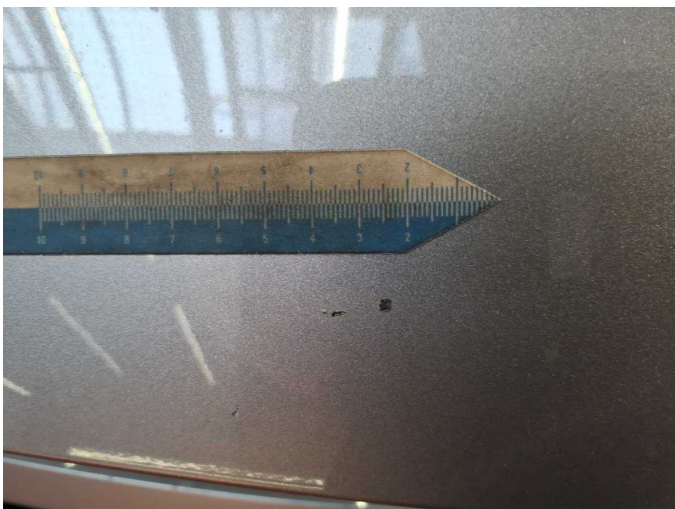
| No. | Component group | Description |
|---|---|---|
| 3 | Boot lid / rear door | Boot lid - Scratch(es) - Smart repair |

Damage 3: Boot lid / rear door: Boot lid - Scratch(es) - Smart repair

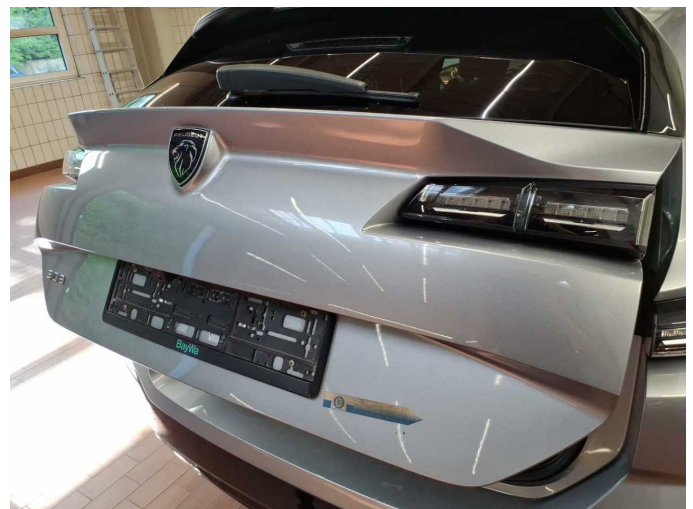
Damage 3: Boot lid / rear door: Boot lid - Scratch(es) - Smart repair

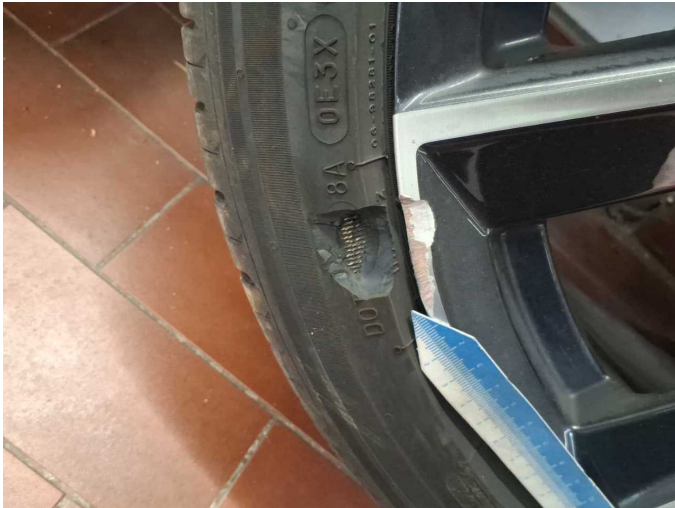
| No. | Component group | Description |
|---|---|---|
| 4 | 2nd wheel set | 1 tyre - Broken / torn - Replace |

Damage 4: 2nd wheel set: 1 tyre - Broken / torn - Replace

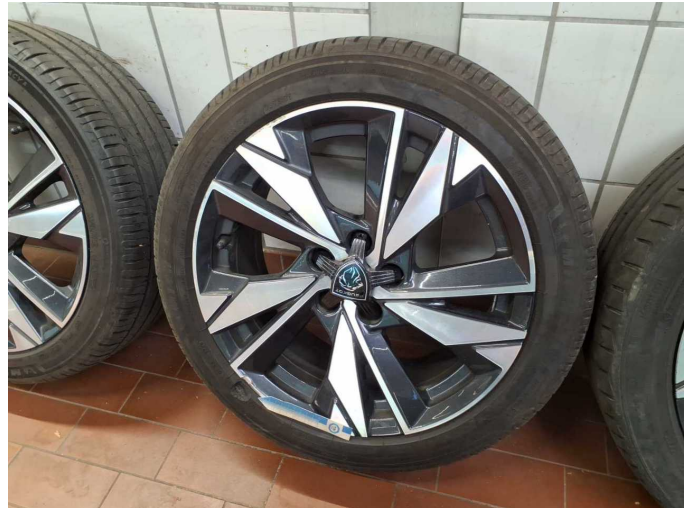
Damage 4: 2nd wheel set: 1 tyre - Broken / torn - Replace

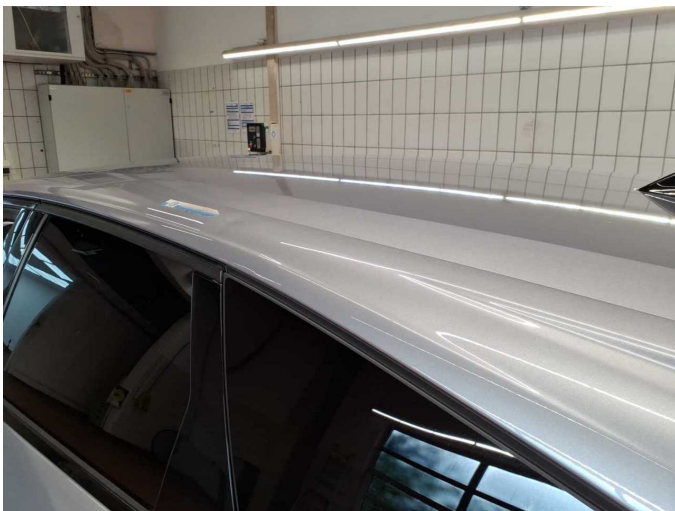
| No. | Component group | Description |
|---|---|---|
| 5 | Roof | Roof rail - left side - dent(s) - Smooth repair work |

Damage 5: Roof: Roof rail - left side - dent(s) - Smooth repair work

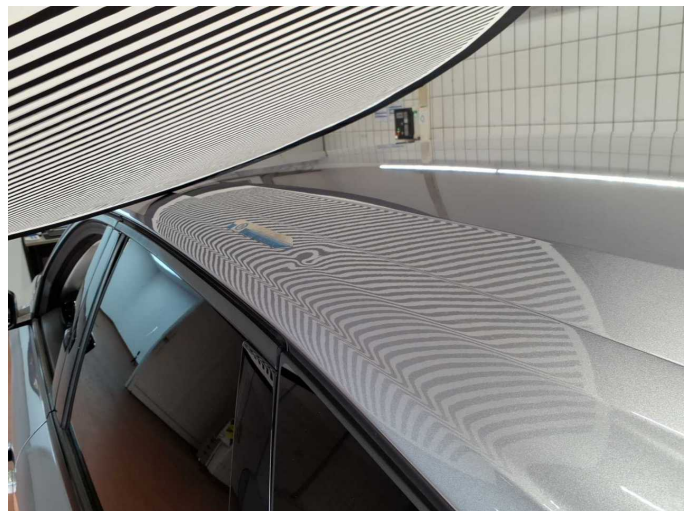
Damage 5: Roof: Roof rail - left side - dent(s) - Smooth repair work

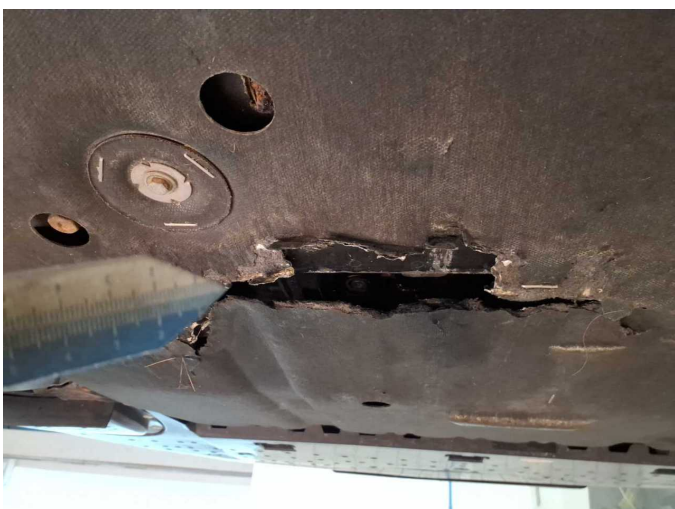
| No. | Component group | Description |
|---|---|---|
| 6 | Body | Underbody panelling (Mehrkosten können entstehen) - Broken / torn - Replace |

Damage 6: Body: Underbody panelling (Mehrkosten können entstehen) - Broken / torn - Replace

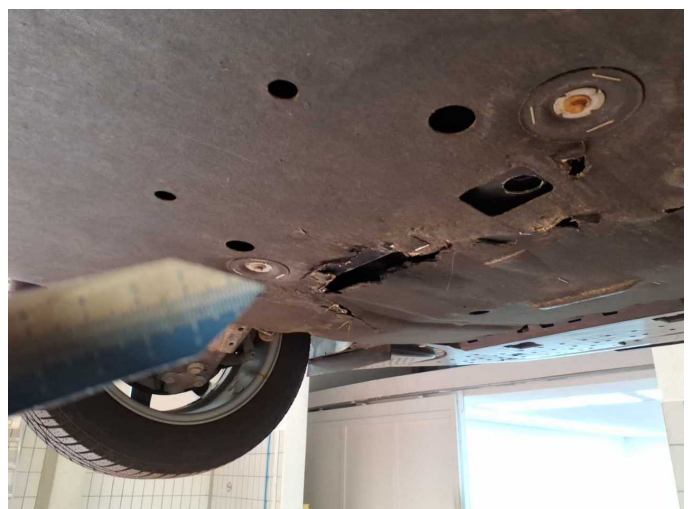
Damage 6: Body: Underbody panelling (Mehrkosten können entstehen) - Broken / torn - Replace

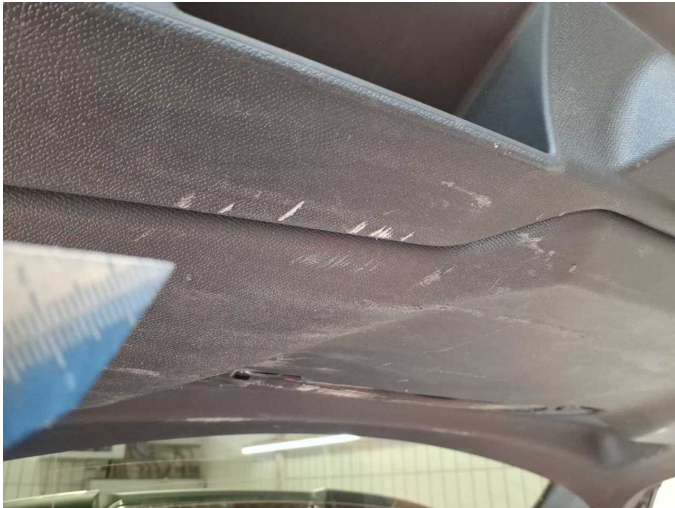
| No. | Component group | Description |
|---|---|---|
| 7 | Trim / covers | Boot lid - interior trim - Scratch(es) - Replace |

Damage 7: Trim / covers: Boot lid - interior trim - Scratch(es) - Replace

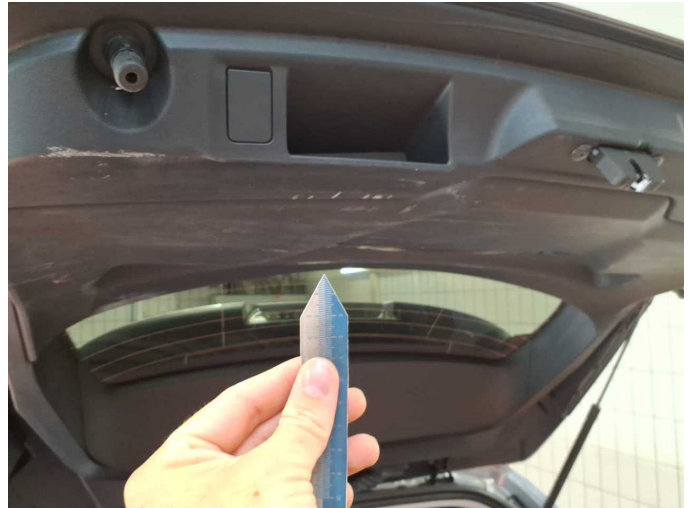
Damage 7: Trim / covers: Boot lid - interior trim - Scratch(es) - Replace

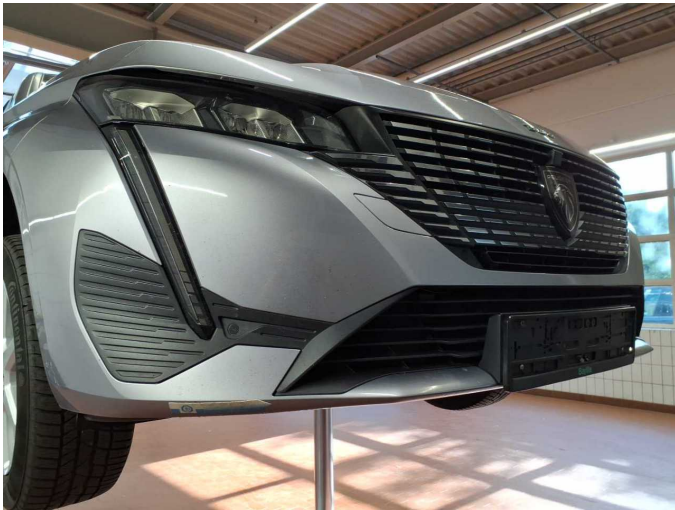
| No. | Component group | Description |
|---|---|---|
| 8 | Front bumper | Front bumper - Scratched - Paint |

Damage 8: Front bumper: Front bumper - Scratched - Paint

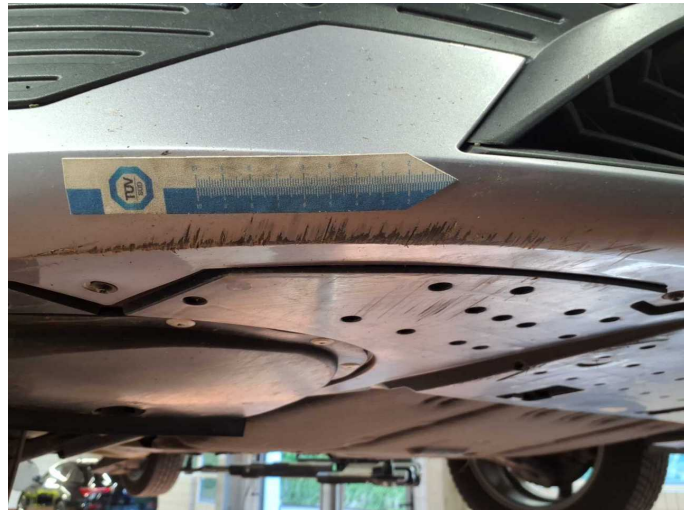
Damage 8: Front bumper: Front bumper - Scratched - Paint

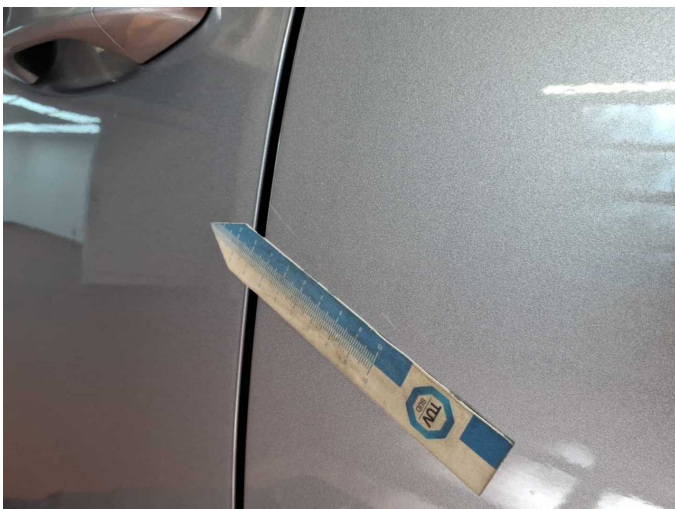
| No. | Component group | Description |
|---|---|---|
| 9 | Door - rear left side | Door - Scratch(es) - Paint |

Damage 9: Door - rear left side: Door - Scratch(es) - Paint

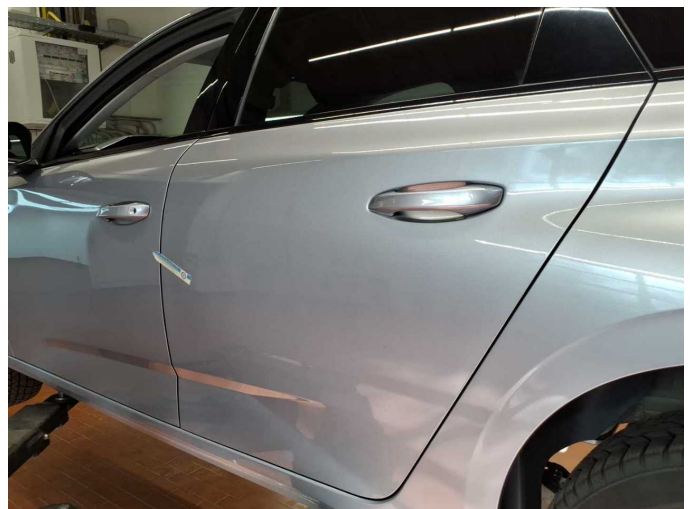
Damage 9: Door - rear left side: Door - Scratch(es) - Paint

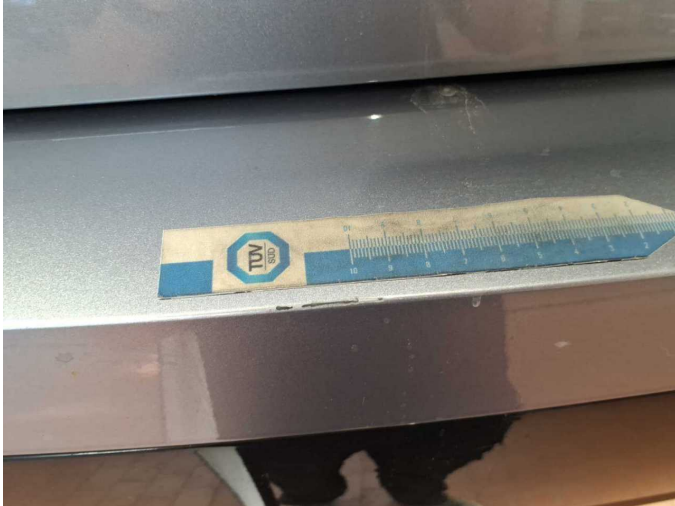
| No. | Component group | Description |
|---|---|---|
| 10 | Rear bumper | Rear bumper - Scratch(es) - Paint |

Damage 10: Rear bumper: Rear bumper - Scratch(es) - Paint

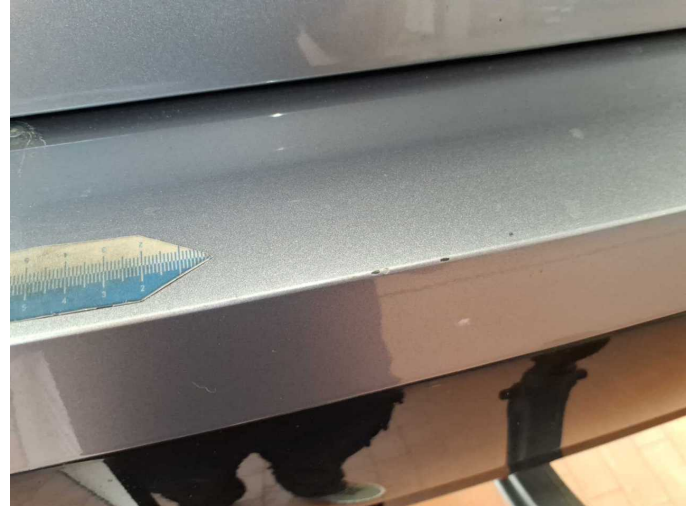
Damage 10: Rear bumper: Rear bumper - Scratch(es) - Paint

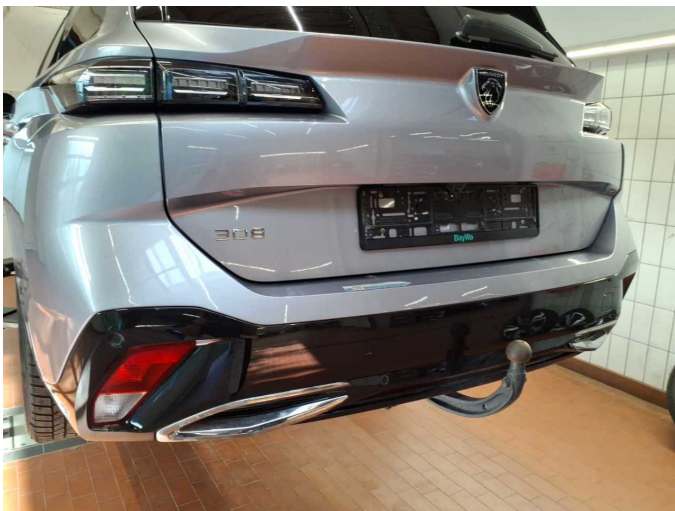
Damage 10: Rear bumper: Rear bumper - Scratch(es) - Paint

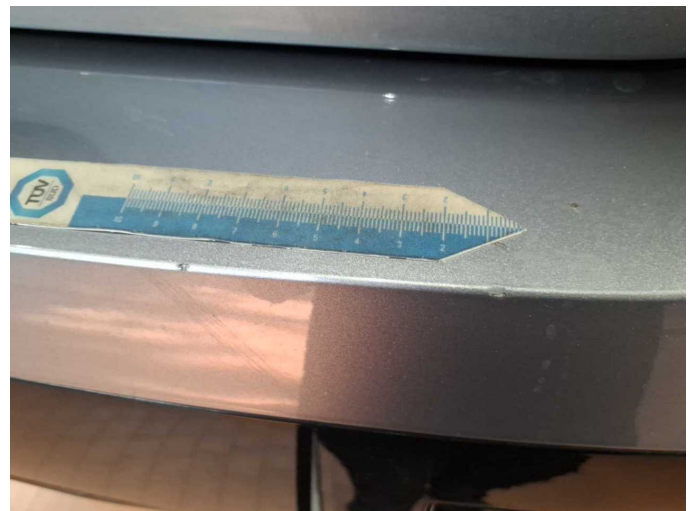
Damage 10: Rear bumper: Rear bumper - Scratch(es) - Paint

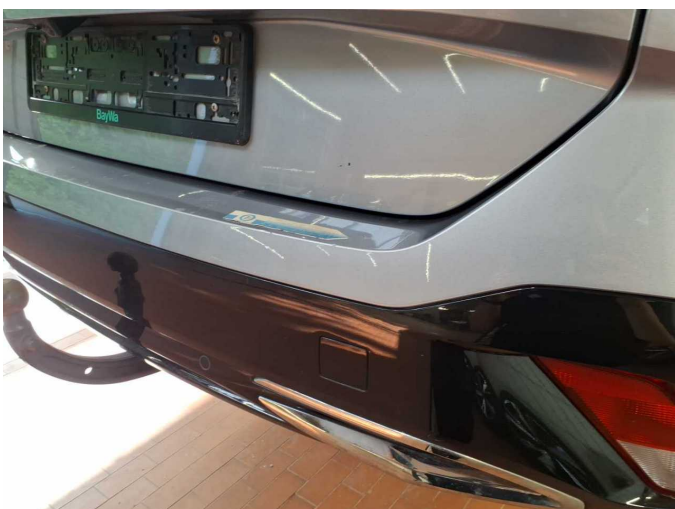
Damage 10: Rear bumper: Rear bumper - Scratch(es) - Paint

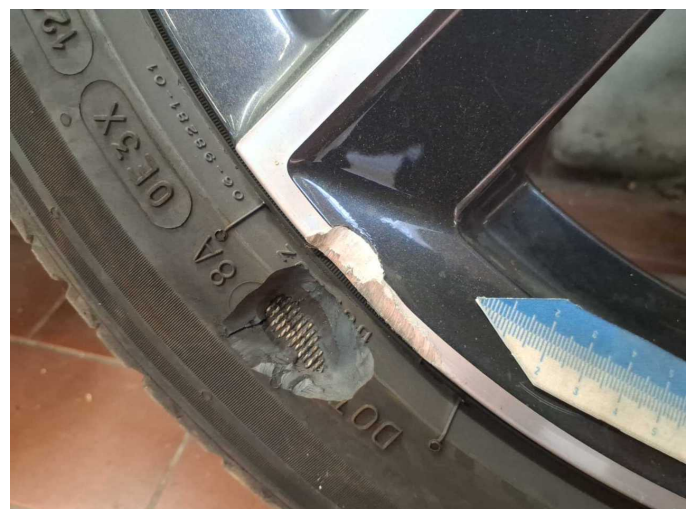
| No. | Component group | Description |
|---|---|---|
| 11 | 2nd wheel set | 2 alloy rims - Scratched - Replace |

Damage 11: 2nd wheel set: 2 alloy rims - Scratched - Replace

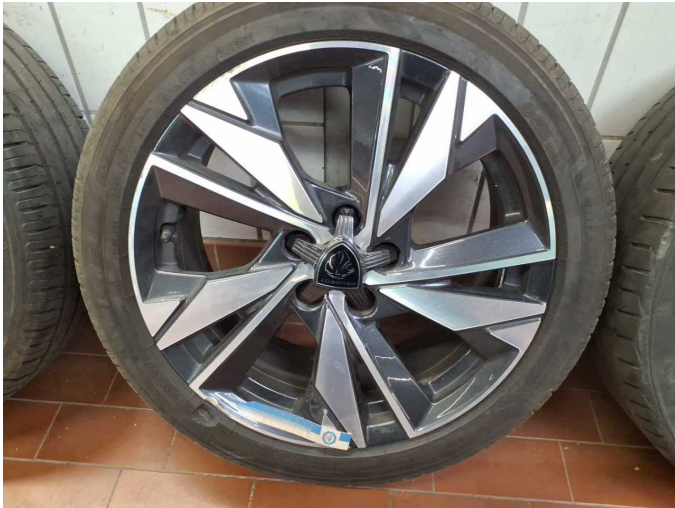
Damage 11: 2nd wheel set: 2 alloy rims - Scratched - Replace

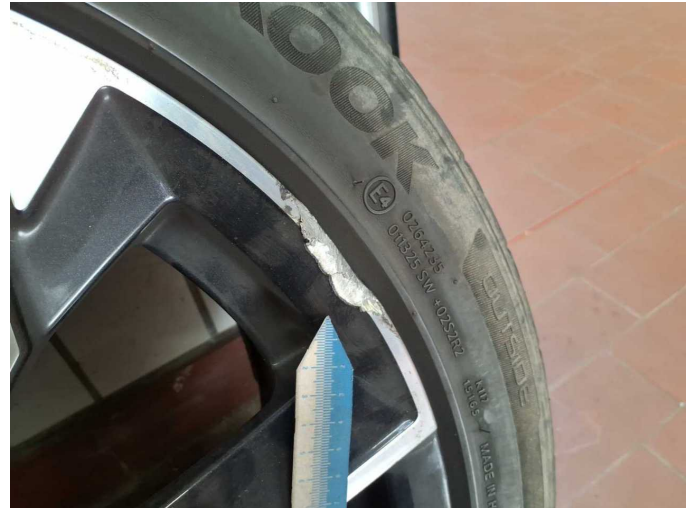
Damage 11: 2nd wheel set: 2 alloy rims - Scratched - Replace

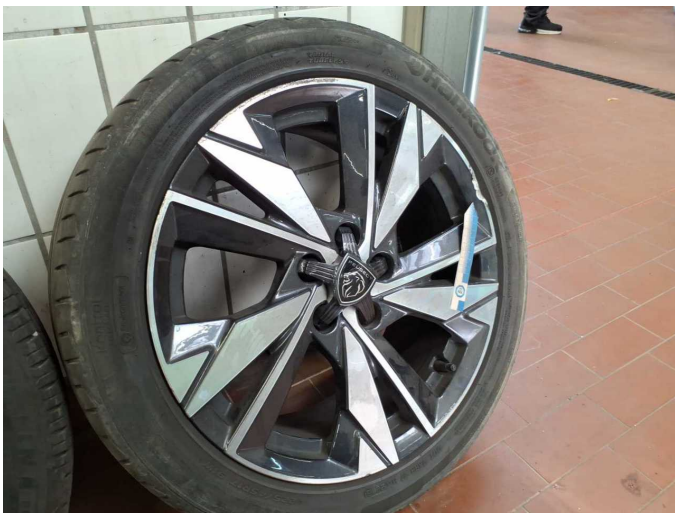
Damage 11: 2nd wheel set: 2 alloy rims - Scratched - Replace

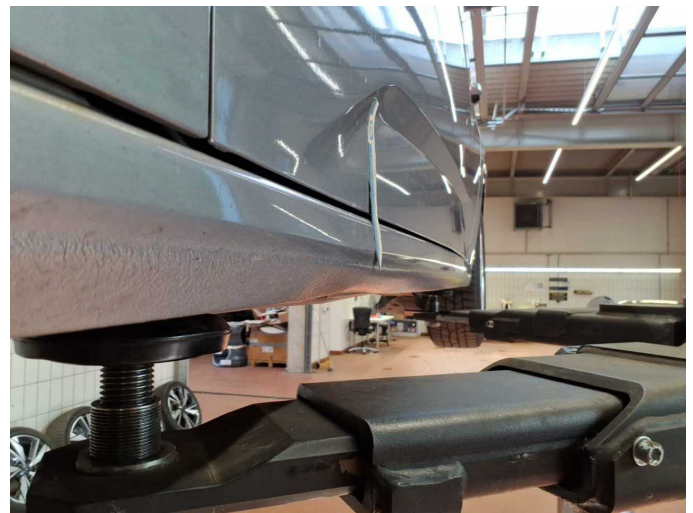
| No. | Component group | Description |
|---|---|---|
| 12 | Sill - left side | Sill - Deformed - Repair and paint |

Damage 12: Sill - left side: Sill - Deformed - Repair and paint

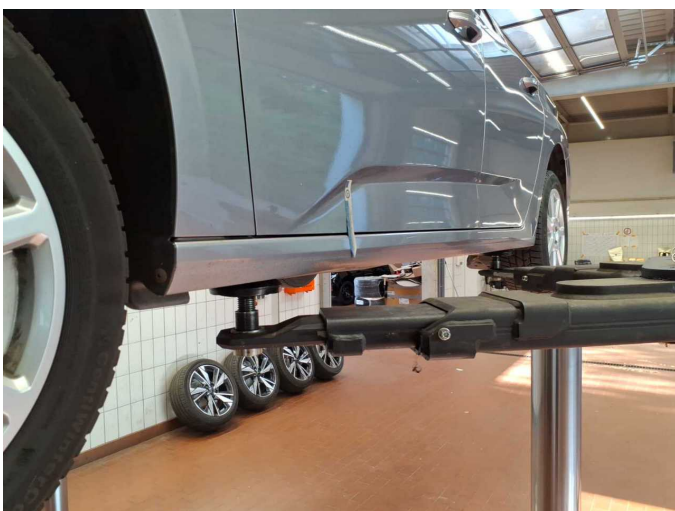
Damage 12: Sill - left side: Sill - Deformed - Repair and paint

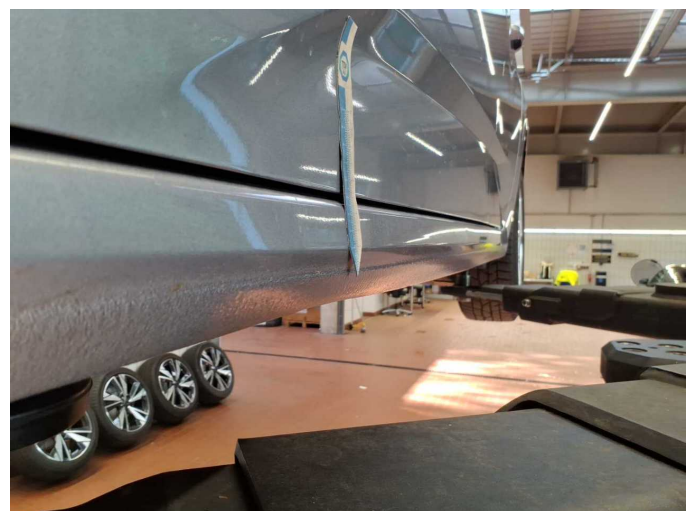
Damage 12: Sill - left side: Sill - Deformed - Repair and paint

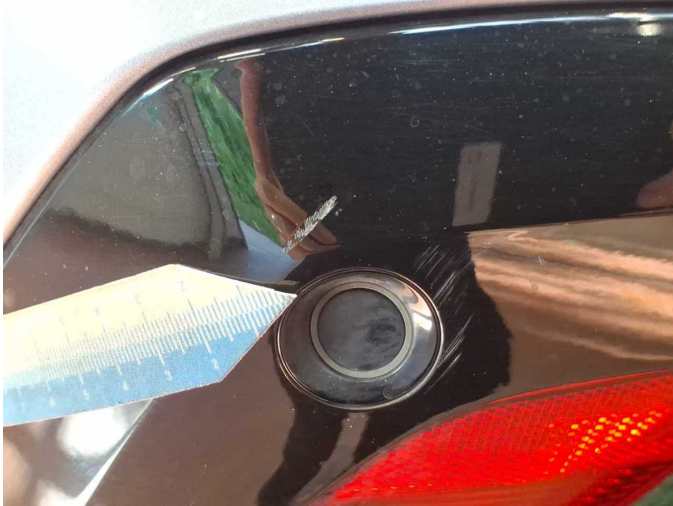
| No. | Component group | Description |
|---|---|---|
| 13 | Rear bumper | Spoiler - Dent / paintcoat damage - Paint |

Damage 13: Rear bumper: Spoiler - Dent / paintcoat damage - Paint

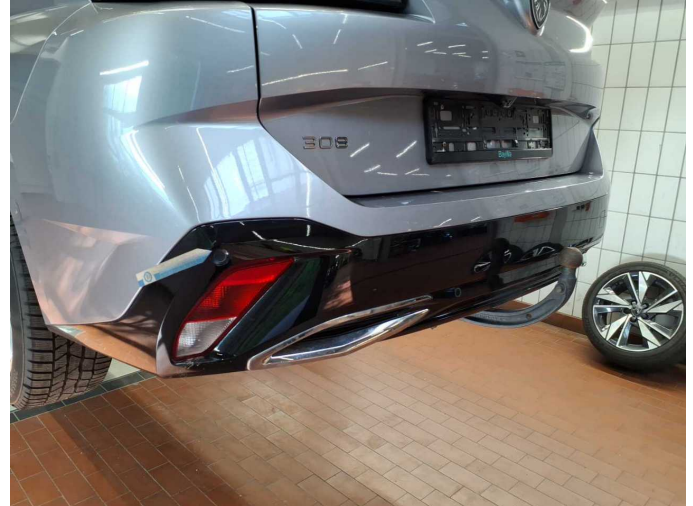
Damage 13: Rear bumper: Spoiler - Dent / paintcoat damage - Paint

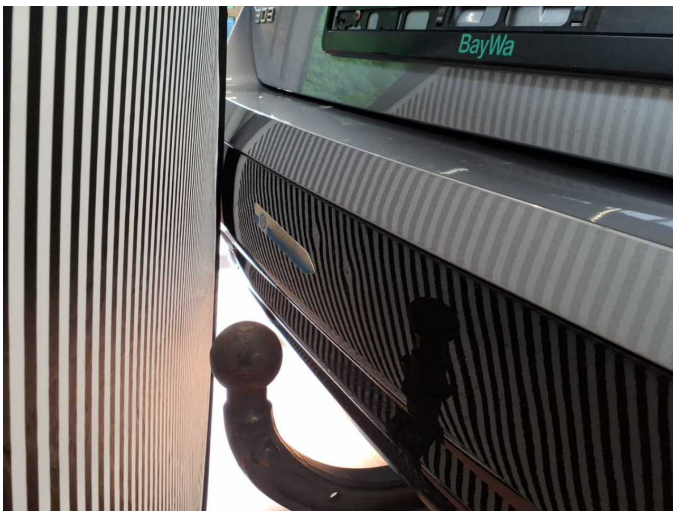
Damage 13: Rear bumper: Spoiler - Dent / paintcoat damage - Paint

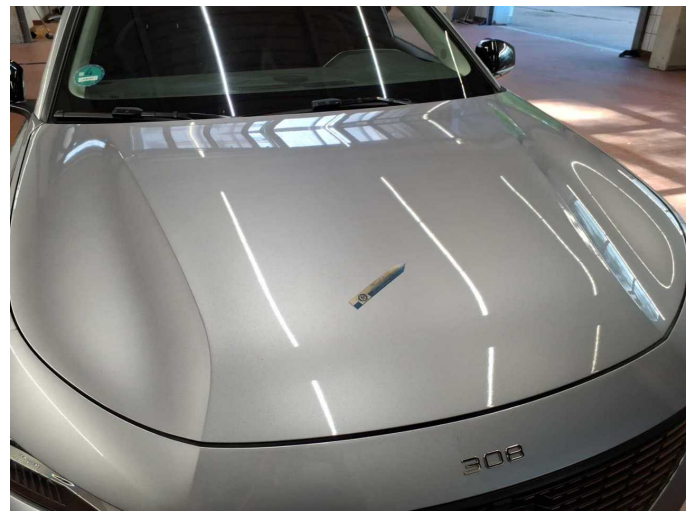
| No. | Component group | Description |
|---|---|---|
| 3 | Bonnet | Bonnet - Stone chips - No deduction |

Wear and tear 3: Bonnet: Bonnet - Stone chips - No deduction

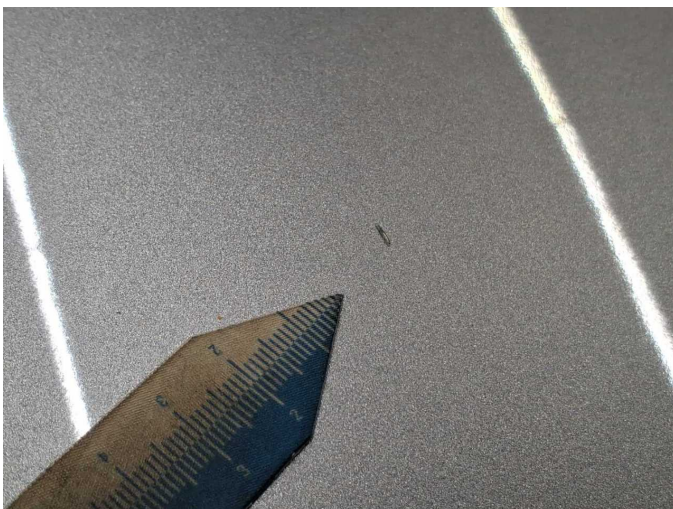
Wear and tear 3: Bonnet: Bonnet - Stone chips - No deduction

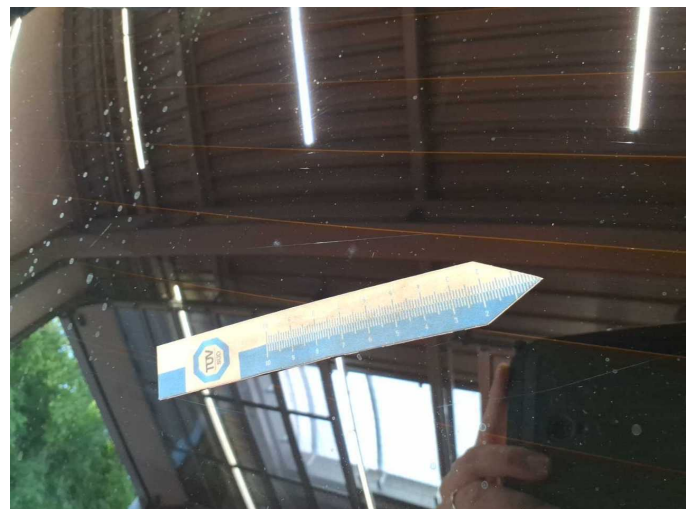
| No. | Component group | Description |
|---|---|---|
| 4 | Vehicle glazing | Rear window - Scratch(es) - No deduction |

Wear and tear 4: Vehicle glazing: Rear window - Scratch(es) - No deduction

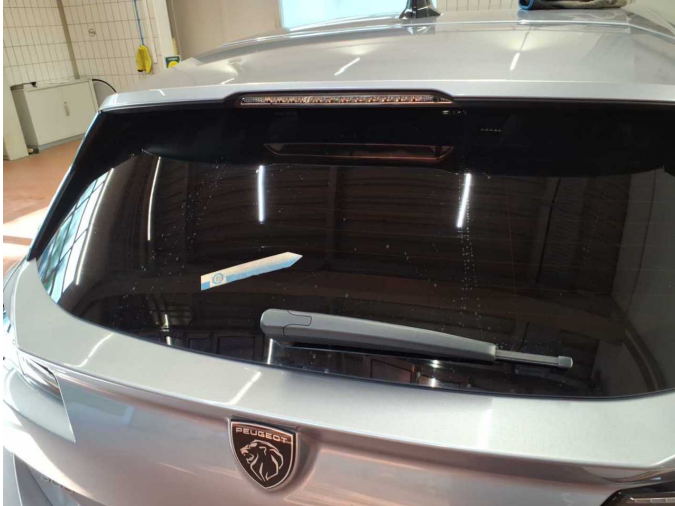
Wear and tear 4: Vehicle glazing: Rear window - Scratch(es) - No deduction

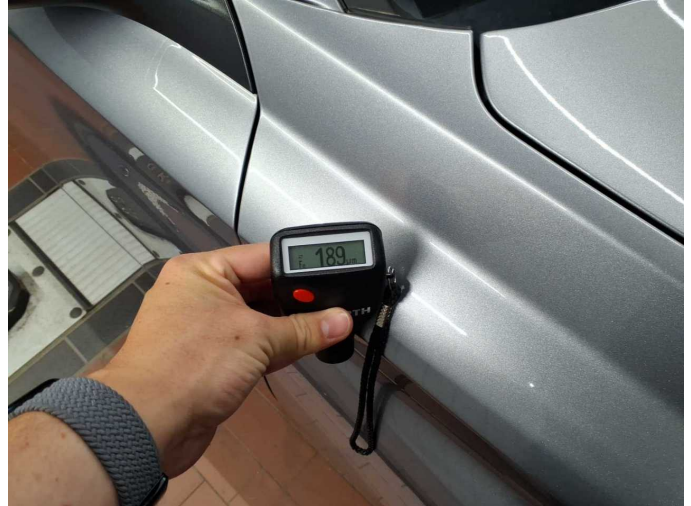
| No. | Repainting |
|---|--|
| 1 | Mudguard - right side, Professionally carried out, Invoice of repair done Non-existent |

| Mudguard - right side | 189 µm | Door - rear right side | 176 µm |

Repainting 1: Mudguard - right side

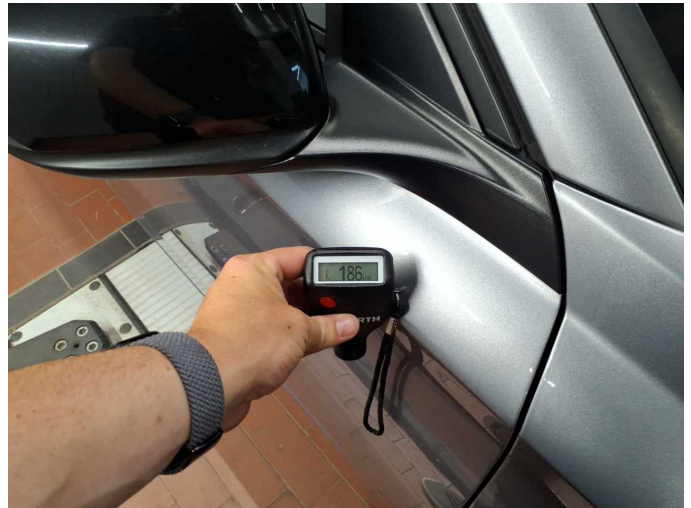
| No. | Repainting |
|---|--|
| 3 | Door - front right side, Professionally carried out, Invoice of repair done Non-existent |

| Door - front right side | 186 µm | | |

Repainting 3: Door - front right side
