Expertise

Protocol number: 45443515
Order No. / Reference: 26430857
Inspection date: 13 May 2026

Model: Proace 2,0-I-D-4D L2 Comfort

VIN: YARVFEHTMGZ253941

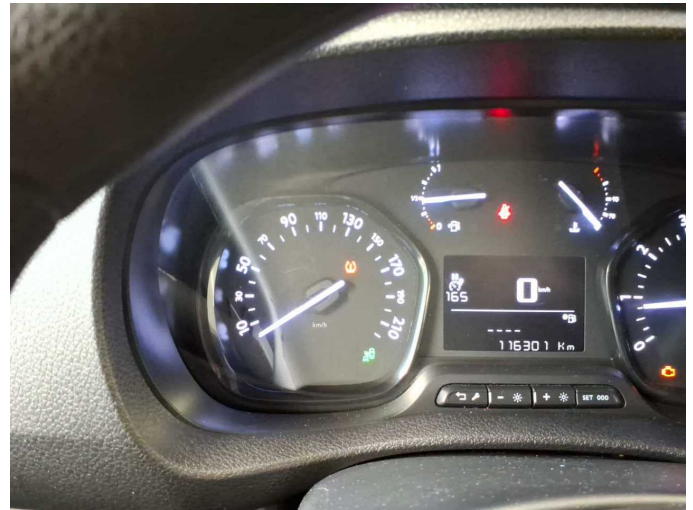
Damage 1: Instrument panel: Indicator light (Reifendruck) - on - Perform diagnosis

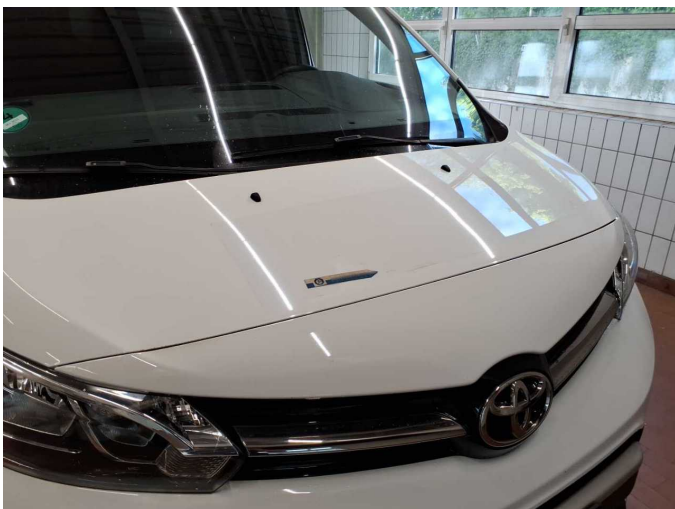
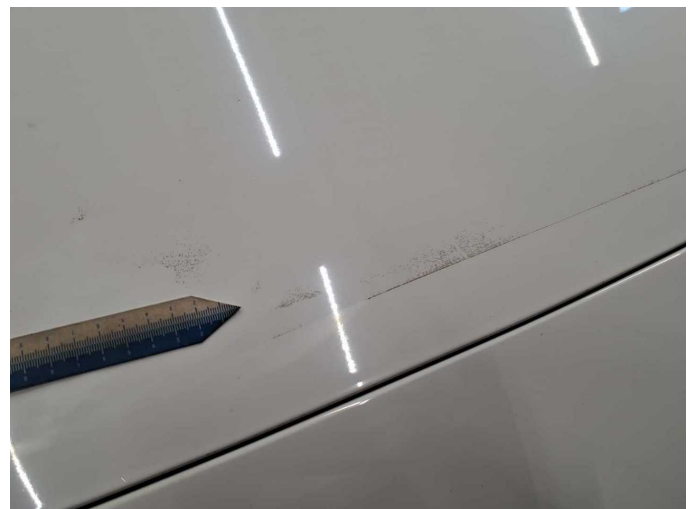
Damage 2: Bonnet: Bonnet (Klebereste) - Soiled - De-glué / neutralise

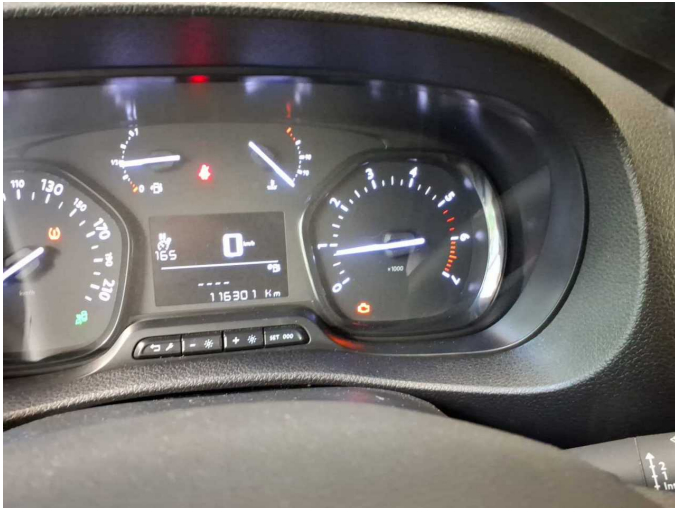
Damage 3: Instrument panel: Indicator light (Motorkontrolle) - on - Perform diagnosis

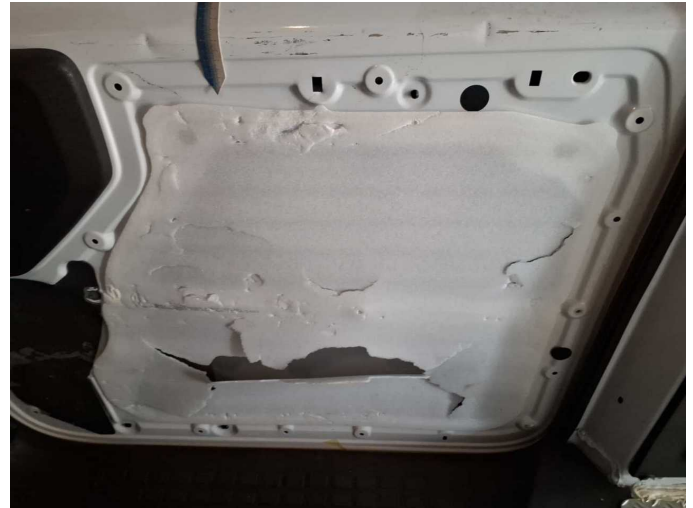
Damage 4: Sliding door, right: Door seal (Dämmung) - Broken / torn - Replace

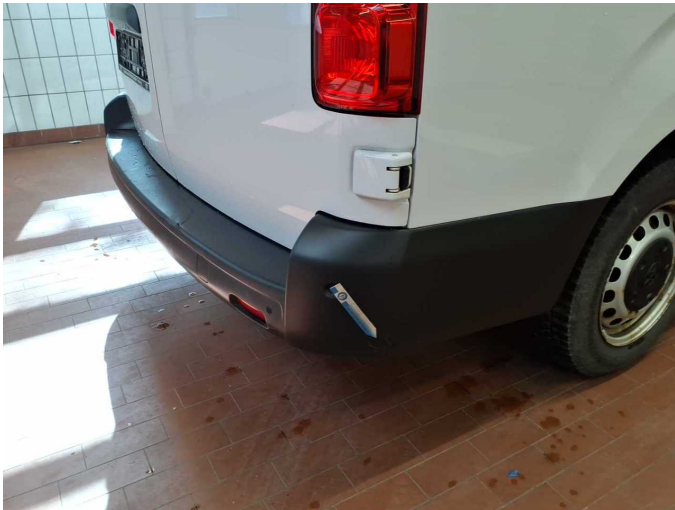
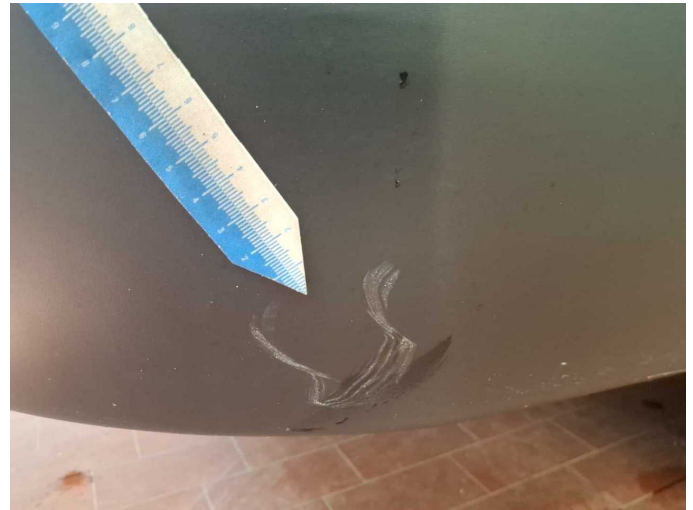
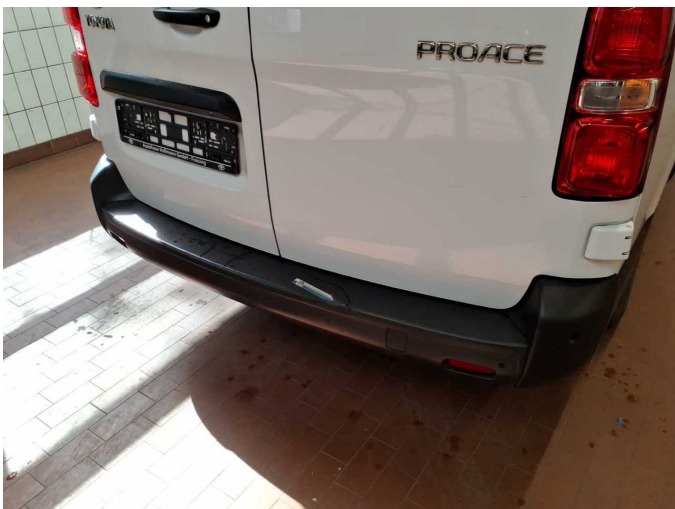
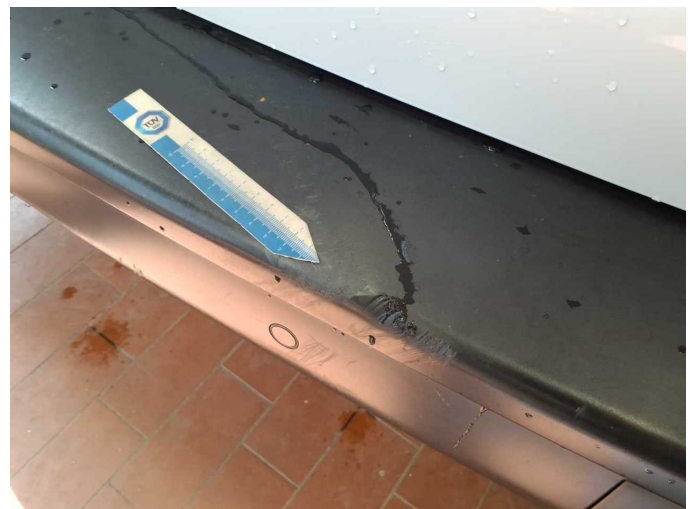
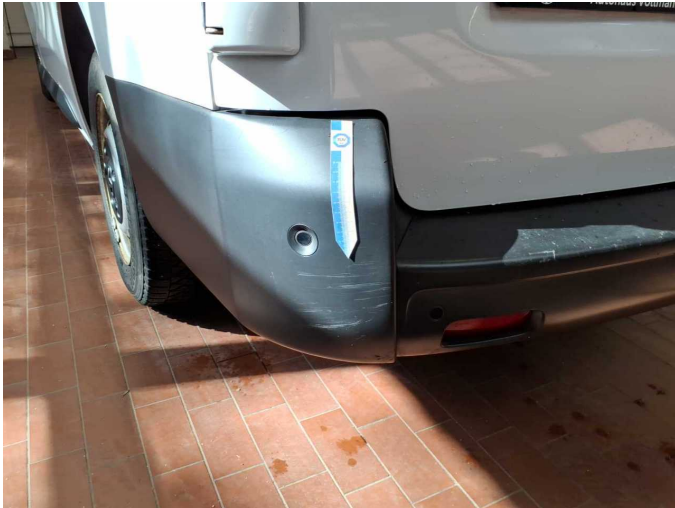
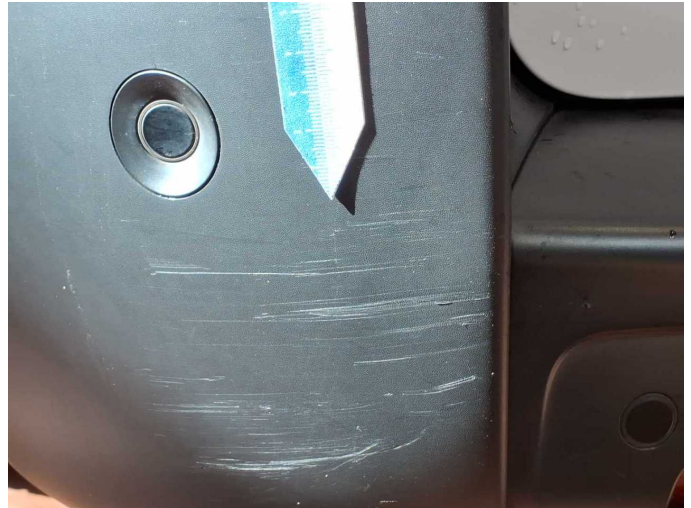
Damage 5: Rear bumper: Rear bumper - Scratched - Replace

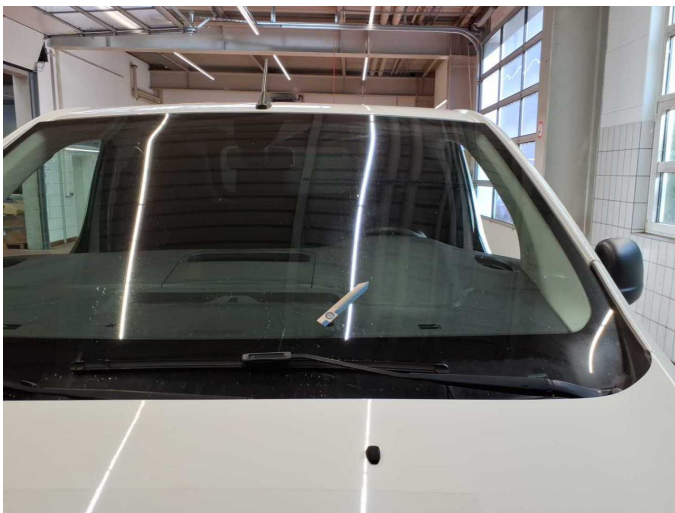
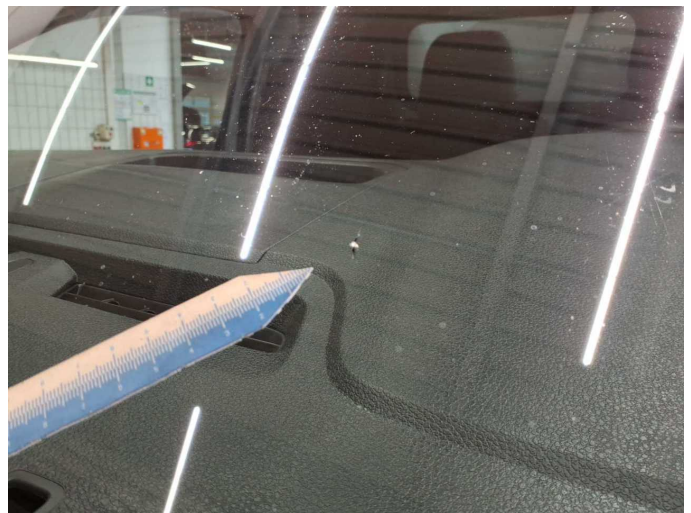
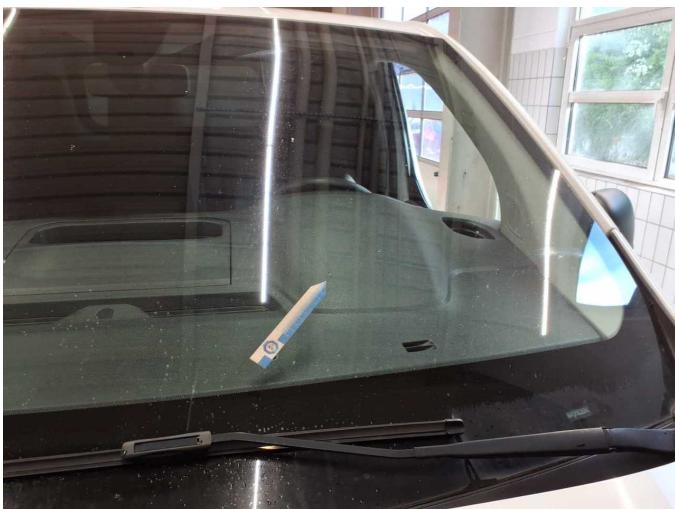
Damage 6: Vehicle glazing: Windscreen (Rissbildung) - Stone chips - Replace

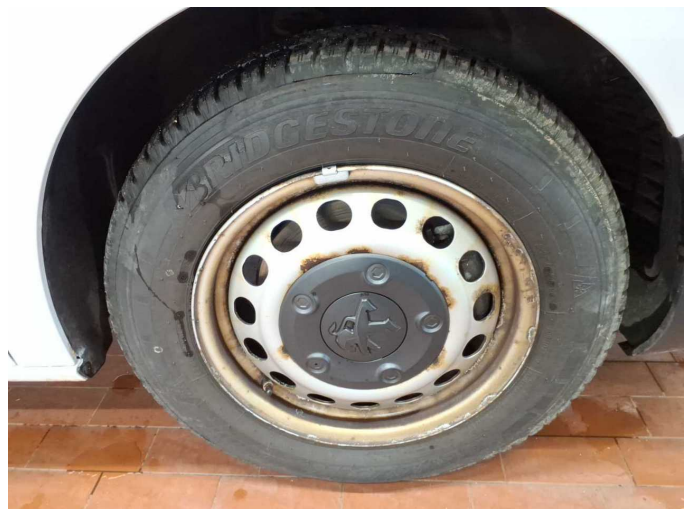
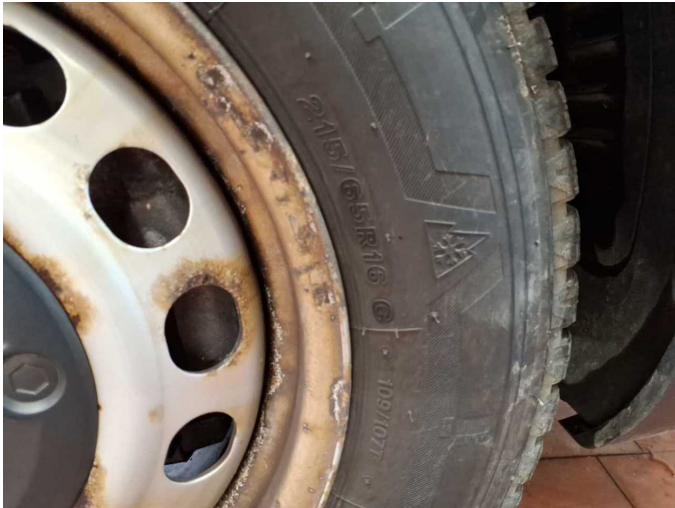
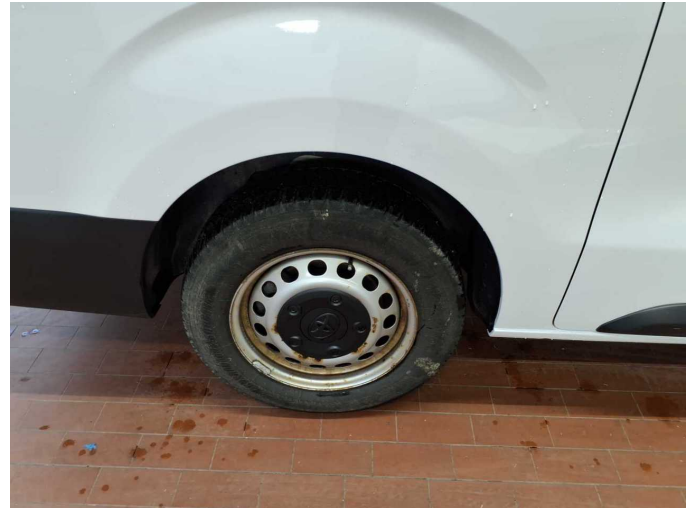
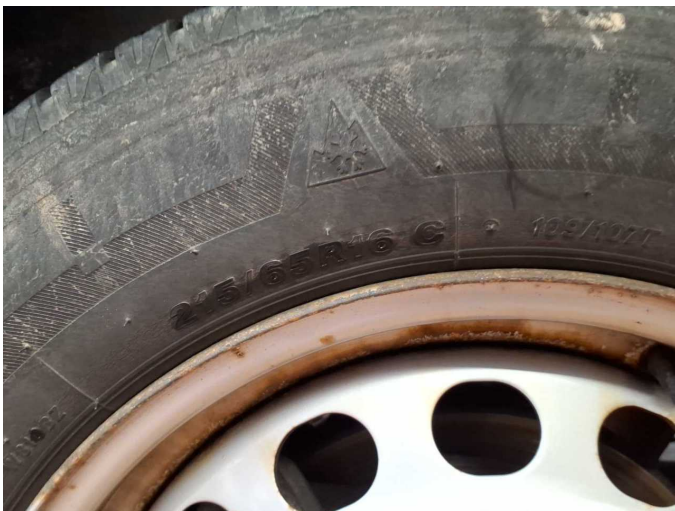
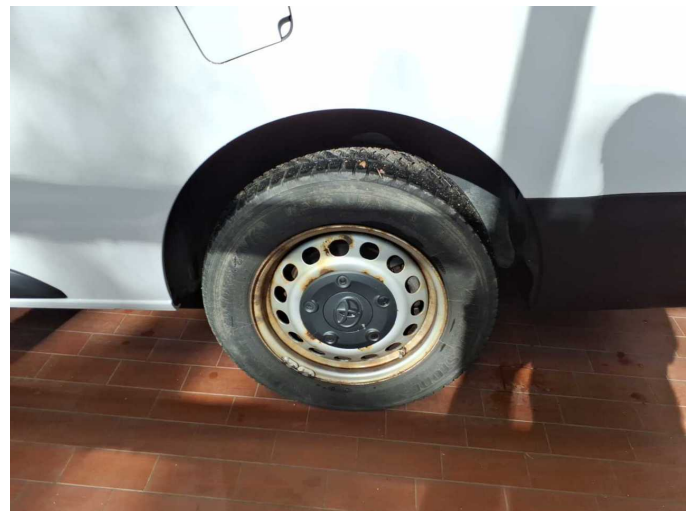
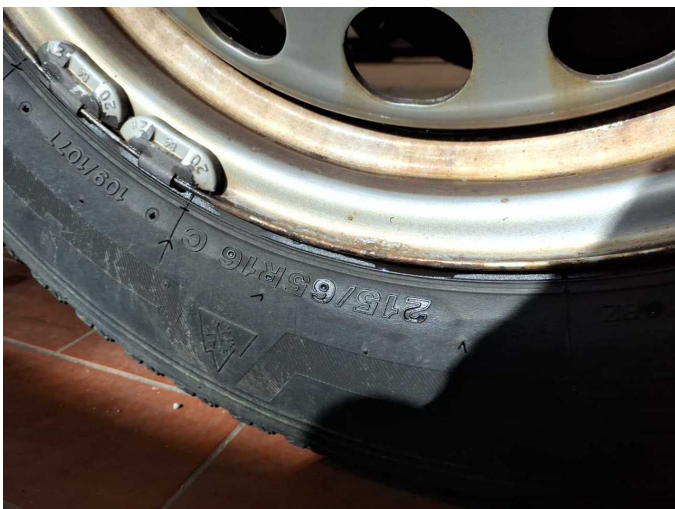
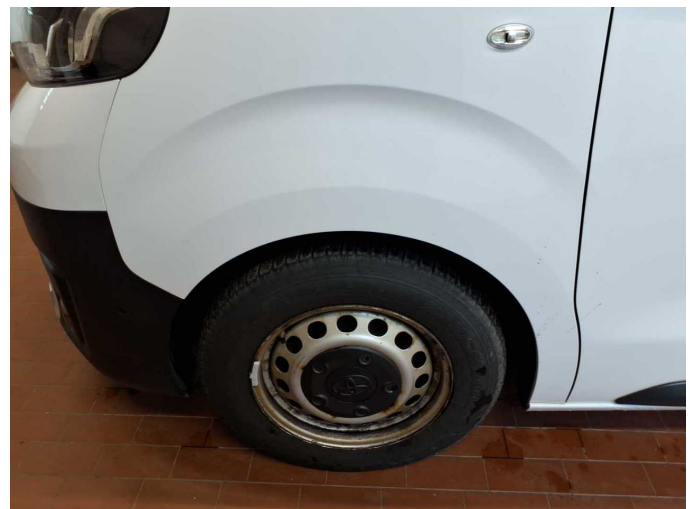
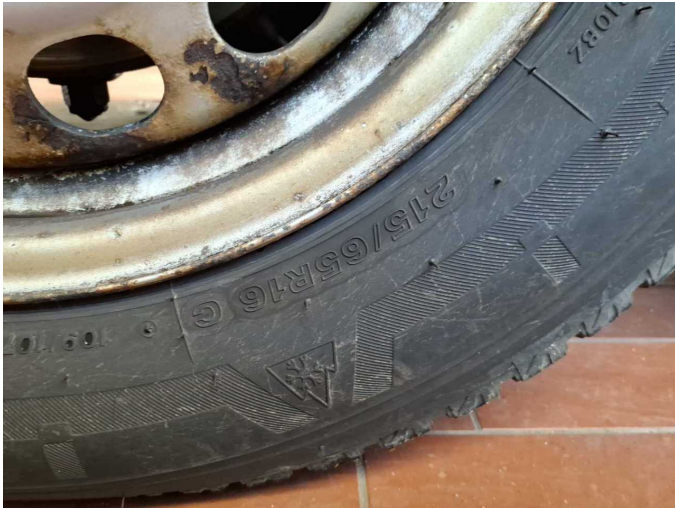
Damage 7: Wheel / tyres: Wheelset - complete (16 Zoll statt 17 Zoll) - Differs from the original configuration - Replace

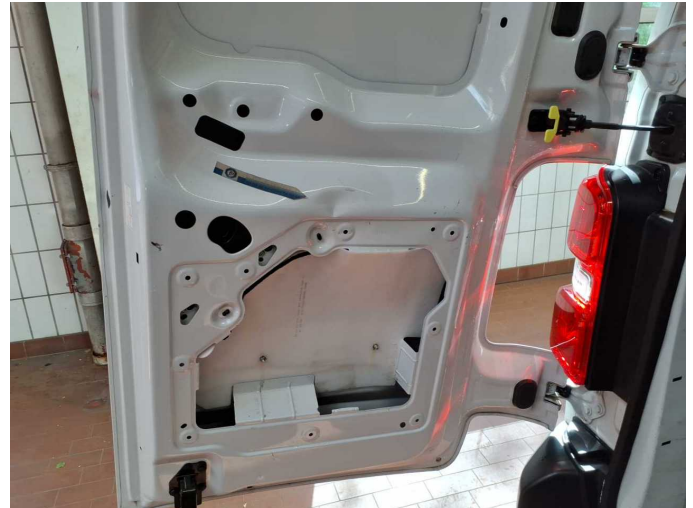
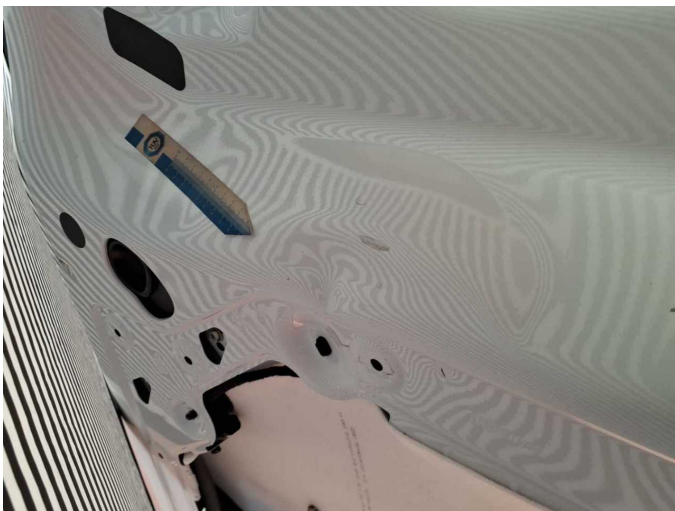
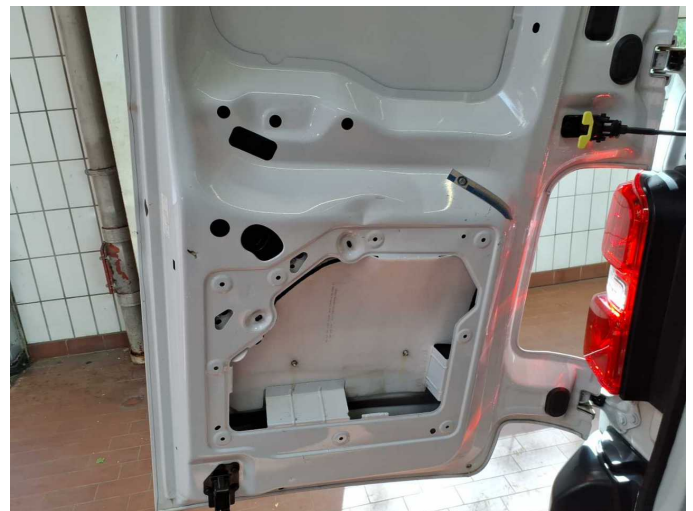
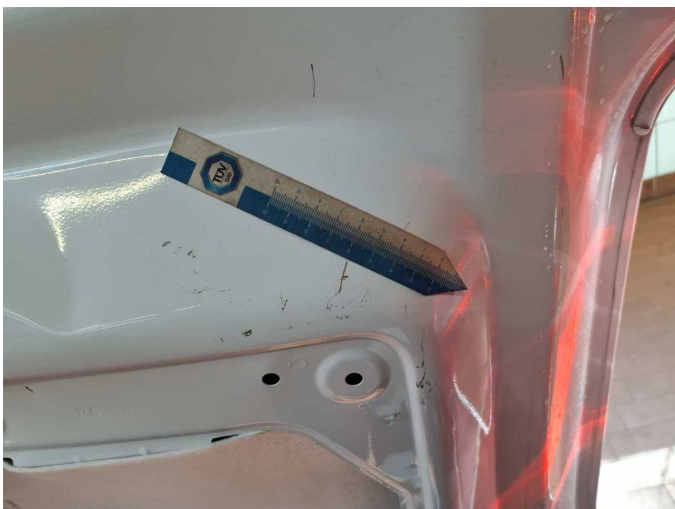
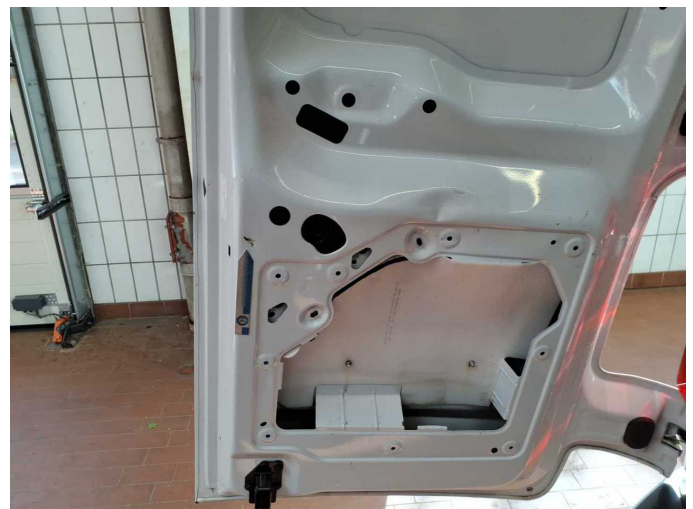
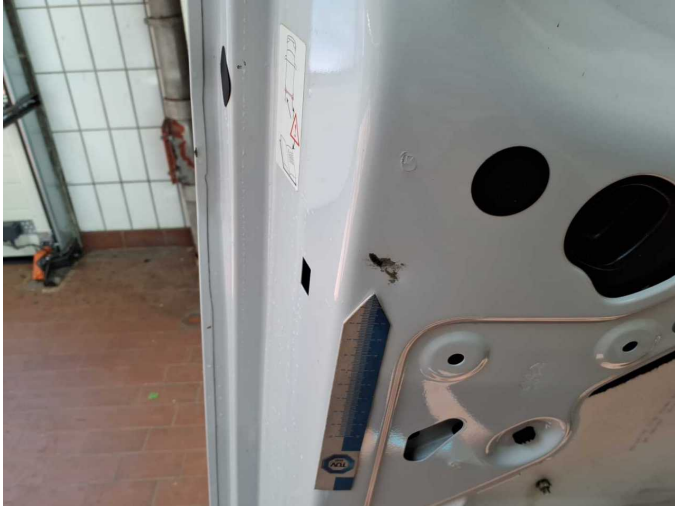
Damage 8: Boot lid / rear door: Rear door - left side (innen) - Dent / paintcoat damage - Repair and paint

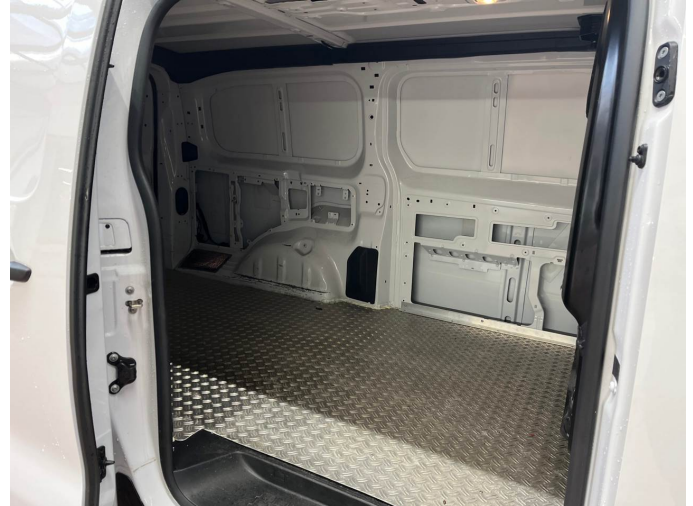
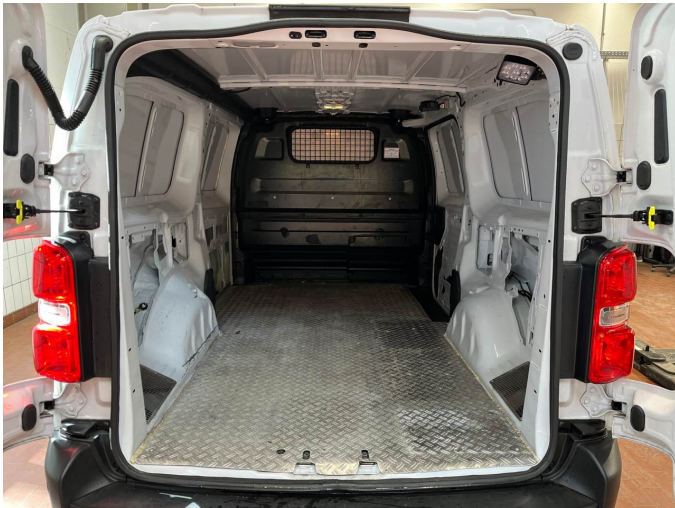
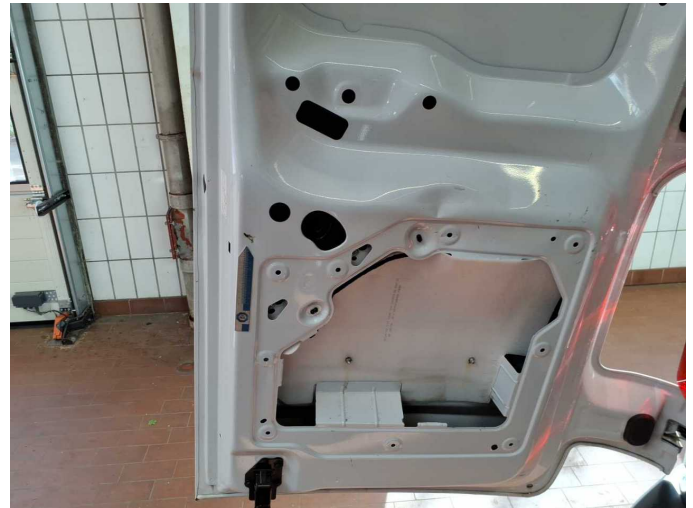
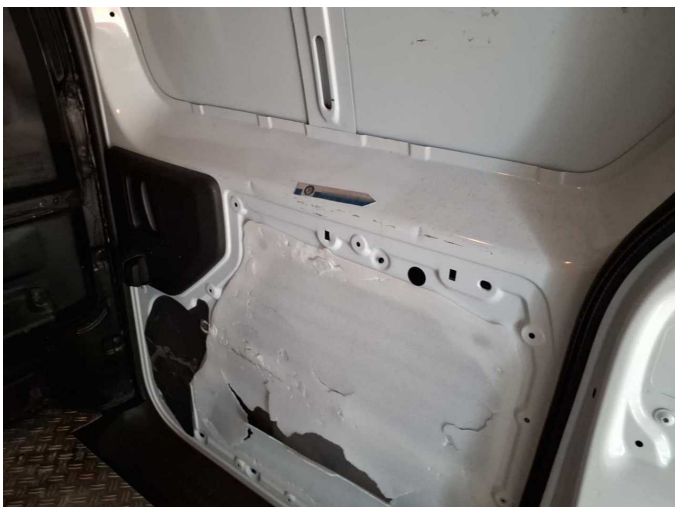
Damage 9: Trim / covers: Trim / covers (alle Laderaumverkleidungen) - Missing - Replace

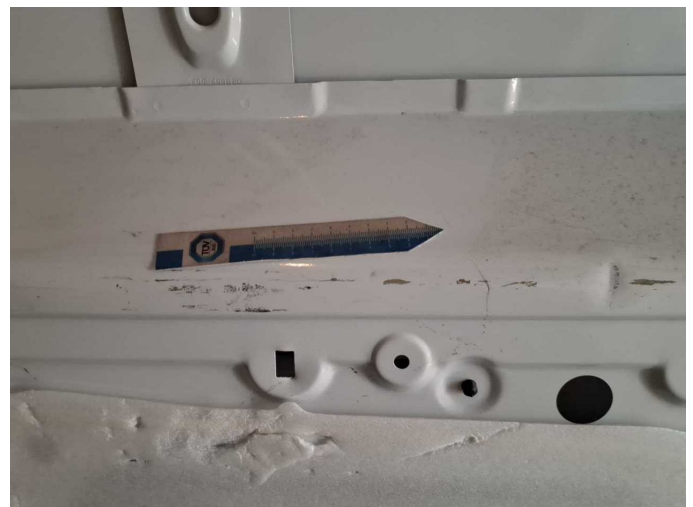
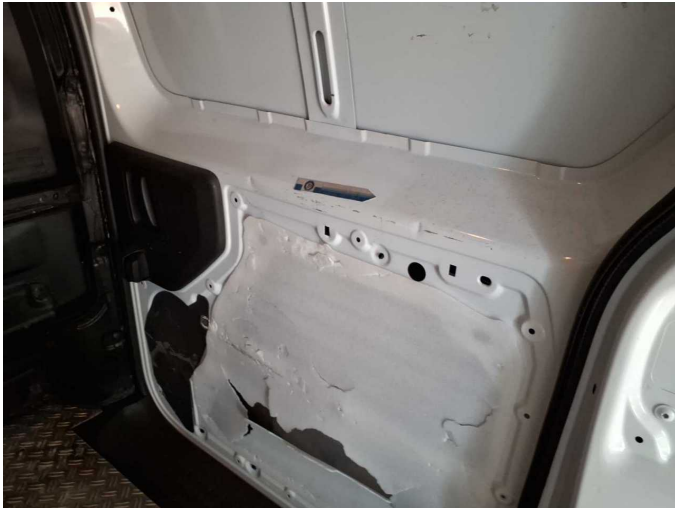
Wear and tear 1: Sliding door, right: Sliding door - Scratch(es) - No deduction

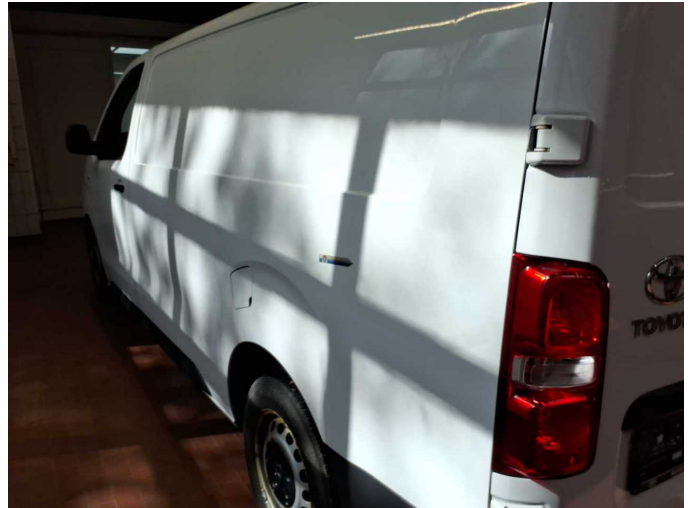
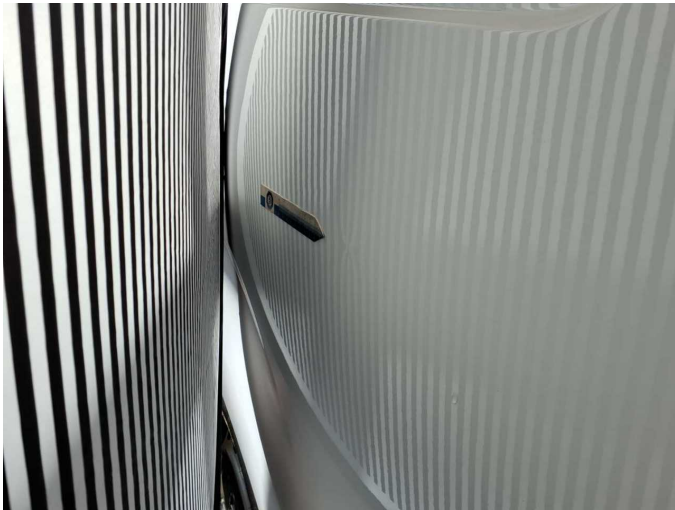
Wear and tear 2: Side panel - rear left side: Side panel - dent(s) - No deduction

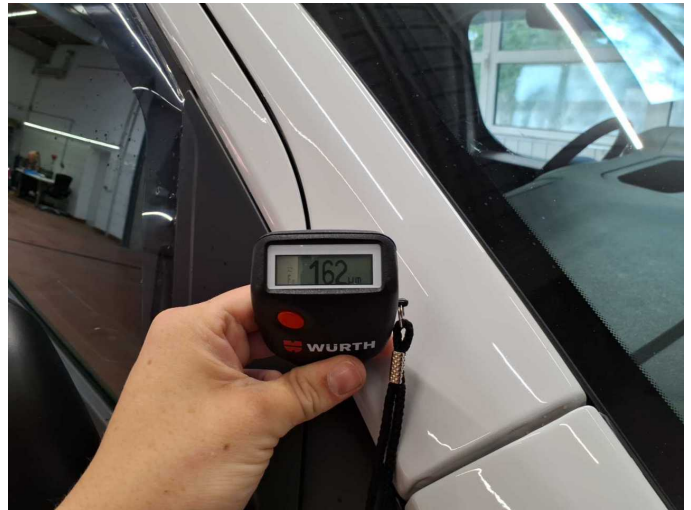
Roof rail - right side	162 µm	Door - rear right side	168 µm
------------------------	--------	------------------------	--------

Repainting 1: Roof rail - right side

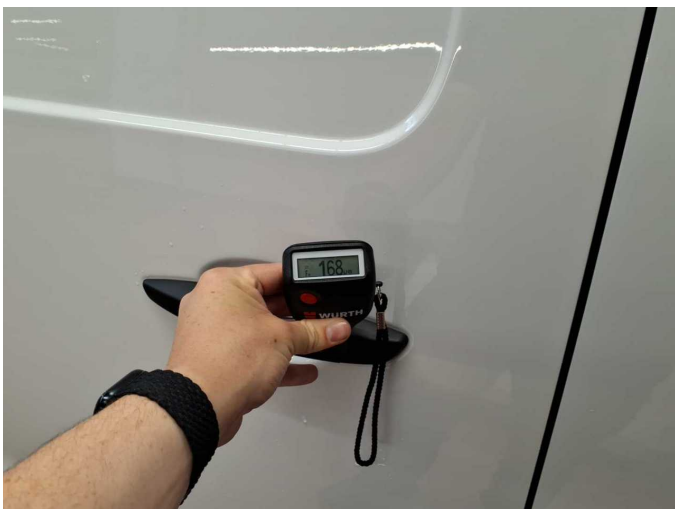
Repainting 2: Door - rear right side
