## Expertise

Protocol number: 45859478  
Order No. / Reference: 26423164  
Inspection date: 9 Jun 2026

Manufacturer: Skoda

Model: Karoq 2.0 TDI SCR Ambition

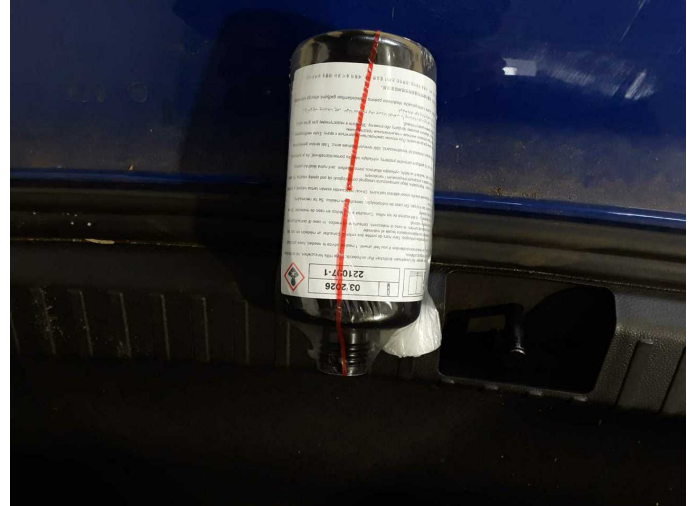
Damage 1: Equipment: Tirefit filler - Expired - Replace

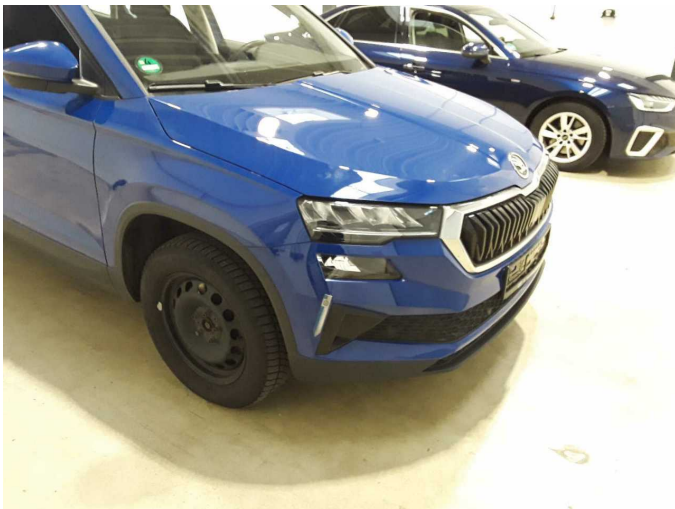
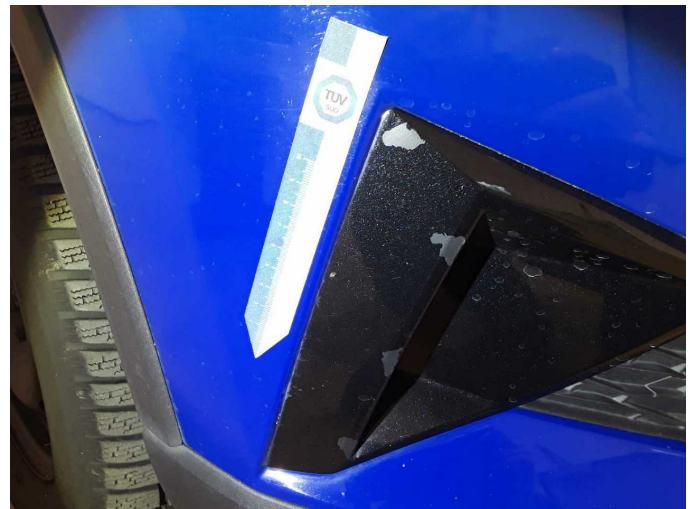
Damage 2: Front bumper: Cover bumper - front - Paint defect - Smart repair

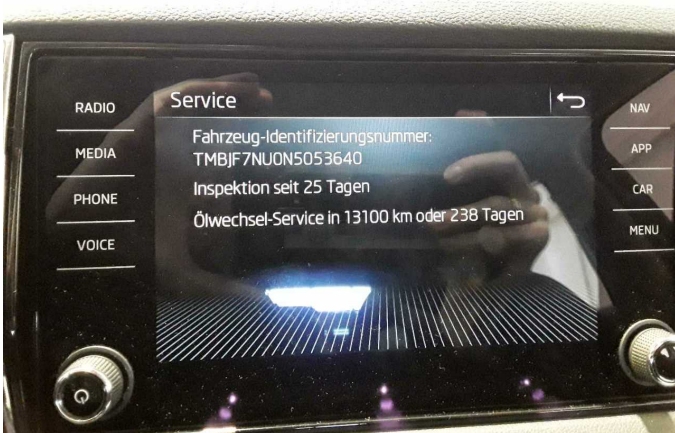
Damage 3: Misc.: Inspection / maintenance - Due - Perform

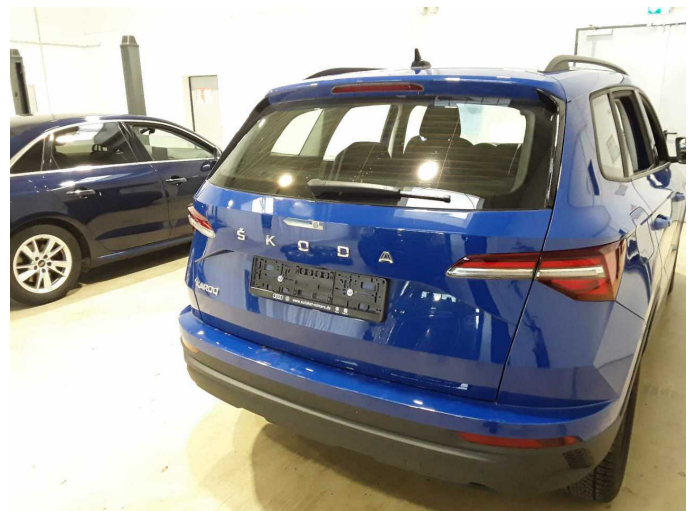
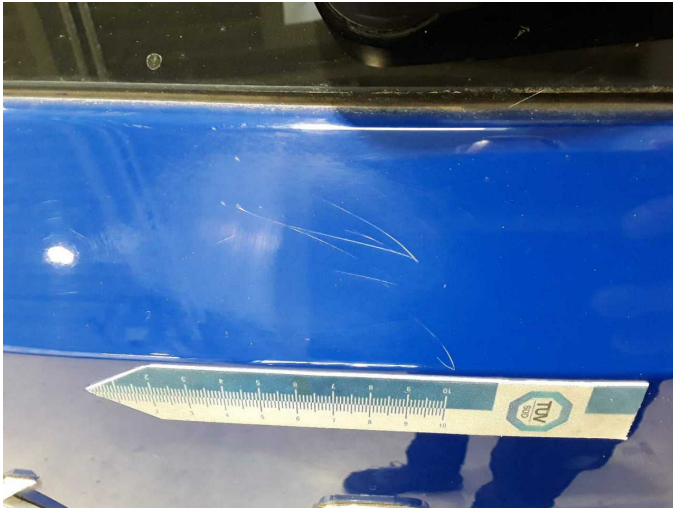
Damage 4: Boot lid / rear door: Boot lid - Scratch(es) - Paint

**Damage 4:** Boot lid / rear door: Boot lid - Scratch(es) - Paint

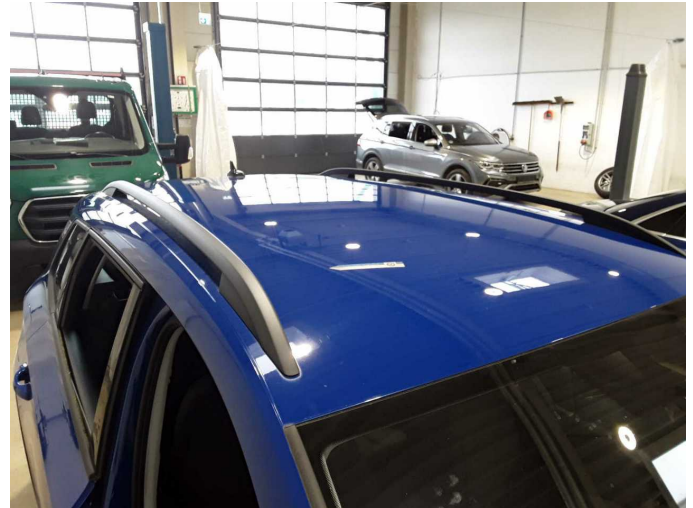
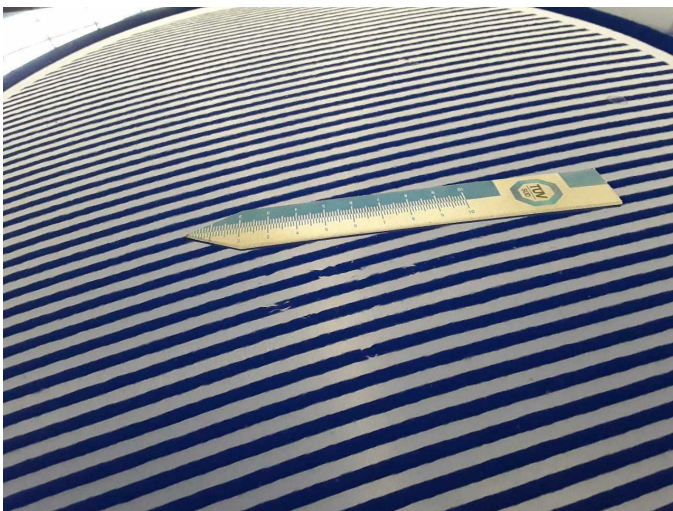
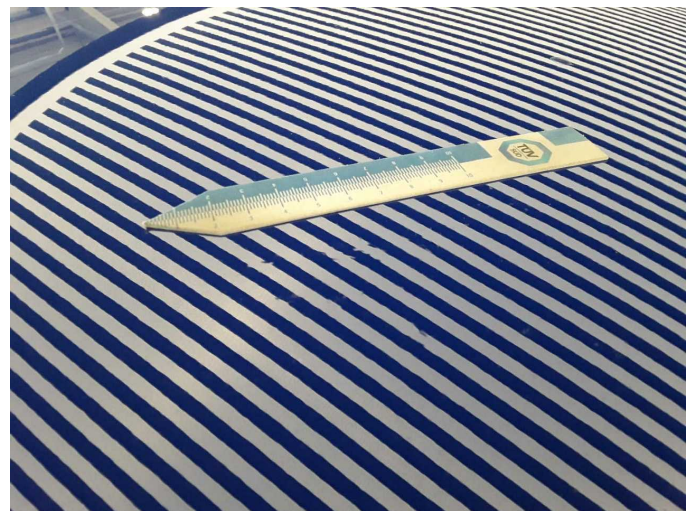
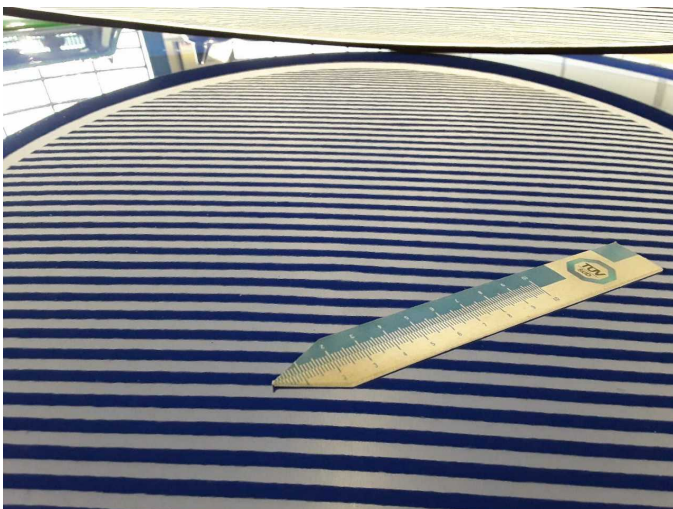
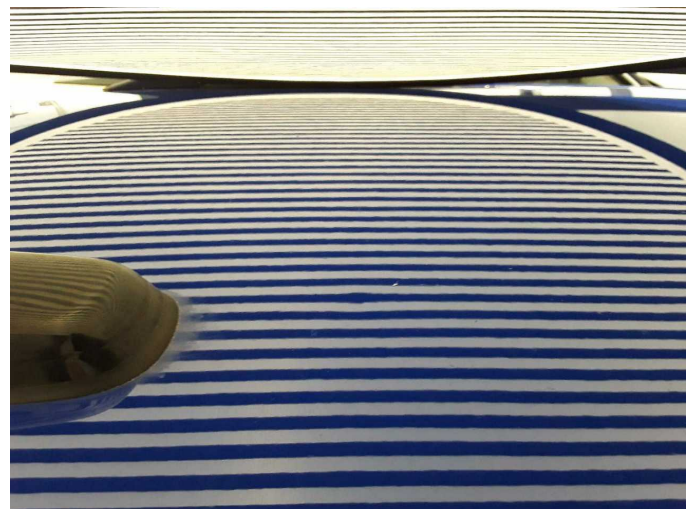
**Damage 5:** Roof: Roof (Anätzung) - Dent / paintcoat damage - repair according to calculation
