Expertise

Protocol number: 46711063  
Order No. / Reference: 26547120  
Inspection date: 16 Jul 2026

Model: Touran 2.0 TDI SCR Comfortline

VIN: WVGZZZ1T2PW024376

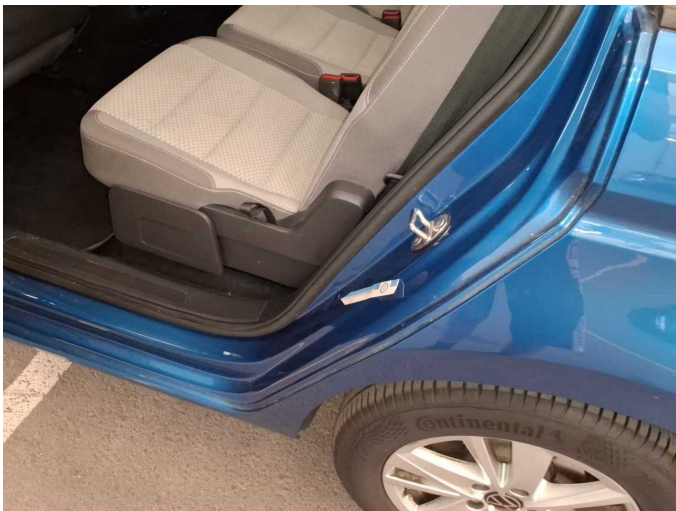
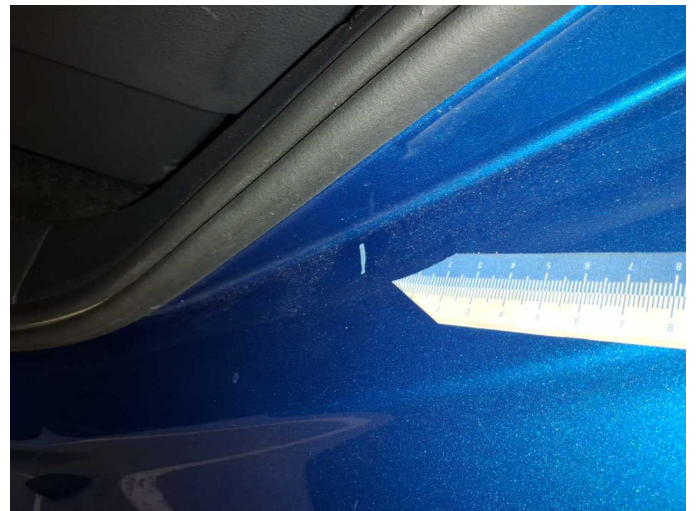
| No. | Component group | Description |
|---|---|---|
| 2 | Side panel - rear left side | Sill - Scratch(es) - Smart repair |

**Damage 2:** Side panel - rear left side: Sill - Scratch(es) - Smart repair

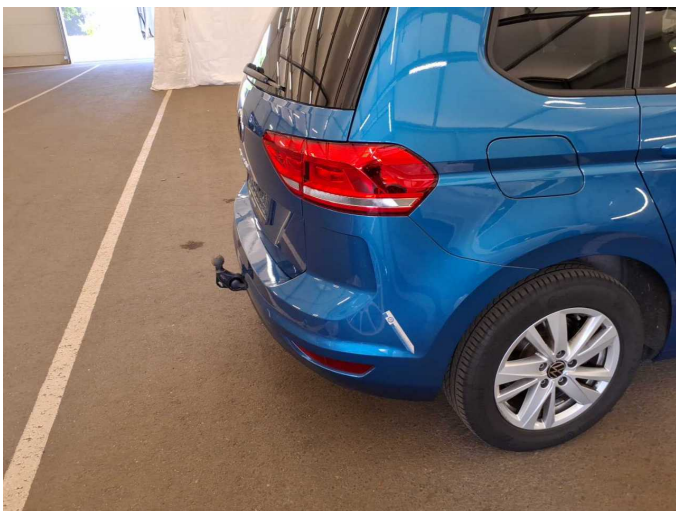
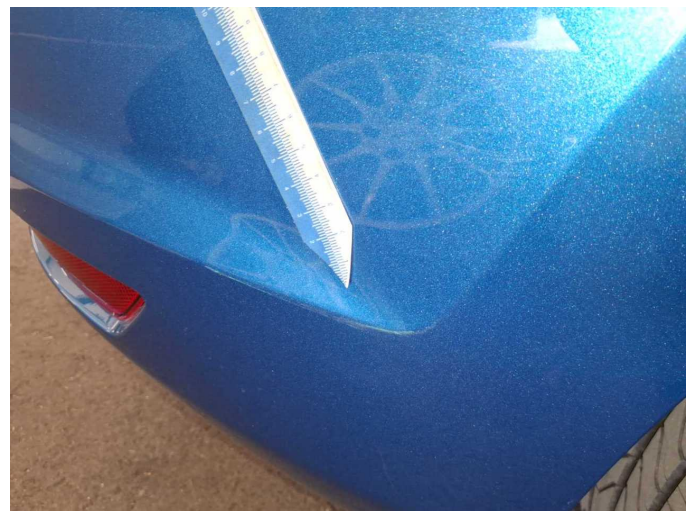
| No. | Component group | Description |
|---|---|---|
| 3 | Rear bumper | Rear bumper - Scratch(es) - Smart repair |

**Damage 3:** Rear bumper: Rear bumper - Scratch(es) - Smart repair

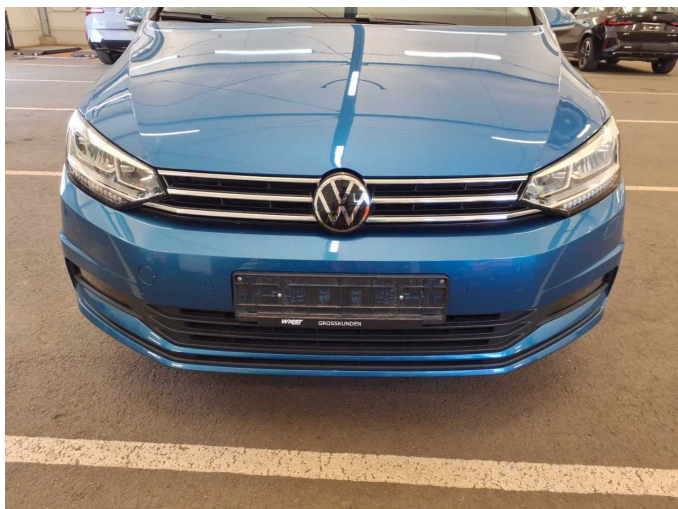
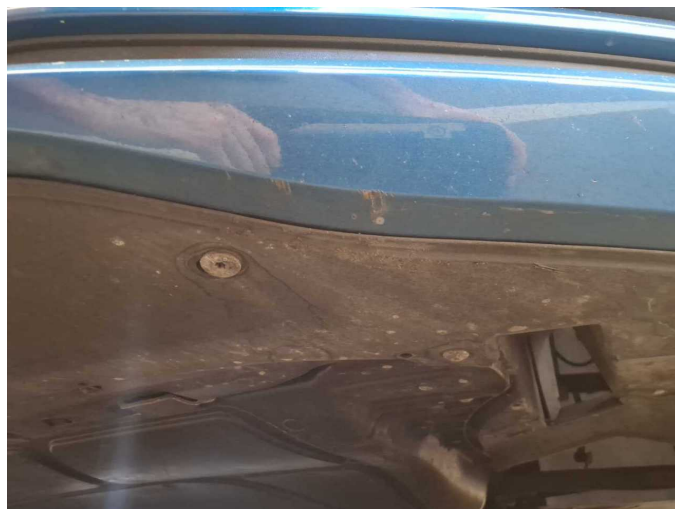
| No. | Component group | Description |
|---|---|---|
| 4 | Front bumper | Front bumper - Scratched - Smart repair |

**Damage 4:** Front bumper: Front bumper - Scratched - Smart repair

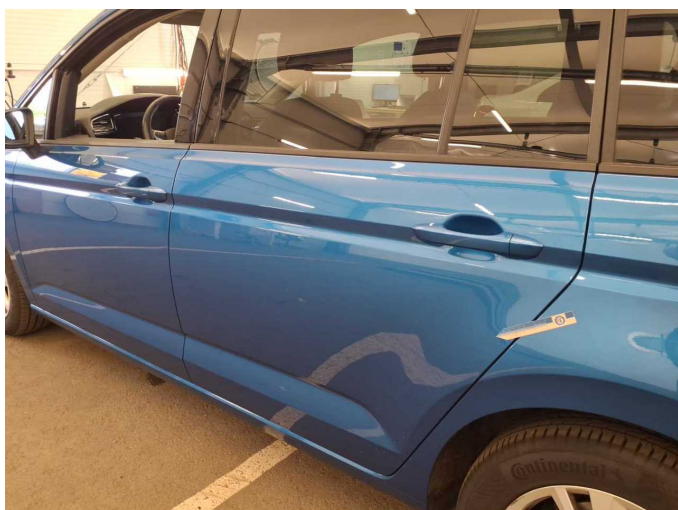
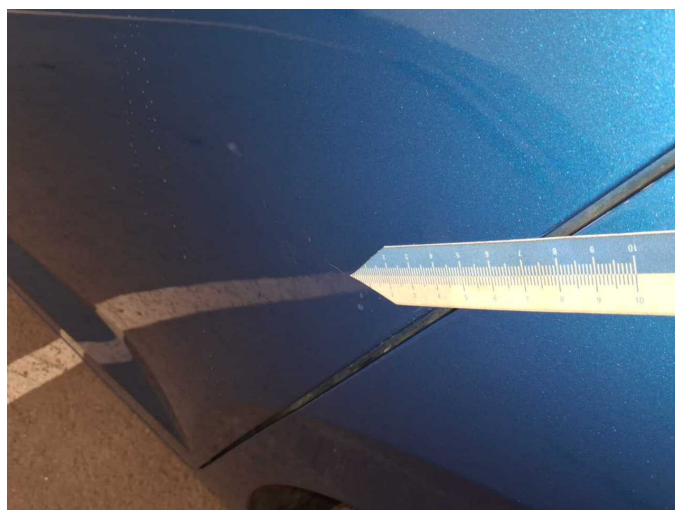
| No. | Component group | Description |
|---|---|---|
| 5 | Door - rear left side | Door - Scratch(es) - Smart repair |

**Damage 5:** Door - rear left side: Door - Scratch(es) - Smart repair

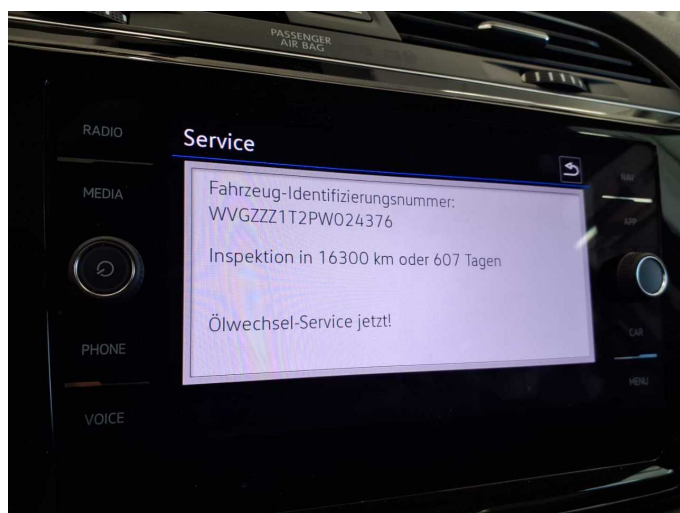
| No. | Component group | Description |
|---|---|---|
| 1 | Misc. | Inspection / maintenance (Motorölservice fällig, Wartungsnachweis unvollständig) - No evidence - No deduction |
| 6 | Misc. | Inspection / maintenance - Due - Perform |

**Damage 6:** Misc.: Inspection / maintenance - Due - Perform

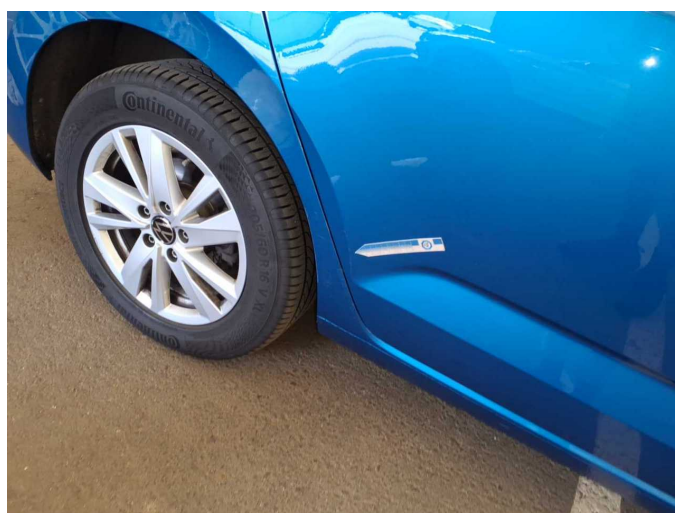
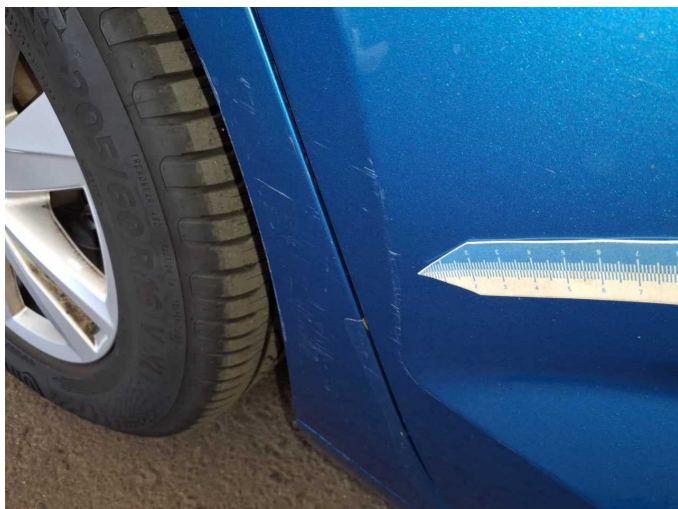
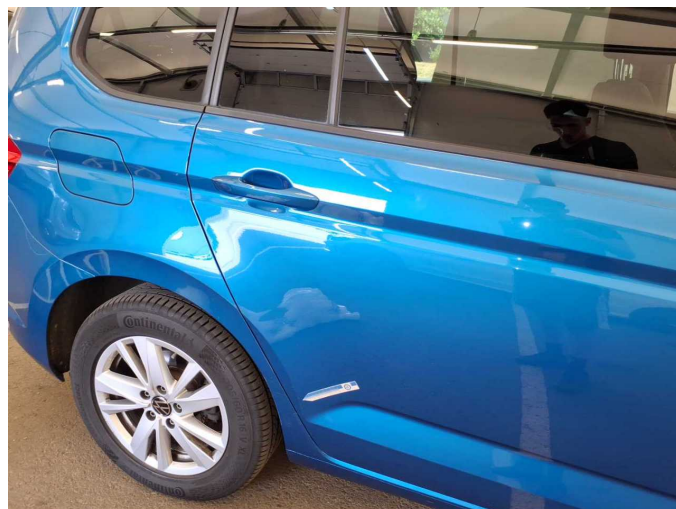
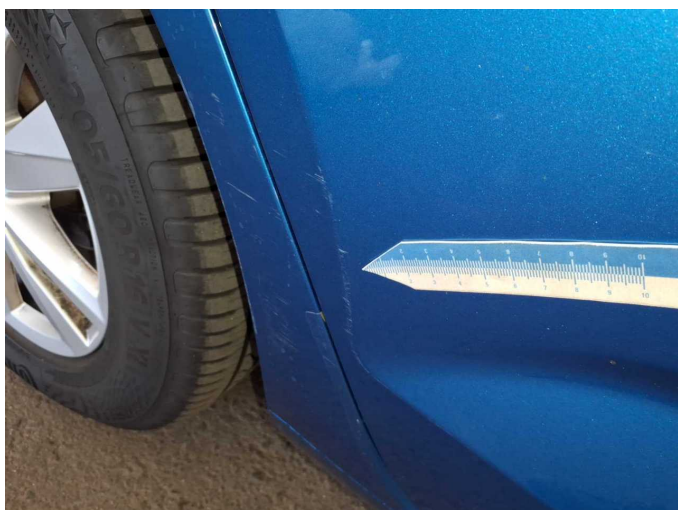
| No. | Accident |
|---|---|
| 1 | Side right |

**Accident 1:** Side right

**Accident 1: Side right**

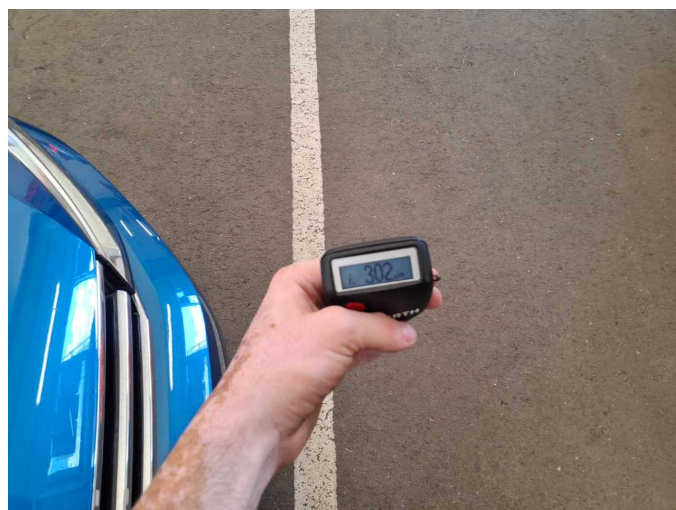
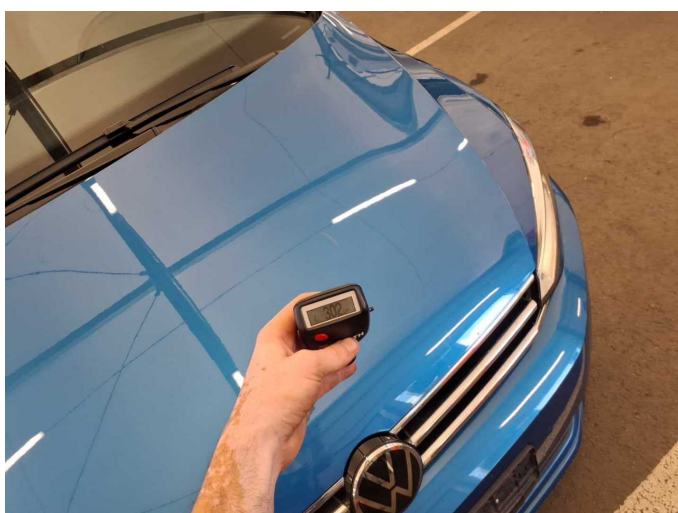
| No. | Repainting |
|---|---|
| 1 | Bonnet, Professionally carried out, Invoice of repair done Non-existent |

| Bonnet | 302 µm |

**Repainting 1: Bonnet**
