Expertise

Protocol number: 46383769  
Order No. / Reference: 26483985  
Inspection date: 7 Jul 2026

Manufacturer: Skoda  
VIN: TMBAH7NP3N7020690

Model: Superb 2.0 TDI DSG Premium Edition

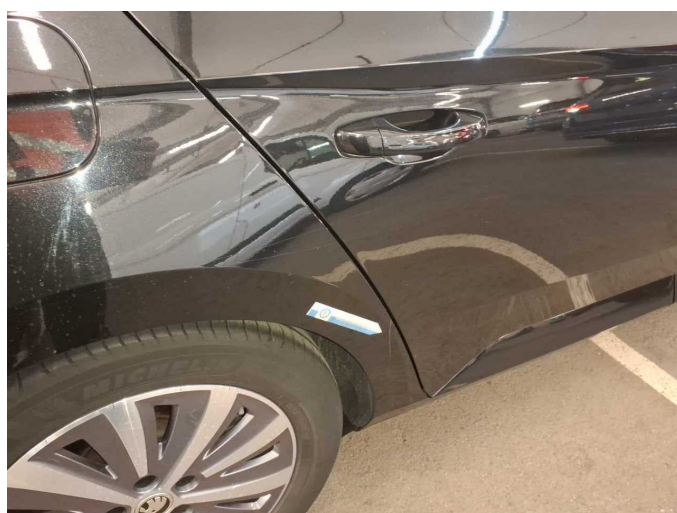
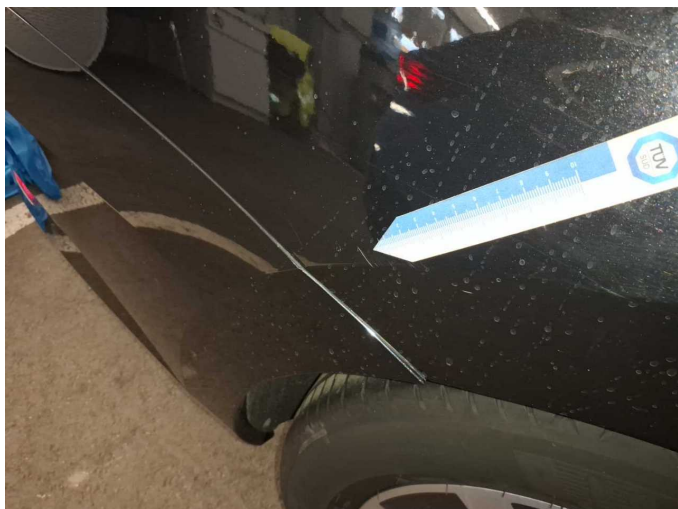
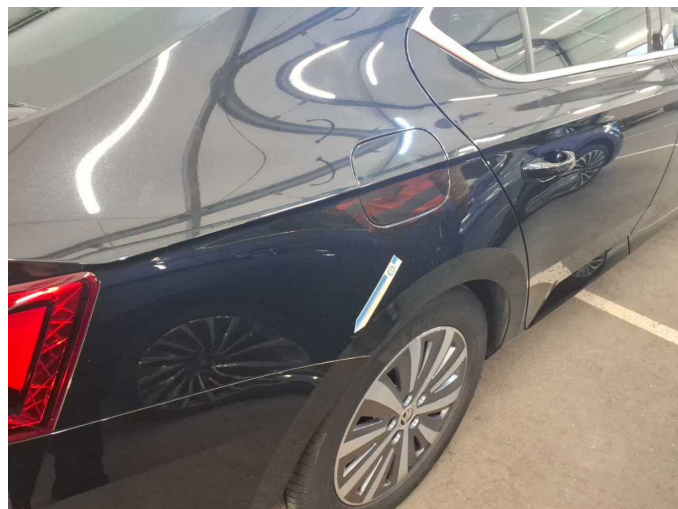
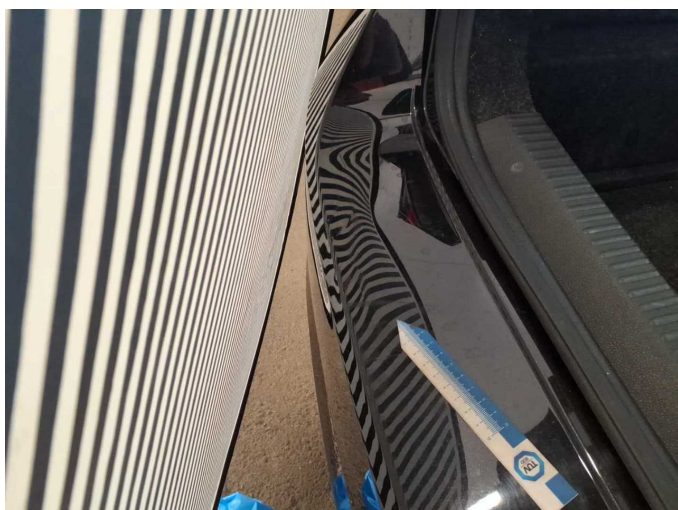
| No. | Component group | Description |
|---|---|---|
| 3 | Side panel - rear right side | Side panel - Scratch(es) - Paint |

**Damage 3:** Side panel - rear right side: Side panel - Scratch(es) - Paint

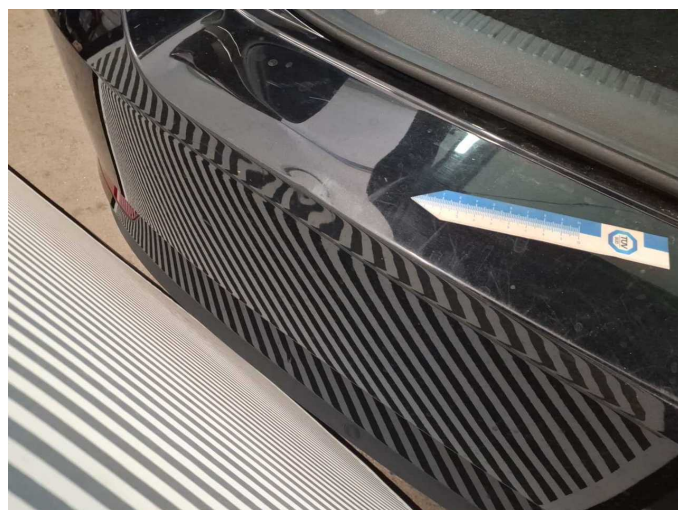
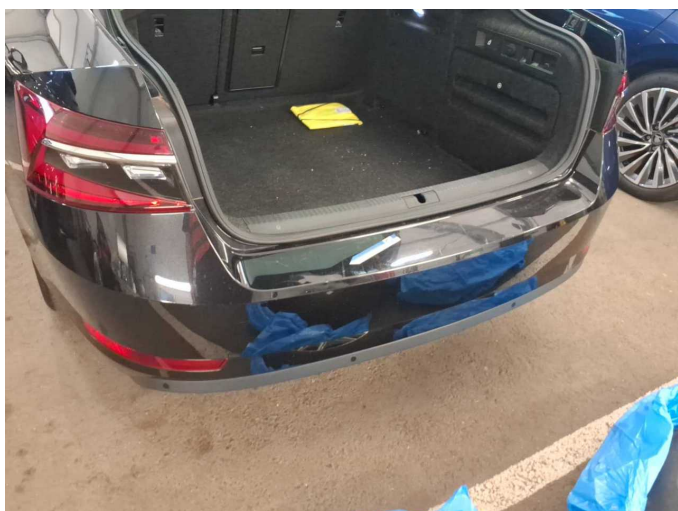
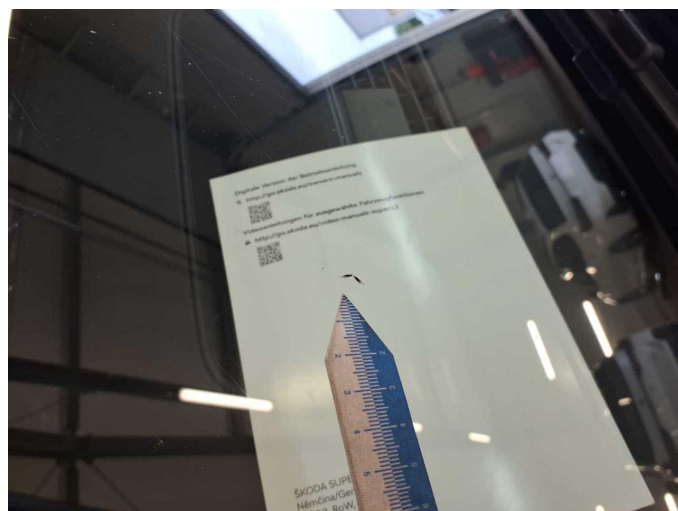
| No. | Component group | Description |
|---|---|---|
| 4 | Rear bumper | Rear bumper - Deformed - Repair and paint |

**Damage 4:** Rear bumper: Rear bumper - Deformed - Repair and paint

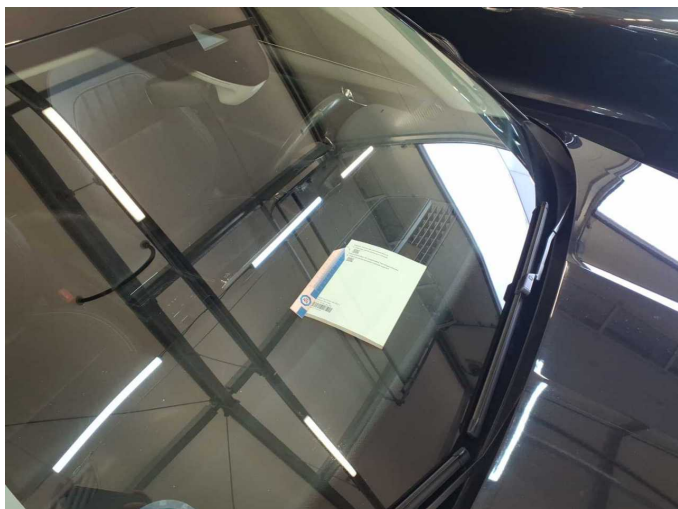
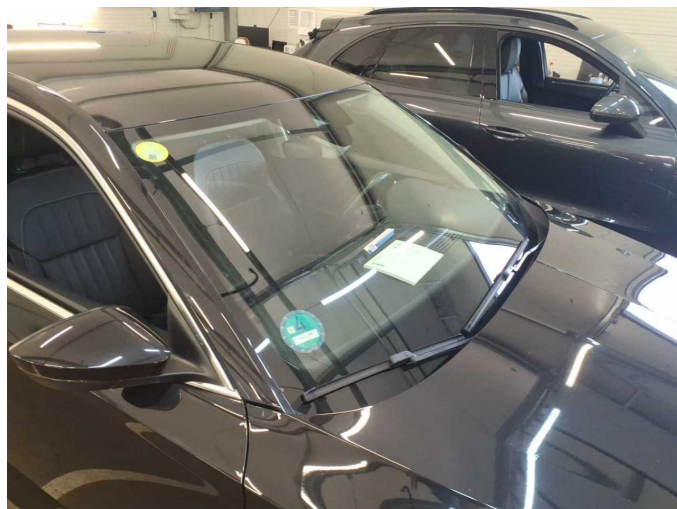
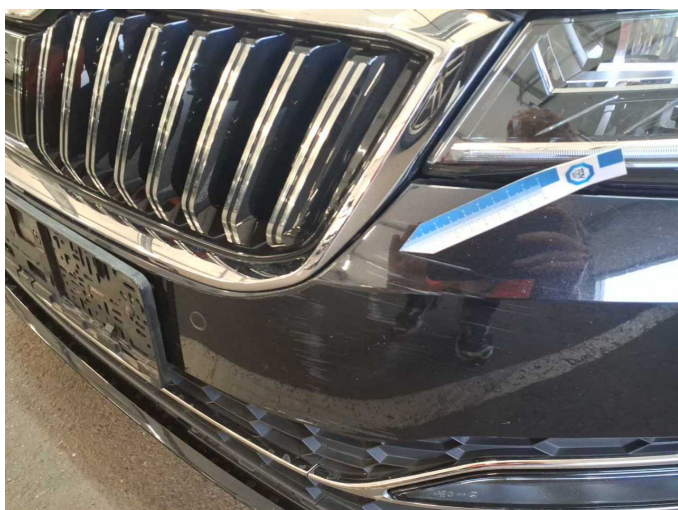
| No. | Component group | Description |
|---|---|---|
| 5 | Vehicle glazing | Windscreen - Broken / torn - Replace |

**Damage 5:** Vehicle glazing: Windscreen - Broken / torn - Replace

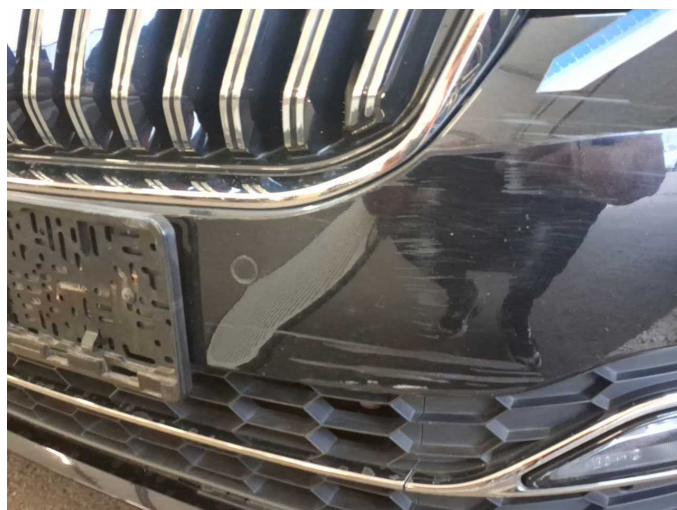
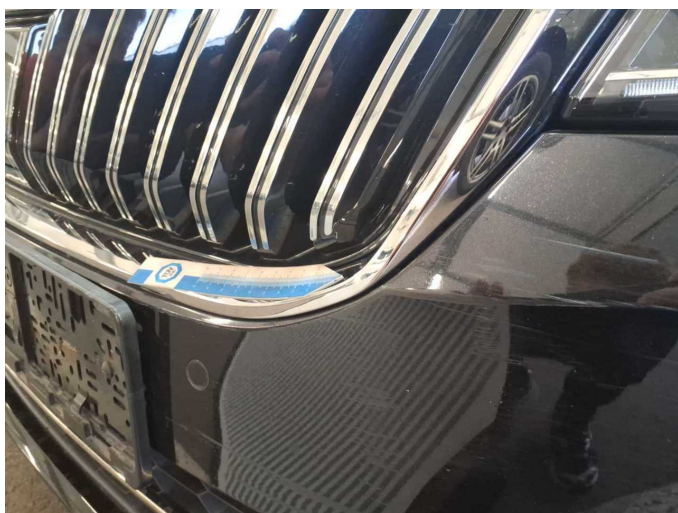
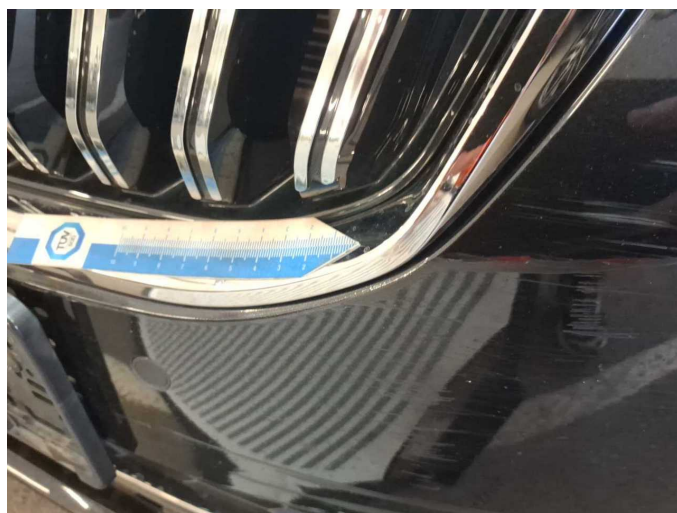
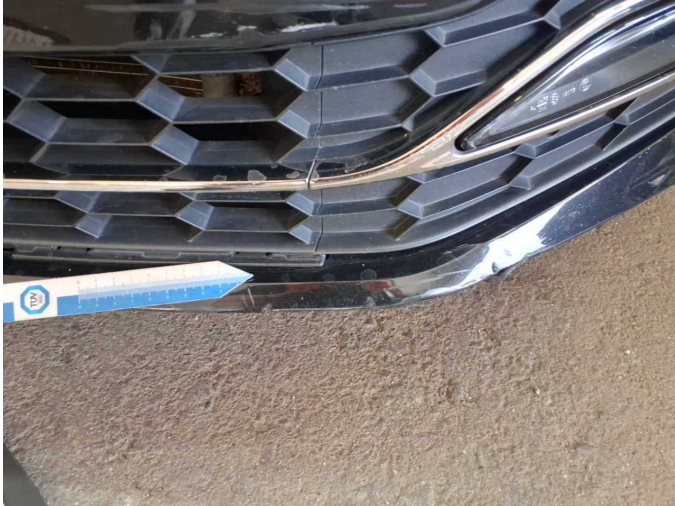
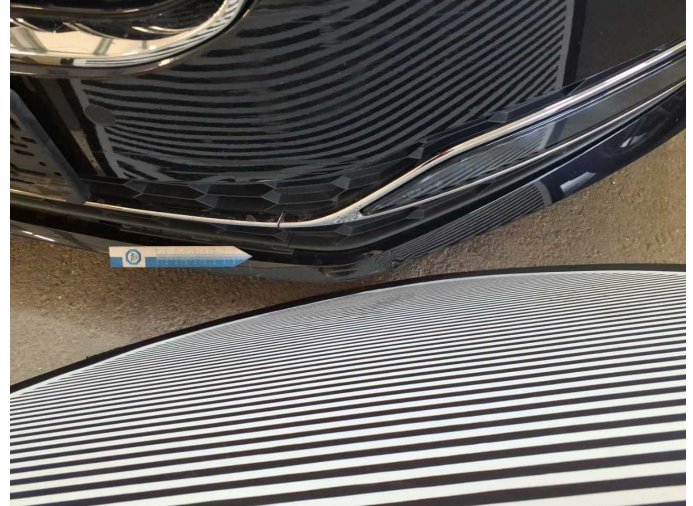
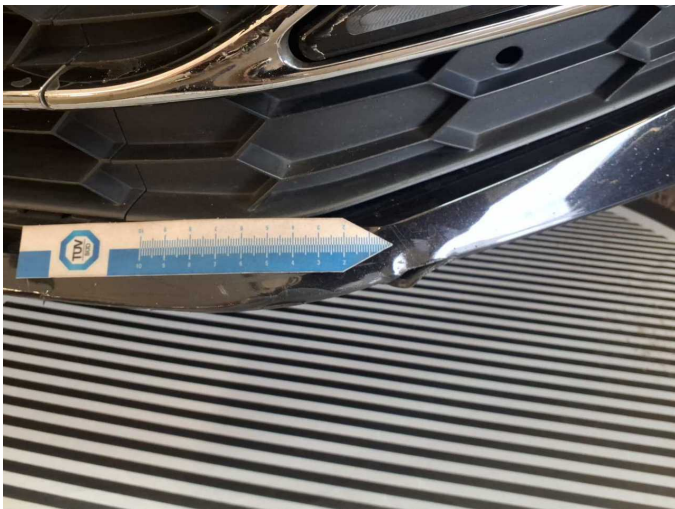
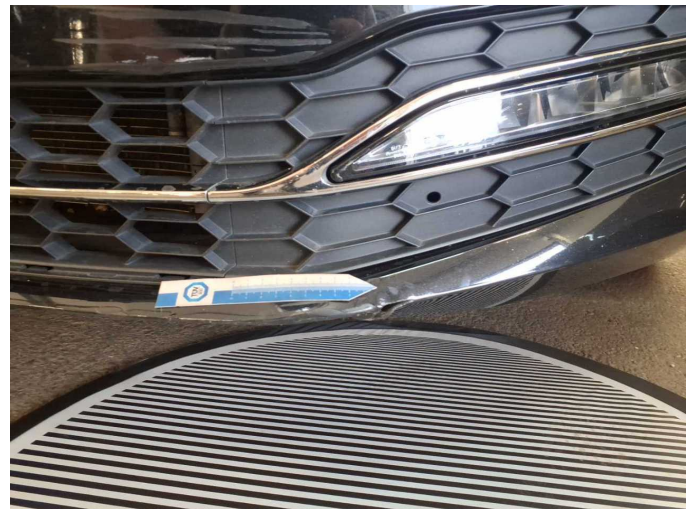
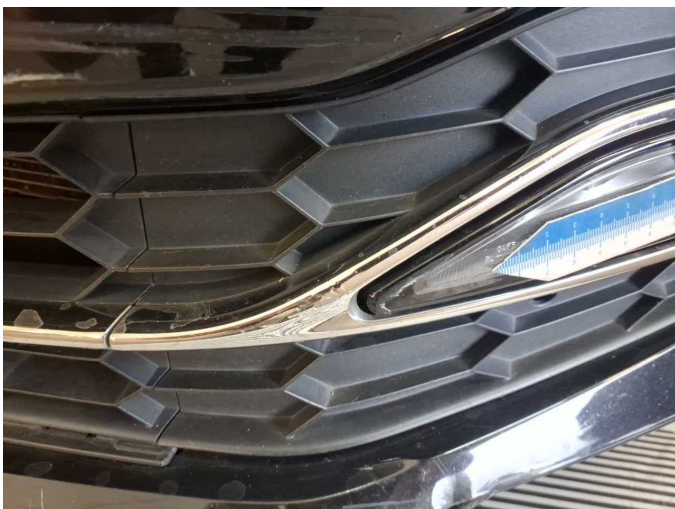
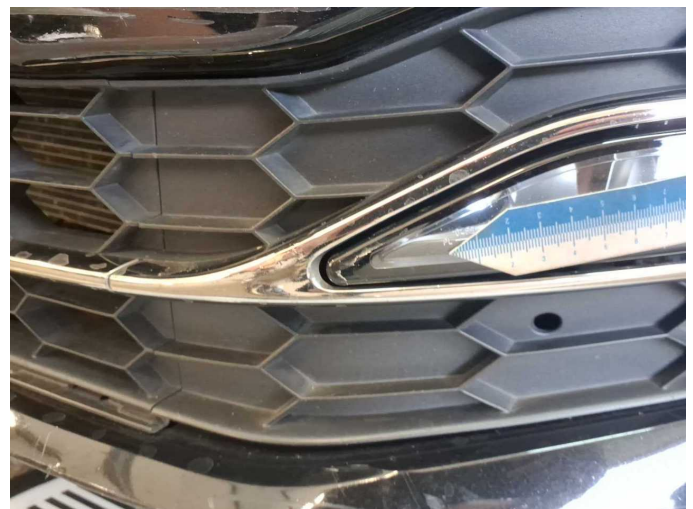
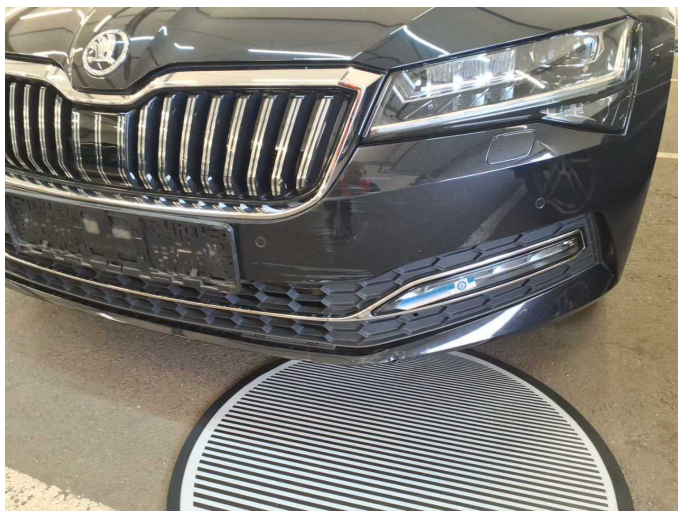
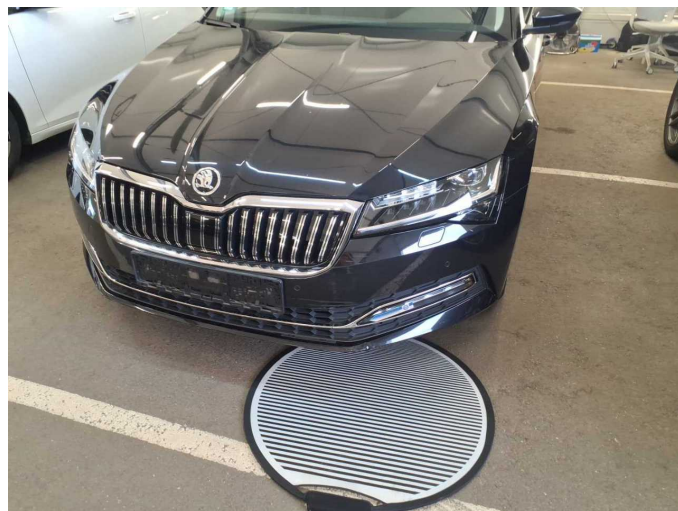
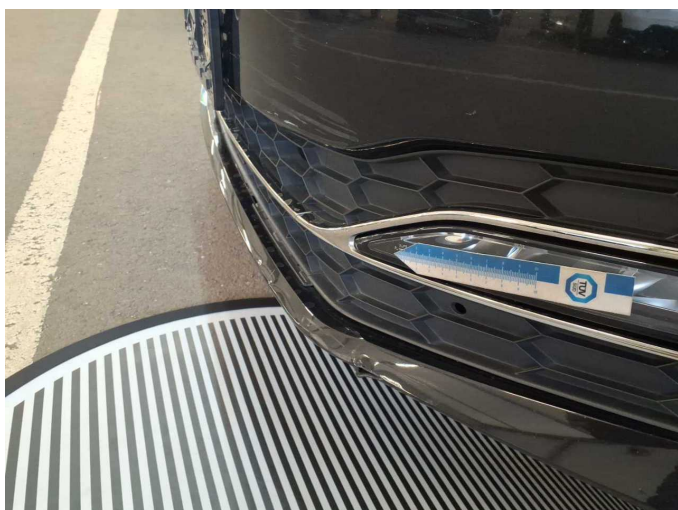
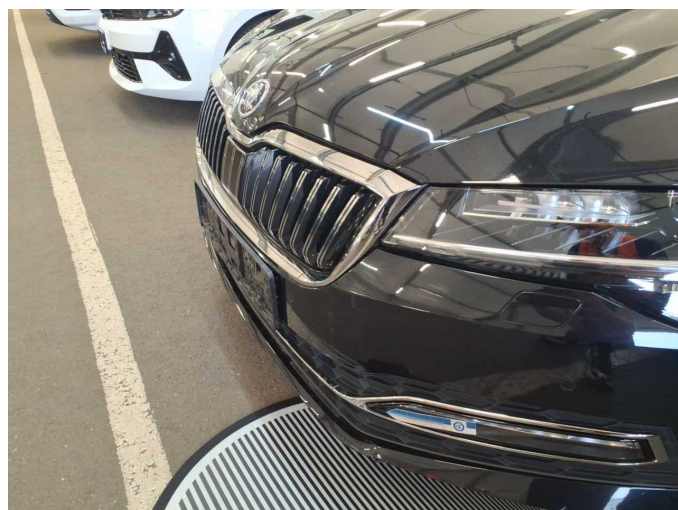
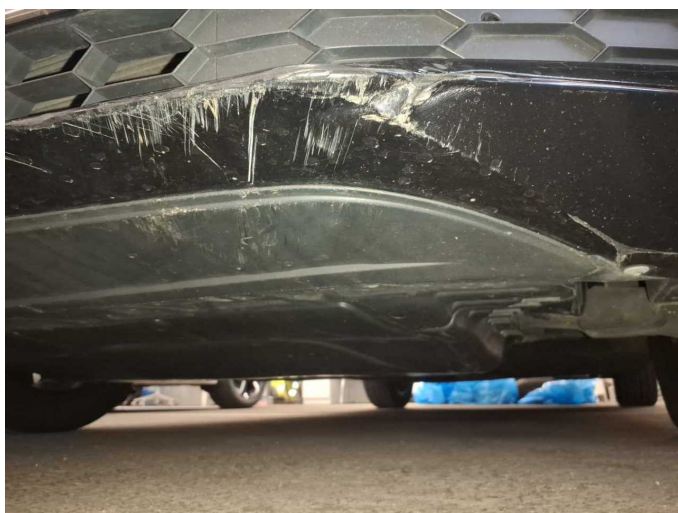
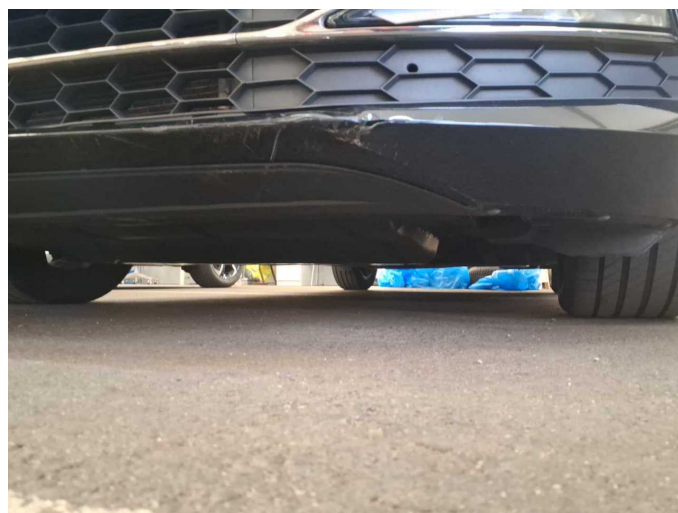
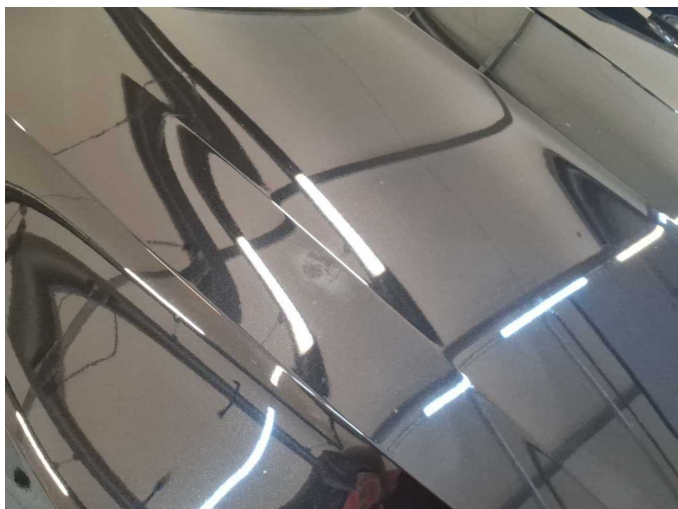
| No. | Component group | Description |
|---|---|---|
| 6 | Front bumper | Front bumper (inkl. diverse Anbauteile verformt & verkratzt) - Broken / torn - Replace |

**Damage 6:** Front bumper: Front bumper (inkl. diverse Anbauteile verformt & verkratzt) - Broken / torn - Replace

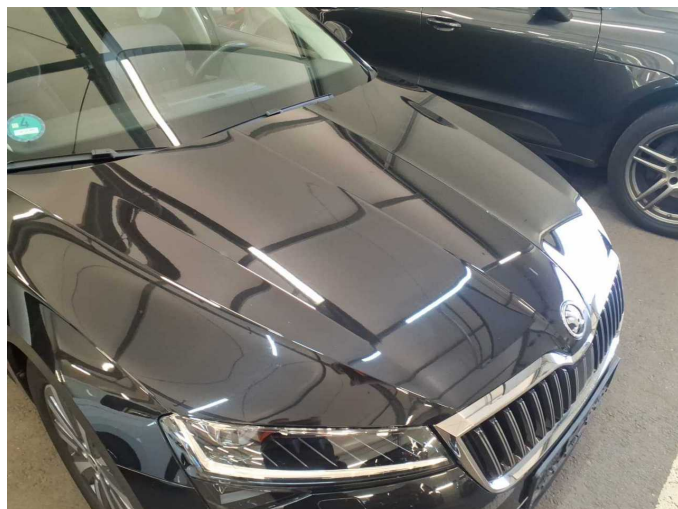
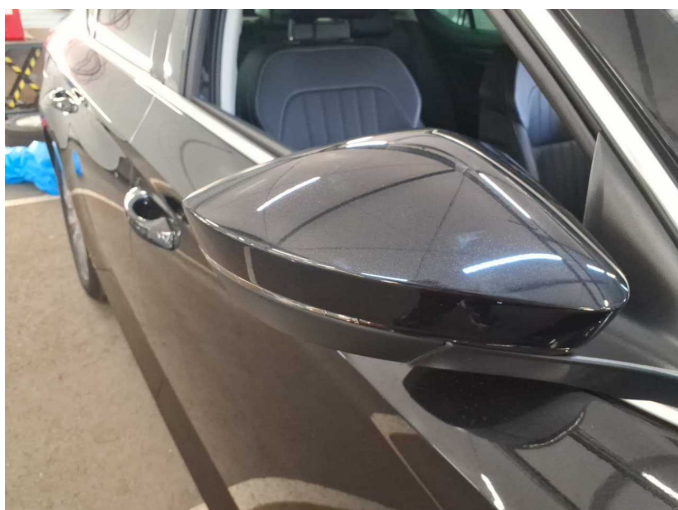
| No. | Component group | Description |
|---|---|---|
| 1 | Bonnet | Bonnet - Scratch(es) - No deduction |

**Wear and tear 1:** Bonnet: Bonnet - Scratch(es) - No deduction

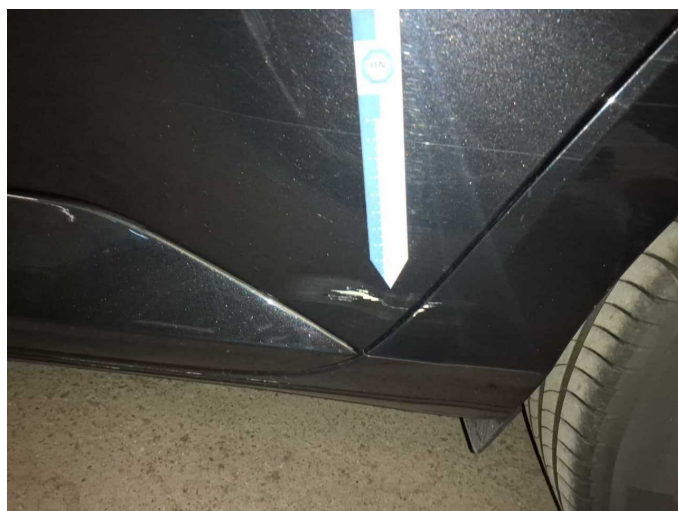
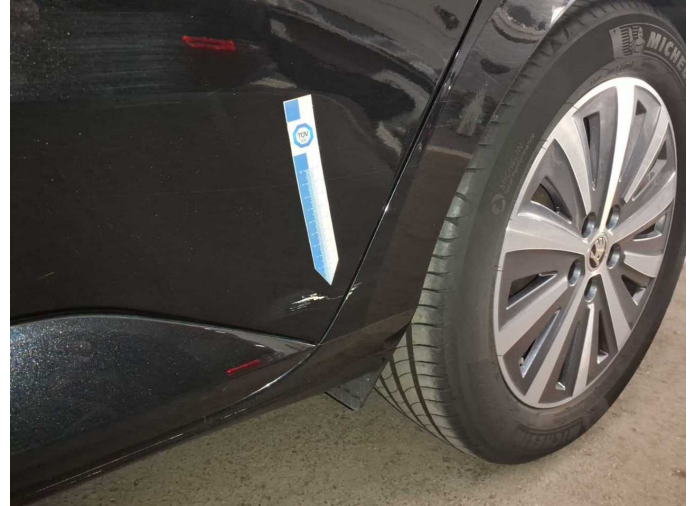
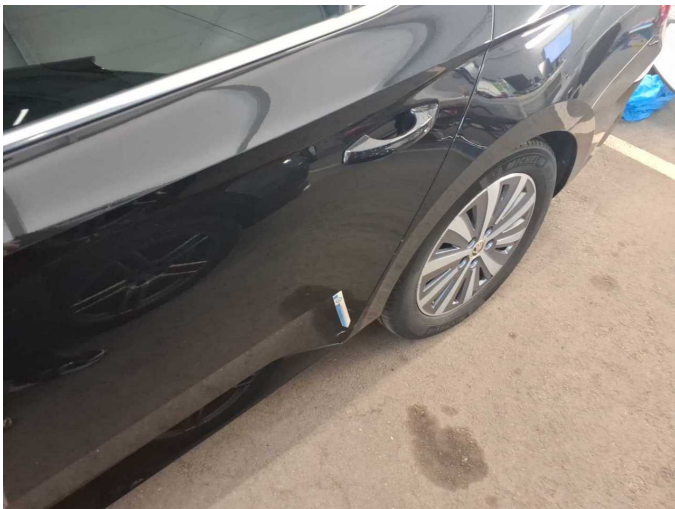
| No. | Accident |
|---|---|
| 1 | Side - left |

**Accident 1:** Side - left

**Accident 1: Side - left**
