# MACDAM

## Ford Mustang '19 BEV

### Vehicle information

### Damage summary

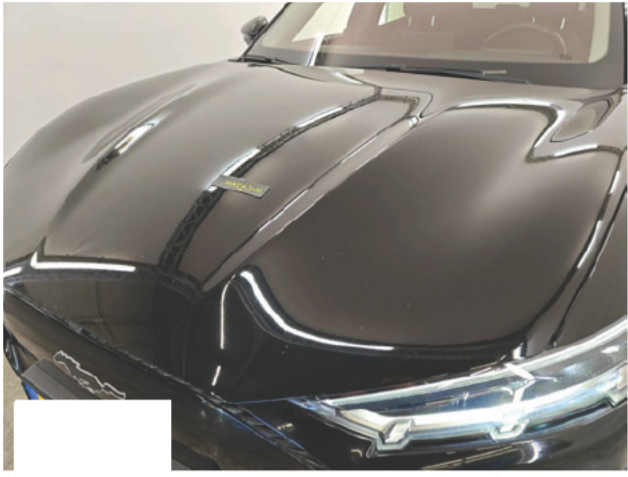
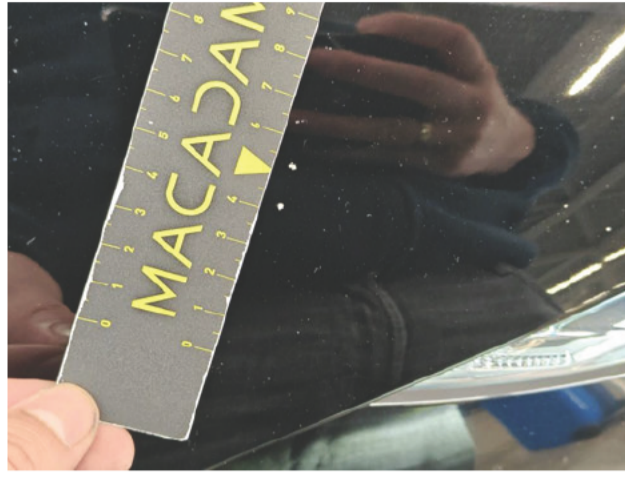
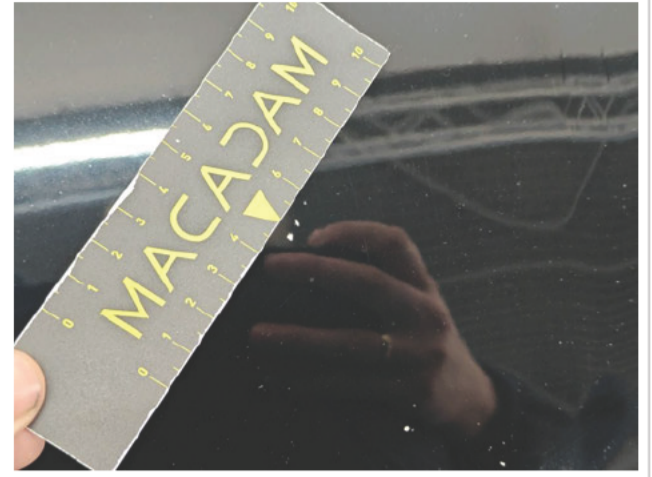
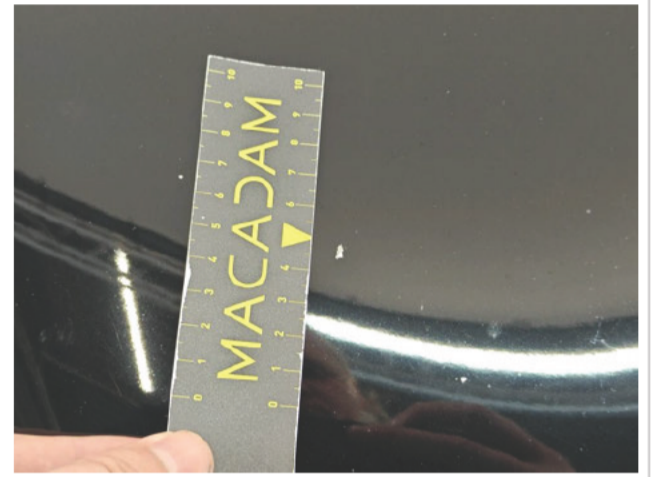
**Bonnet**

Stone chip(s)

Repair and paint (complete)

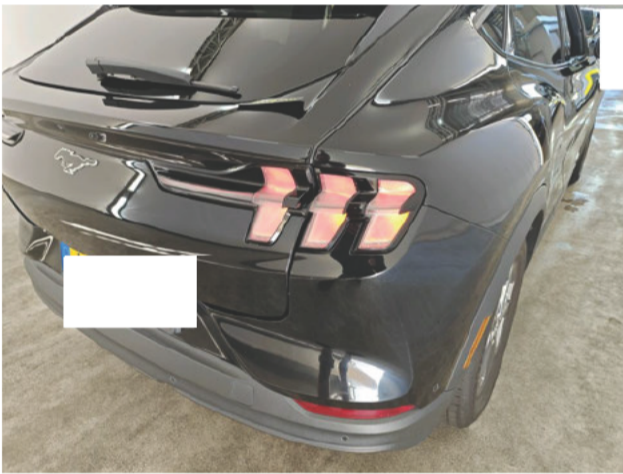
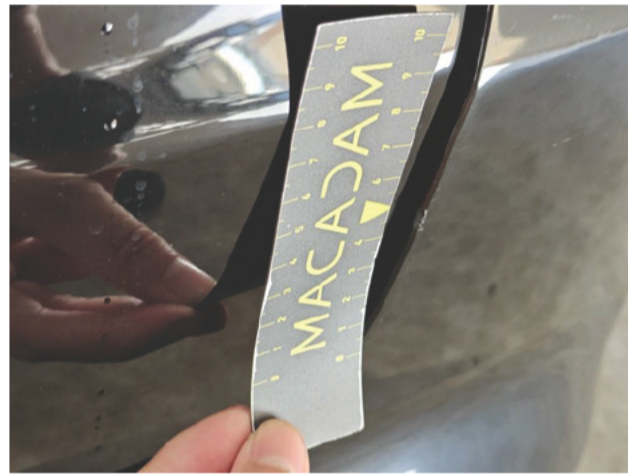
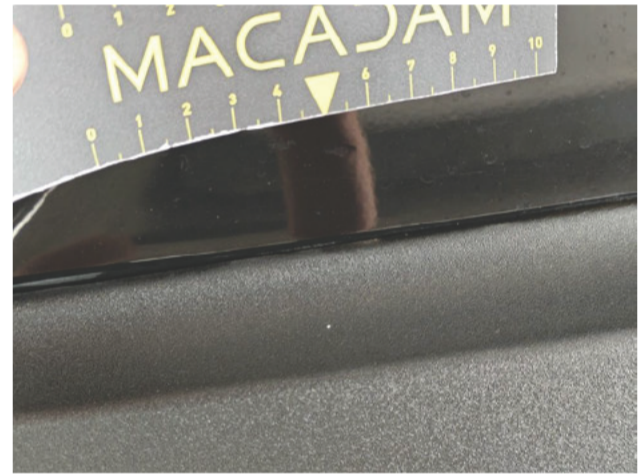
**Bumper R**

Scratch(es)

Repair and paint (complete)

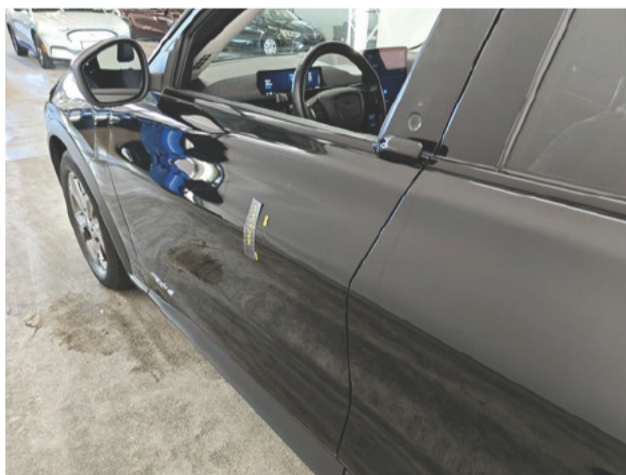
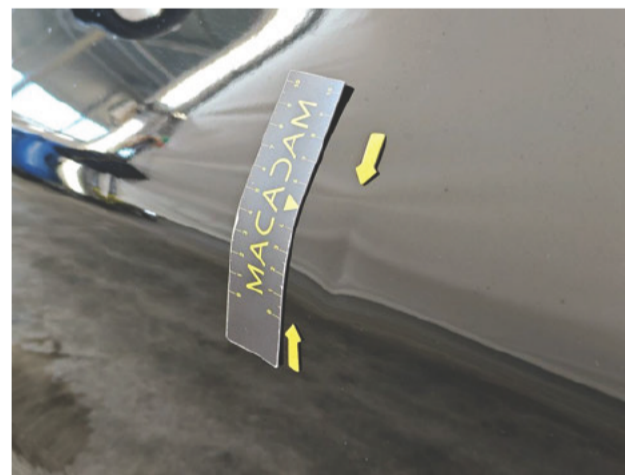
**Door FL**

Dent(s)

Repair and paint (complete)

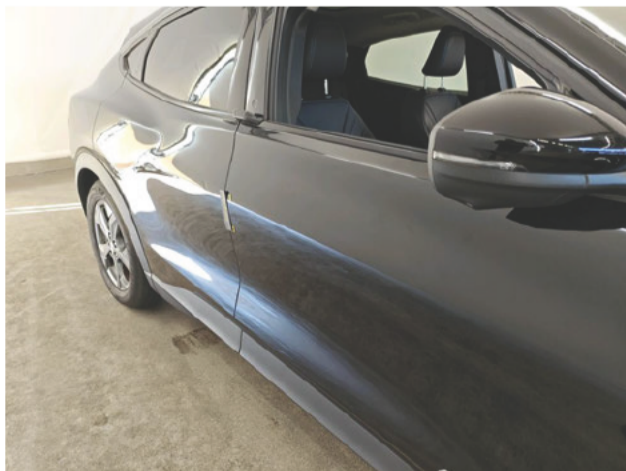
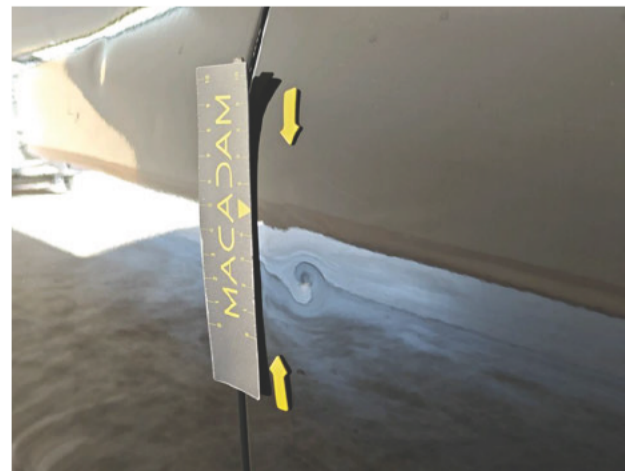
**Door FR**

Dent(s)

Repair and paint (complete)

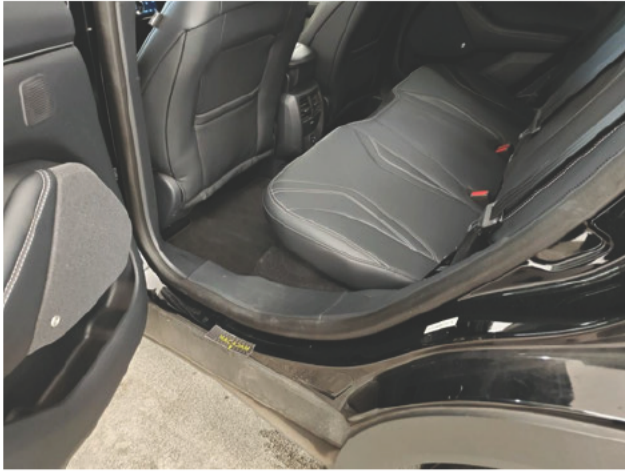
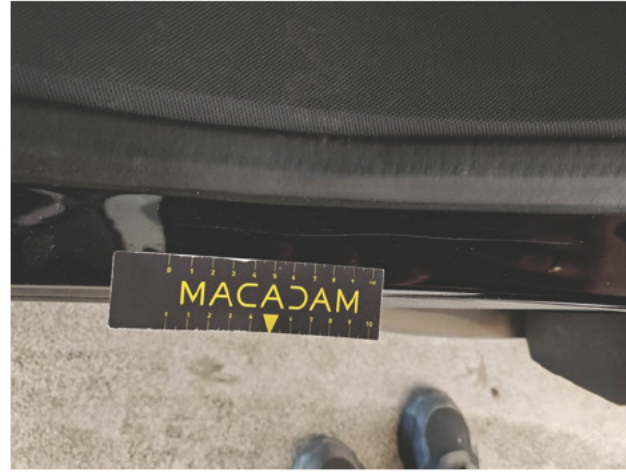
**Door frame RL**

Scratch(es)  
Repair and paint (partial)  
Left

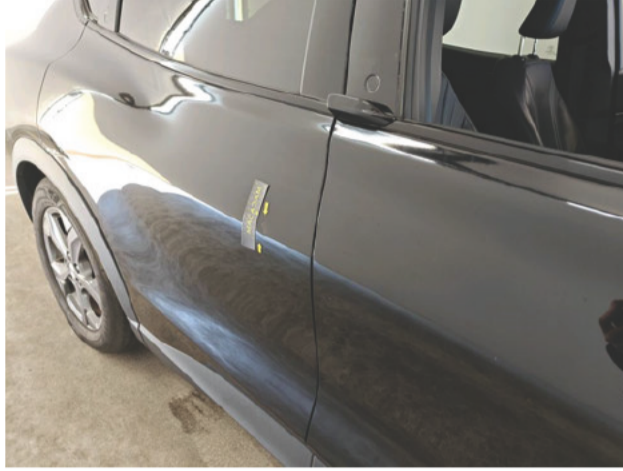
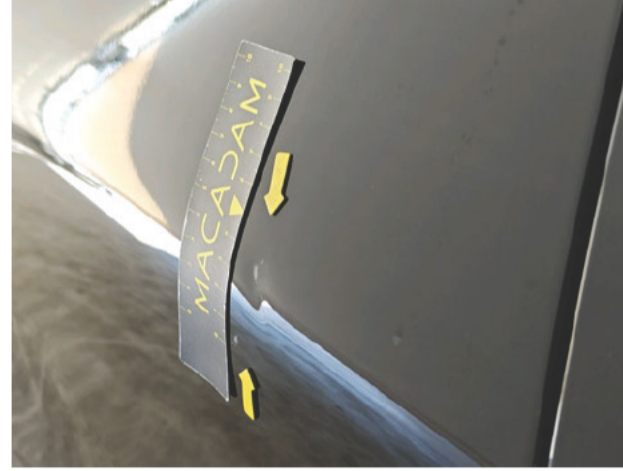
**Door RR**

Dent(s)  
Repair and paint (complete)  
Right

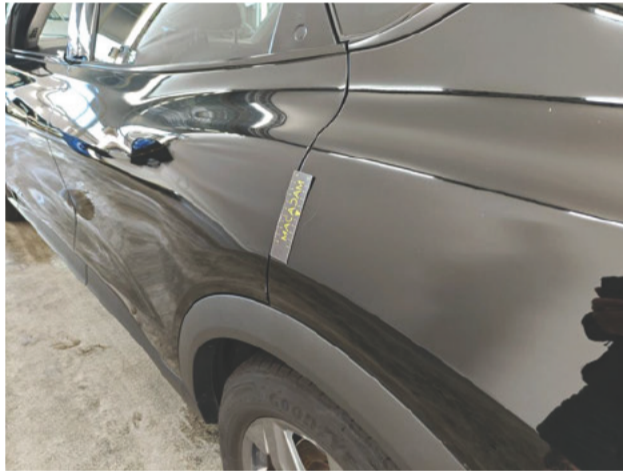
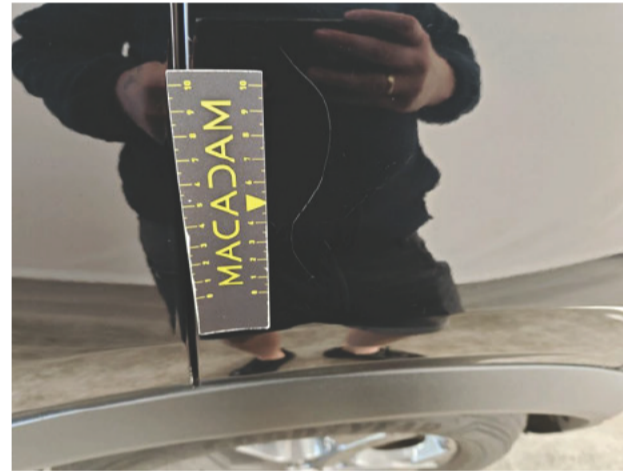
**Wing RL**

Scratch(es)  
Repair and paint (complete)  
Left

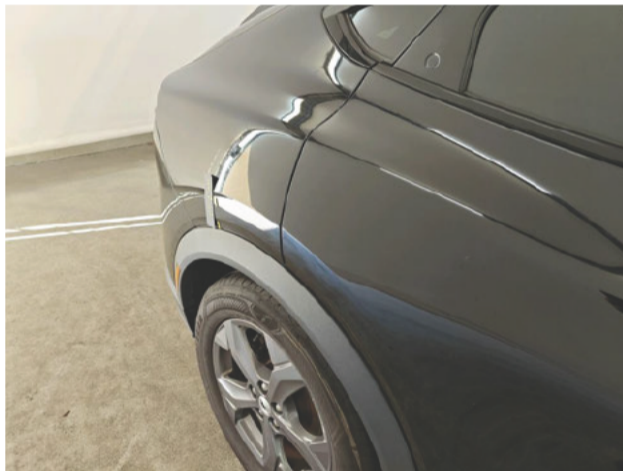
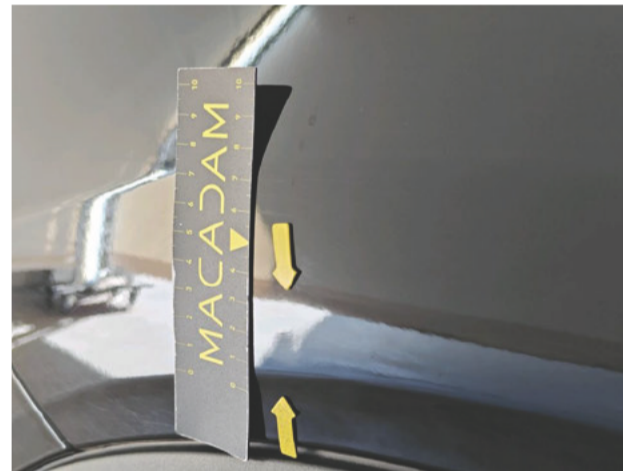
**Wing RR**

Dent(s)  
Repair and paint (complete)  
Right
