Expertise

Protocol number: 46188344
Order No. / Reference: 26151960
Inspection date: 22 Jun 2026

Model: 319 CDI Sprinter 4x4 Standard 9G-TRONIC PRO

VIN: W1V3MBTZ6TP849884

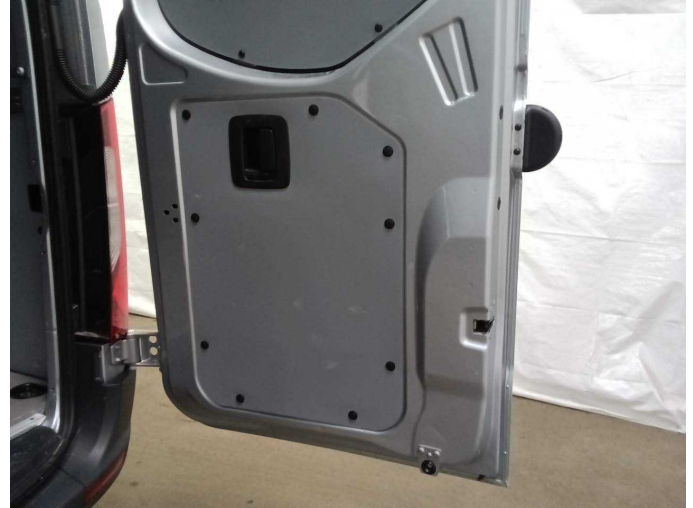
Damage 1: Trim / covers: Boot lid - interior trim - Damaged - Loss in value

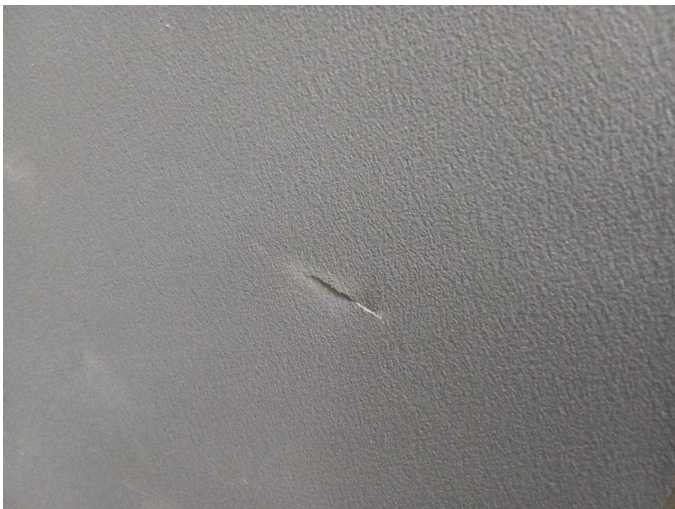
Damage 1: Trim / covers: Boot lid - interior trim - Damaged - Loss in value

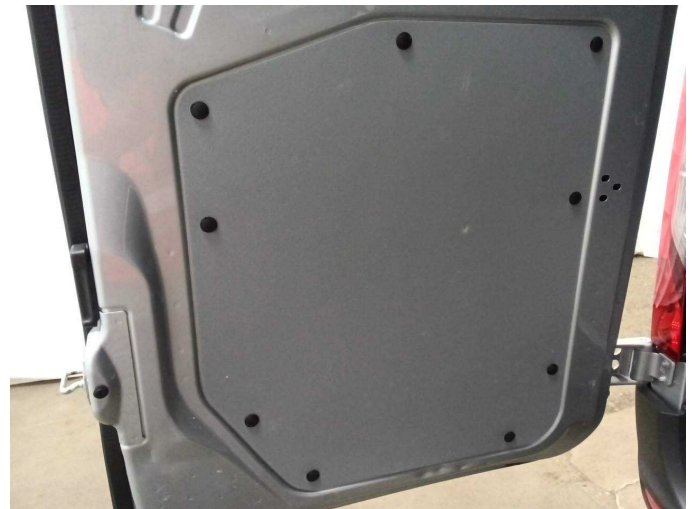
Damage 1: Trim / covers: Boot lid - interior trim - Damaged - Loss in value

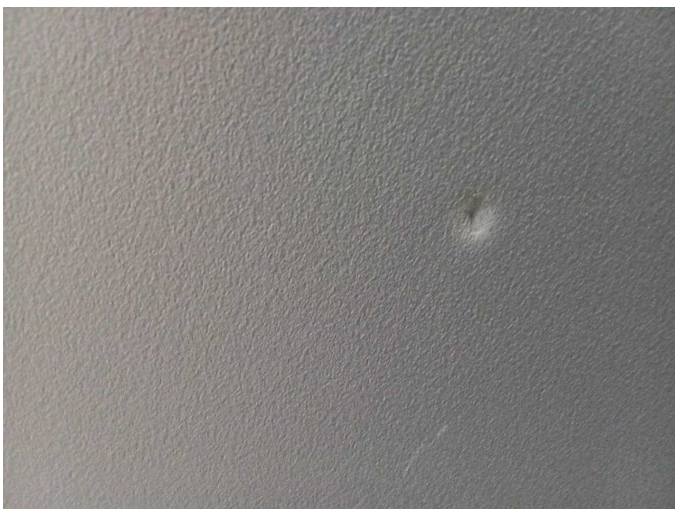
Damage 1: Trim / covers: Boot lid - interior trim - Damaged - Loss in value

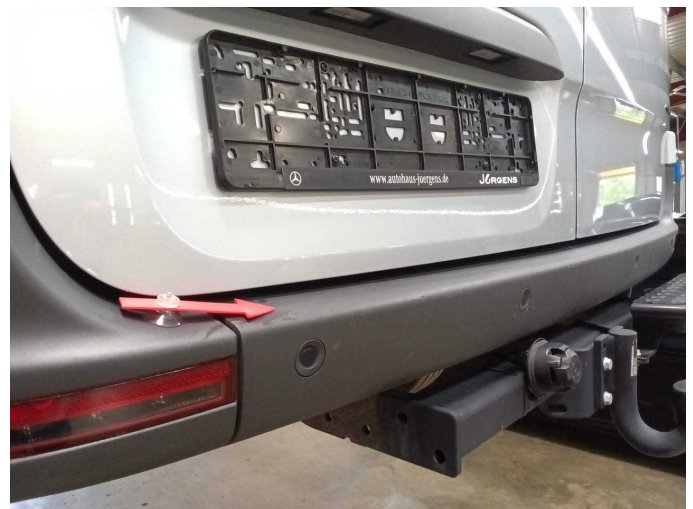
Damage 2: Rear bumper: Rear bumper - Scratched - Replace

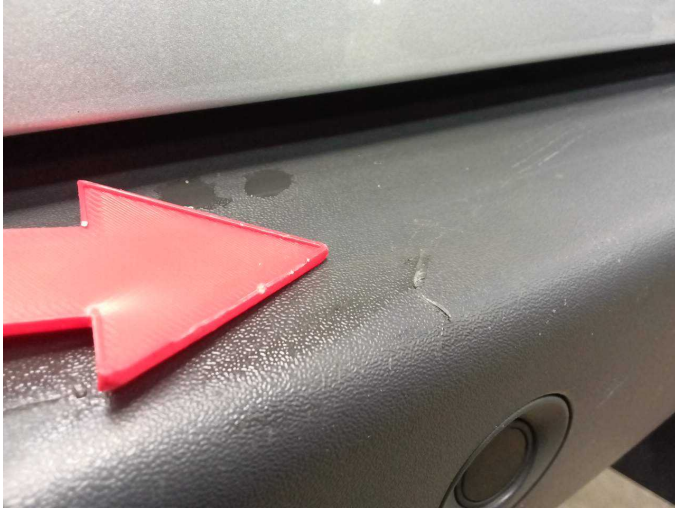
Damage 2: Rear bumper: Rear bumper - Scratched - Replace

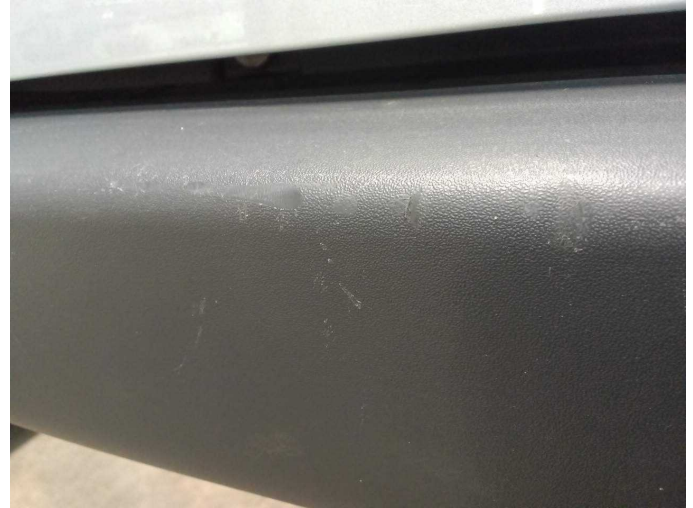
Damage 2: Rear bumper: Rear bumper - Scratched - Replace

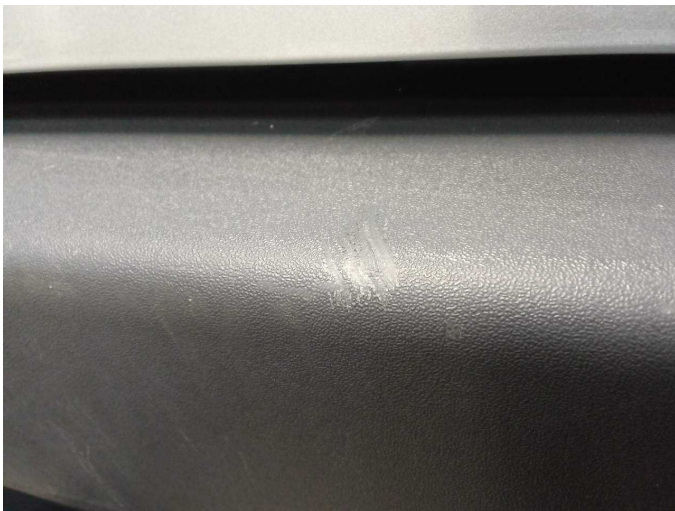
Damage 2: Rear bumper: Rear bumper - Scratched - Replace

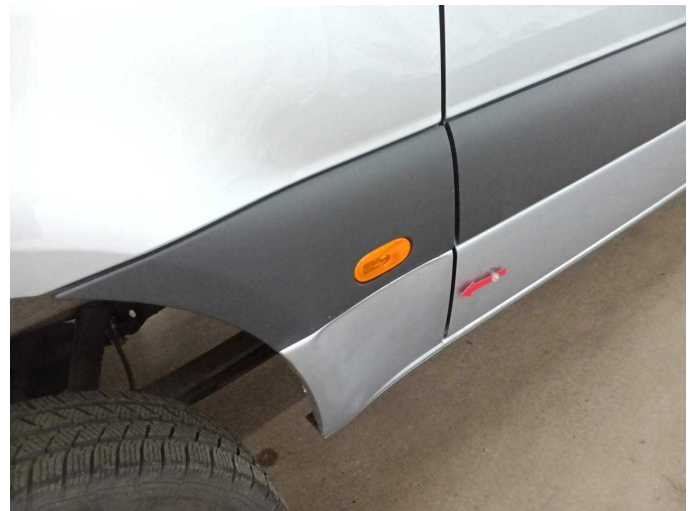
Damage 3: Side panel - rear right side: Side panel - Unprofessionally repaired - Repair and paint

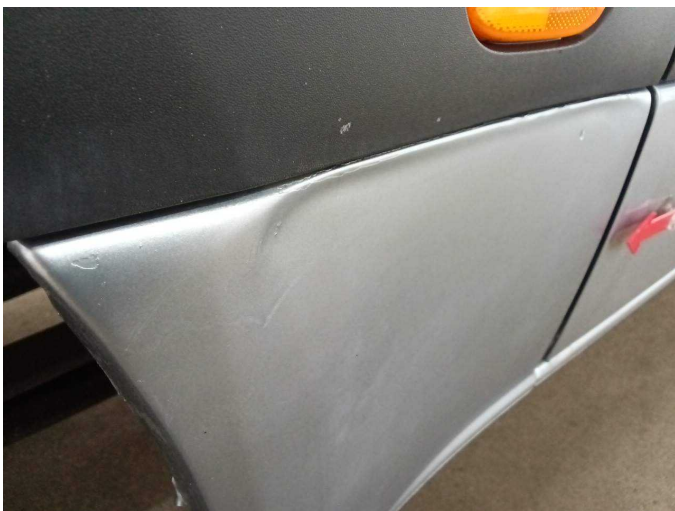
Damage 3: Side panel - rear right side: Side panel - Unprofessionally repaired - Repair and paint

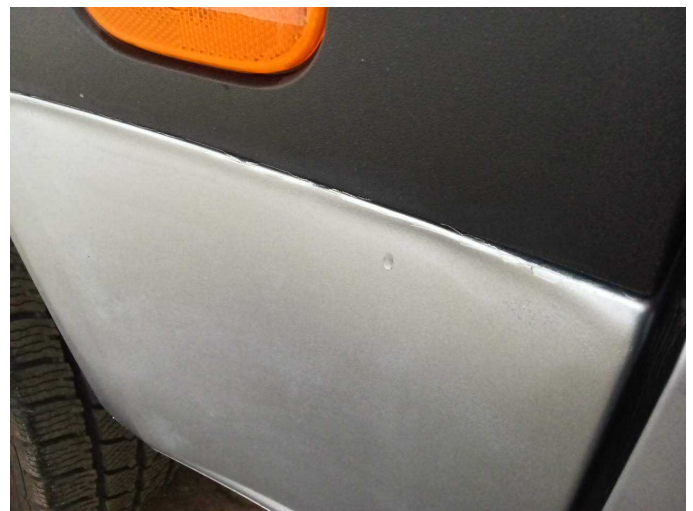
Damage 3: Side panel - rear right side: Side panel - Unprofessionally repaired - Repair and paint

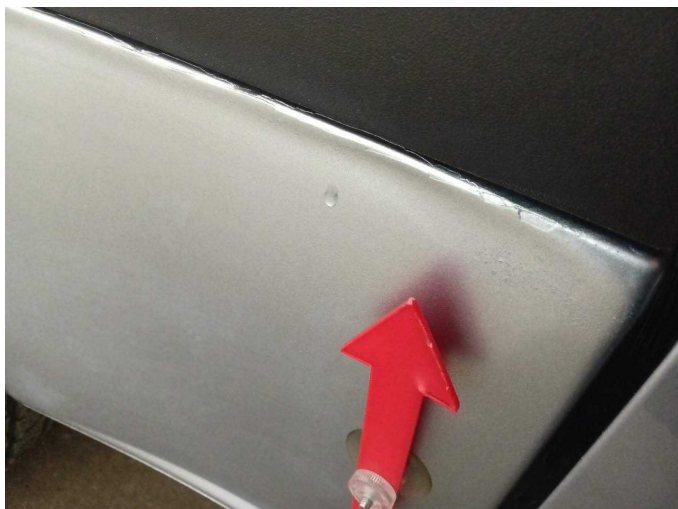
Damage 3: Side panel - rear right side: Side panel - Unprofessionally repaired - Repair and paint
