Expertise

Protocol number: 45785285
Order No. / Reference: 26529585
Inspection date: 5 Jun 2026

Manufacturer: Ford

Model: Focus Turnier 1.5 EcoBlue Start-Stopp-System Aut. TITANIUM

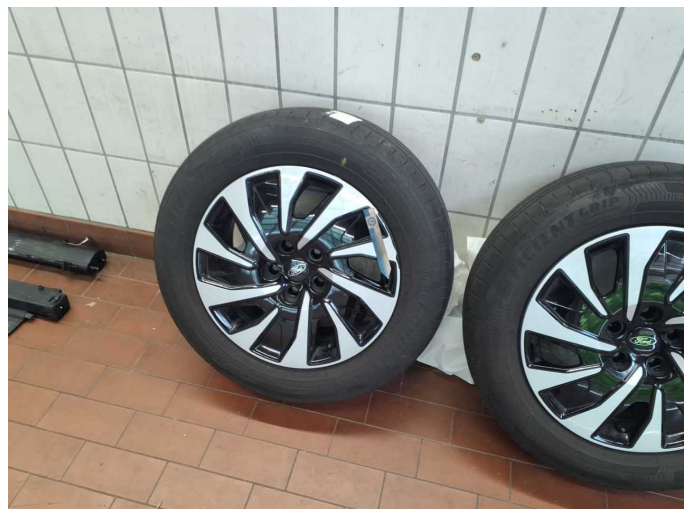
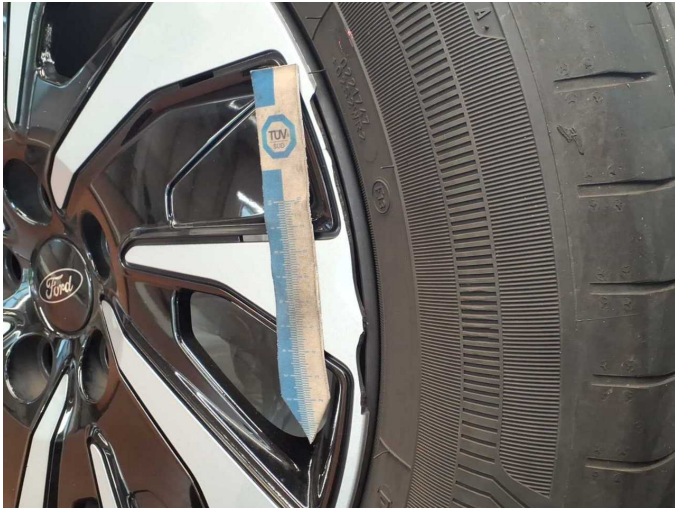
Damage 1: 2nd wheel set: 1 wheel cover - Broken / torn - Replace

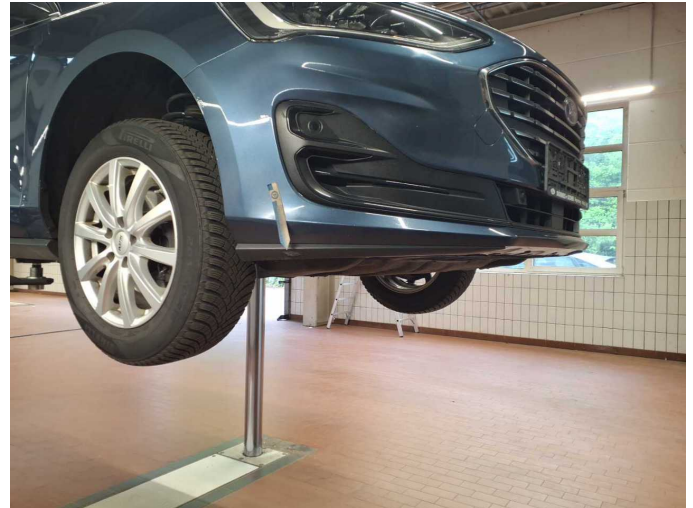
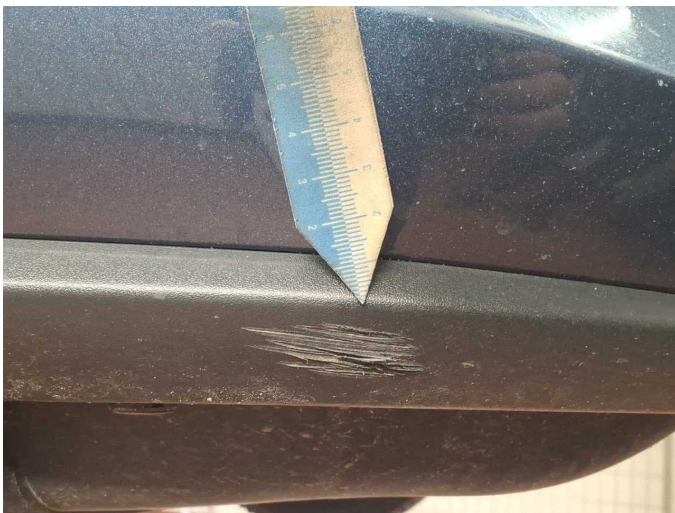
Damage 2: Front bumper: Spoiler (Rechts) - Scratched - Replace

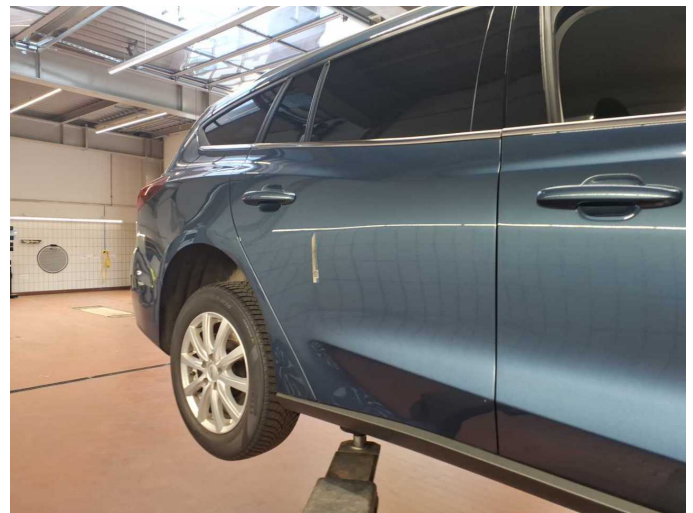
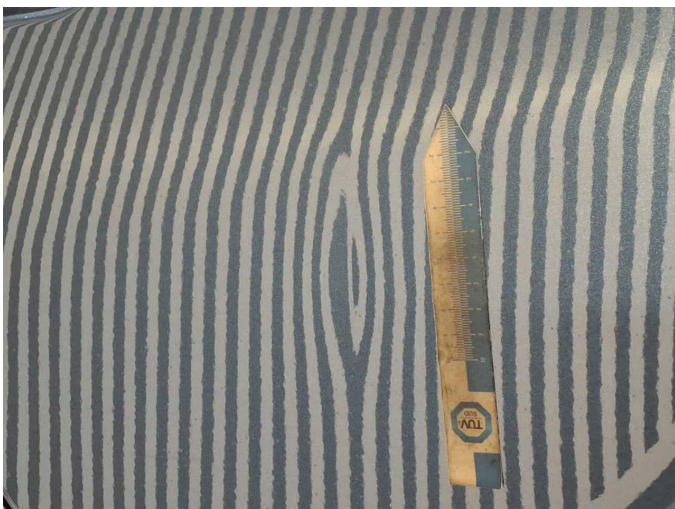
Damage 3: Door - rear right side: Door - dent(s) - Smart repair

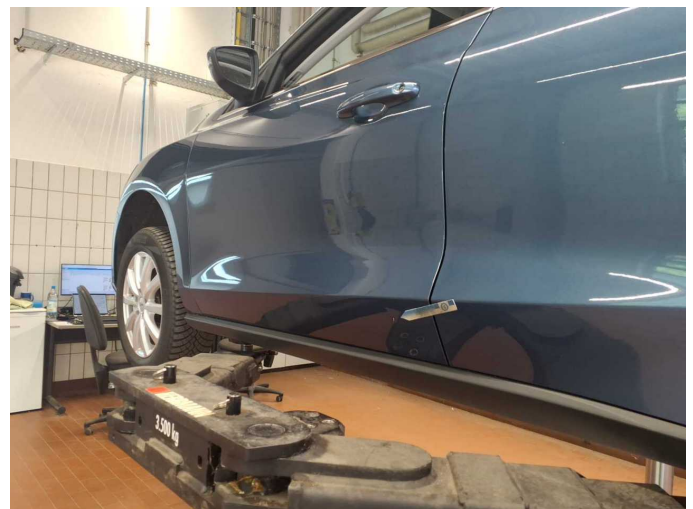
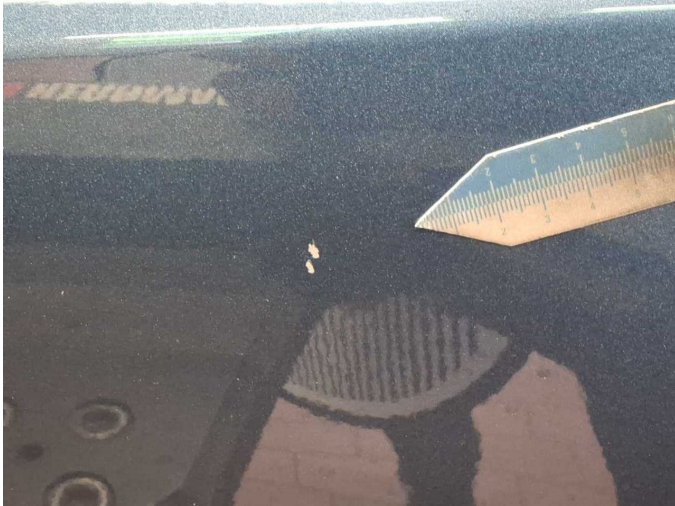
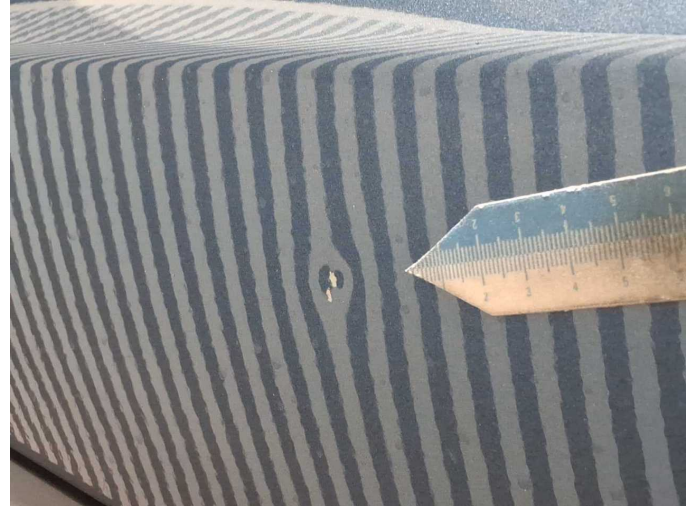
Damage 4: Door - front left side: Door - Dent / paintcoat damage - Smart repair

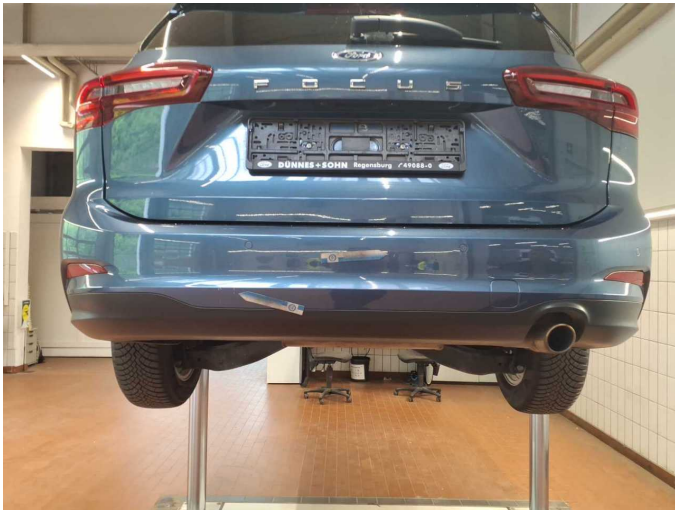
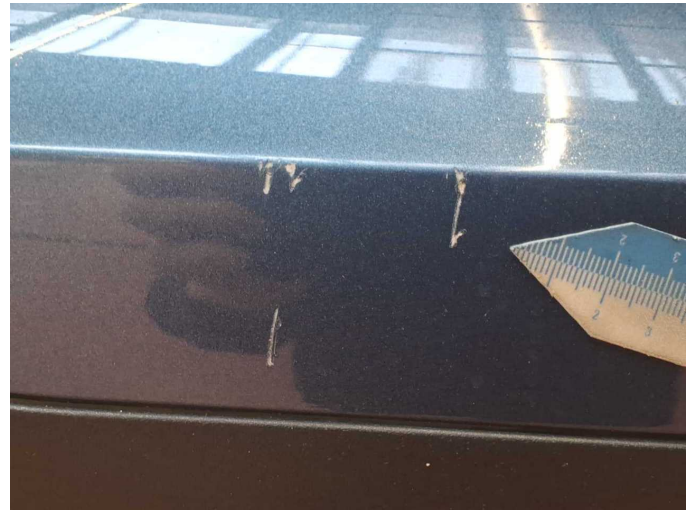
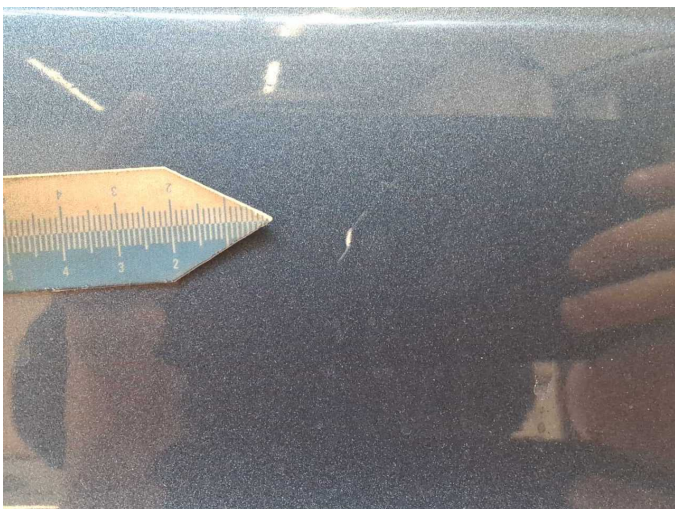
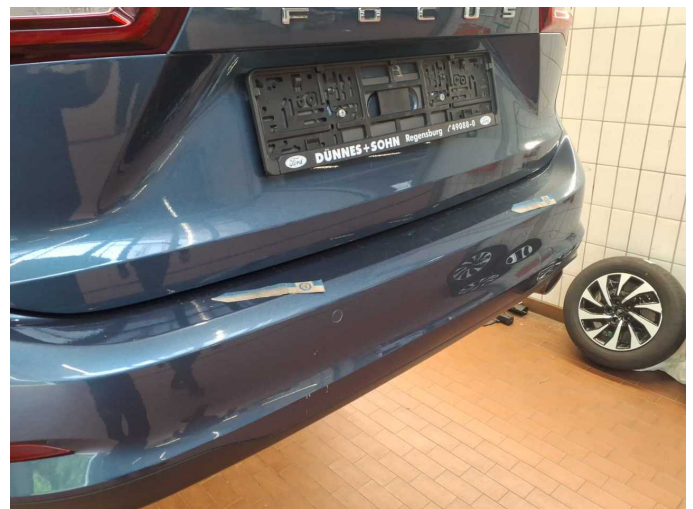
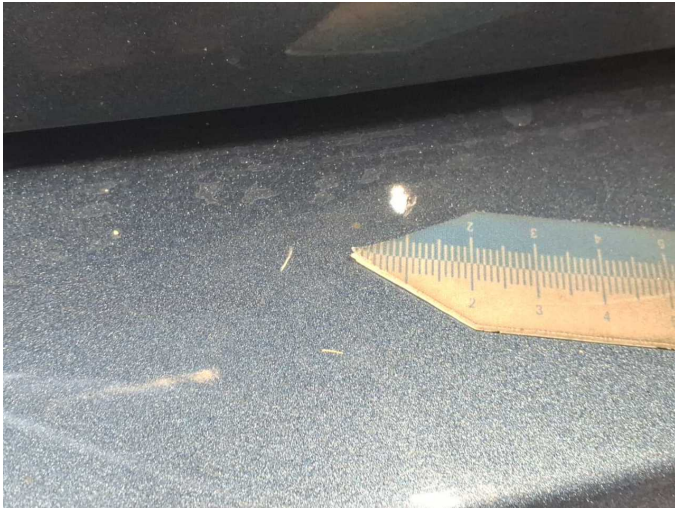
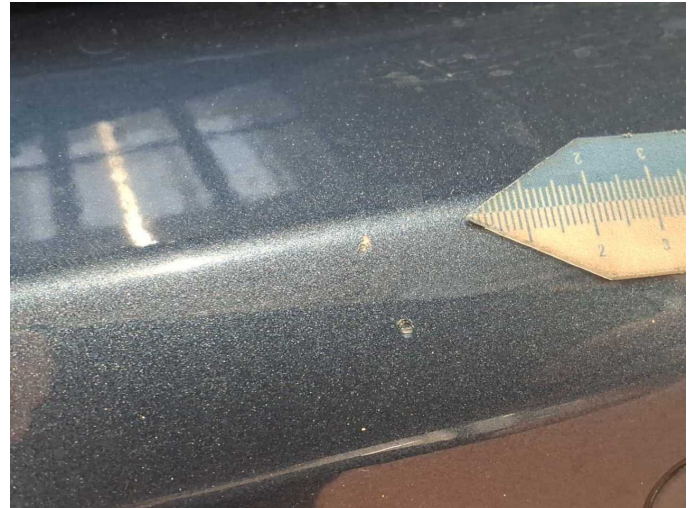
Damage 6: Rear bumper: Rear bumper - Scratch(es) - Paint

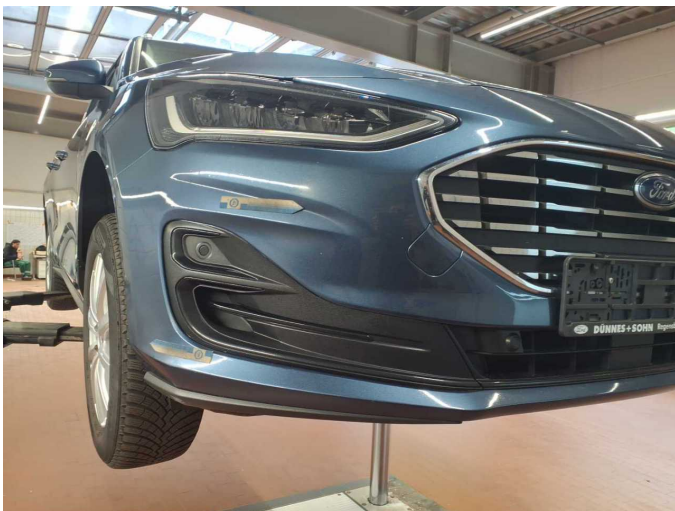
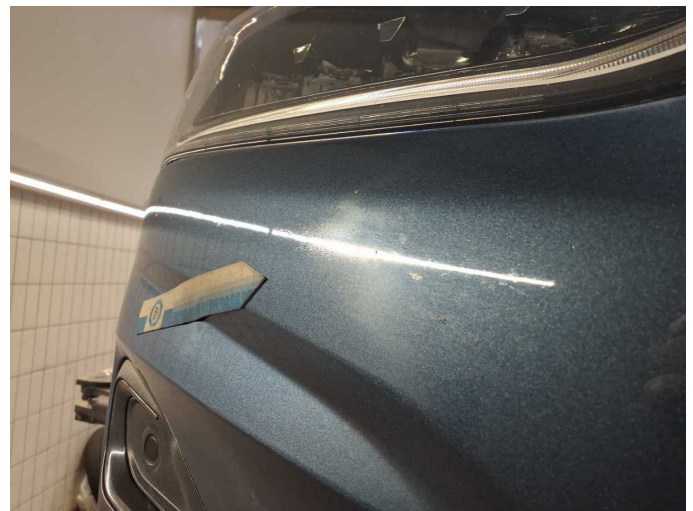
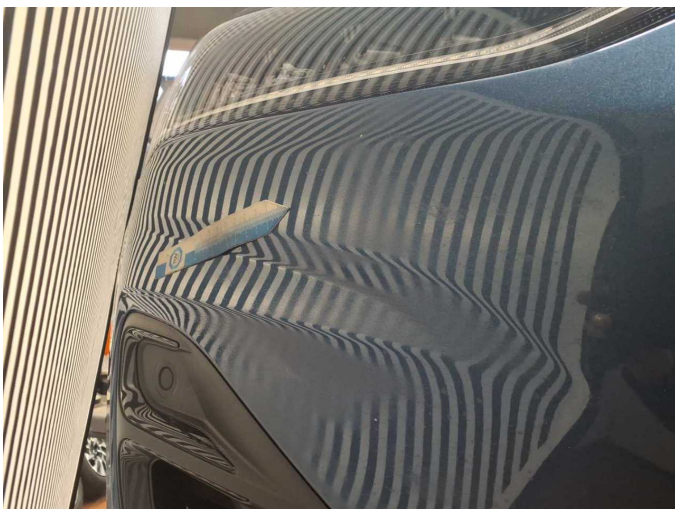
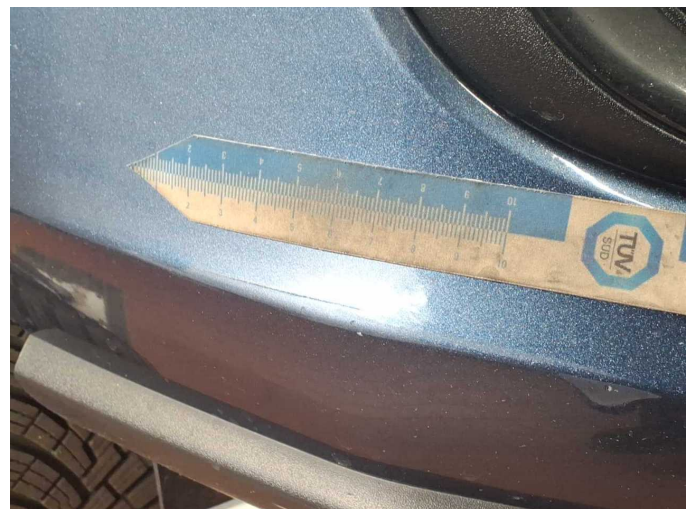
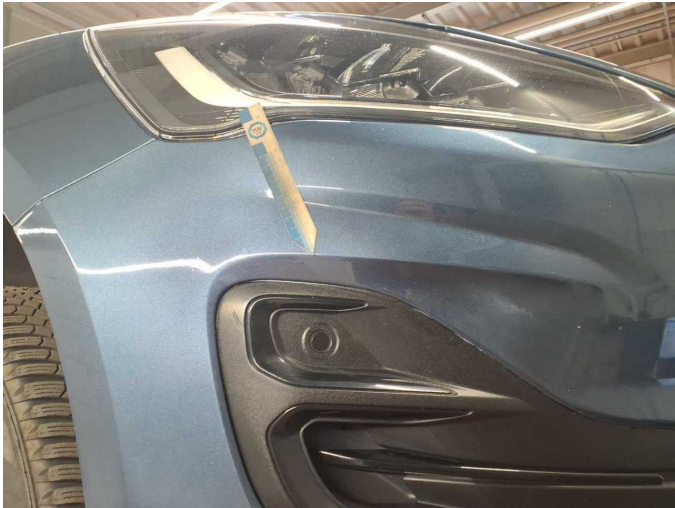
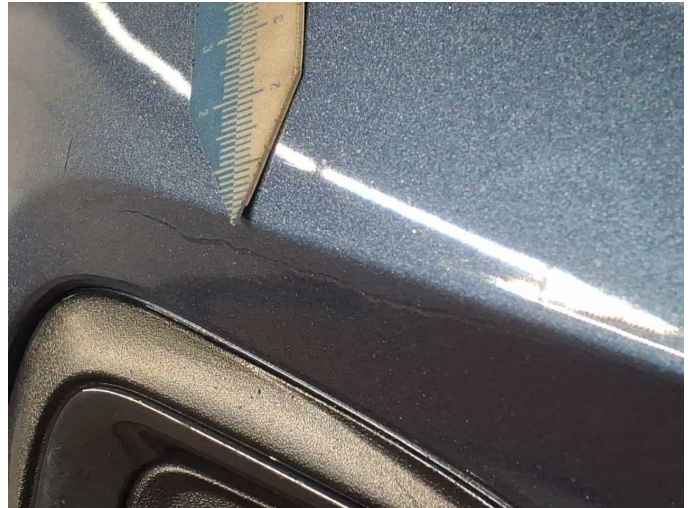
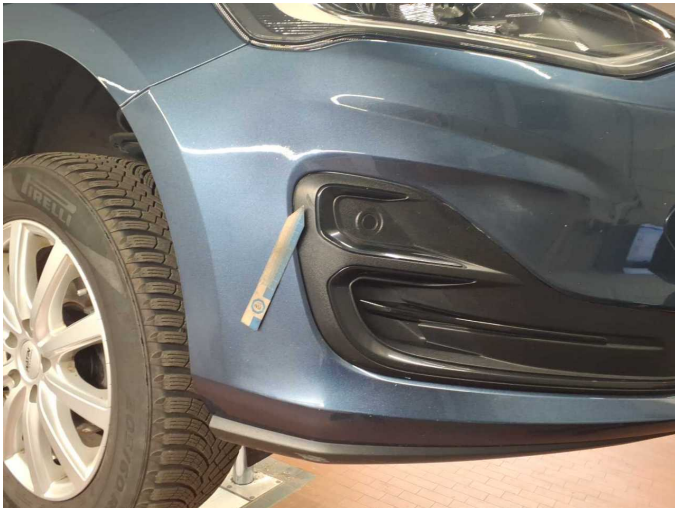
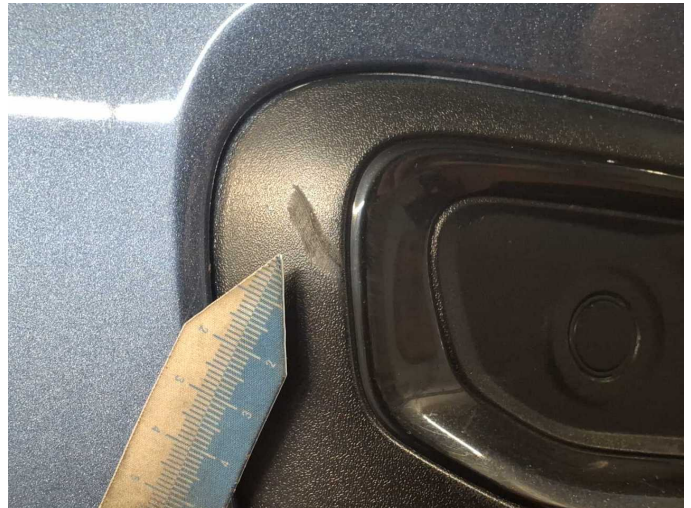
Damage 7: Front bumper: Front bumper (Lackläufer, Lackeinschlüsse) - Unprofessionally repaired - Repair and paint

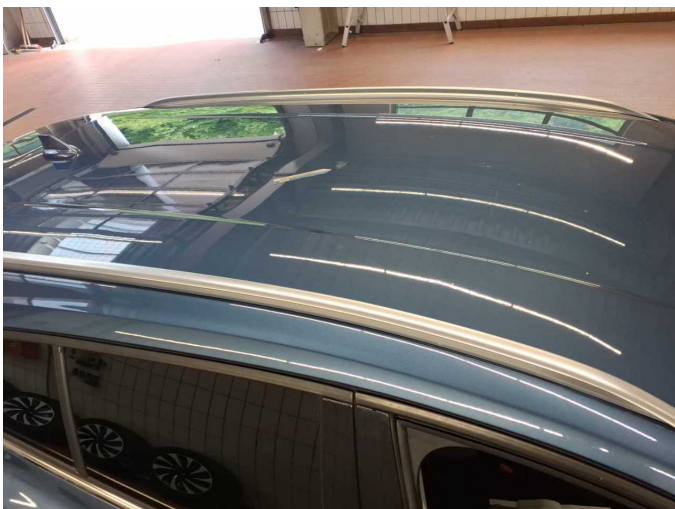
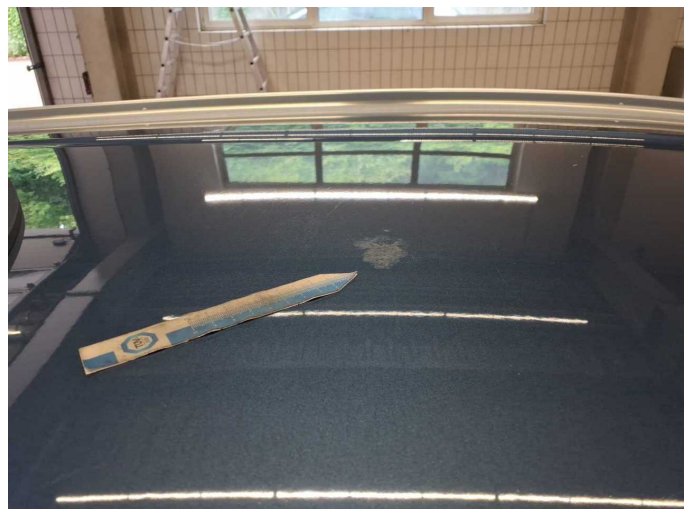
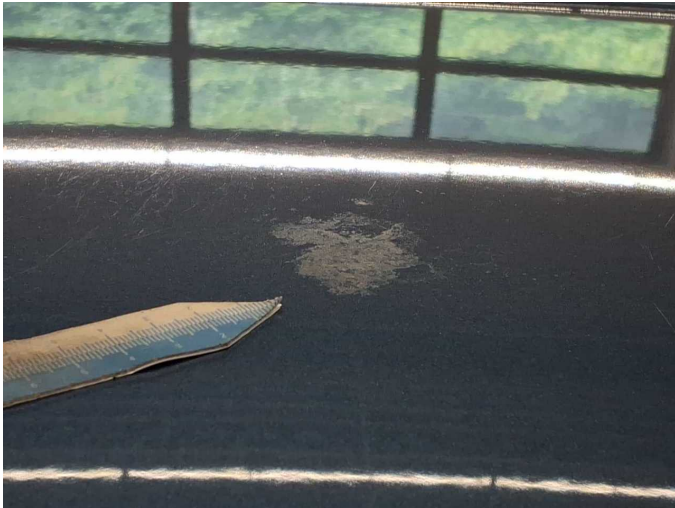
Damage 8: Roof: Roof (Verätzung) - Paint defect - Paint

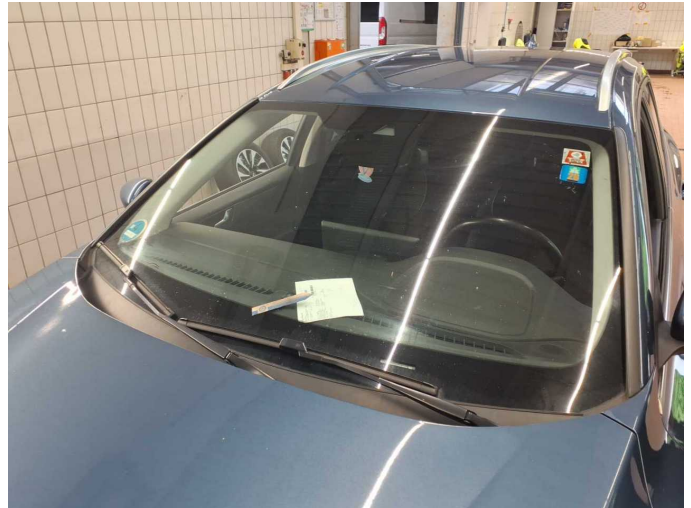
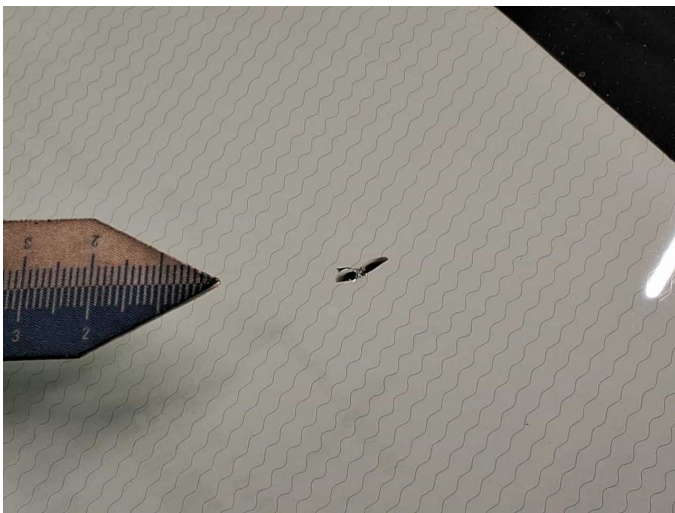
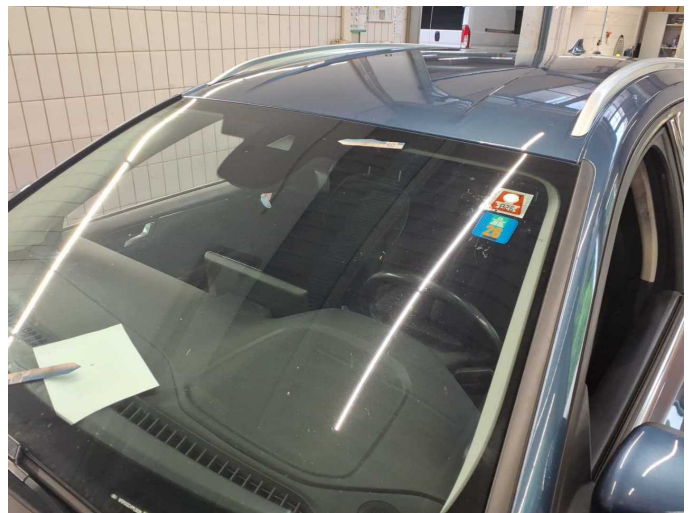
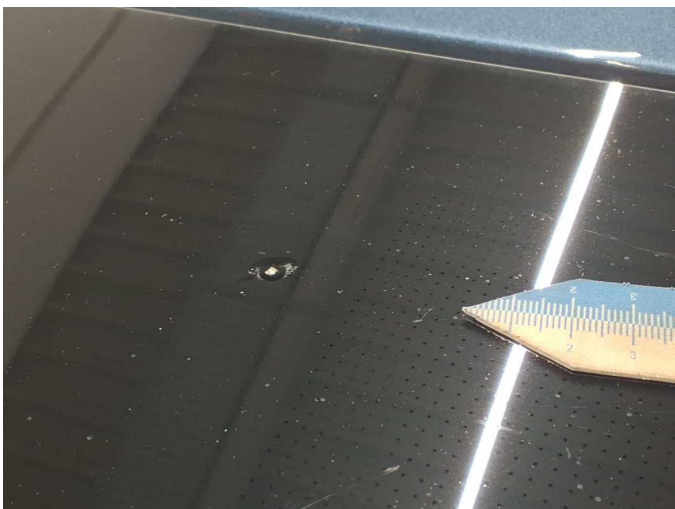
Damage 9: Vehicle glazing: Windscreen (mit Heizung) - Stone chips - Replace

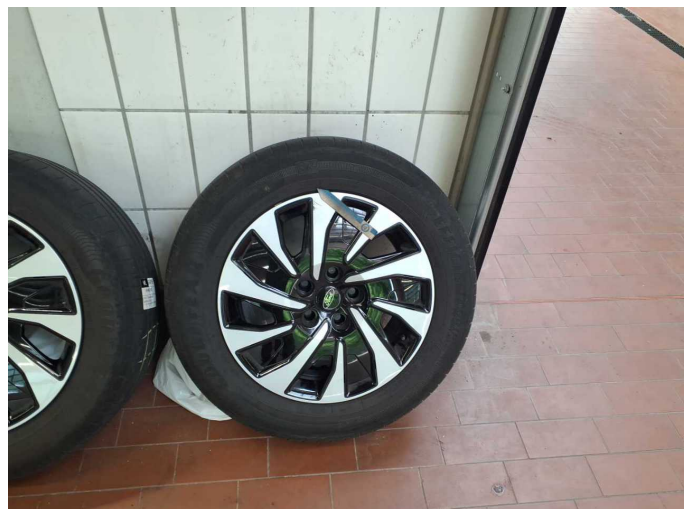
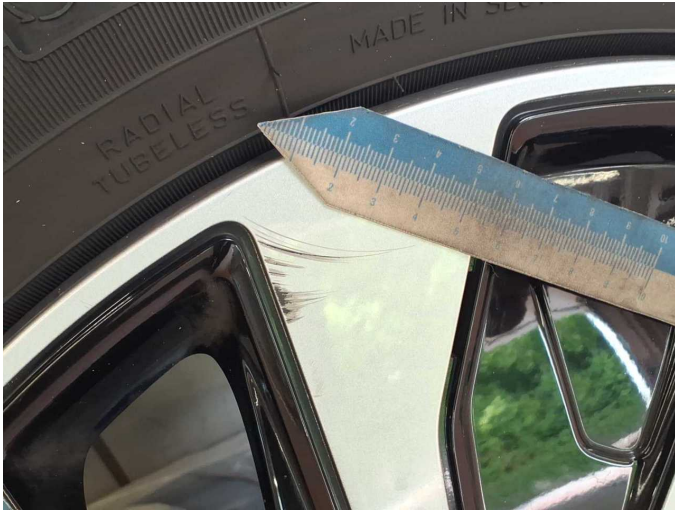
Wear and tear 2: 2nd wheel set: 1 wheel cover - Scratch(es) - No deduction

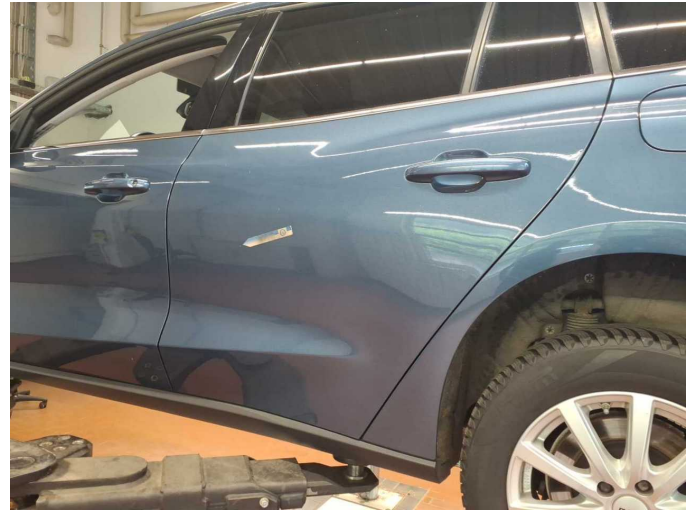
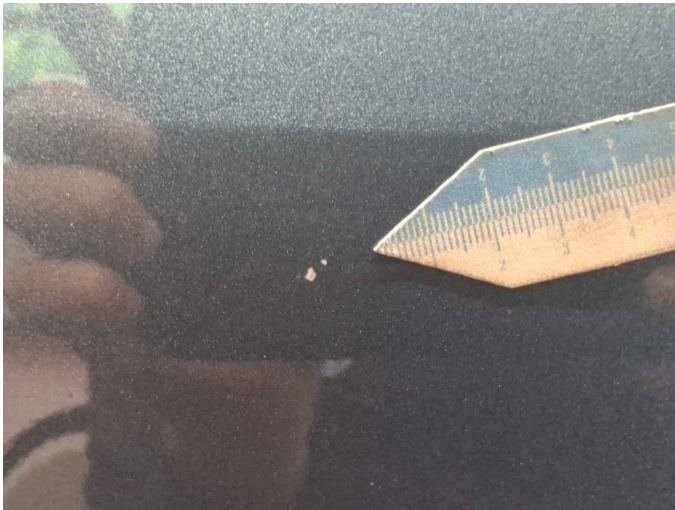
Wear and tear 4: Door - rear left side: Door - Scratch(es) - No deduction

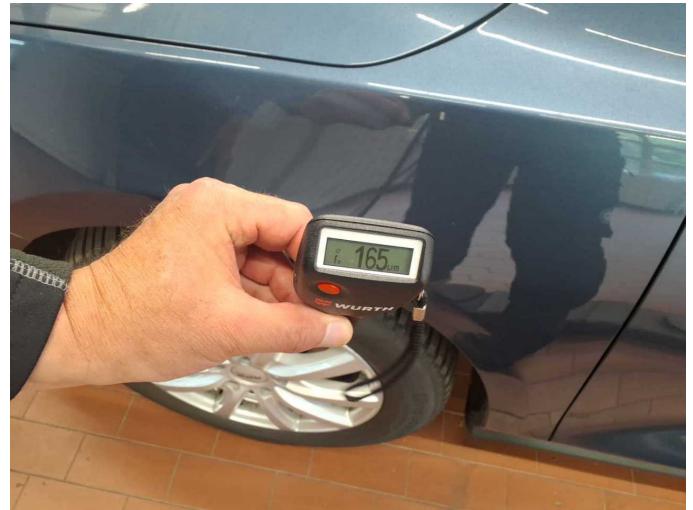
Mudguard - left side 165 µm | Door - front left side 195 µm

Repainting 1: Mudguard - left side

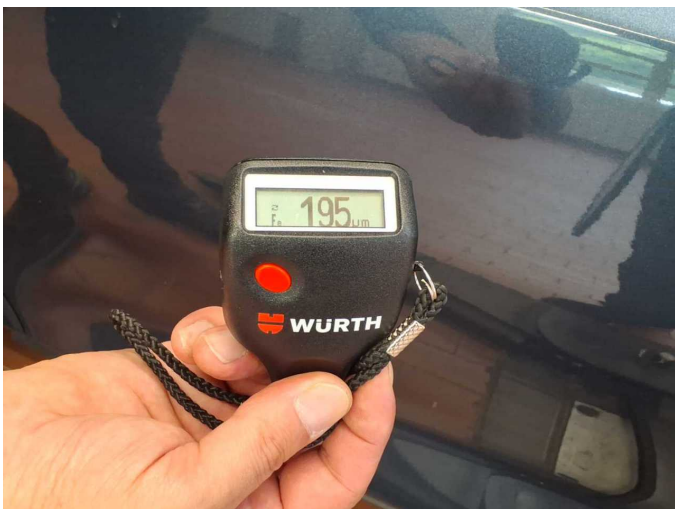
Repainting 2: Door - front left side
