Expertise

Protocol number: 45440513
Order No. / Reference: 26104880
Inspection date: 12 May 2026

Manufacturer: Opel

Model: Astra Sports Tourer 1.5 D Automatik Elegance

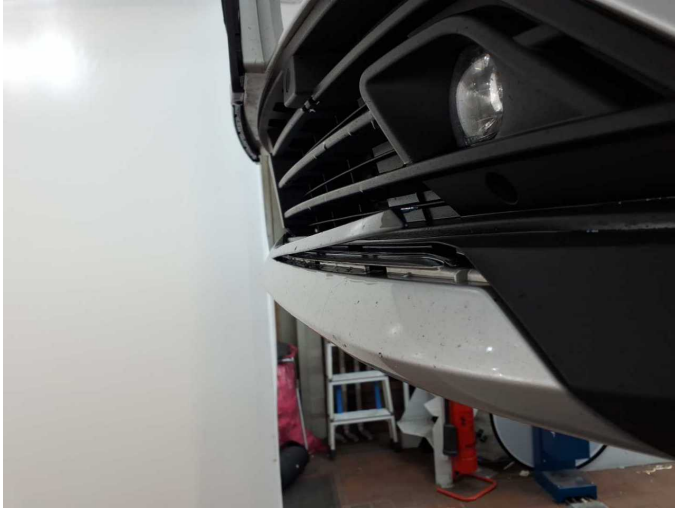
Damage 1: Trim / covers: Brightware / decorative strip - Loose - Repair

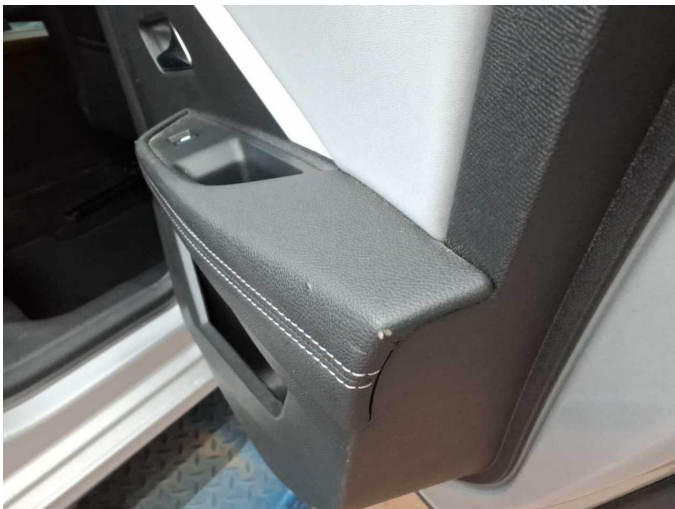
Damage 2: Trim / covers: Door trim - rear right side - Scratch(es) - Loss in value

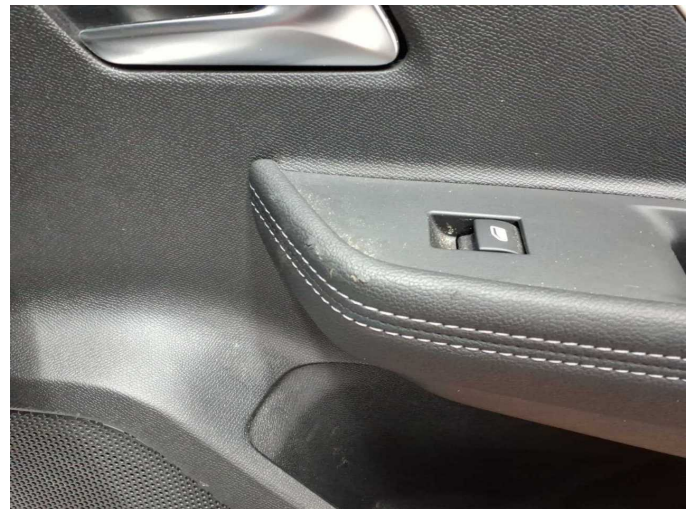
Damage 2: Trim / covers: Door trim - rear right side - Scratch(es) - Loss in value

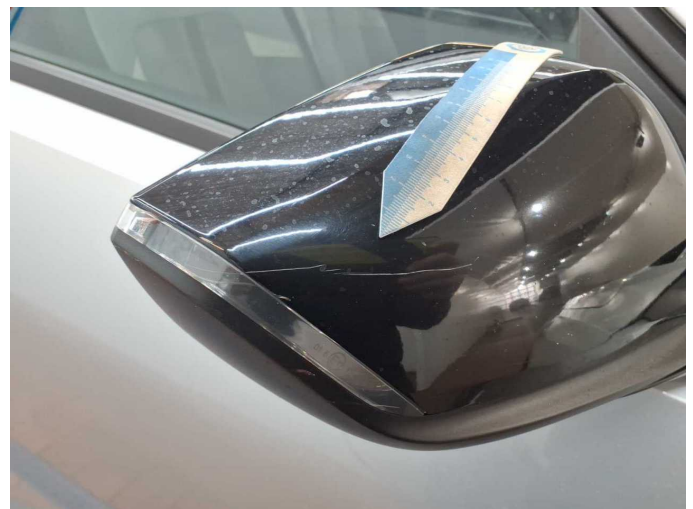
Damage 3: Wing mirror - right side: Cap - Scratch(es) - Smart repair

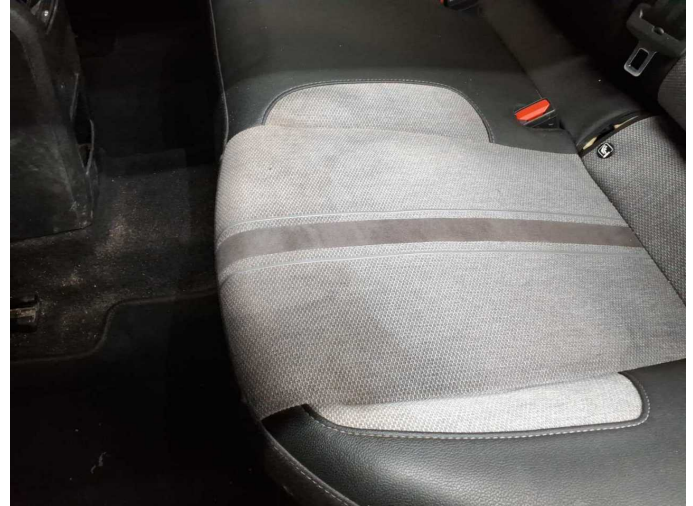
Damage 4: Seat - rear: Back seat - Soiled - Clean

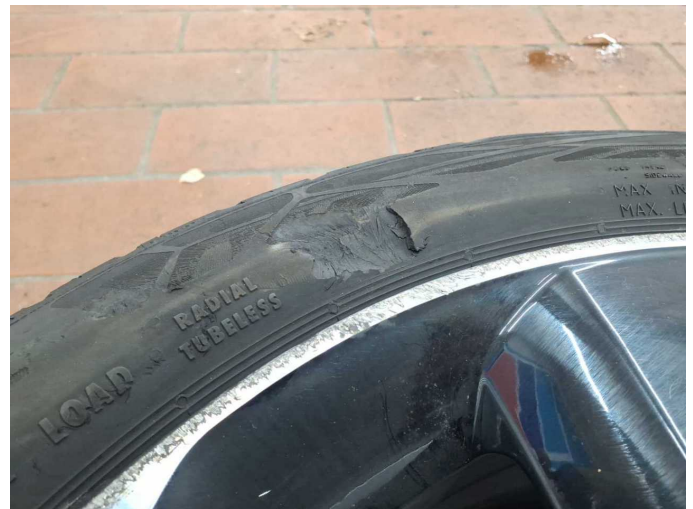
Damage 5: 2nd wheel set: 1 tyre - Damaged - Replace

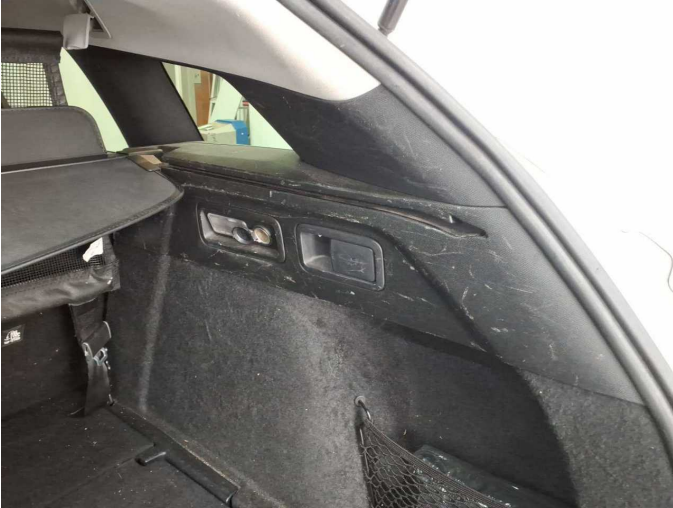
Damage 7: Interior: Interior - Scratch(es) - Loss in value

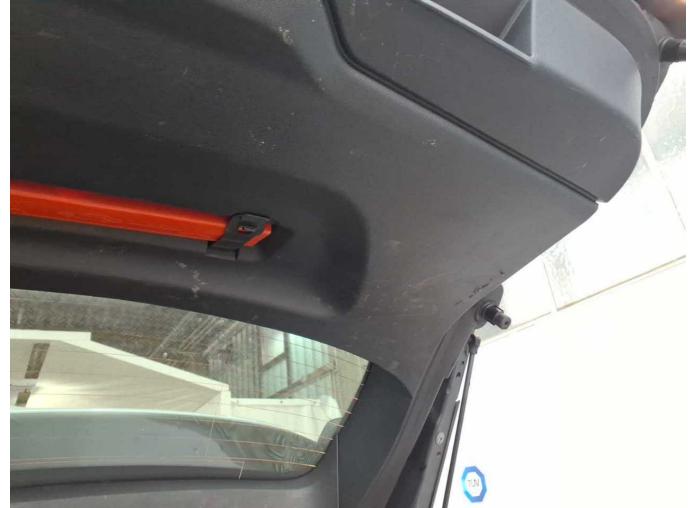
Damage 7: Interior: Interior - Scratch(es) - Loss in value

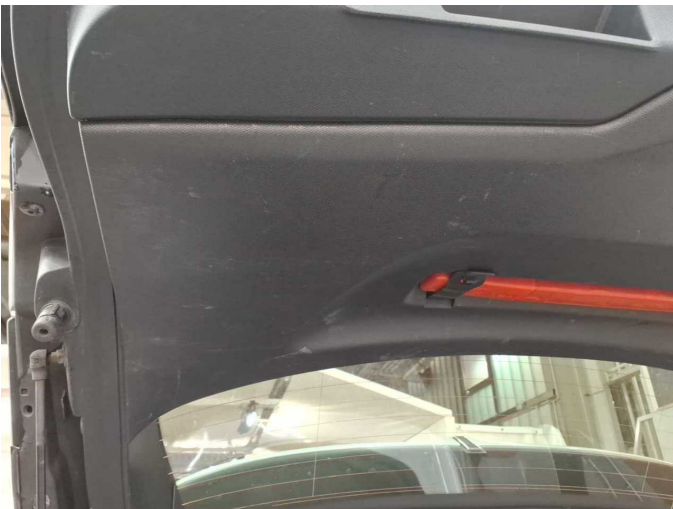
Damage 7: Interior: Interior - Scratch(es) - Loss in value

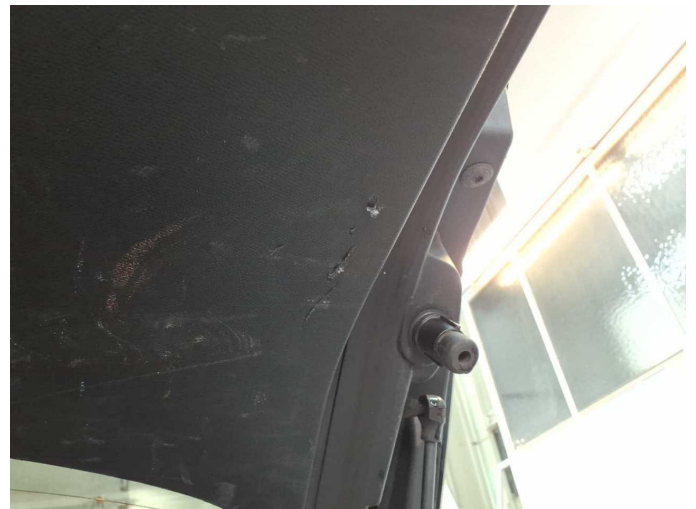
Damage 7: Interior: Interior - Scratch(es) - Loss in value

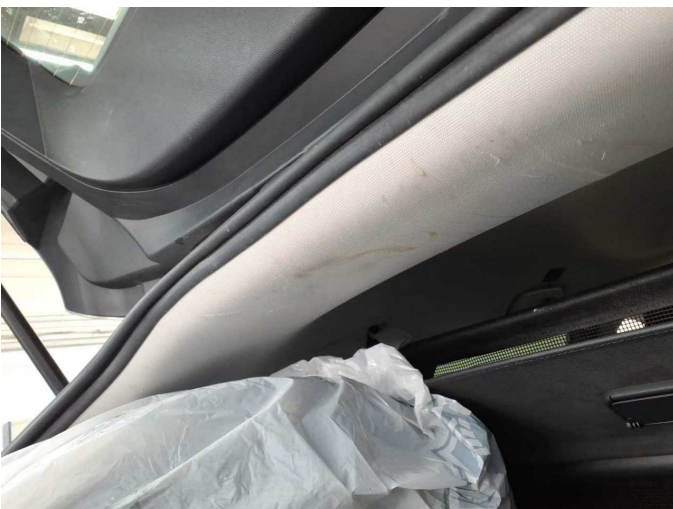
Damage 7: Interior: Interior - Scratch(es) - Loss in value

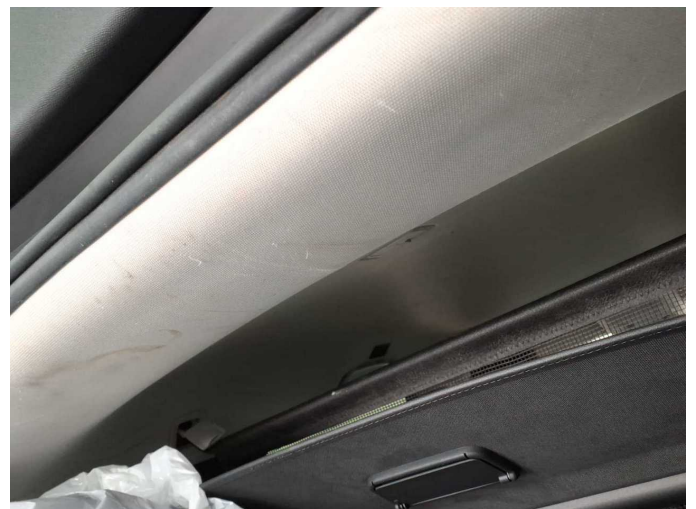
Damage 7: Interior: Interior - Scratch(es) - Loss in value

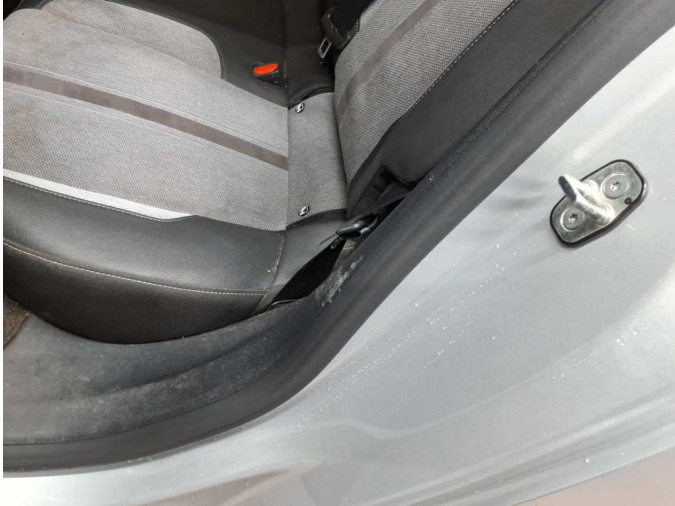
Damage 7: Interior: Interior - Scratch(es) - Loss in value

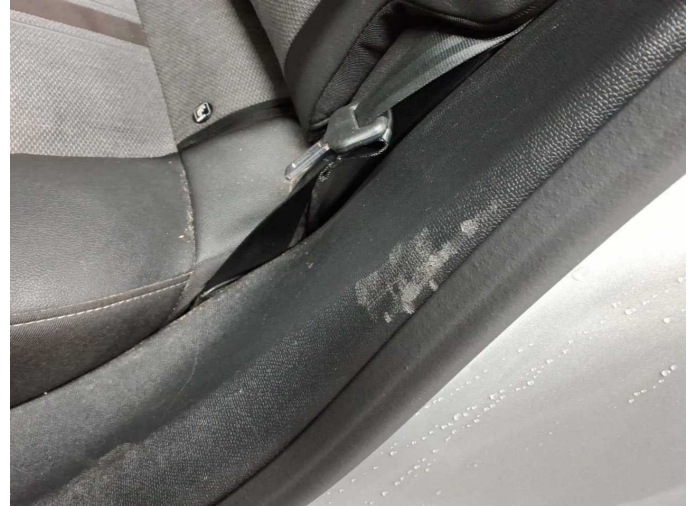
Damage 7: Interior: Interior - Scratch(es) - Loss in value

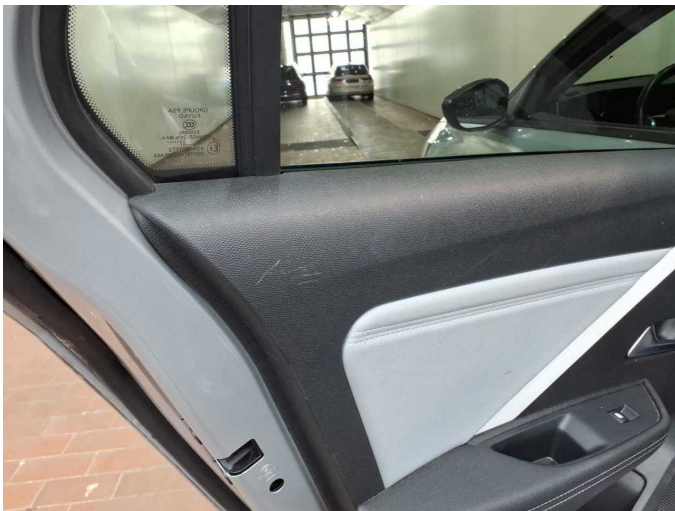
Damage 7: Interior: Interior - Scratch(es) - Loss in value

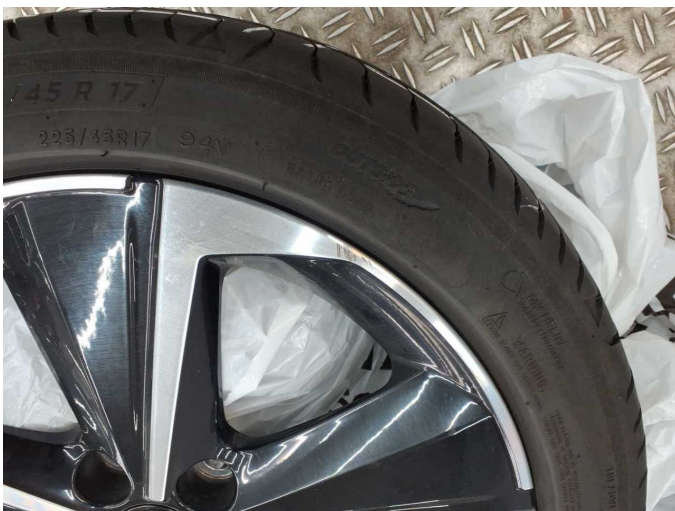
Damage 8: 2nd wheel set: 2 alloy rims - Scratch(es) - Loss in value

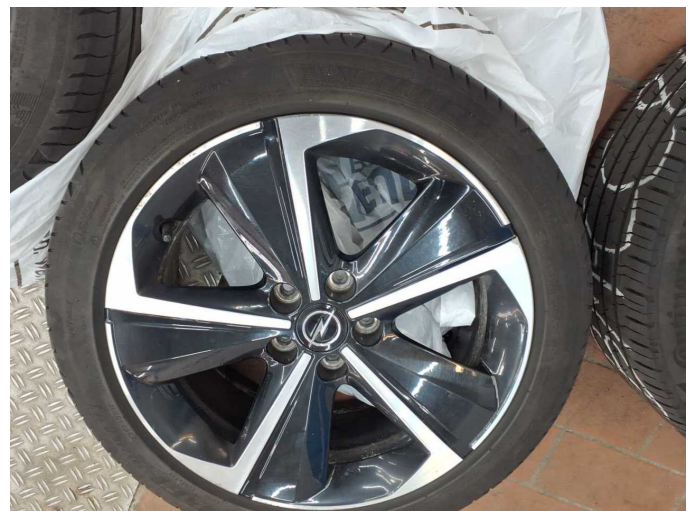
Damage 8: 2nd wheel set: 2 alloy rims - Scratch(es) - Loss in value

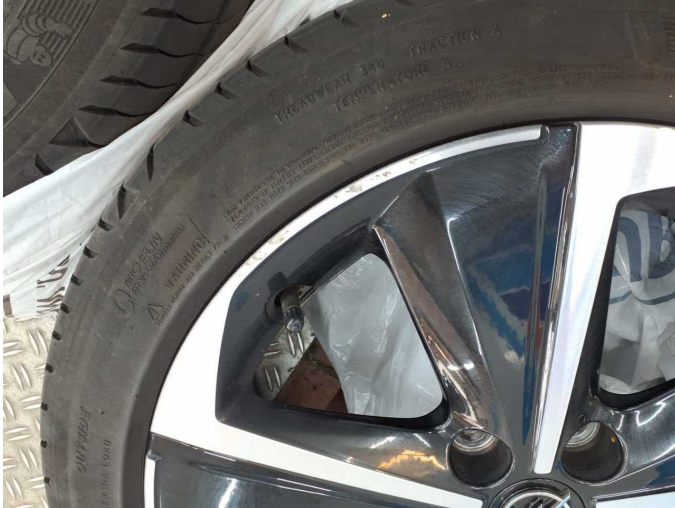
Damage 8: 2nd wheel set: 2 alloy rims - Scratch(es) - Loss in value

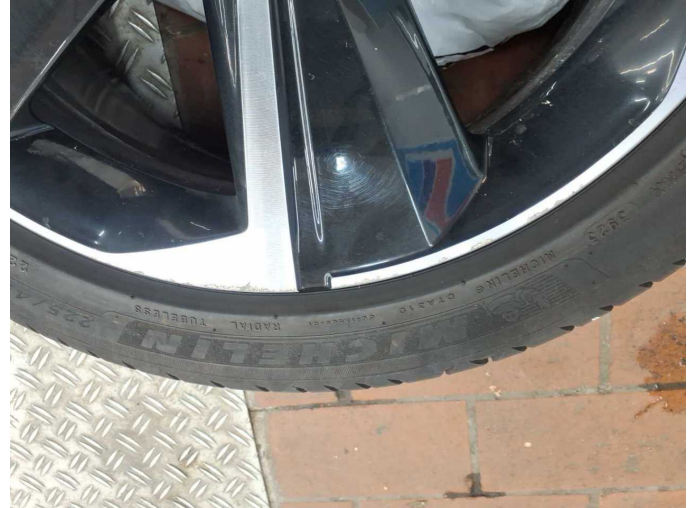
Damage 8: 2nd wheel set: 2 alloy rims - Scratch(es) - Loss in value

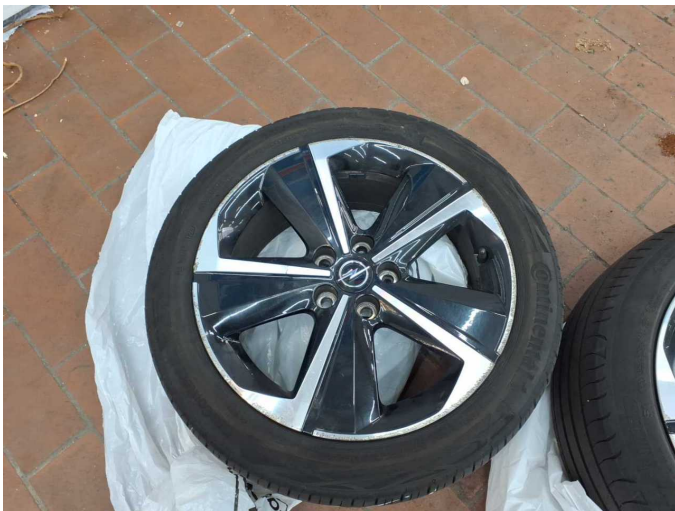
Damage 8: 2nd wheel set: 2 alloy rims - Scratch(es) - Loss in value

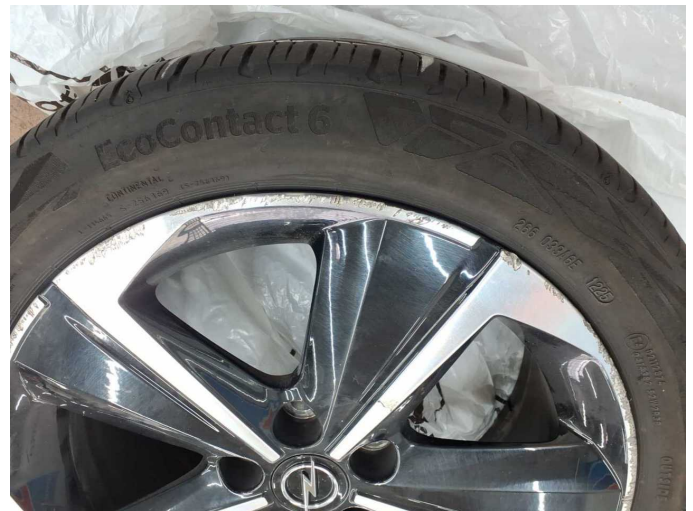
Damage 9: 2nd wheel set: 2 alloy rims - Scratched - Replace

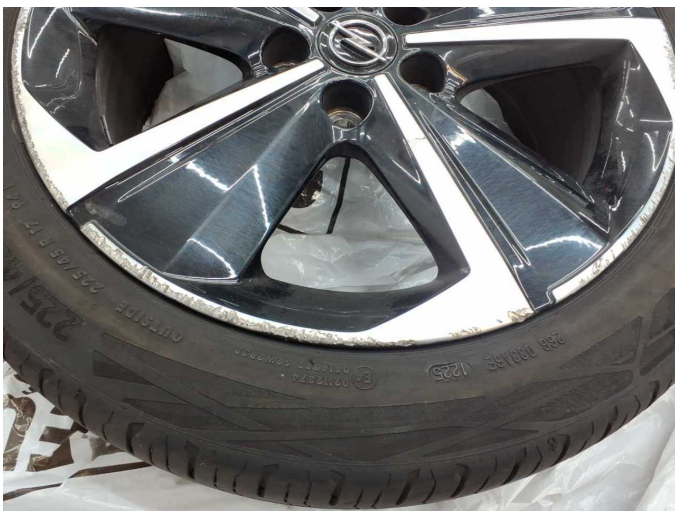
Damage 9: 2nd wheel set: 2 alloy rims - Scratched - Replace

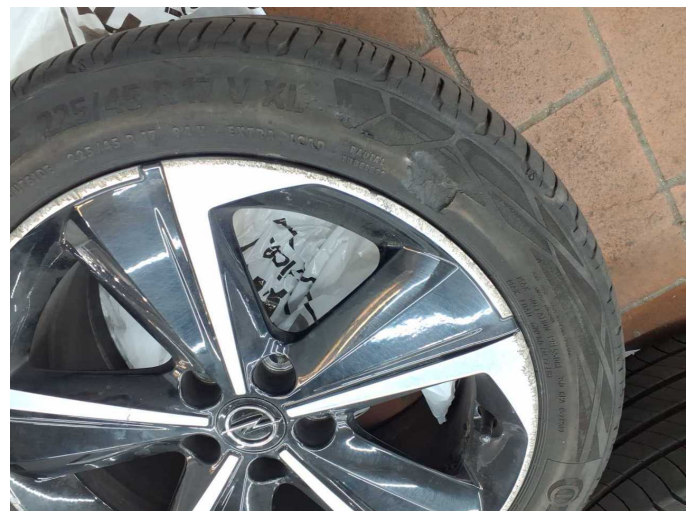
Damage 9: 2nd wheel set: 2 alloy rims - Scratched - Replace

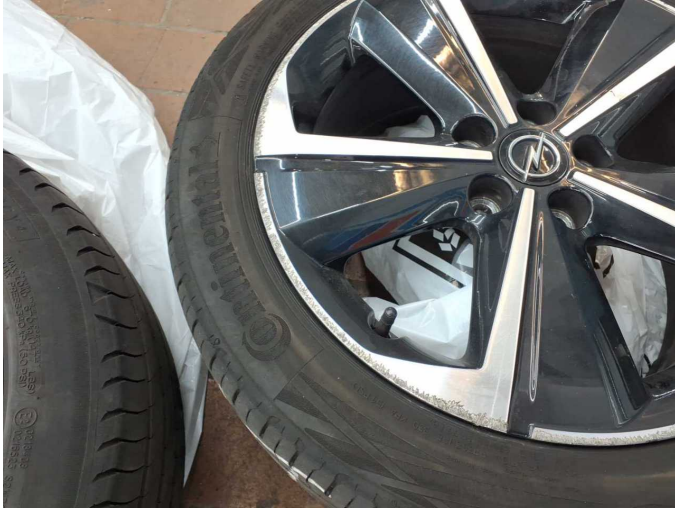
Damage 9: 2nd wheel set: 2 alloy rims - Scratched - Replace

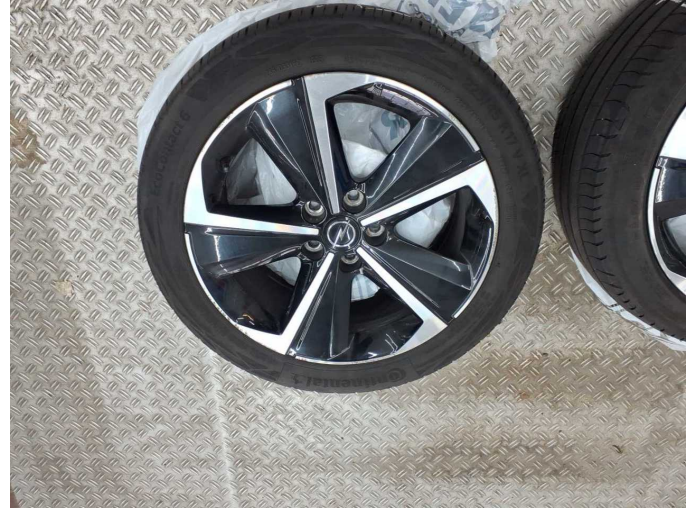
Damage 9: 2nd wheel set: 2 alloy rims - Scratched - Replace

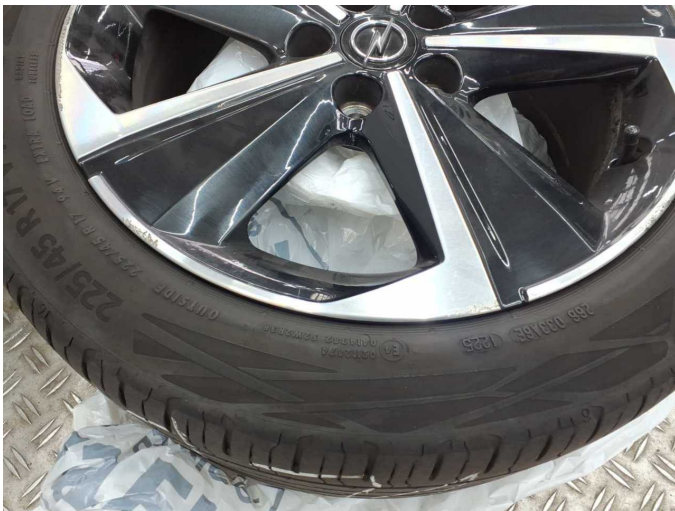
Damage 9: 2nd wheel set: 2 alloy rims - Scratched - Replace

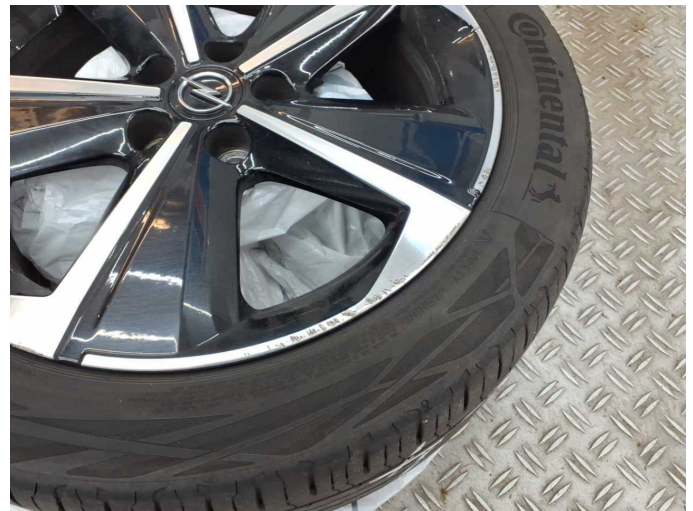
Damage 9: 2nd wheel set: 2 alloy rims - Scratched - Replace

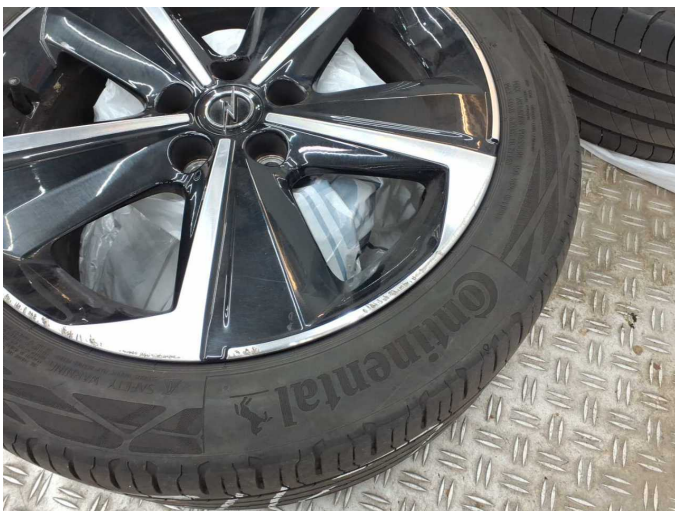
Damage 9: 2nd wheel set: 2 alloy rims - Scratched - Replace

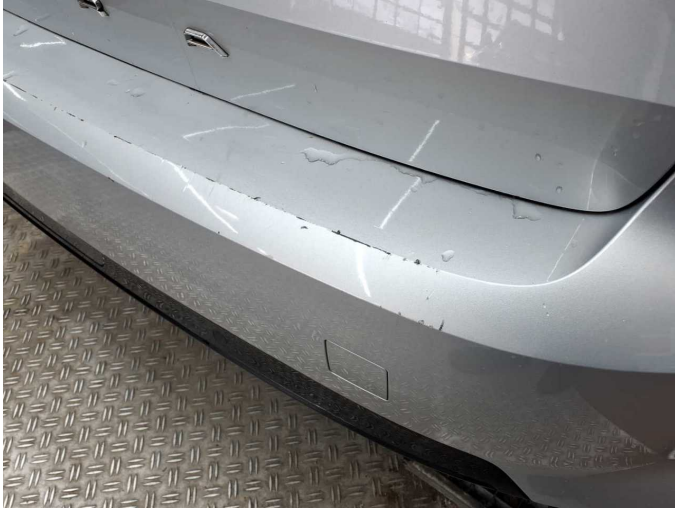
Damage 10: Rear bumper: Rear bumper - Scratch(es) - Paint

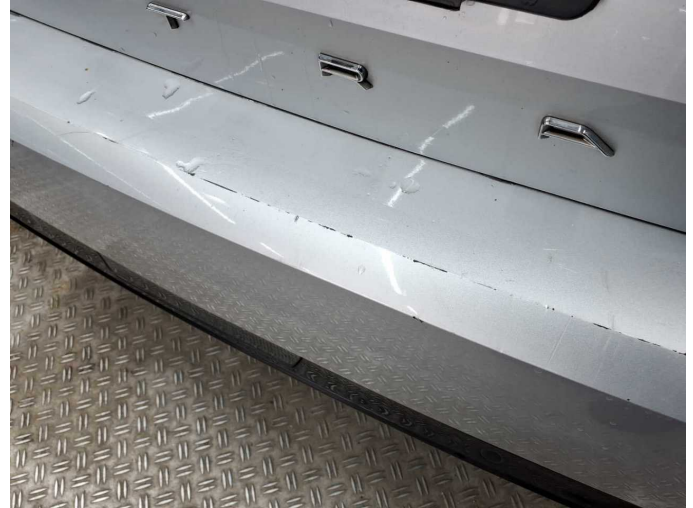
Damage 10: Rear bumper: Rear bumper - Scratch(es) - Paint

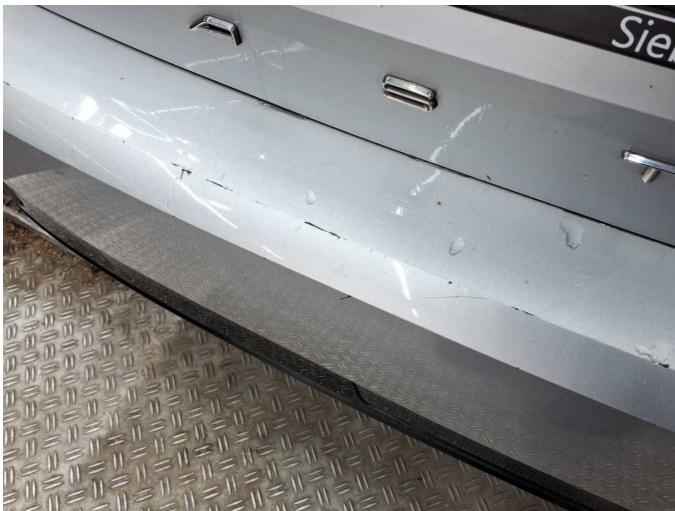
Damage 10: Rear bumper: Rear bumper - Scratch(es) - Paint

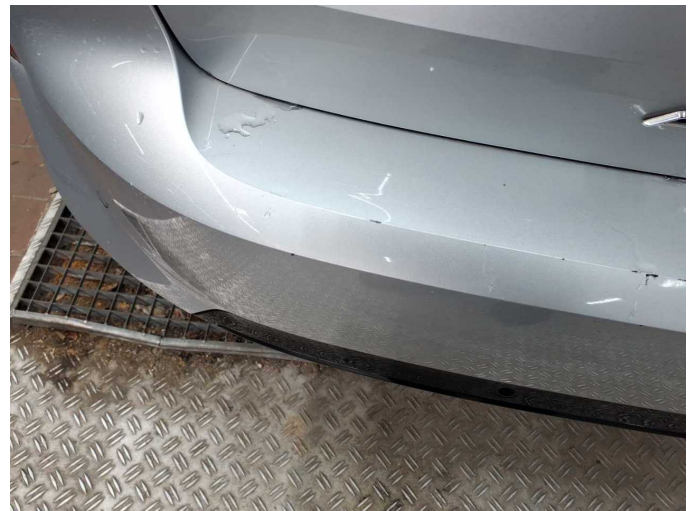
Damage 10: Rear bumper: Rear bumper - Scratch(es) - Paint

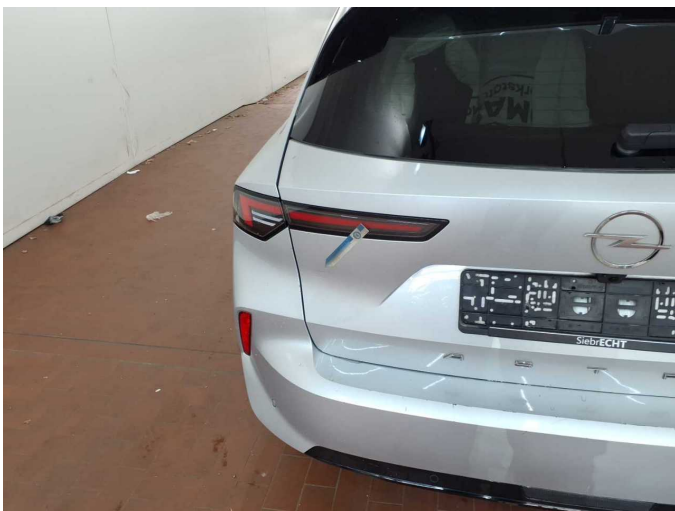
Damage 10: Rear bumper: Rear bumper - Scratch(es) - Paint

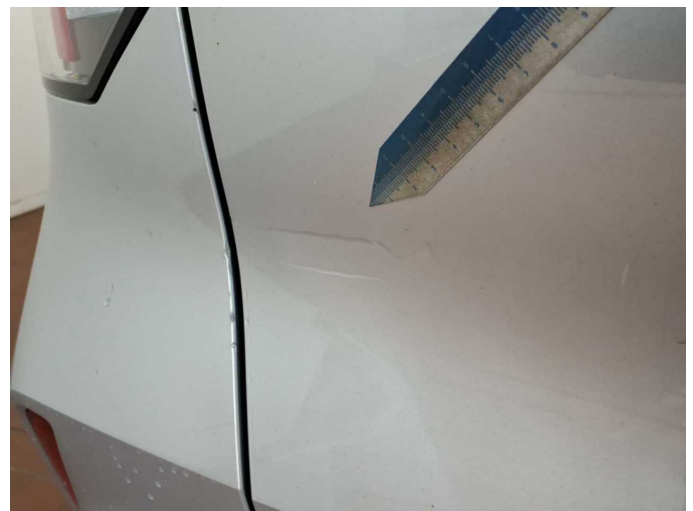
Damage 11: Boot lid / rear door: Boot lid - Scratch(es) - Paint

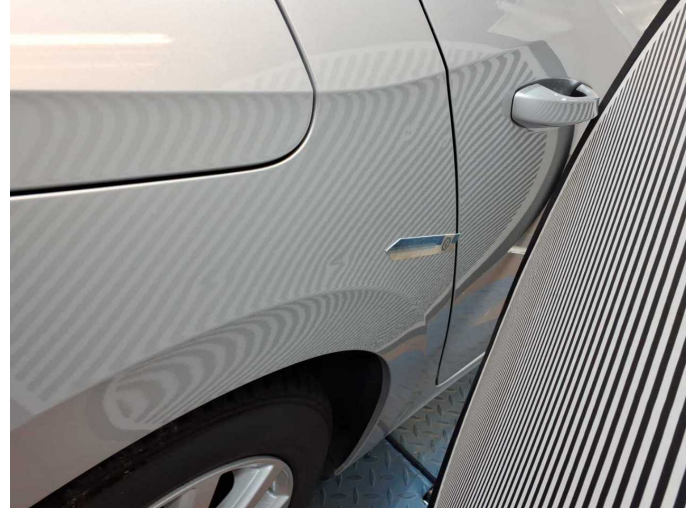
Damage 12: Side panel - rear right side: Side panel - Dent / paintcoat damage - Repair and paint

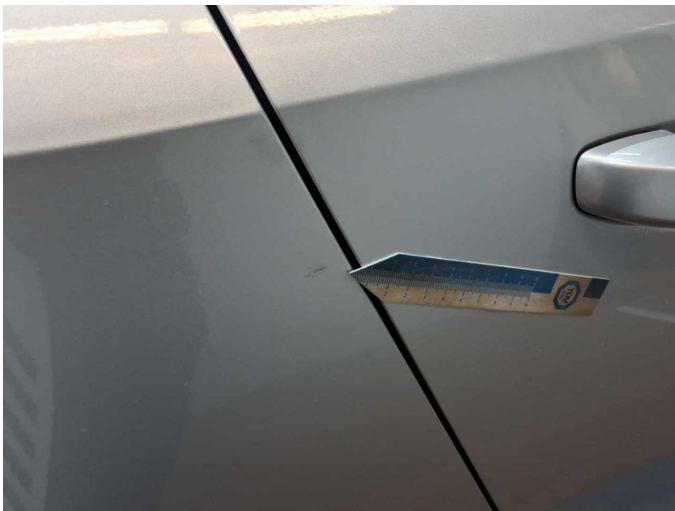
Damage 12: Side panel - rear right side: Side panel - Dent / paintcoat damage - Repair and paint

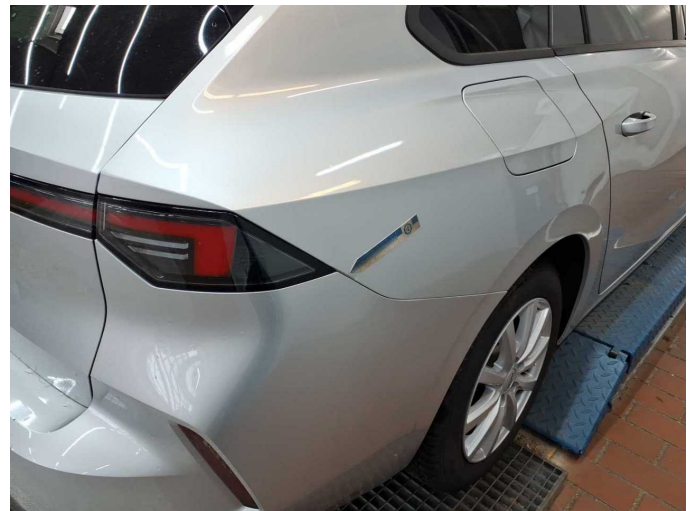
Damage 12: Side panel - rear right side: Side panel - Dent / paintcoat damage - Repair and paint

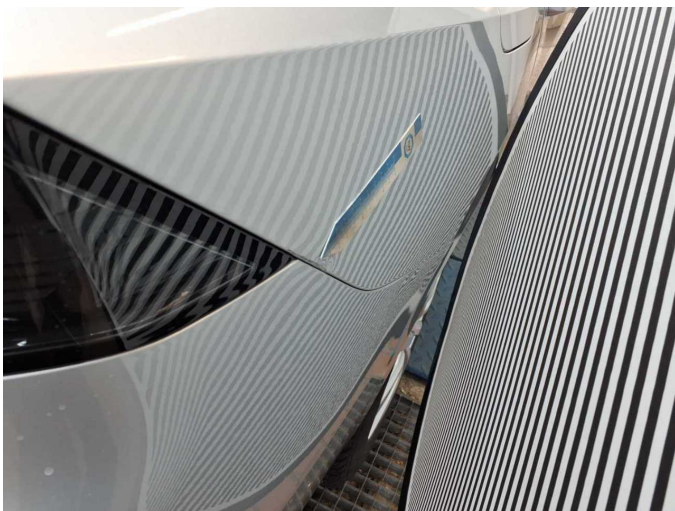
Damage 12: Side panel - rear right side: Side panel - Dent / paintcoat damage - Repair and paint

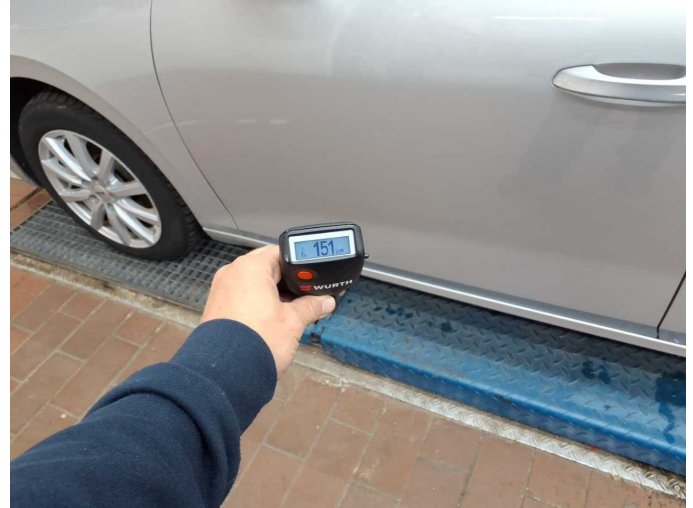
Repainting 1: Side panel - rear left side, Door - rear right side
