Expertise

Protocol number: 46537488  
Order No. / Reference: 26605196  
Inspection date: 15 Jul 2026

Manufacturer: Kia

Model: Niro 1.6 GDI PHEV 2WD OPF Aut. Vision

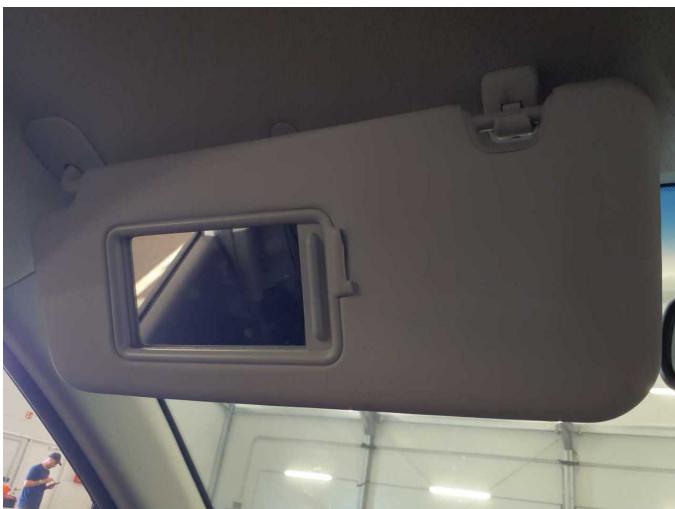
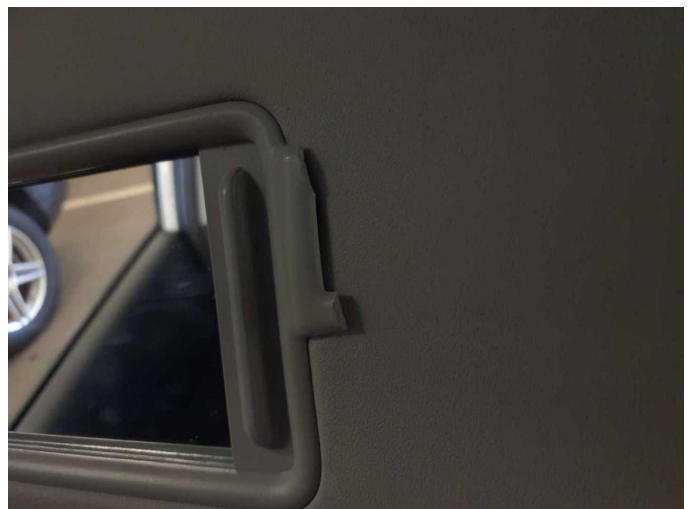
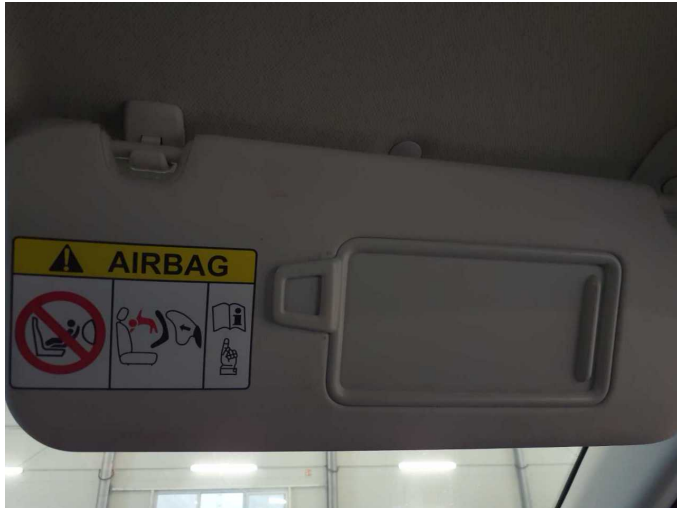
| No. | Component group | Description |
|---|---|---|
| 1 | Interior | Sun visor - left side - Broken / torn - Replace |

Damage 1: Interior: Sun visor - left side - Broken / torn - Replace

**Damage 1:** Interior: Sun visor - left side - Broken / torn - Replace

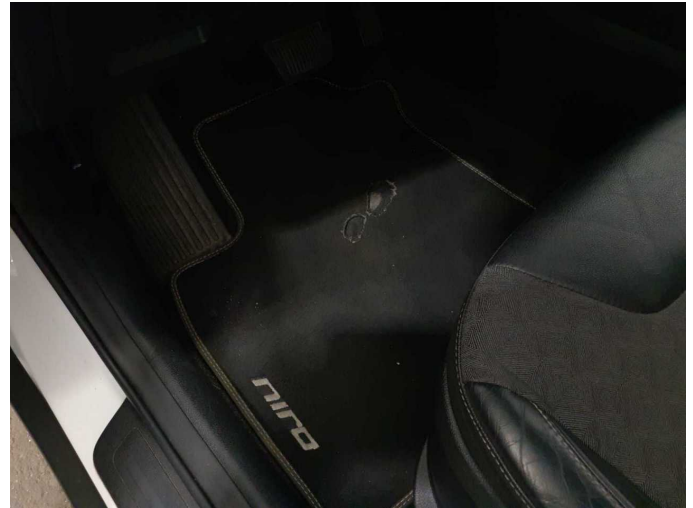
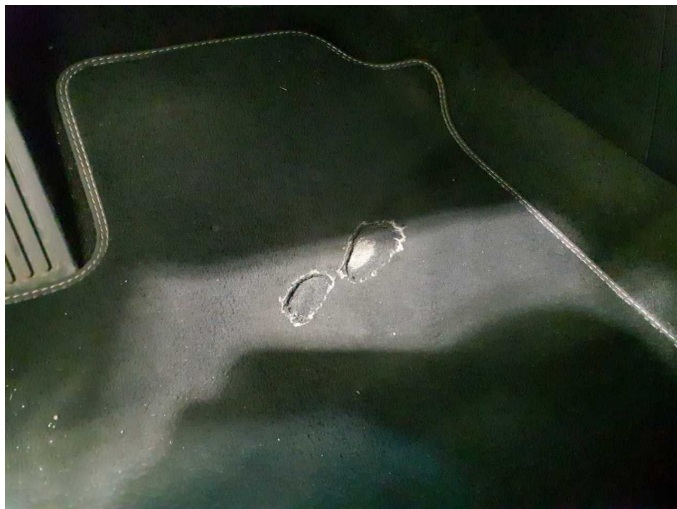
| No. | Component group | Description |
|---|---|---|
| 2 | Trim / covers | Floor mats - Broken / torn - Replace |

**Damage 2:** Trim / covers: Floor mats - Broken / torn - Replace

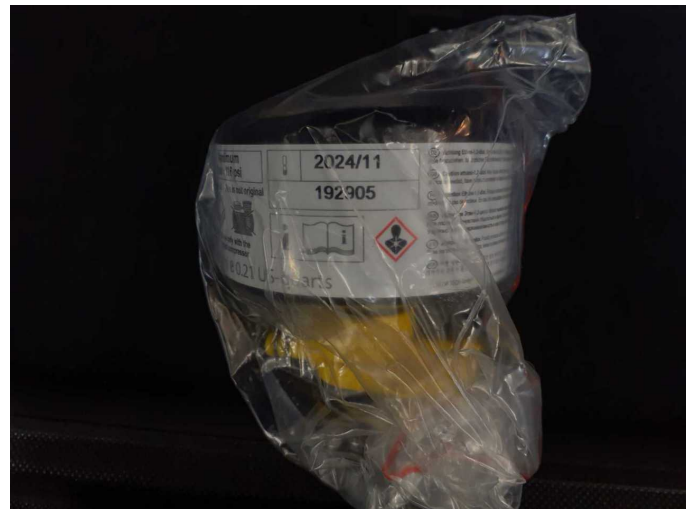
| No. | Component group | Description |
|---|---|---|
| 3 | Equipment | Tirefit filler - Expired - Replace |

**Damage 3:** Equipment: Tirefit filler - Expired - Replace

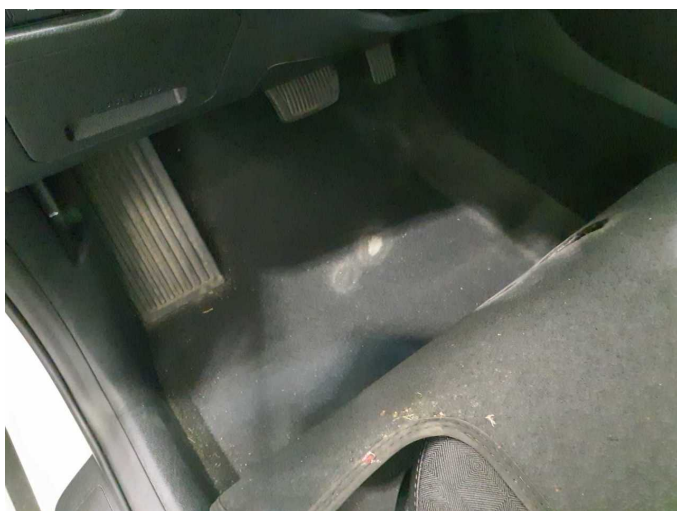
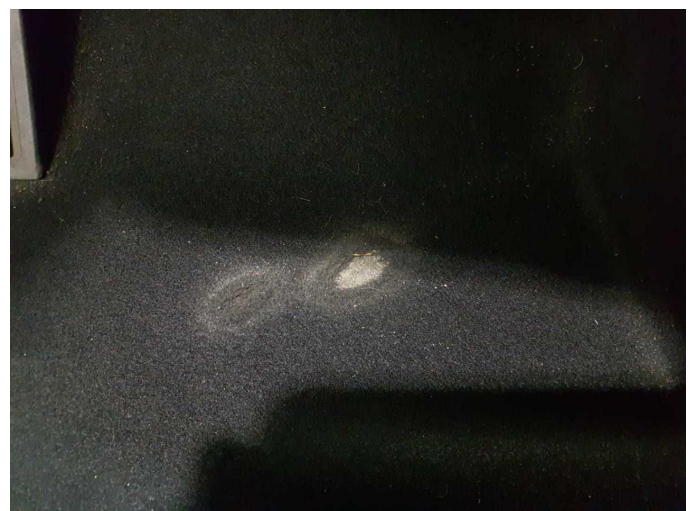
| No. | Component group | Description |
|---|---|---|
| 4 | Trim / covers | Carpet - front left side - Broken / torn - Loss in value |

**Damage 4:** Trim / covers: Carpet - front left side - Broken / torn - Loss in value

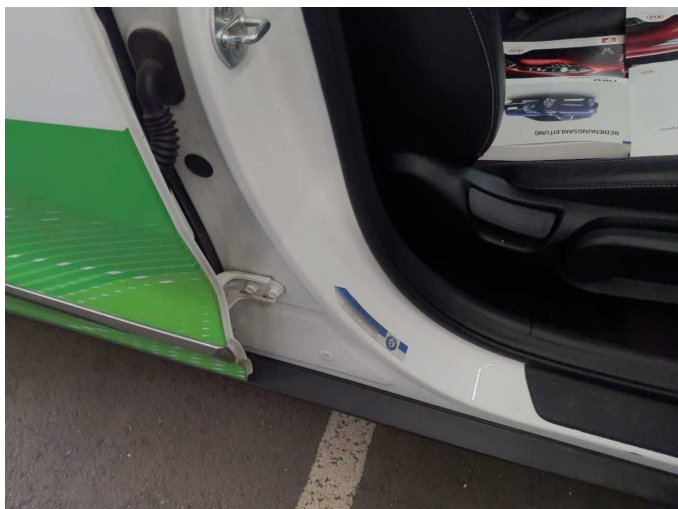
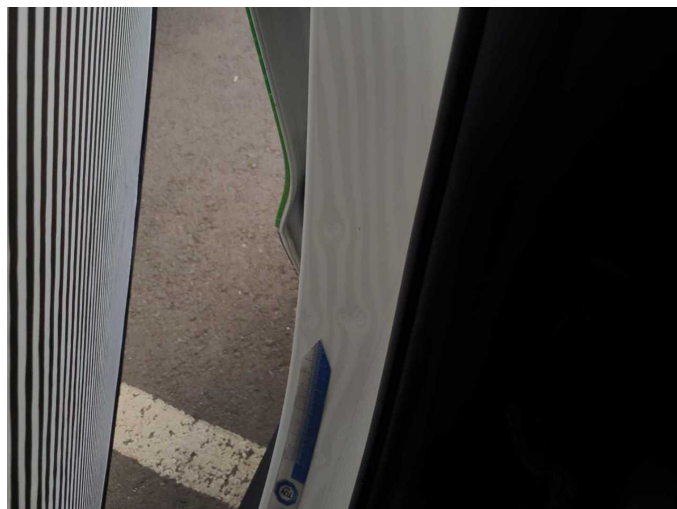
| No. | Component group | Description |
|---|---|---|
| 5 | Sill - right side | Sill - dent(s) - Smart repair |

**Damage 5:** Sill - right side: Sill - dent(s) - Smart repair

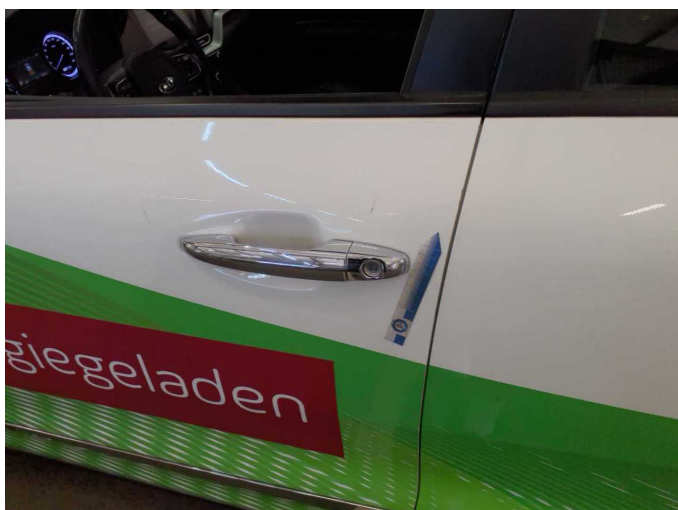
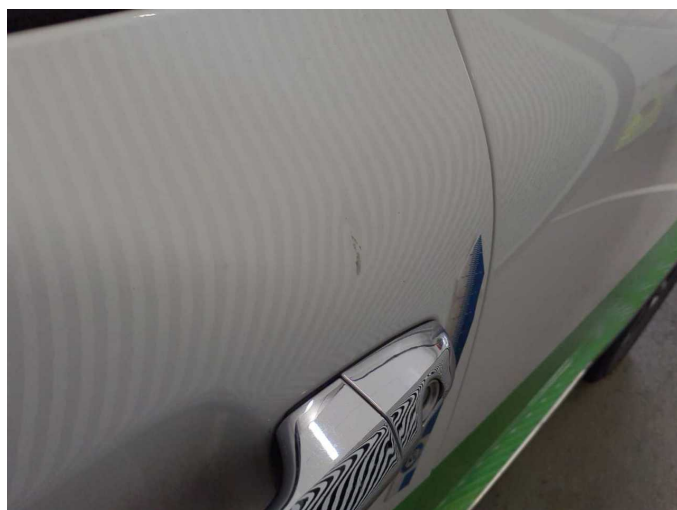
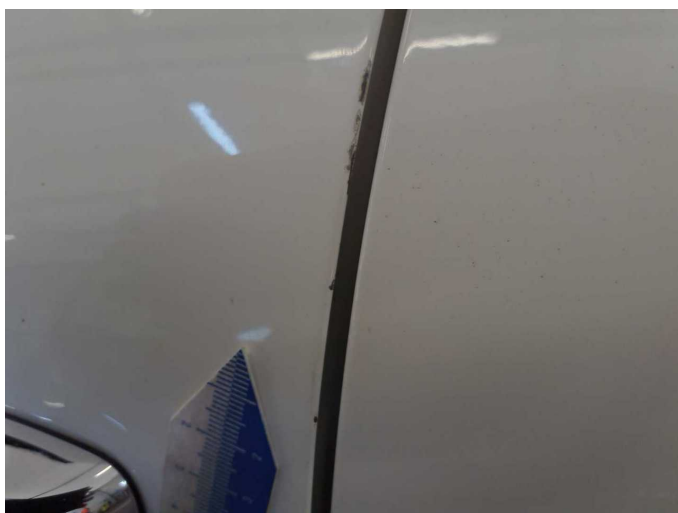
| No. | Component group | Description |
|---|---|---|
| 6 | Door - front left side | Door - Dent / paintcoat damage - Smart repair |

**Damage 6:** Door - front left side: Door - Dent / paintcoat damage - Smart repair

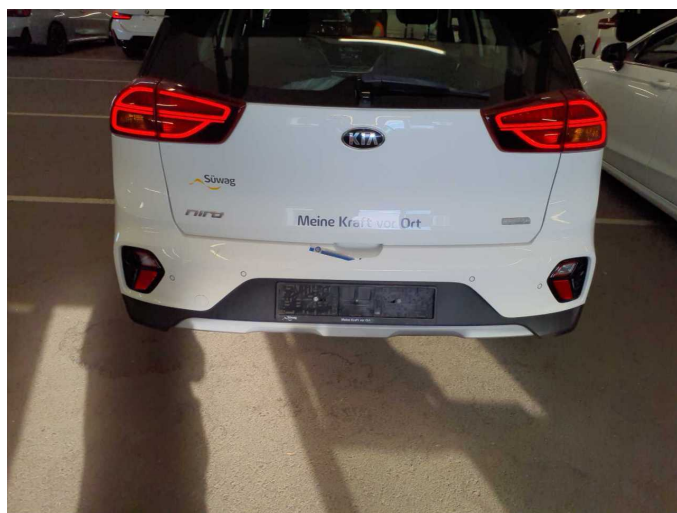
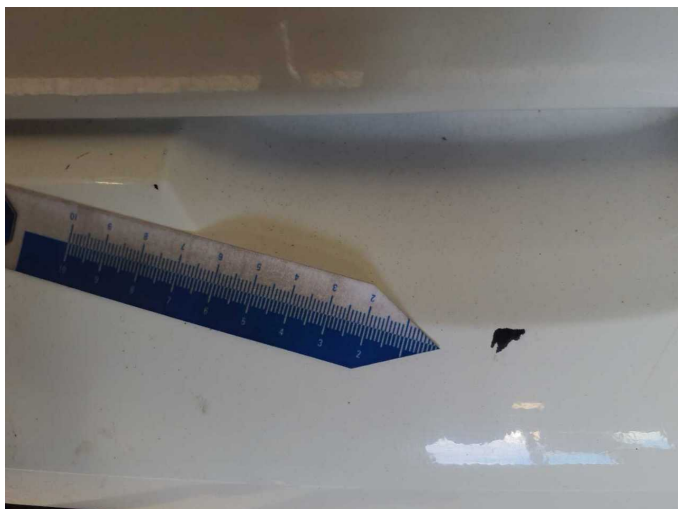
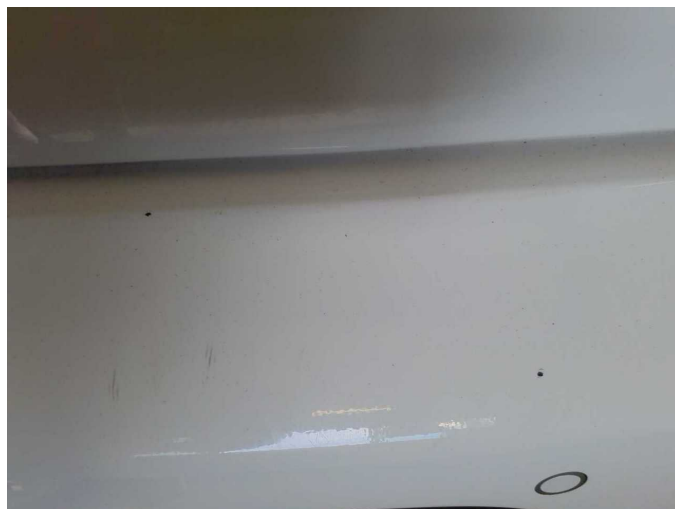
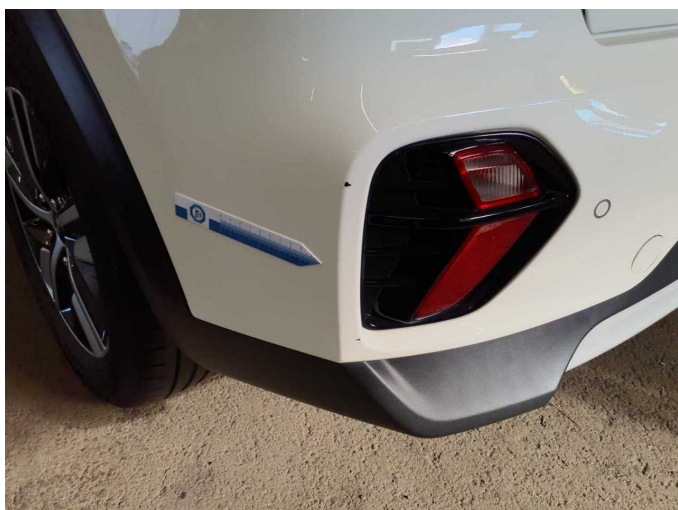
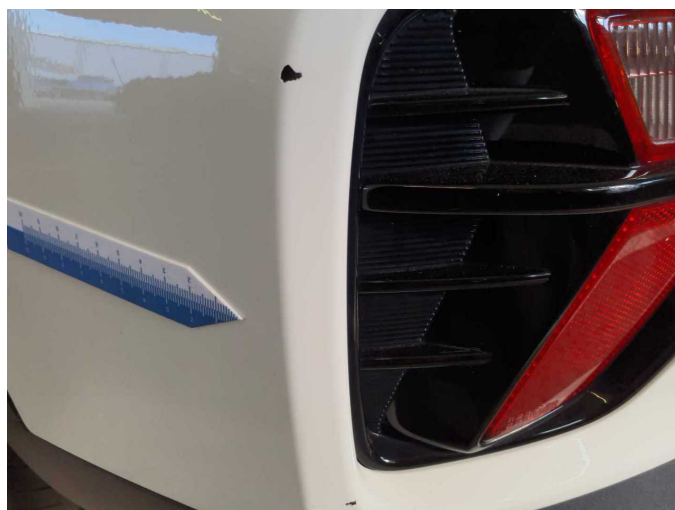
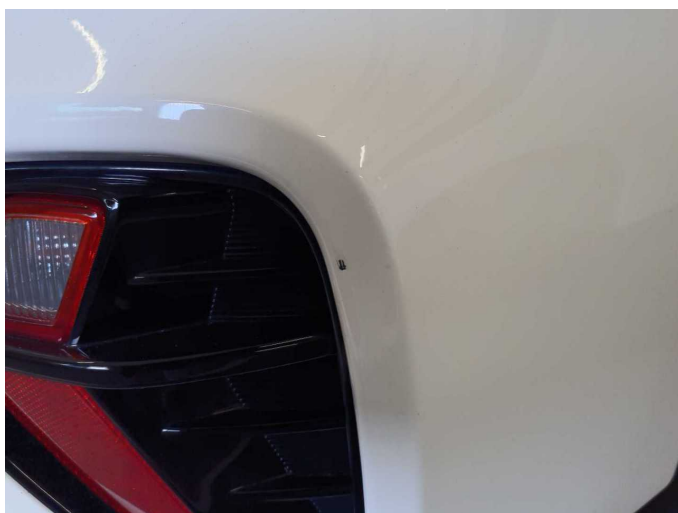
| No. | Component group | Description |
|---|---|---|
| 7 | Rear bumper | Rear bumper - Scratch(es) - Smart repair |

**Damage 7:** Rear bumper: Rear bumper - Scratch(es) - Smart repair

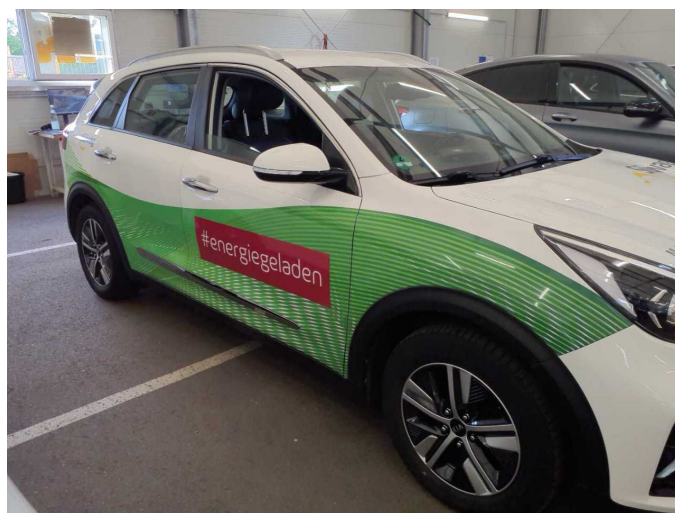
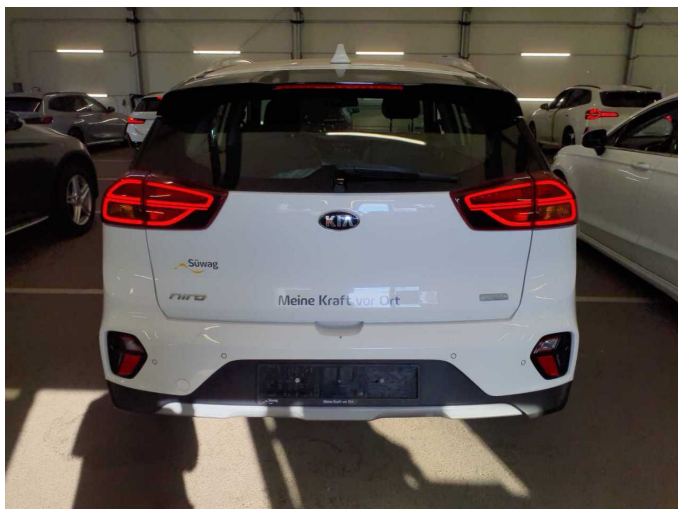
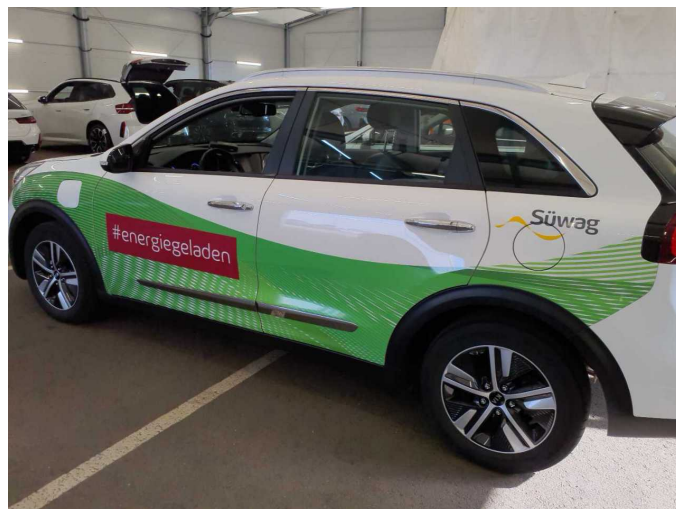
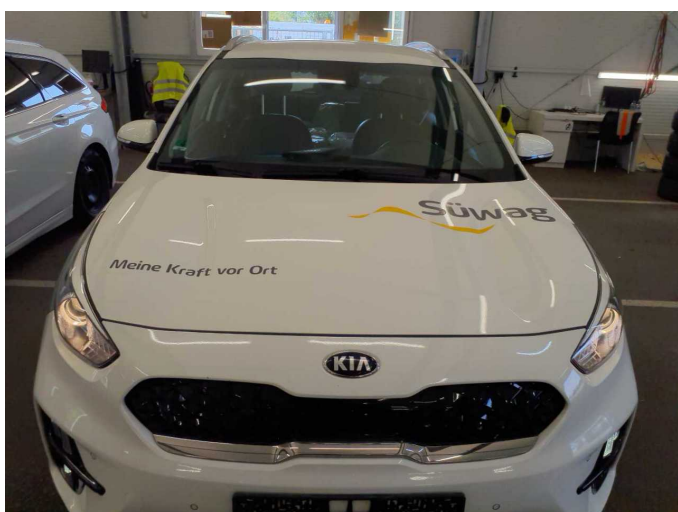
| No. | Component group | Description |
|---|---|---|
| 8 | Body | Body - Glued / labelled - De-glue / neutralise |

**Damage 8:** Body: Body - Glued / labelled - De-glue / neutralise

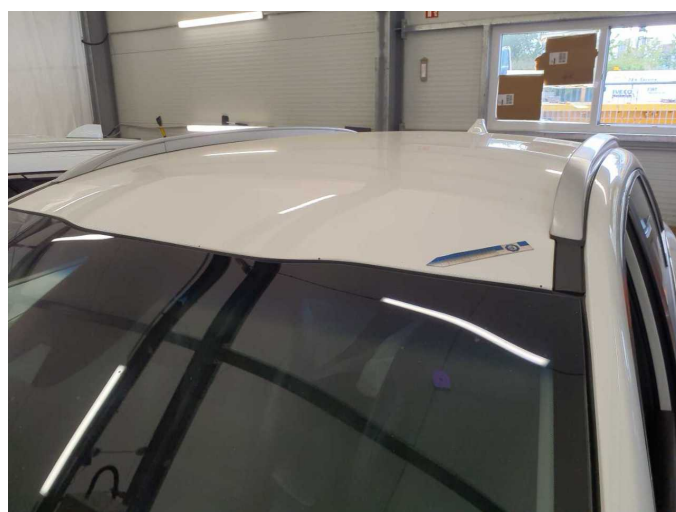
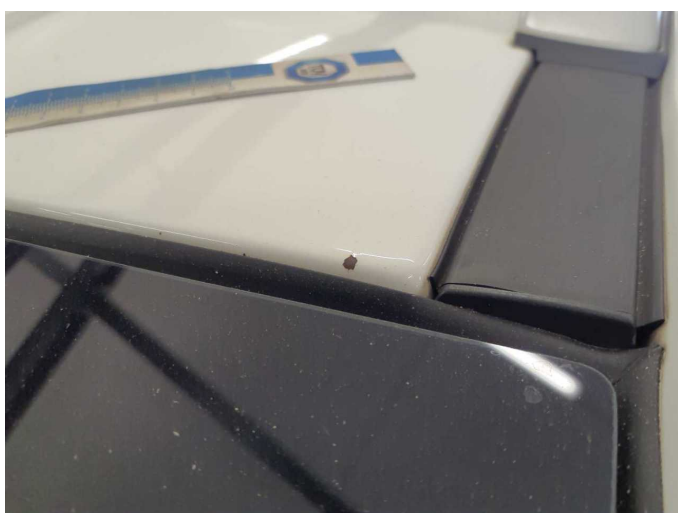
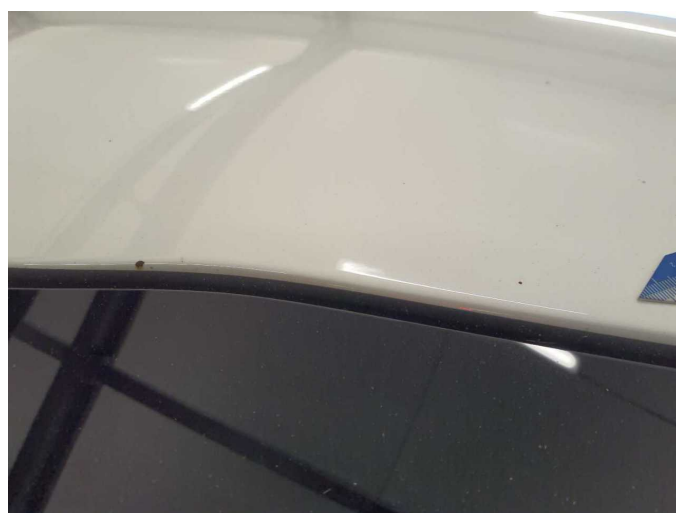
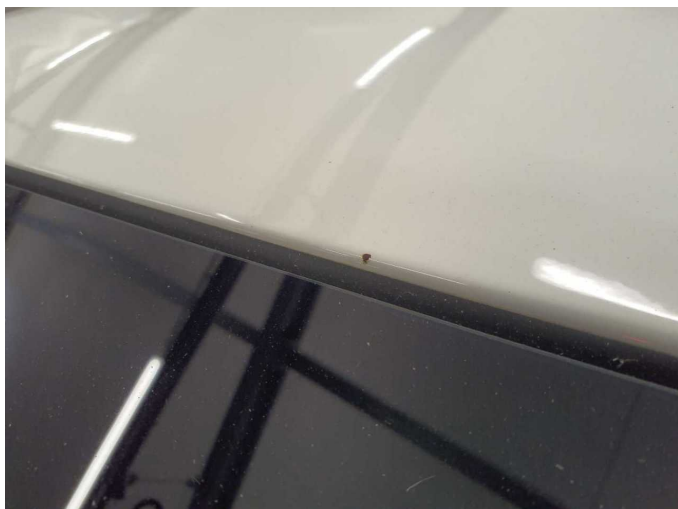
| No. | Component group | Description |
|---|---|---|
| 9 | Roof | Roof (Korrosion) - Stone chips - Repair and paint |

**Damage 9:** Roof: Roof (Korrosion) - Stone chips - Repair and paint

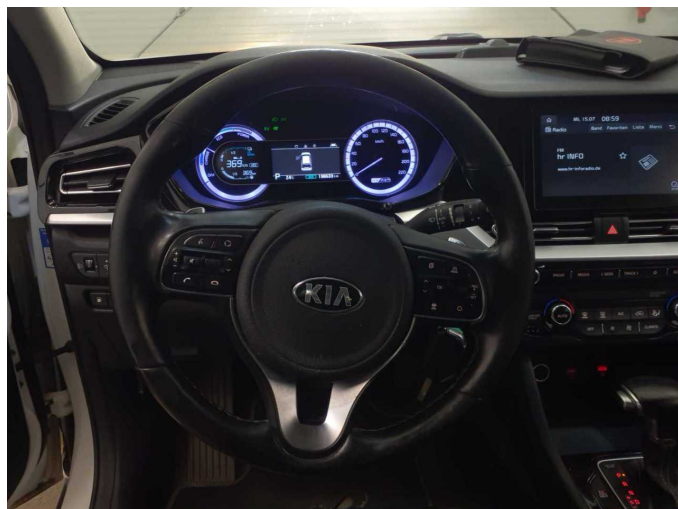
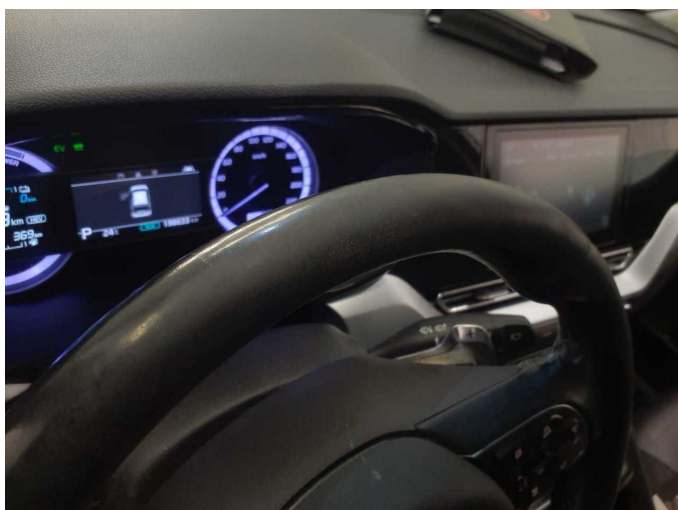
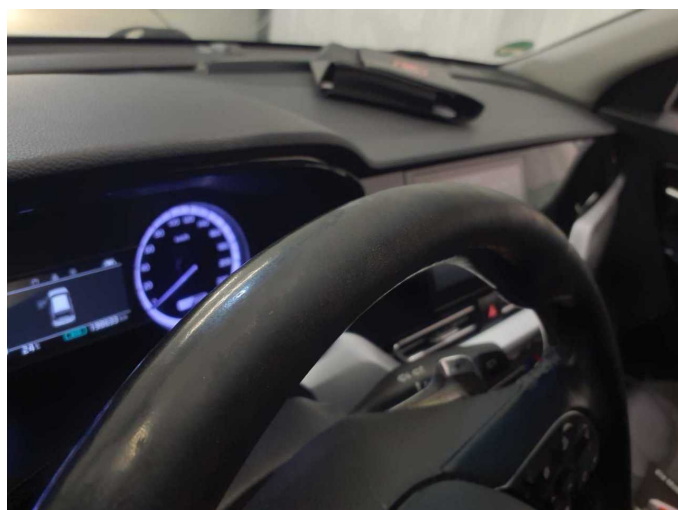
| No. | Component group | Description |
|---|---|---|
| 1 | Steering system | Steering wheel sheath - Abrasion - No deduction |

**Wear and tear 1:** Steering system: Steering wheel sheath - Abrasion - No deduction
