Expertise

Protocol number: 46303373  
Order No. / Reference: 26645603  
Inspection date: 3 Jul 2026

Manufacturer: Ford

Model: Transit Connect 210 L2 S&S Trend

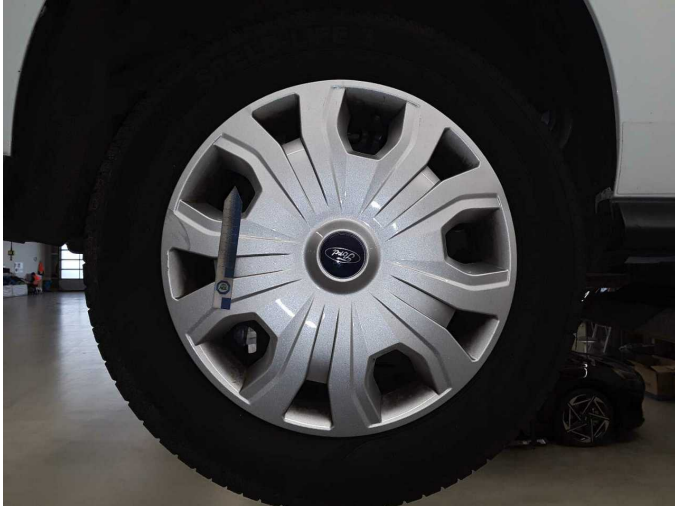
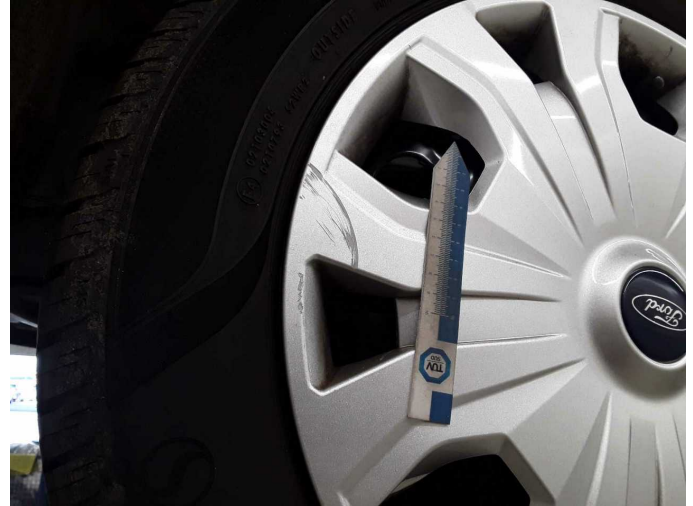
| No. | Component group | Description |
|---|---|---|
| 1 | Wheel / tyres | Wheel cover - rear right side - Scratched - Replace |

**Damage 1:** Wheel / tyres: Wheel cover - rear right side - Scratched - Replace

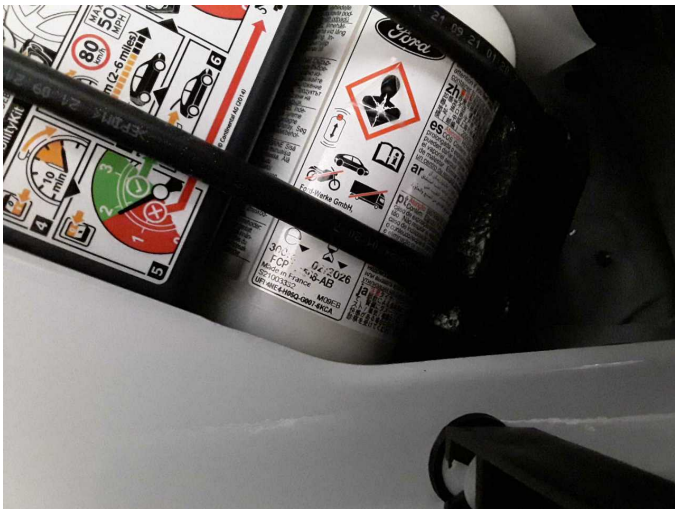
| No. | Component group | Description |
|---|---|---|
| 2 | Equipment | Tirefit filler - Due - Replace |

**Damage 2:** Equipment: Tirefit filler - Due - Replace

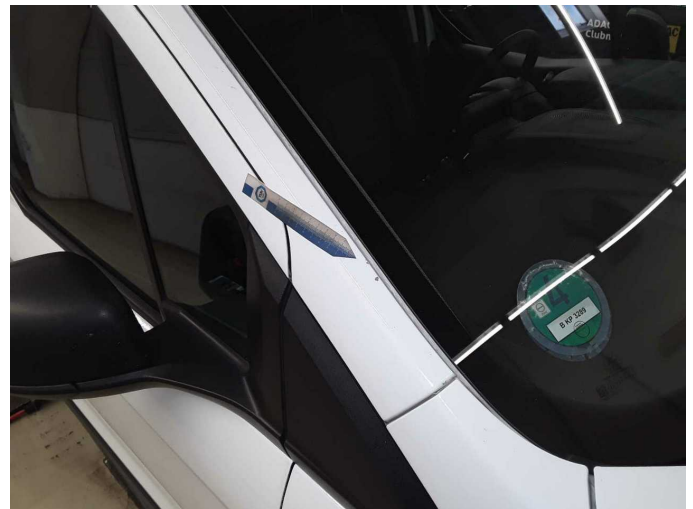
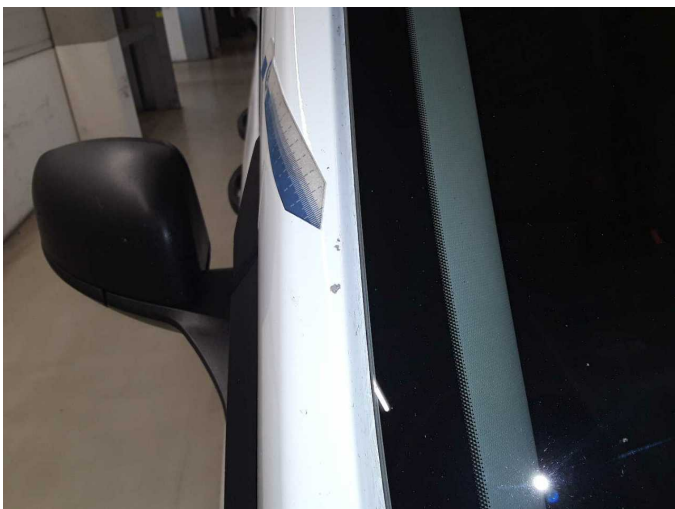
| No. | Component group | Description |
|---|---|---|
| 3 | Roof | Roof rail - right side - Stone chips - Smart repair |

**Damage 3:** Roof: Roof rail - right side - Stone chips - Smart repair

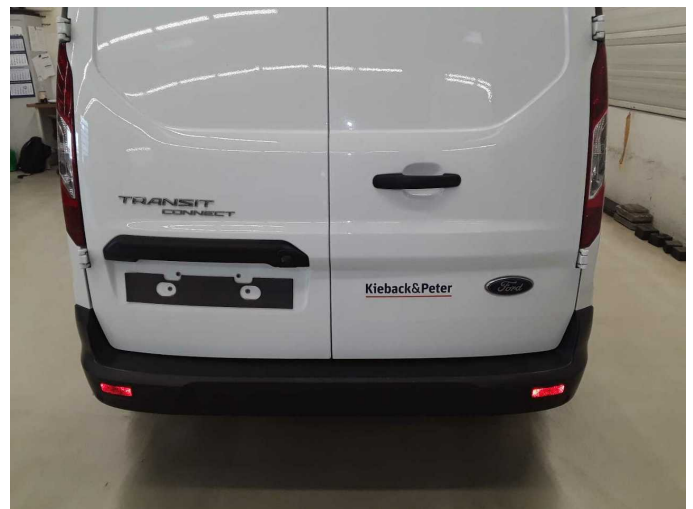
| No. | Component group | Description |
|---|---|---|
| 4 | Body | Body - Glued / labelled - De-glue / neutralise |

**Damage 4:** Body: Body - Glued / labelled - De-glue / neutralise

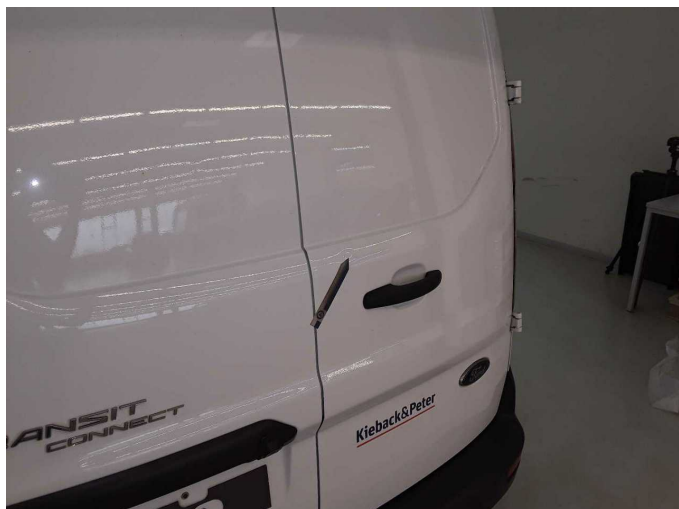
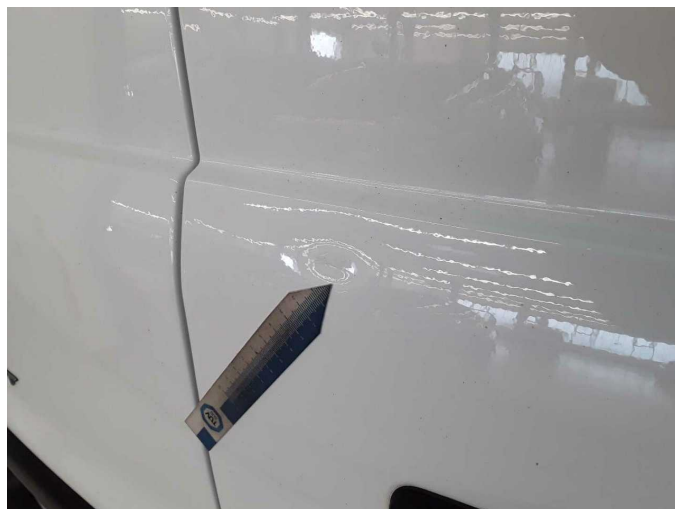
| No. | Component group | Description |
|---|---|---|
| 5 | Boot lid / rear door | Rear door - right side - dent(s) - Smart repair |

**Damage 5:** Boot lid / rear door: Rear door - right side - dent(s) - Smart repair

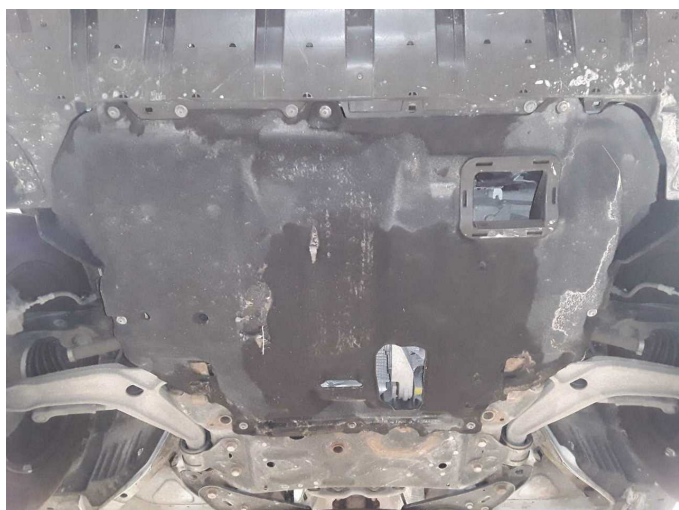
| No. | Component group | Description |
|---|---|---|
| 6 | Body | Underbody panelling (Motor/Getriebe) - Leaking - Perform diagnosis |

**Damage 6:** Body: Underbody panelling (Motor/Getriebe) - Leaking - Perform diagnosis

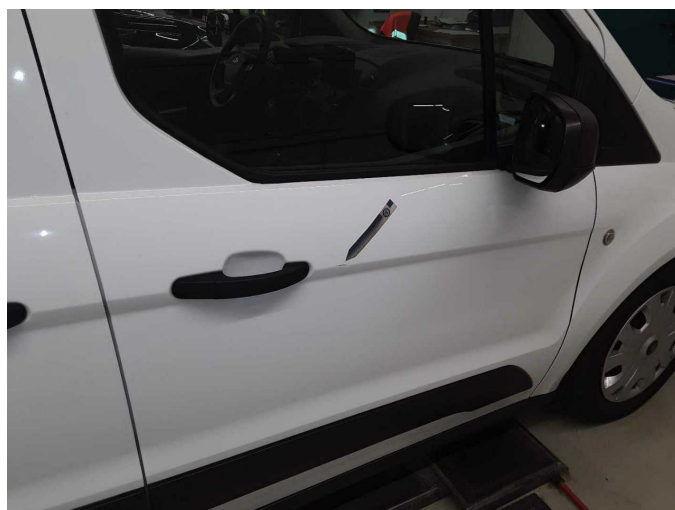
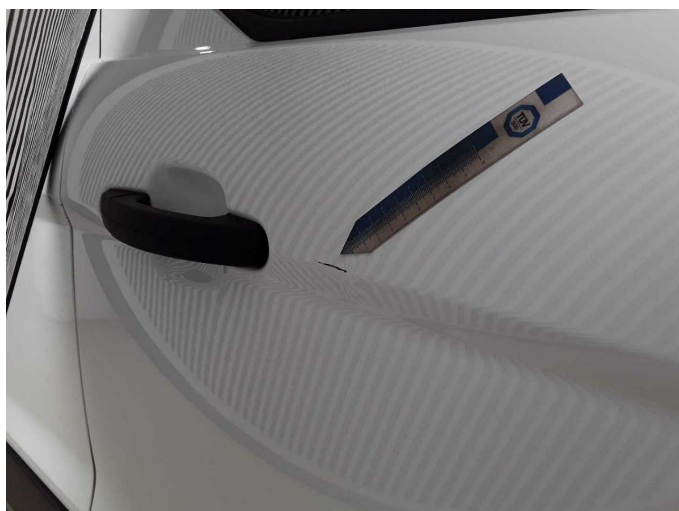
| No. | Component group | Description |
|---|---|---|
| 7 | Door - front right side | Door - Dent / paintcoat damage - Smart repair |

**Damage 7:** Door - front right side: Door - Dent / paintcoat damage - Smart repair

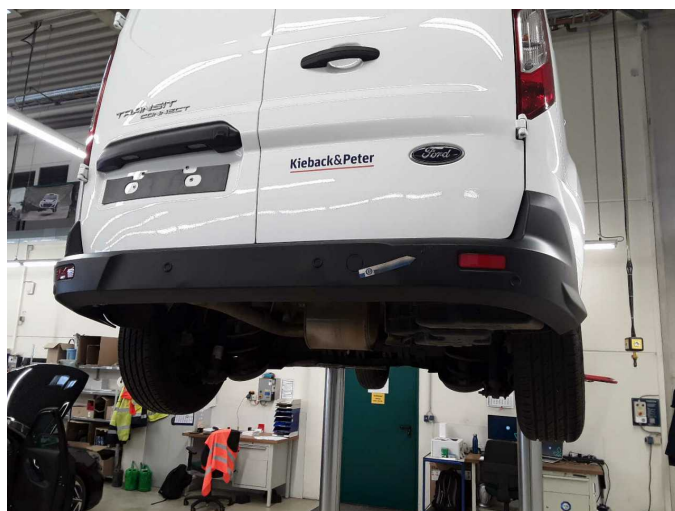
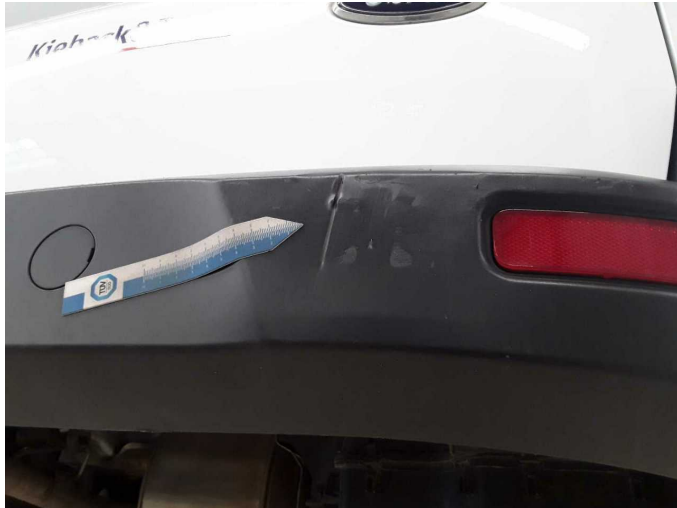
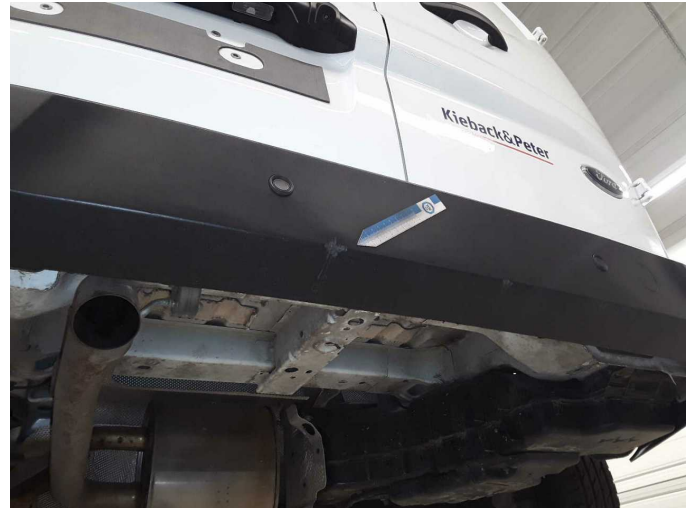
| No. | Component group | Description |
|---|---|---|
| 8 | Rear bumper | Rear bumper (unpainted) - Scratched - Replace |

**Damage 8:** Rear bumper: Rear bumper (unpainted) - Scratched - Replace

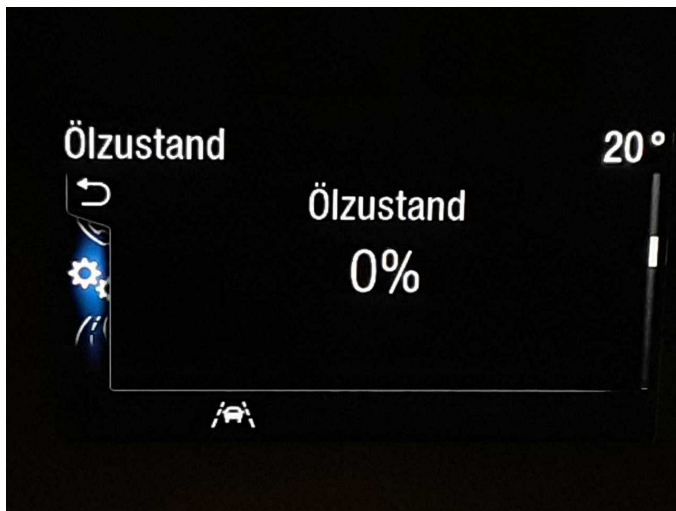
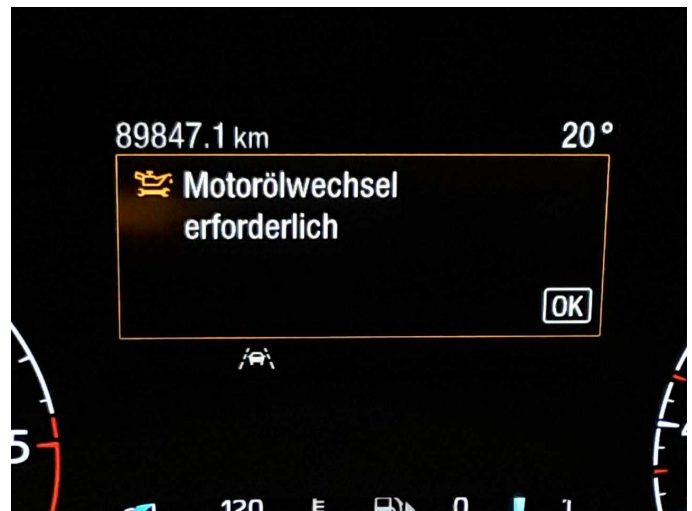
| No. | Component group | Description |
|---|---|---|
| 9 | Misc. | Inspection / maintenance - Due - Perform |

**Damage 9:** Misc.: Inspection / maintenance - Due - Perform

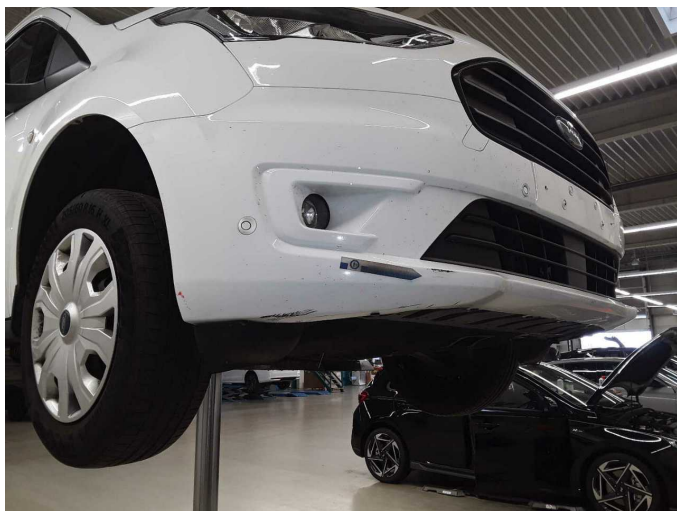
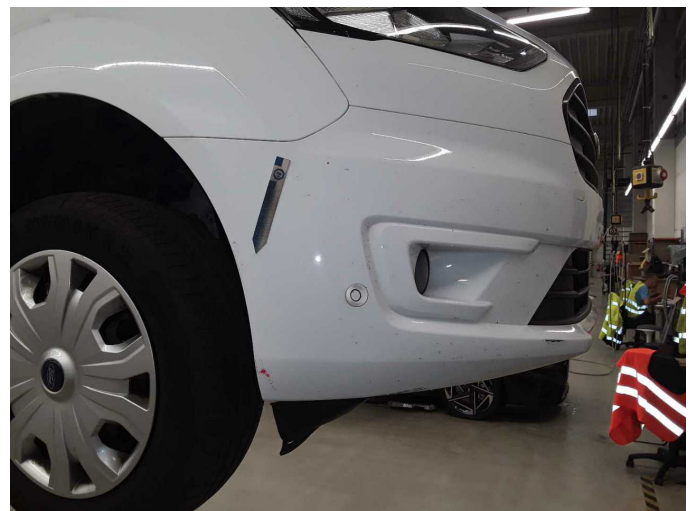
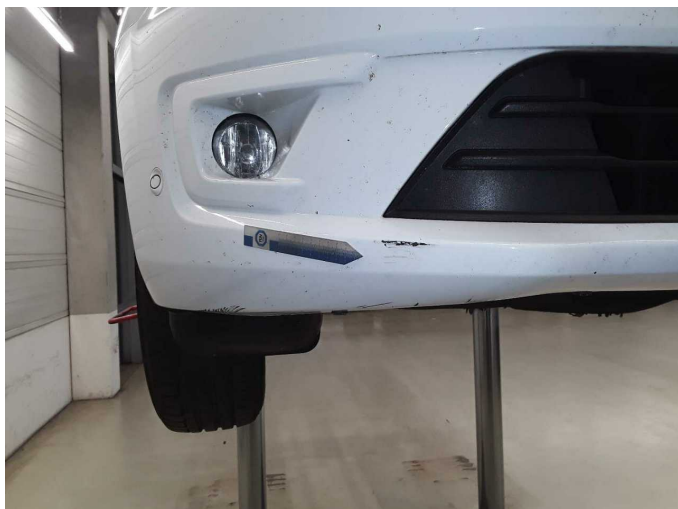
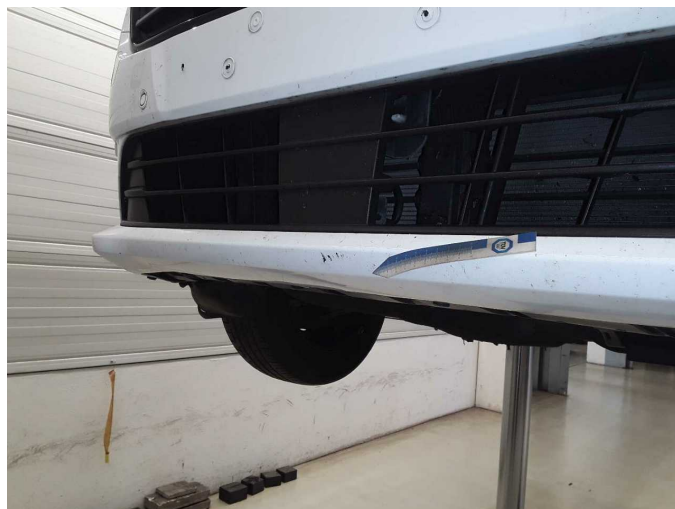
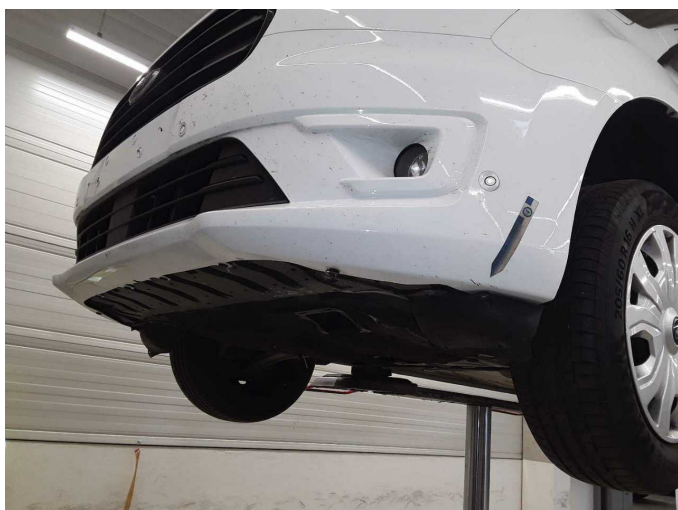
| No. | Component group | Description |
|---|---|---|
| 10 | Front bumper | Front bumper - Scratched - Repair and paint |

**Damage 10:** Front bumper: Front bumper - Scratched - Repair and paint

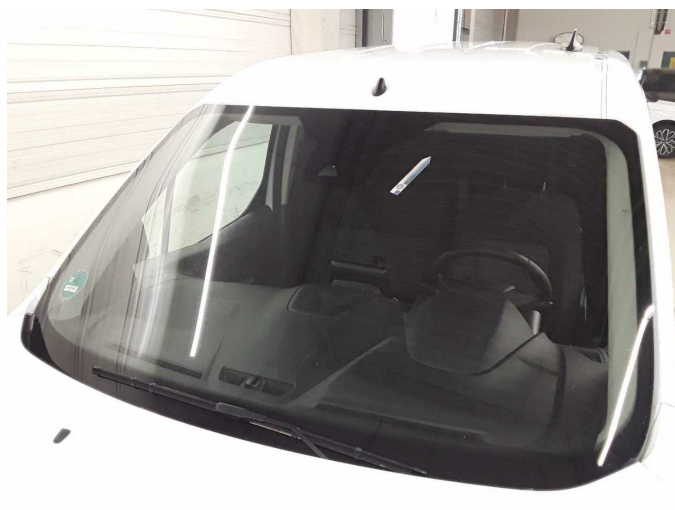
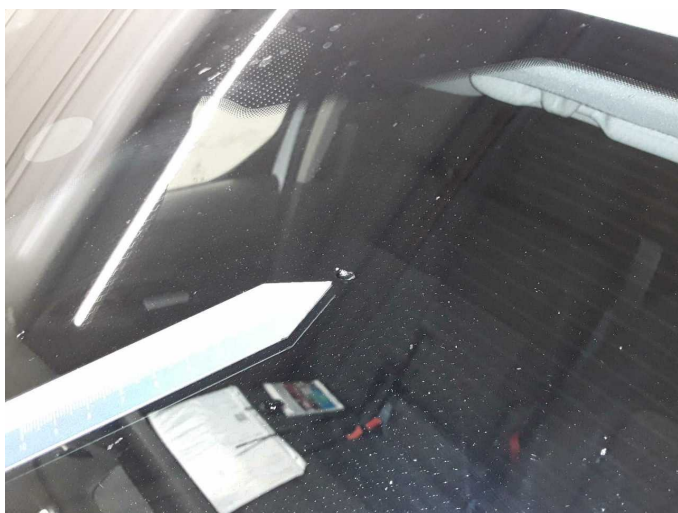
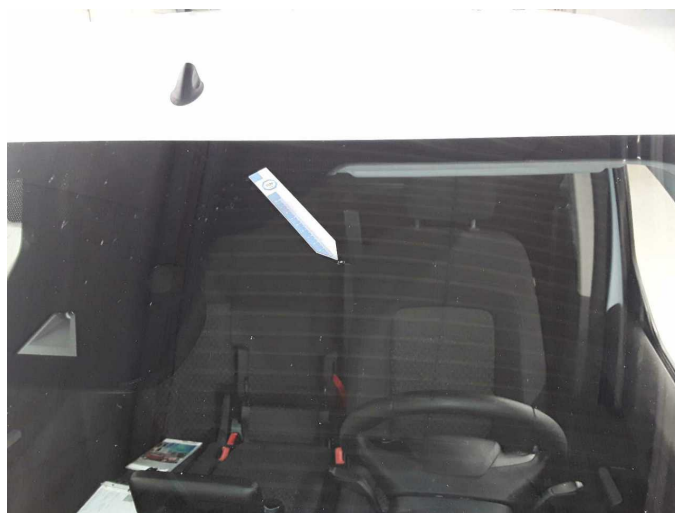
| No. | Component group | Description |
|---|---|---|
| 11 | Vehicle glazing | Windscreen - Stone chips - Replace |

**Damage 11:** Vehicle glazing: Windscreen - Stone chips - Replace

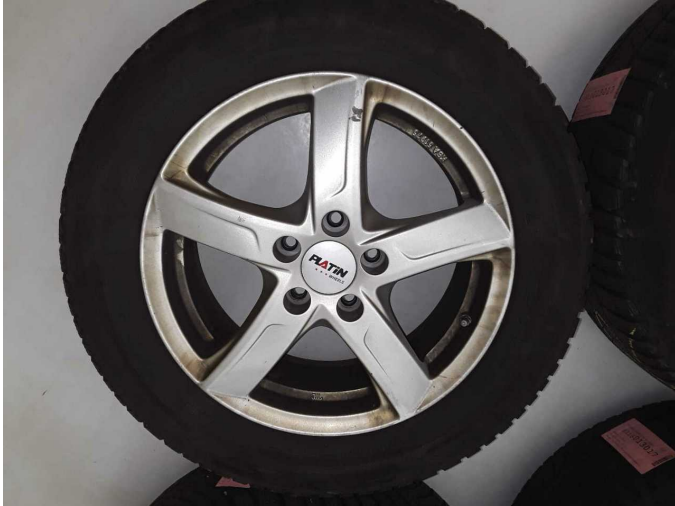
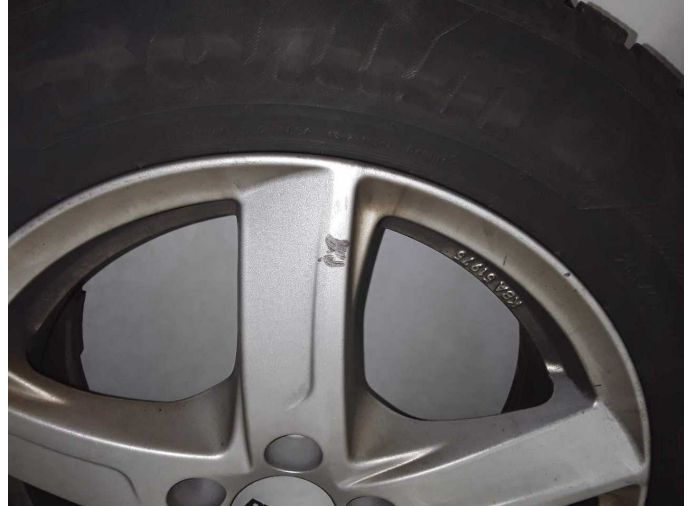
| No. | Component group | Description |
|---|---|---|
| 1 | 2nd wheel set | 1 alloy rim - Scratched - No deduction |

**Wear and tear 1:** 2nd wheel set: 1 alloy rim - Scratched - No deduction

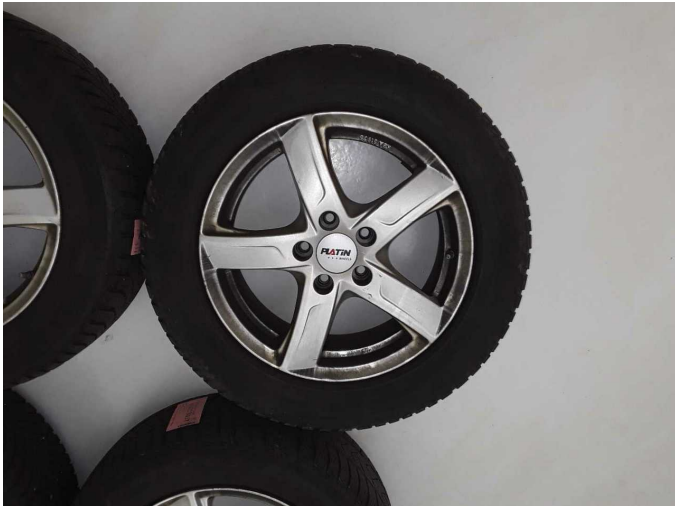
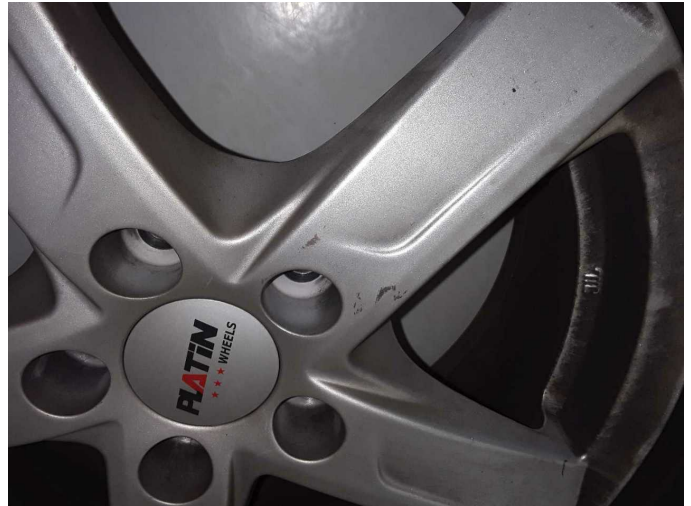
| No. | Component group | Description |
|---|---|---|
| 2 | 2nd wheel set | 1 alloy rim - Scratch(es) - No deduction |

**Wear and tear 2:** 2nd wheel set: 1 alloy rim - Scratch(es) - No deduction

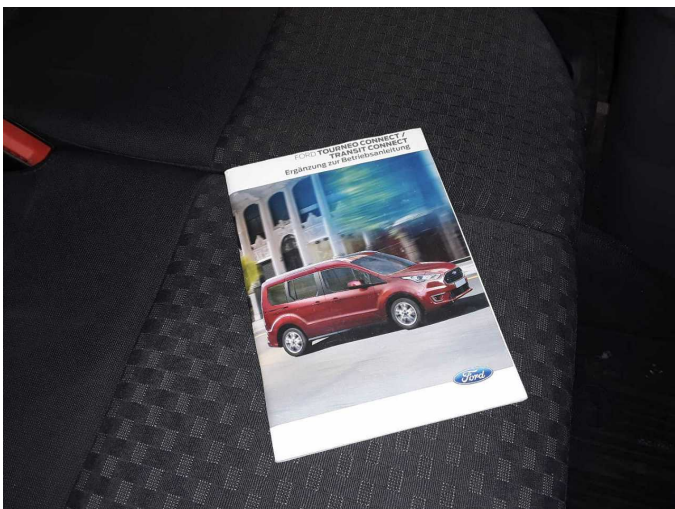
Documents - Owner's manual

**Missing part 1:** Documents: Owner's manual - Missing - Replace

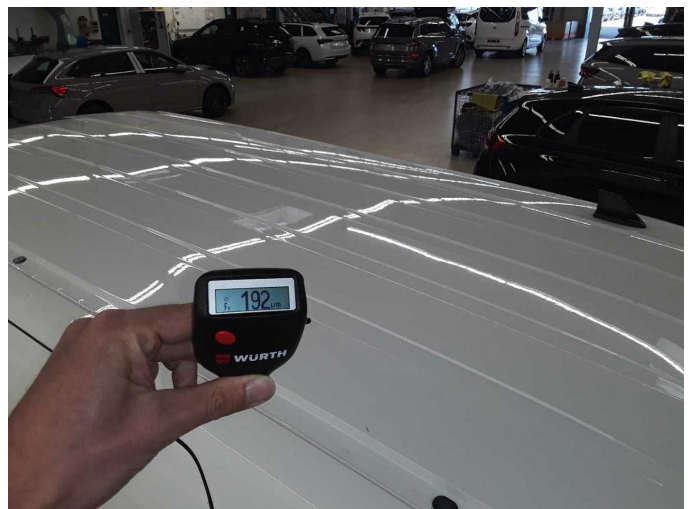
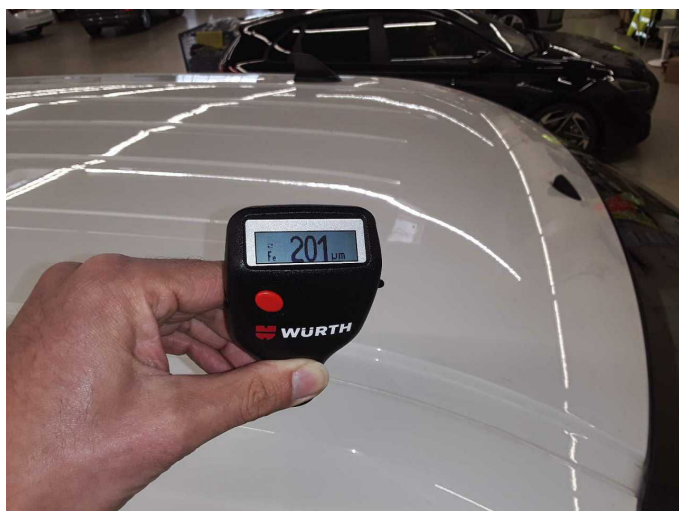
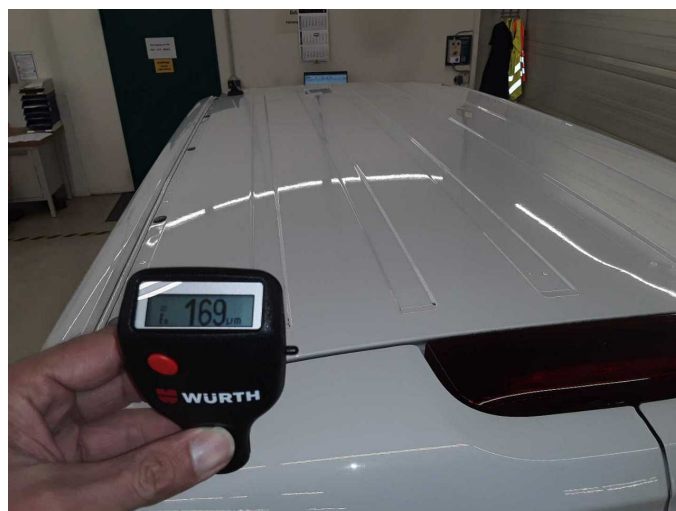
- 1 Roof, Professionally carried out

Roof 201 µm

**Roof:** 201 µm

Roof: 201 µm
