Expertise

Protocol number: 46616050  
Order No. / Reference: 26637709  
Inspection date: 21 Jul 2026

Manufacturer: Ford

Model: Transit Connect 220 L1 Trend

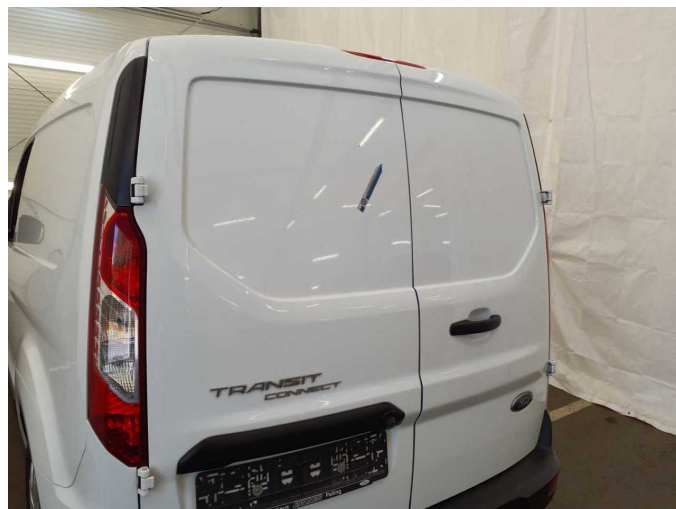
| No. | Component group | Description |
|---|---|---|
| 1 | Boot lid / rear door | Rear door - left side - dent(s) - Smart repair |

**Damage 1:** Boot lid / rear door: Rear door - left side - dent(s) - Smart repair

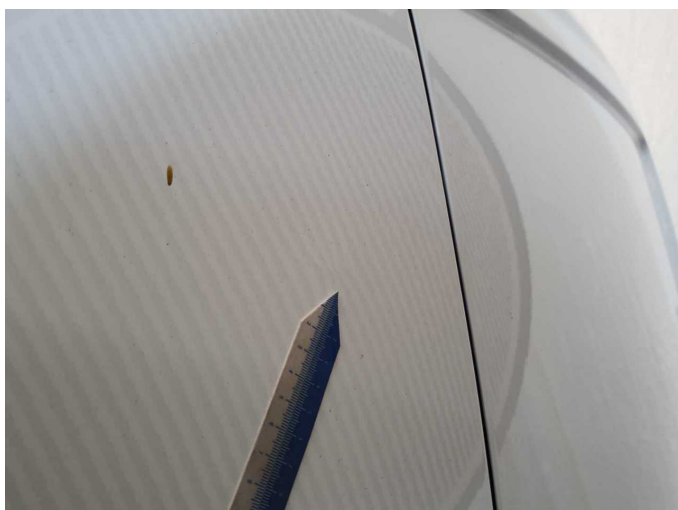
**Damage 1:** Boot lid / rear door: Rear door - left side - dent(s) - Smart repair

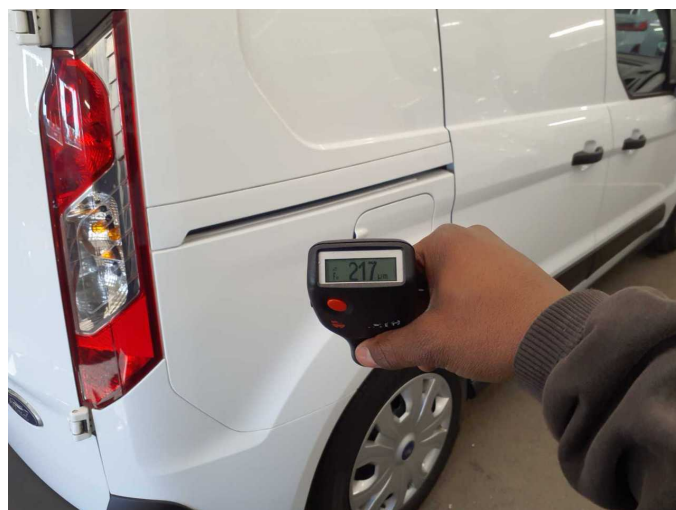
| 1 | Side panel - rear left side, Professionally carried out, Invoice of repair done Non-existent |

| Side panel - rear left side | 217 µm |

**Repainting 1:** Side panel - rear left side

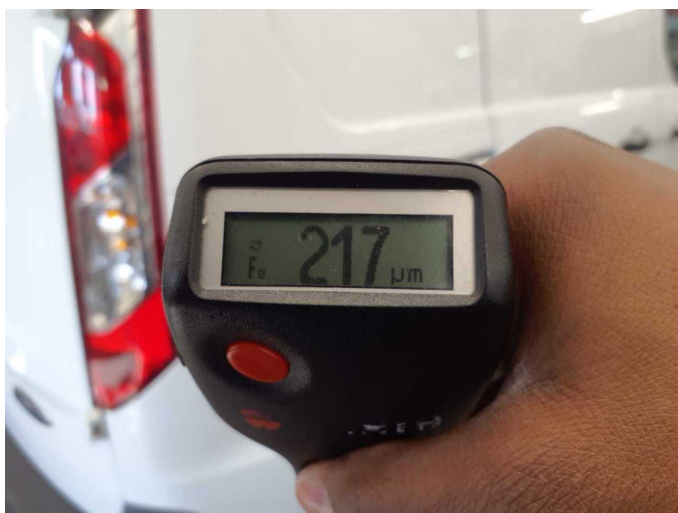
**Repainting 1:** Side panel - rear left side
