## Expertise

Protocol number: 46001116  
Order No. / Reference: 26431235  
Inspection date: 17 Jun 2026

Model: Focus Turnier 1.5 EcoBlue Start-Stopp-System Aut.  
COOL&CONNECT

VIN: WF0PXXGCHPNR10953

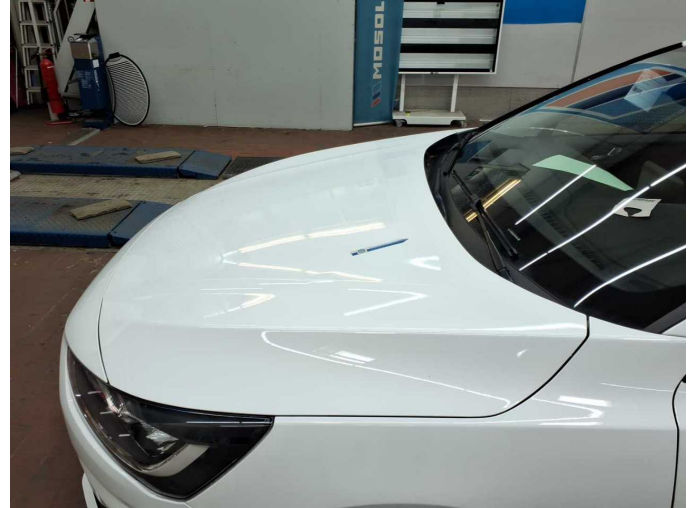
No.	Component group	Description
1	Bonnet	Bonnet - dent(s) - Smooth repair work
2	Trim / covers	Roof lining - Holes - Smart repair
3	Front bumper	Spoiler - Scratched - Replace

Damage 1: Bonnet: Bonnet - dent(s) - Smooth repair work

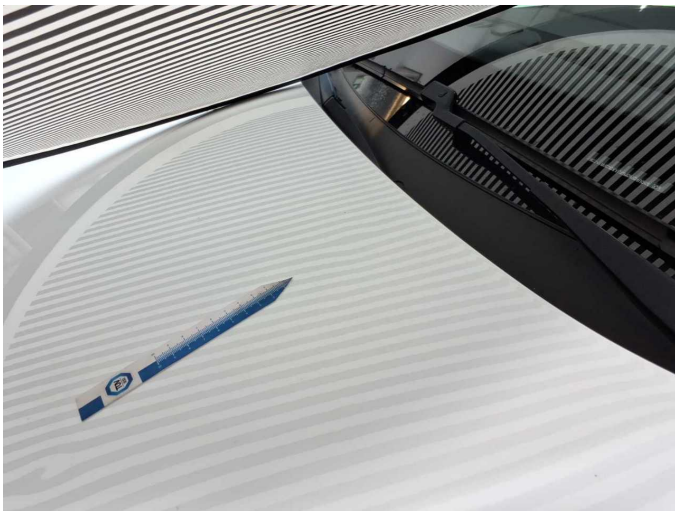
Damage 1: Bonnet: Bonnet - dent(s) - Smooth repair work

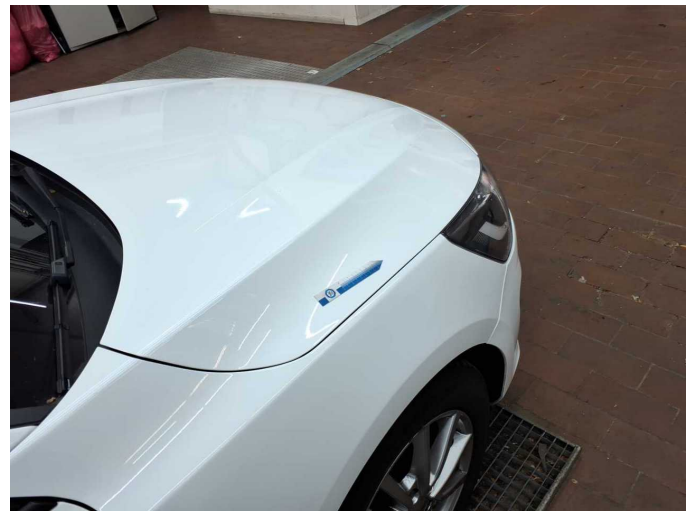
Damage 1: Bonnet: Bonnet - dent(s) - Smooth repair work

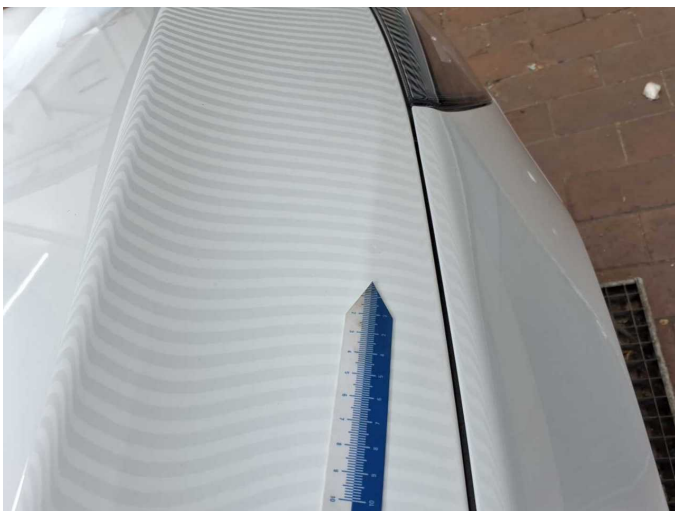
Damage 1: Bonnet: Bonnet - dent(s) - Smooth repair work

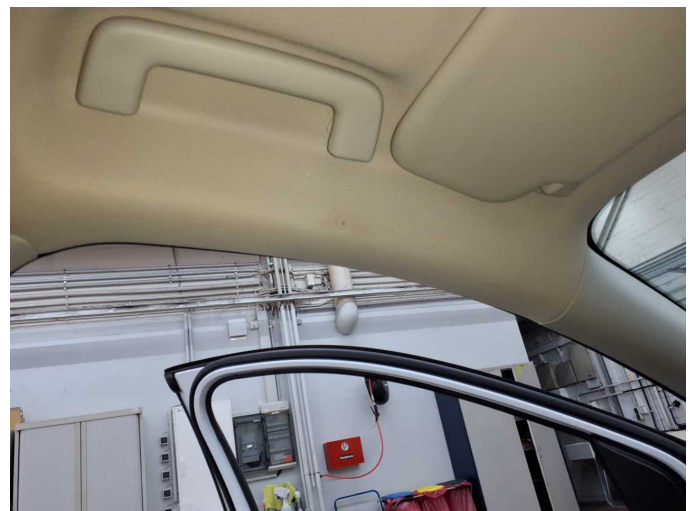
Damage 2: Trim / covers: Roof lining - Holes - Smart repair

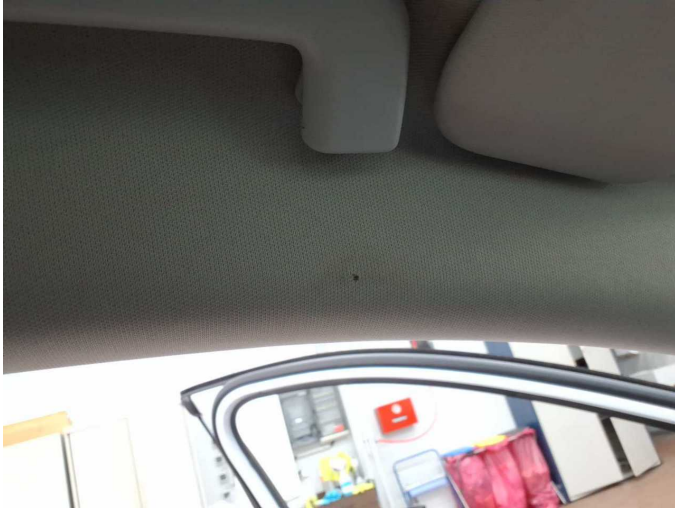
**Damage 2:** Trim / covers: Roof lining - Holes - Smart repair

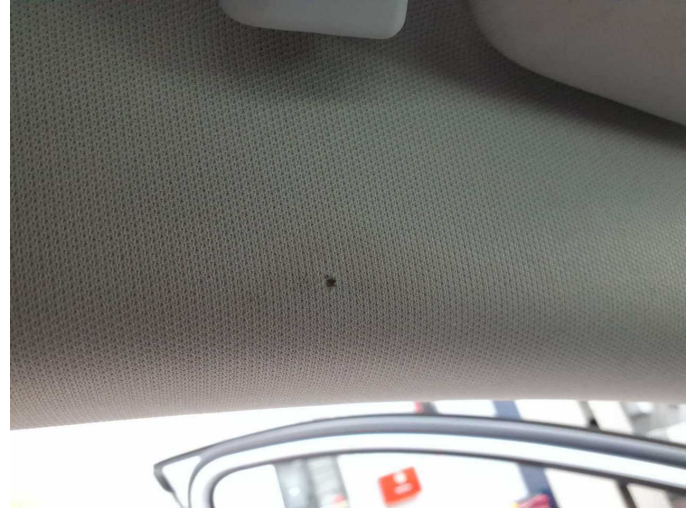
**Damage 2:** Trim / covers: Roof lining - Holes - Smart repair

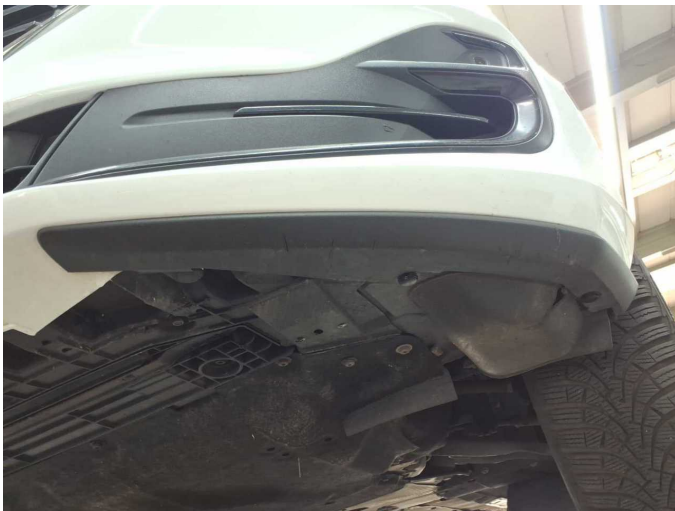
**Damage 3:** Front bumper: Spoiler - Scratched - Replace

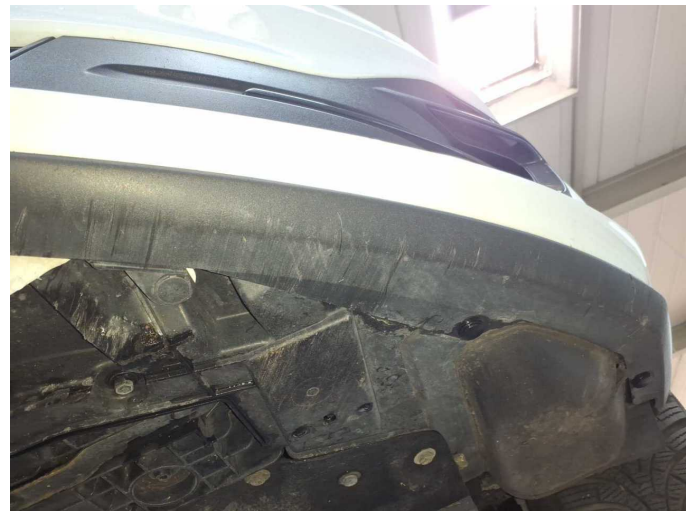
**Damage 3:** Front bumper: Spoiler - Scratched - Replace

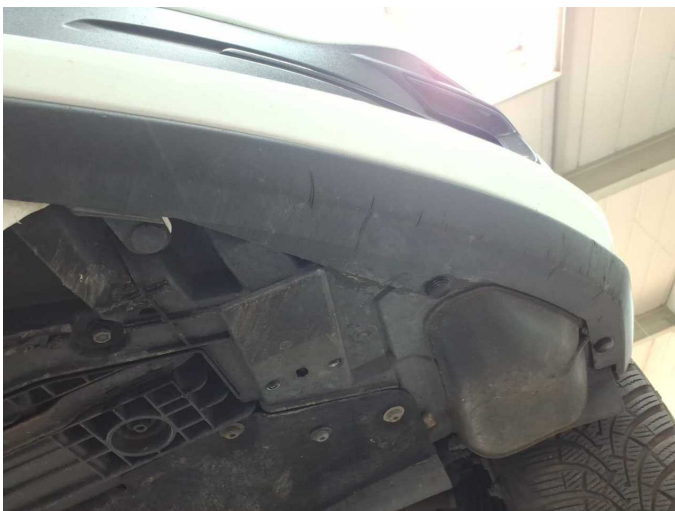
**Damage 3:** Front bumper: Spoiler - Scratched - Replace

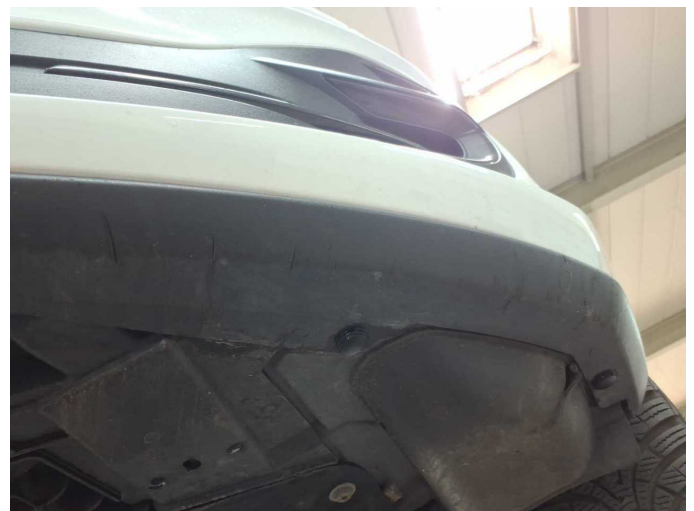
**Damage 3:** Front bumper: Spoiler - Scratched - Replace

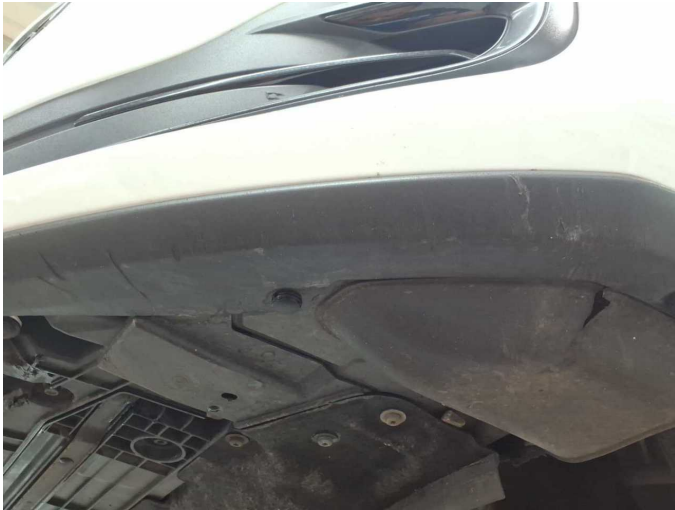
**Damage 3:** Front bumper: Spoiler - Scratched - Replace

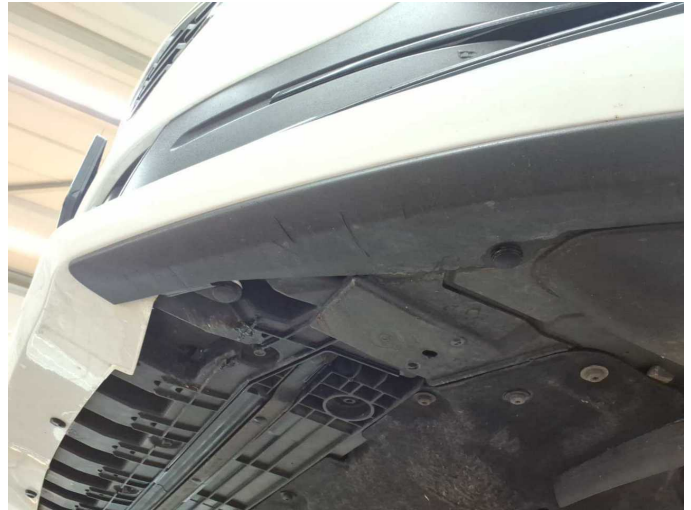
**Damage 3:** Front bumper: Spoiler - Scratched - Replace

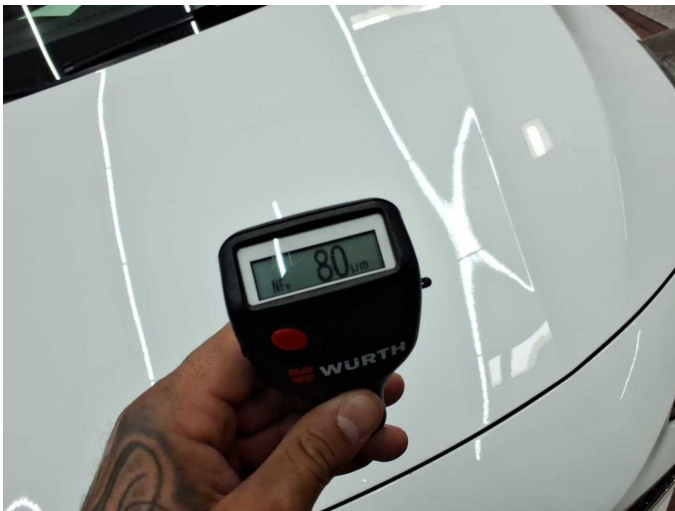
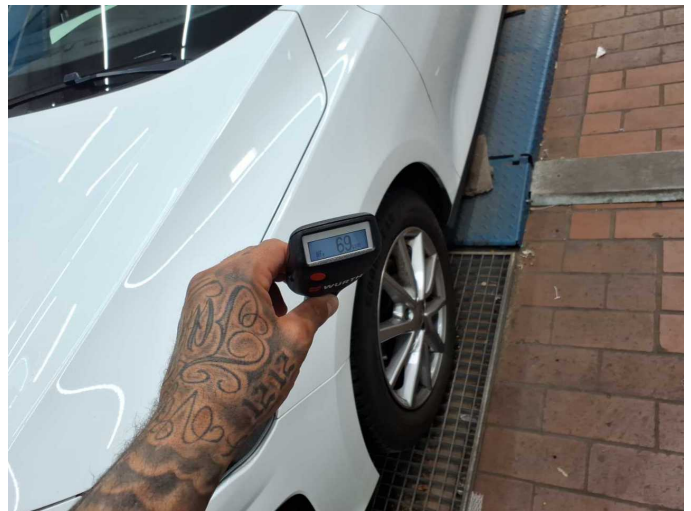
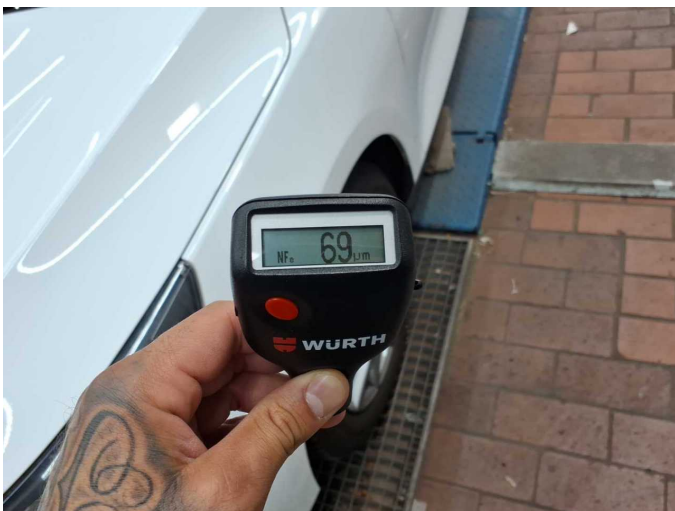
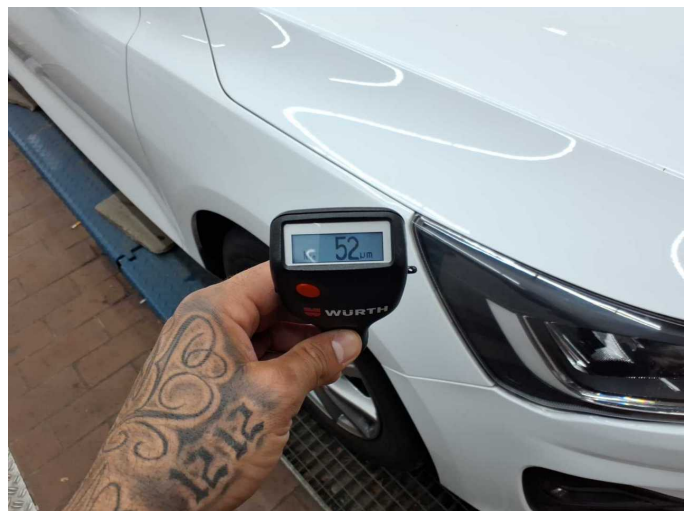
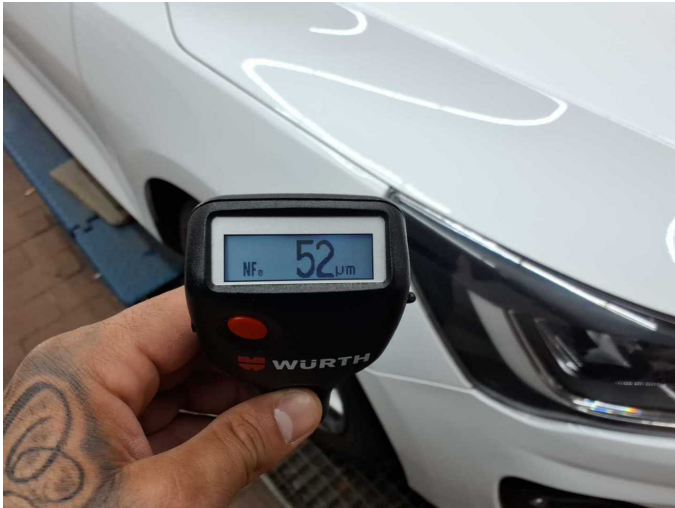
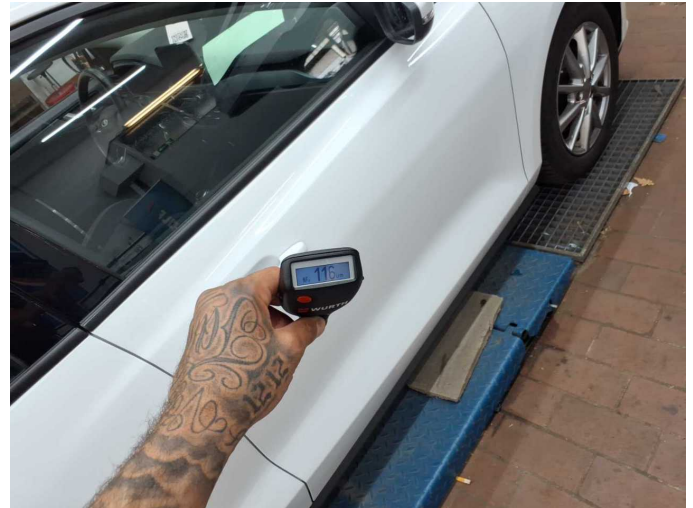
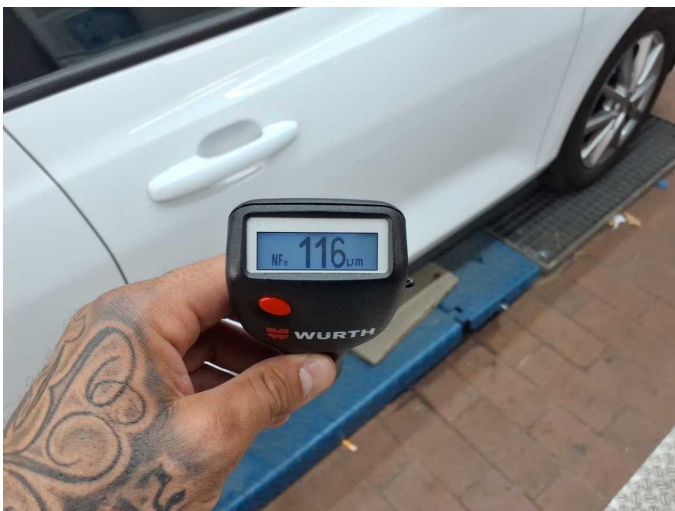
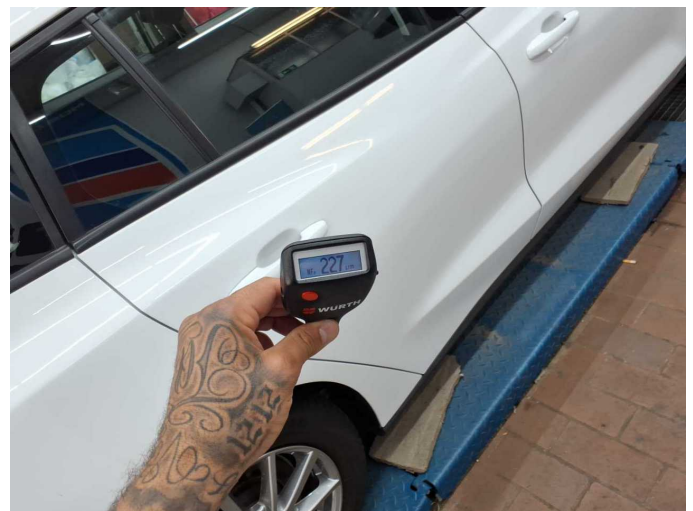
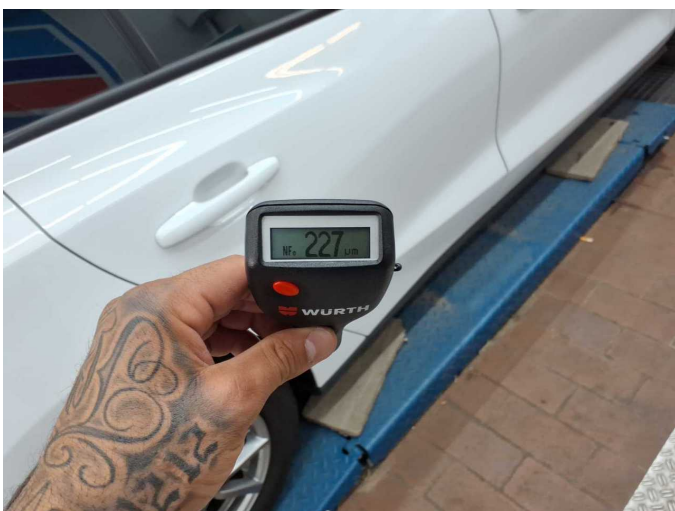
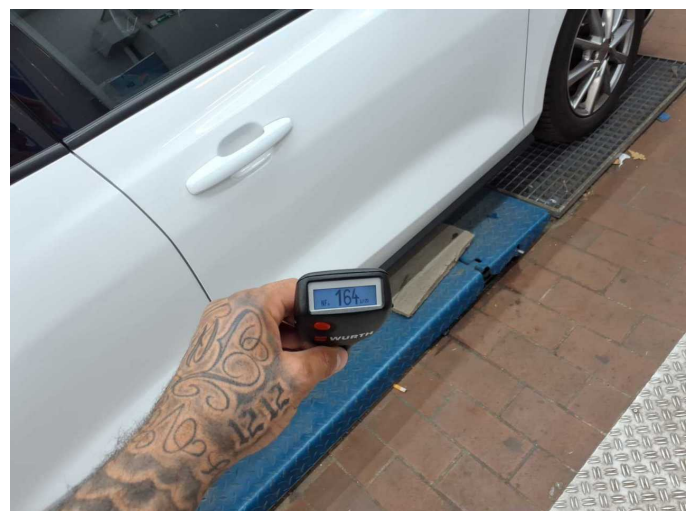
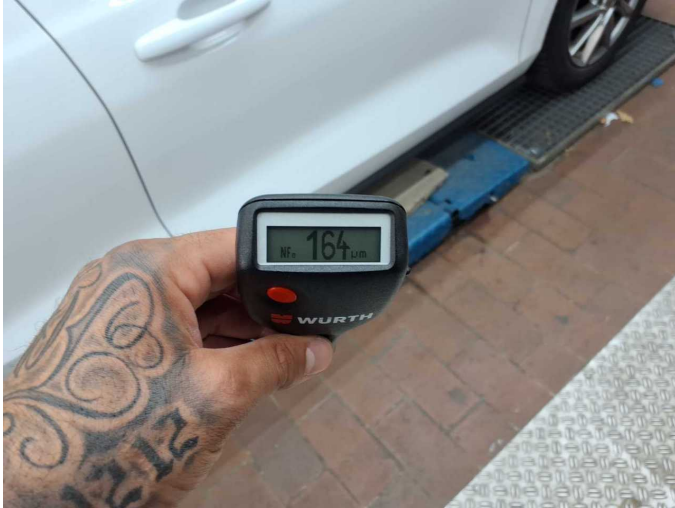
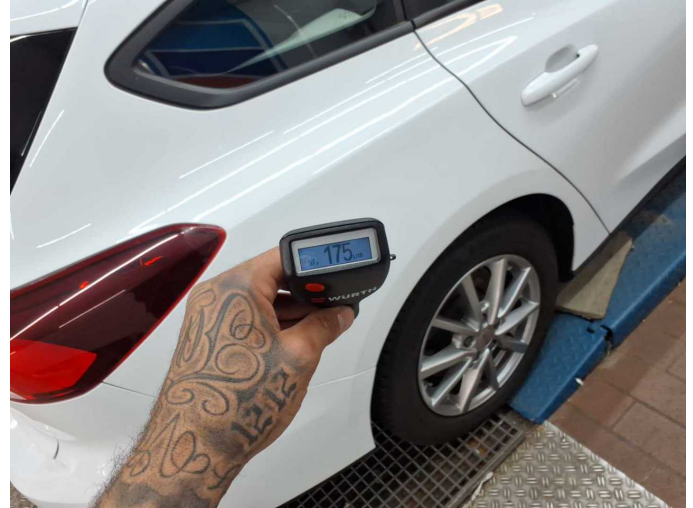
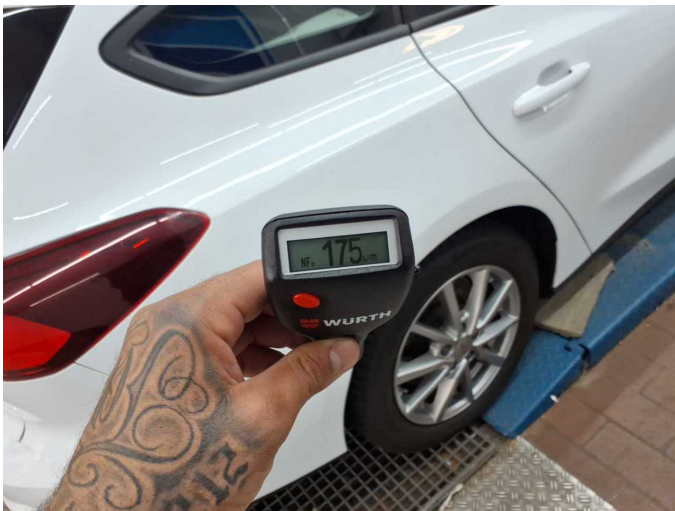
No.	Previous damage	Extent of damage (Net)
1	Front, Side right, Professionally repaired, Invoice of repair done Non-existent, from 20 Feb 2025	3.492,63 €

Professionally repaired previous damages were found at the vehicle.

**Previous damage 1:** Front, Side right

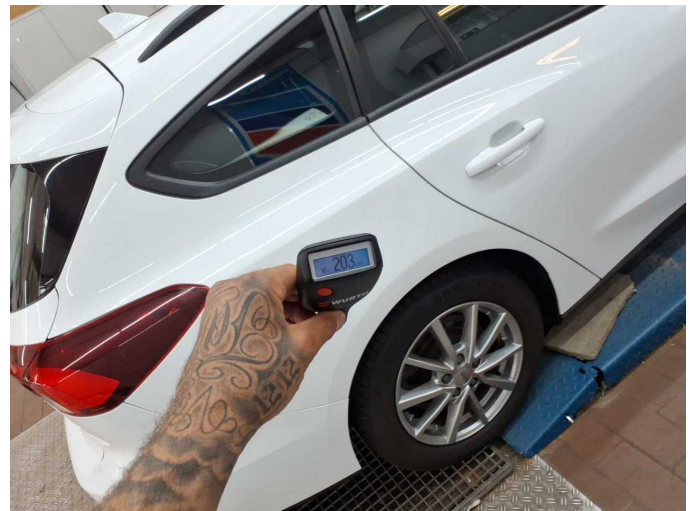
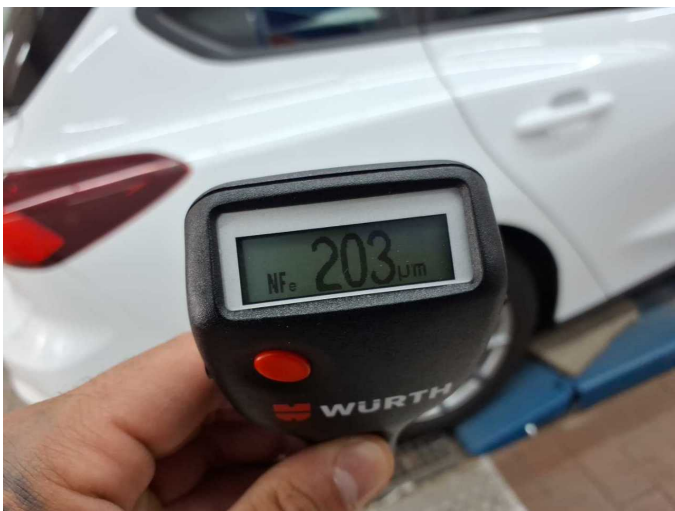
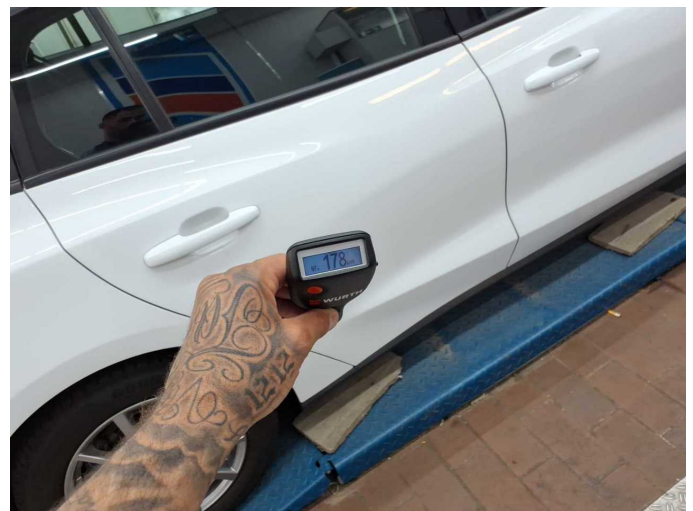
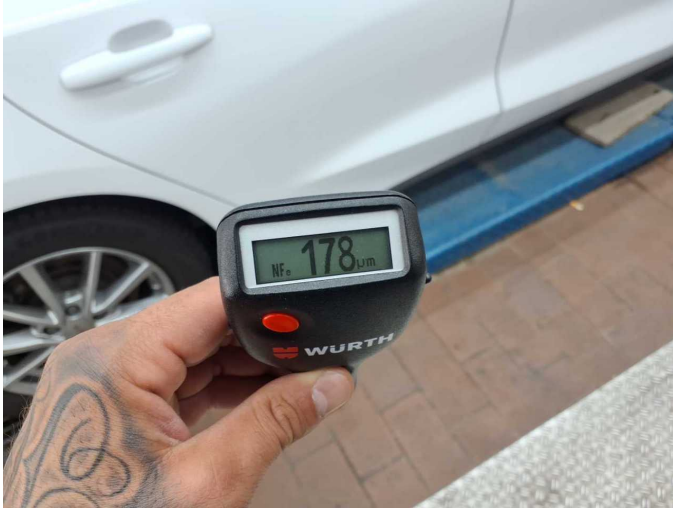
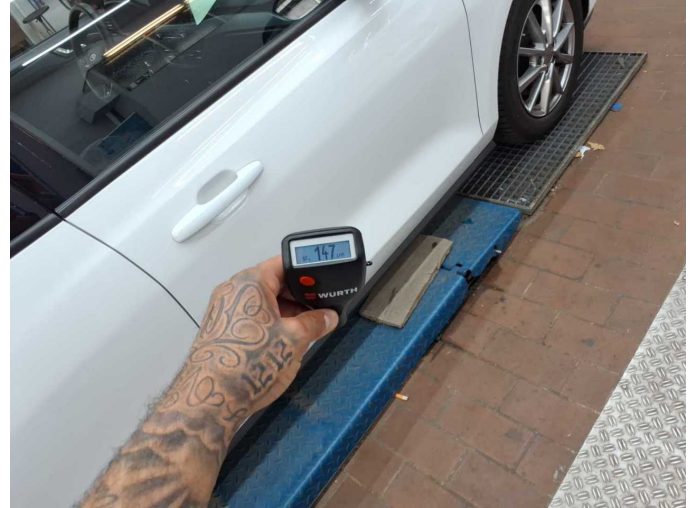
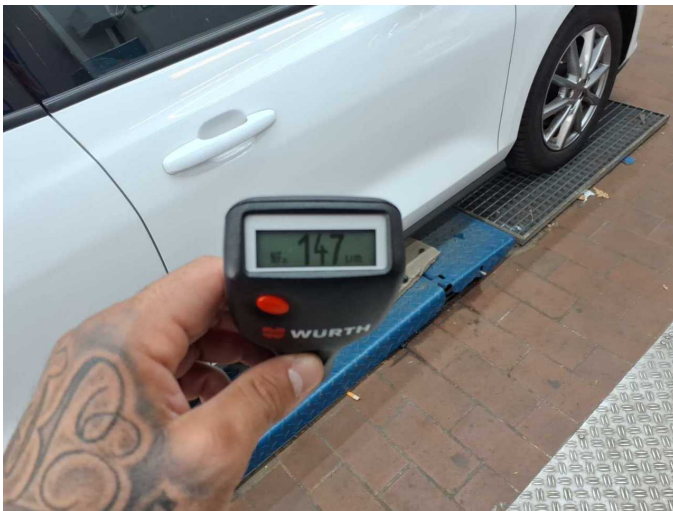
No.	Repainting
1	Side panel - rear right side, Door - rear right side, Door - front right side, Professionally carried out, Invoice of repair done Non-existent

Side panel - rear right side	203 µm	Door - rear right side	178 µm
Door - front right side	147 µm

**Repainting 1:** Side panel - rear right side, Door - rear right side, Door - front right side
