Expertise

Protocol number: 44953788
Order No. / Reference: 26234223
Inspection date: 13 Apr 2026

Manufacturer: Ford

Model: Kuga 2.0 EcoBlue 4x4 Aut. TITANIUM

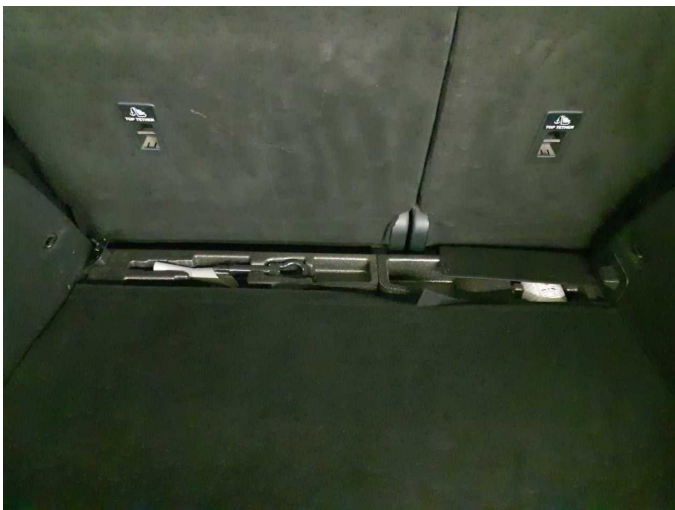
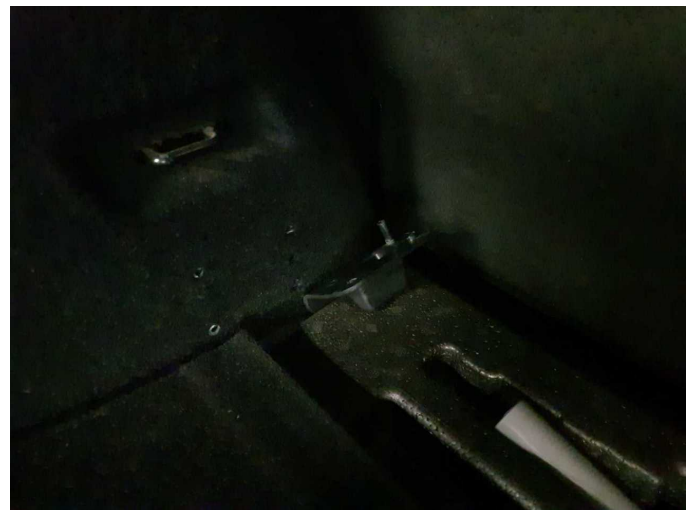
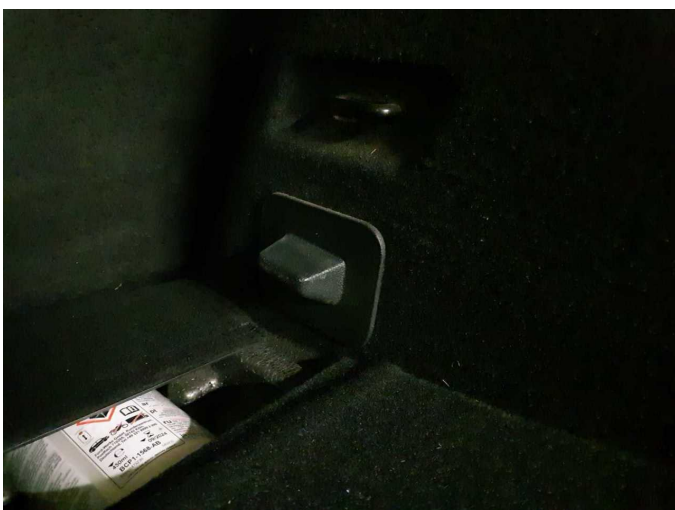
Damage 1: Interior: Cargo area floor (Stütze) - Broken / torn - Replace

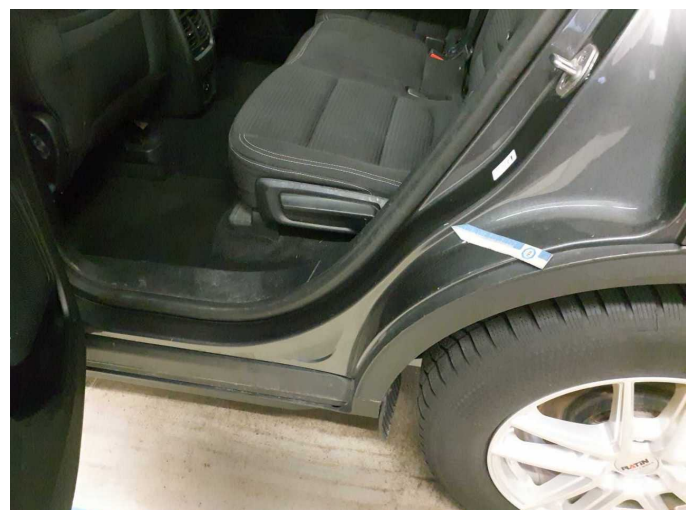
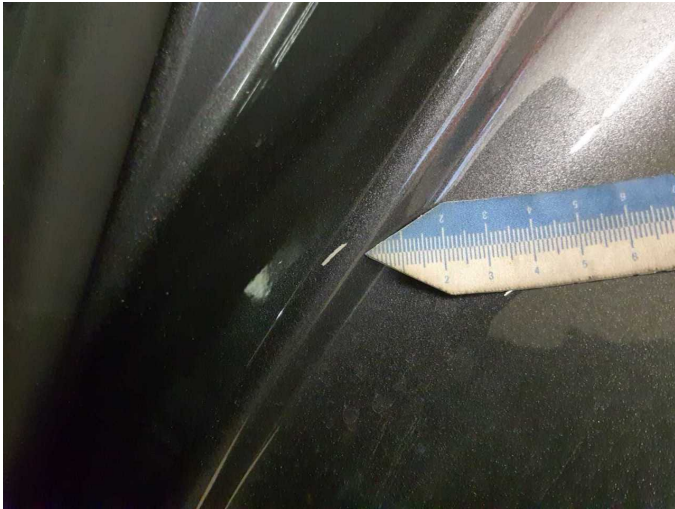
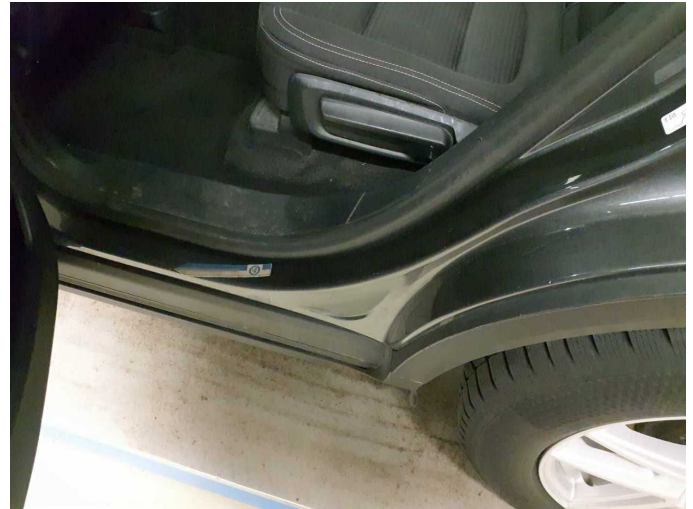
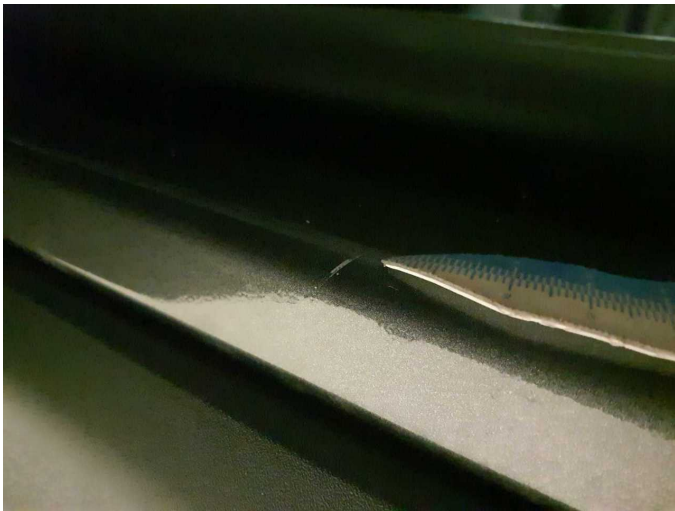
Damage 3: Side panel - rear left side: Sill - Scratch(es) - Smart repair

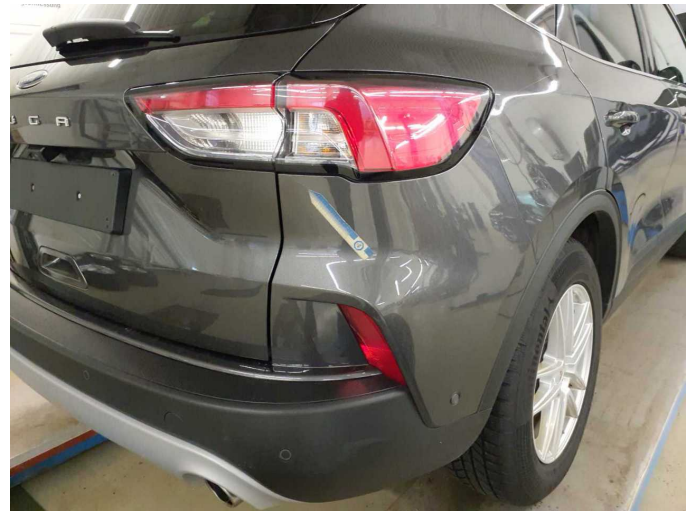
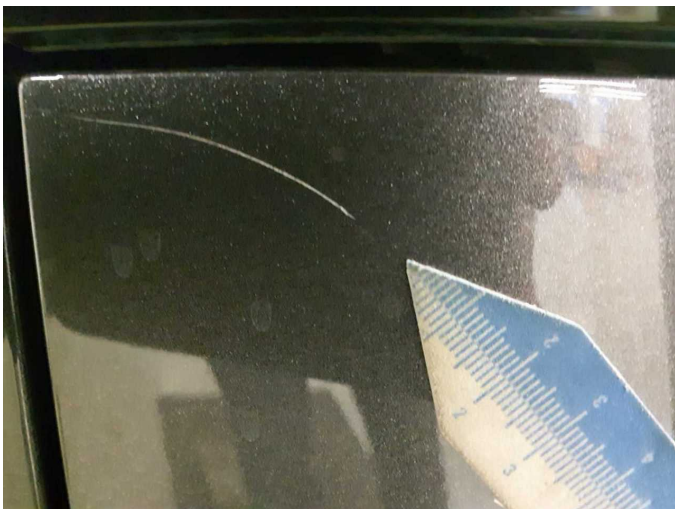
Damage 4: Rear bumper: Rear bumper - Scratch(es) - Smart repair

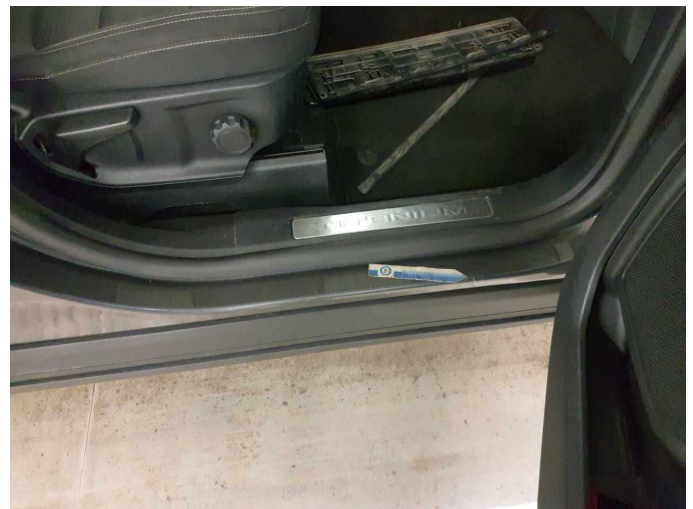
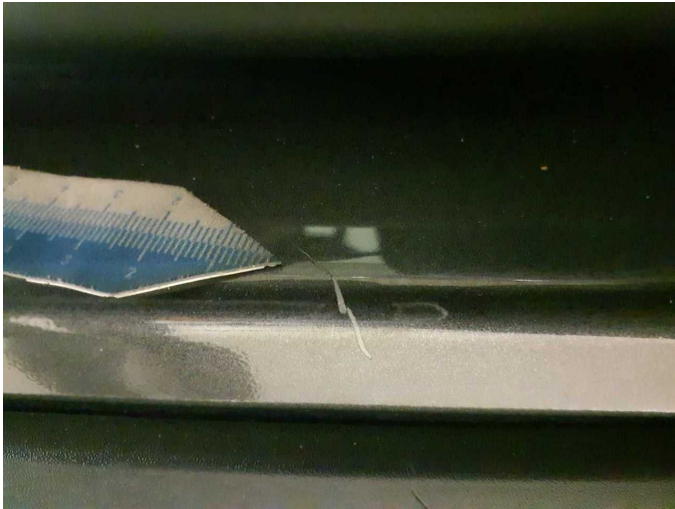
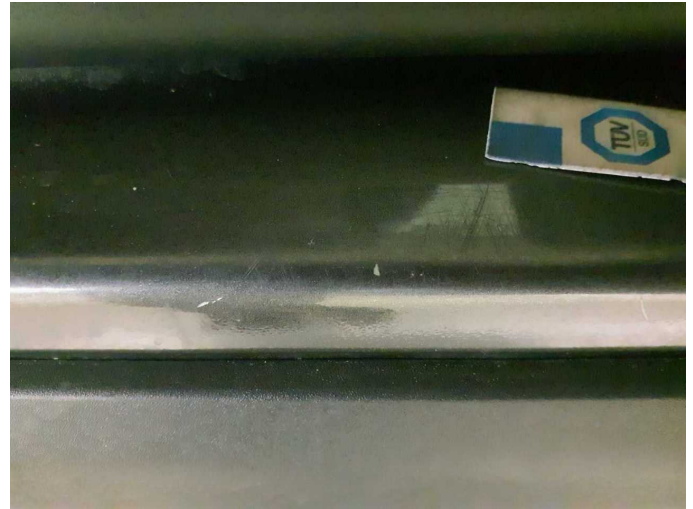
Damage 5: Sill - right side: Sill - Scratch(es) - Smart repair

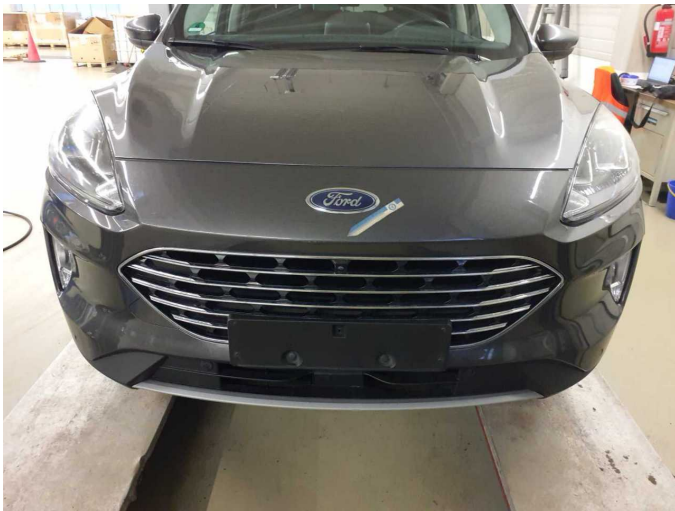
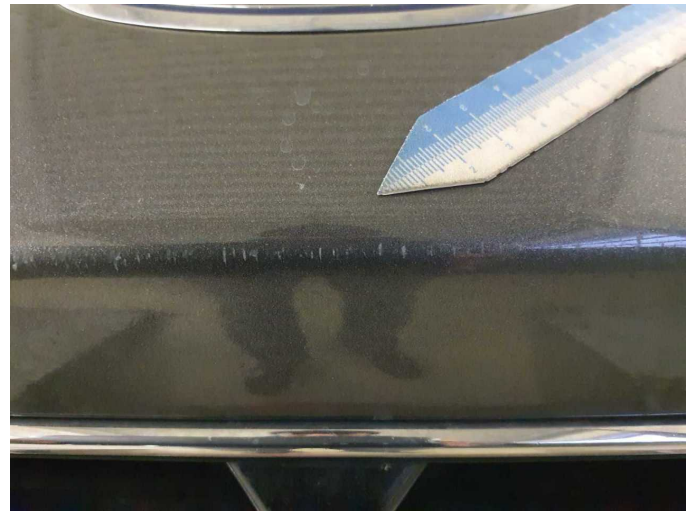
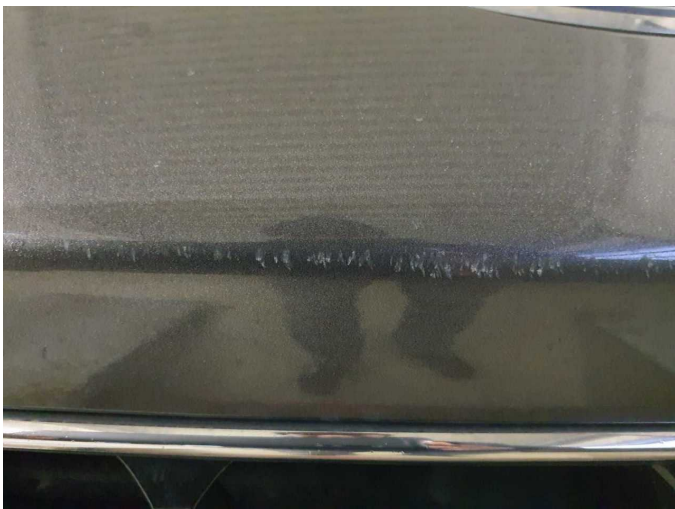
Damage 6: Front bumper: Front bumper - Scratch(es) - Smart repair

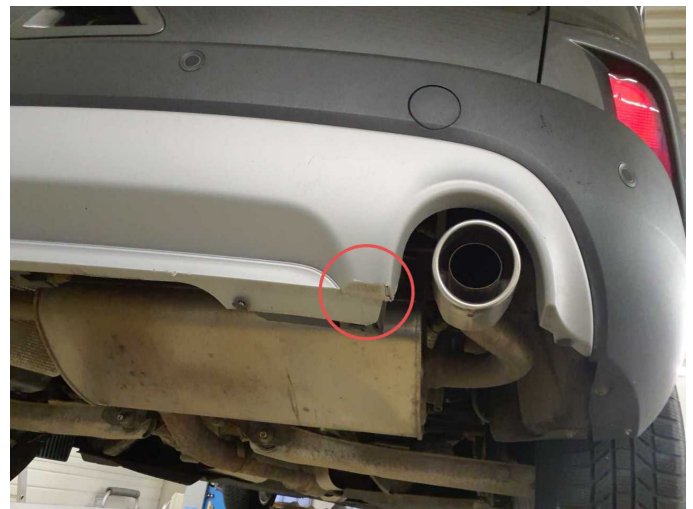
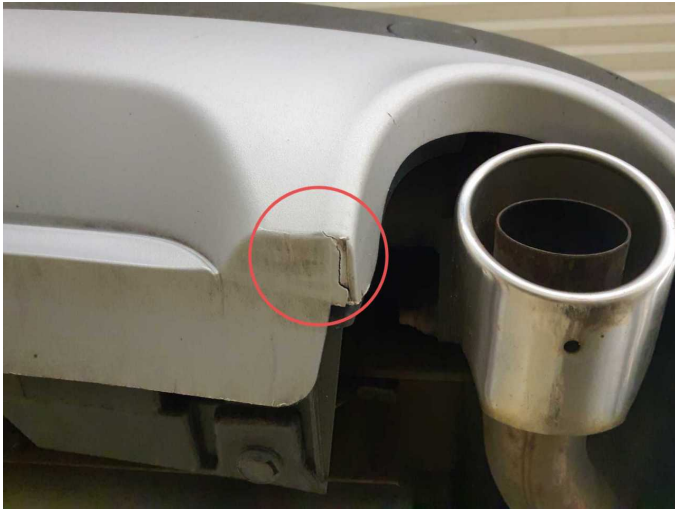
Damage 7: Rear bumper: Spoiler - Broken / torn - Replace

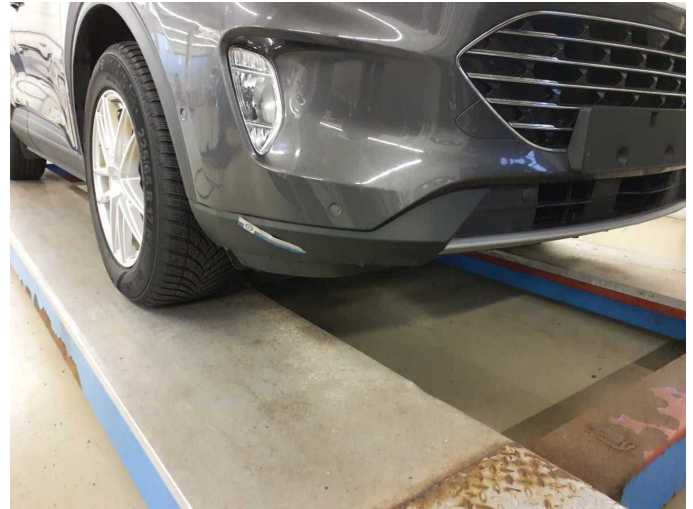
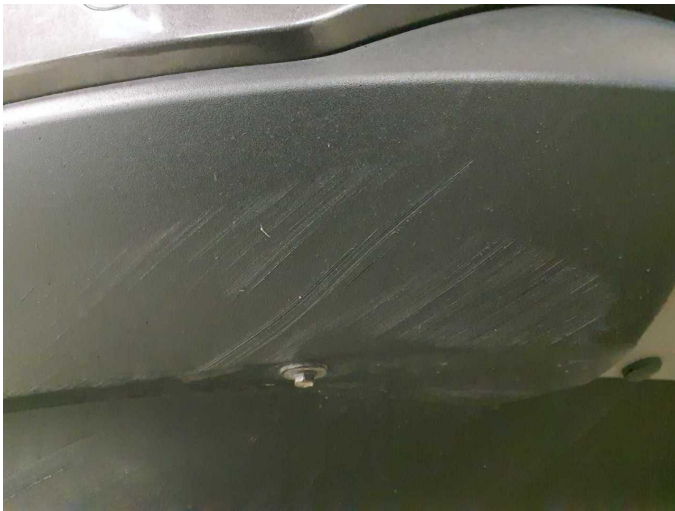
Damage 8: Front bumper: Spoiler - Scratch(es) - Replace

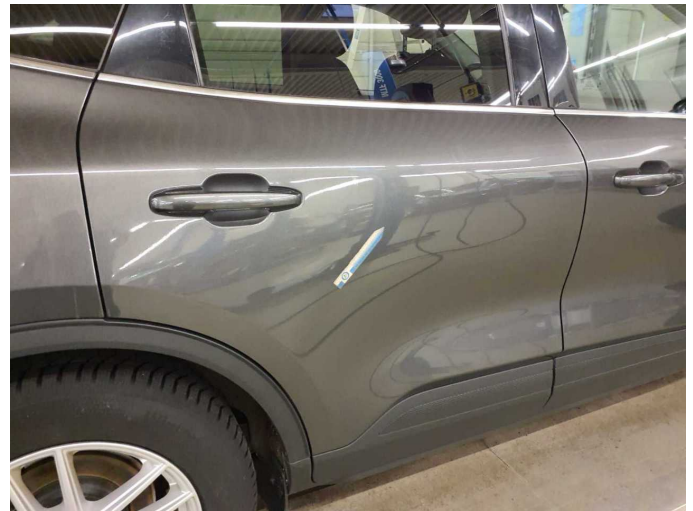
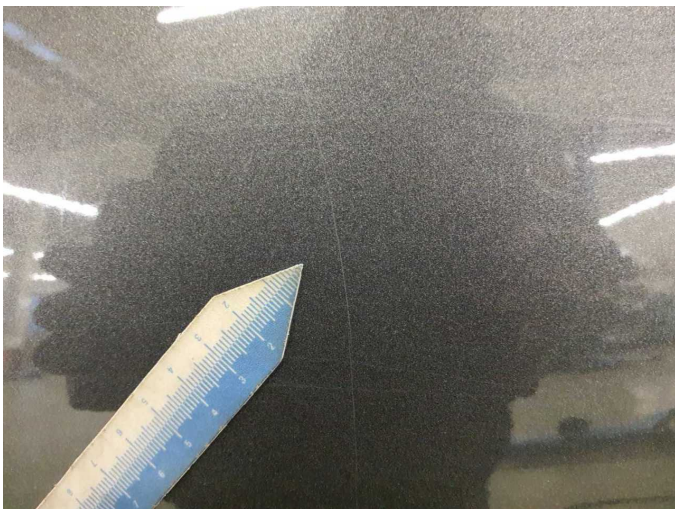
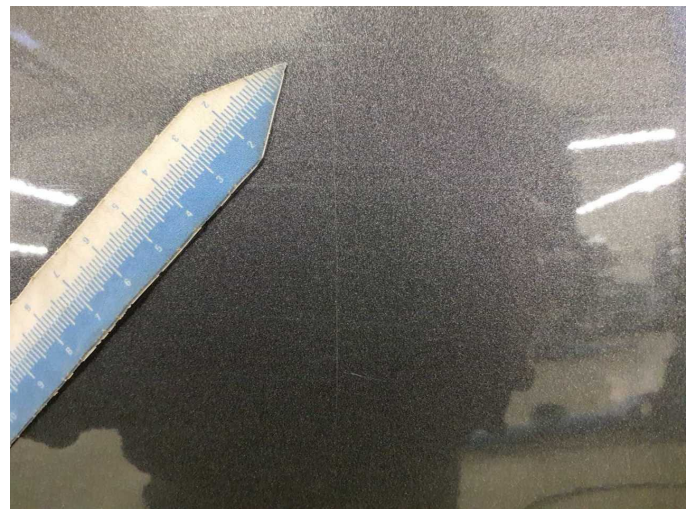
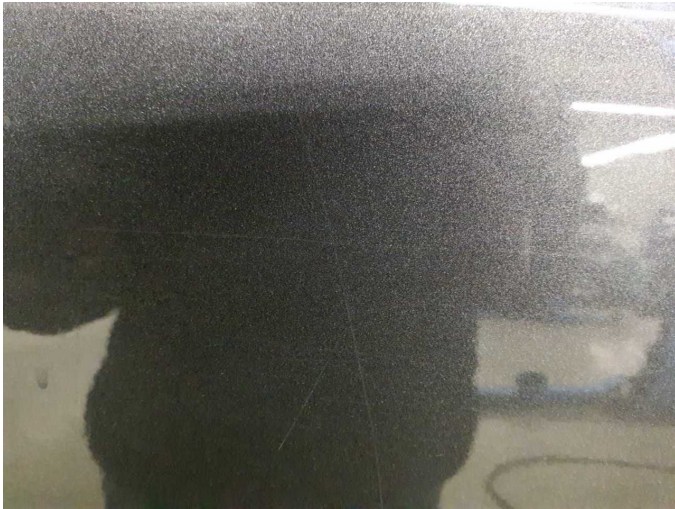
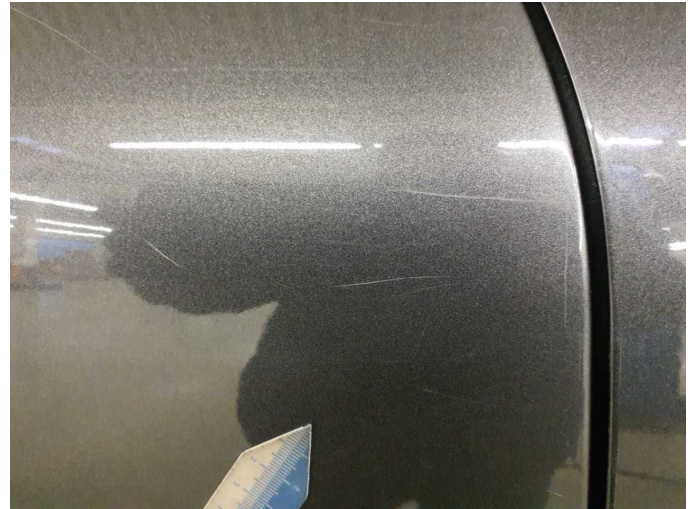
Damage 9: Door - rear right side: Door - Scratch(es) - Paint

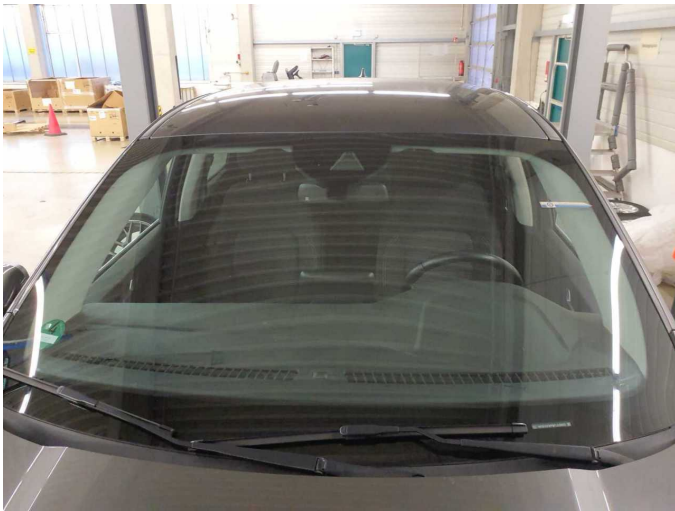
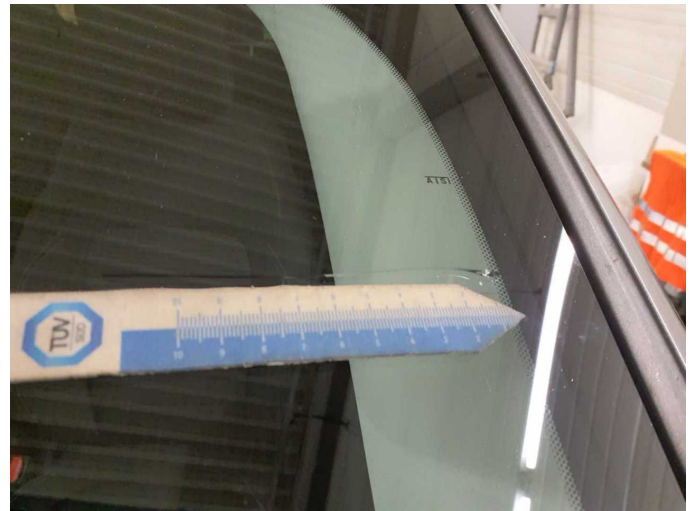
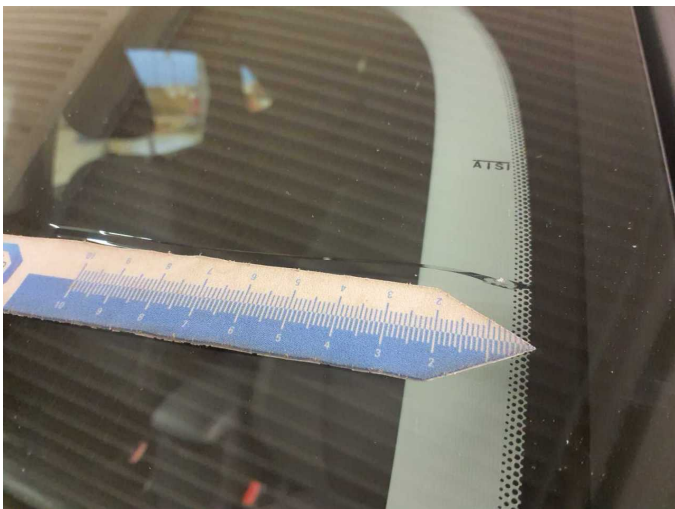
Damage 10: Vehicle glazing: Windscreen with lane departure assistant - Broken / torn - Replace

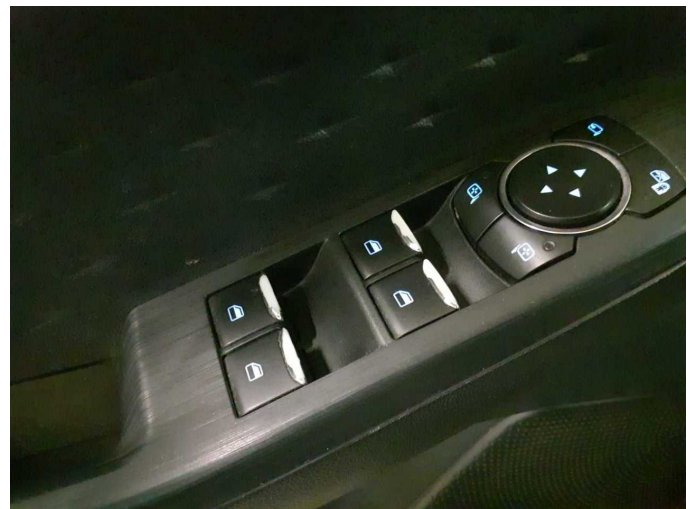
Wear and tear 1: Door - front left side: Window regulator (Chrome löst sich) - Loose - No deduction

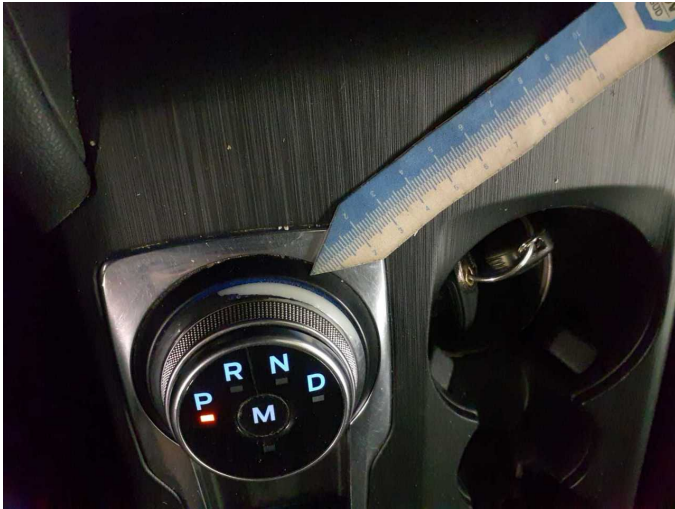
Wear and tear 2: Gearbox: Gear knob (Chrome löst sich) - Loose - No deduction

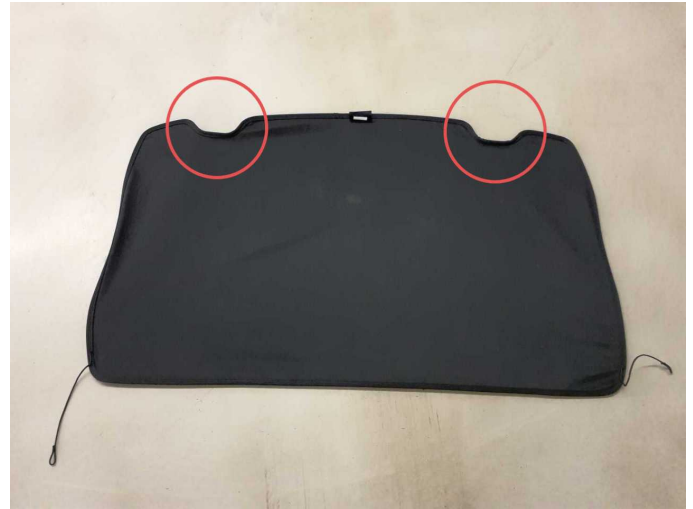
Missing part 1: Interior: Boot cover / roller cover (Halterungen) - Missing - Replace
