Expertise

Protocol number: 46850927  
Order No. / Reference: 26836657  
Inspection date: 3 Aug 2026

Manufacturer: Toyota  
VIN: YARECYHT2GJ019007

Model: Proace City Verso 1.5 D-4D L1 Shuttle

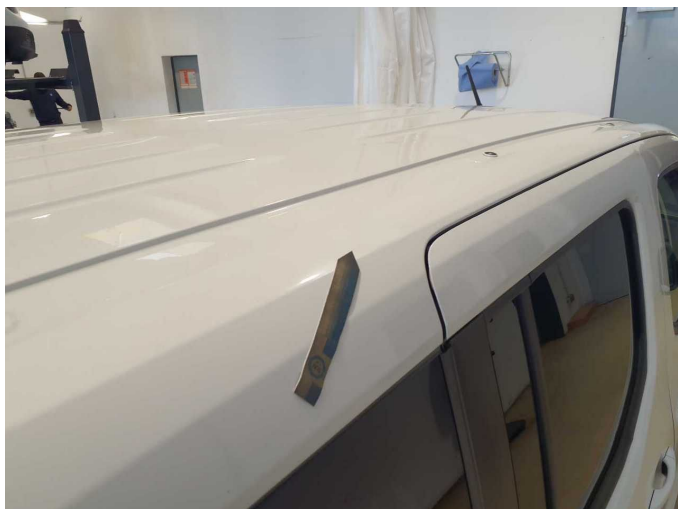
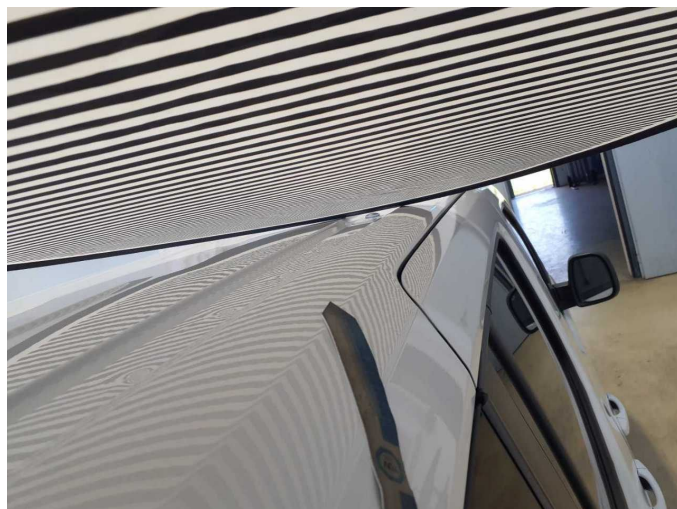
| No. | Component group | Description |
|---|---|---|
| 2 | Roof | Roof rail - right side - dent(s) - Smooth repair work |

**Damage 2:** Roof: Roof rail - right side - dent(s) - Smooth repair work

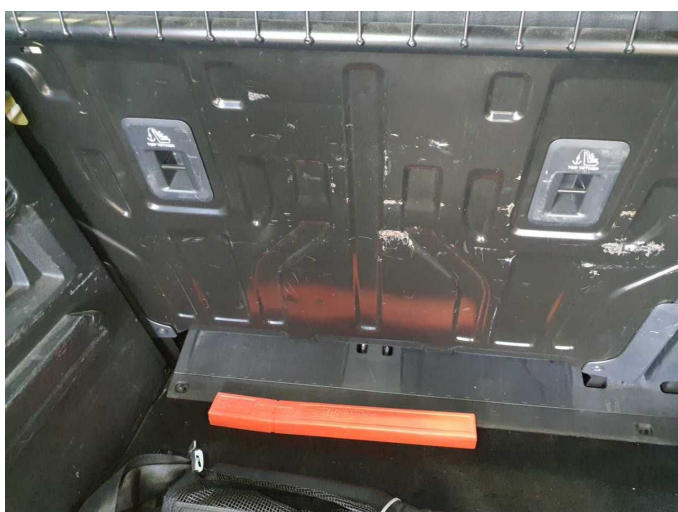
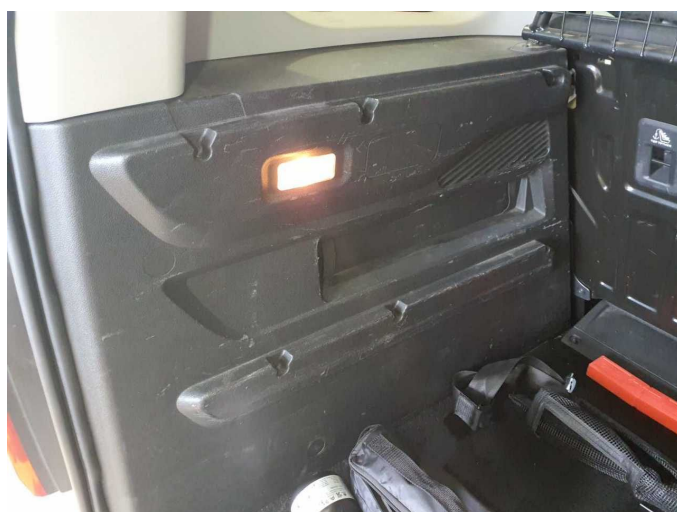
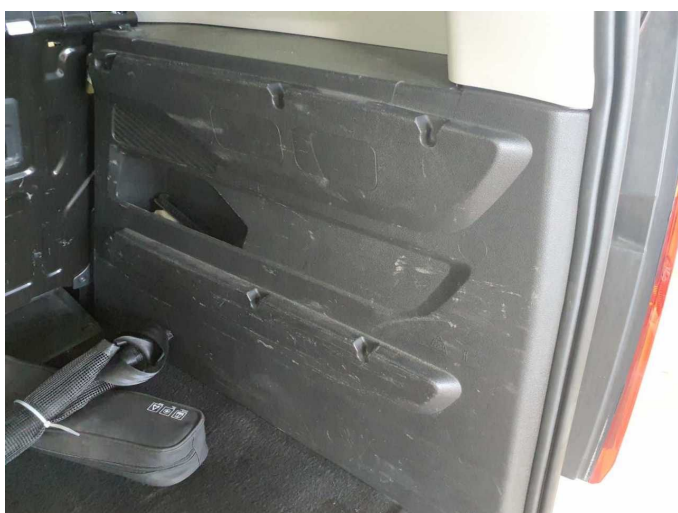
| No. | Component group | Description |
|---|---|---|
| 3 | Trim / covers | Boot lining - Scratch(es) - Loss in value |

**Damage 3:** Trim / covers: Boot lining - Scratch(es) - Loss in value

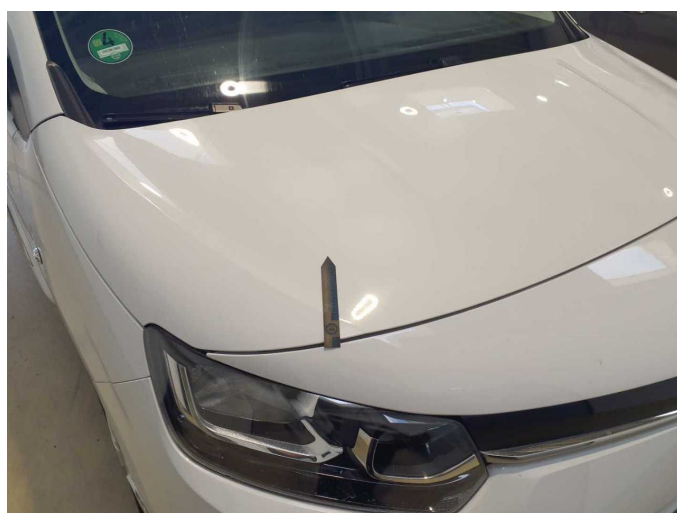
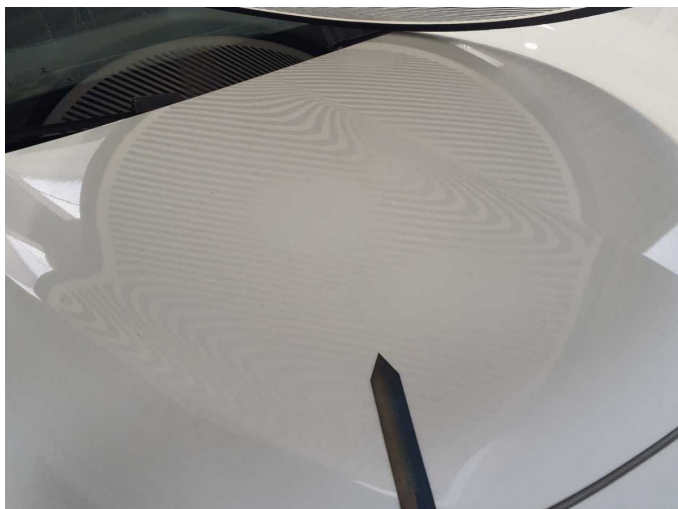
| No. | Component group | Description |
|---|---|---|
| 4 | Bonnet | Bonnet (Matt) - Paint defect - Conditioning |

**Damage 4:** Bonnet: Bonnet (Matt) - Paint defect - Conditioning

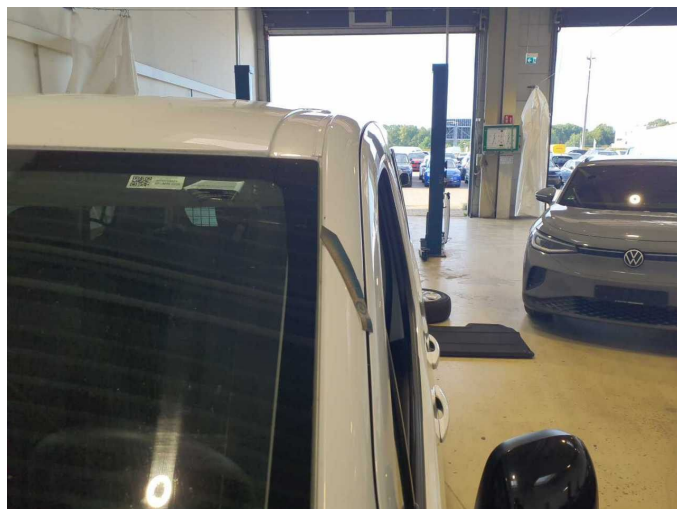
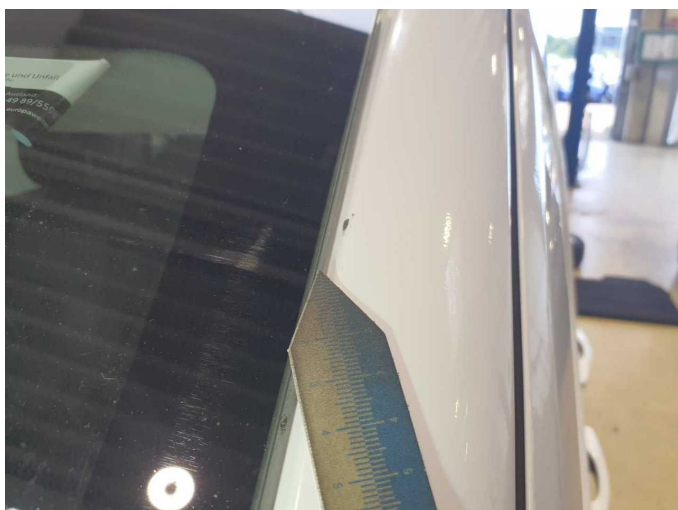
| No. | Component group | Description |
|---|---|---|
| 5 | Body | A-pillar - left side - Scratch(es) - Smart repair |

**Damage 5:** Body: A-pillar - left side - Scratch(es) - Smart repair

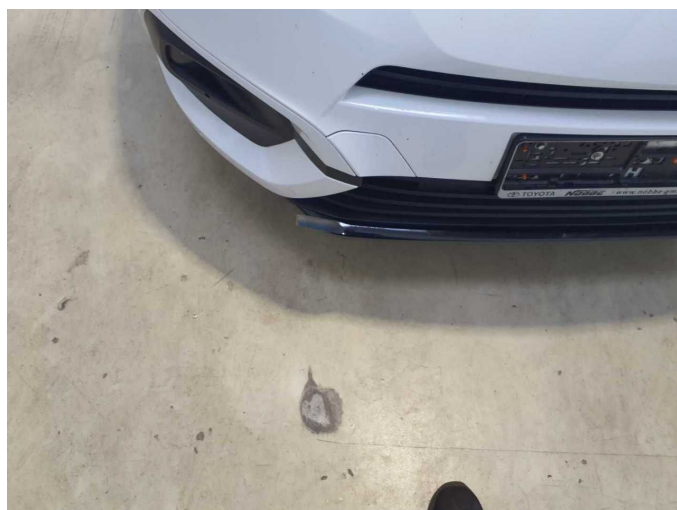
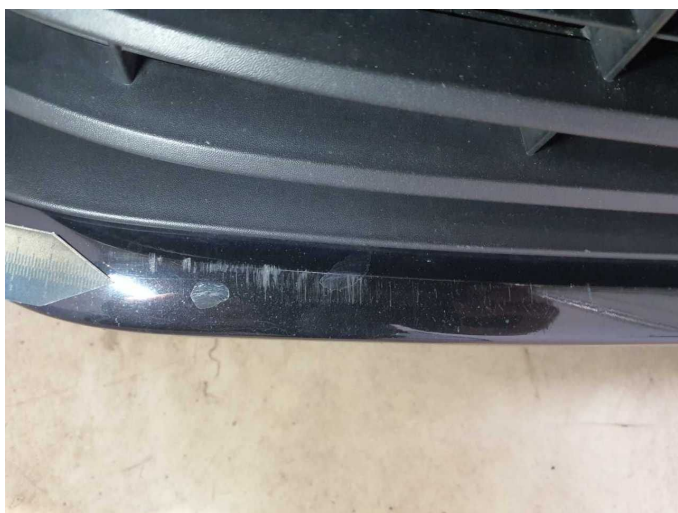
| No. | Component group | Description |
|---|---|---|
| 6 | Front bumper | Spoiler - Scratch(es) - Smart repair |

**Damage 6:** Front bumper: Spoiler - Scratch(es) - Smart repair

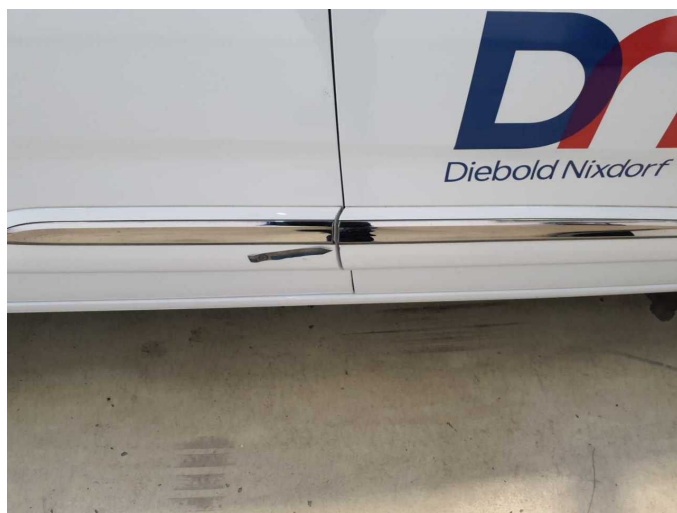
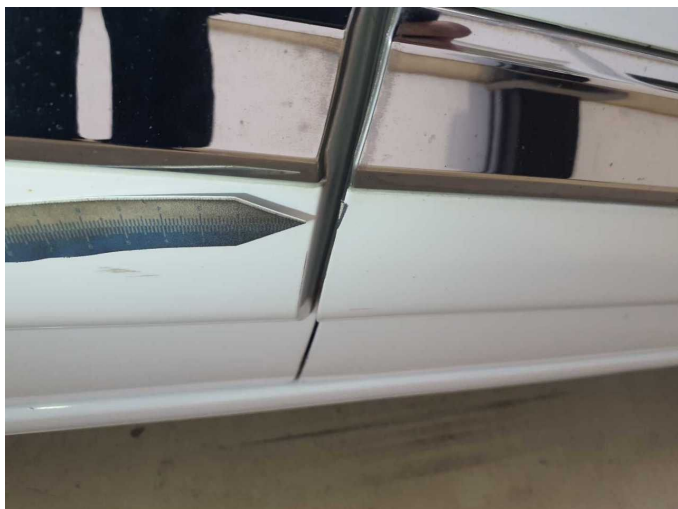
| No. | Component group | Description |
|---|---|---|
| 7 | Door - front right side | Brightware - lower - Scratch(es) - Smart repair |

**Damage 7:** Door - front right side: Brightware - lower - Scratch(es) - Smart repair

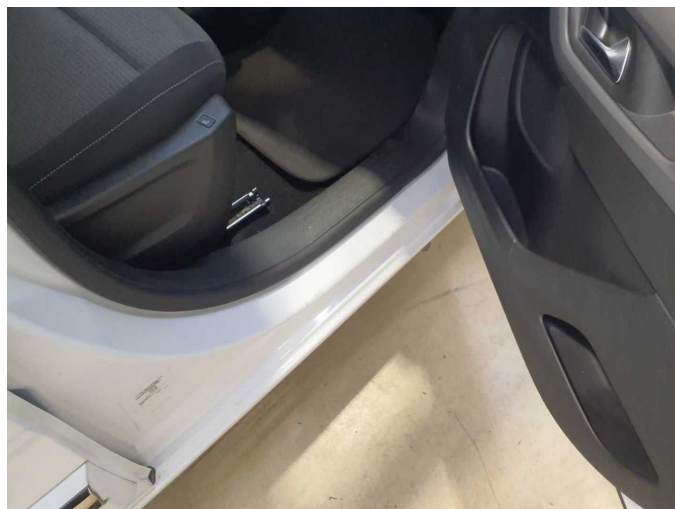
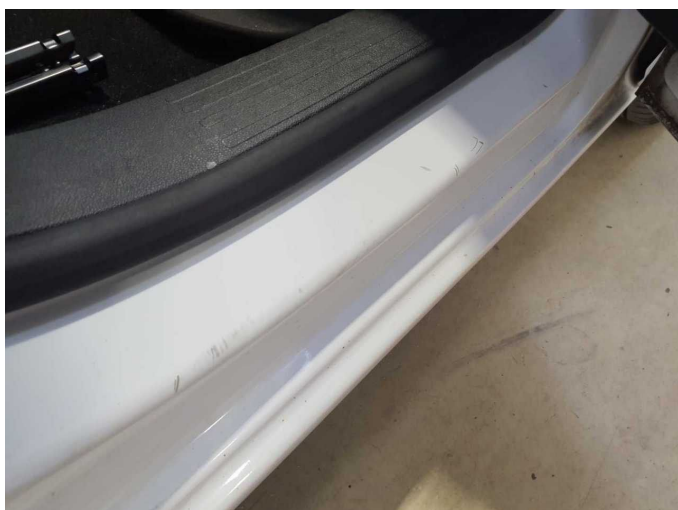
| No. | Component group | Description |
|---|---|---|
| 8 | Sill - right side | Sill - Dent / paintcoat damage - Smart repair |

**Damage 8:** Sill - right side: Sill - Dent / paintcoat damage - Smart repair

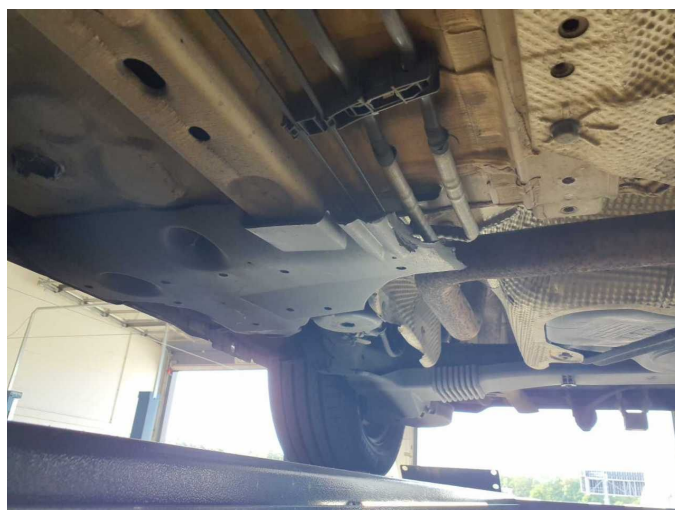
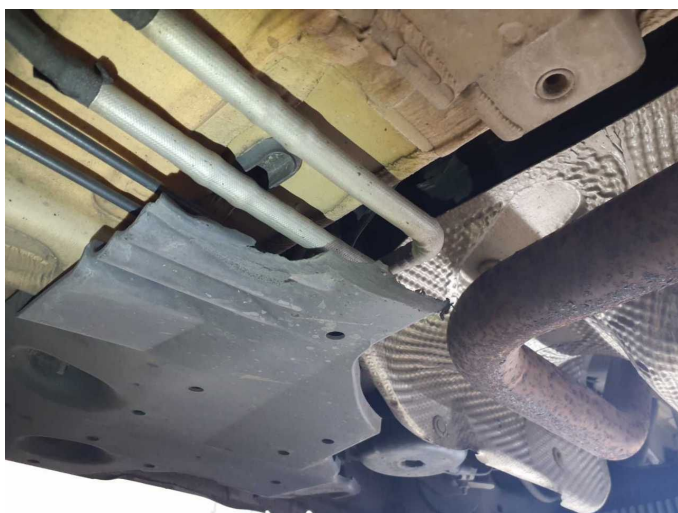
| No. | Component group | Description |
|---|---|---|
| 9 | Body | Underbody panelling - Broken / torn - Replace |

**Damage 9:** Body: Underbody panelling - Broken / torn - Replace

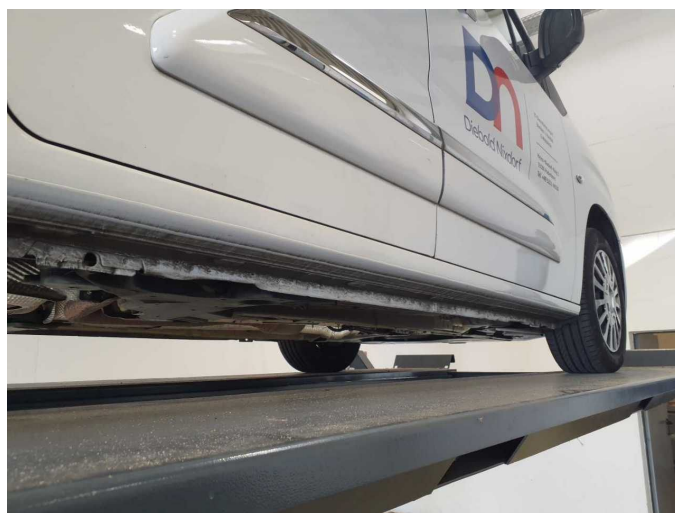
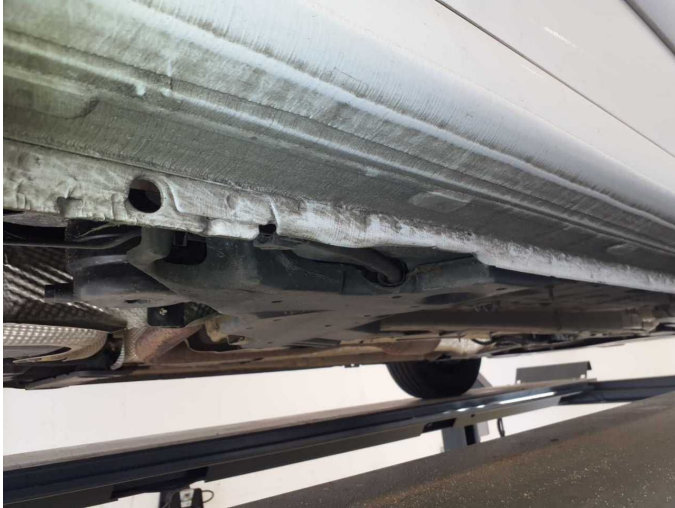
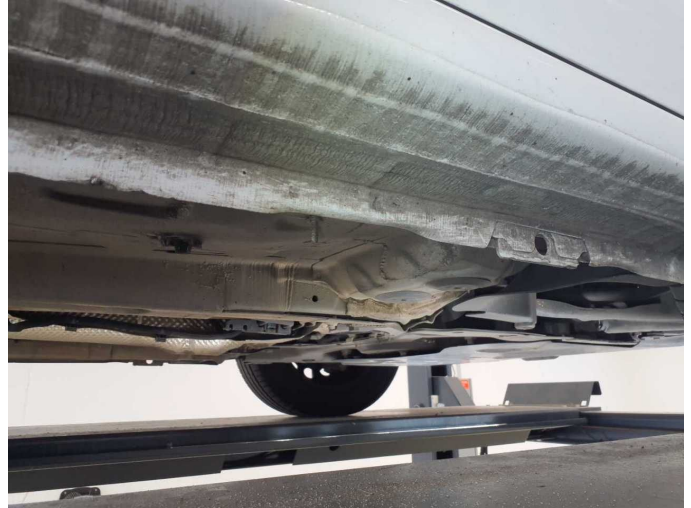
| No. | Component group | Description |
|---|---|---|
| 10 | Sill - right side | Sill - Deformed - Smart repair |

**Damage 10:** Sill - right side: Sill - Deformed - Smart repair

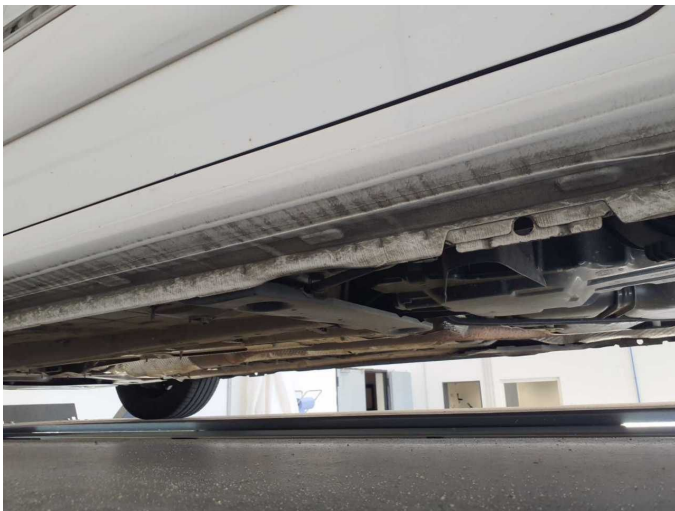
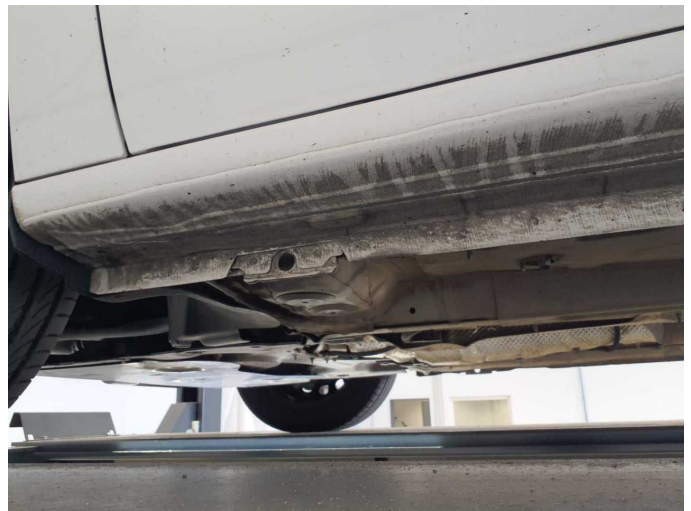
| No. | Component group | Description |
|---|---|---|
| 11 | Sill - left side | Sill - Deformed - Smart repair |

**Damage 11:** Sill - left side: Sill - Deformed - Smart repair

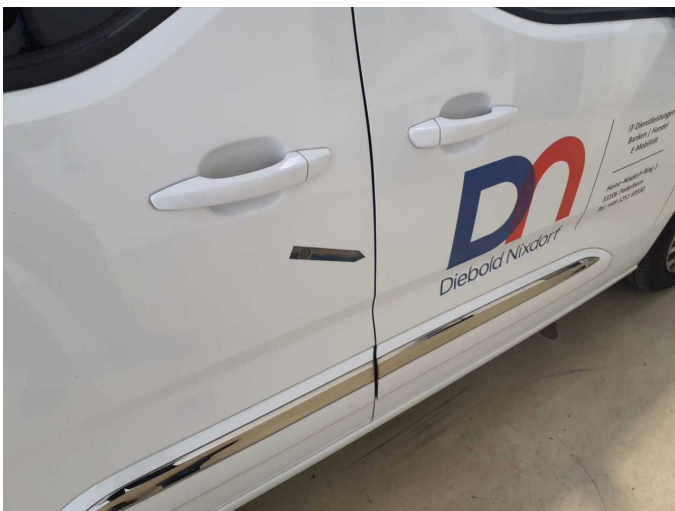
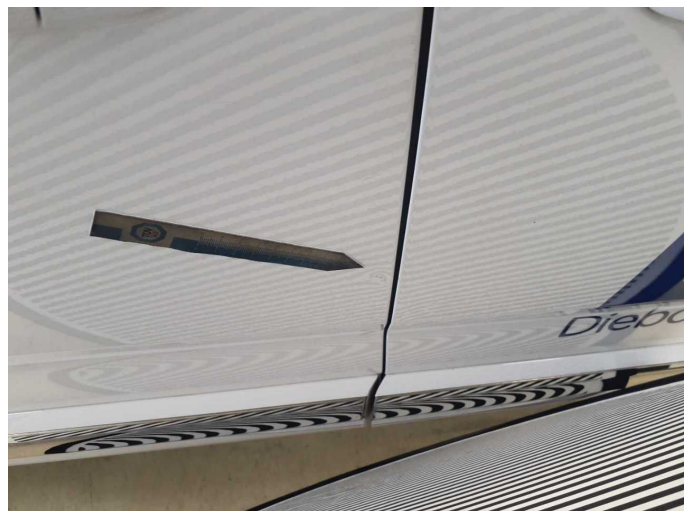
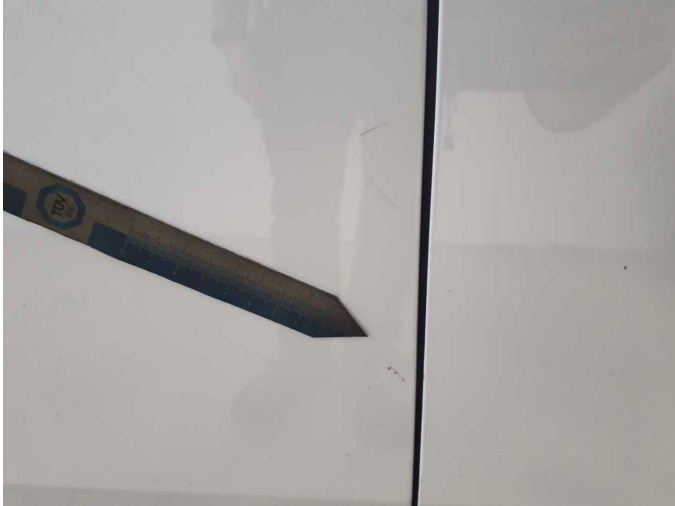
| No. | Component group | Description |
|---|---|---|
| 12 | Sliding door, right | Sliding door - Dent / paintcoat damage - Smart repair |

**Damage 12:** Sliding door, right: Sliding door - Dent / paintcoat damage - Smart repair

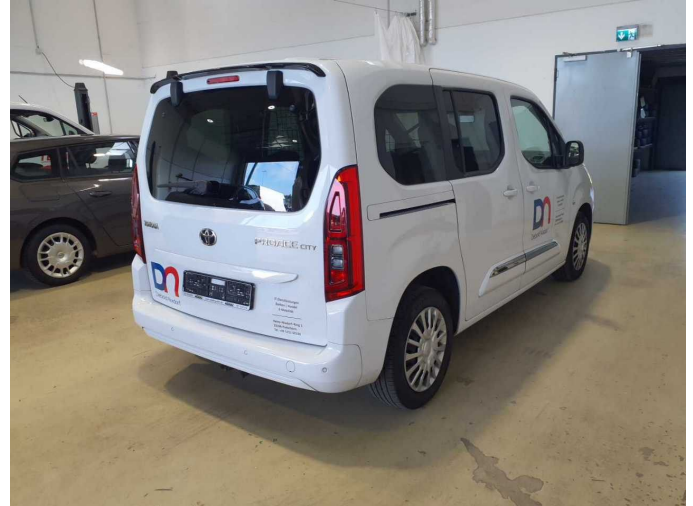
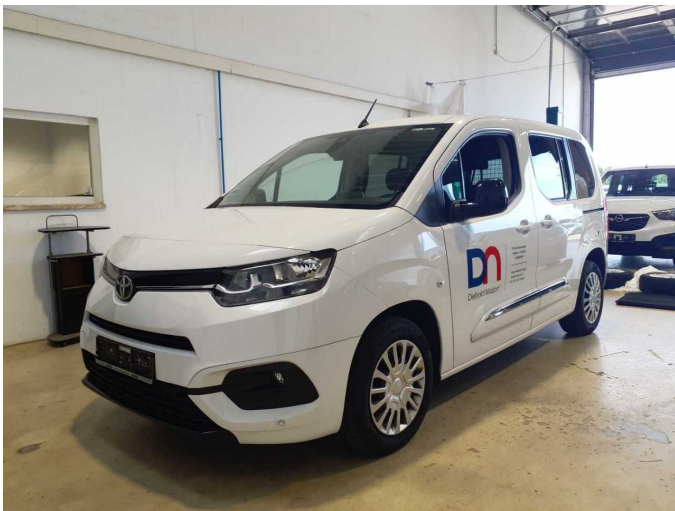
| No. | Component group | Description |
|---|---|---|
| 13 | Body | Body - Glued / labelled - De-glue / neutralise |

**Damage 13:** Body: Body - Glued / labelled - De-glue / neutralise

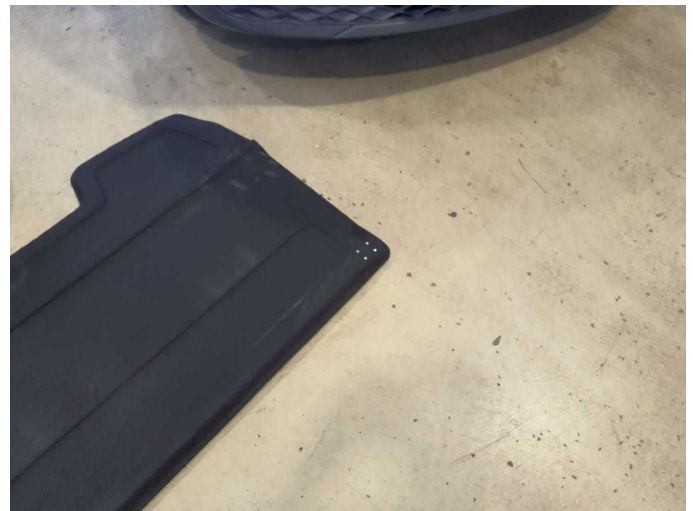
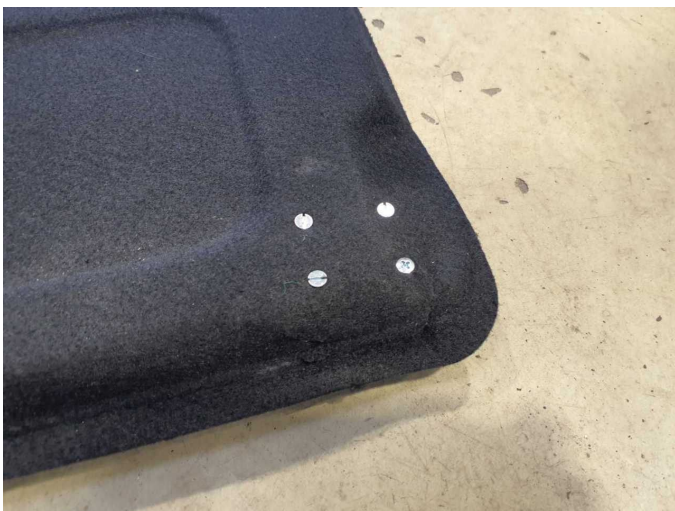
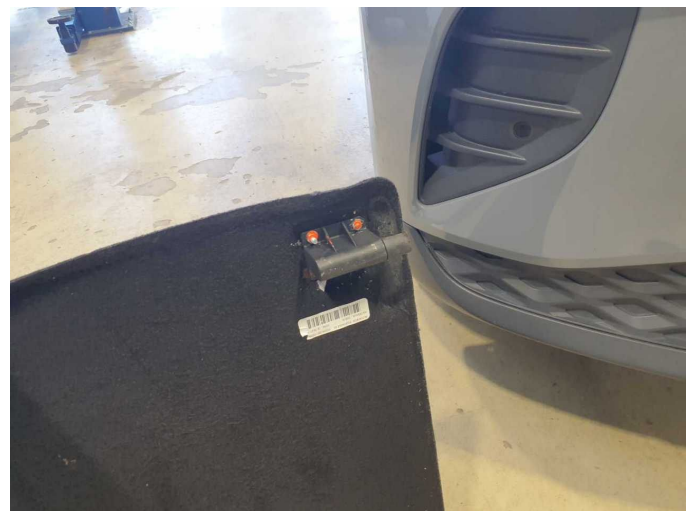
| No. | Component group | Description |
|---|---|---|
| 14 | Interior | Boot cover / roller cover (unfachmännisch repariert) - Differs from the original configuration - Replace |

**Damage 14:** Interior: Boot cover / roller cover (unfachmännisch repariert) - Differs from the original configuration - Replace

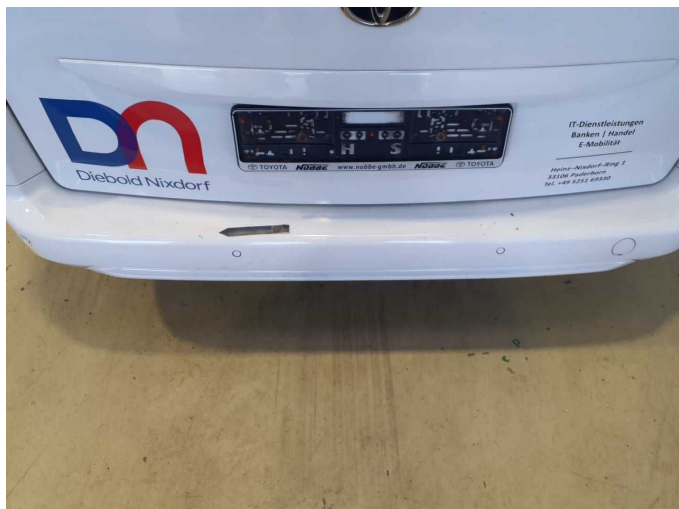
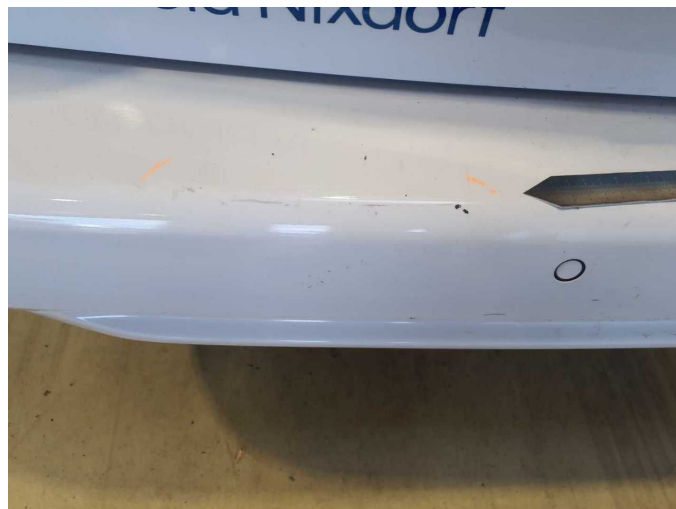
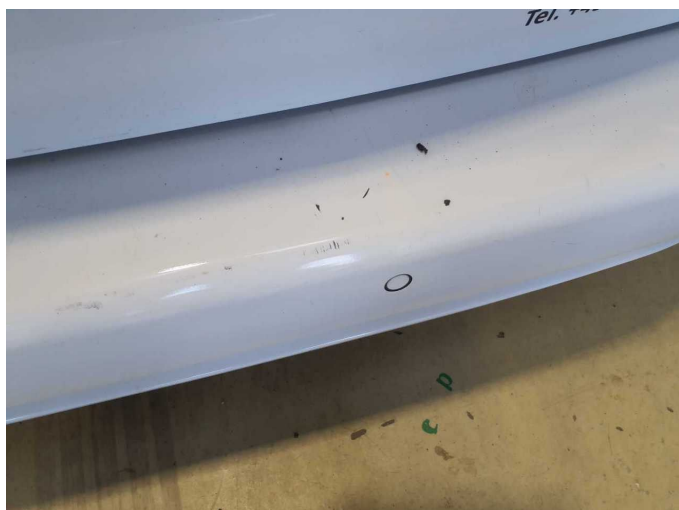
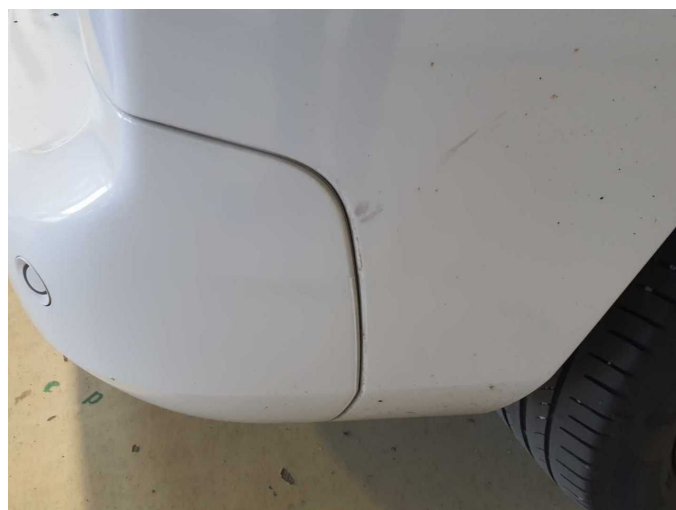
| No. | Component group | Description |
|---|---|---|
| 15 | Rear bumper | Rear bumper - Scratch(es) - Paint |

**Damage 15:** Rear bumper: Rear bumper - Scratch(es) - Paint

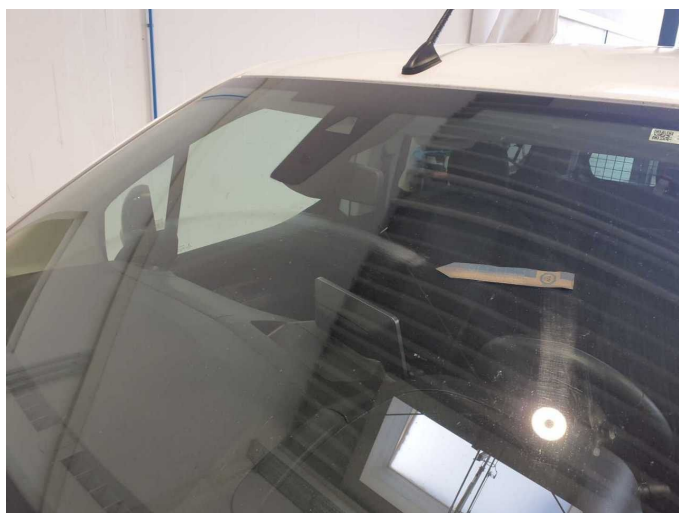
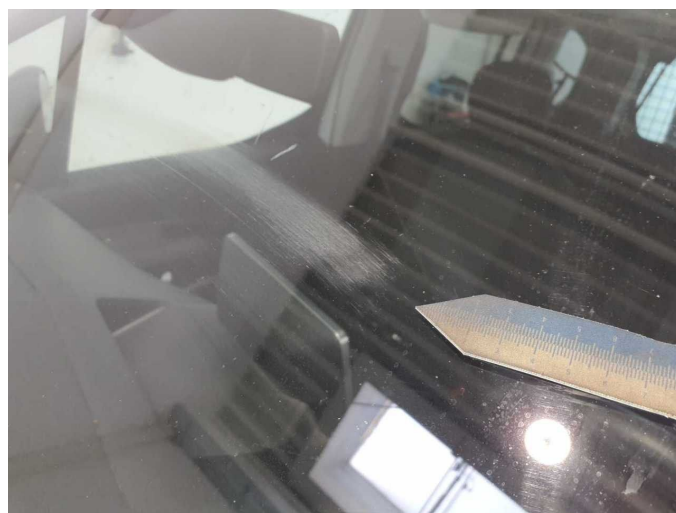
| No. | Component group | Description |
|---|---|---|
| 16 | Vehicle glazing | Windscreen - Scratched - Replace |

**Damage 16:** Vehicle glazing: Windscreen - Scratched - Replace

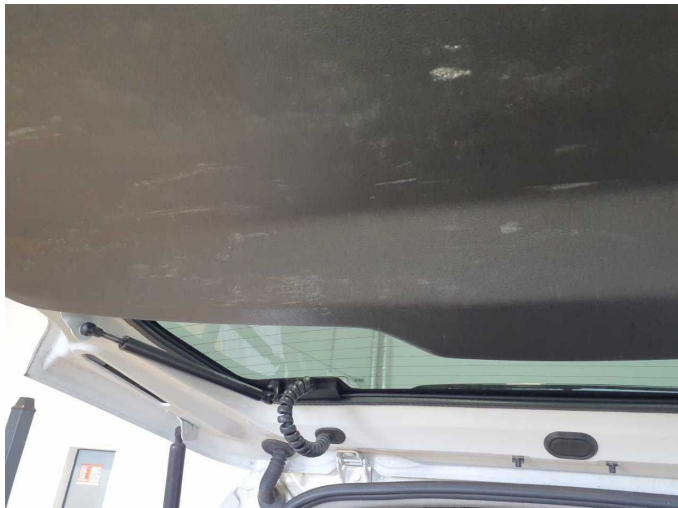
| No. | Component group | Description |
|---|---|---|
| 2 | Trim / covers | Boot lid - interior trim - Scratch(es) - No deduction |

**Wear and tear 2:** Trim / covers: Boot lid - interior trim - Scratch(es) - No deduction

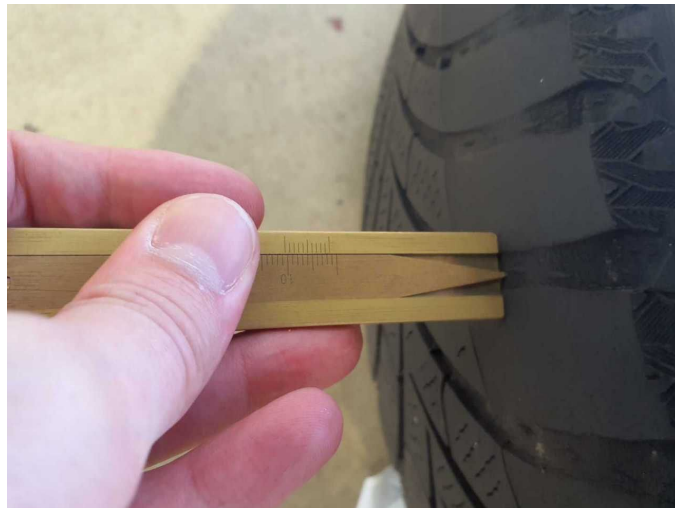
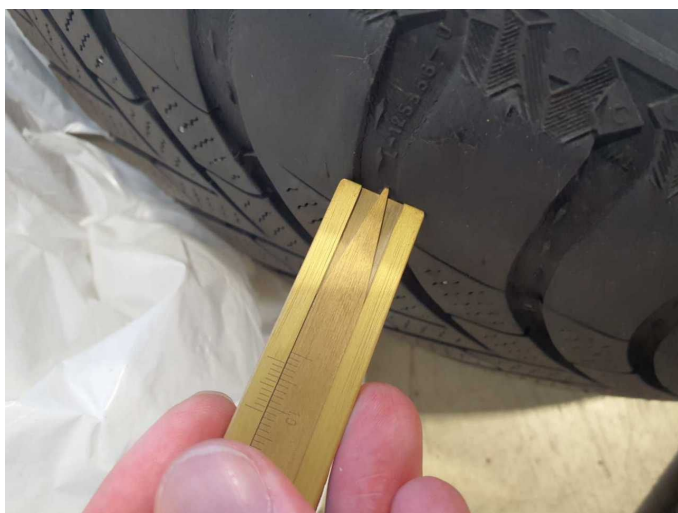
| No. | Component group | Description |
|---|---|---|
| 6 | 2nd wheel set | 2 tyres (gehören nicht zur Ausstattung) - Worn - No deduction |

**Wear and tear 6:** 2nd wheel set: 2 tyres (gehören nicht zur Ausstattung) - Worn - No deduction

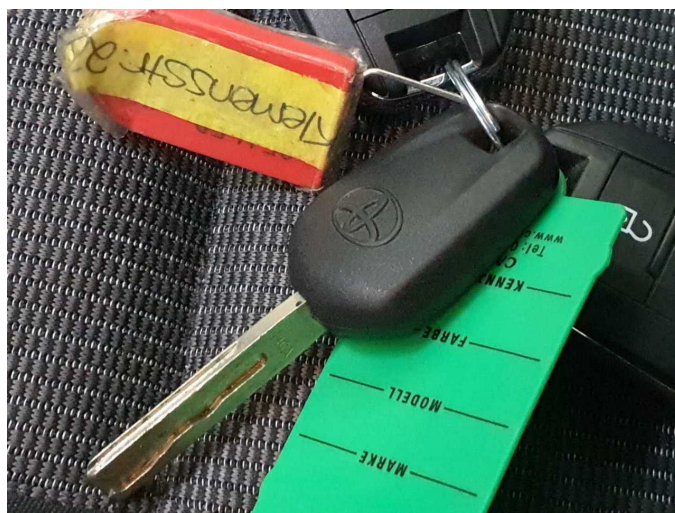
| No. | Component group | Description |
|---|---|---|
| 7 | Equipment | Vehicle key (Startet nicht mit dem Schlüssel, nur f. Kofferraum) - Functional / admissibility - No deduction |

**Wear and tear 7:** Equipment: Vehicle key (Startet nicht mit dem Schlüssel, nur f. Kofferraum) - Functional / admissibility - No deduction

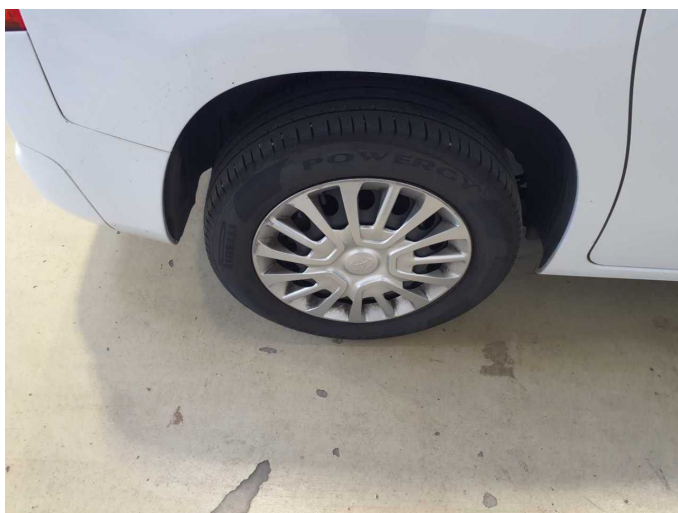
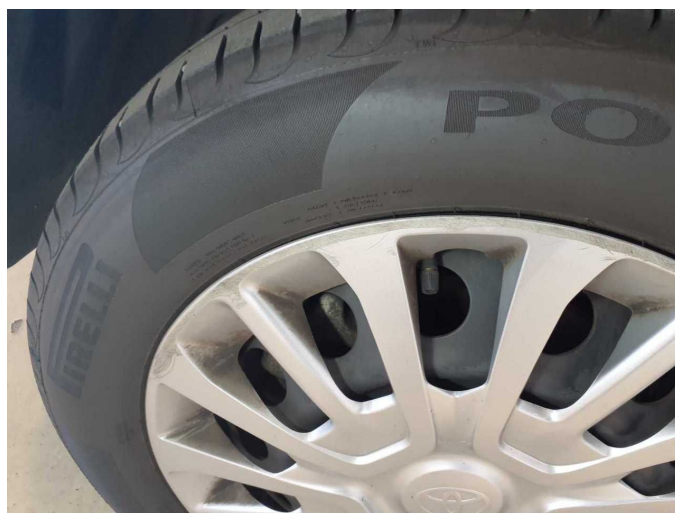
| No. | Component group | Description |
|---|---|---|
| 8 | Wheel / tyres | Wheel cover - rear right side - Scratch(es) - No deduction |

**Wear and tear 8:** Wheel / tyres: Wheel cover - rear right side - Scratch(es) - No deduction

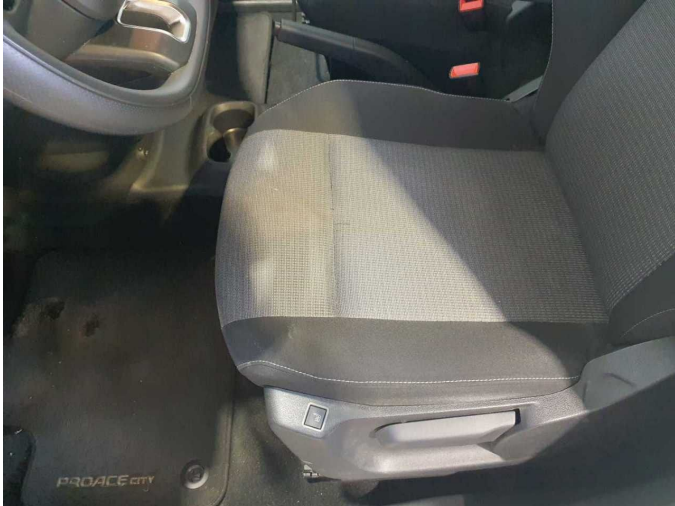
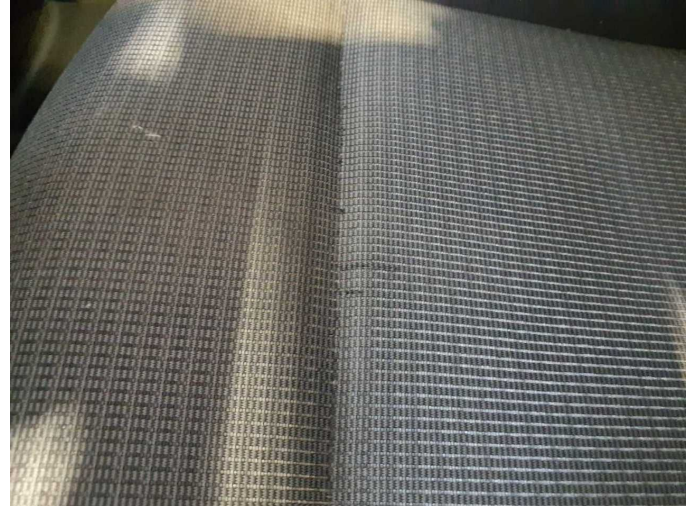
| No. | Component group | Description |
|---|---|---|
| 9 | Seat - front | Seat cover - left side - Scratch(es) - No deduction |

**Wear and tear 9:** Seat - front: Seat cover - left side - Scratch(es) - No deduction

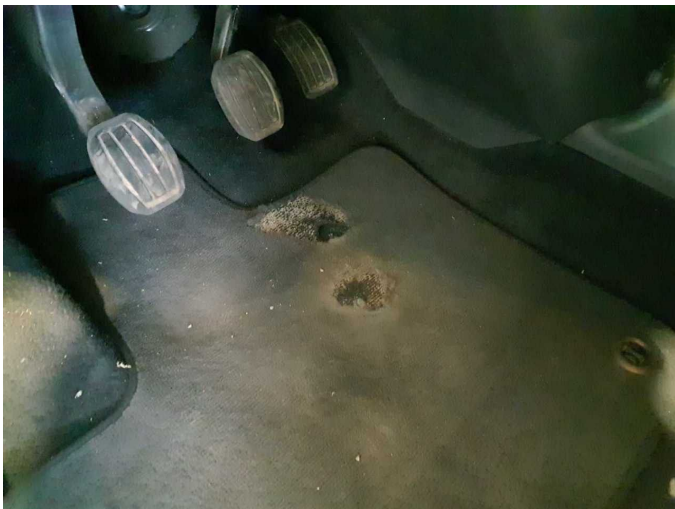
| No. | Component group | Description |
|---|---|---|
| 10 | Trim / covers | Floor mats - Broken / torn - No deduction |

**Wear and tear 10:** Trim / covers: Floor mats - Broken / torn - No deduction
