Expertise

Protocol number: 45786034
Order No. / Reference: 26446372
Inspection date: 2 Jun 2026

Manufacturer: Mercedes-Benz

Model: E 300 e 9G-TRONIC Exclusive

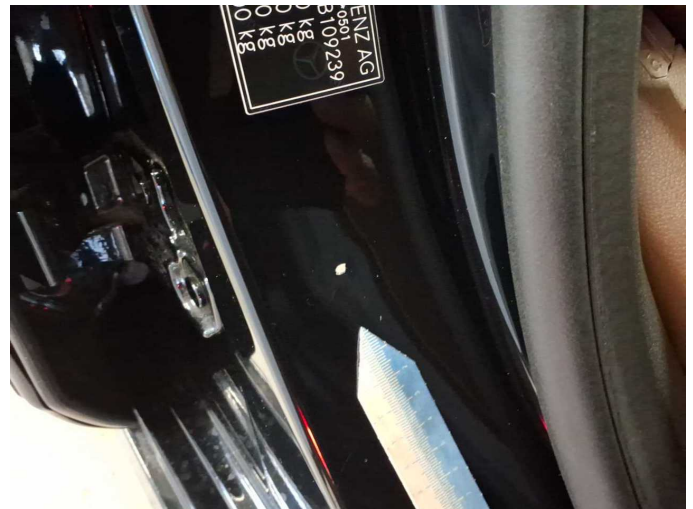
Damage 1: Body: B-pillar - right side - Dent / paintcoat damage - Smart repair

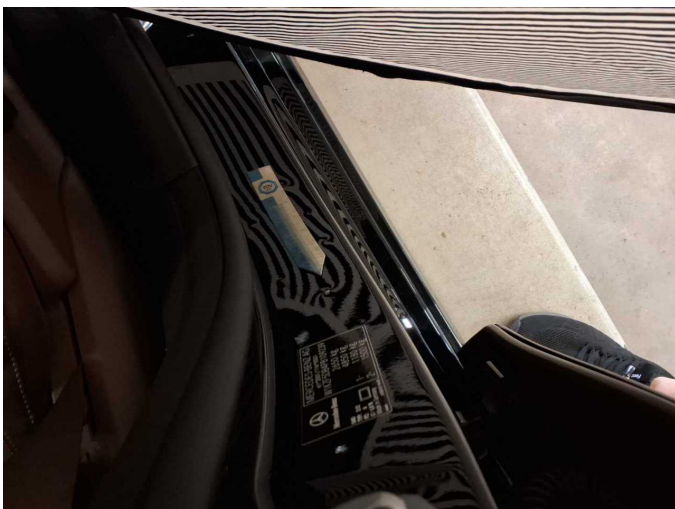
Damage 1: Body: B-pillar - right side - Dent / paintcoat damage - Smart repair

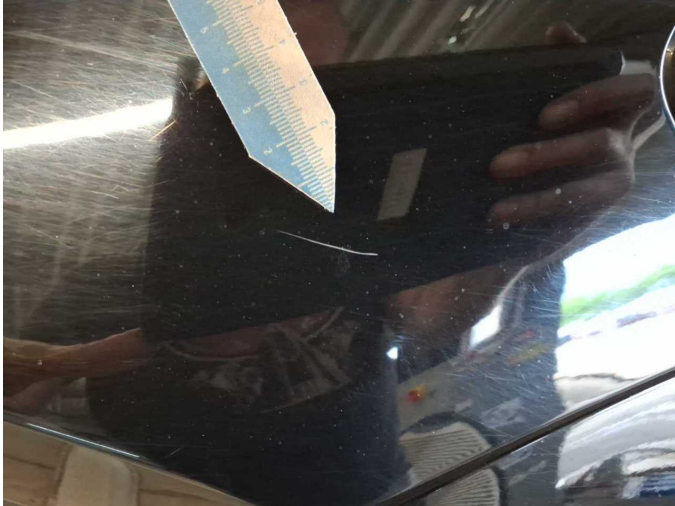
Damage 2: Mudguard - right side: Mudguard - right side - Scratch(es) - Smart repair

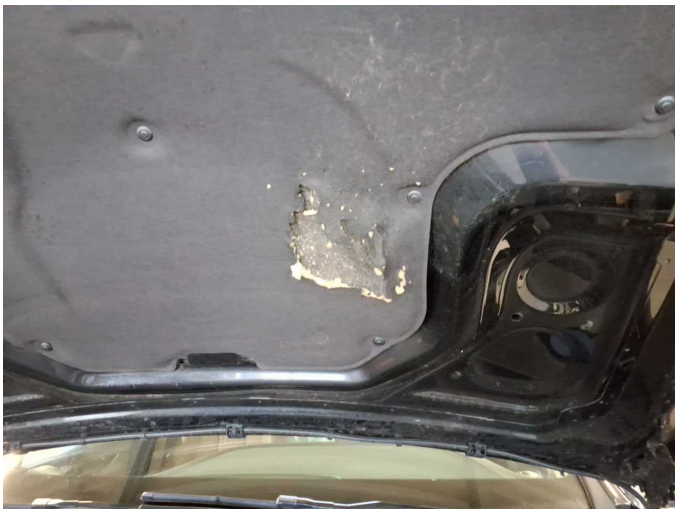
Damage 3: Bonnet: Insulation lining - Damage caused by marten / rodent - Replace

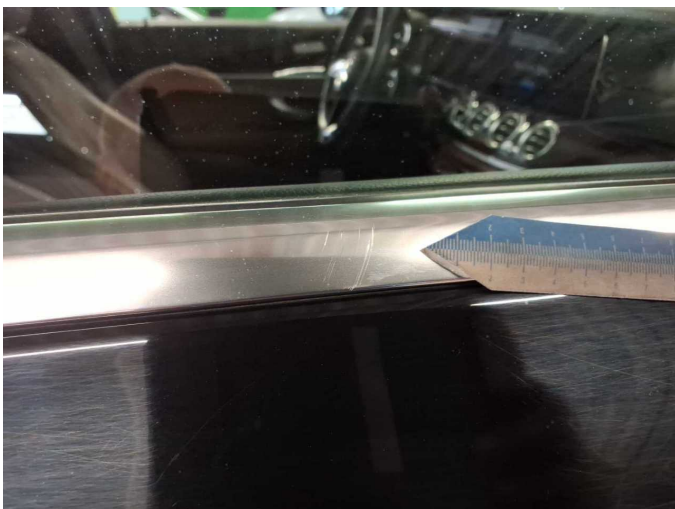
Damage 4: Door - front right side: Strip - outer - Scratch(es) - Replace

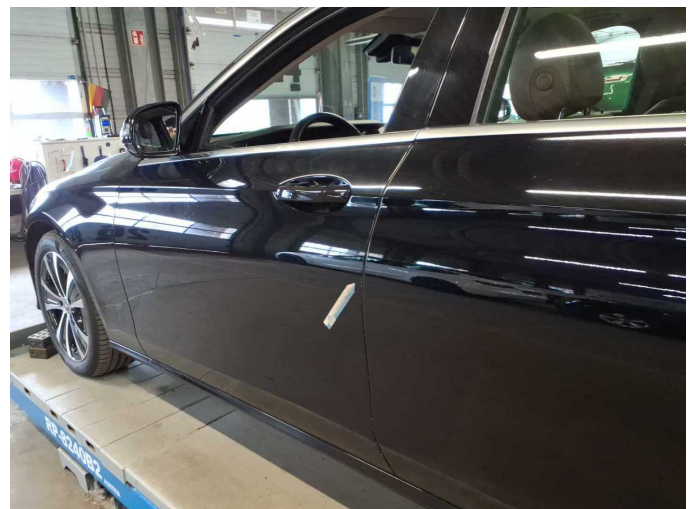
Damage 4: Door - front right side: Strip - outer - Scratch(es) - Replace

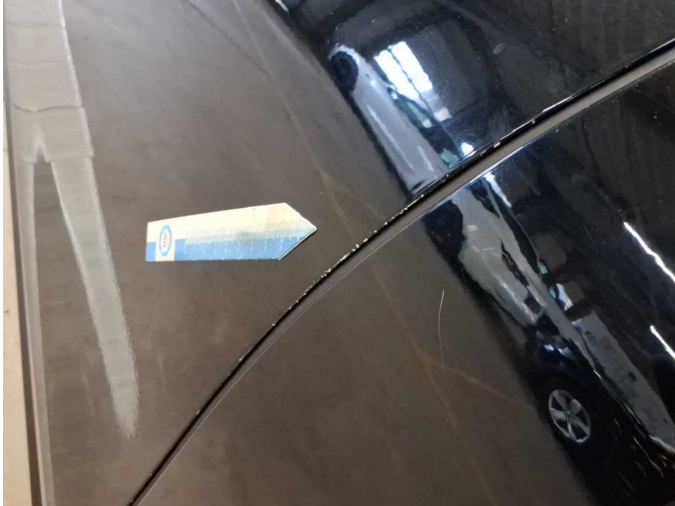
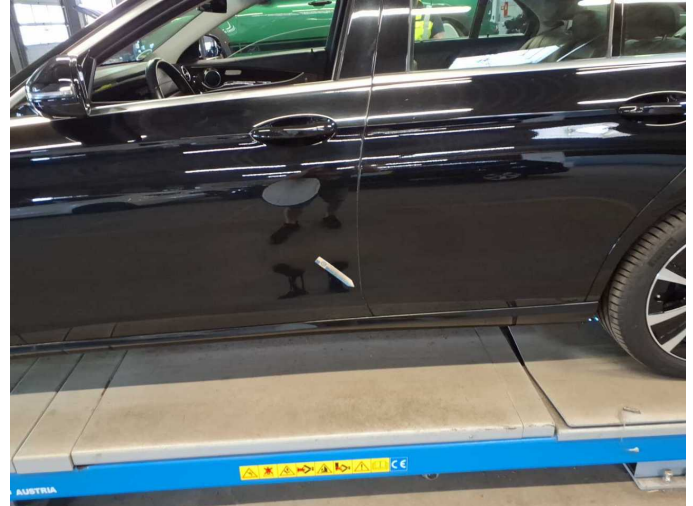
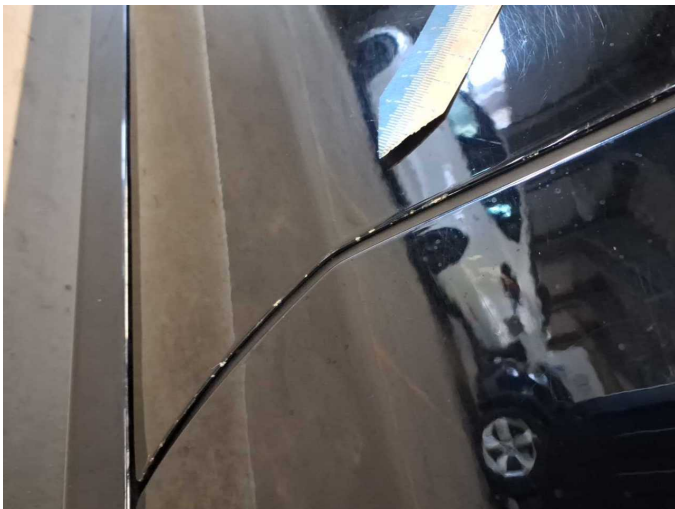
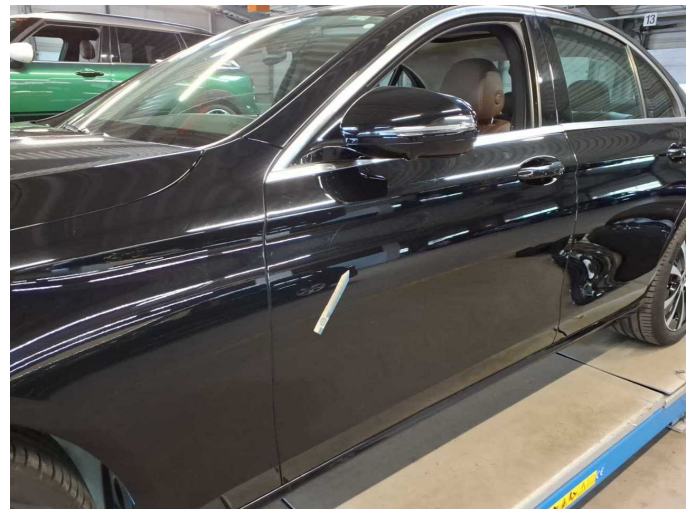
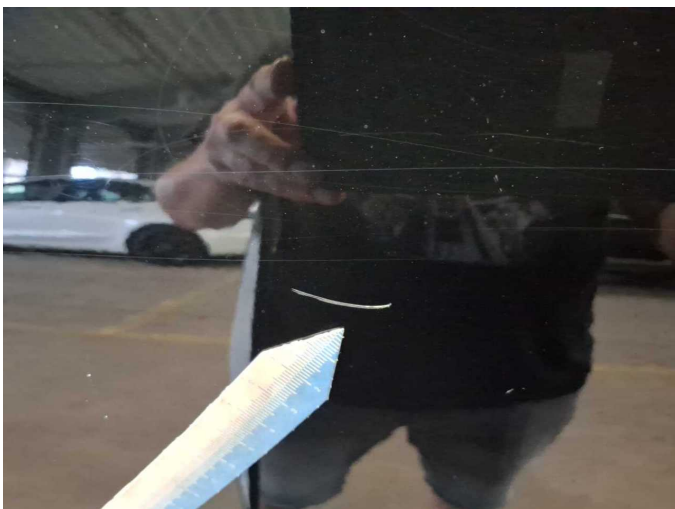
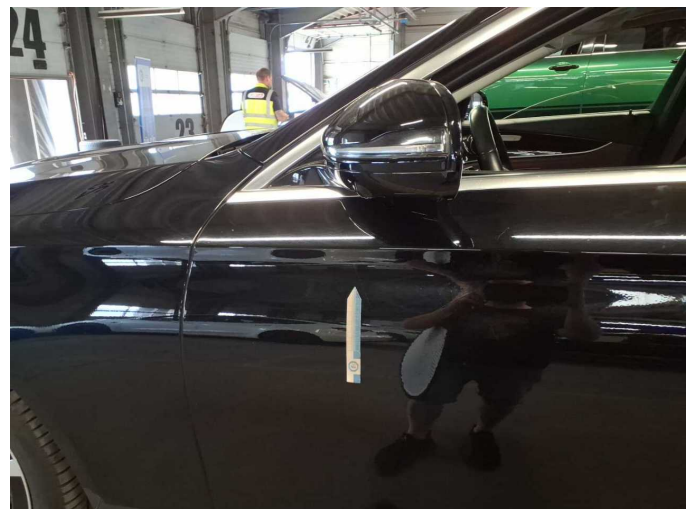
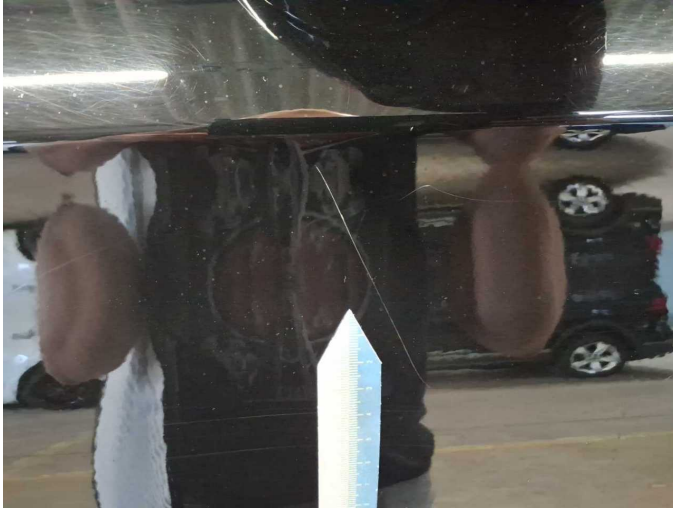
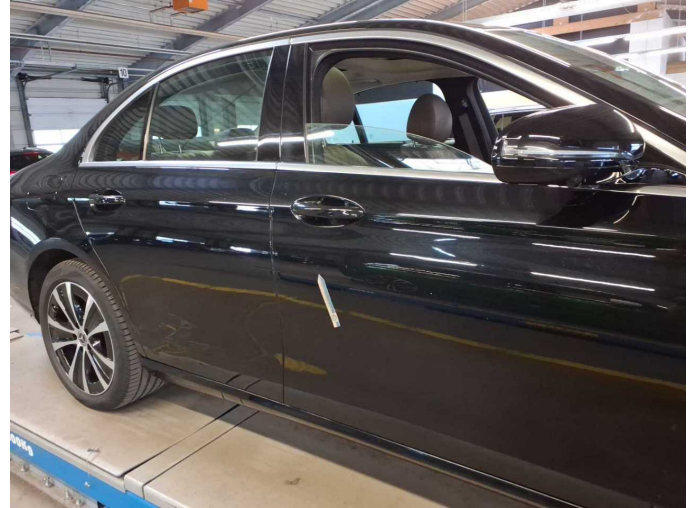
Damage 5: Door - front left side: Door - Scratched - Paint

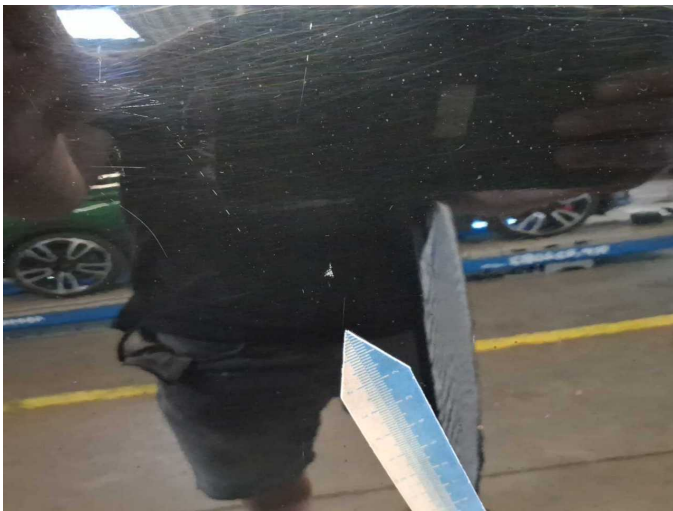
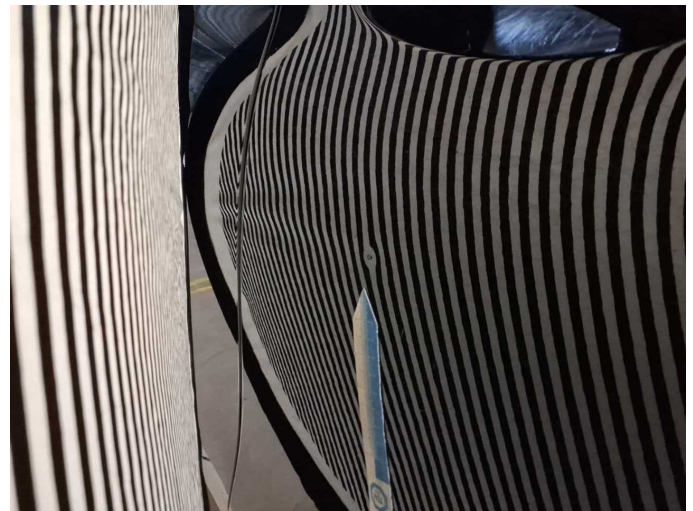
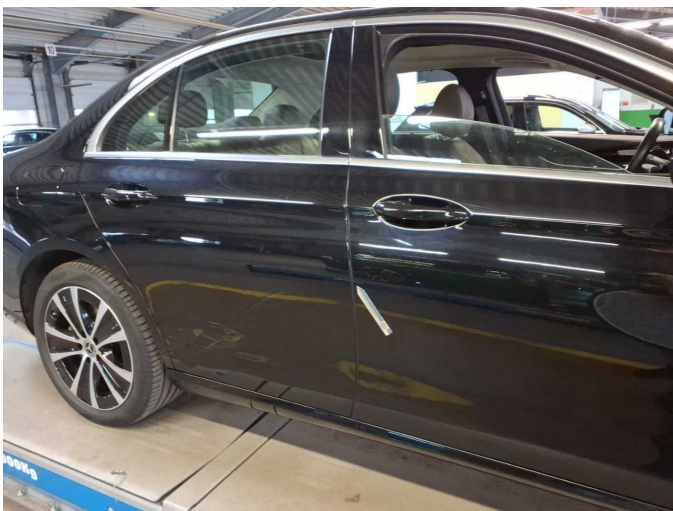
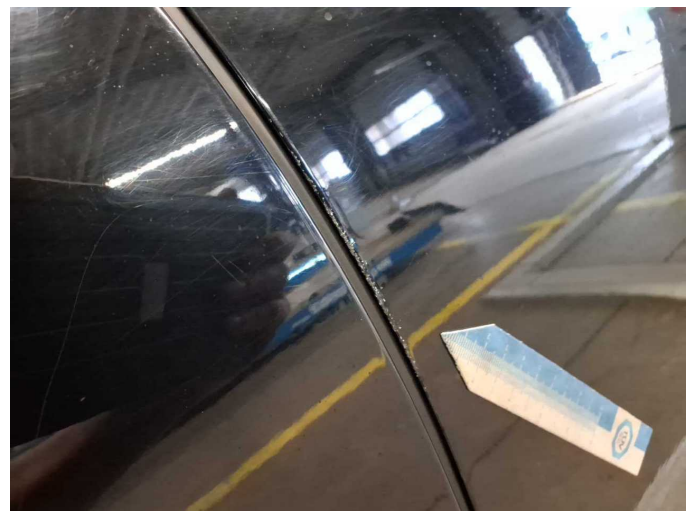
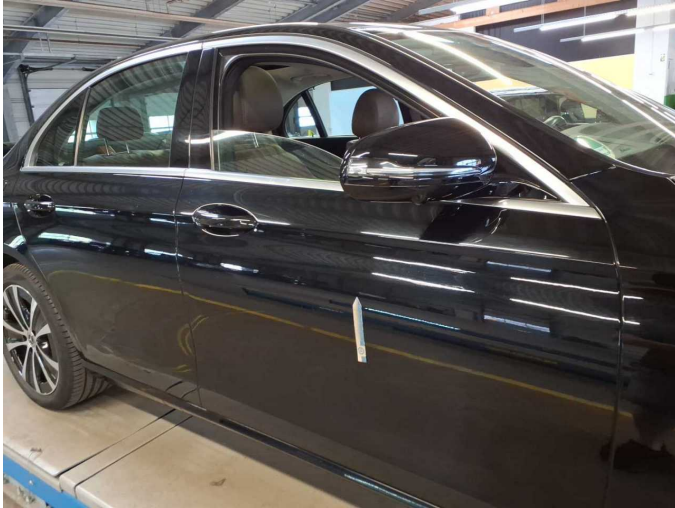
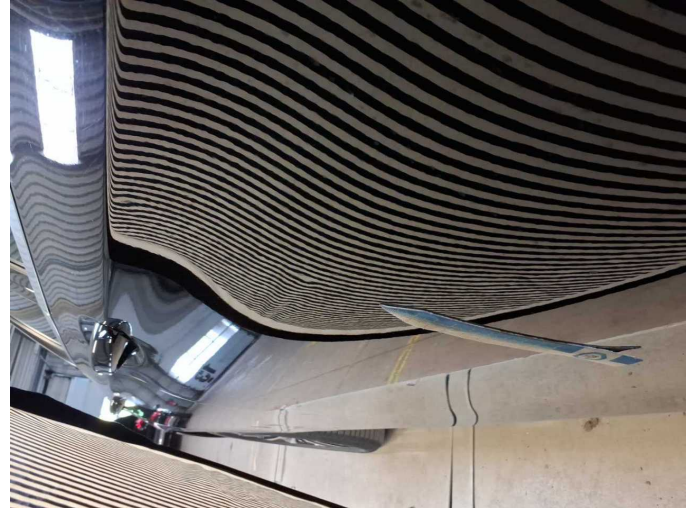
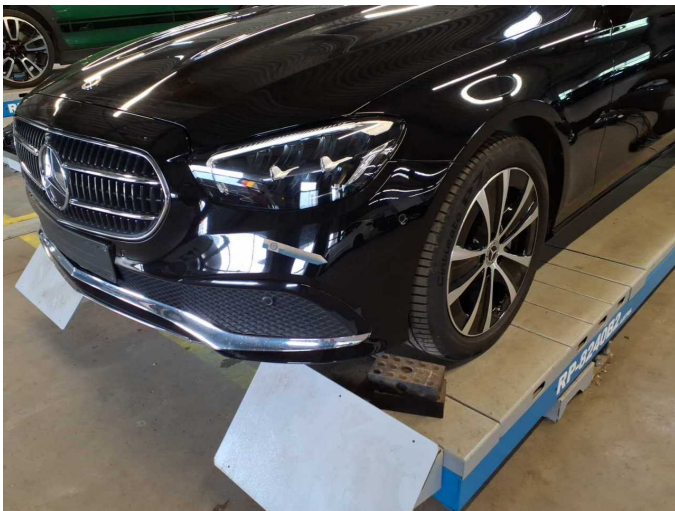
Damage 6: Door - front right side: Door - Dent / paintcoat damage - Repair and paint

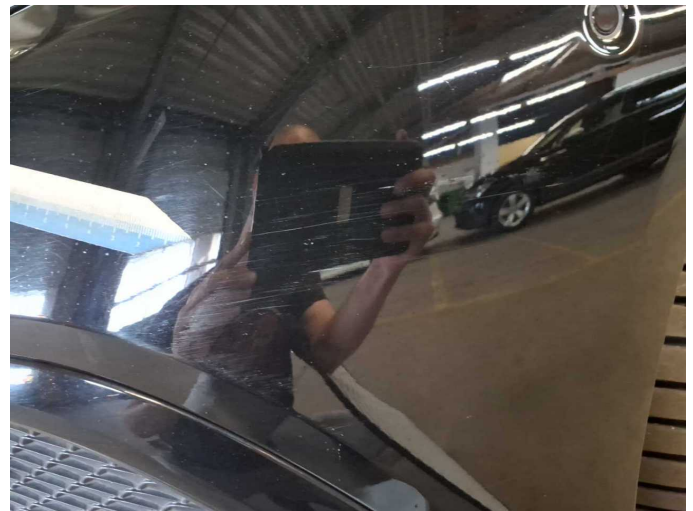
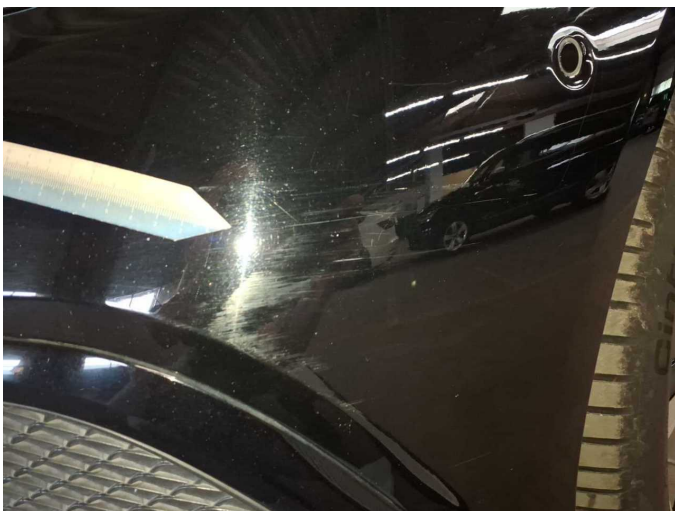
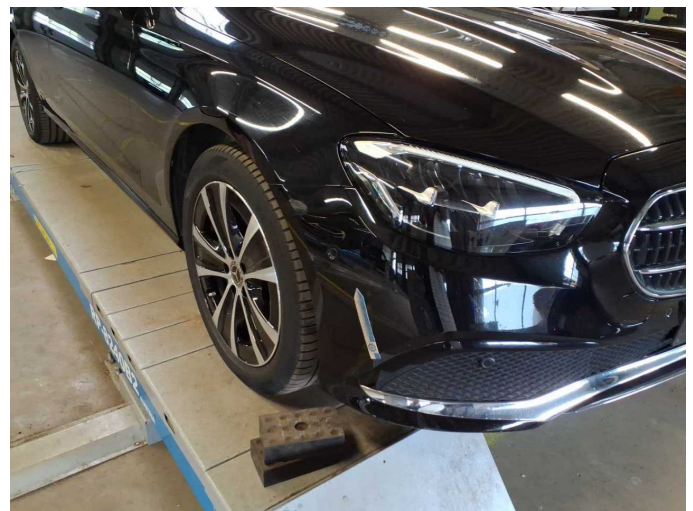
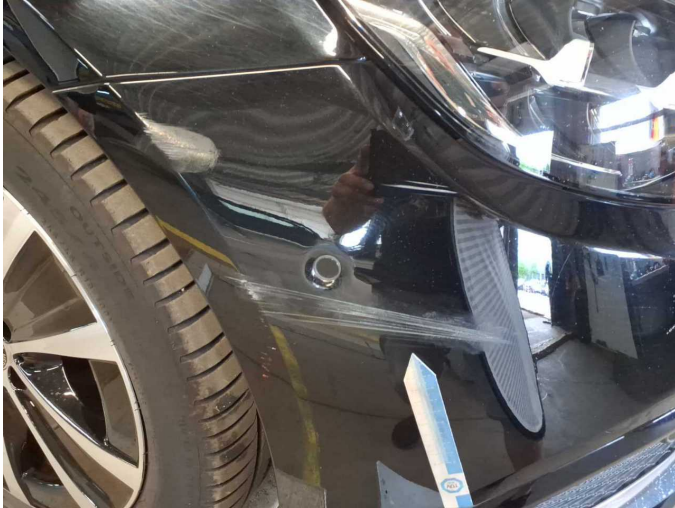
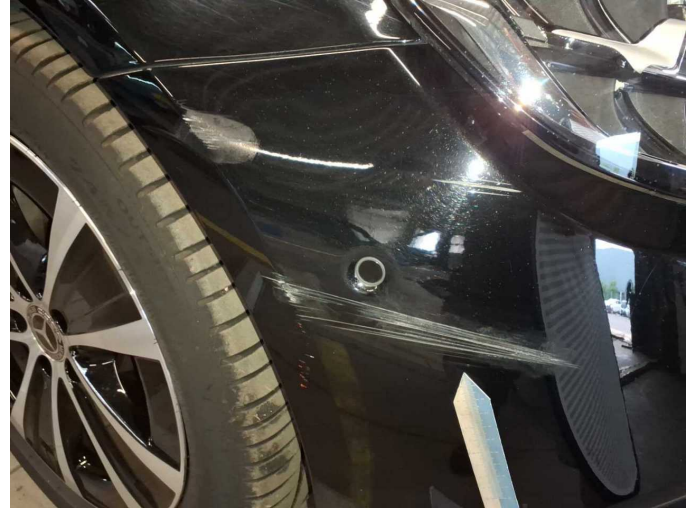
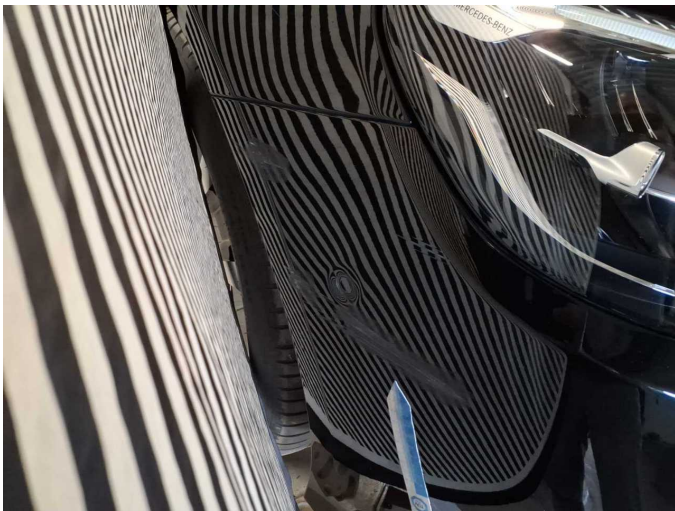
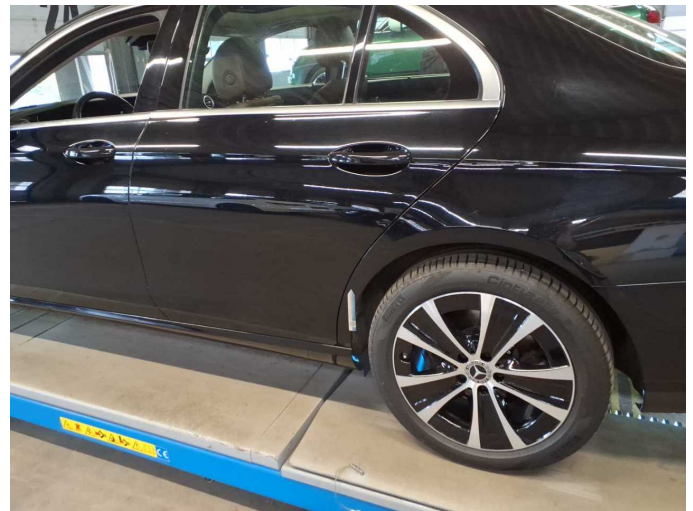
Damage 7: Front bumper: Front bumper - Scratched - Paint

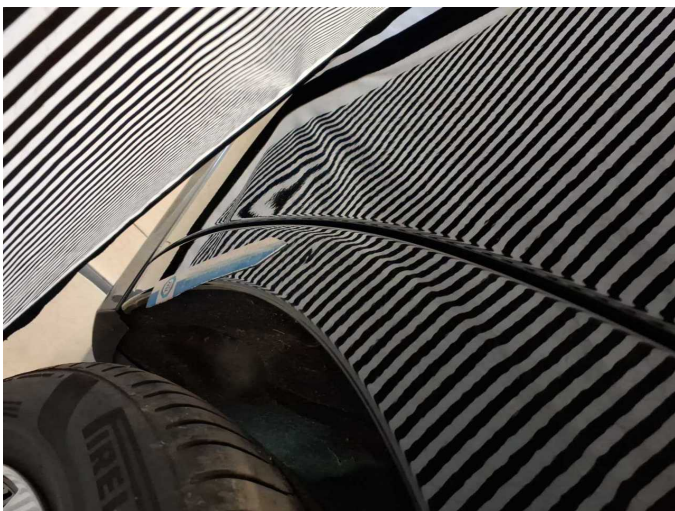
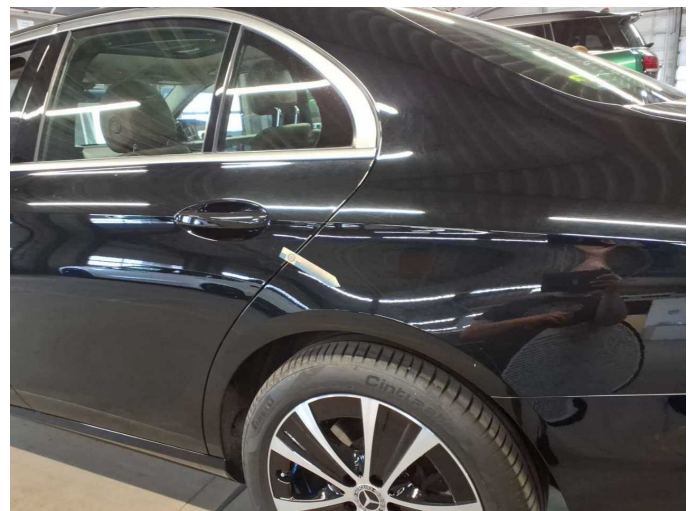
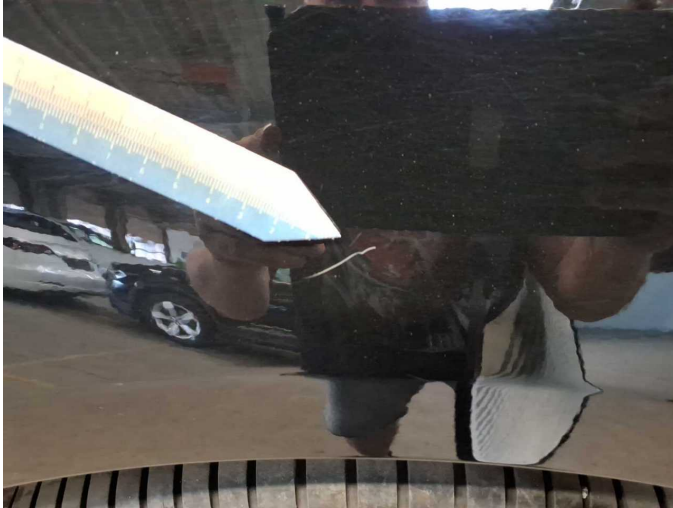
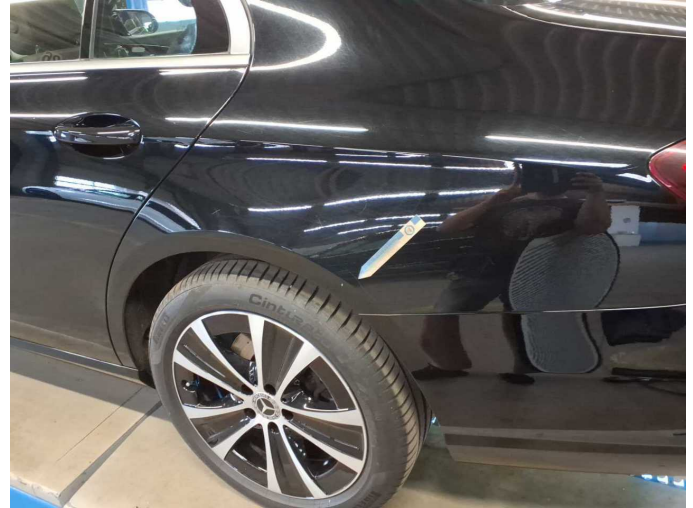
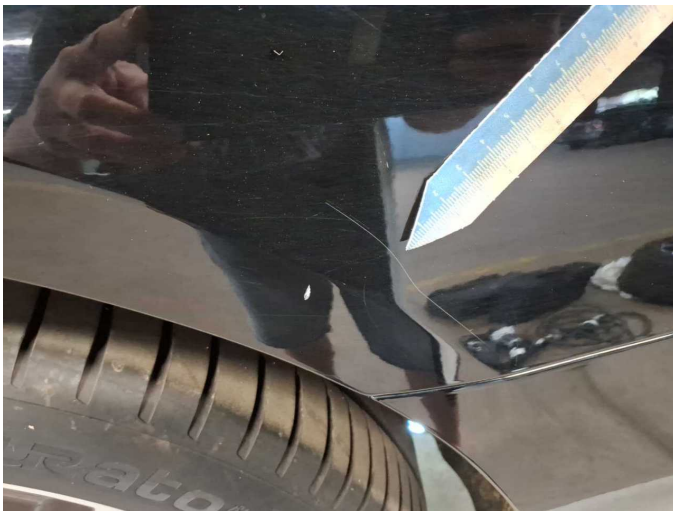
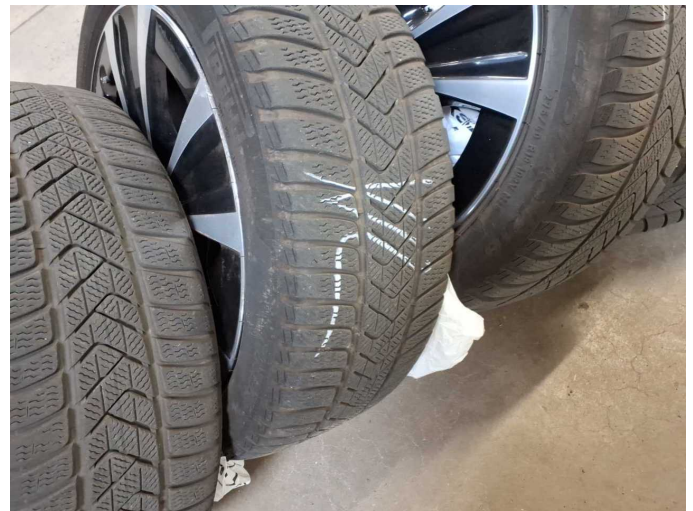
Damage 8: Side panel - rear left side: Side panel - Dent / paintcoat damage - Repair and paint

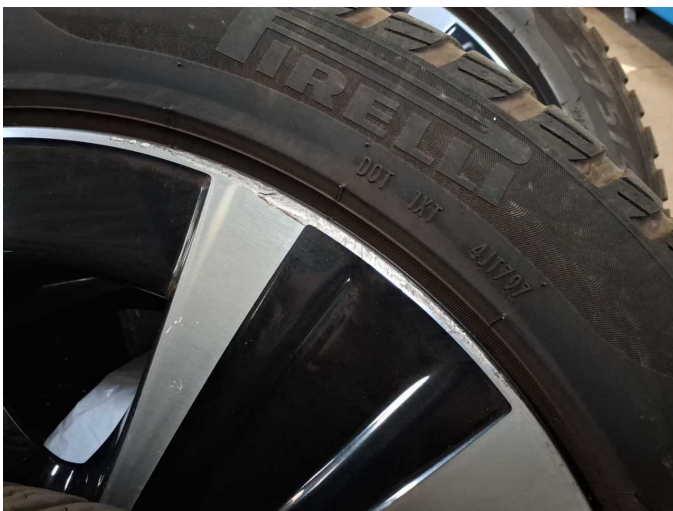
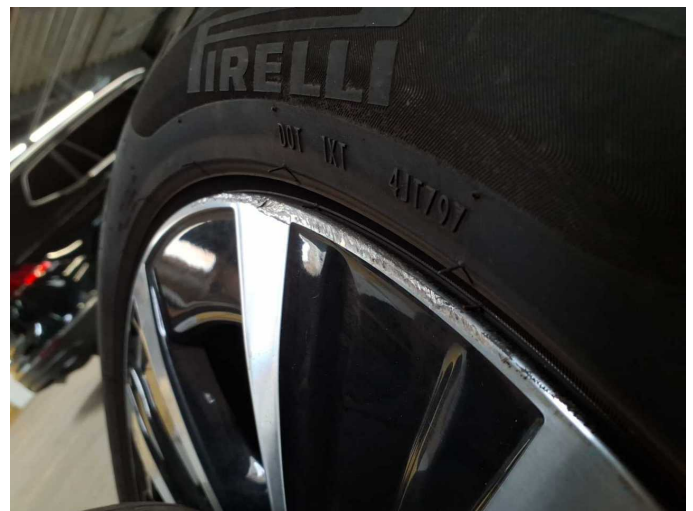
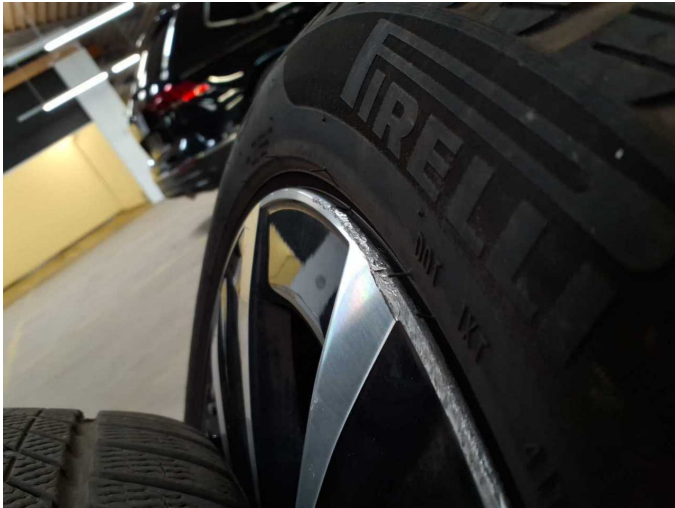
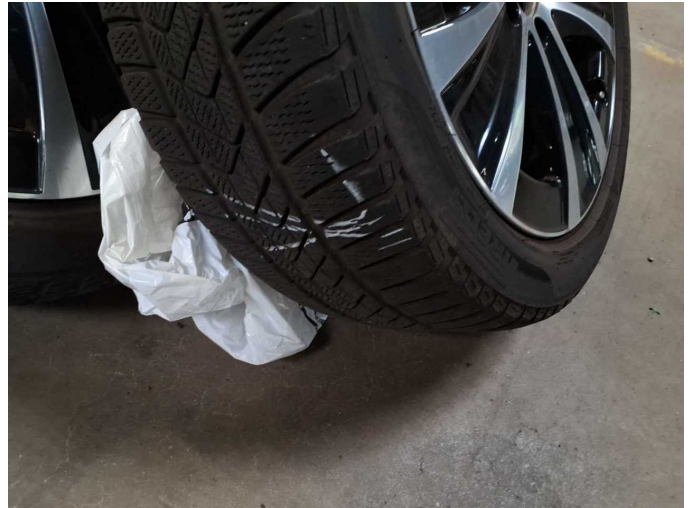
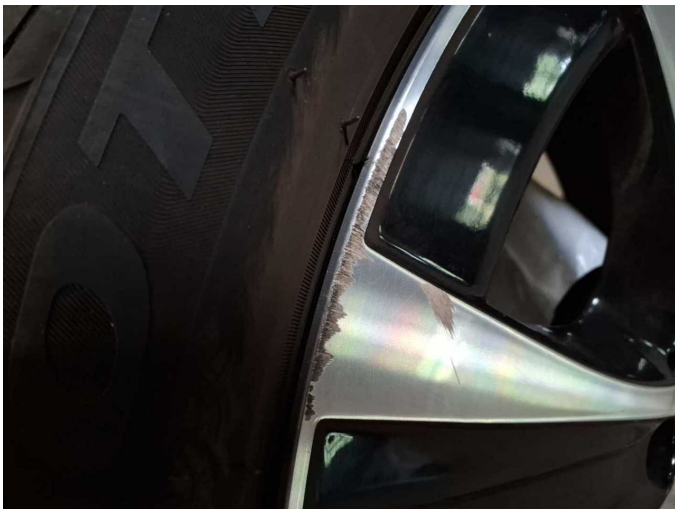
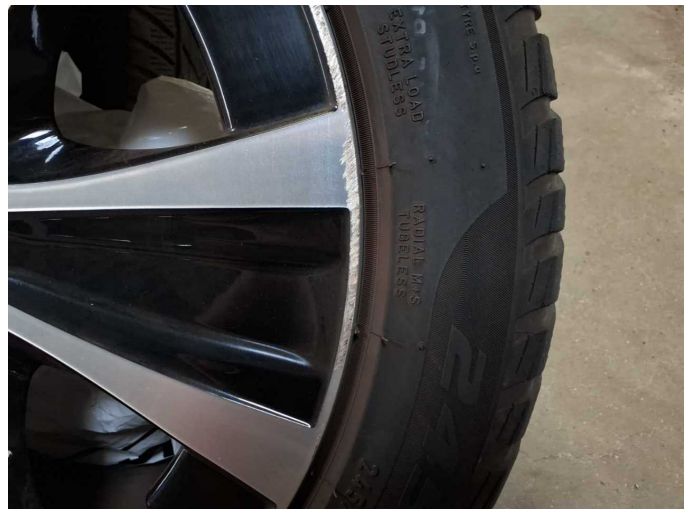
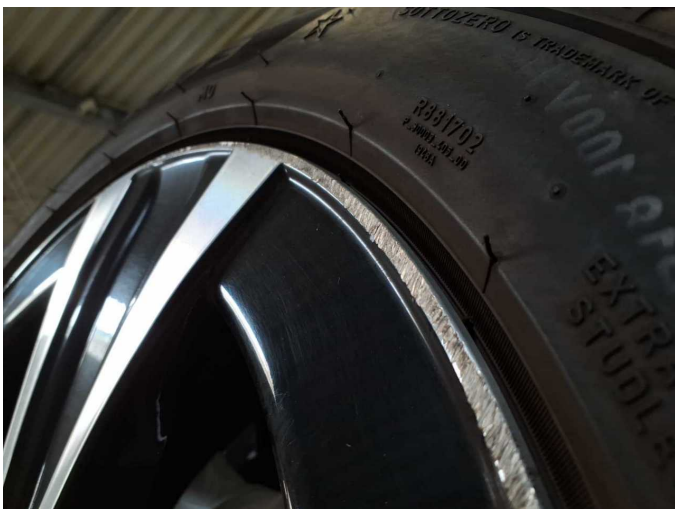
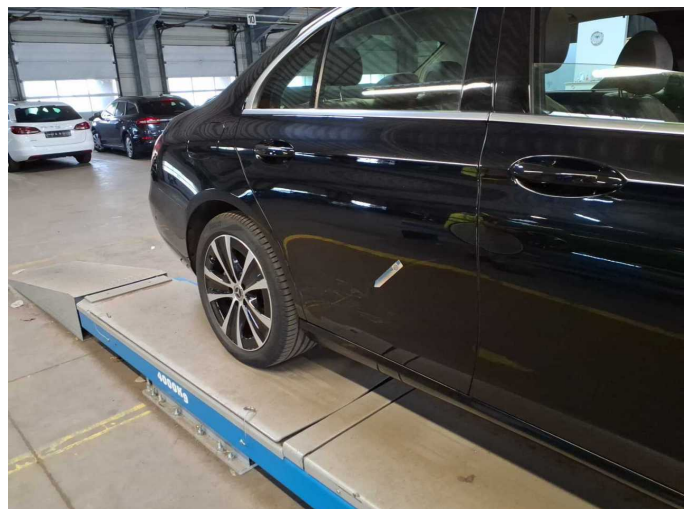
Wear and tear 2: 2nd wheel set: 2 alloy rims (Materialabtrag) - Scratched - No deduction

Wear and tear 2: 2nd wheel set: 2 alloy rims (Materialabtrag) - Scratched
- No deduction

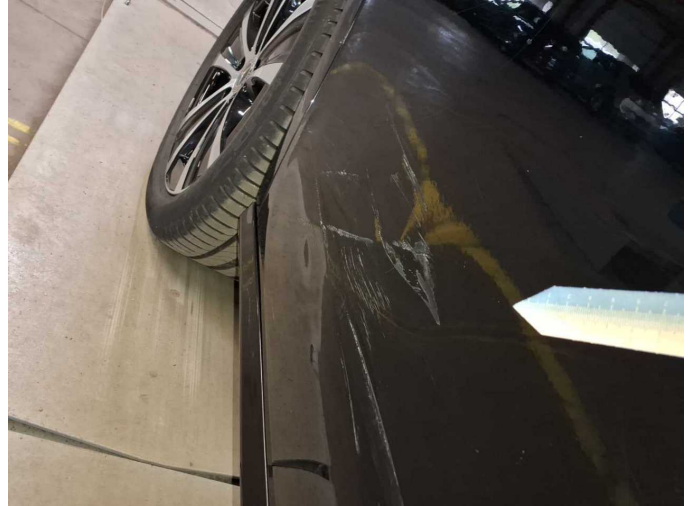
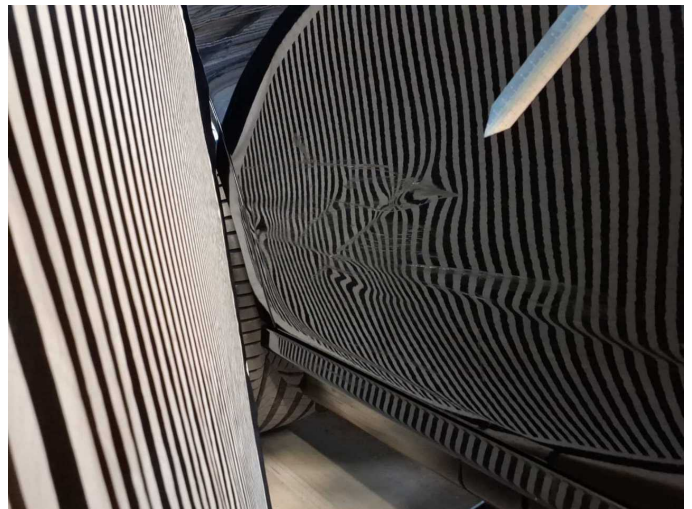
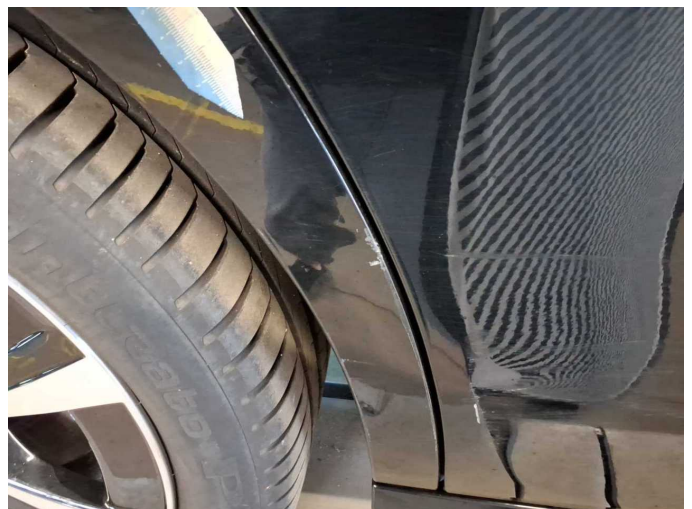
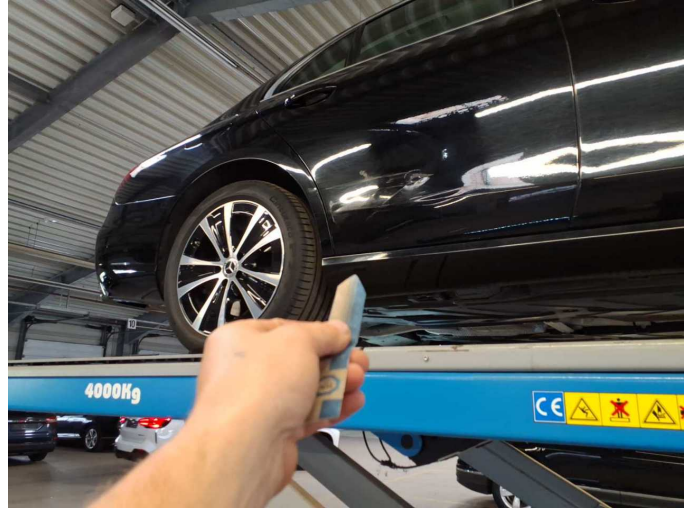
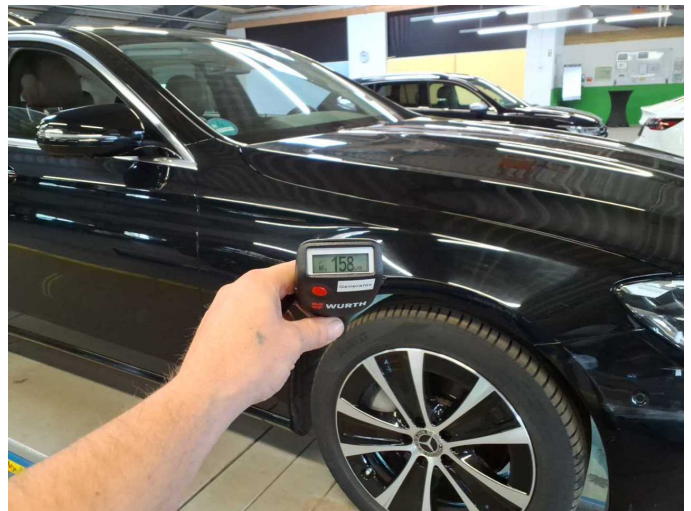
No.	Accident
1	Side right

Accident 1: Side right
