Expertise

Protocol number: 46257805  
Order No. / Reference: 26562594  
Inspection date: 30 Jun 2026

| Manufacturer: Opel | Model: Astra Sports Tourer 1.5 D Automatik Business Elegance |

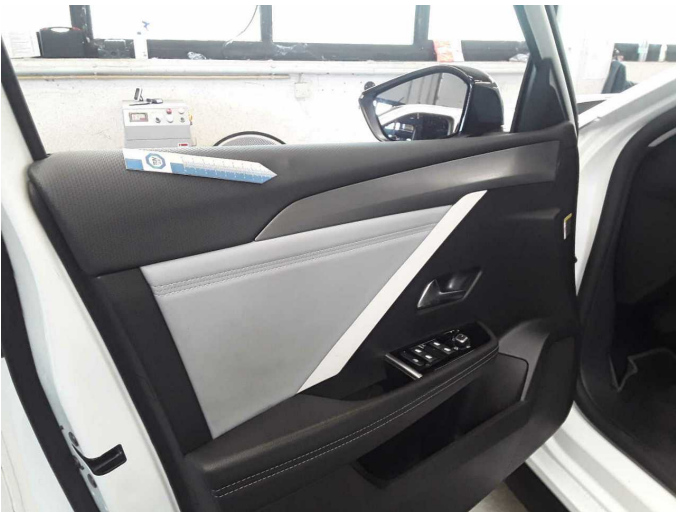
| No. | Component group | Description |
|---|---|---|
| 1 | Trim / covers | Door trim - front left side - dent(s) - Loss in value |

Damage 1: Trim / covers: Door trim - front left side - dent(s) - Loss in value

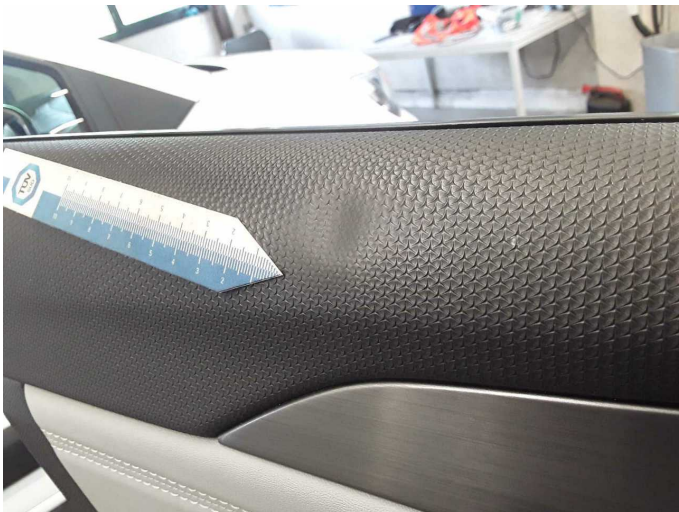
Damage 1: Trim / covers: Door trim - front left side - dent(s) - Loss in value

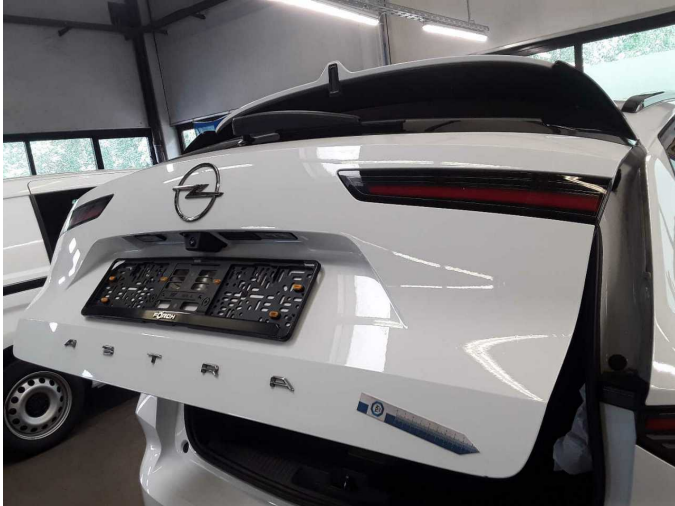
| No. | Component group | Description |
|---|---|---|
| 2 | Boot lid / rear door | Boot lid - Scratch(es) - Smart repair |

**Damage 2:** Boot lid / rear door: Boot lid - Scratch(es) - Smart repair

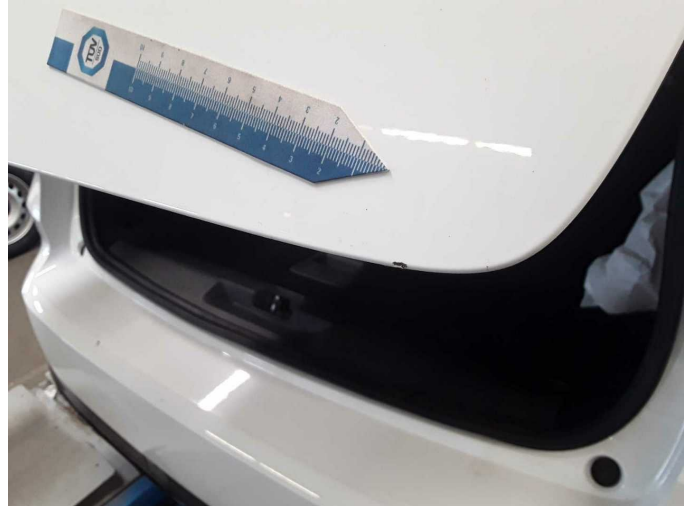
**Damage 2:** Boot lid / rear door: Boot lid - Scratch(es) - Smart repair

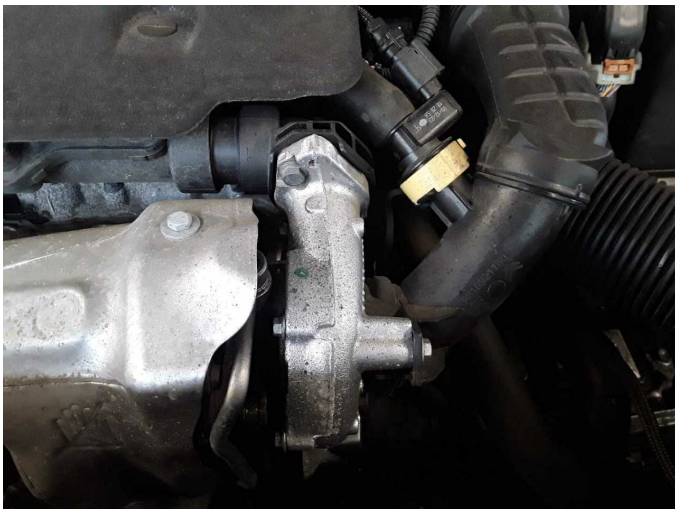
| No. | Component group | Description |
|---|---|---|
| 3 | Engine | Engine - Leaking - Diagnosed and repair if necessary |

**Damage 3:** Engine: Engine - Leaking - Diagnosed and repair if necessary

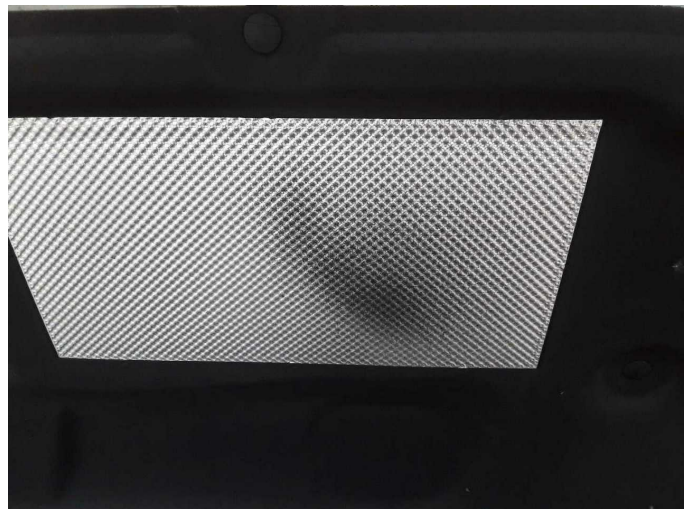
**Damage 3:** Engine: Engine - Leaking - Diagnosed and repair if necessary

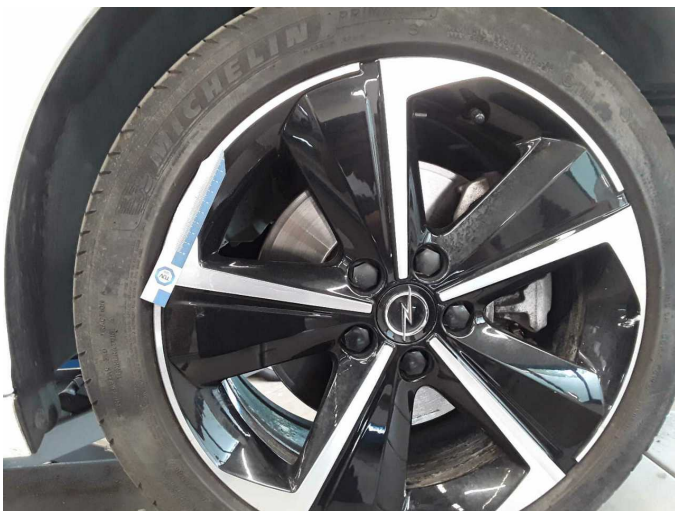
| No. | Component group | Description |
|---|---|---|
| 4 | Wheel / tyres | Alloy rim - front right side - Scratch(es) - Loss in value |

**Damage 4:** Wheel / tyres: Alloy rim - front right side - Scratch(es) - Loss in value

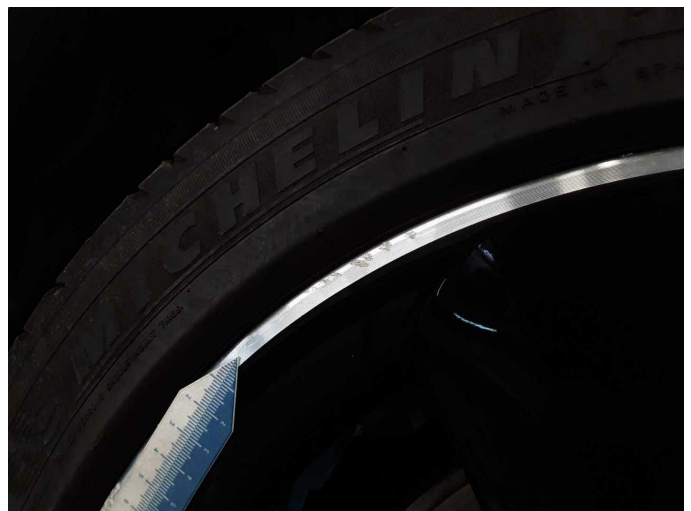
**Damage 4:** Wheel / tyres: Alloy rim - front right side - Scratch(es) - Loss in value

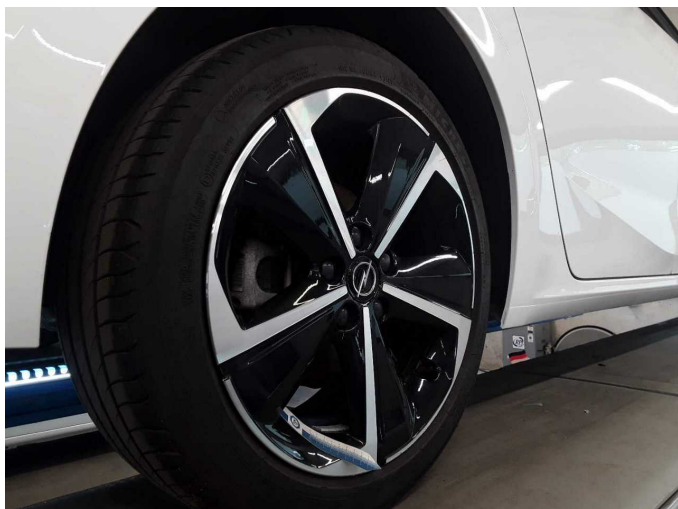
| No. | Component group | Description |
|---|---|---|
| 5 | Wheel / tyres | Alloy rim - rear right side - Scratched - Loss in value |

**Damage 5:** Wheel / tyres: Alloy rim - rear right side - Scratched - Loss in value

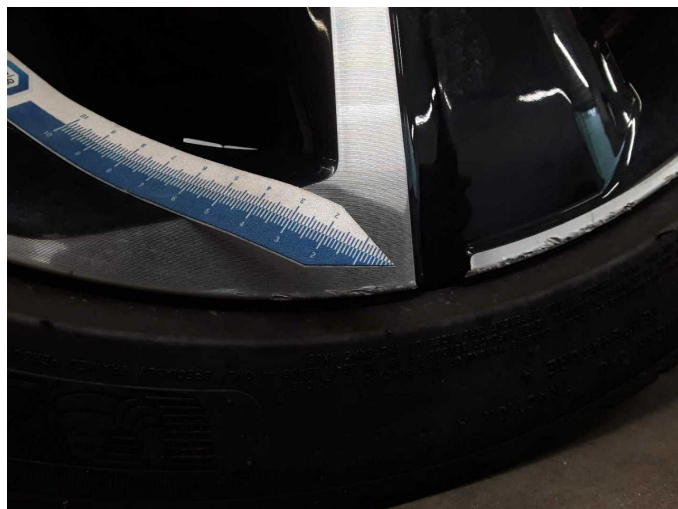
**Damage 5:** Wheel / tyres: Alloy rim - rear right side - Scratched - Loss in value

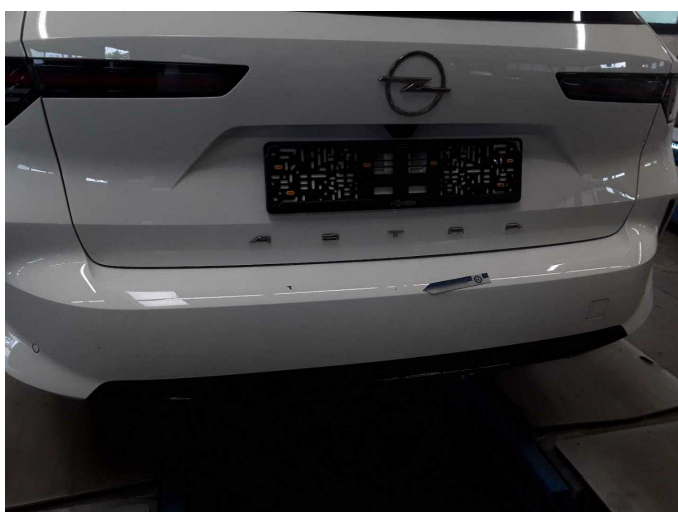
| No. | Component group | Description |
|---|---|---|
| 6 | Rear bumper | Rear bumper - Scratch(es) - Paint |

**Damage 6:** Rear bumper: Rear bumper - Scratch(es) - Paint

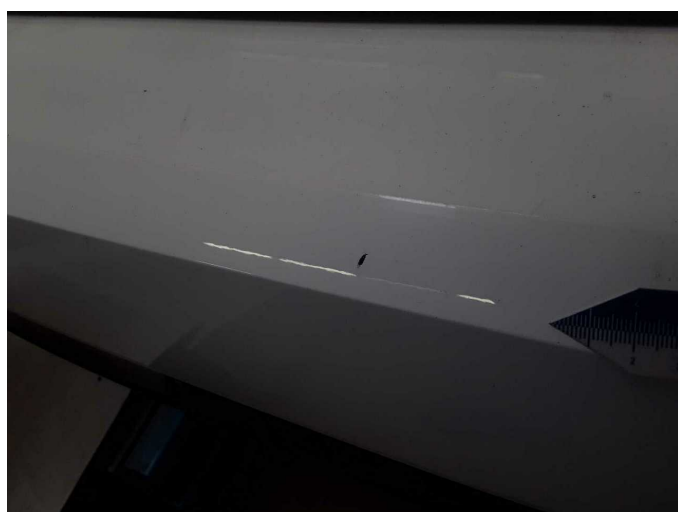
**Damage 6:** Rear bumper: Rear bumper - Scratch(es) - Paint

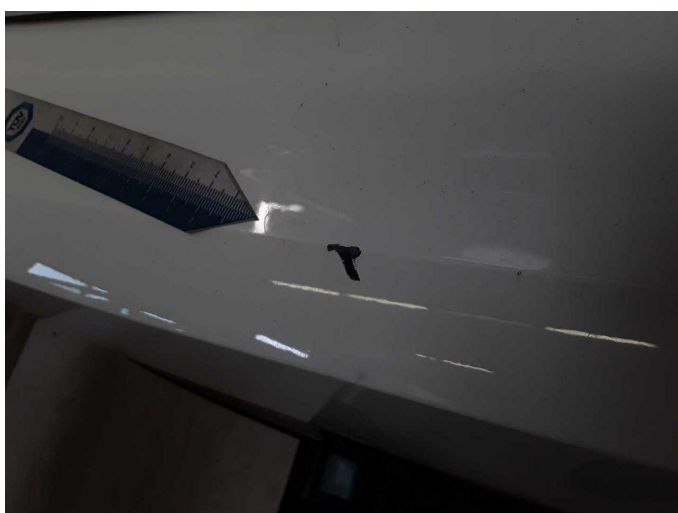
**Damage 6:** Rear bumper: Rear bumper - Scratch(es) - Paint

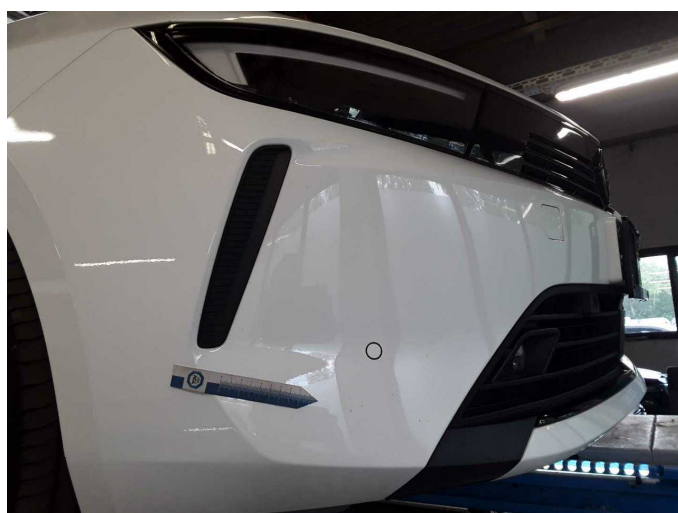
| No. | Component group | Description |
|---|---|---|
| 2 | Front bumper | Front bumper - Stone chips - No deduction |

**Wear and tear 2:** Front bumper: Front bumper - Stone chips - No deduction

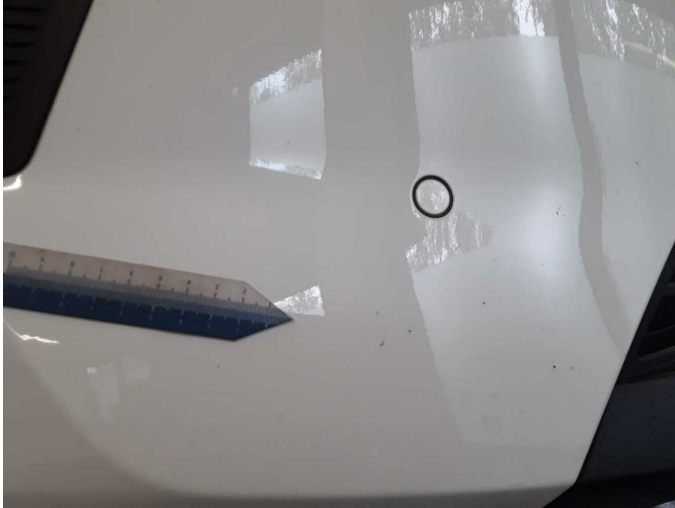
**Wear and tear 2:** Front bumper: Front bumper - Stone chips - No deduction

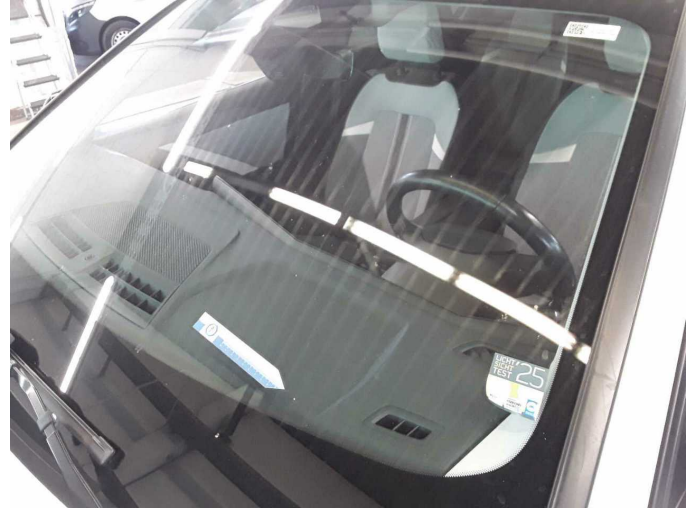
| No. | Component group | Description |
|---|---|---|
| 3 | Vehicle glazing | Windscreen - Stone chips - No deduction |

**Wear and tear 3:** Vehicle glazing: Windscreen - Stone chips - No deduction

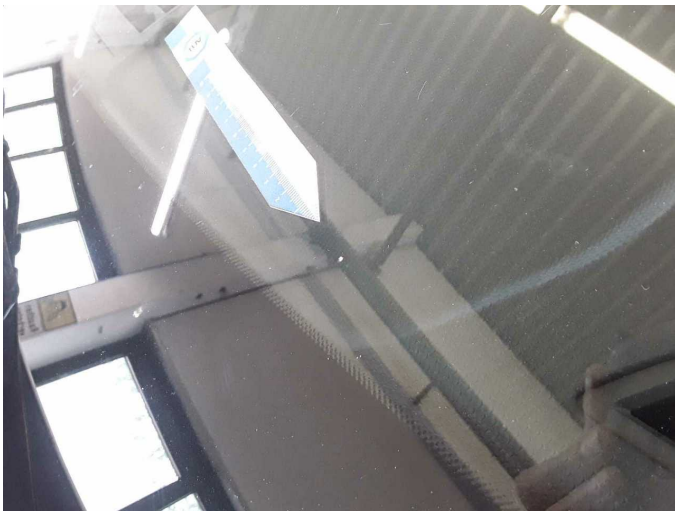
**Wear and tear 3:** Vehicle glazing: Windscreen - Stone chips - No deduction
