Expertise

Protocol number: 46840730  
Order No. / Reference: 26786750  
Inspection date: 3 Aug 2026

Manufacturer: Ford  
VIN: WF0SXXWPGSPK43836

Model: Transit Connect 230 L2 Trend

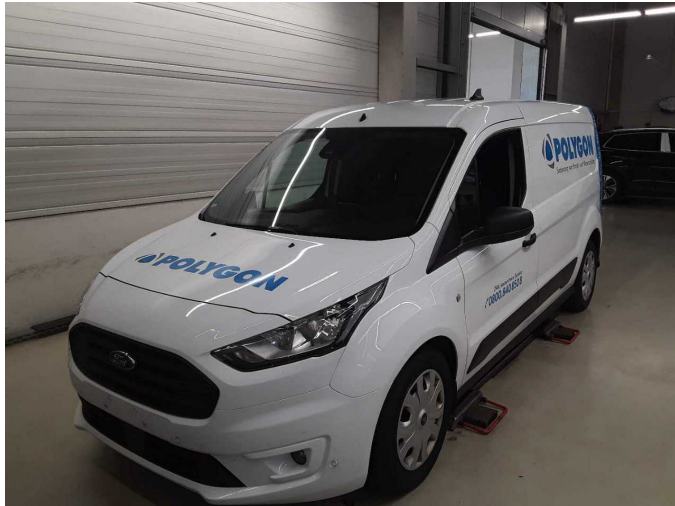
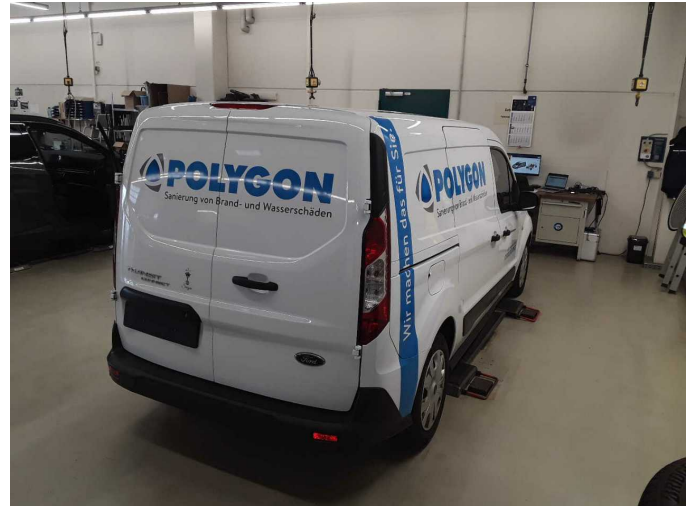
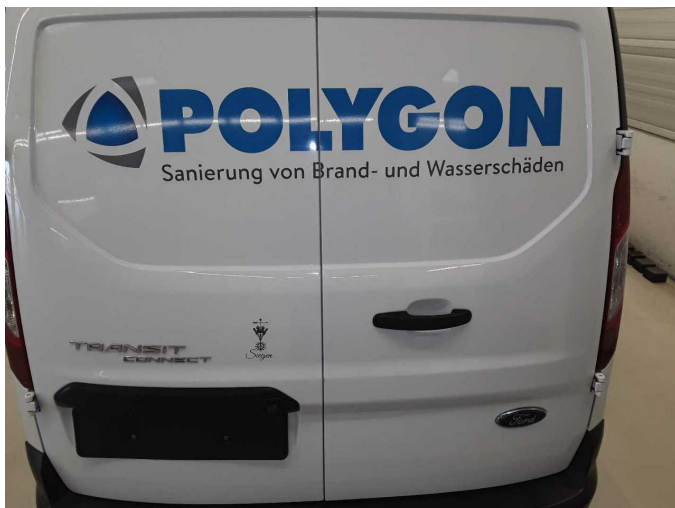
| No. | Component group | Description |
|---|---|---|
| 2 | Body | Body - Glued / labelled - De-glue / neutralise |

**Damage 2:** Body: Body - Glued / labelled - De-glue / neutralise

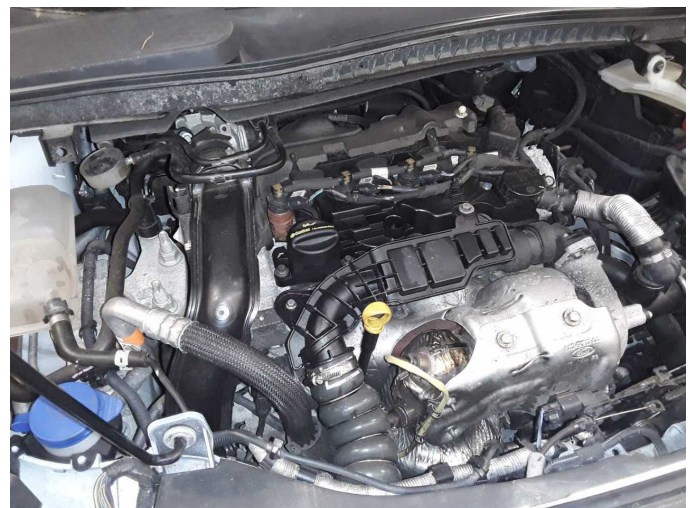
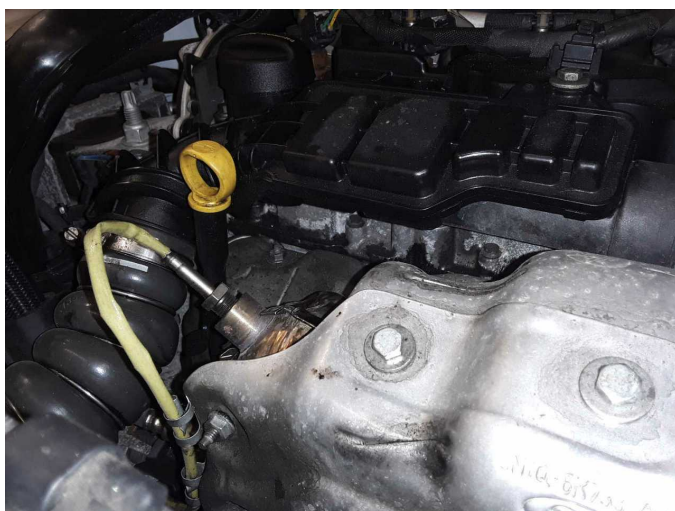
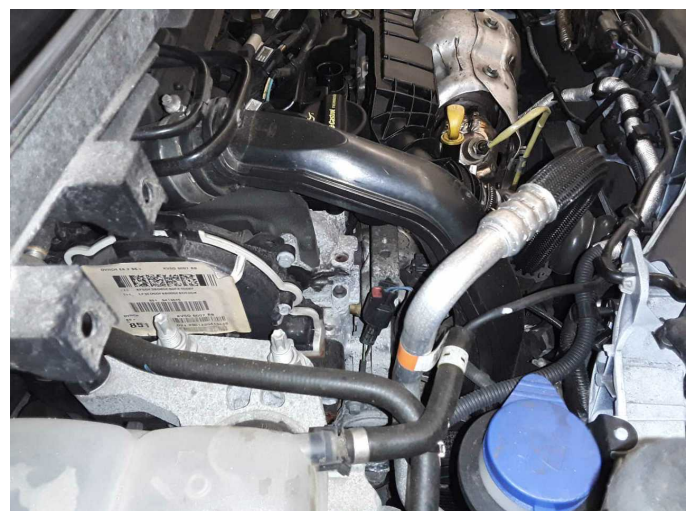
| No. | Component group | Description |
|---|---|---|
| 1 | Engine | Engine (Ölspuren erkennbar) - No deduction |

**Wear and tear 1:** Engine: Engine (Ölspuren erkennbar) - No deduction

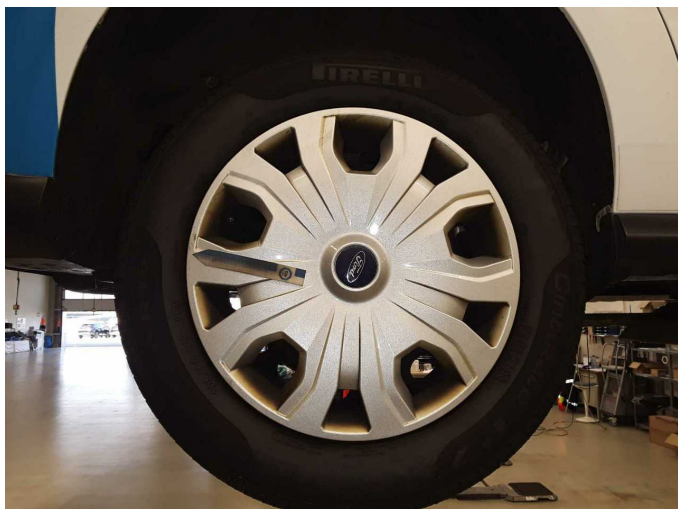
| No. | Component group | Description |
|---|---|---|
| 2 | Wheel / tyres | Wheel cover - rear right side - Scratch(es) - No deduction |

**Wear and tear 2:** Wheel / tyres: Wheel cover - rear right side -  
Scratch(es) - No deduction

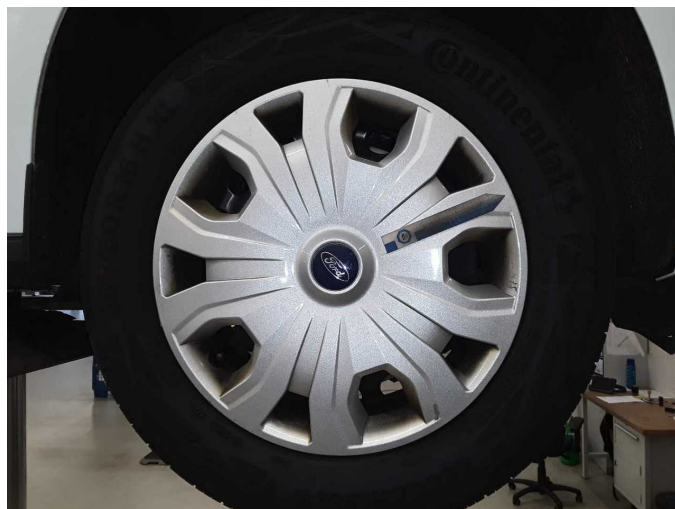
| No. | Component group | Description |
|---|---|---|
| 3 | Wheel / tyres | Wheel cover - front right side - Scratch(es) - No deduction |

**Wear and tear 3:** Wheel / tyres: Wheel cover - front right side -  
Scratch(es) - No deduction

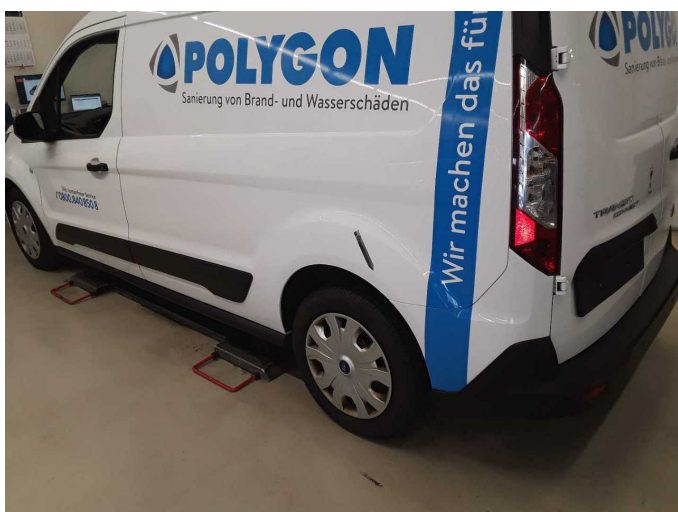
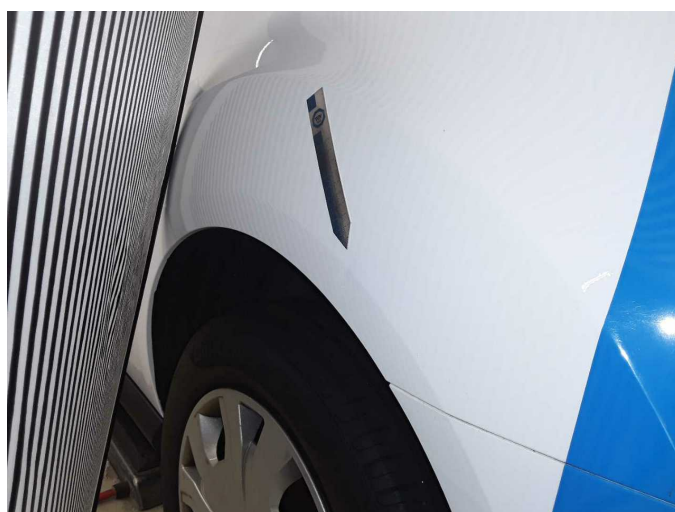
| No. | Component group | Description |
|---|---|---|
| 4 | Side panel - rear left side | Side panel - dent(s) - No deduction |

**Wear and tear 4:** Side panel - rear left side: Side panel - dent(s) - No  
deduction
