# MACDAM

## Skoda Enyaq '21 BEV

### Vehicle information

### Damage summary

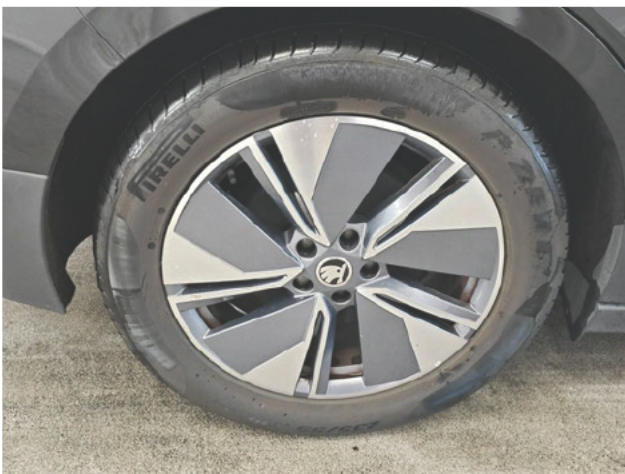
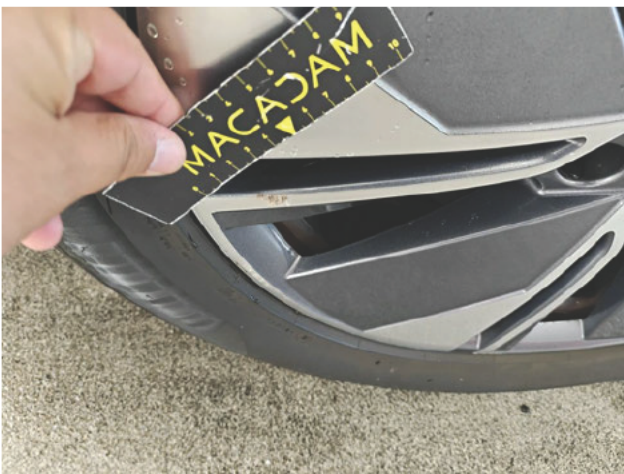
| Damages | | | | |
|---|---|--|--|--|
| <b>Alloy rim RR</b><br>Scratch(es)<br>Repair and paint (complete)<br>Right | | | | |

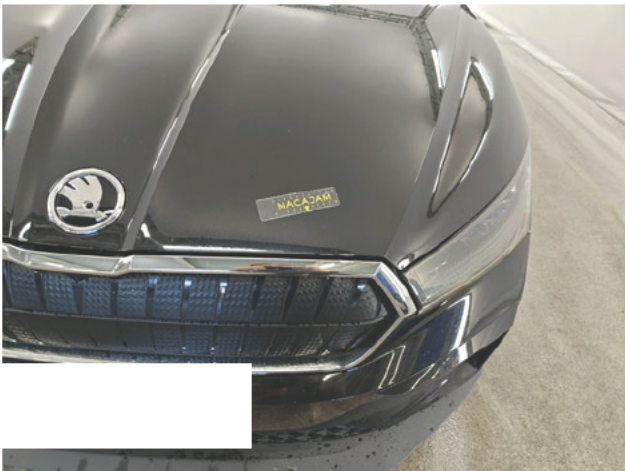
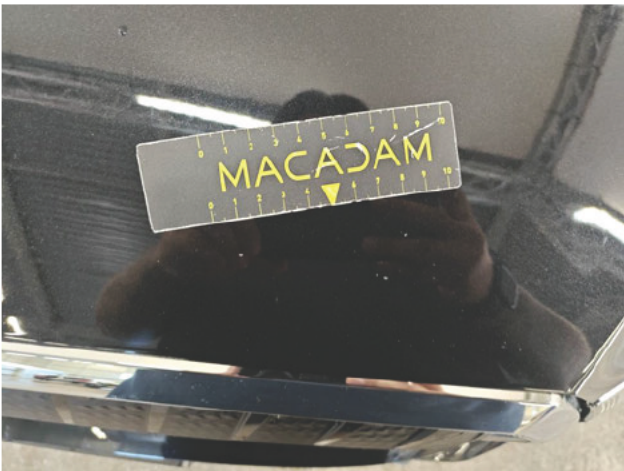
| Damages | | | | |
|---|---|--|--|--|
| <b>Bonnet</b><br>Stone chip(s)<br>Repair and paint (complete)<br>Front | | | | |

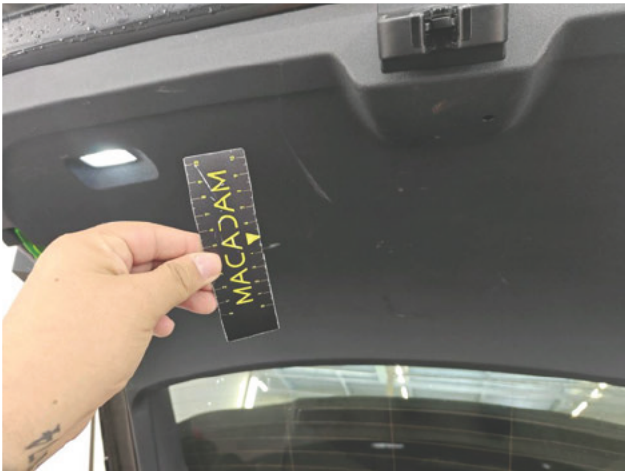
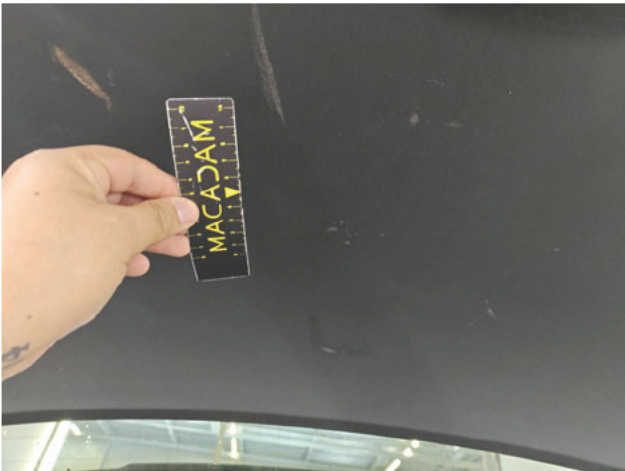
| Damages | | | | |
|---|---|--|--|--|
| <b>Boot lid covering R</b><br>Scratch(es)<br>Smart repair<br>Rear | | | | |

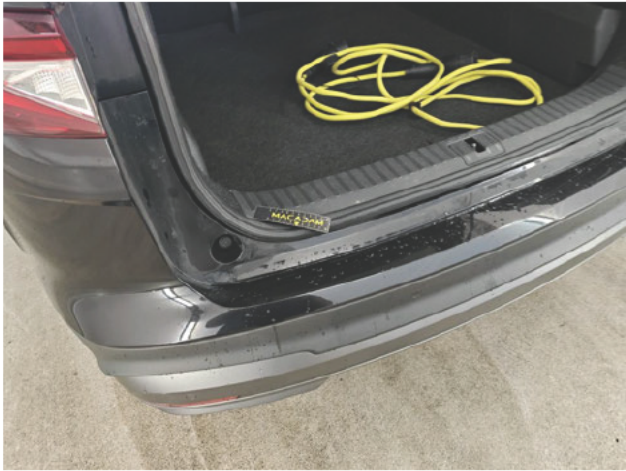
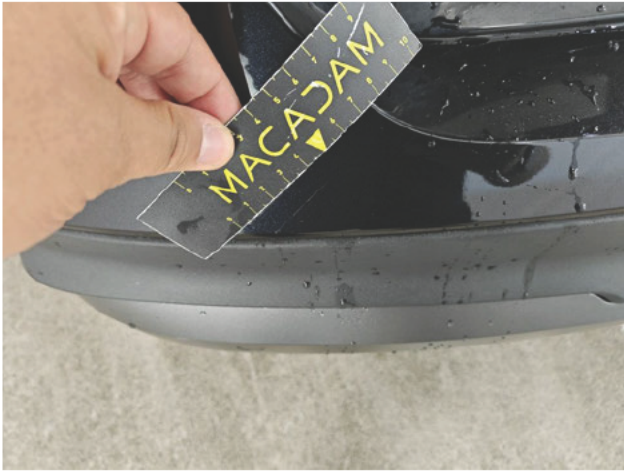
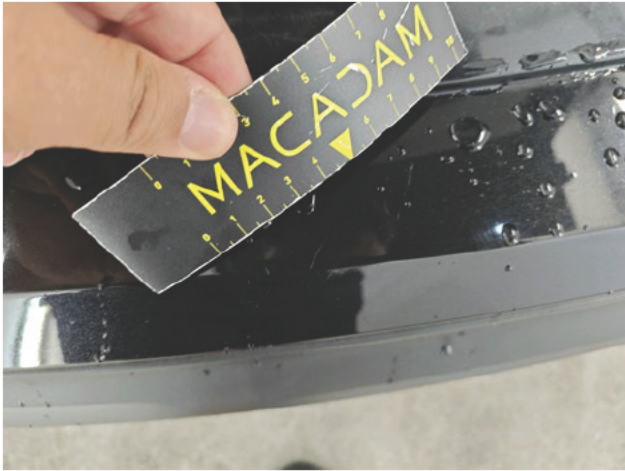
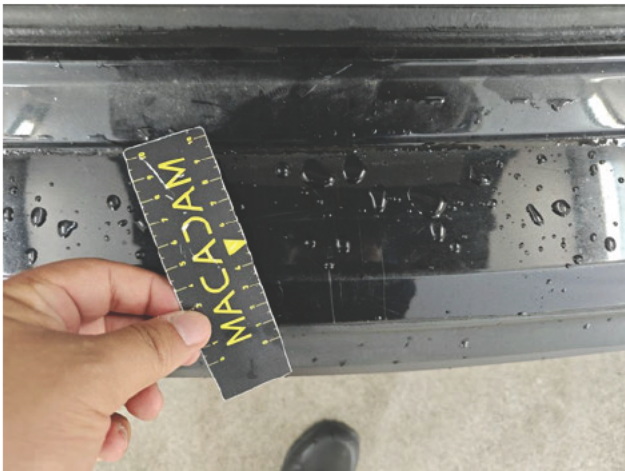
| Damages | | | | |
|---|---|--|--|--|
| <b>Bumper R</b><br>Scratch(es)<br>Repair and paint (complete)<br>Rear | | | | |

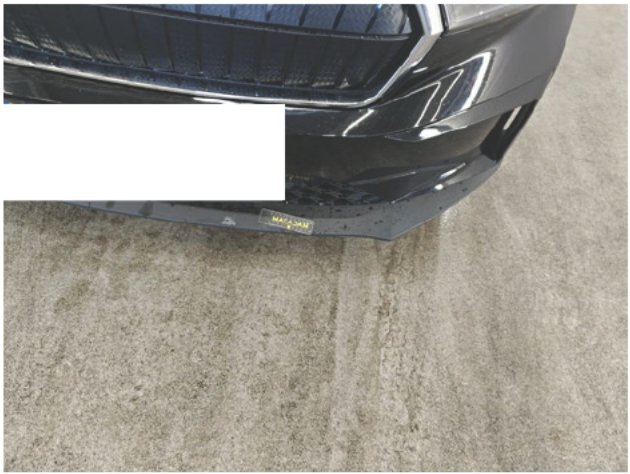
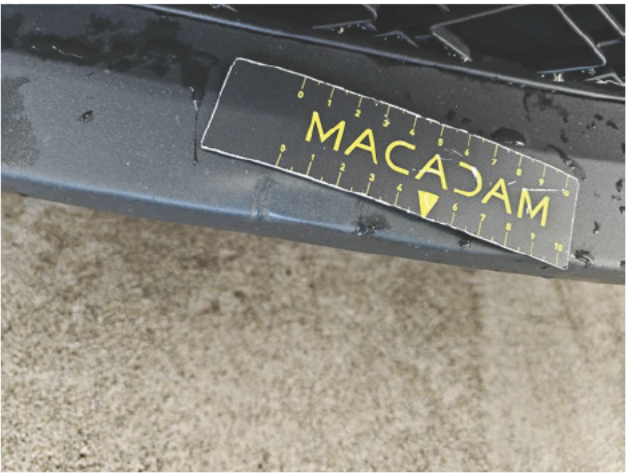
**Bumper trim F**  
Scratch(es)  
Replace  
Front

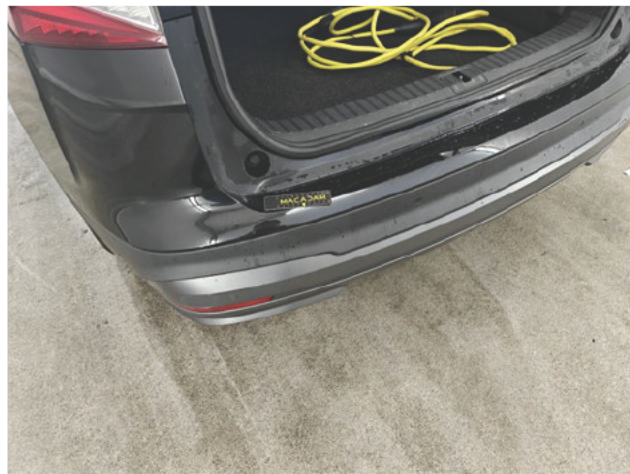
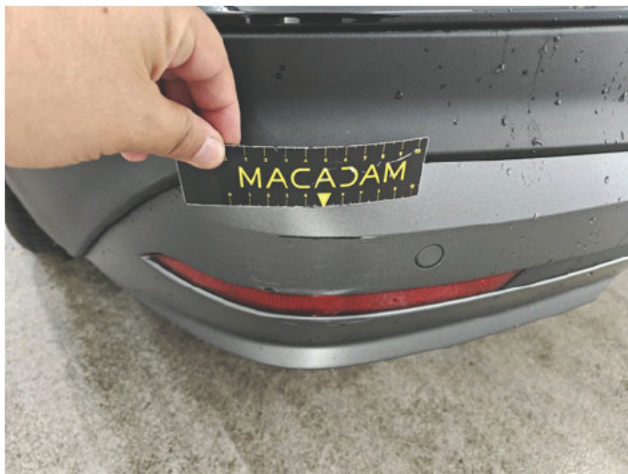
**Bumper trim R**  
Scratch(es)  
Replace  
Rear

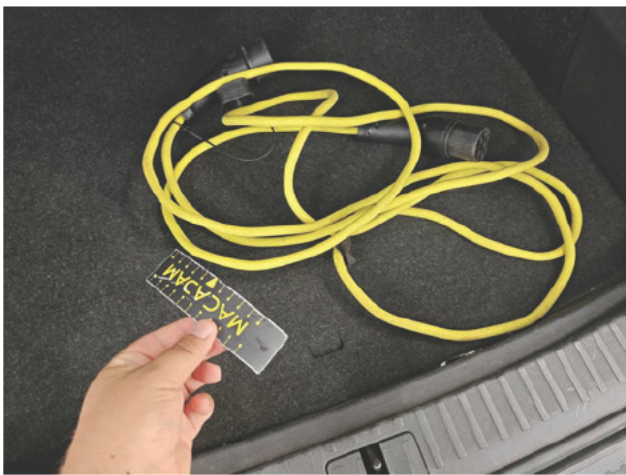
**Charging cable (normal)**  
Missing  
Replace  
Rear

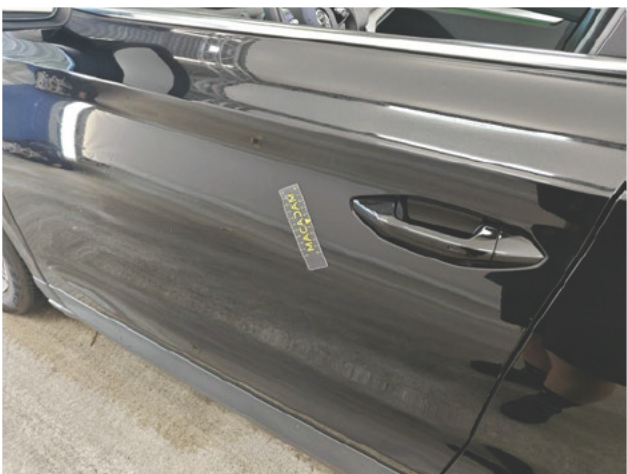
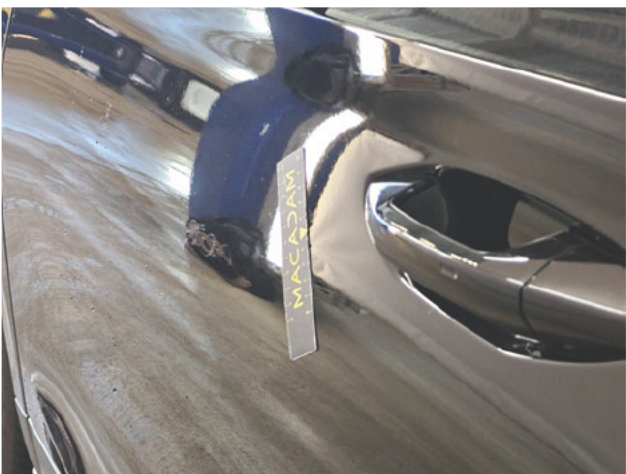
**Door FL**  
Bad repair  
Repair and paint (complete)  
Left

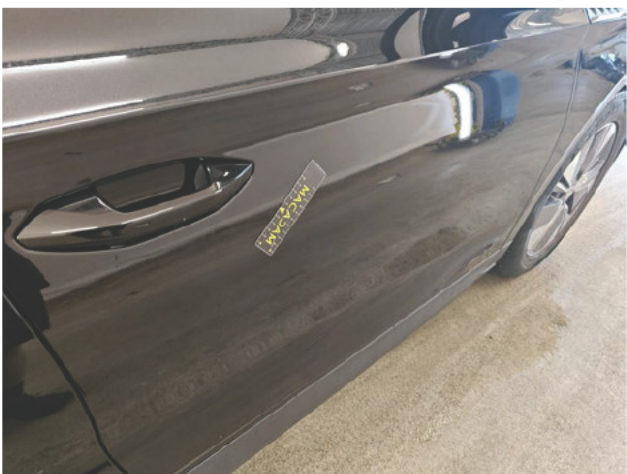
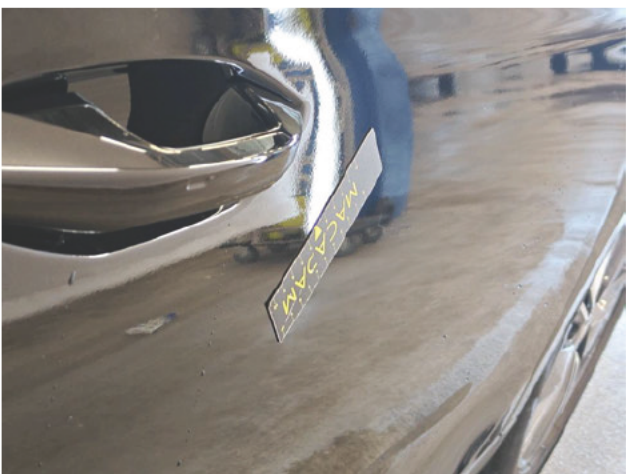
**Door FR**  
Bad repair  
Repair and paint (complete)  
Right

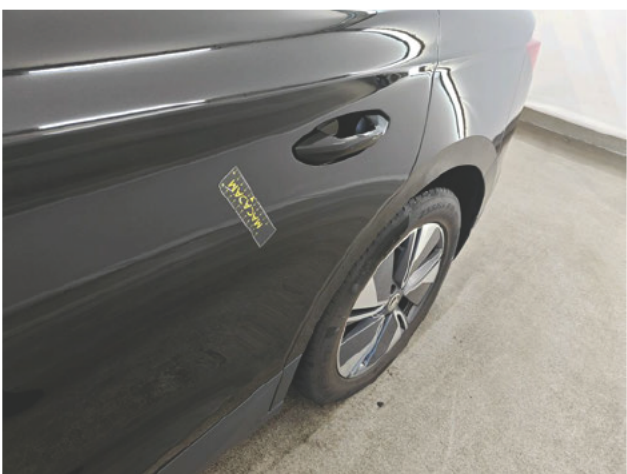
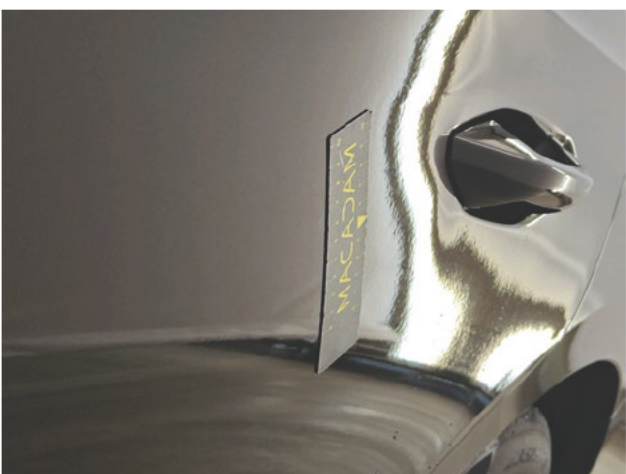
**Door RL**  
Bad repair  
Repair and paint (complete)  
Left

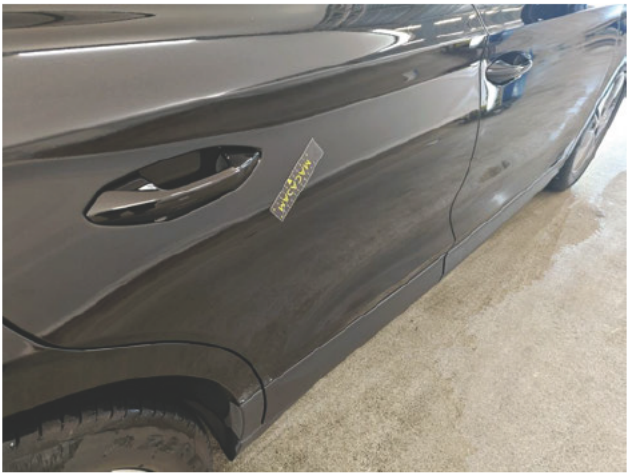
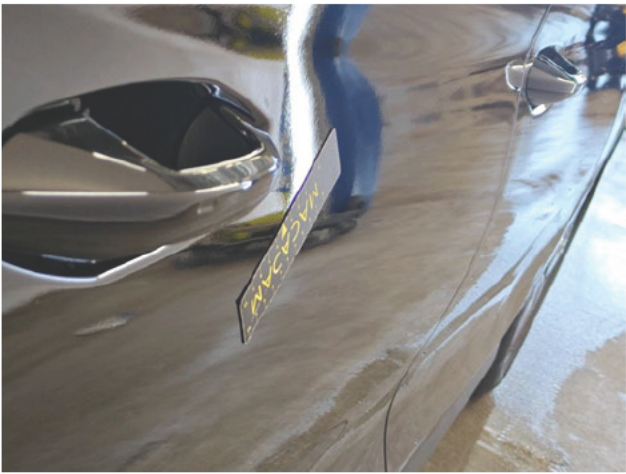
**Door RR**  
Bad repair  
Repair and paint (complete)  
Right

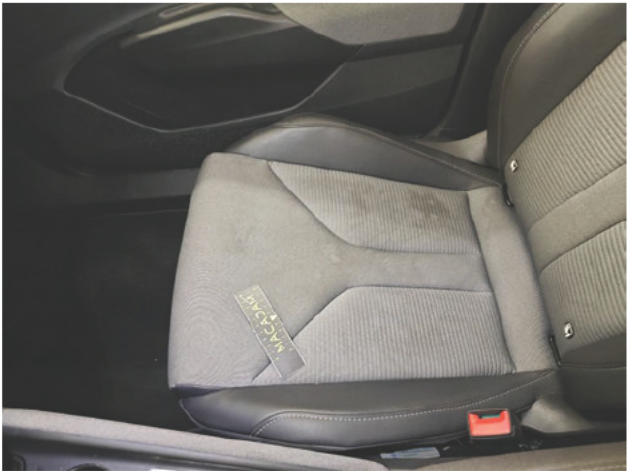
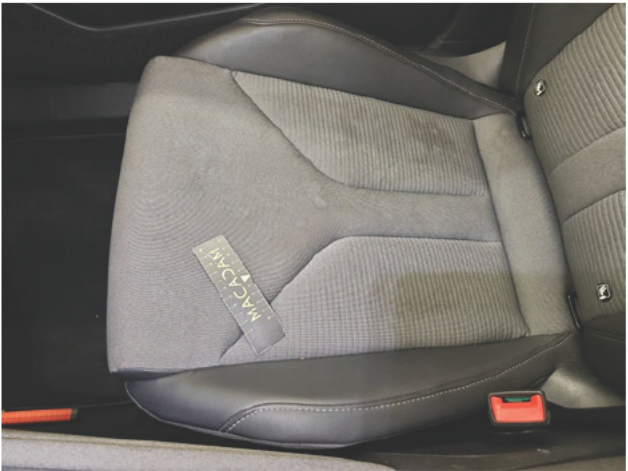
**Interior**  
Stain  
Cleaning  
Interior

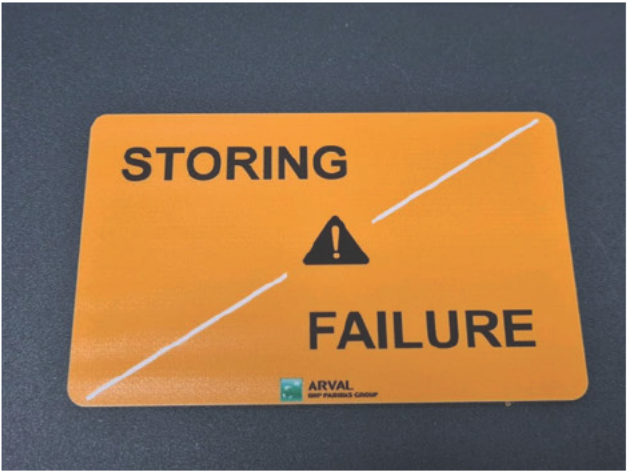
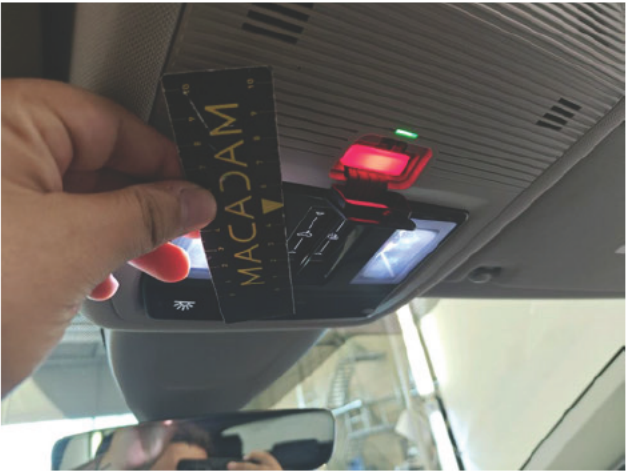
**Malfunction**  
Not functioning (well)  
Diagnosis  
Interior

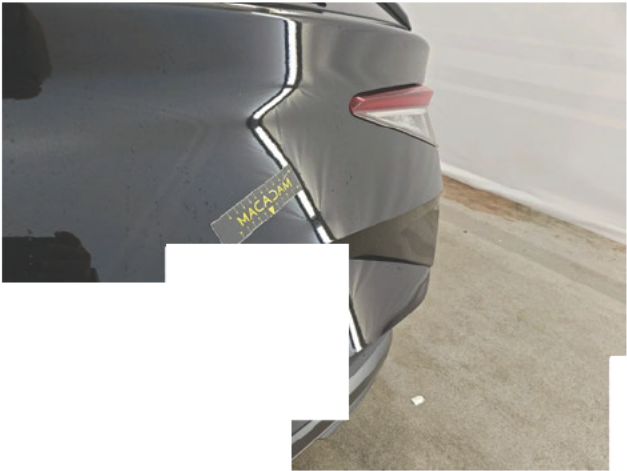
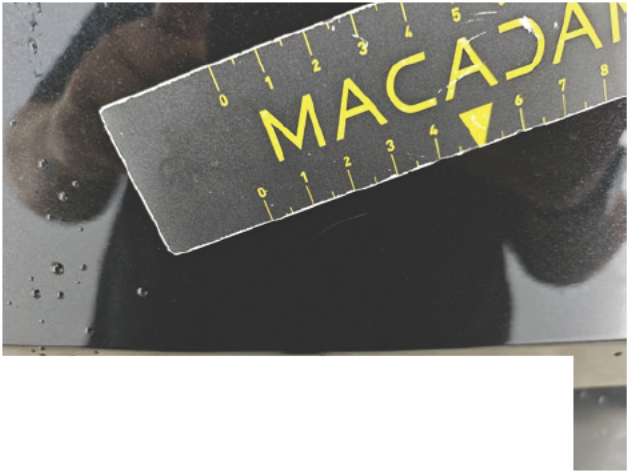
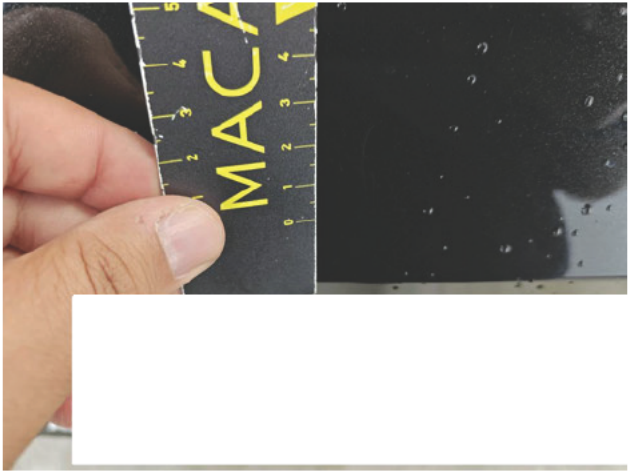
**Tailgate / Boot**  
Scratch(es)  
Repair and paint (partial)  
Rear
