Expertise

Protocol number: 46351402
Order No. / Reference: 26185466
Inspection date: 2 Jul 2026

Manufacturer: Mercedes-Benz

Model: Vito 116 CDI Lang HA Aut. PRO

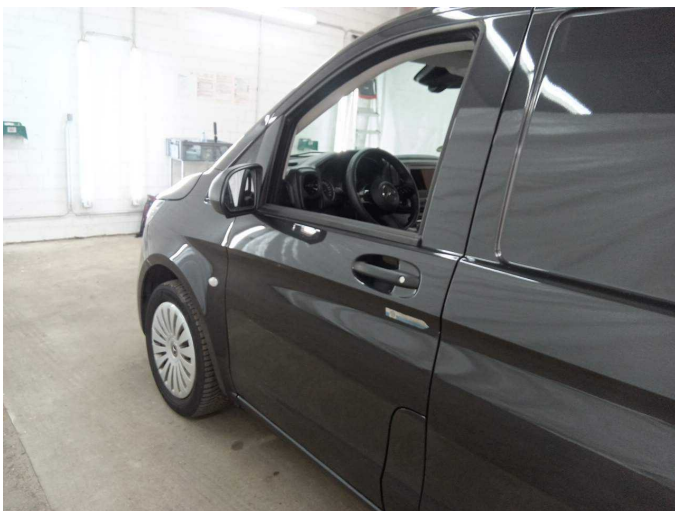
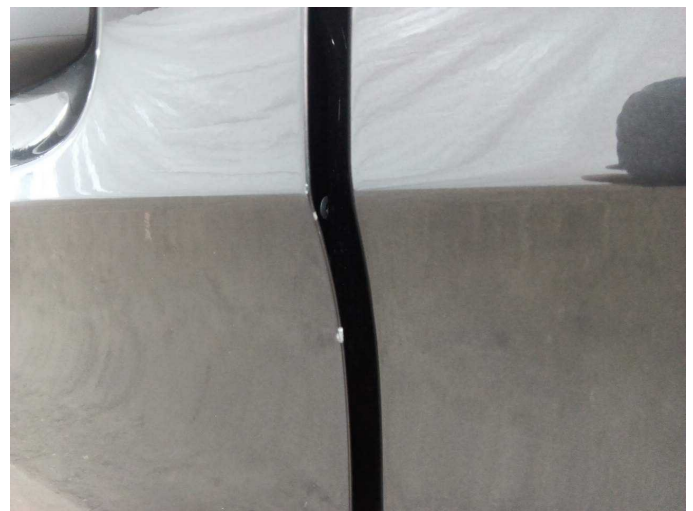
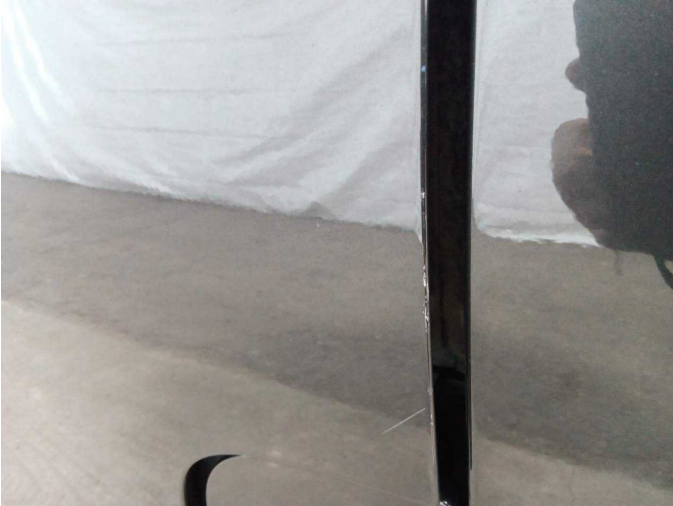
Damage 1: Door - front left side: Door edge - Scratch(es) - Smart repair

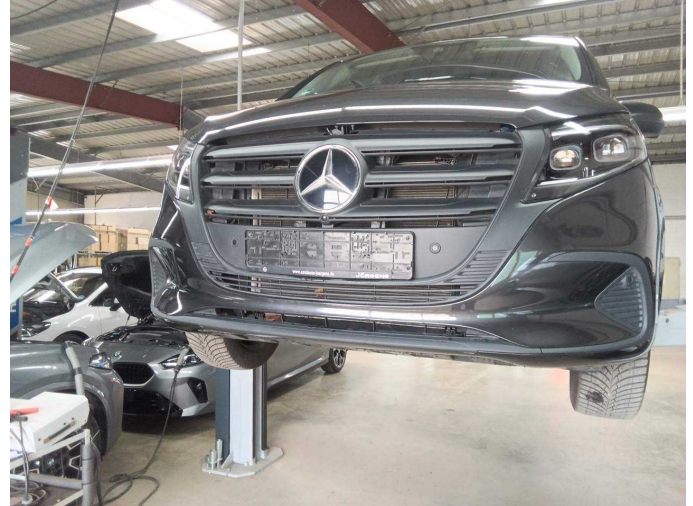
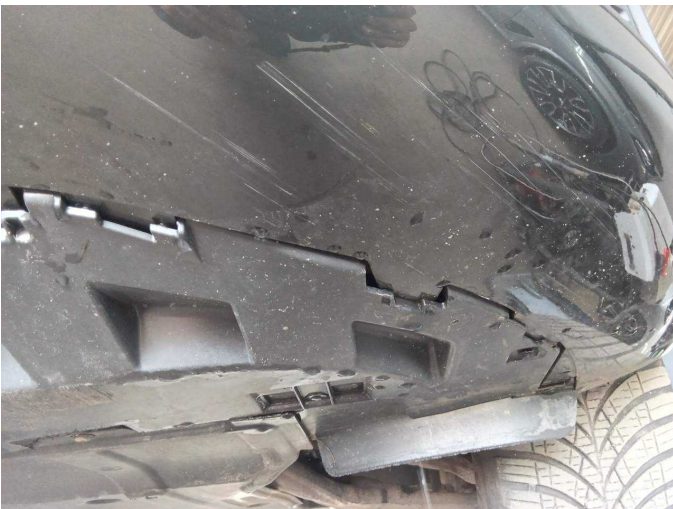
Damage 2: Front bumper: Front bumper - Scratch(es) - Smart repair

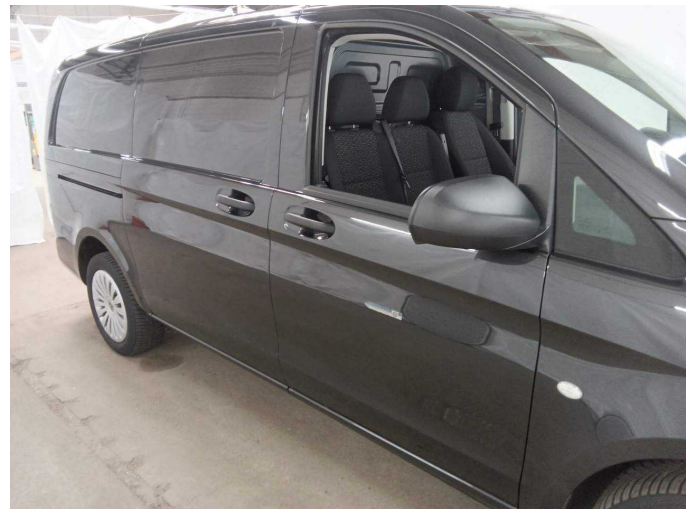
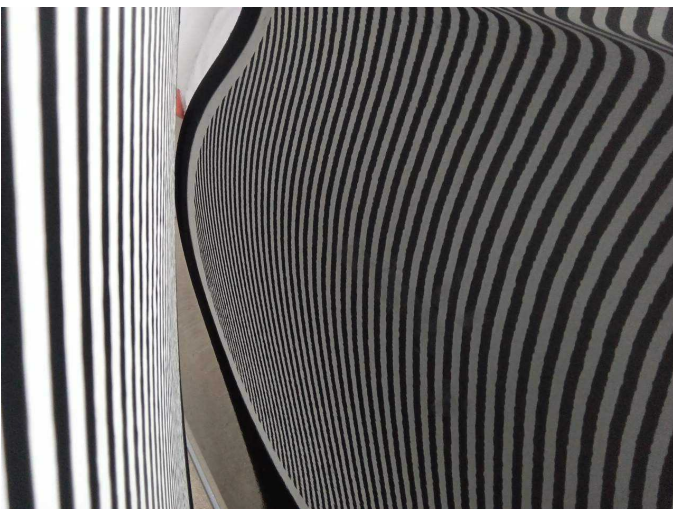
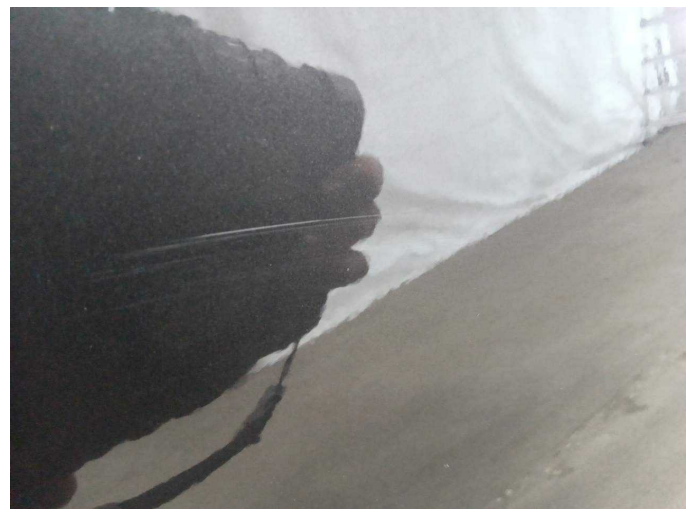
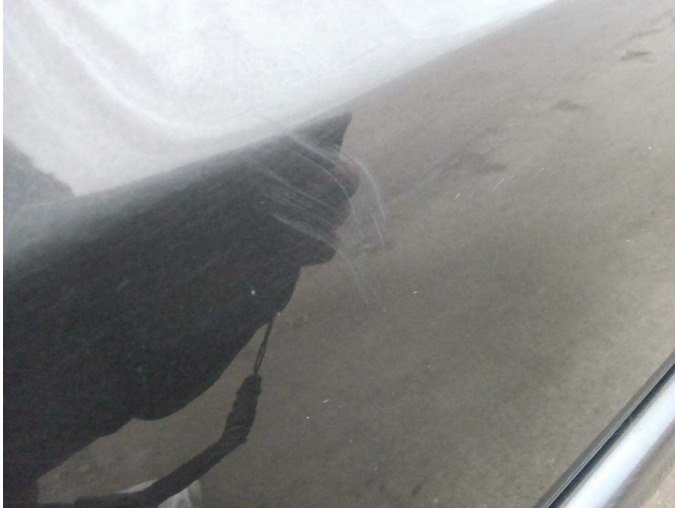
Damage 3: Door - front right side: Door - Dent / paintcoat damage - Repair and paint

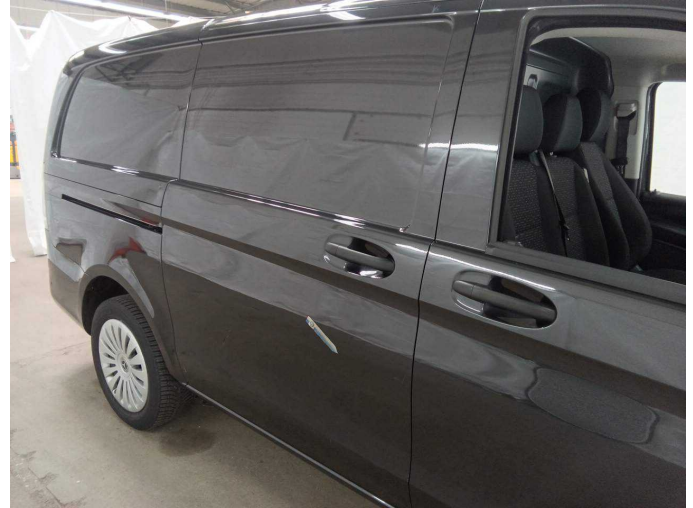
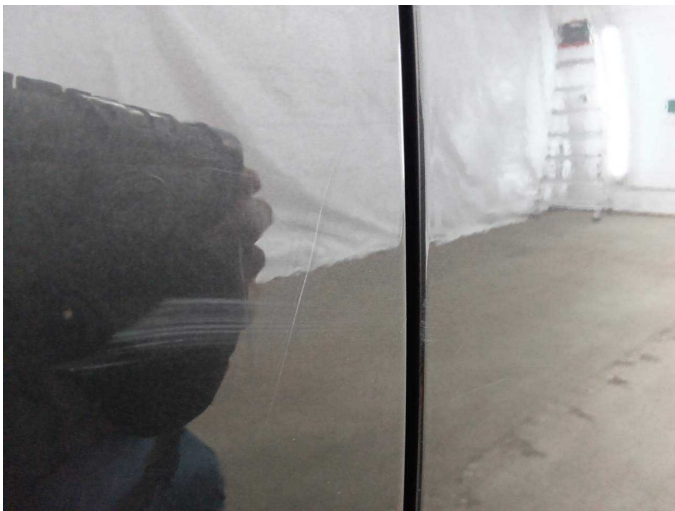
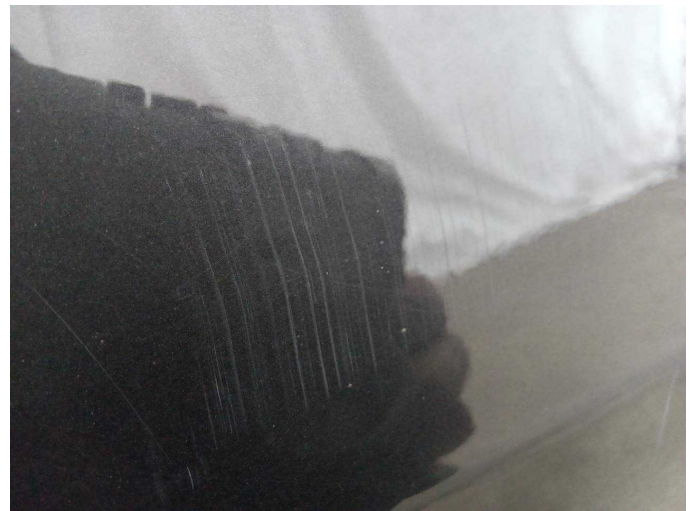
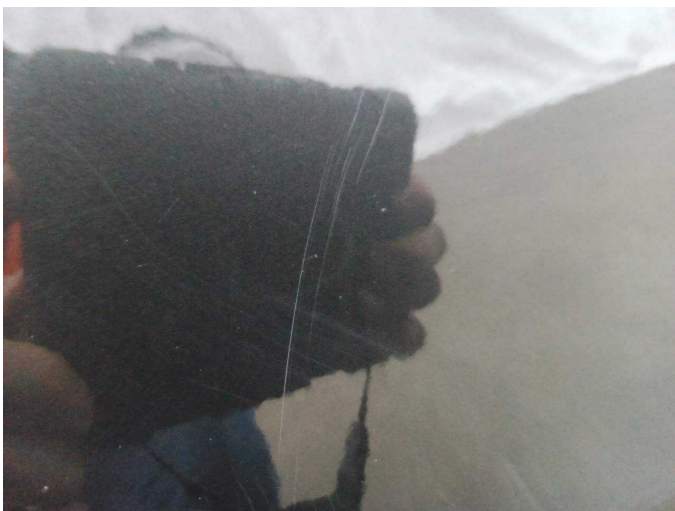
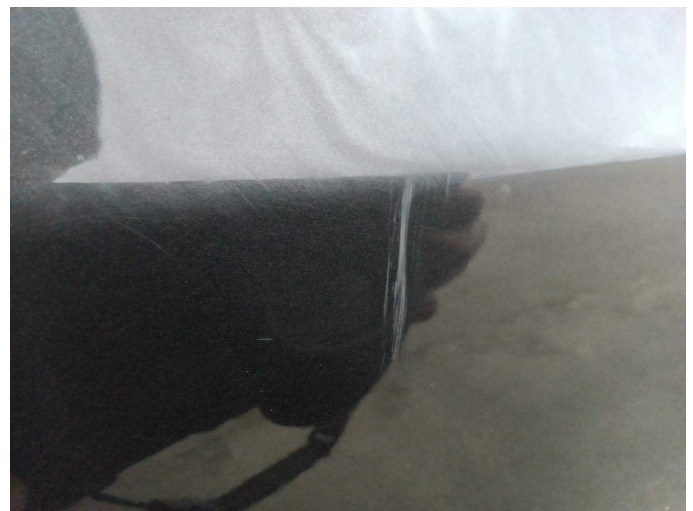
Damage 4: Sliding door, right: Sliding door - Scratch(es) - Paint

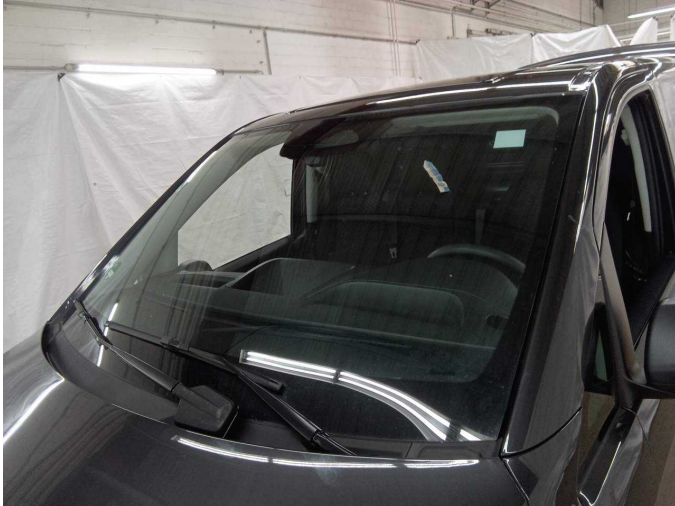
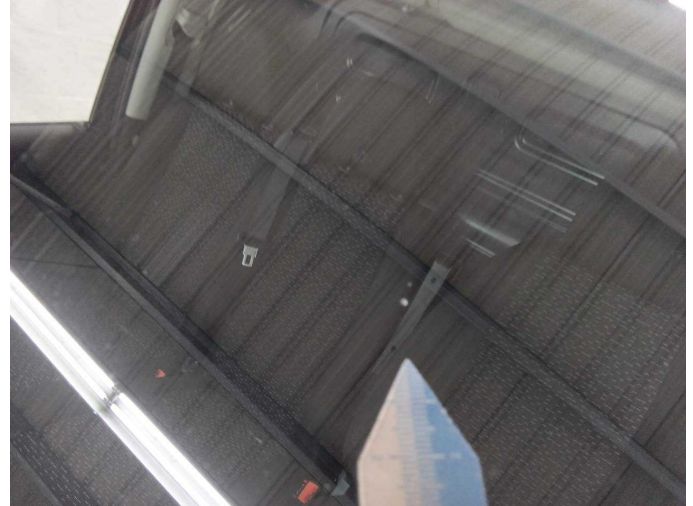
Wear and tear 1: Vehicle glazing: Windscreen - Stone chips - No deduction

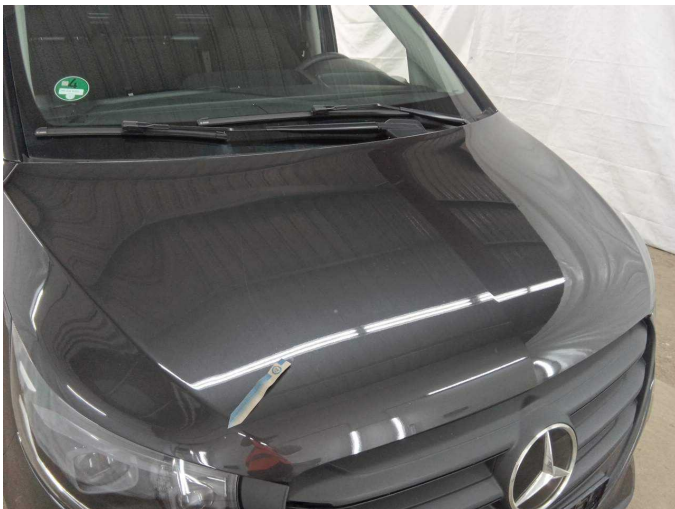
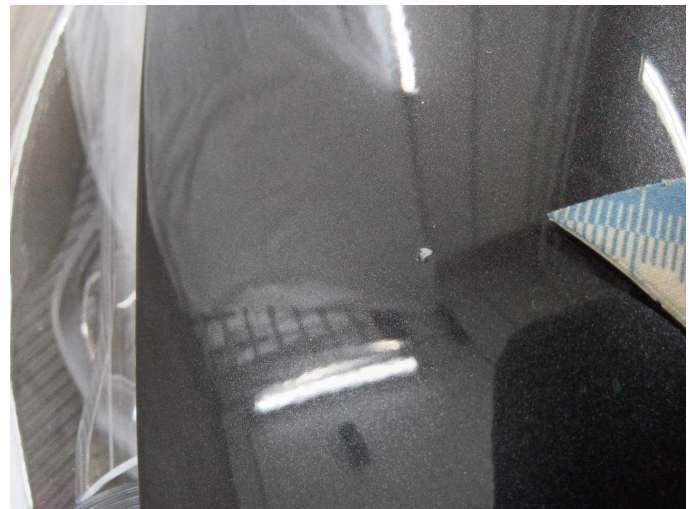
Wear and tear 2: Bonnet: Bonnet - Stone chips - No deduction

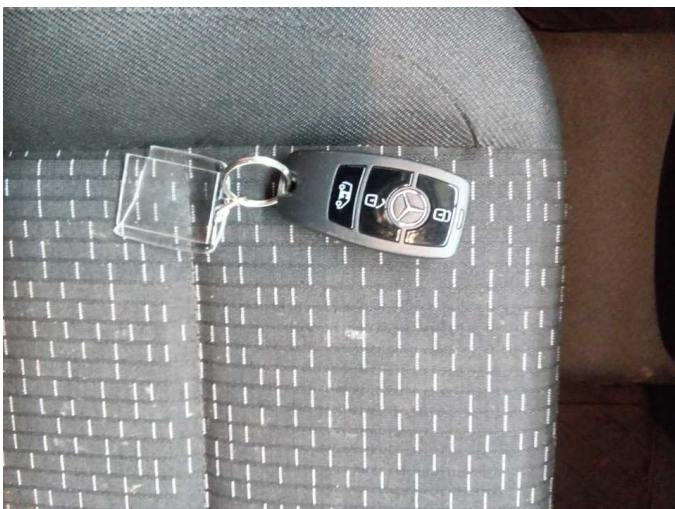
Missing part 1: Equipment: Vehicle key - Missing - Replace

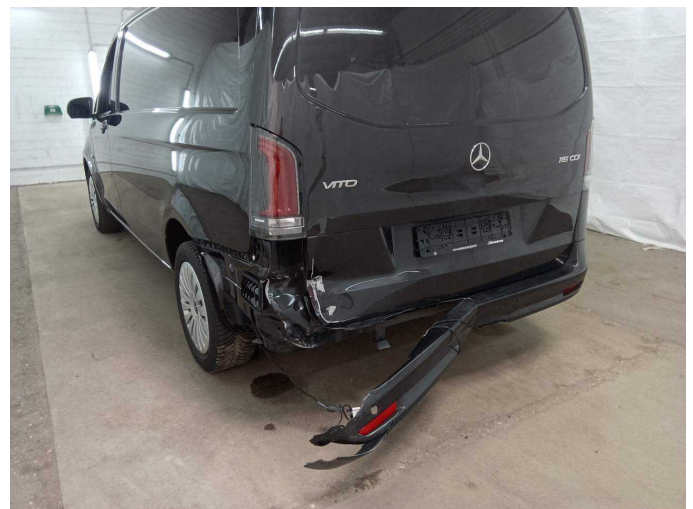
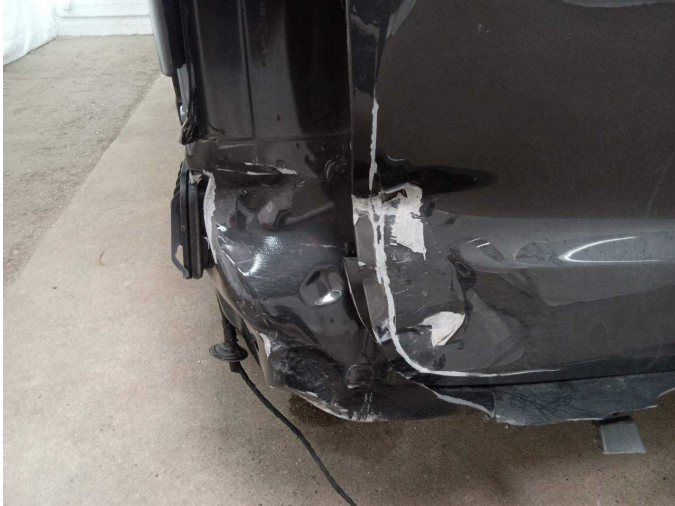
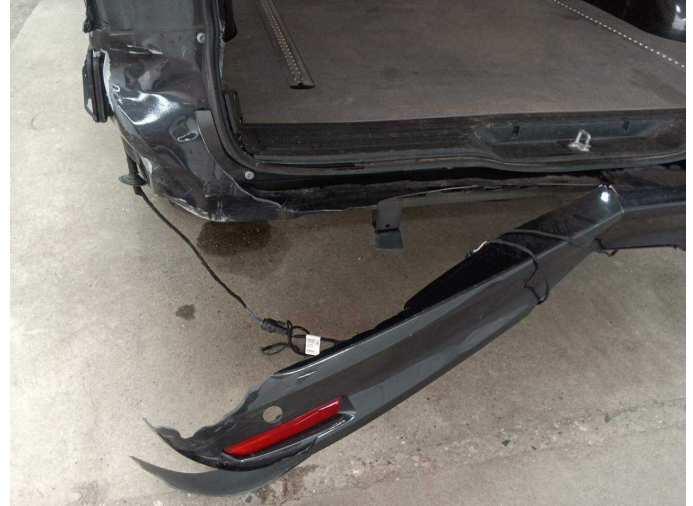
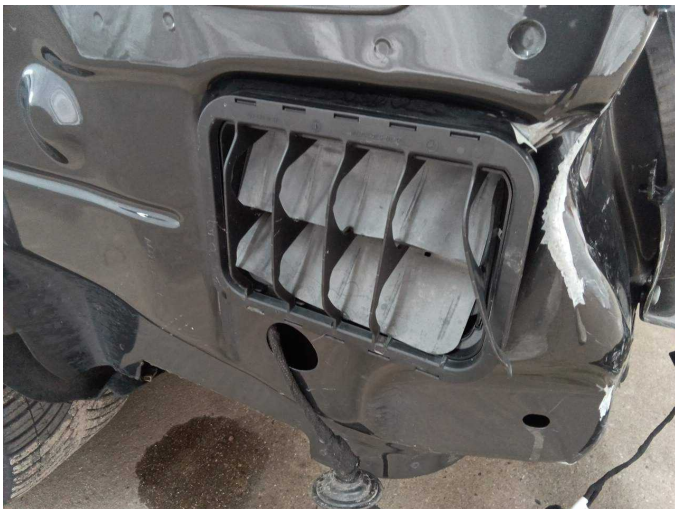
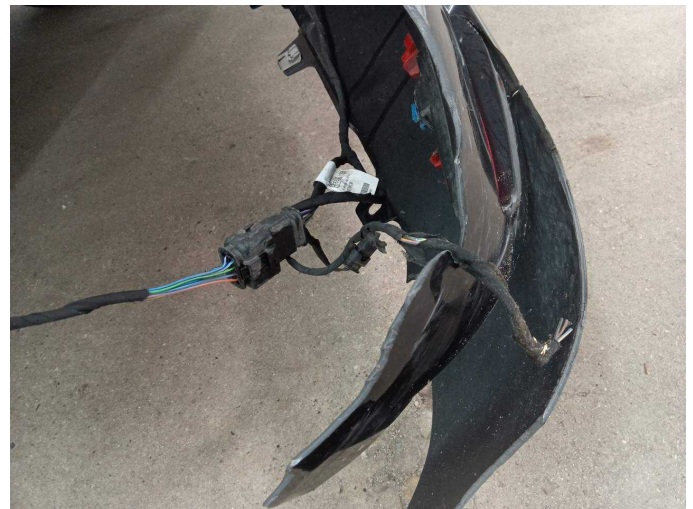
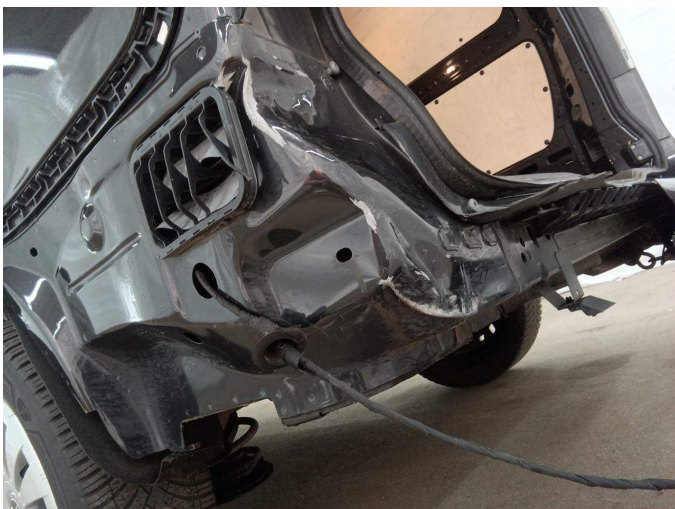
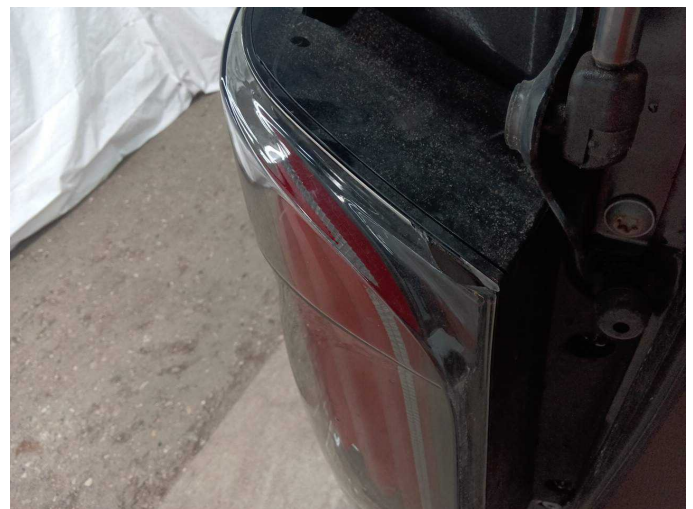
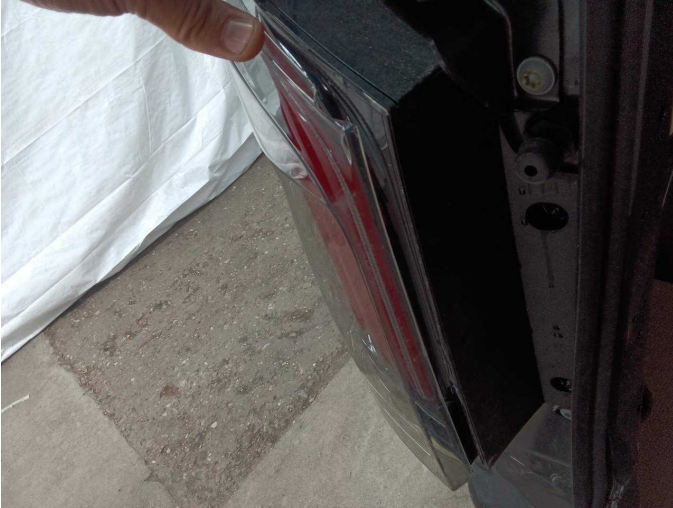
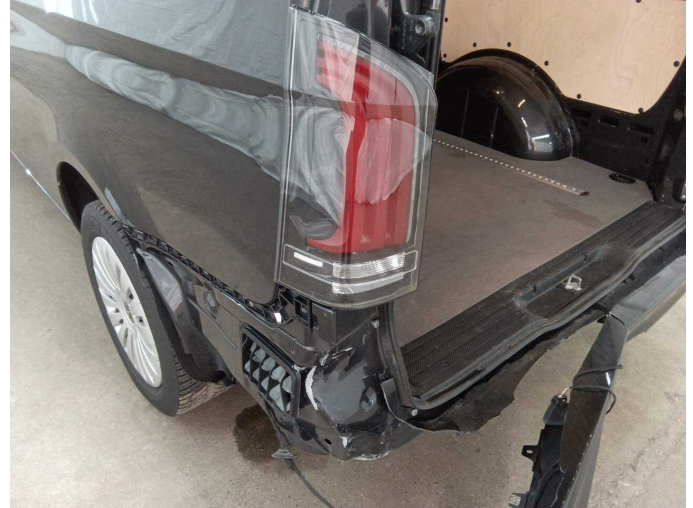
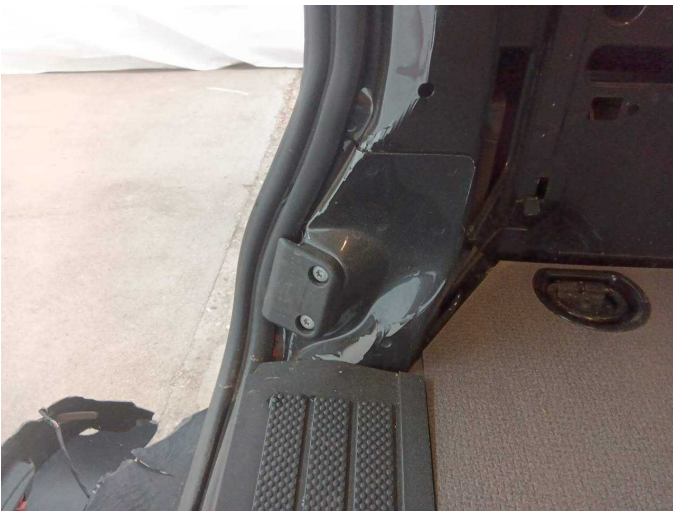
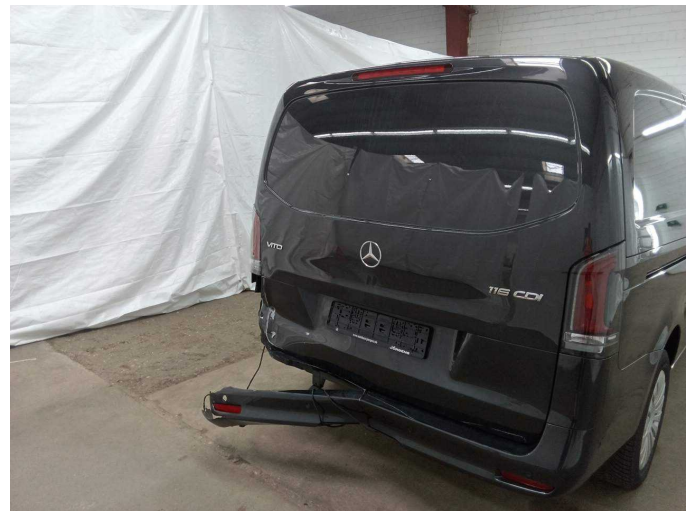
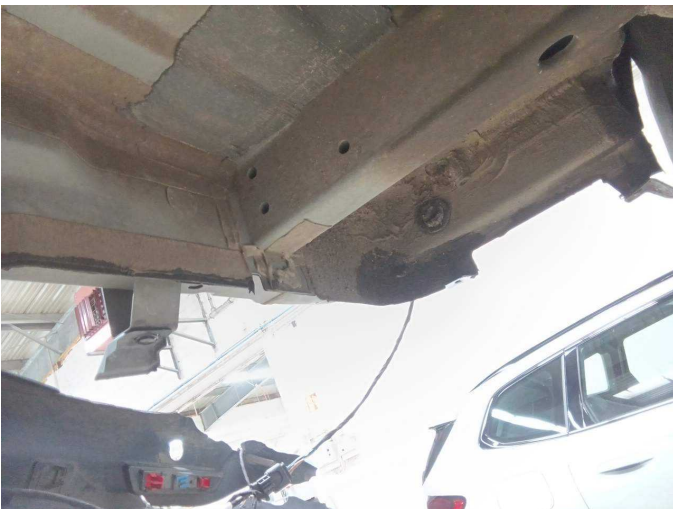
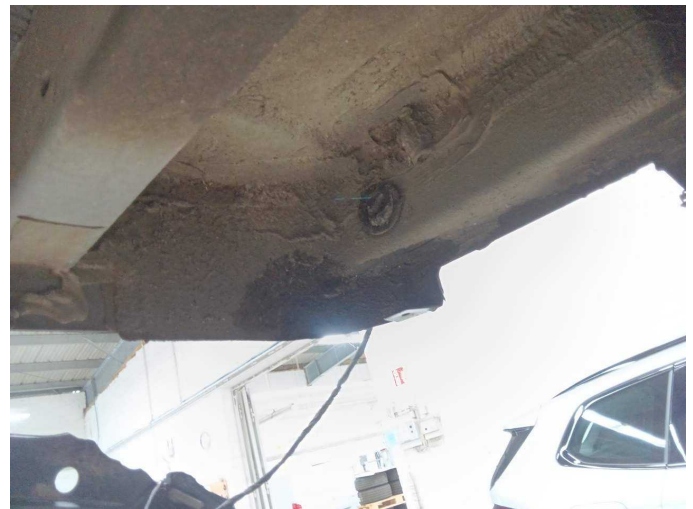
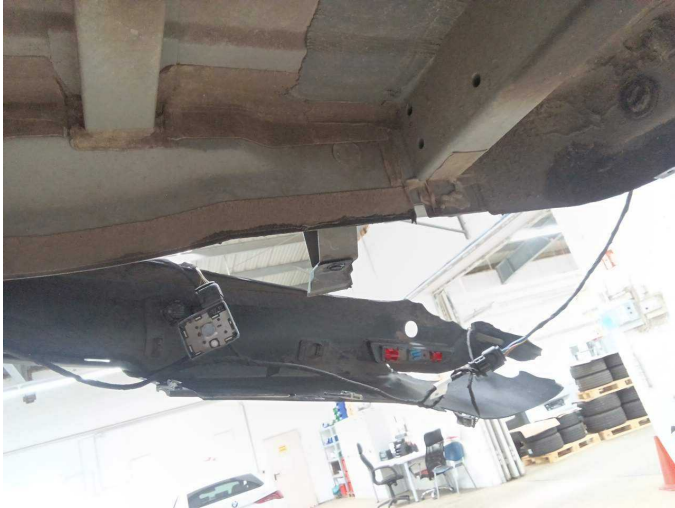
Accident 1: Rear

Non-repaired previous damages were found at the vehicle. The necessary repair costs are listed in the expert report or if necessary, are listed in detail in a separately enclosed repair cost calculation.
