Expertise

Protocol number: 46907980  
Order No. / Reference: 26811263  
Inspection date: 4 Aug 2026

Manufacturer: Toyota  
VIN: YARECYHT2GJ018815

Model: Proace City Verso 1.5 D-4D L1 Shuttle

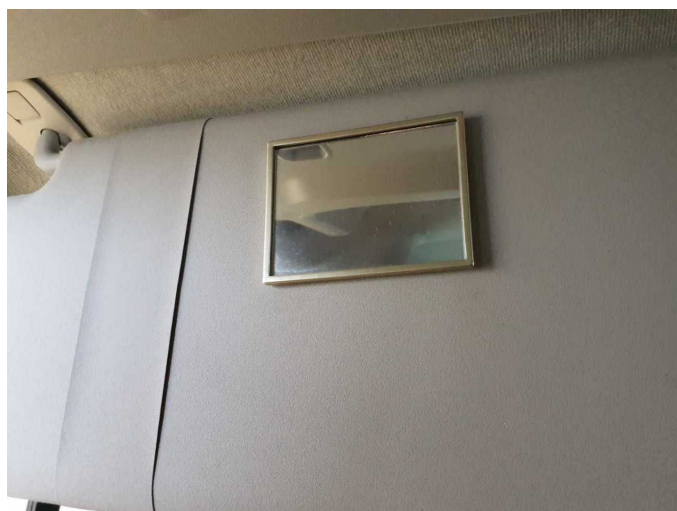
| No. | Component group | Description |
|---|---|---|
| 1 | Interior | Sun visor - left side (Spiegel angebracht) - Differs from the original configuration - No deduction |

**Damage 1:** Interior: Sun visor - left side (Spiegel angebracht) - Differs from the original configuration - No deduction

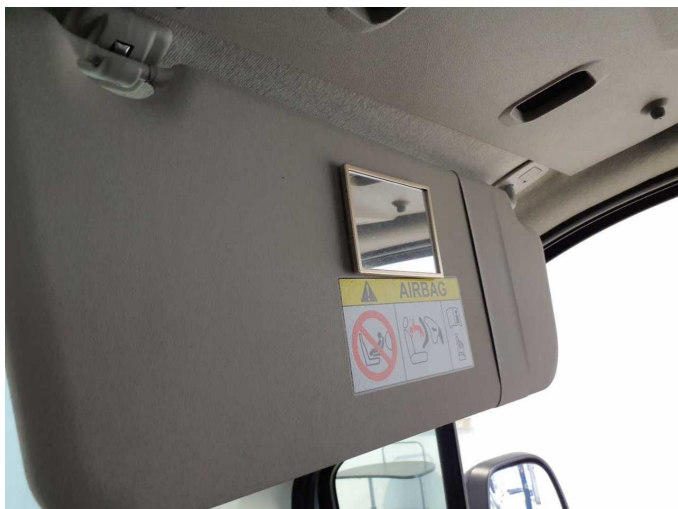
| No. | Component group | Description |
|---|---|---|
| 2 | Interior | Sun visor - right side (Spiegel angebracht) - Differs from the original configuration - No deduction |

**Damage 2:** Interior: Sun visor - right side (Spiegel angebracht) - Differs from the original configuration - No deduction

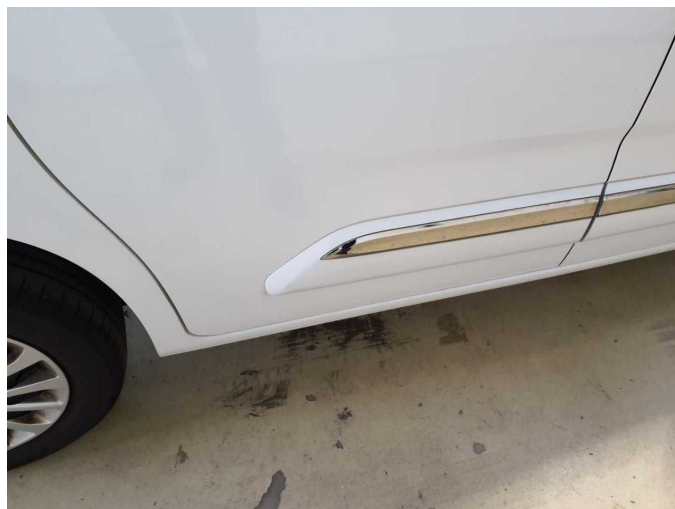
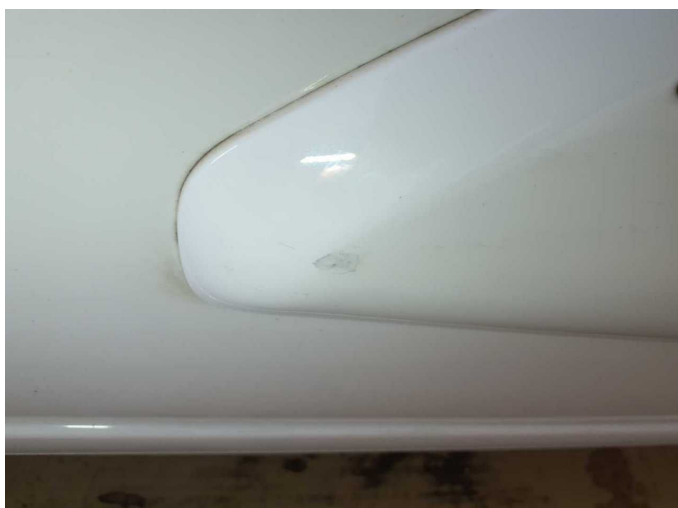
| No. | Component group | Description |
|---|---|---|
| 4 | Door - rear right side | Brightware - lower - Scratch(es) - Loss in value |

**Damage 4:** Door - rear right side: Brightware - lower - Scratch(es) - Loss in value

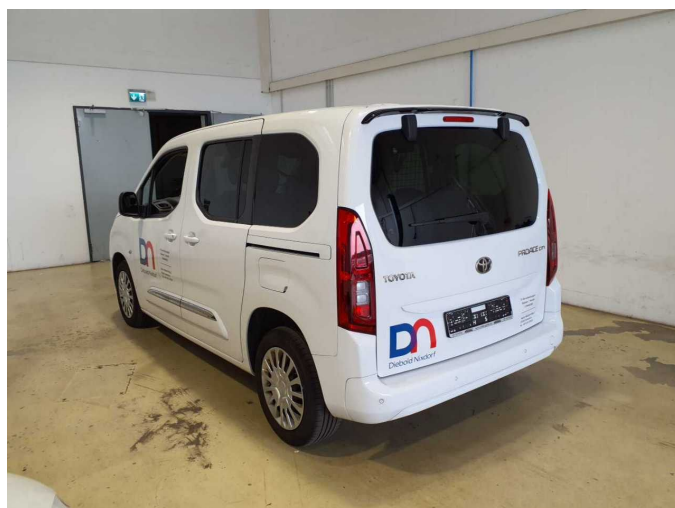
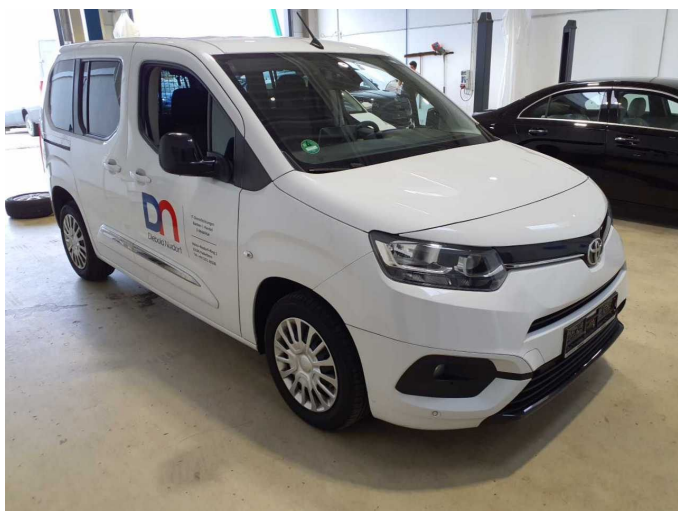
| No. | Component group | Description |
|---|---|---|
| 5 | Body | Body - Glued / labelled - De-glue / neutralise |

**Damage 5:** Body: Body - Glued / labelled - De-glue / neutralise

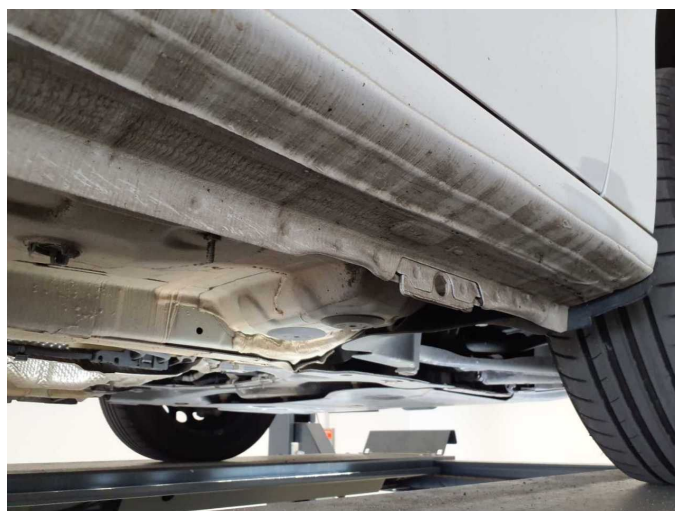
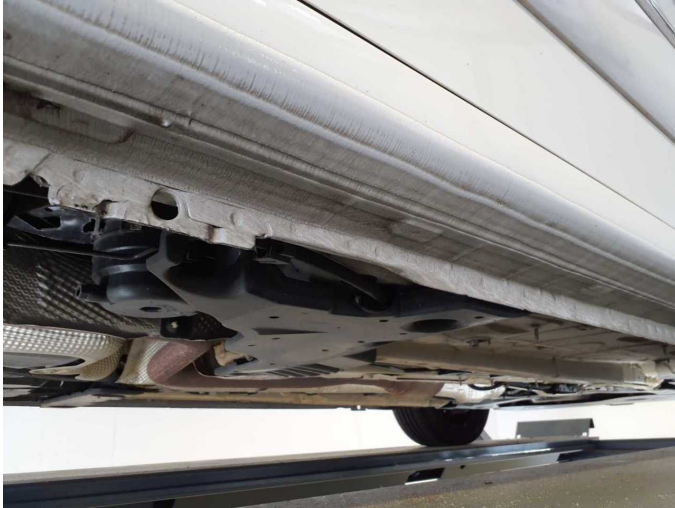
| No. | Component group | Description |
|---|---|---|
| 6 | Sill - right side | Sill - dent(s) - Smart repair |

**Damage 6:** Sill - right side: Sill - dent(s) - Smart repair

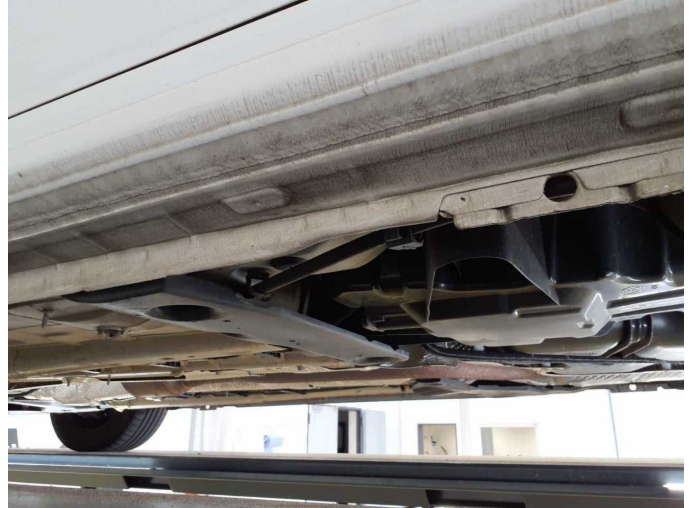
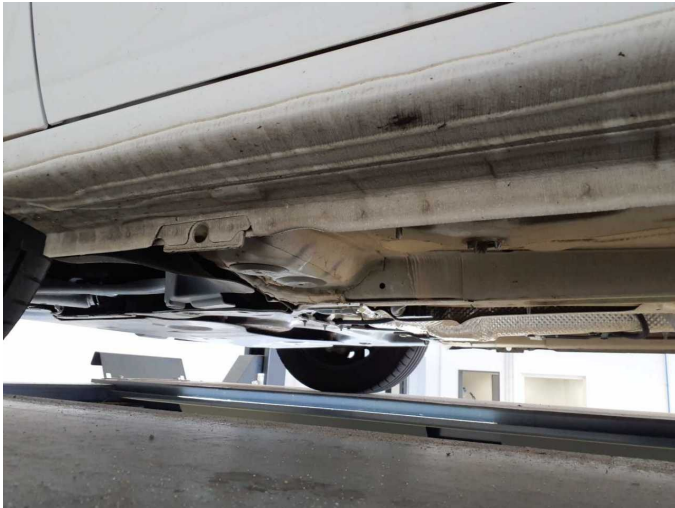
| No. | Component group | Description |
|---|---|---|
| 7 | Sill - left side | Sill - dent(s) - Smart repair |

**Damage 7:** Sill - left side: Sill - dent(s) - Smart repair

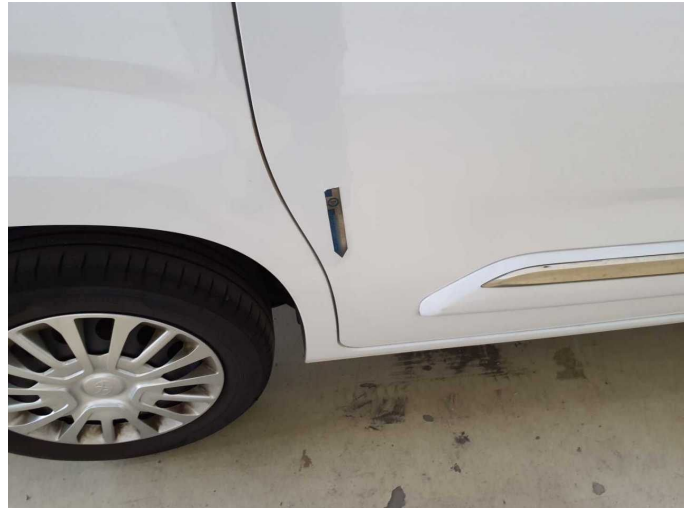
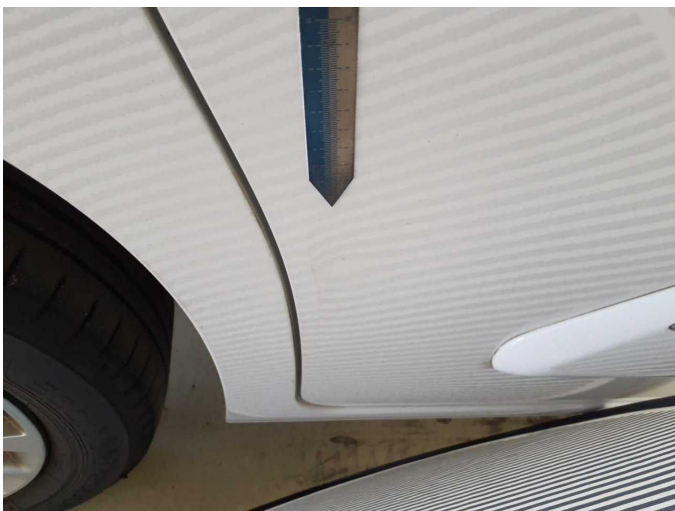
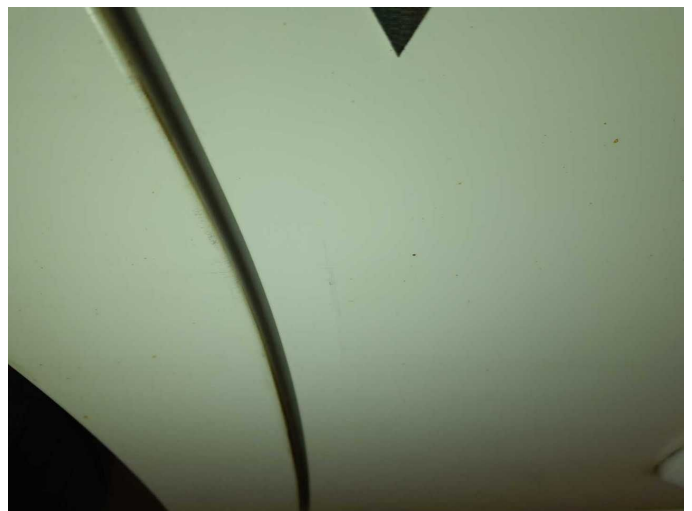
| No. | Component group | Description |
|---|---|---|
| 8 | Door - rear right side | Door - Dent / paintcoat damage - Smart repair |

**Damage 8:** Door - rear right side: Door - Dent / paintcoat damage - Smart repair

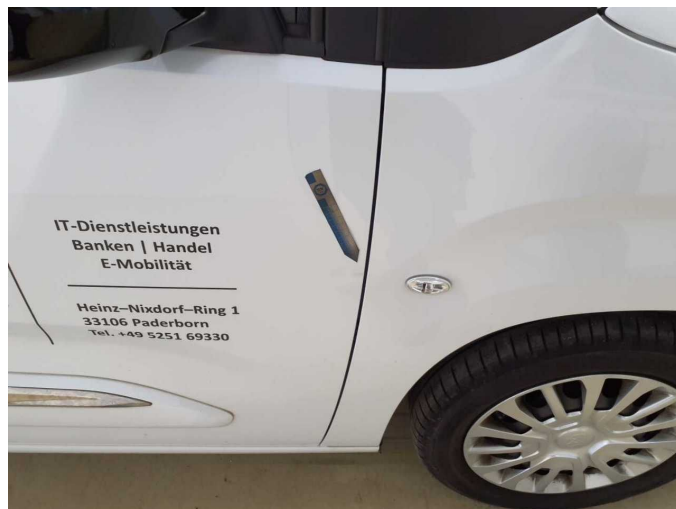
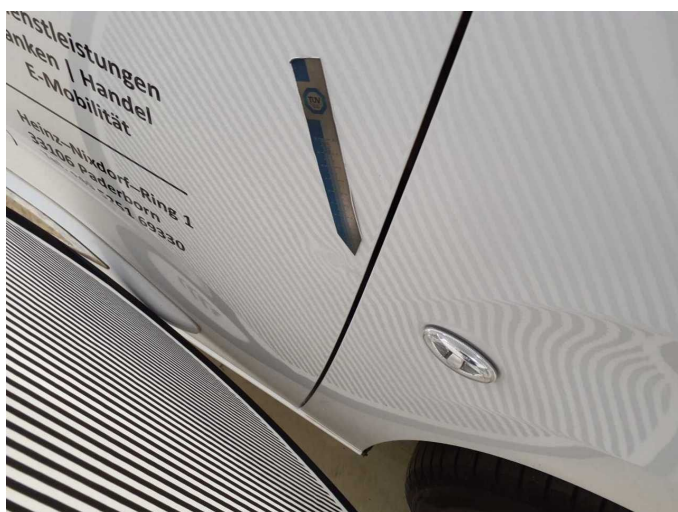
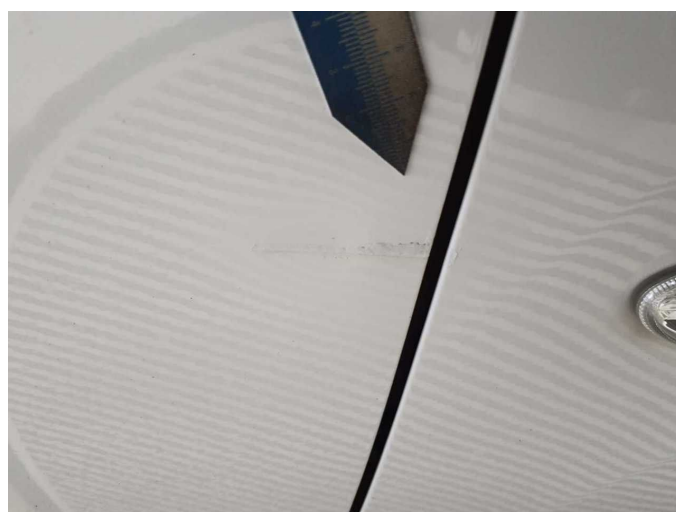
| No. | Component group | Description |
|---|---|---|
| 9 | Door - front right side | Door - Dent / paintcoat damage - Smart repair |

**Damage 9:** Door - front right side: Door - Dent / paintcoat damage - Smart repair

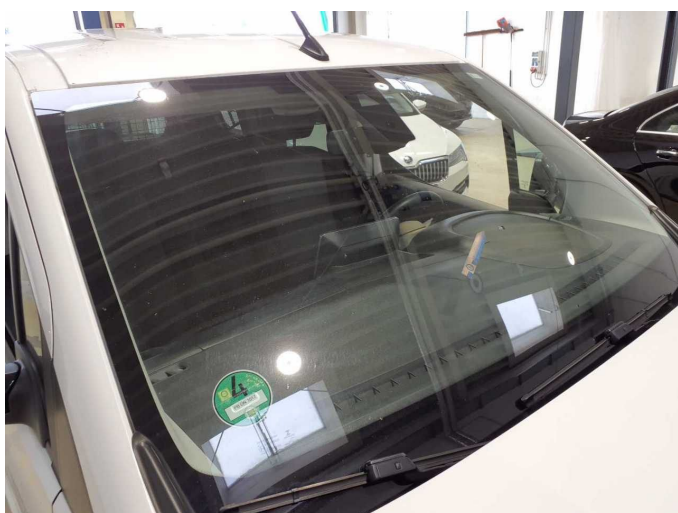
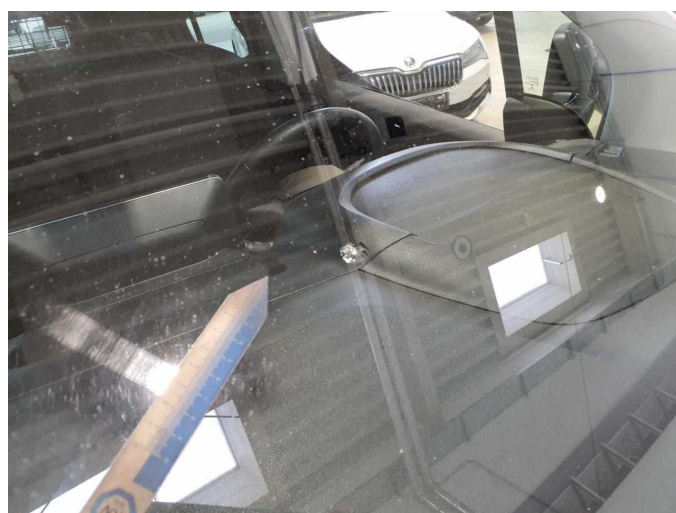
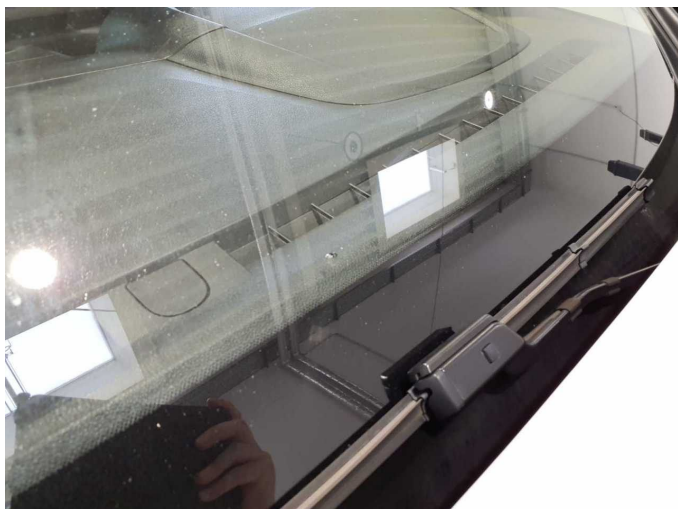
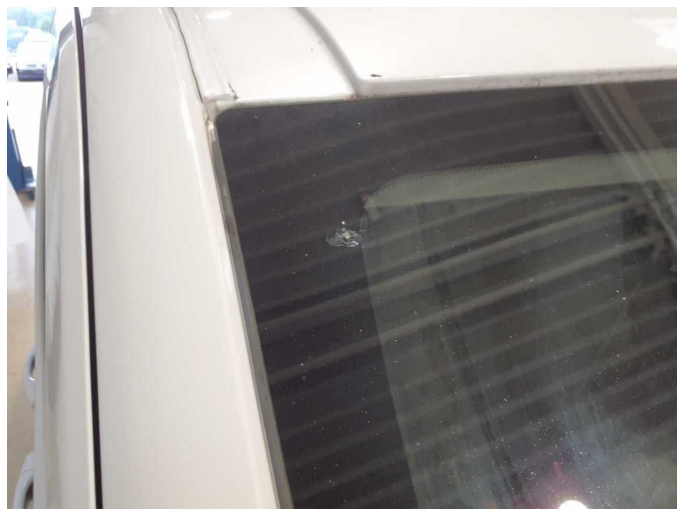
| No. | Component group | Description |
|---|---|---|
| 10 | Vehicle glazing | Windscreen (kein Staubschutz) - Broken / torn - Replace |

**Damage 10:** Vehicle glazing: Windscreen (kein Staubschutz) - Broken / torn - Replace

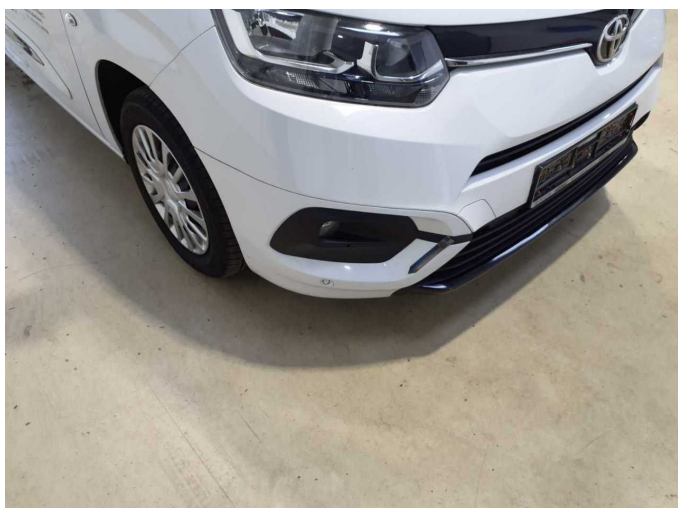
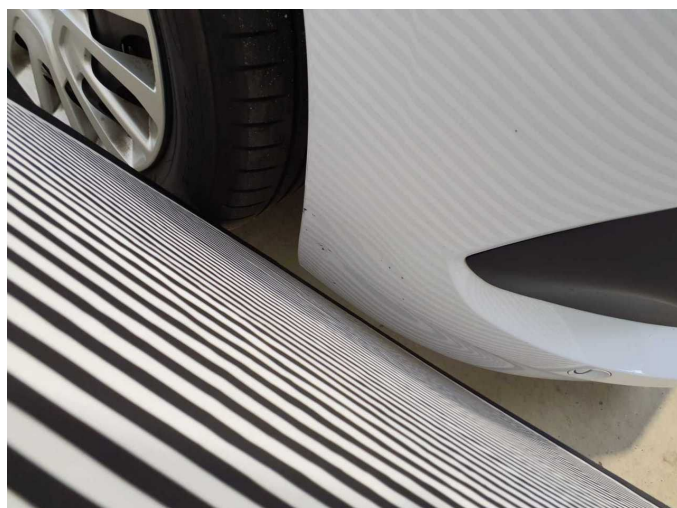
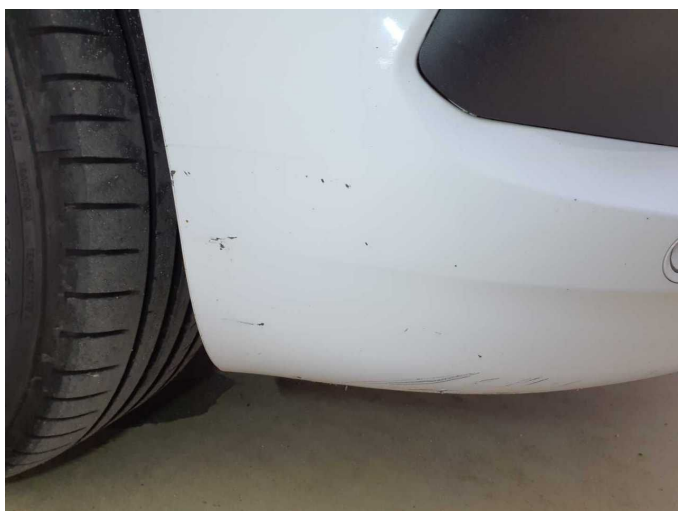
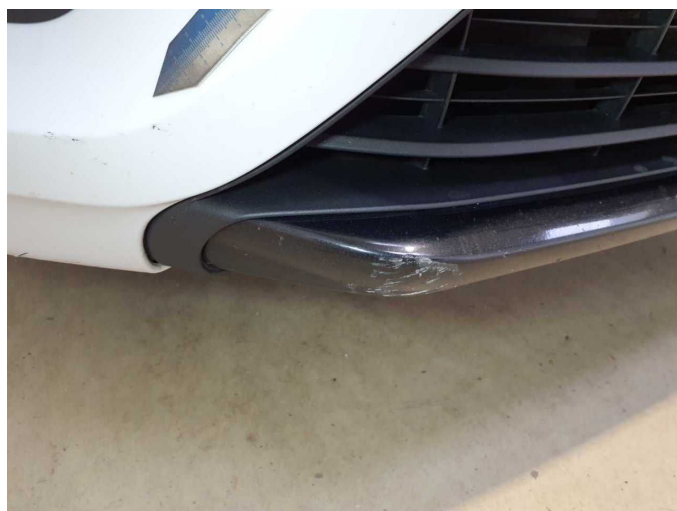
| No. | Component group | Description |
|---|---|---|
| 11 | Front bumper | Front bumper (Inklusive anbauteile) - Dent / paintcoat damage - Repair and paint |

**Damage 11:** Front bumper: Front bumper (Inklusive anbauteile) - Dent / paintcoat damage - Repair and paint

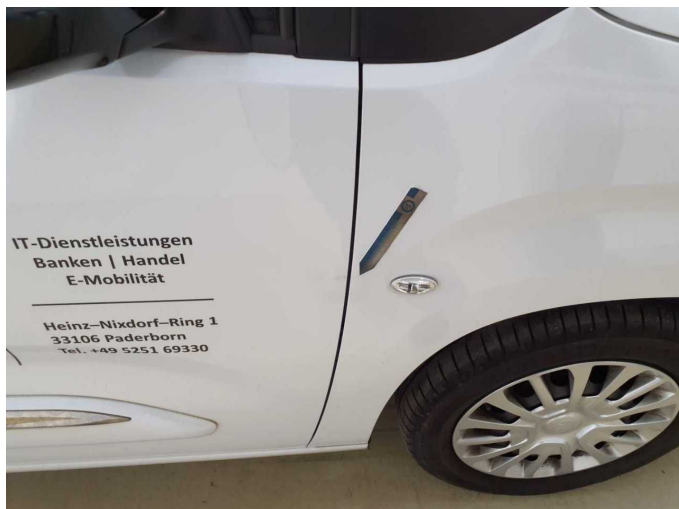
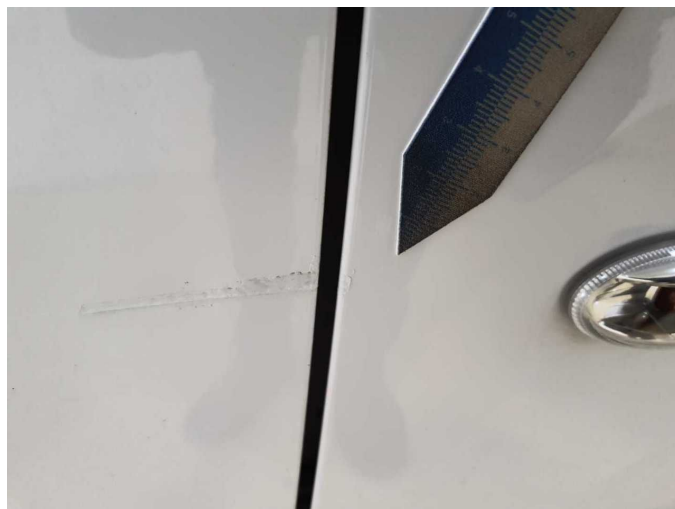
| No. | Component group | Description |
|---|---|---|
| 9 | Mudguard - right side | Mudguard - right side - Scratch(es) - Cover / polish |

**Wear and tear 9:** Mudguard - right side: Mudguard - right side - Scratch(es) - Cover / polish

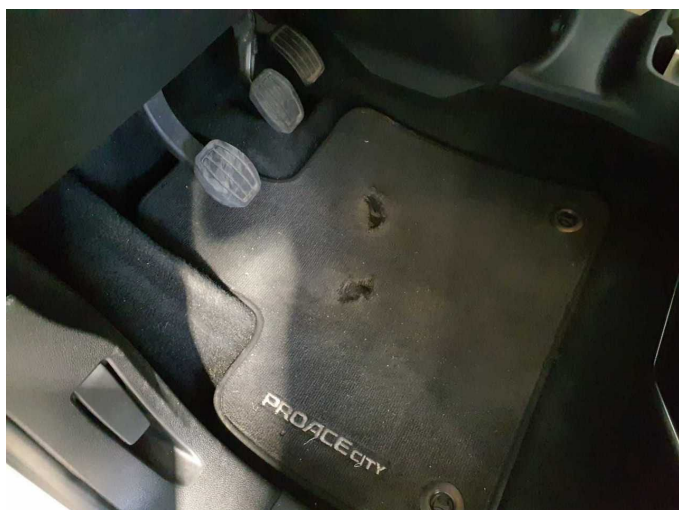
| No. | Component group | Description |
|---|---|---|
| 10 | Trim / covers | Floor mats - Broken / torn - No deduction |

**Wear and tear 10:** Trim / covers: Floor mats - Broken / torn - No deduction

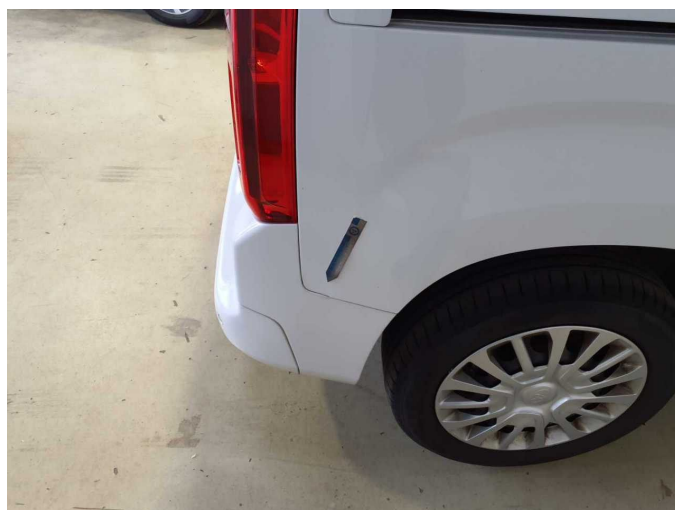
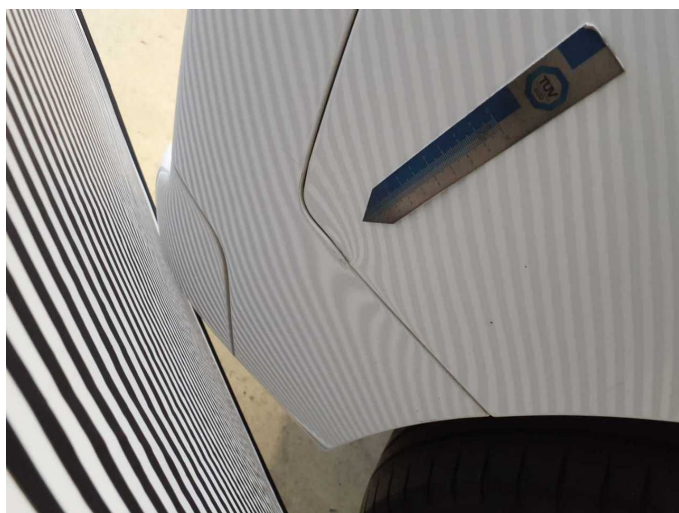
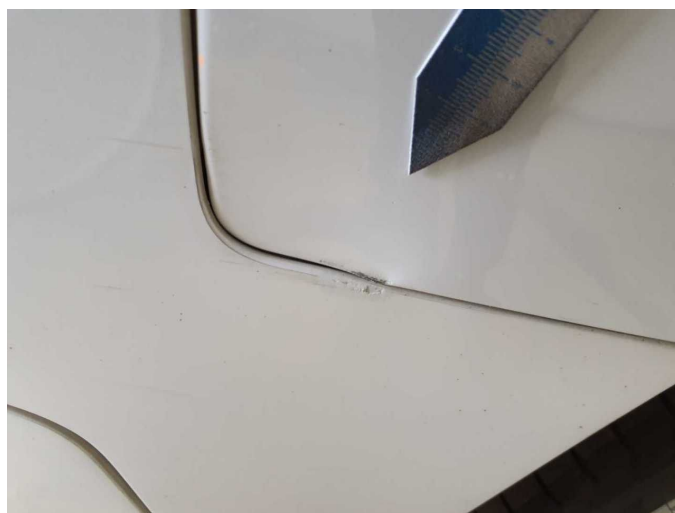
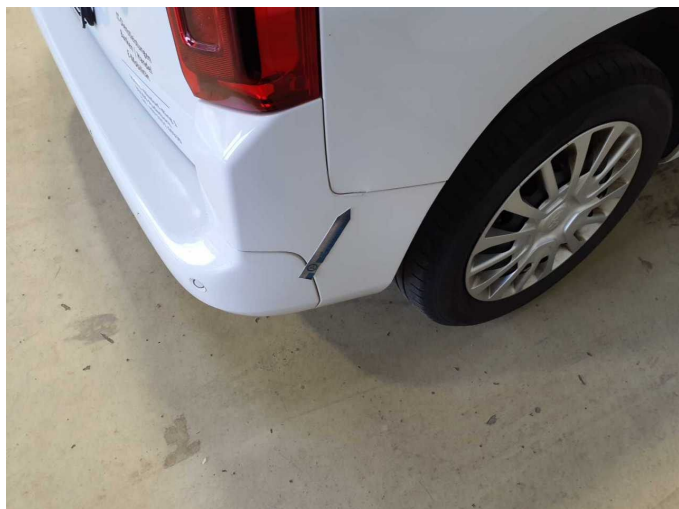
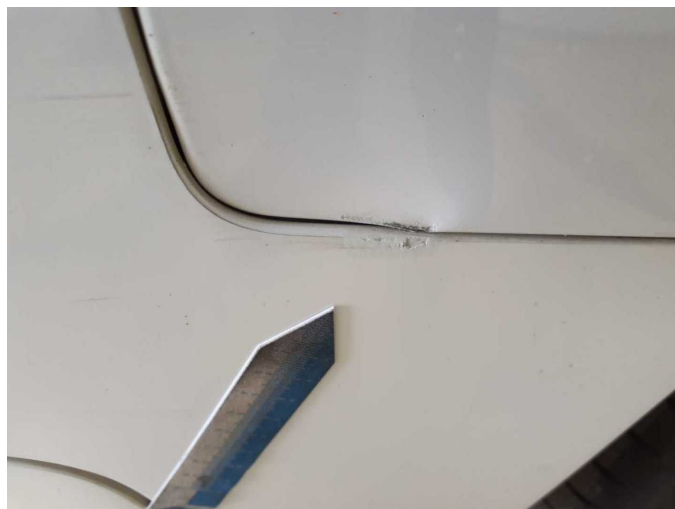
1 Rear, Side right

Non-repaired previous damages were found at the vehicle. The necessary repair costs are listed in the expert report or if necessary, are listed in detail in a separately enclosed repair cost calculation.

**Accident 1:** Rear, Side right
