## Expertise

Protocol number: 46280423  
Order No. / Reference: 26554200  
Inspection date: 1 Jul 2026

Model: Focus Turnier 1.5 EcoBlue Start-Stopp-System  
COOL&CONNECT

VIN: WF0PXXGCHPLS81489

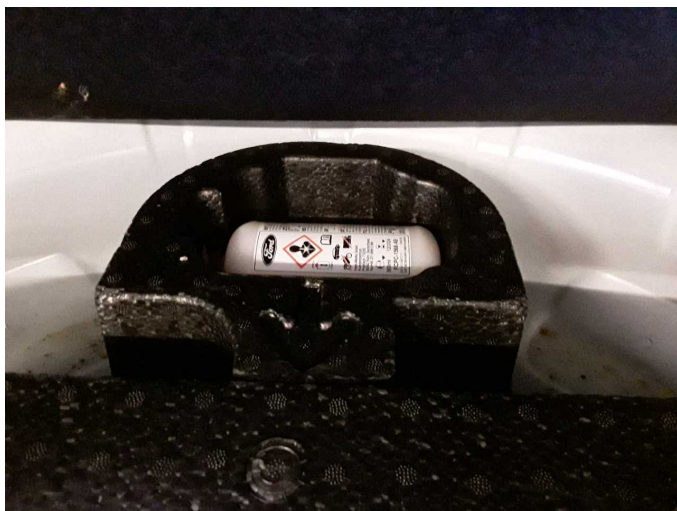
No.	Component group	Description
1	Misc.	Main inspection - No evidence - No deduction
2	Equipment	Tirefit filler - Expired - Replace
3	Rear bumper	Rear bumper - Scratch(es) - Paint
4	Door - front right side	Door - Dent / paintcoat damage - Repair and paint

Damage 2: Equipment: Tirefit filler - Expired - Replace

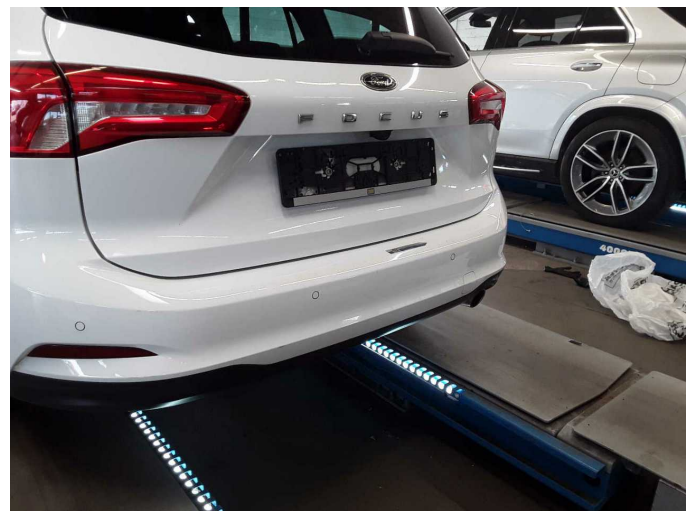
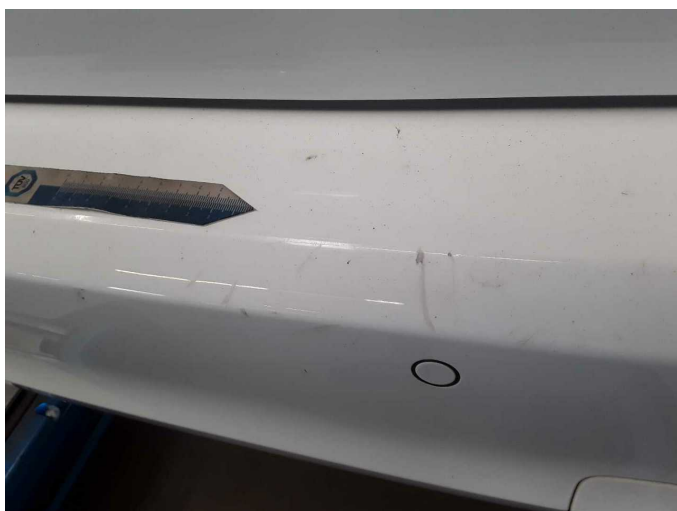
Damage 3: Rear bumper: Rear bumper - Scratch(es) - Paint

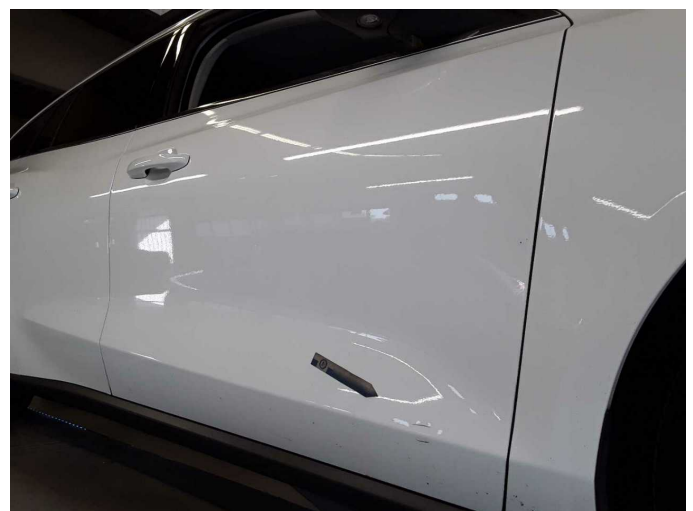
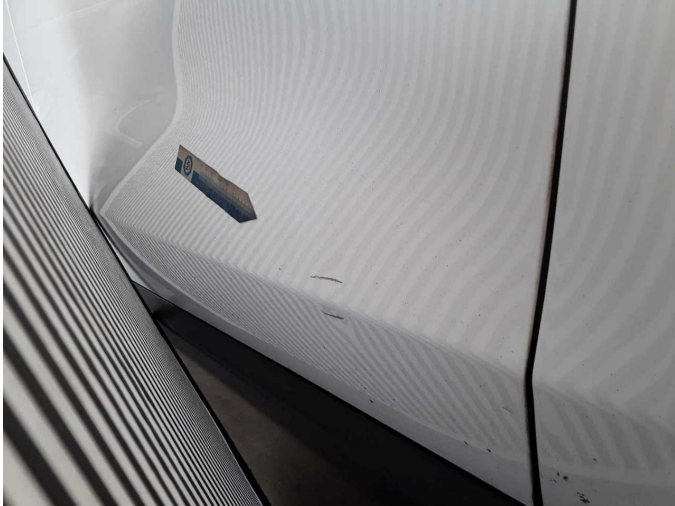
Damage 4: Door - front right side: Door - Dent / paintcoat damage - Repair and paint

**Damage 4:** Door - front right side: Door - Dent / paintcoat damage - Repair and paint

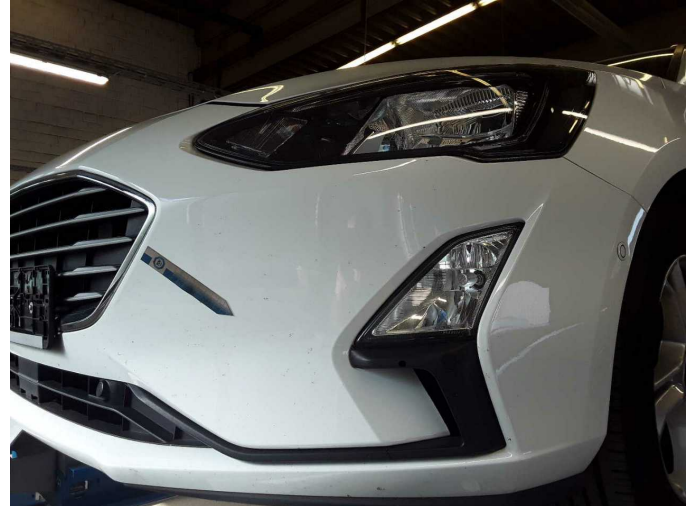
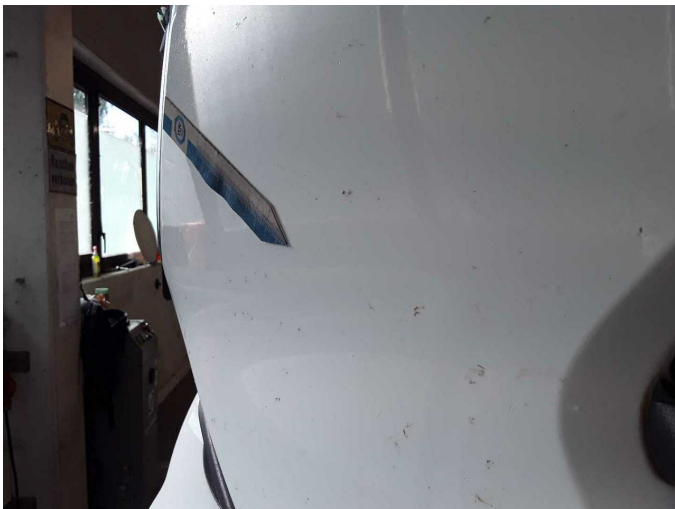
**Wear and tear 1:** Front bumper: Front bumper - Stone chips - No deduction

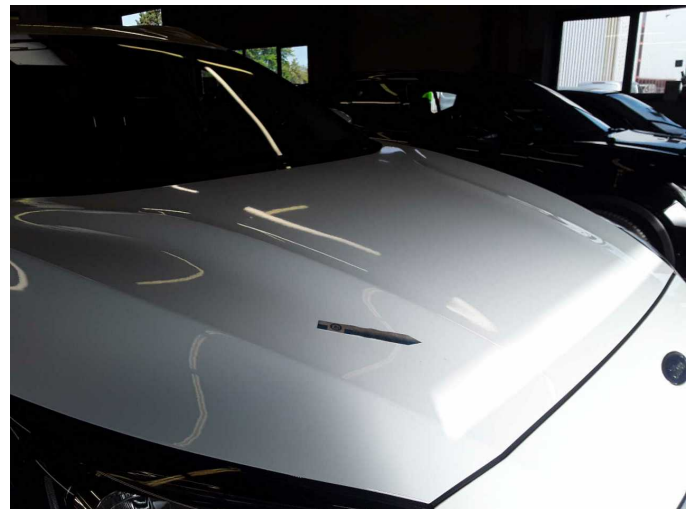
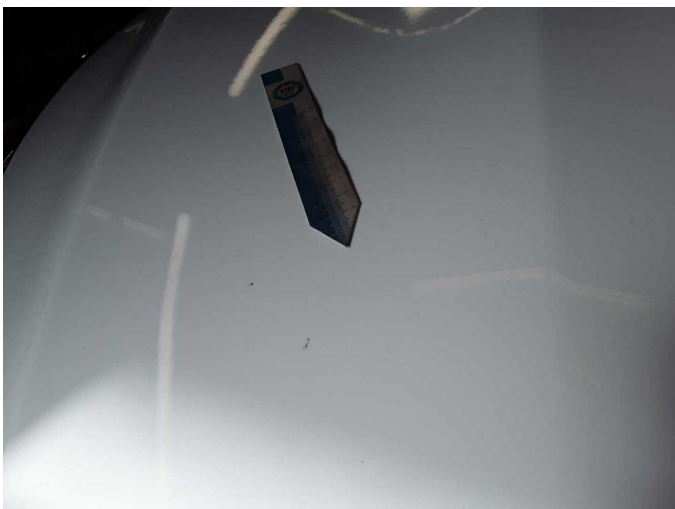
**Wear and tear 2:** Bonnet: Bonnet - Stone chips - No deduction

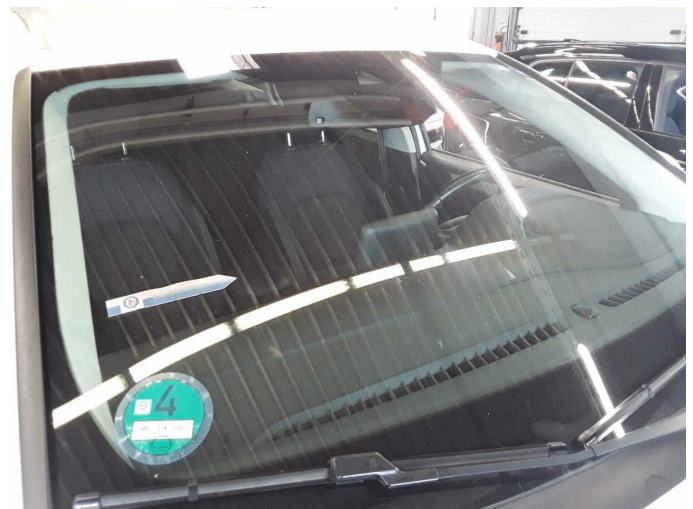
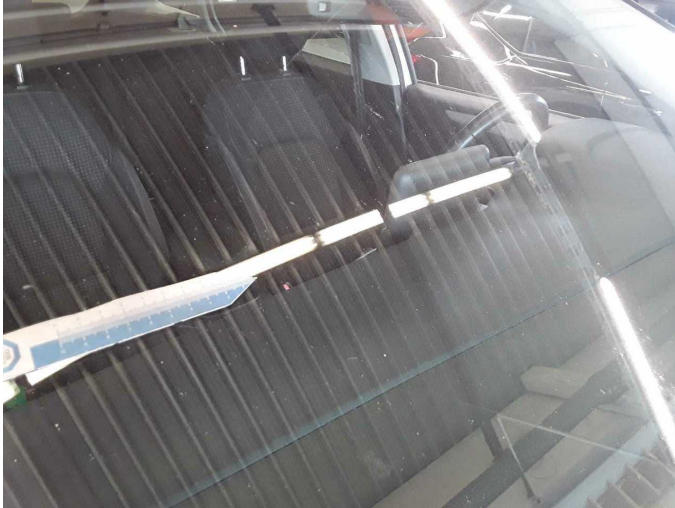
**Wear and tear 3:** Vehicle glazing: Windscreen - Stone chips - No deduction

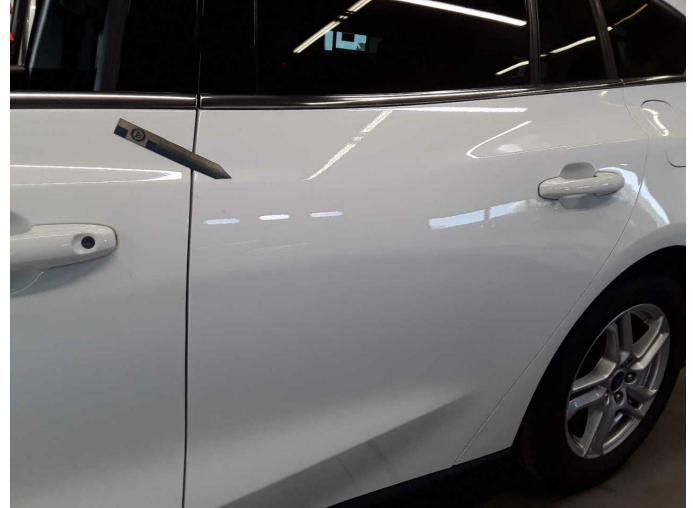
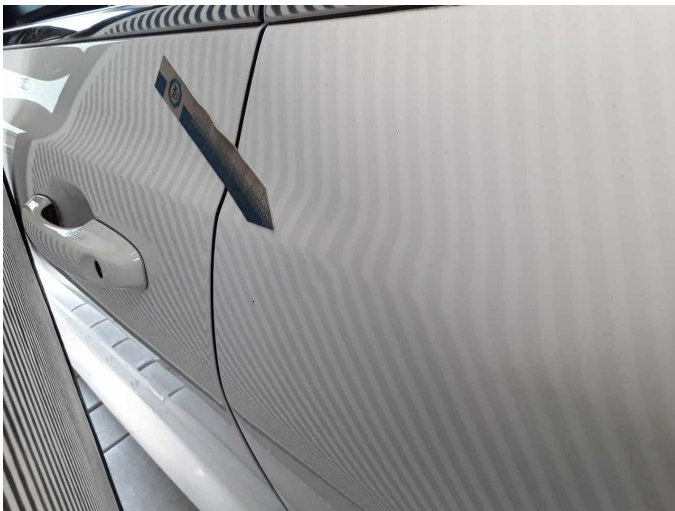
**Wear and tear 6:** Door - rear left side: Door - dent(s) - Smooth repair work

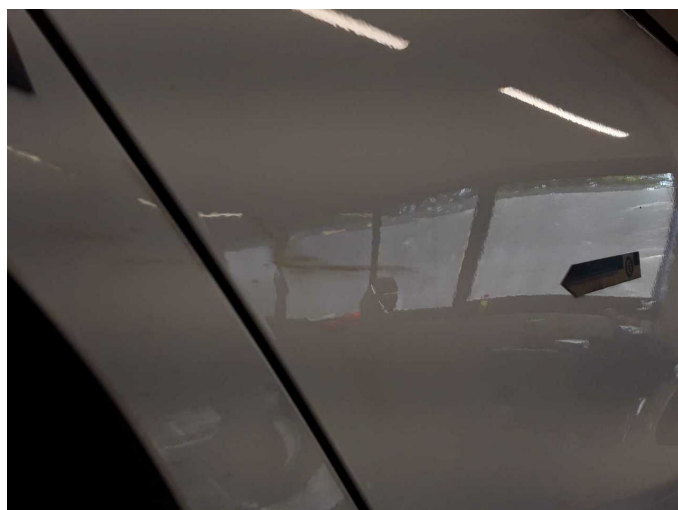
Accident 1: Side right
