Expertise

Protocol number: 46407092  
Order No. / Reference: 26539918  
Inspection date: 8 Jul 2026

Manufacturer: Volkswagen

Model: Caddy 2.0 TDI BMT (7-Si.) DSG Life Maxi

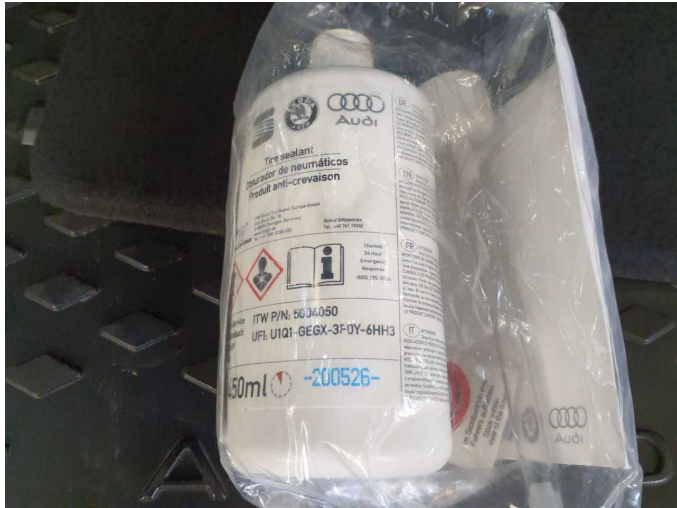
| No. | Component group | Description |
|---|---|---|
| 2 | Equipment | Tirefit filler - Expired - Replace |

**Damage 2:** Equipment: Tirefit filler - Expired - Replace

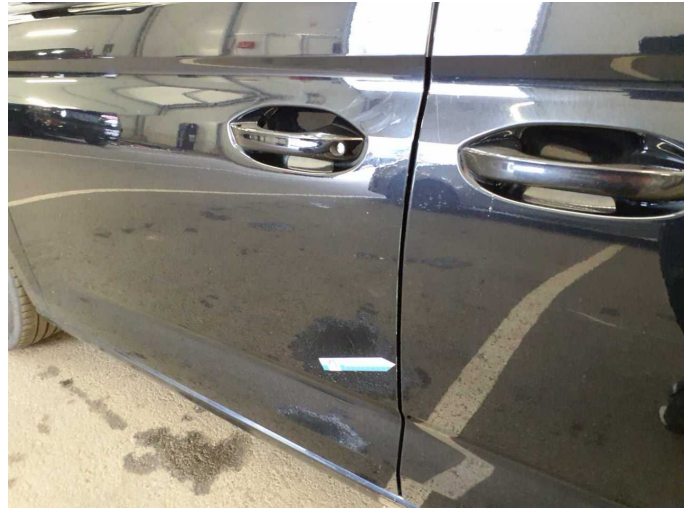
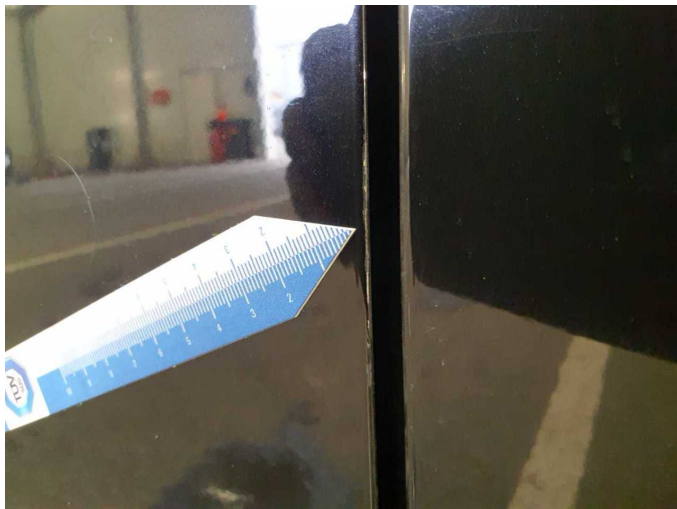
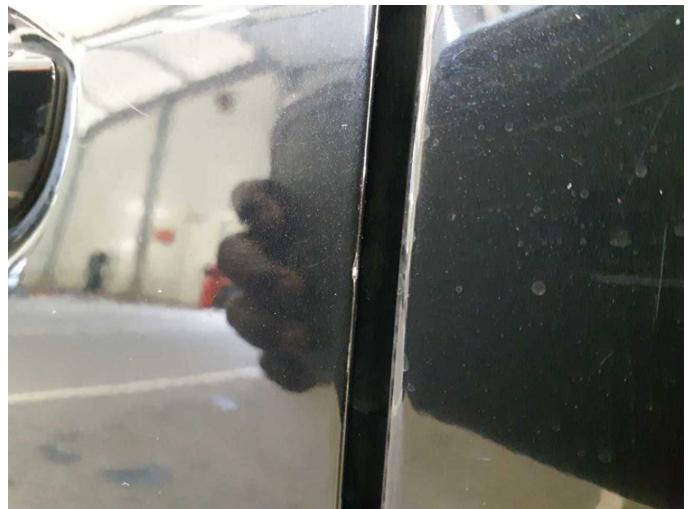
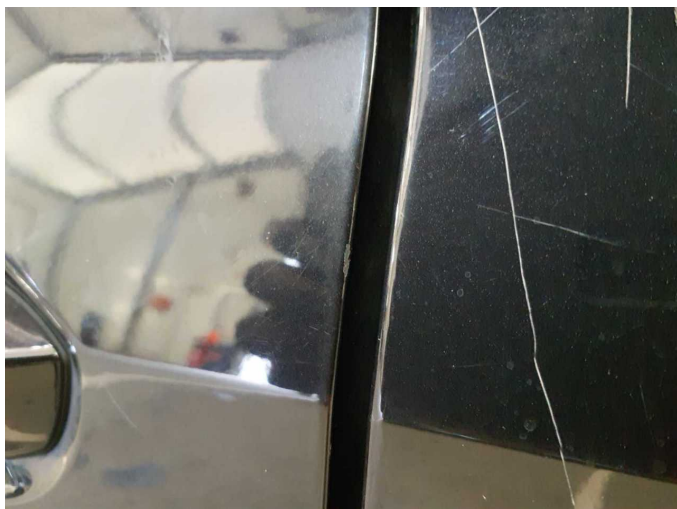
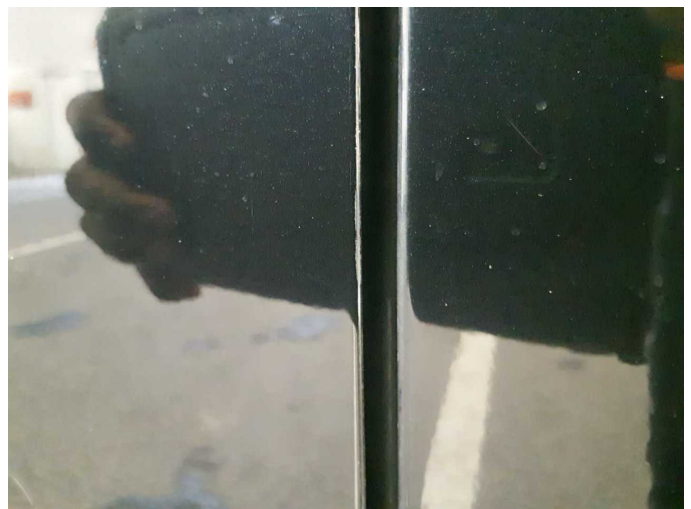
| No. | Component group | Description |
|---|---|---|
| 3 | Door - front left side | Door edge - Scratch(es) - Smart repair |

**Damage 3:** Door - front left side: Door edge - Scratch(es) - Smart repair

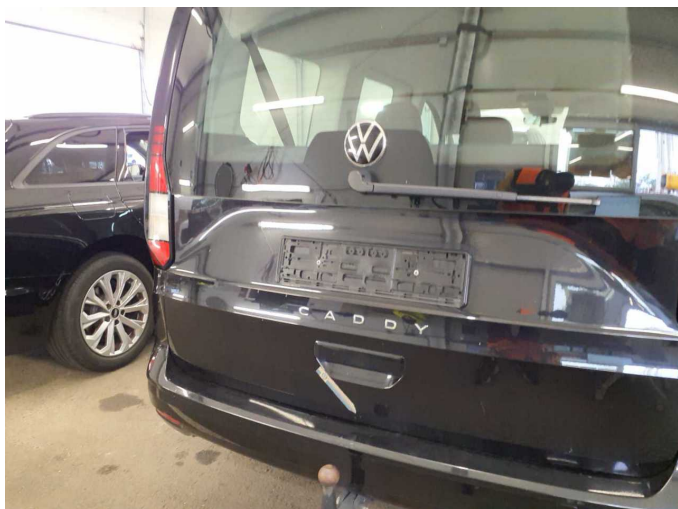
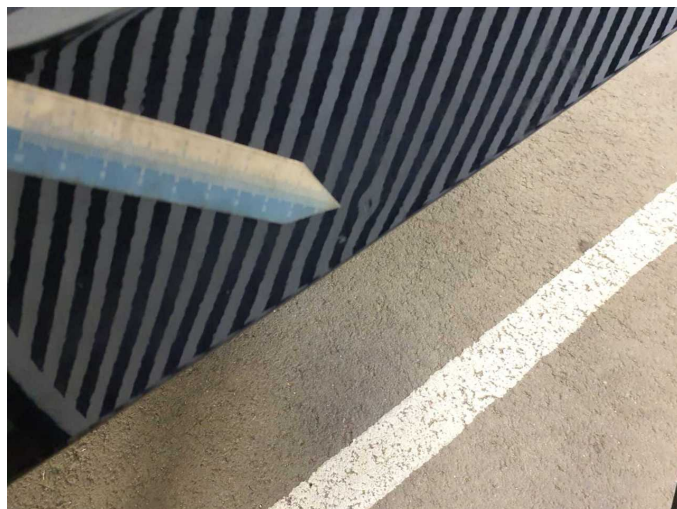
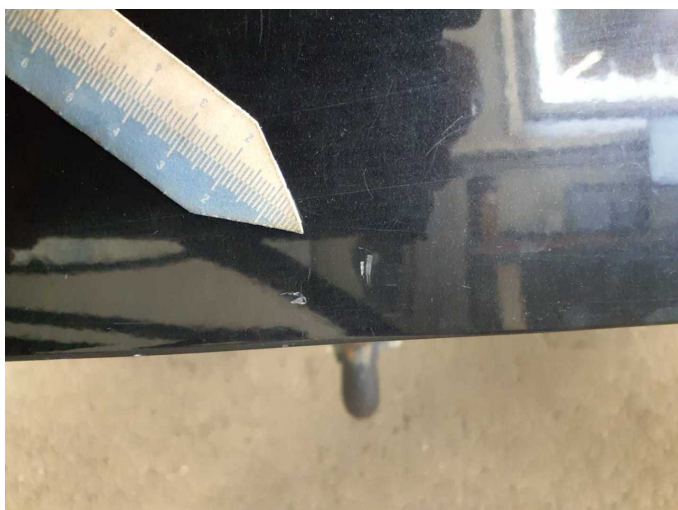
| No. | Component group | Description |
|---|---|---|
| 4 | Boot lid / rear door | Boot lid - dent(s) - Paint |

**Damage 4:** Boot lid / rear door: Boot lid - dent(s) - Paint

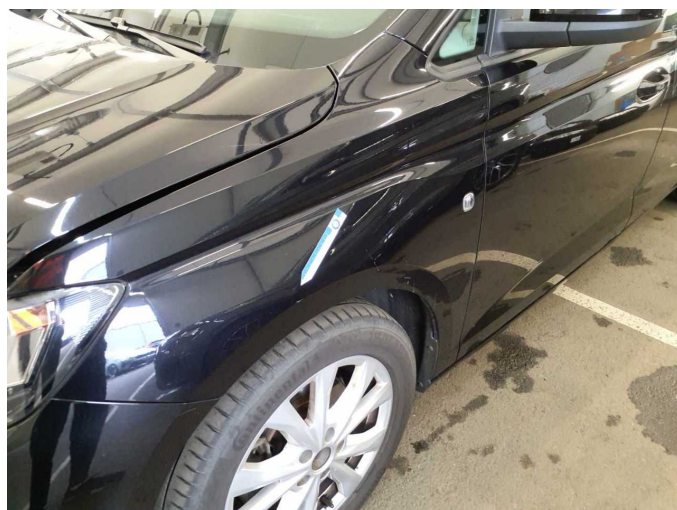
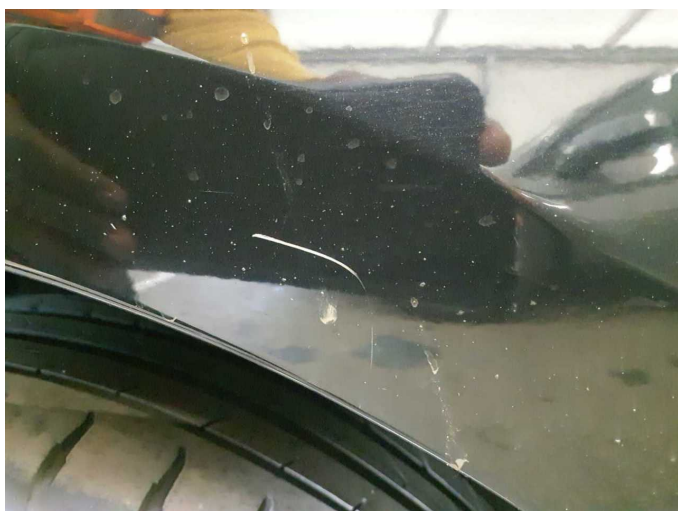
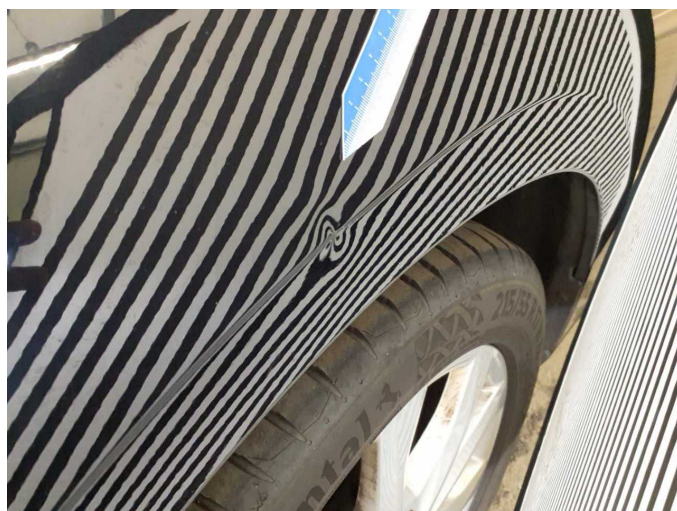
| No. | Component group | Description |
|---|---|---|
| 5 | Mudguard - left side | Mudguard - left side - Dent / paintcoat damage - Repair and paint |

**Damage 5:** Mudguard - left side: Mudguard - left side - Dent / paintcoat damage - Repair and paint

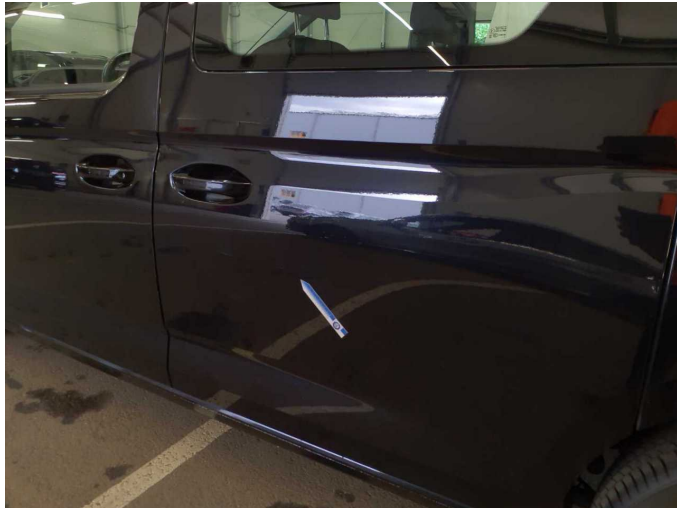
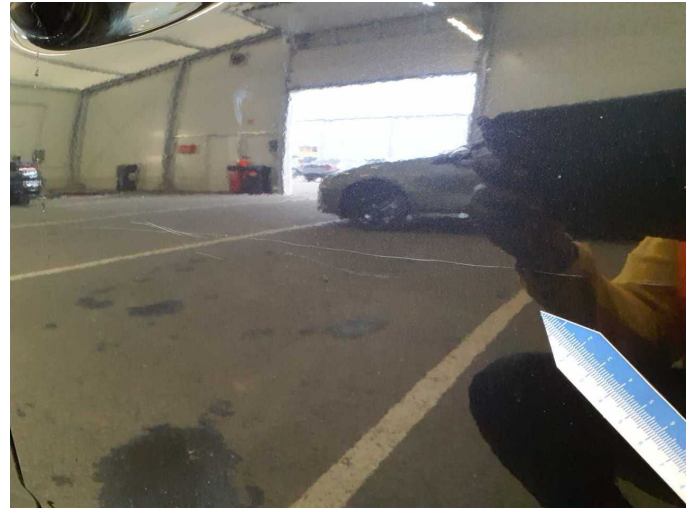
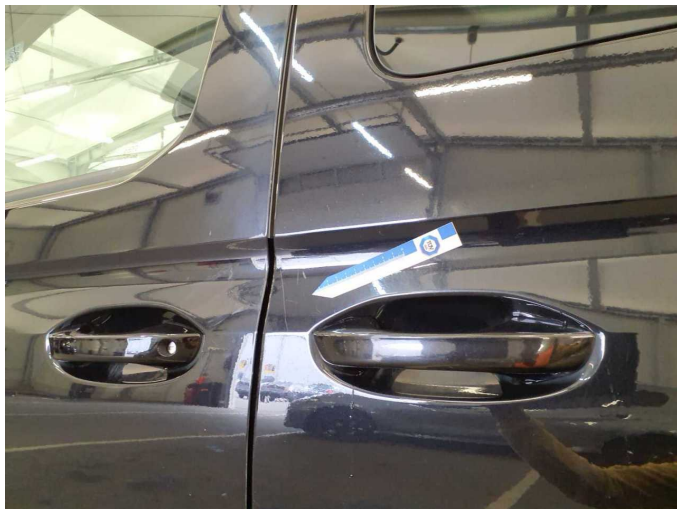
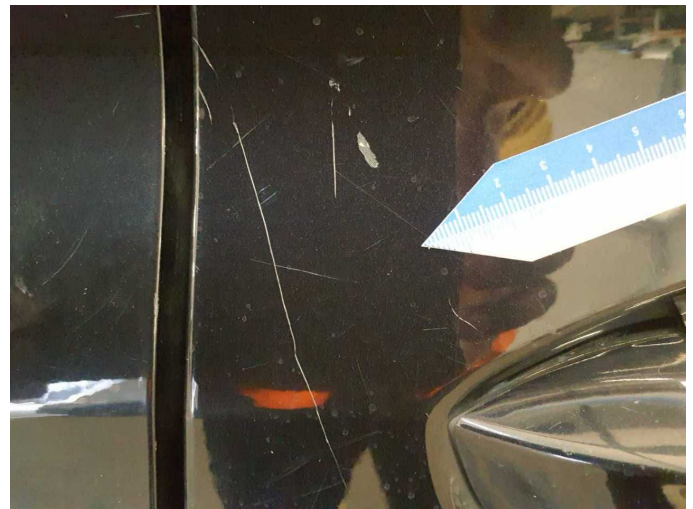
| No. | Component group | Description |
|---|---|---|
| 6 | Sliding door - left side | Sliding door with glass panel - Scratch(es) - Paint |

**Damage 6:** Sliding door - left side: Sliding door with glass panel - Scratch(es) - Paint

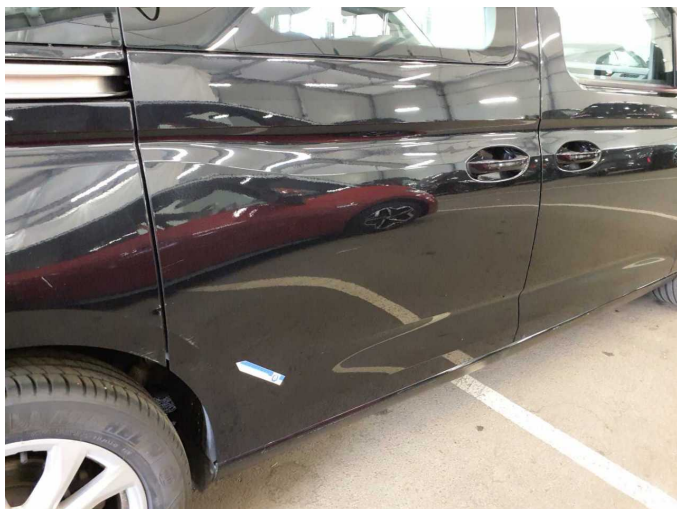
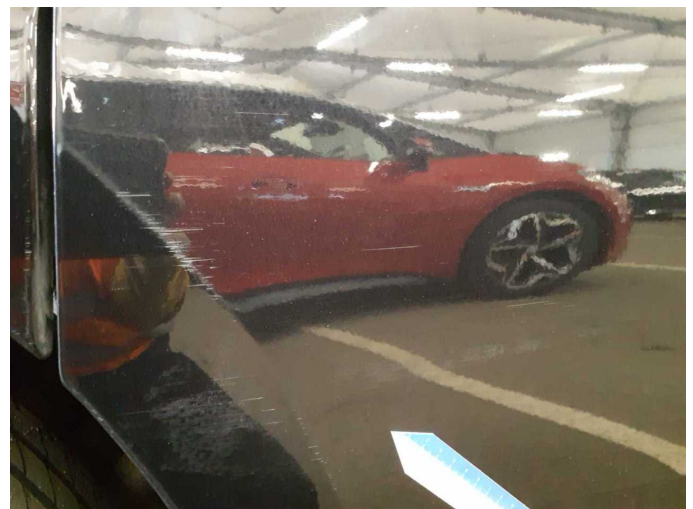
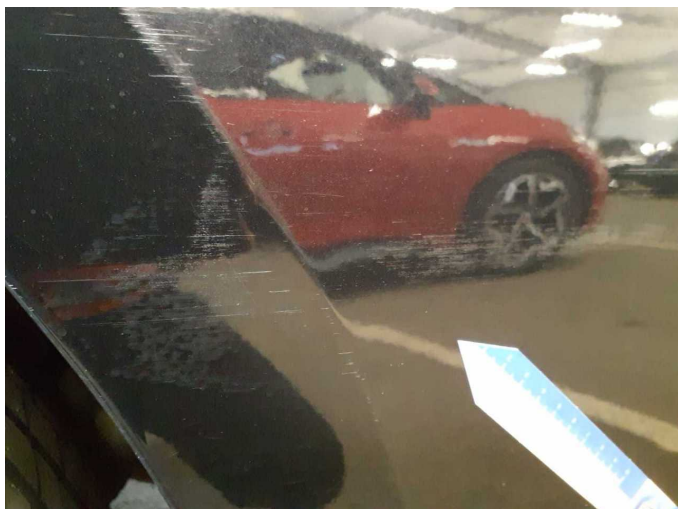
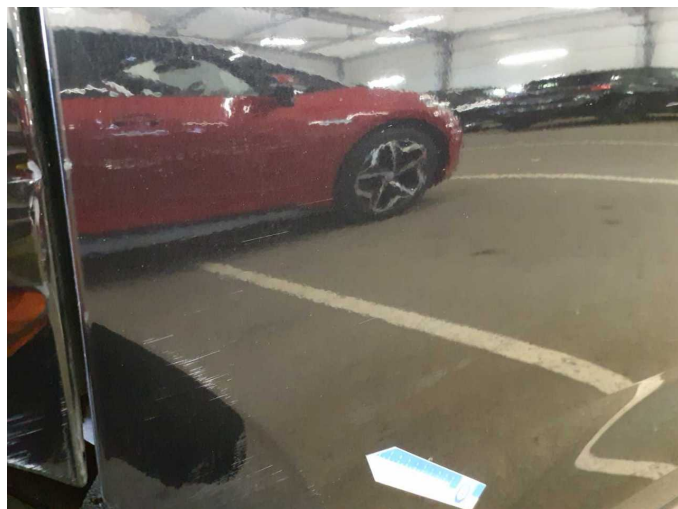
| No. | Component group | Description |
|---|---|---|
| 7 | Sliding door, right | Sliding door with glass panel - Scratch(es) - Paint |

**Damage 7:** Sliding door, right: Sliding door with glass panel - Scratch(es) - Paint

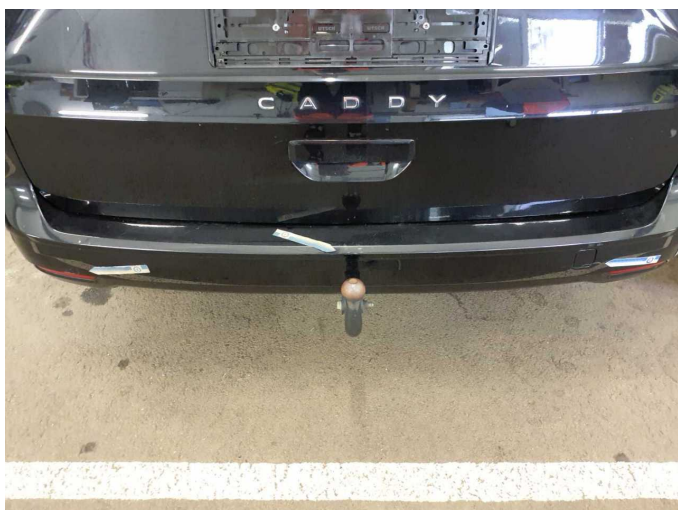
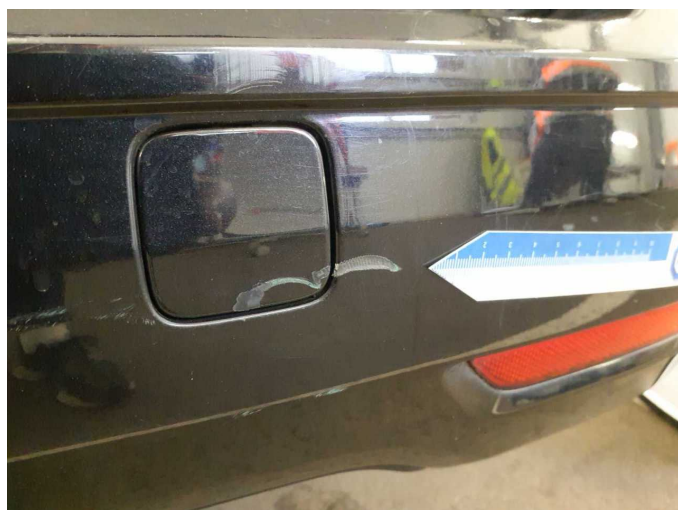
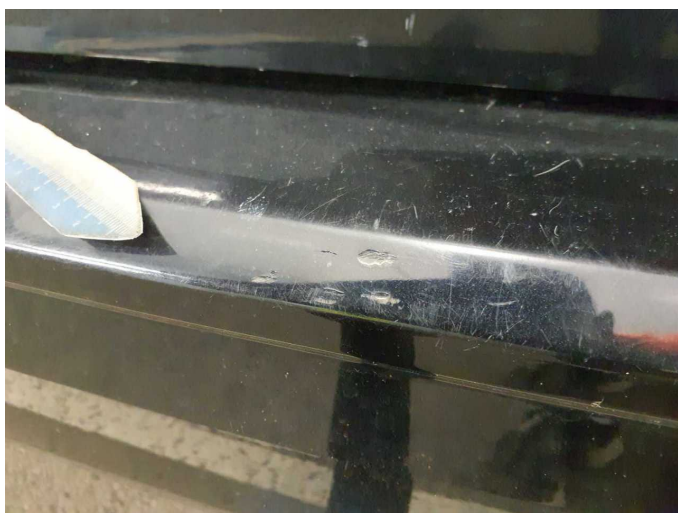
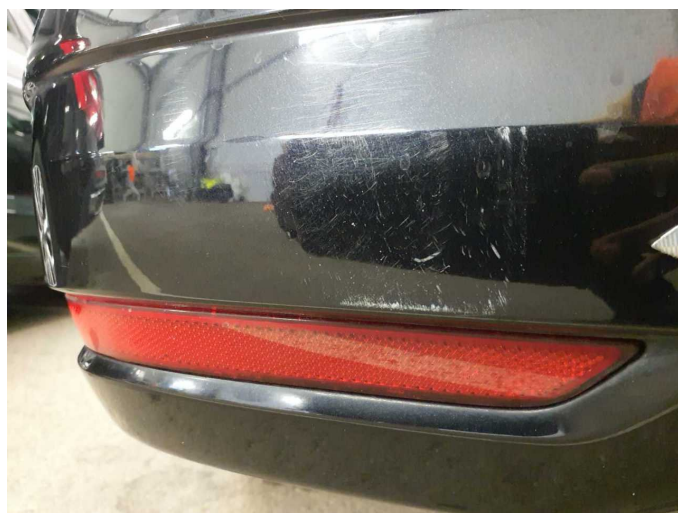
| No. | Component group | Description |
|---|---|---|
| 8 | Rear bumper | Rear bumper - Scratch(es) - Paint |

**Damage 8:** Rear bumper: Rear bumper - Scratch(es) - Paint

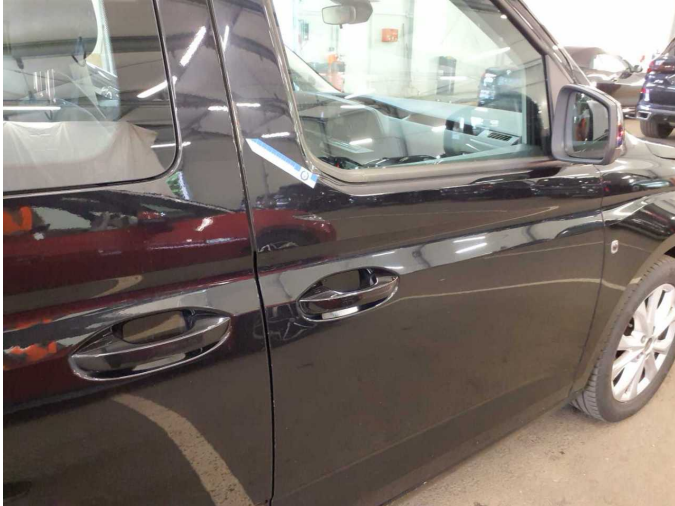
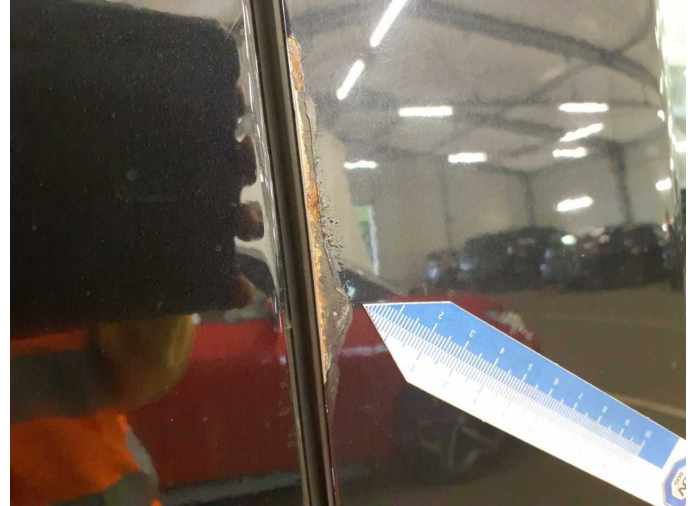
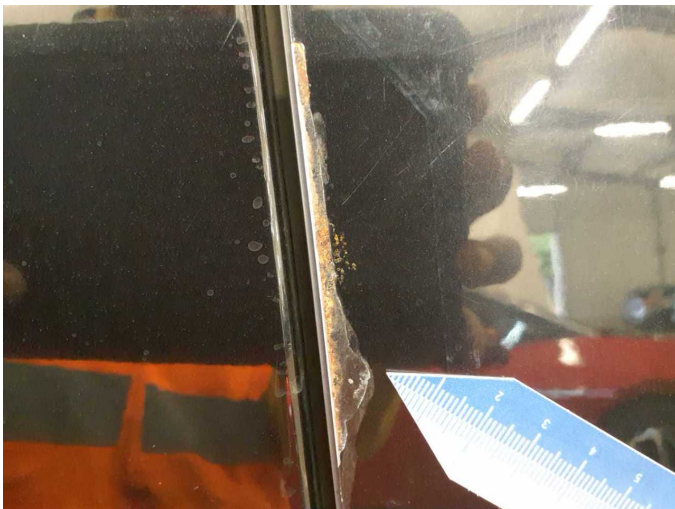
| No. | Component group | Description |
|---|---|---|
| 9 | Door - front right side | Door edge (+ Korrosion) - Paint defect - Repair and paint |

**Damage 9:** Door - front right side: Door edge (+ Korrosion) - Paint defect  
- Repair and paint

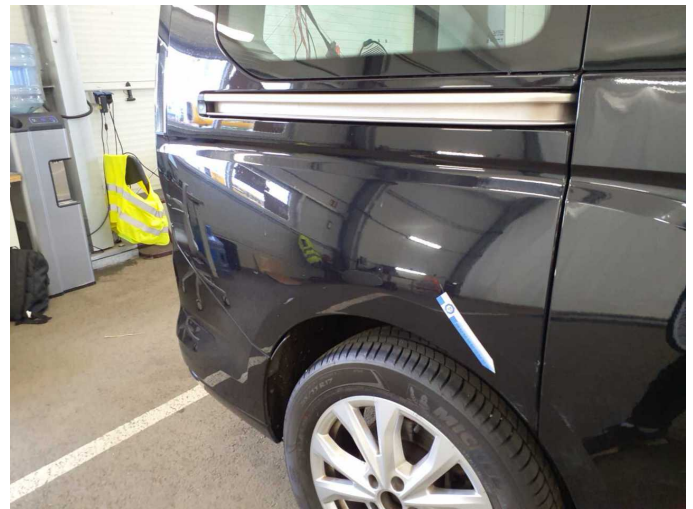
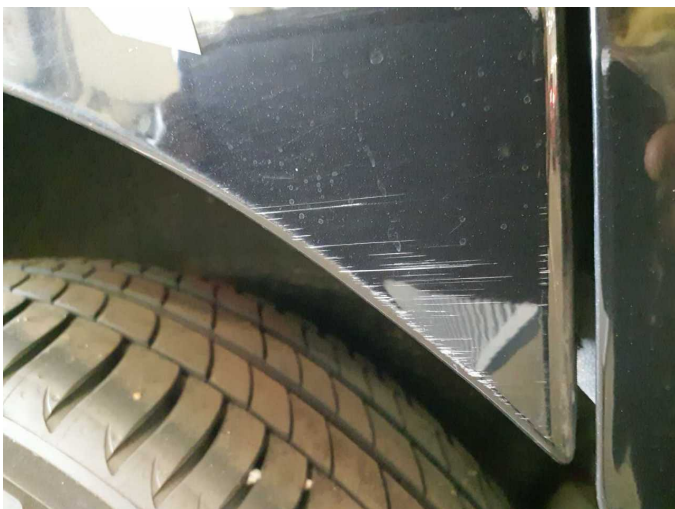
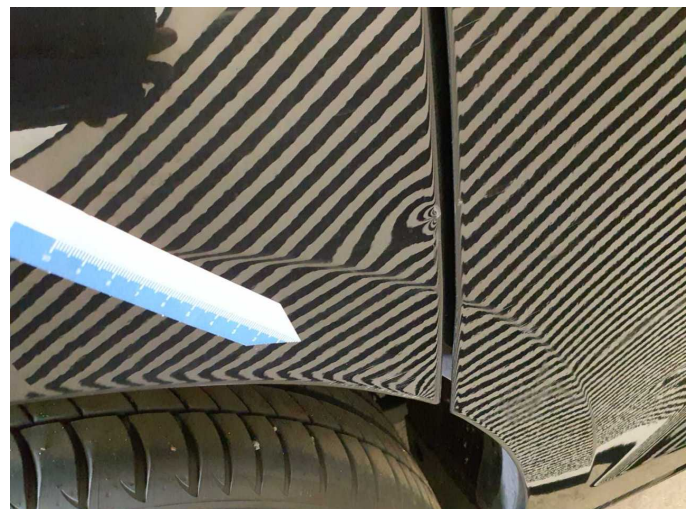
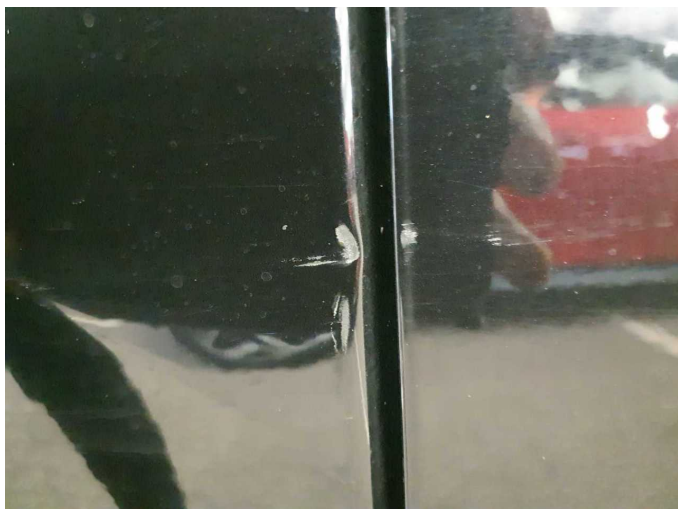
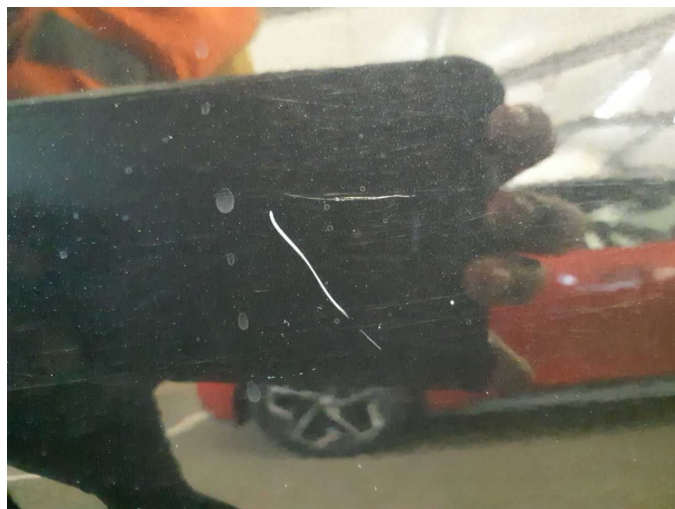
| No. | Component group | Description |
|---|---|---|
| 10 | Side panel - rear right side | Side panel - Dent / paintcoat damage - Repair and paint |

**Damage 10:** Side panel - rear right side: Side panel - Dent / paintcoat  
damage - Repair and paint

**Damage 10:** Side panel - rear right side: Side panel - Dent / paintcoat damage - Repair and paint

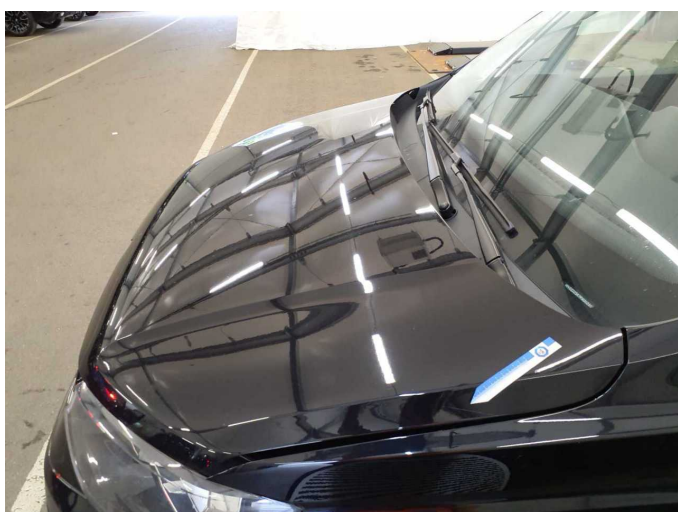
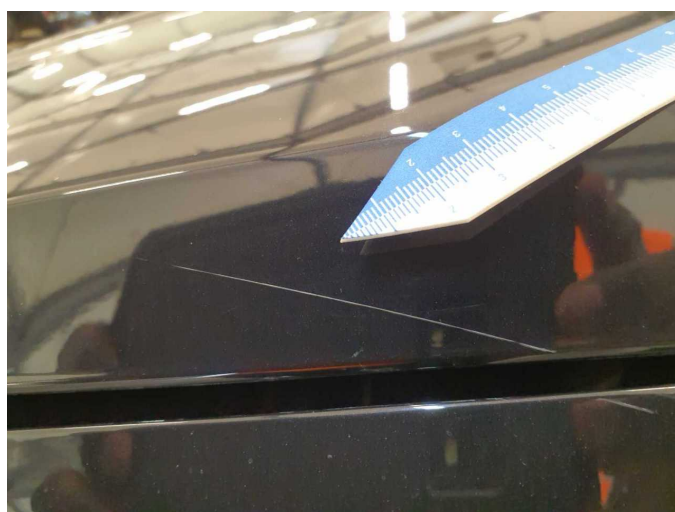
| No. | Component group | Description |
|---|---|---|
| 11 | Bonnet | Bonnet - Scratch(es) - Paint |

**Damage 11:** Bonnet: Bonnet - Scratch(es) - Paint
