## Expertise

Protocol number: 46233401  
Order No. / Reference: 26482930  
Inspection date: 19 Jun 2026

Manufacturer: Volvo

Model: V60 T6 AWD Recharge Core

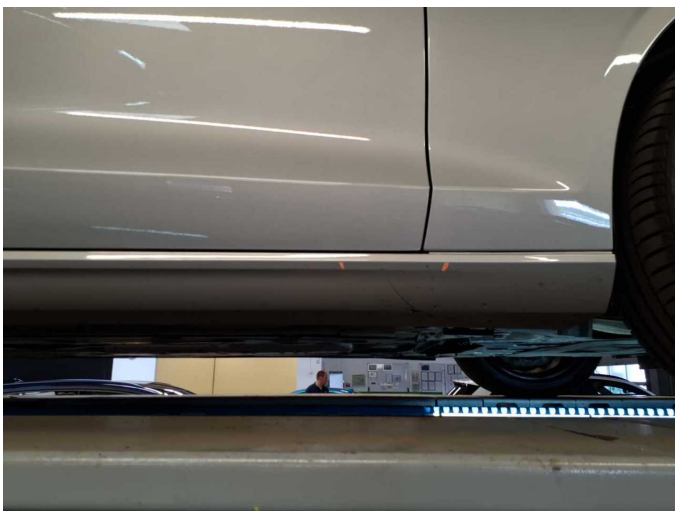
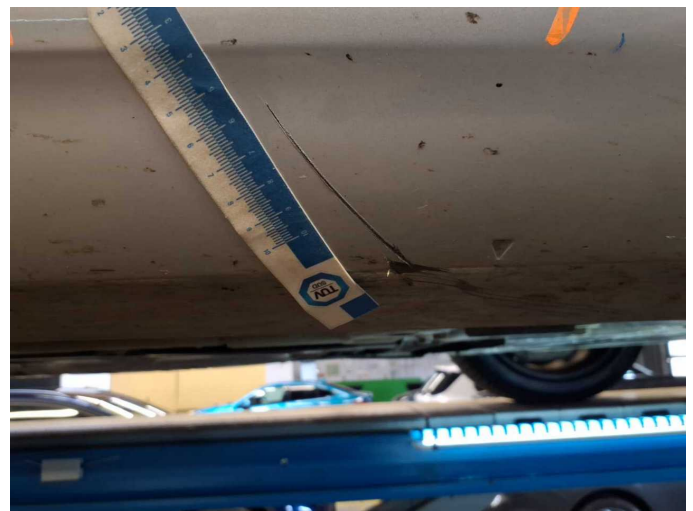
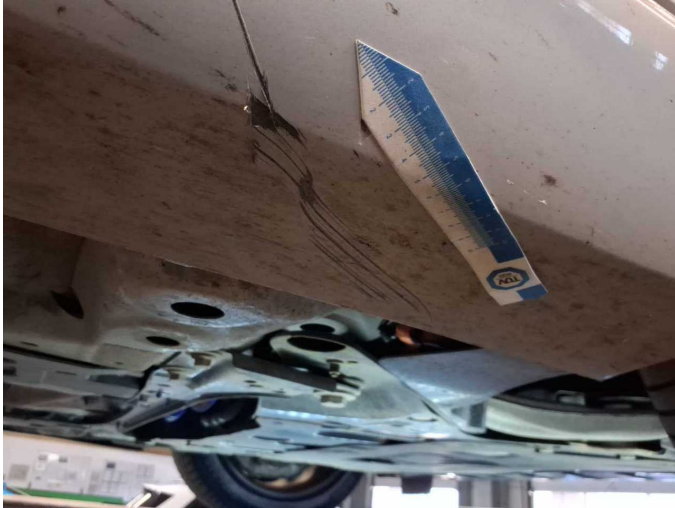
| No. | Component group | Description |
|---|---|---|
| 1 | Sill - right side | Trim - Scratch(es) - Smart repair |

Damage 1: Sill - right side: Trim - Scratch(es) - Smart repair

**Damage 1:** Sill - right side: Trim - Scratch(es) - Smart repair

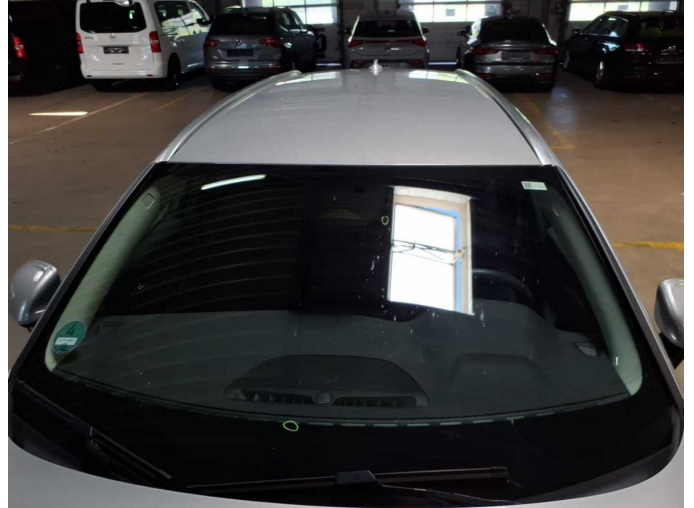
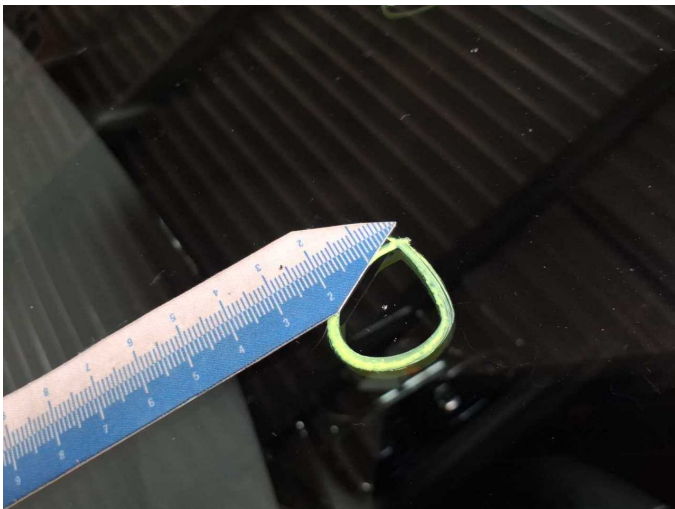
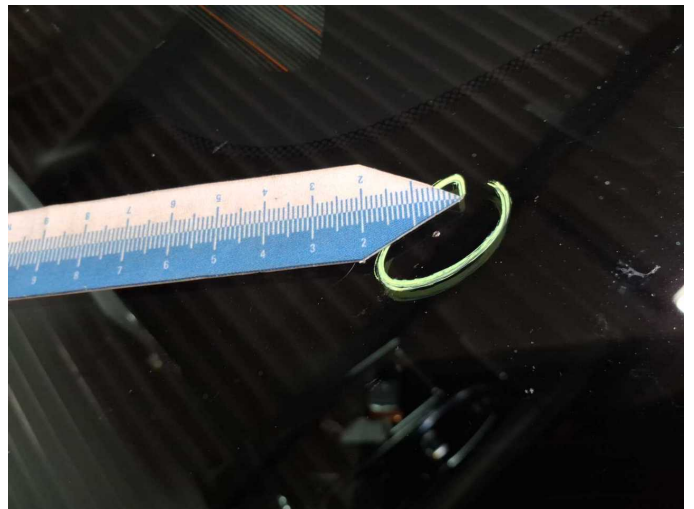
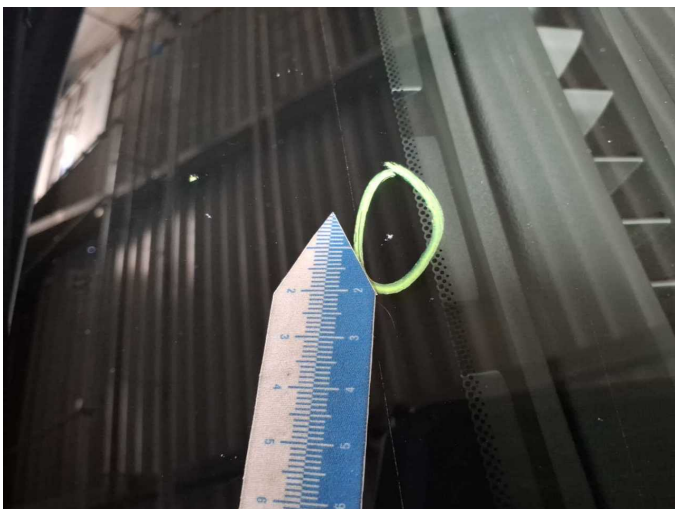
| No. | Component group | Description |
|---|---|---|
| 1 | Vehicle glazing | Windscreen - Stone chips |

**Wear and tear 1:** Vehicle glazing: Windscreen - Stone chips

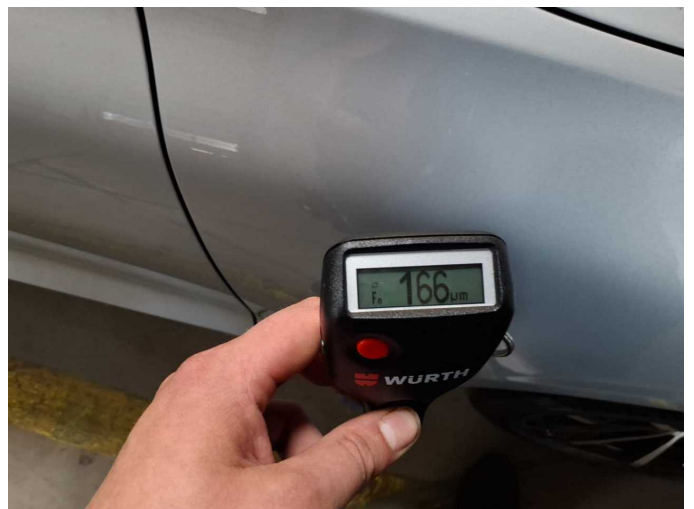
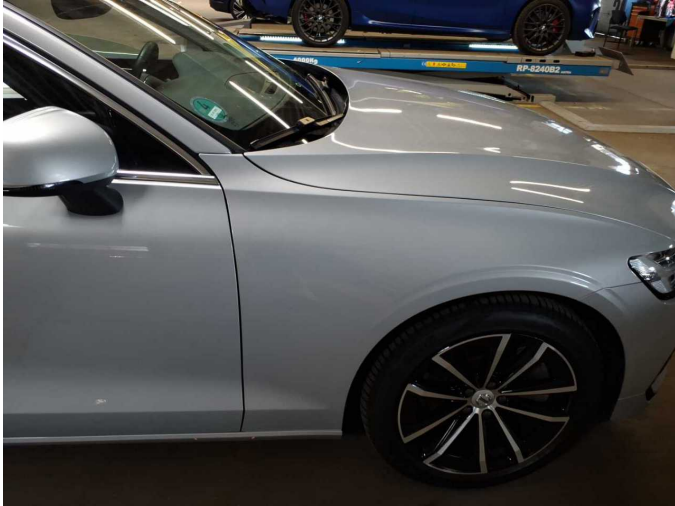
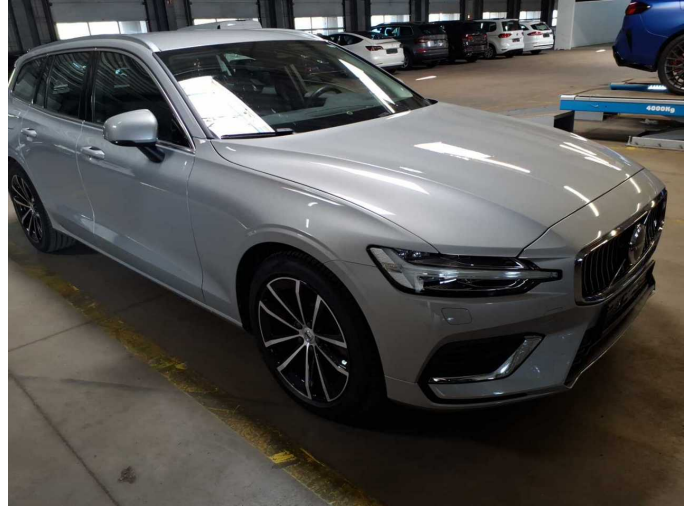
| No. | Repainting |
|---|--|
| 1 | Mudguard - right side, Professionally carried out, Invoice of repair done Non-existent |

**Repainting 1:** Mudguard - right side

Repainting 1: Mudguard - right side

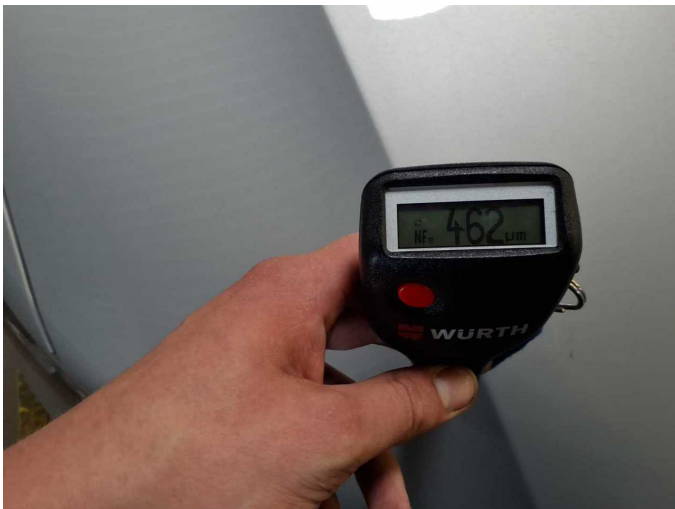
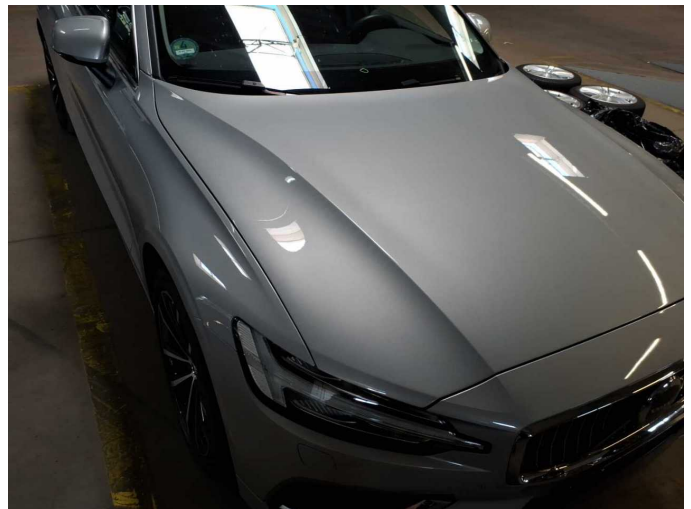
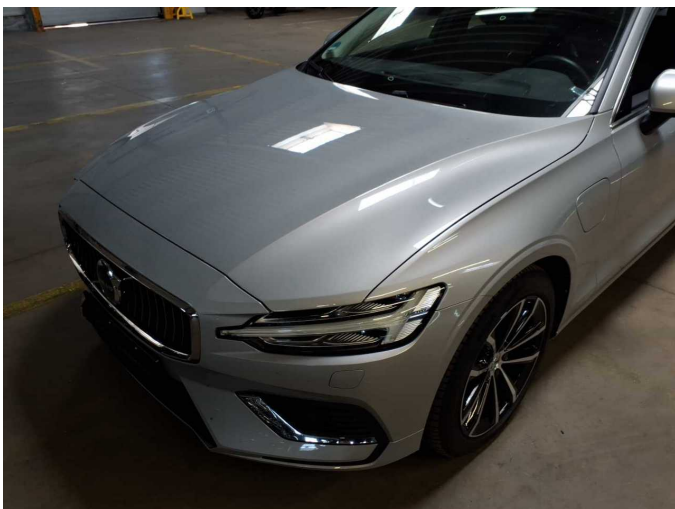
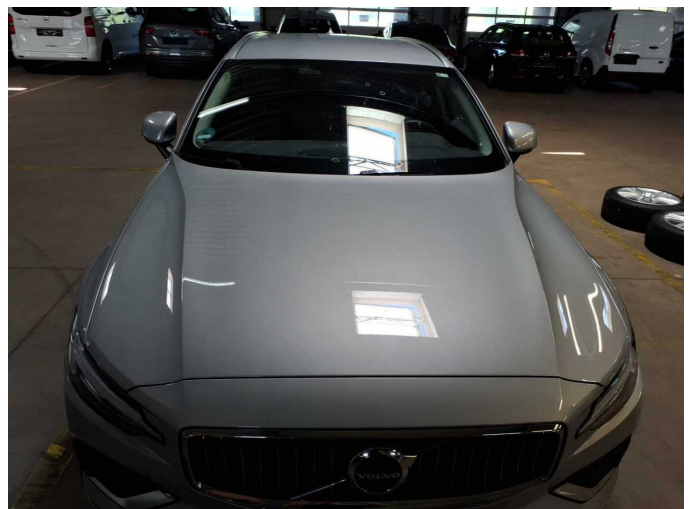
| No. | Repainting |
|---|--|
| 2 | Bonnet, Professionally carried out, Invoice of repair done Non-existent |

Repainting 2: Bonnet

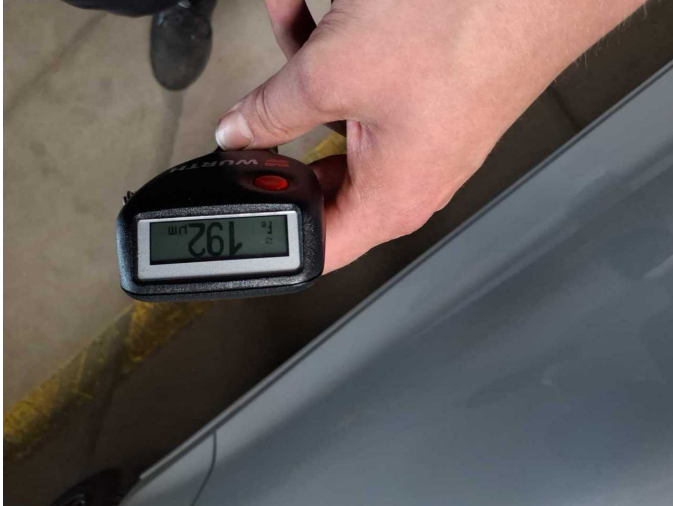
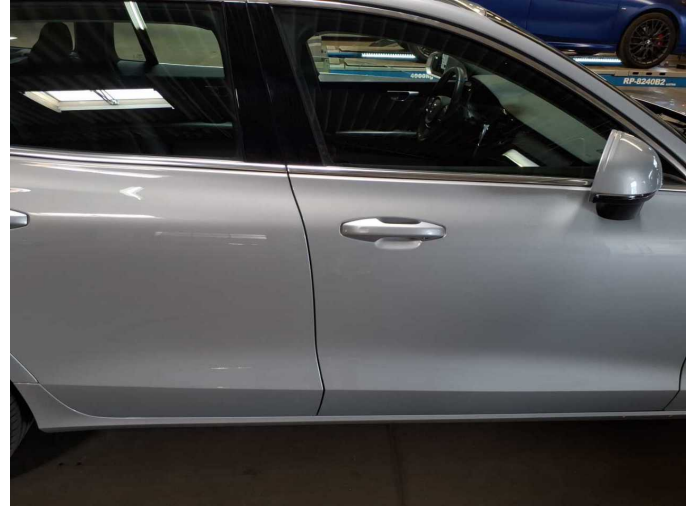
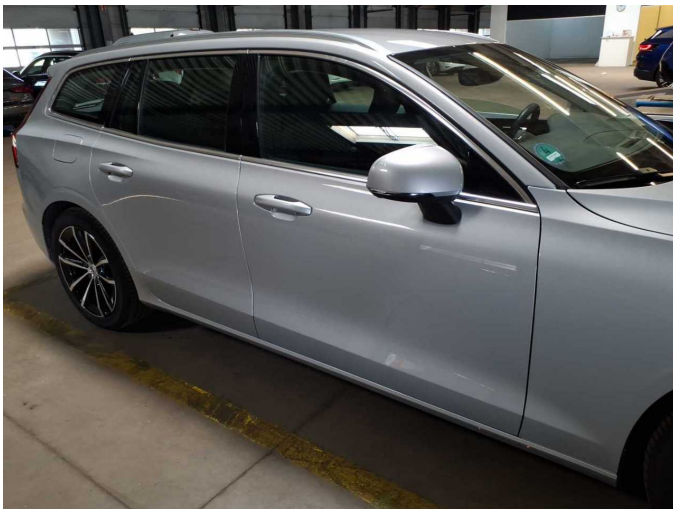
| No. | Repainting |
|---|--|
| 3 | Door - front right side, Professionally carried out, Invoice of repair done Non-existent |

Repainting 3: Door - front right side

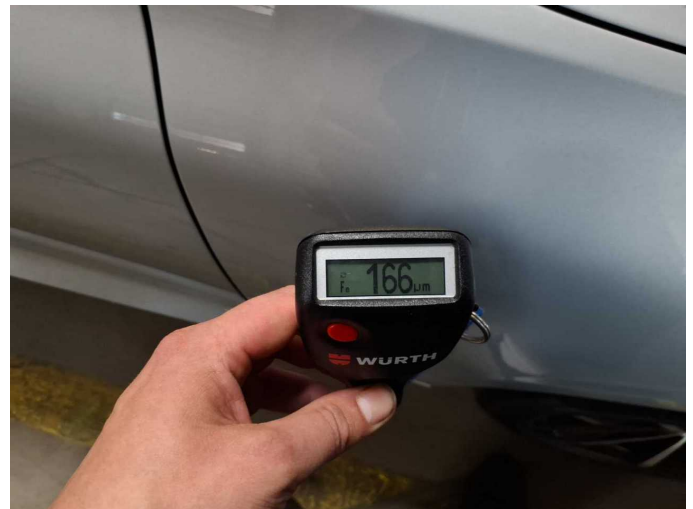
Mudguard - right side: 166 µm

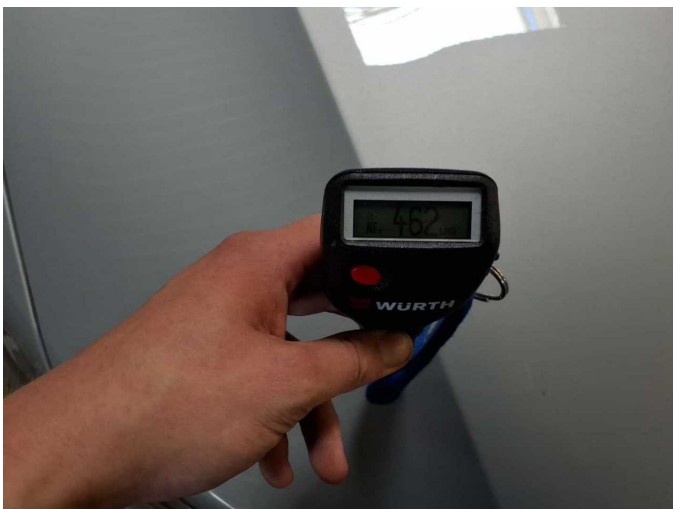
Bonnet: 462 µm

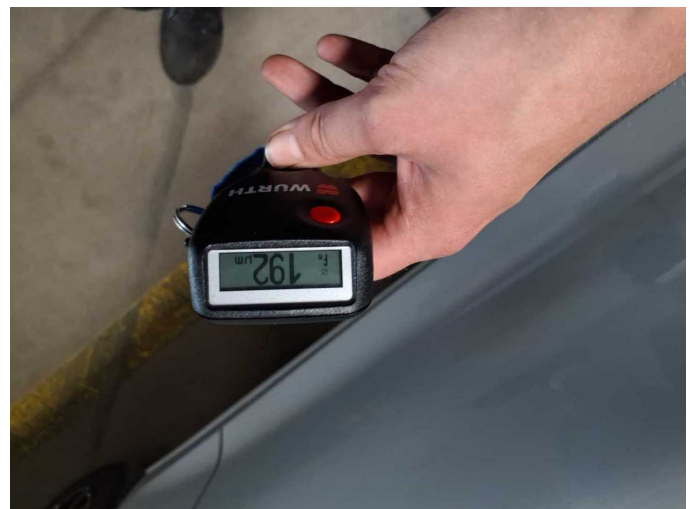
Door - front right side: 192 µm
