Expertise

Protocol number: 47130676  
Order No. / Reference: 26804714  
Inspection date: 18 Aug 2026

Manufacturer: Toyota  
VIN: JTMAABAA70A008336

Model: bZ4X

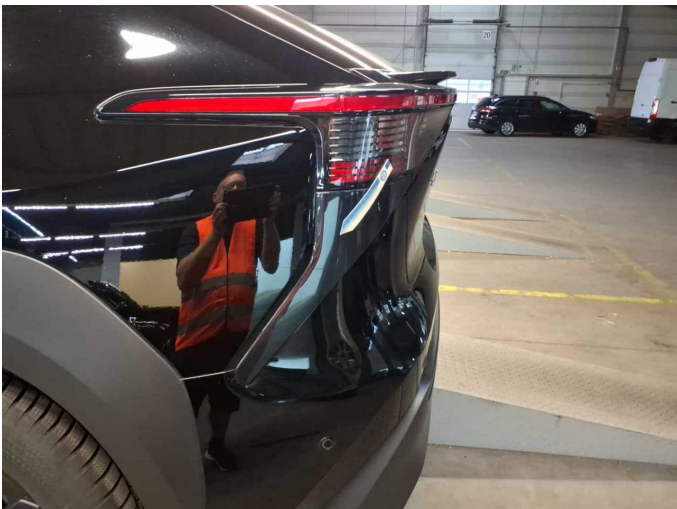
| No. | Component group | Description |
|---|---|---|
| 1 | Tail light | Cover - lower section left side - Scratch(es) - Smart repair |

Damage 1: Tail light: Cover - lower section left side - Scratch(es) - Smart repair

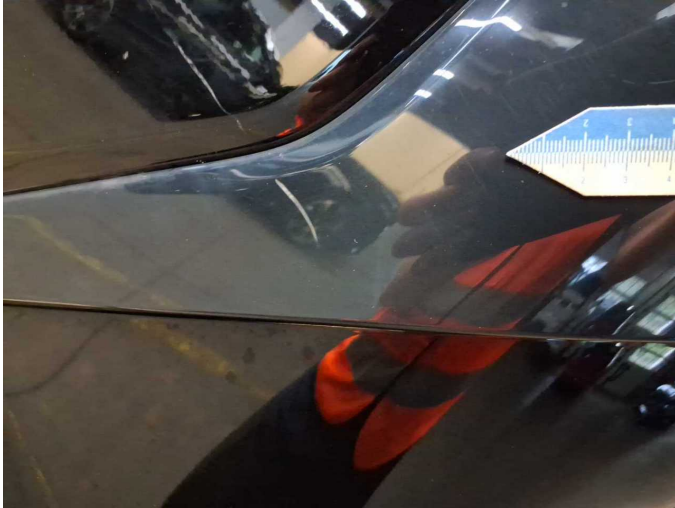
**Damage 1:** Tail light: Cover - lower section left side - Scratch(es) - Smart repair

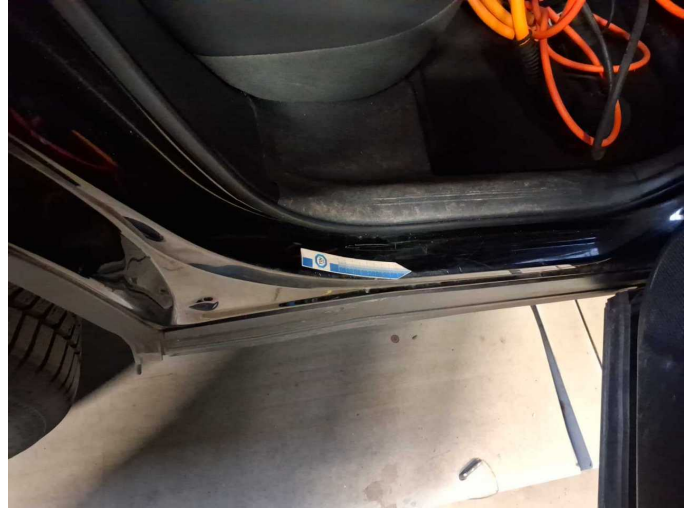
| No. | Component group | Description |
|---|---|---|
| 2 | Side panel - rear right side | Sill - Scratch(es) - Smart repair |

**Damage 2:** Side panel - rear right side: Sill - Scratch(es) - Smart repair

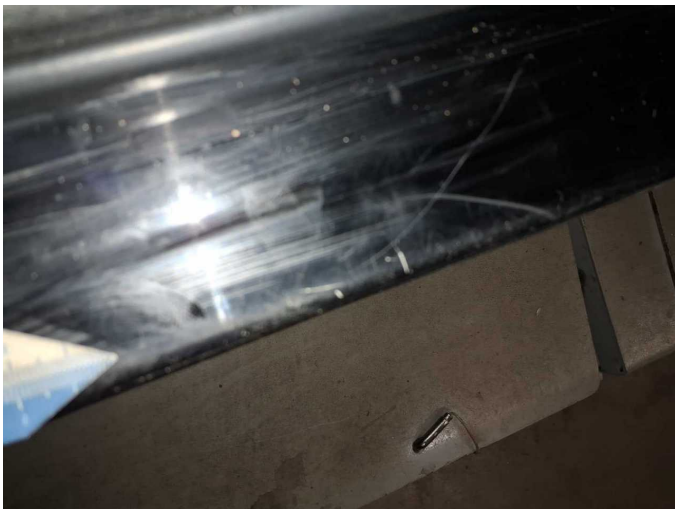
**Damage 2:** Side panel - rear right side: Sill - Scratch(es) - Smart repair

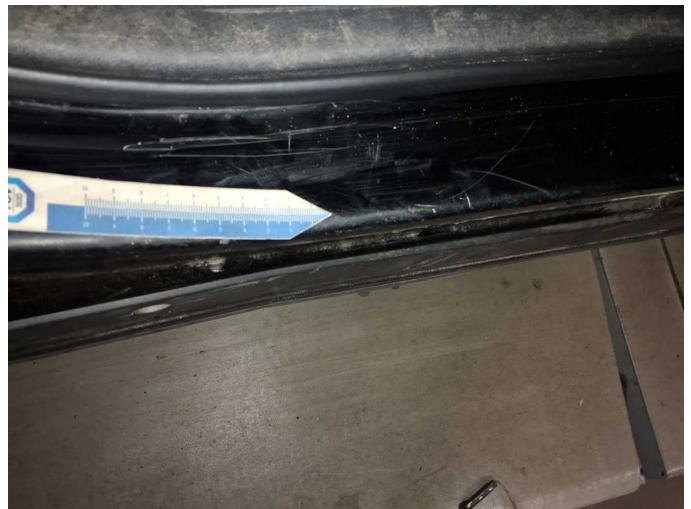
**Damage 2:** Side panel - rear right side: Sill - Scratch(es) - Smart repair

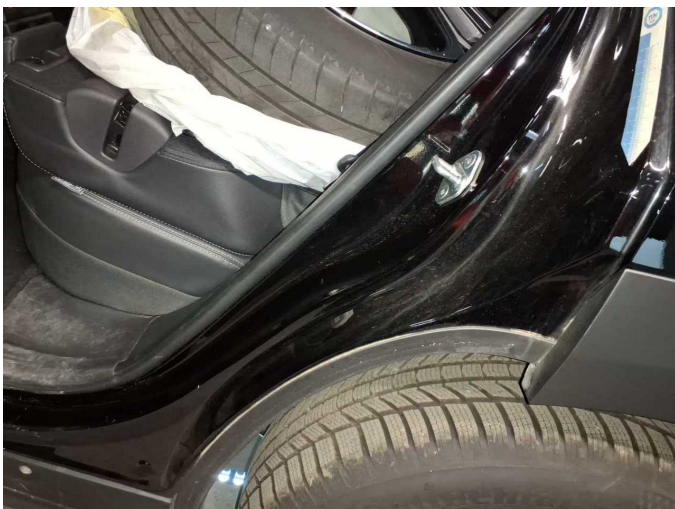
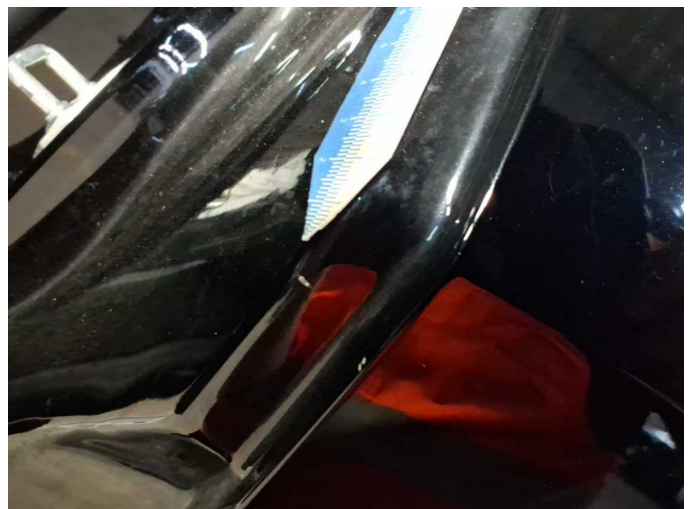
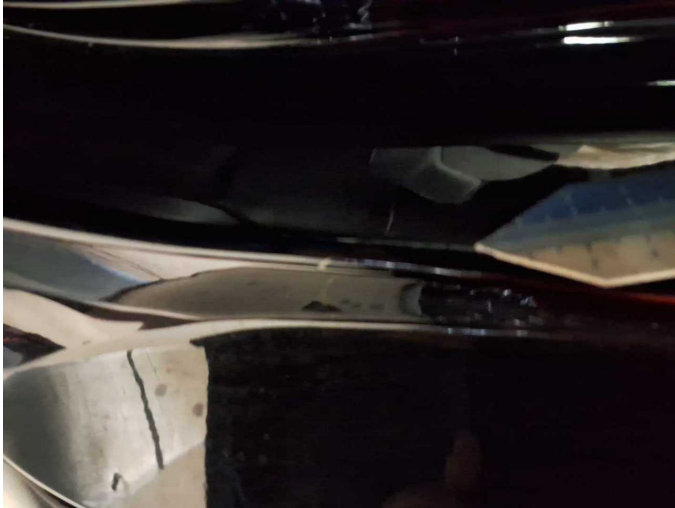
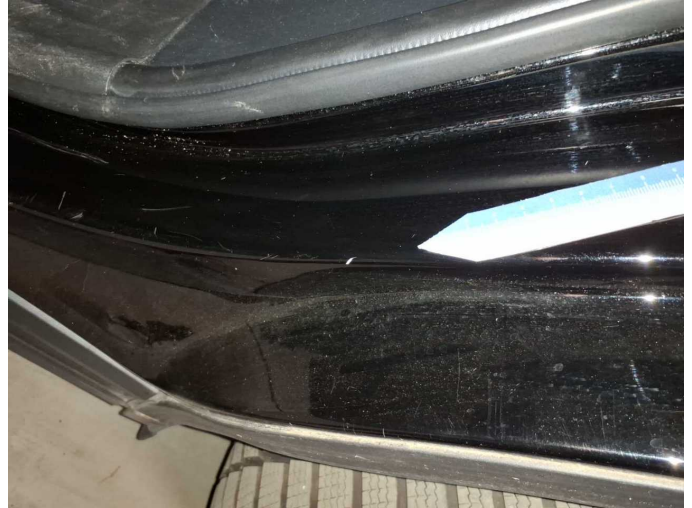
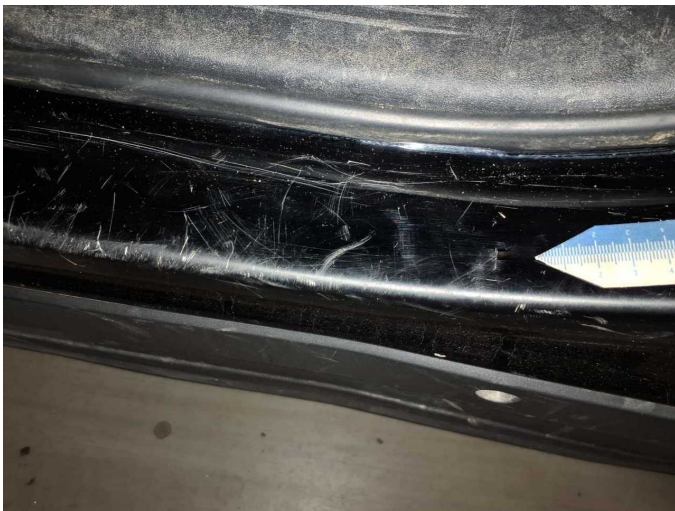
| No. | Component group | Description |
|---|---|---|
| 3 | Side panel - rear left side | Sill - Scratch(es) - Smart repair |

**Damage 3:** Side panel - rear left side: Sill - Scratch(es) - Smart repair

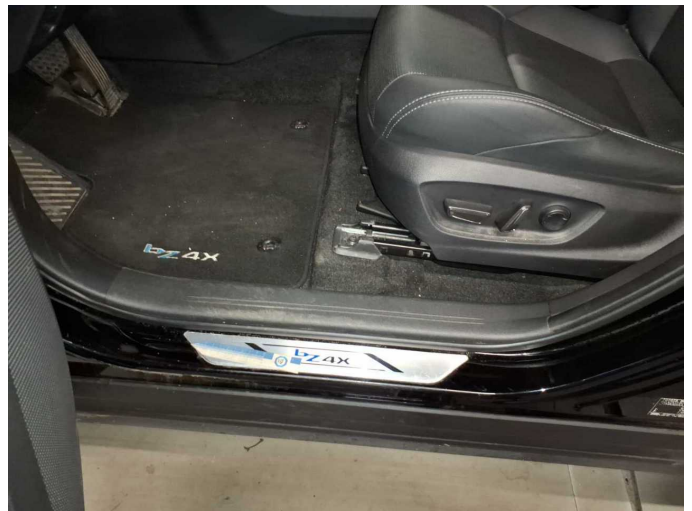
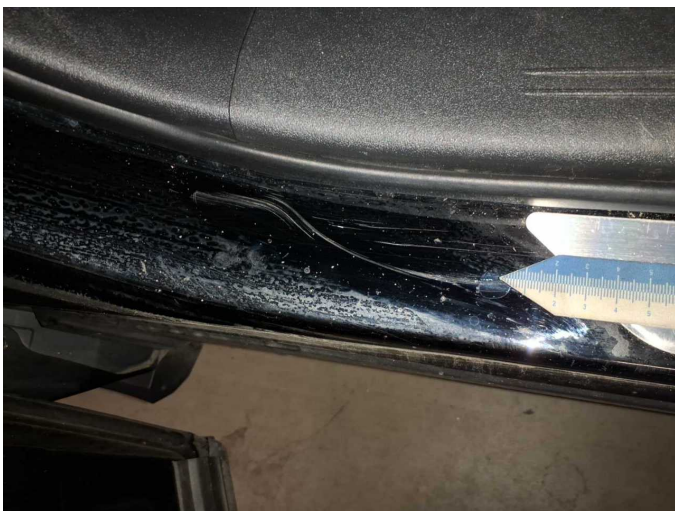
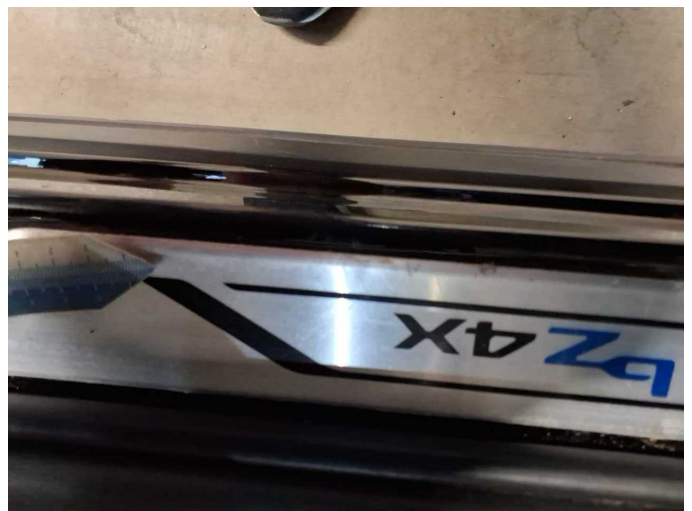
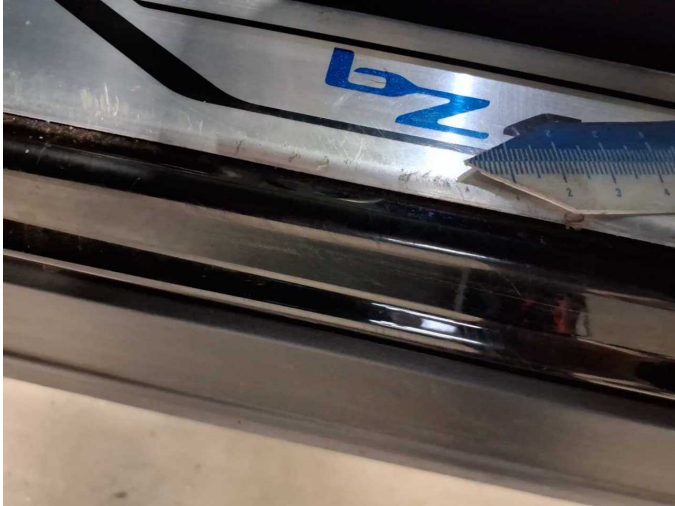
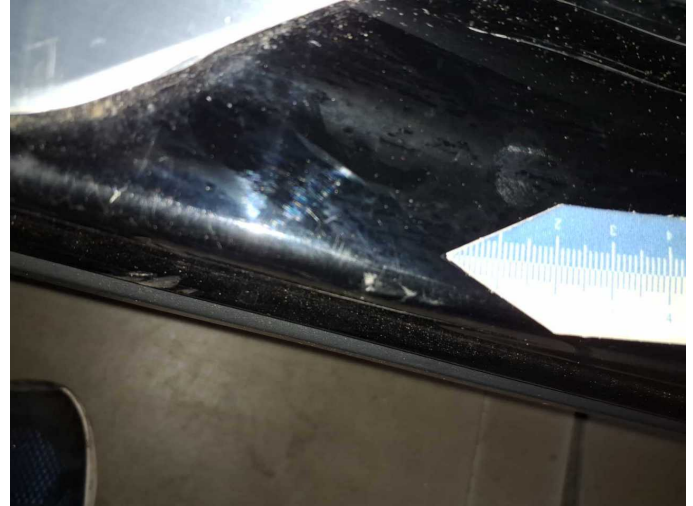
| No. | Component group | Description |
|---|---|---|
| 4 | Sill - left side | Sill - Scratch(es) - Smart repair |

**Damage 4:** Sill - left side: Sill - Scratch(es) - Smart repair

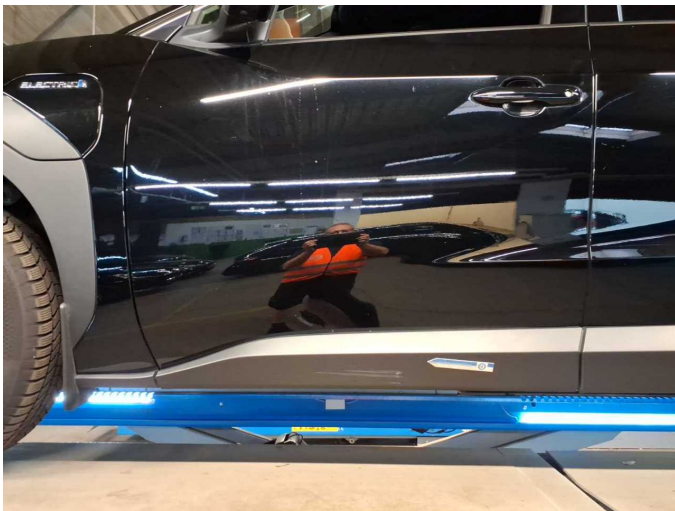
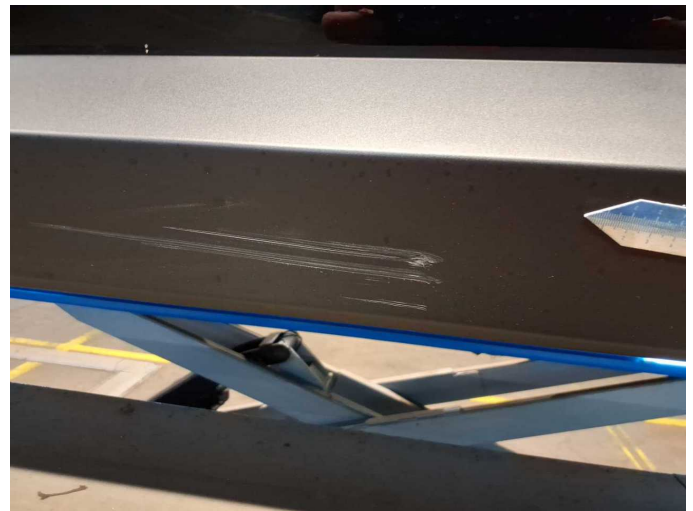
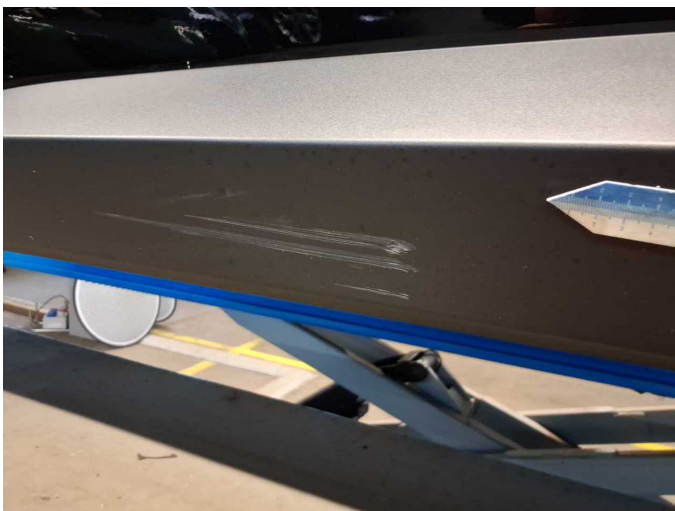
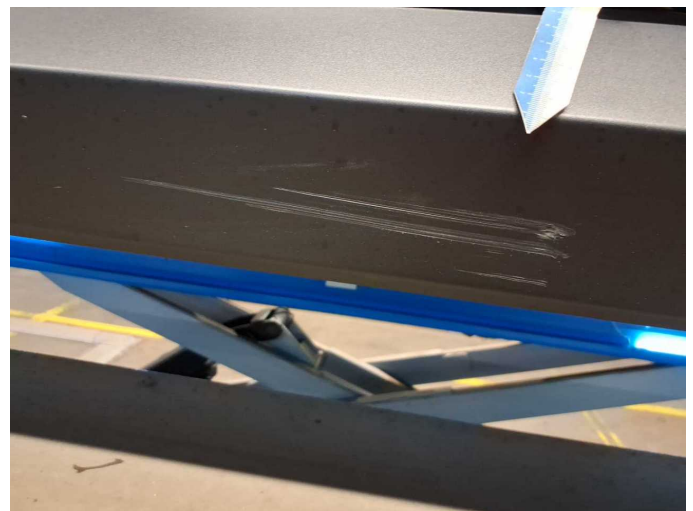
| No. | Component group | Description |
|---|---|---|
| 5 | Door - front left side | Brightware - lower - Scratch(es) - Replace |

**Damage 5:** Door - front left side: Brightware - lower - Scratch(es) - Replace

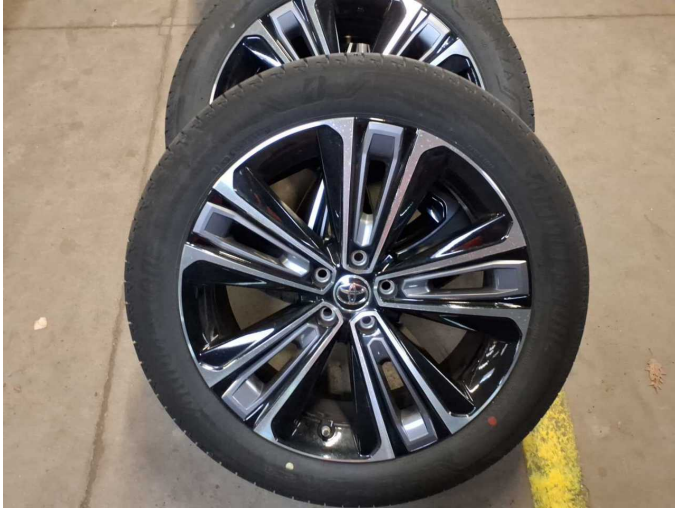
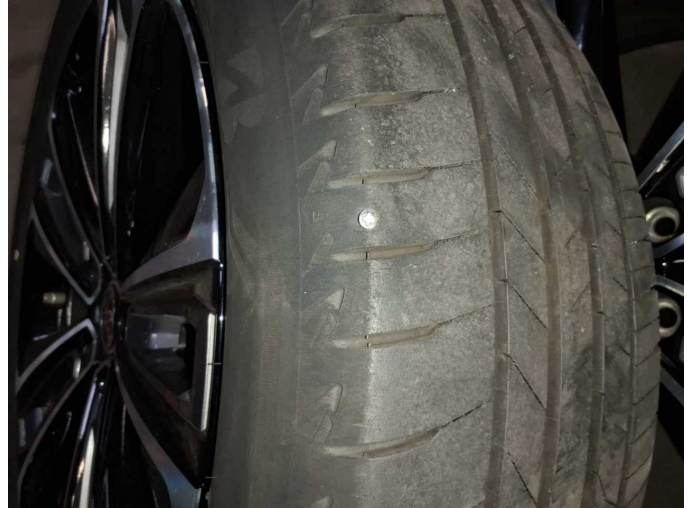
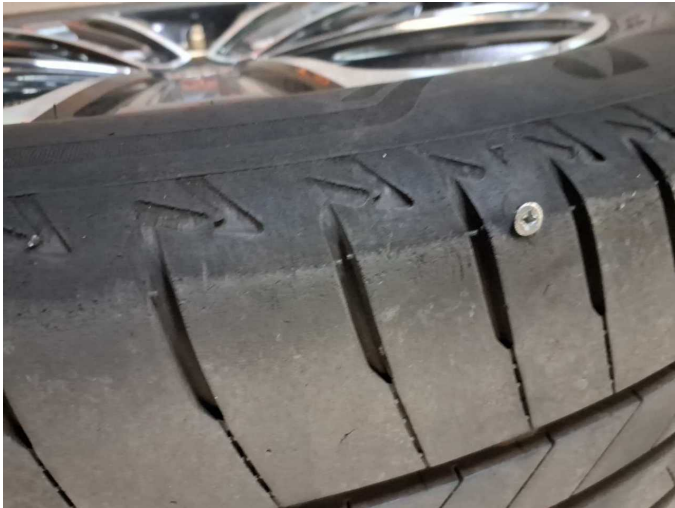
| No. | Component group | Description |
|---|---|---|
| 6 | 2nd wheel set | 1 tyre (Schraube im Reifen) - Damaged - Replace |

**Damage 6:** 2nd wheel set: 1 tyre (Schraube im Reifen) - Damaged - Replace

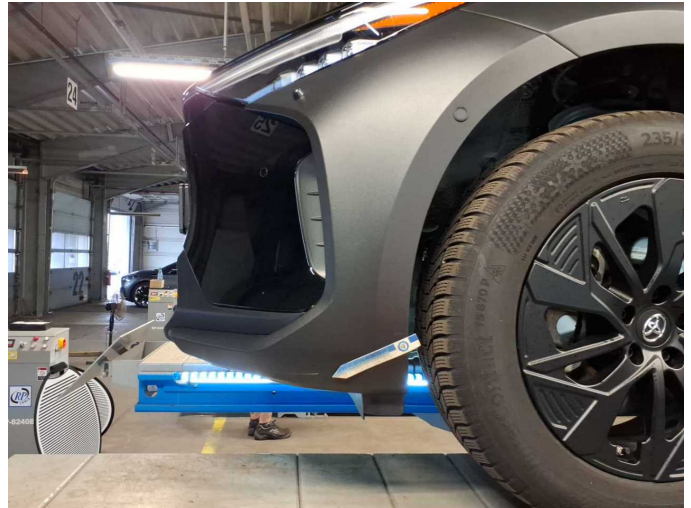
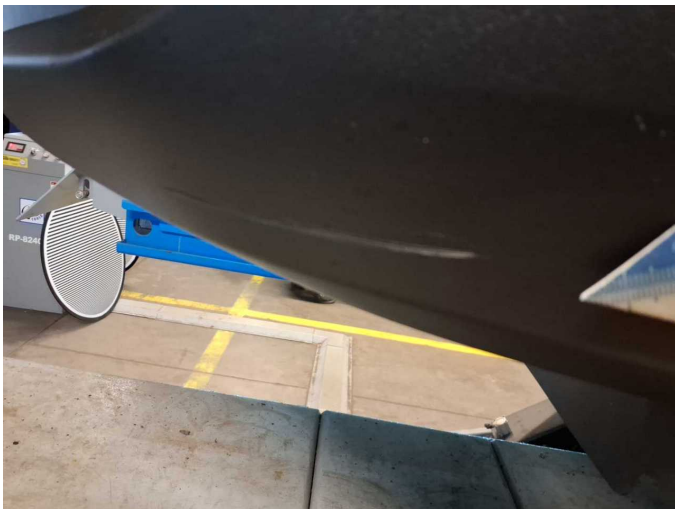
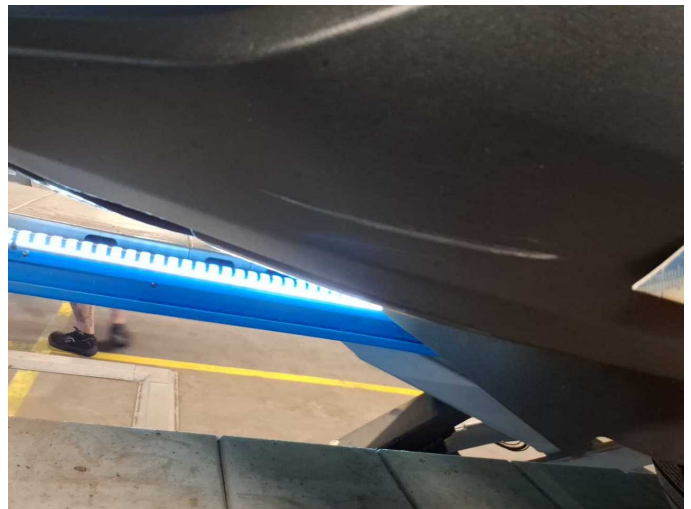
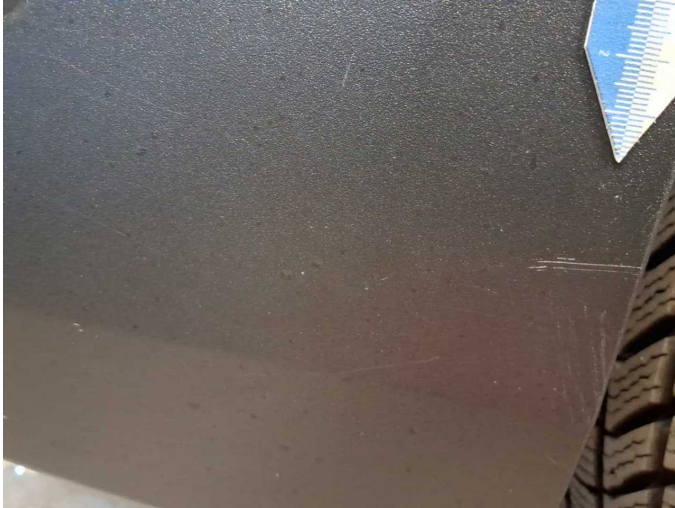
| No. | Component group | Description |
|---|---|---|
| 7 | Front bumper | Cover bumper - front - Scratch(es) - Replace |

**Damage 7:** Front bumper: Cover bumper - front - Scratch(es) - Replace

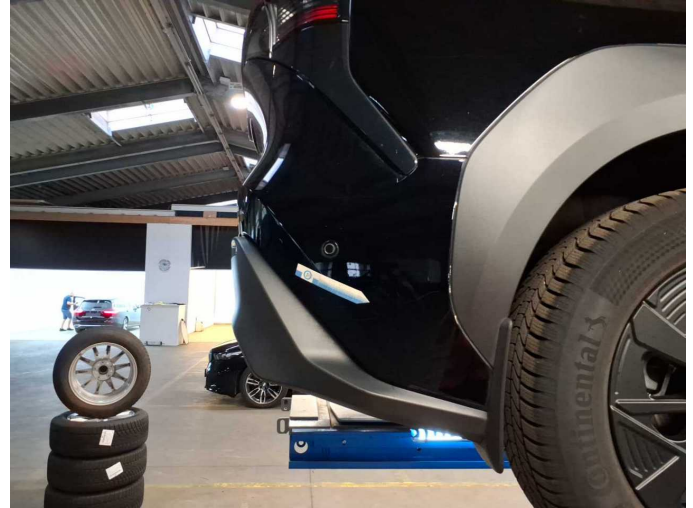
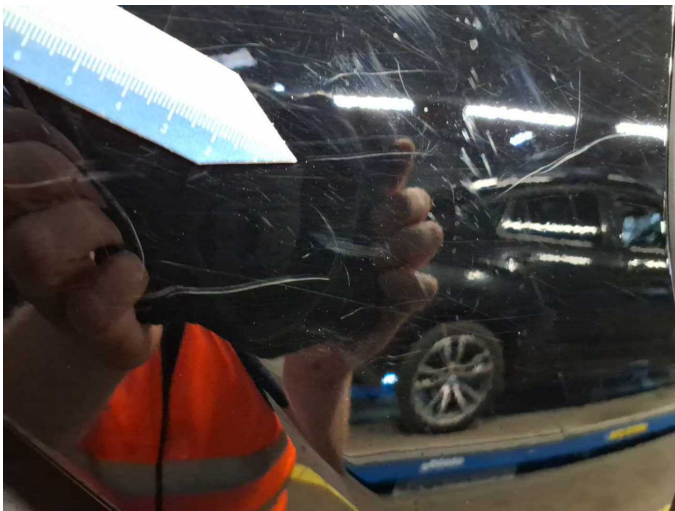
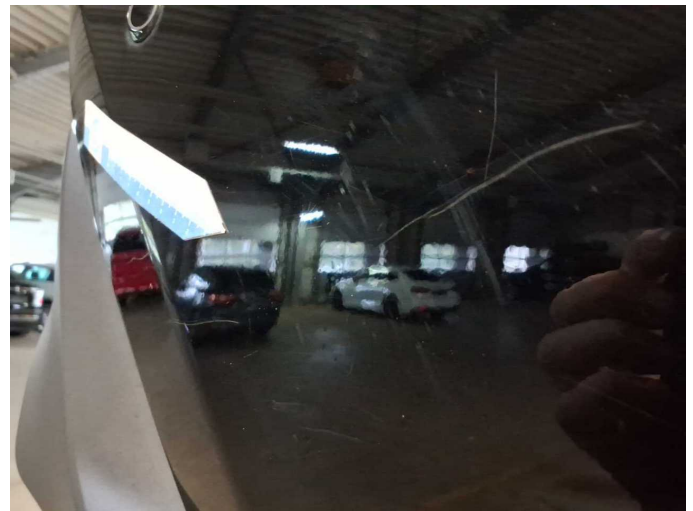
| No. | Component group | Description |
|---|---|---|
| 8 | Rear bumper | Rear bumper - Scratch(es) - Paint |

**Damage 8:** Rear bumper: Rear bumper - Scratch(es) - Paint

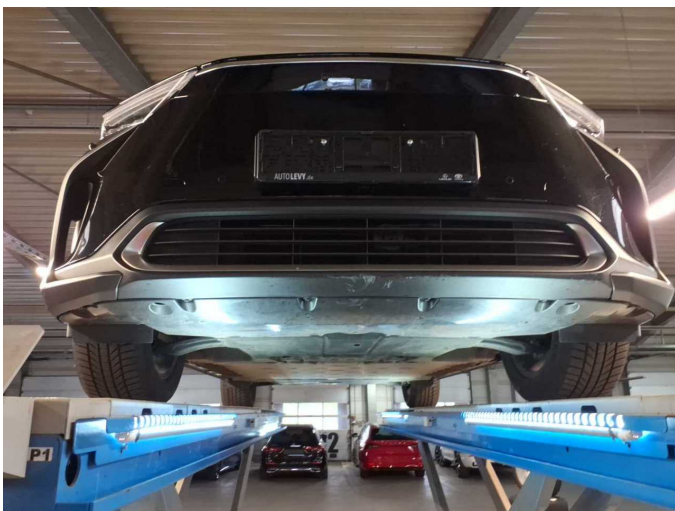
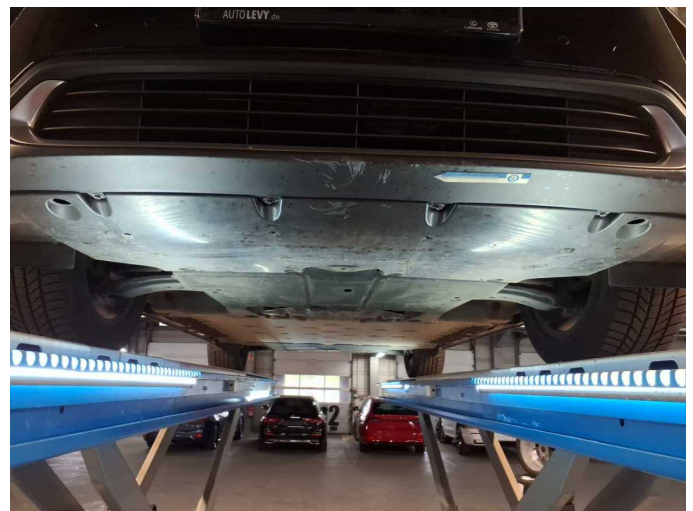
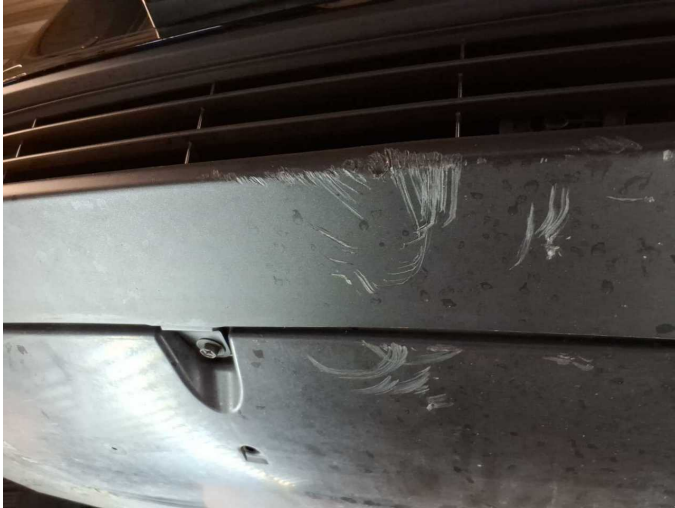
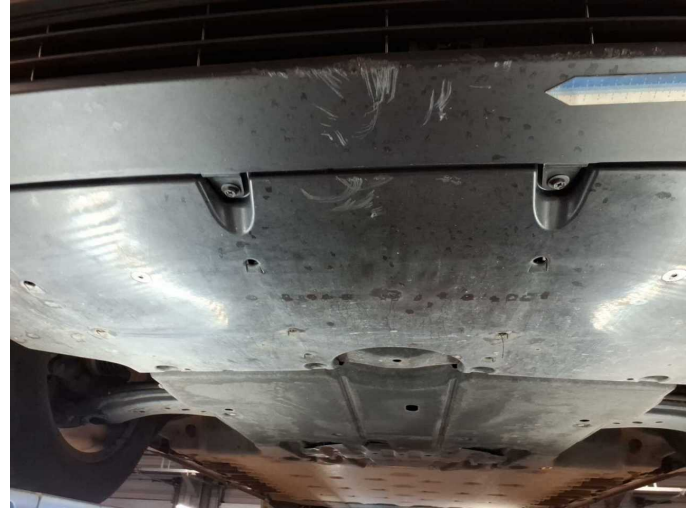
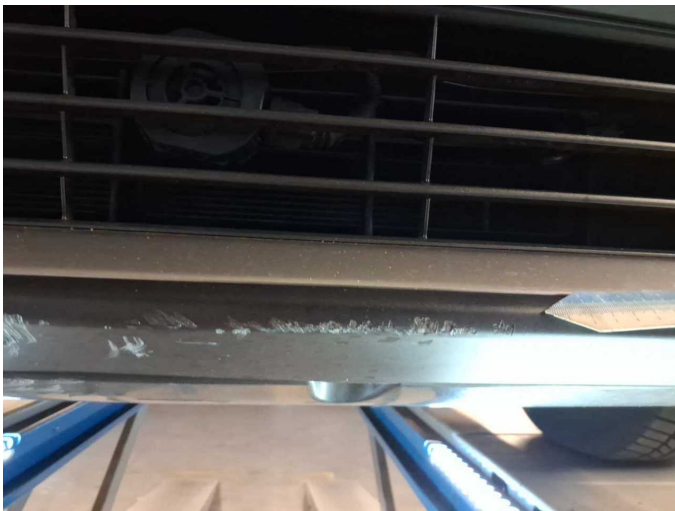
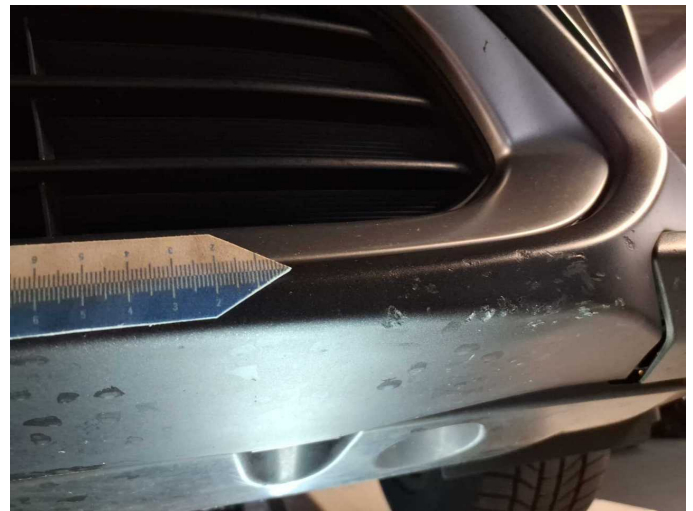
| No. | Component group | Description |
|---|---|---|
| 9 | Front bumper | Spoiler - Scratch(es) - Replace |

**Damage 9:** Front bumper: Spoiler - Scratch(es) - Replace

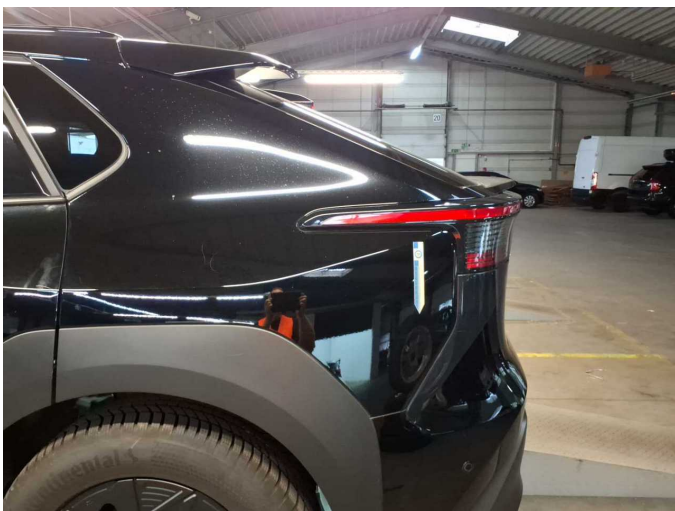
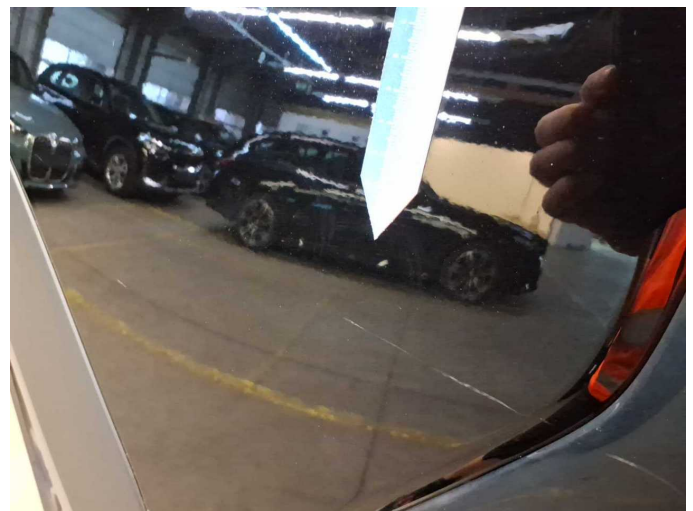
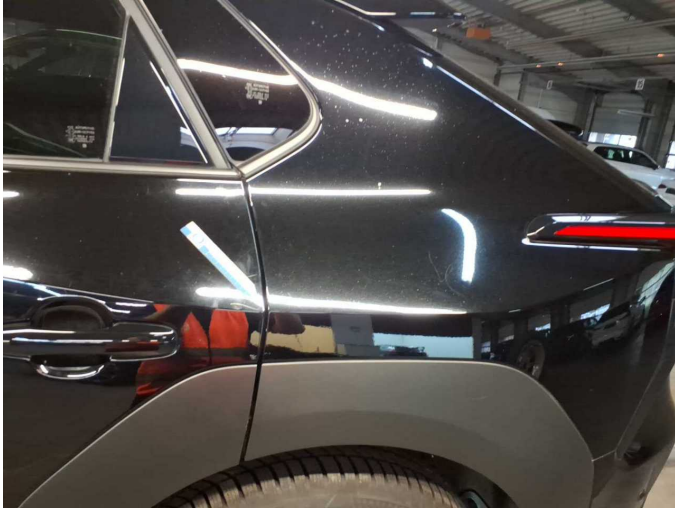
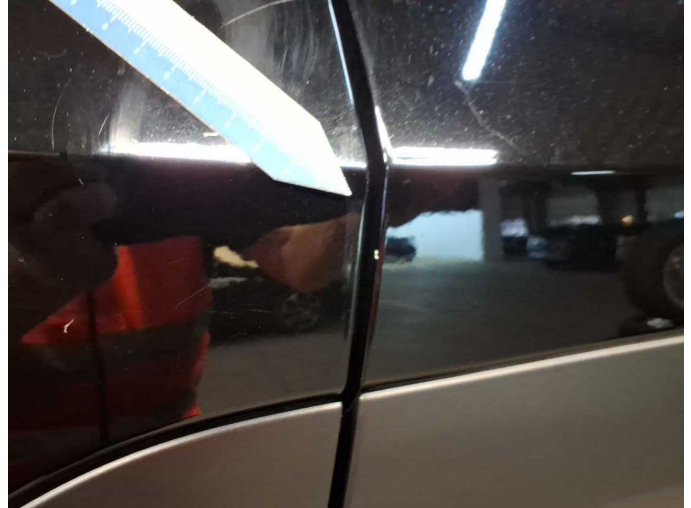
| No. | Component group | Description |
|---|---|---|
| 10 | Side panel - rear left side | Side panel - Scratch(es) - Paint |

**Damage 10:** Side panel - rear left side: Side panel - Scratch(es) - Paint

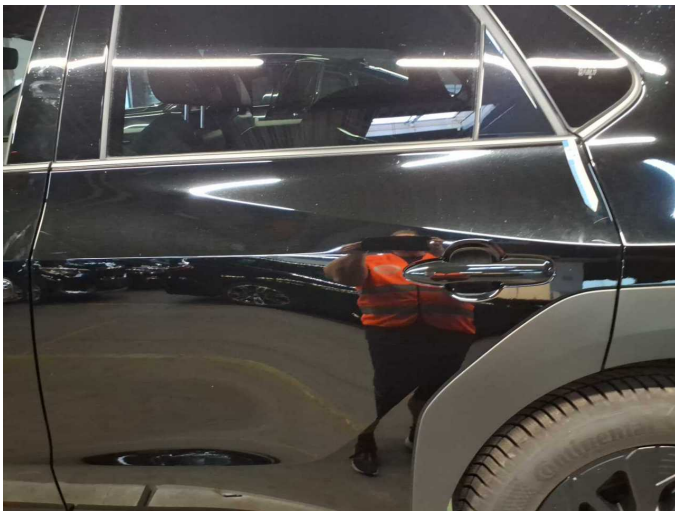
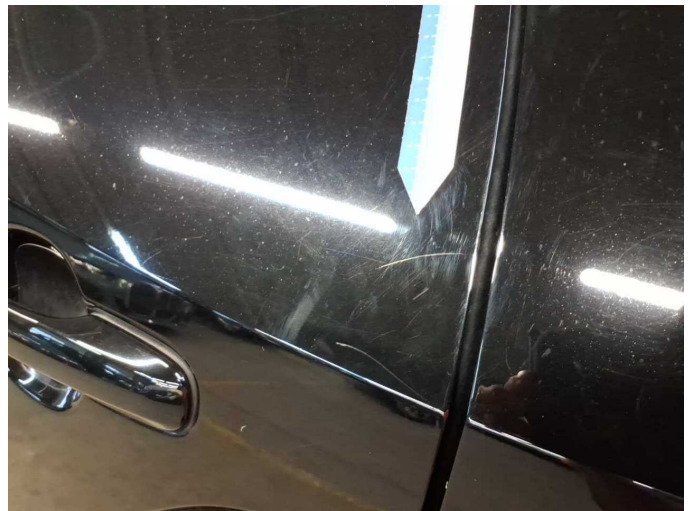
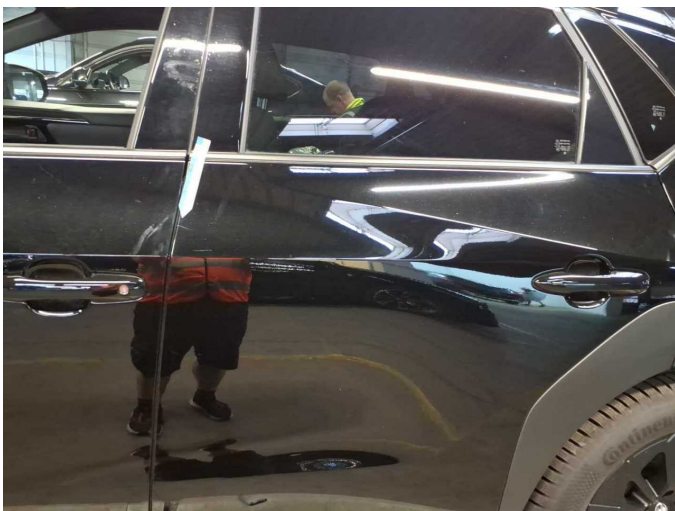
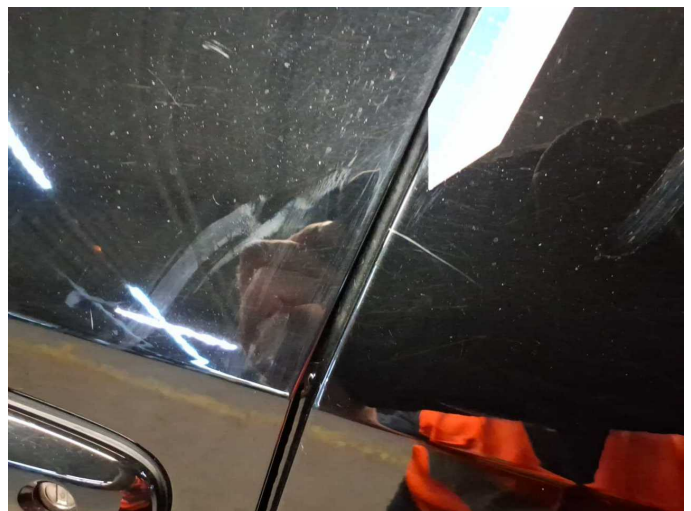
| No. | Component group | Description |
|---|---|---|
| 11 | Door - rear left side | Door - Scratch(es) - Paint |

**Damage 11:** Door - rear left side: Door - Scratch(es) - Paint

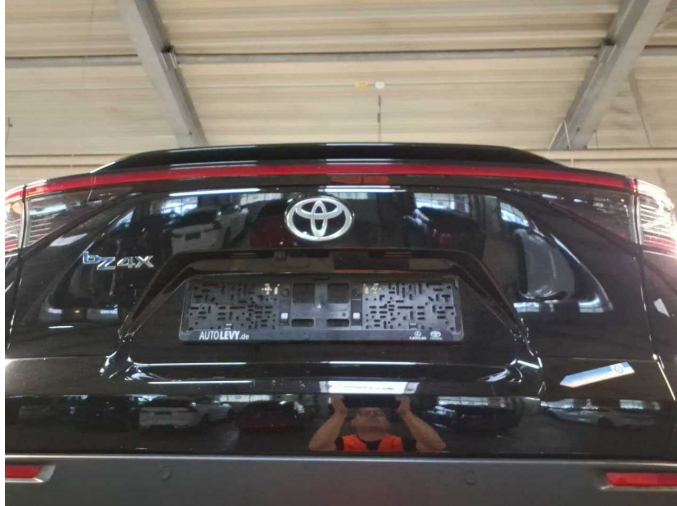
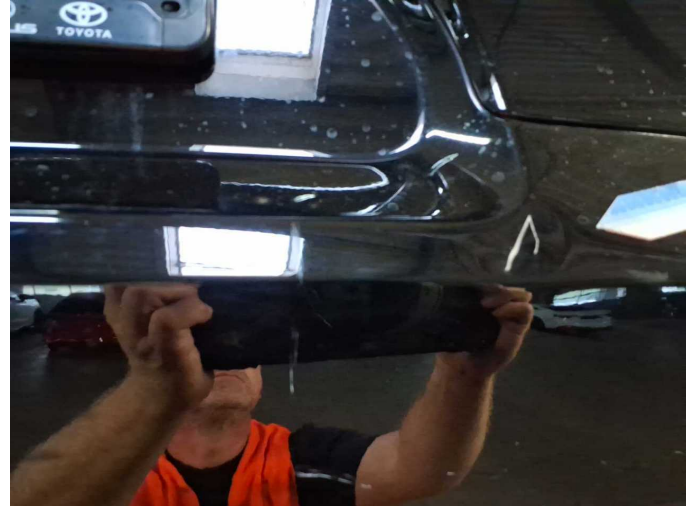
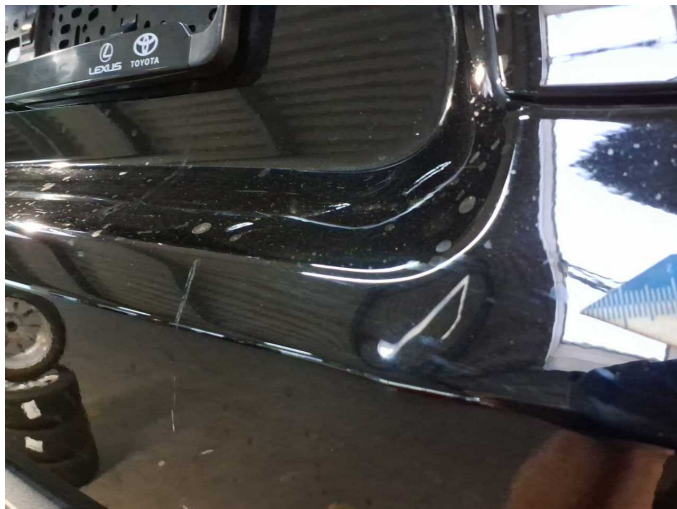
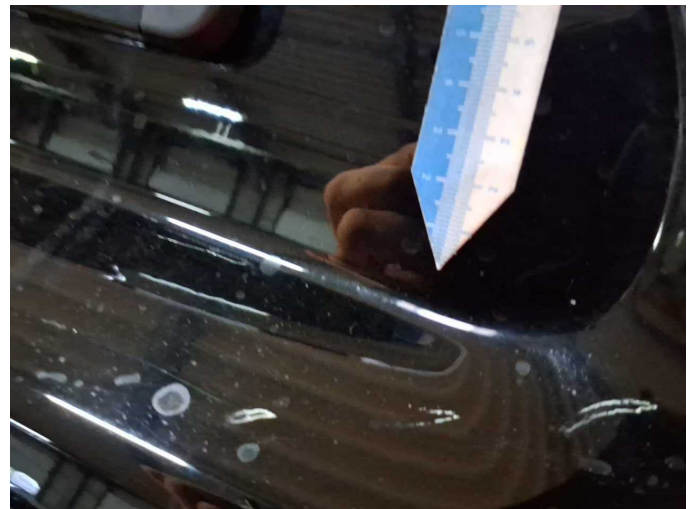
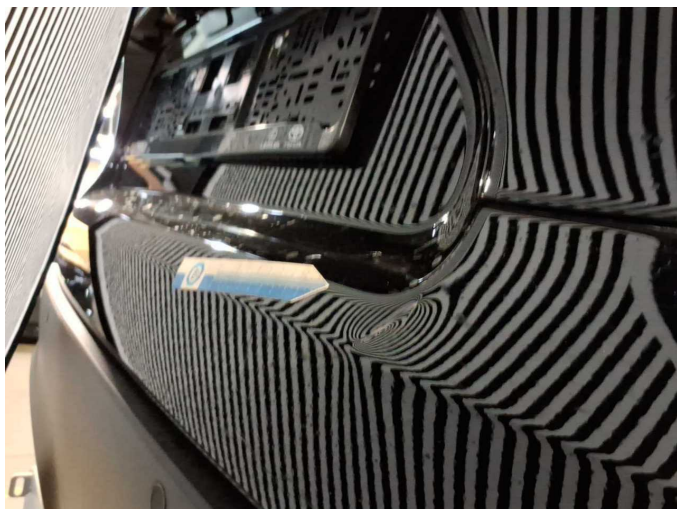
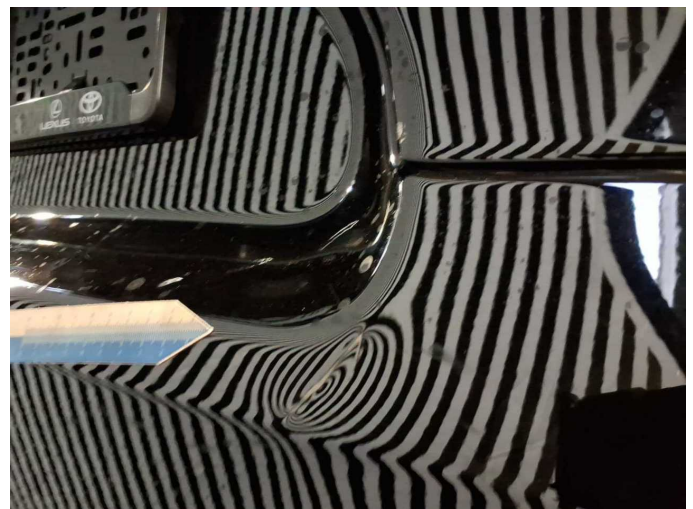
| No. | Component group | Description |
|---|---|---|
| 12 | Boot lid / rear door | Boot lid - Dent / paintcoat damage - Repair and paint |

**Damage 12:** Boot lid / rear door: Boot lid - Dent / paintcoat damage - Repair and paint
