Expertise

Protocol number: 46599198  
Order No. / Reference: 26689039  
Inspection date: 13 Jul 2026

Manufacturer: Volkswagen

Model: Touran 2.0 TDI SCR DSG Comfortline

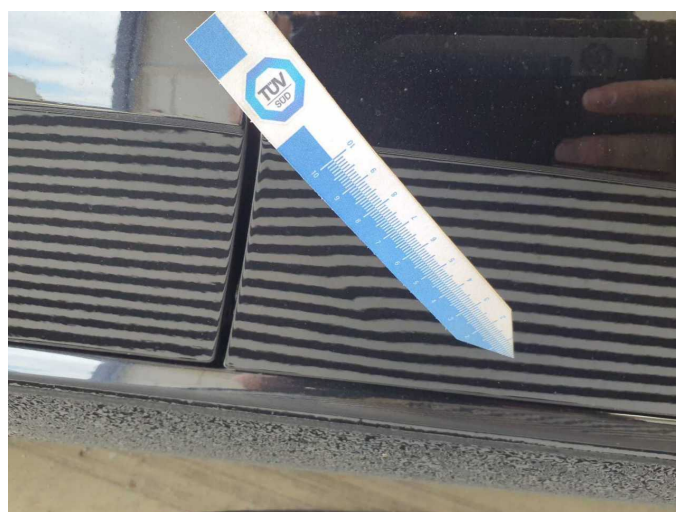
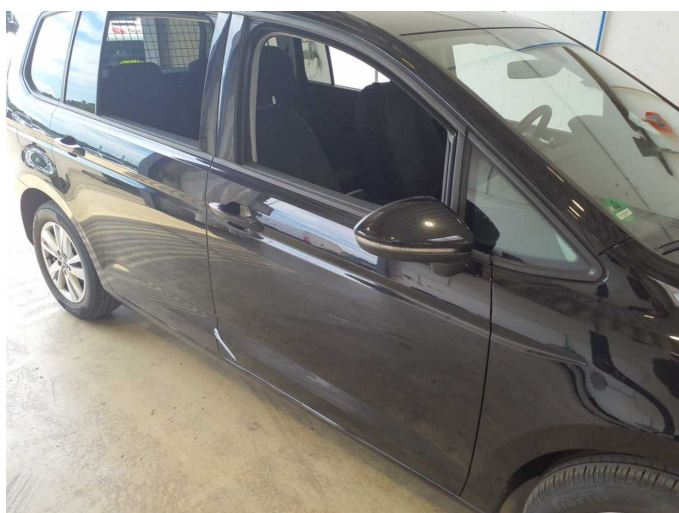
| No. | Component group | Description |
|---|---|---|
| 1 | Door - front right side | Door - dent(s) - Smart repair |

Damage 1: Door - front right side: Door - dent(s) - Smart repair

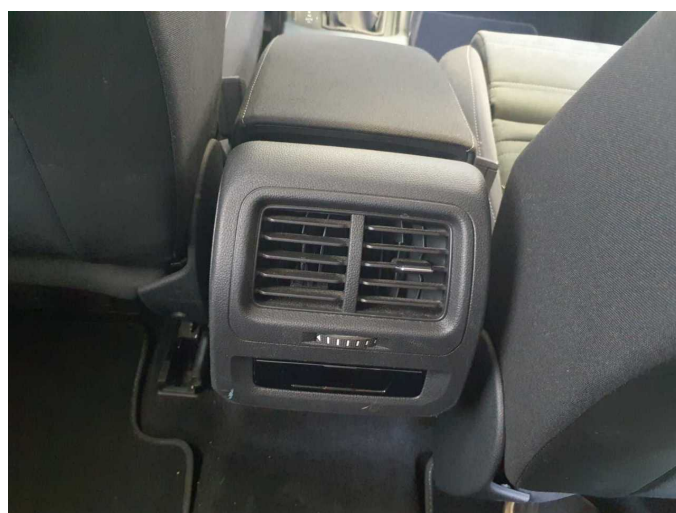
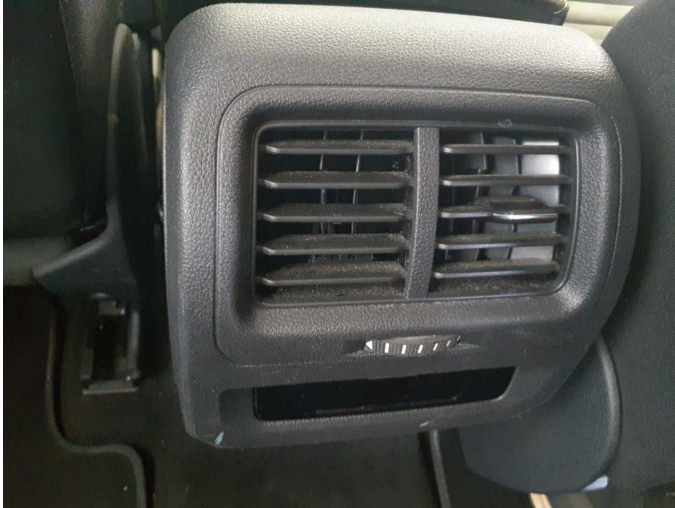
| No. | Component group | Description |
|---|---|---|
| 2 | Instrument panel | Air nozzle - centre (Hinten) - Broken / torn - Replace |

Damage 2: Instrument panel: Air nozzle - centre (Hinten) - Broken / torn - Replace

**Damage 2:** Instrument panel: Air nozzle - centre (Hinten) - Broken / torn - Replace

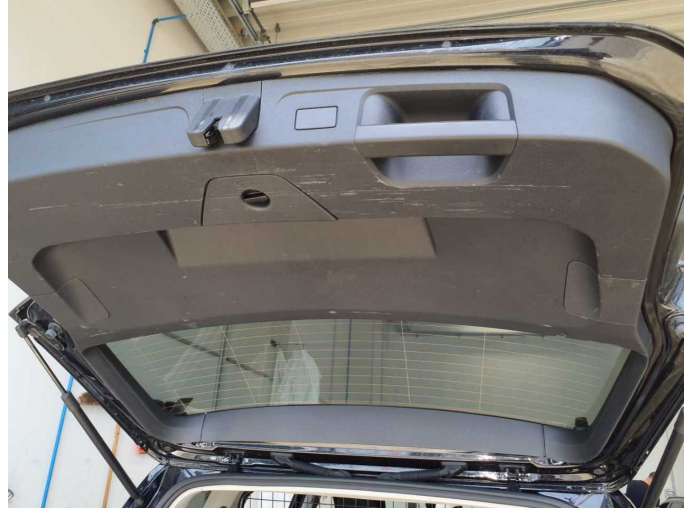
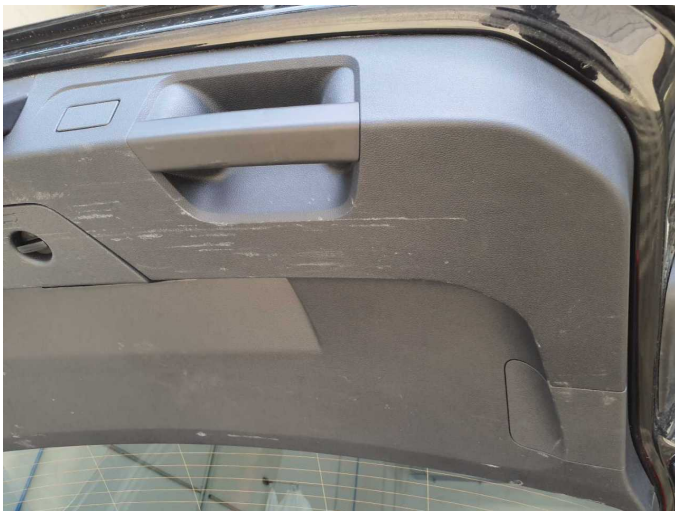
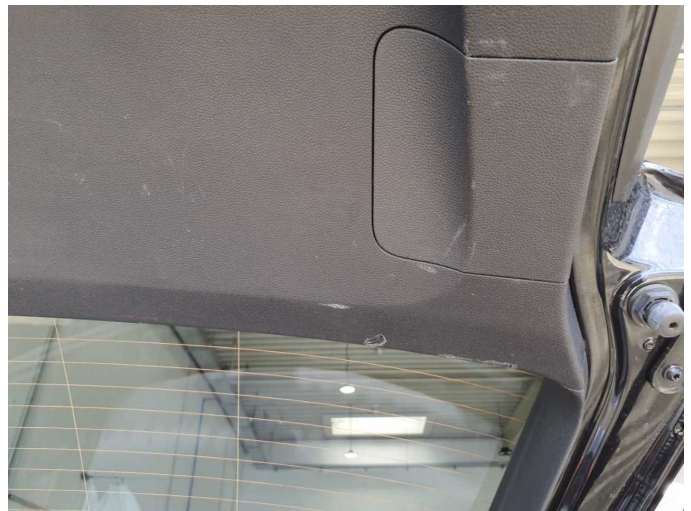
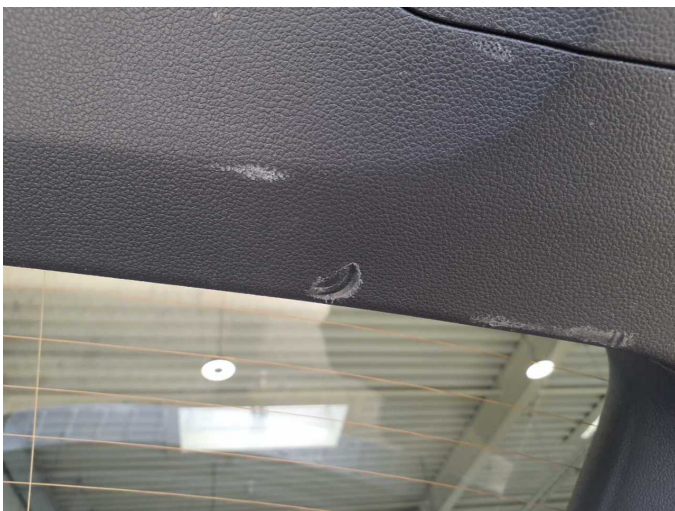
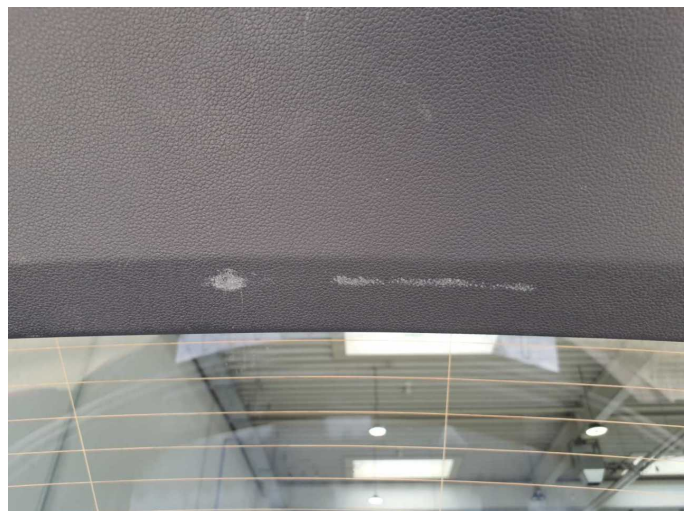
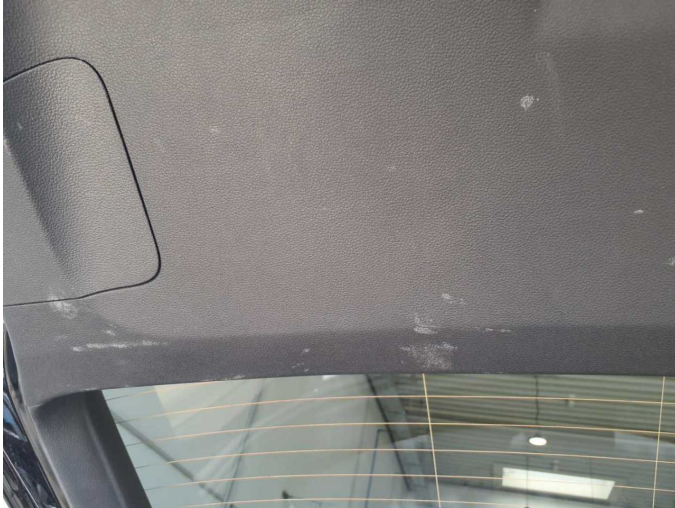
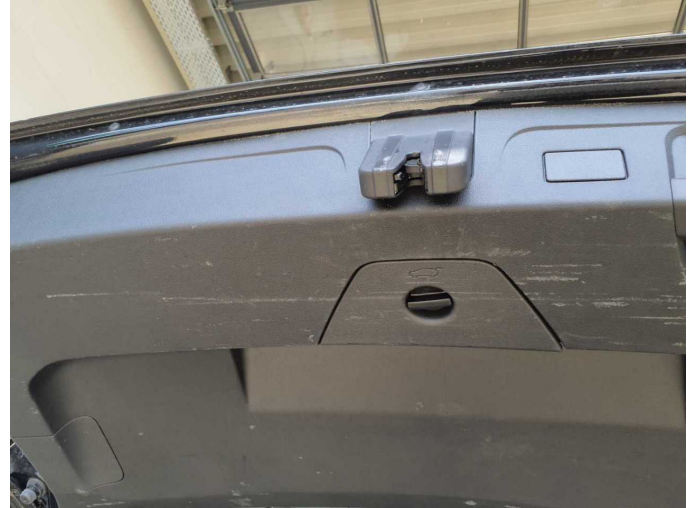
| No. | Component group | Description |
|---|---|---|
| 3 | Trim / covers | Boot lid - interior trim - Scratch(es) - Replace |

**Damage 3:** Trim / covers: Boot lid - interior trim - Scratch(es) - Replace

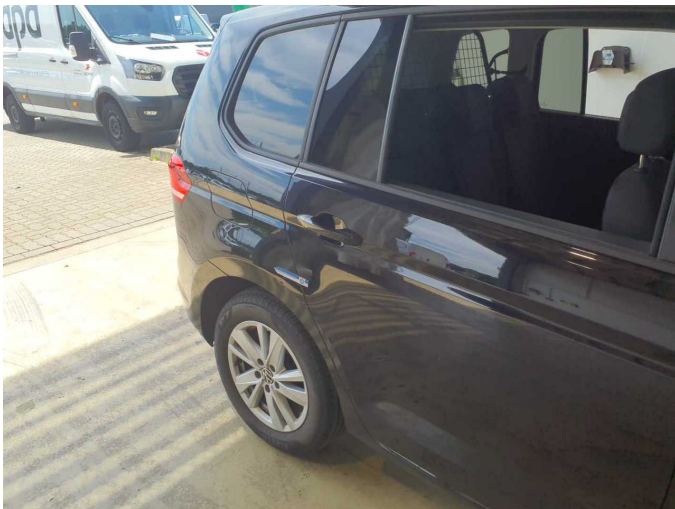
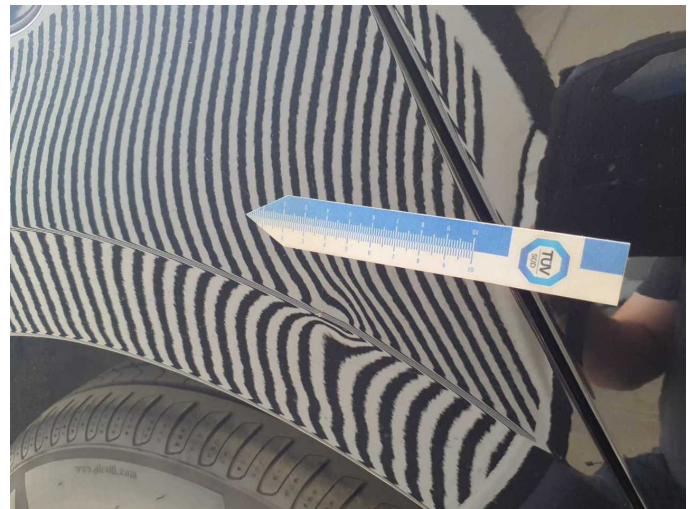
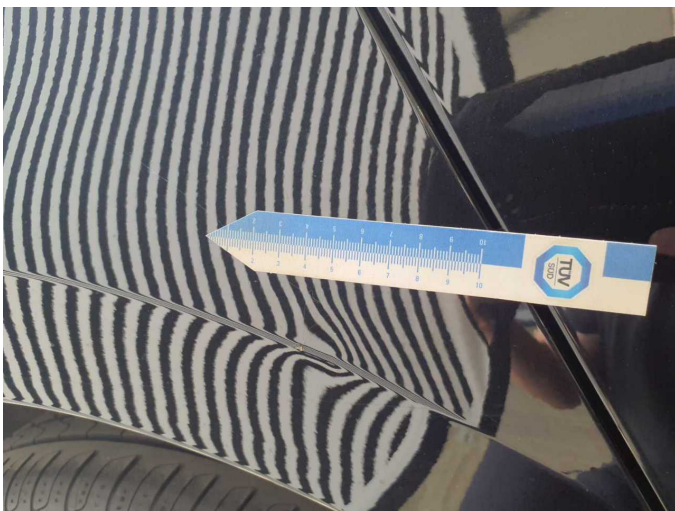
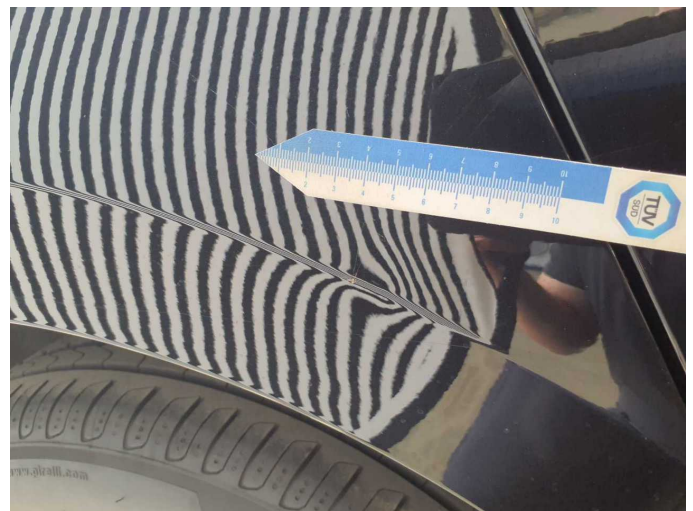
| No. | Component group | Description |
|---|---|---|
| 4 | Side panel - rear right side | Side panel - Deformed - Repair and paint |

**Damage 4:** Side panel - rear right side: Side panel - Deformed - Repair and paint

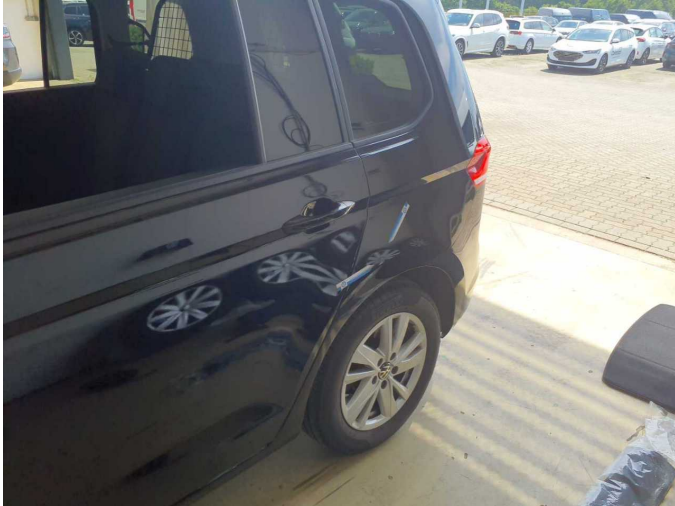
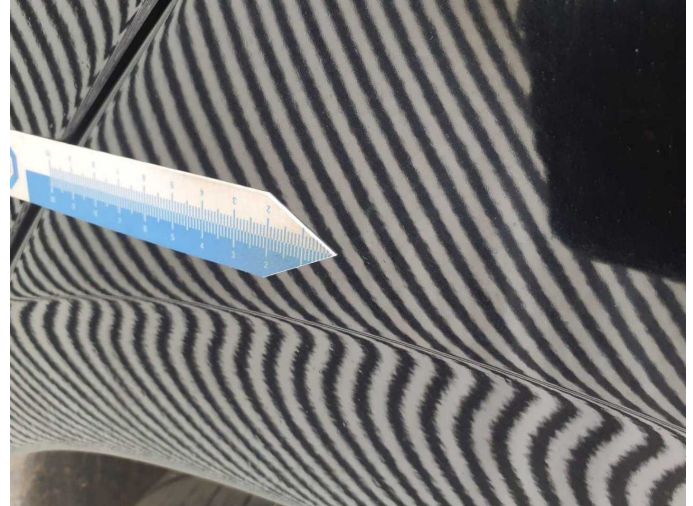
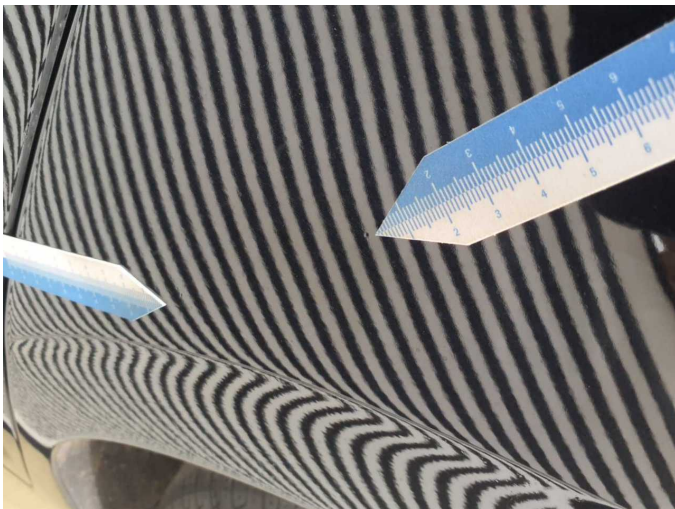
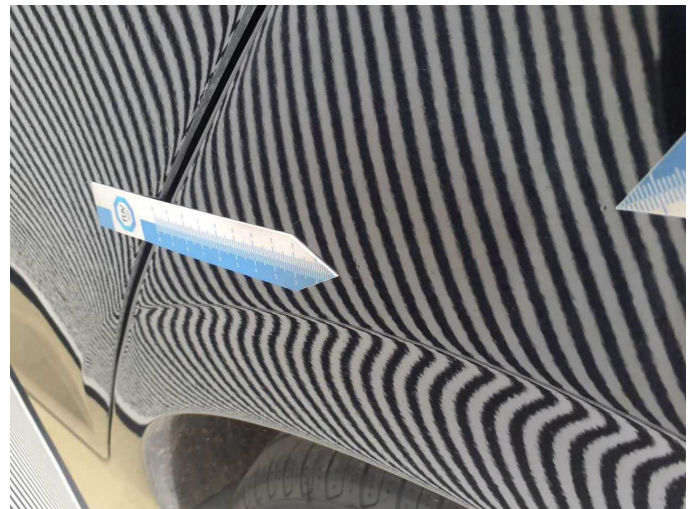
| No. | Component group | Description |
|---|---|---|
| 5 | Side panel - rear left side | Side panel (Spachtelmasse eingefallen) - Unprofessionally repaired - Repair and paint |

| Side panel - rear left side | 1,360<br>µm | Door - rear left side | 504 µm |

**Damage 5:** Side panel - rear left side: Side panel (Spachtelmasse eingefallen) - Unprofessionally repaired - Repair and paint

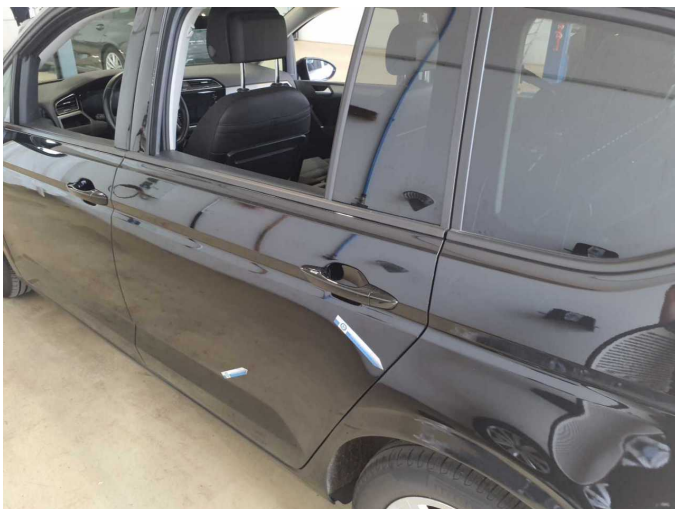
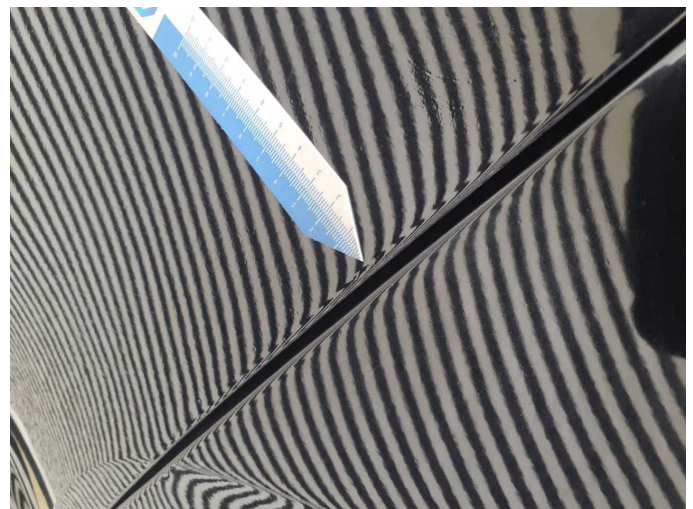
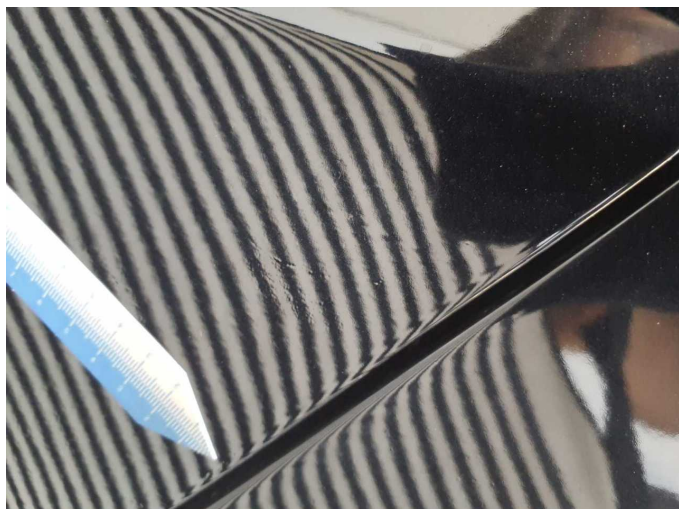
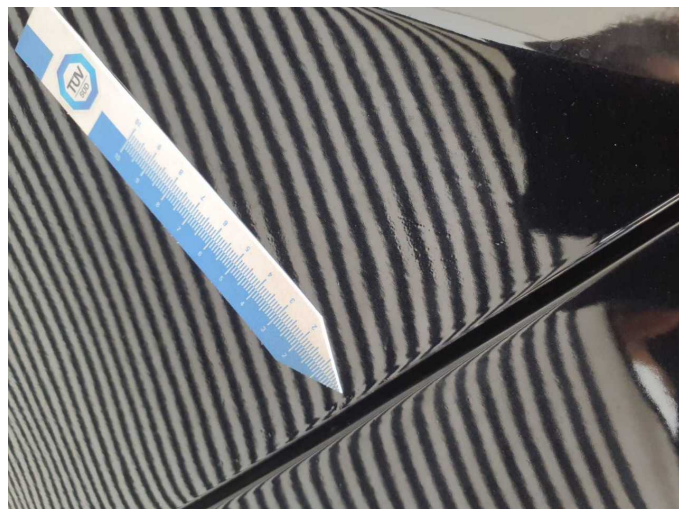
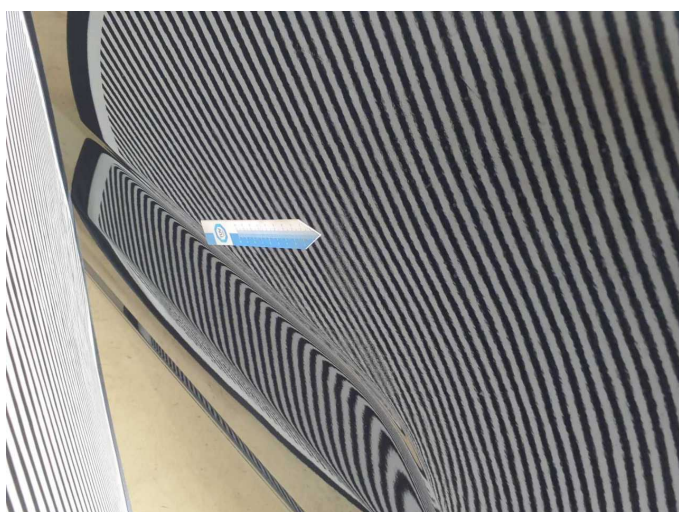
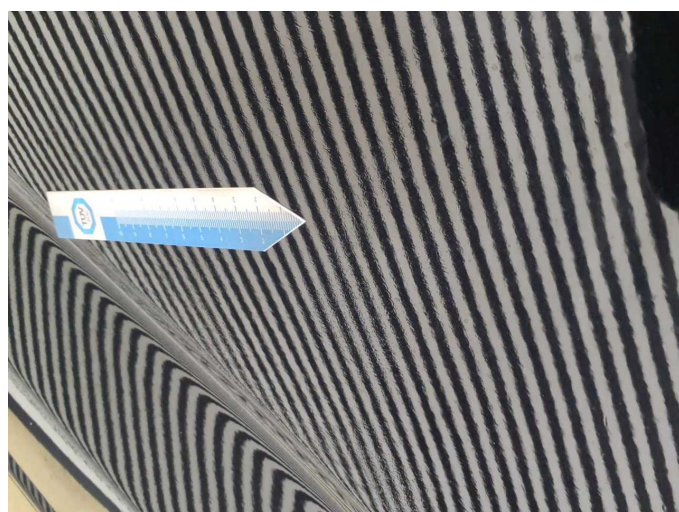
| No. | Component group | Description |
|---|---|---|
| 6 | Door - rear left side | Door (Spachtelmasse eingefallen) - Unprofessionally repaired - Repair and paint |

**Damage 6:** Door - rear left side: Door (Spachtelmasse eingefallen) - Unprofessionally repaired - Repair and paint

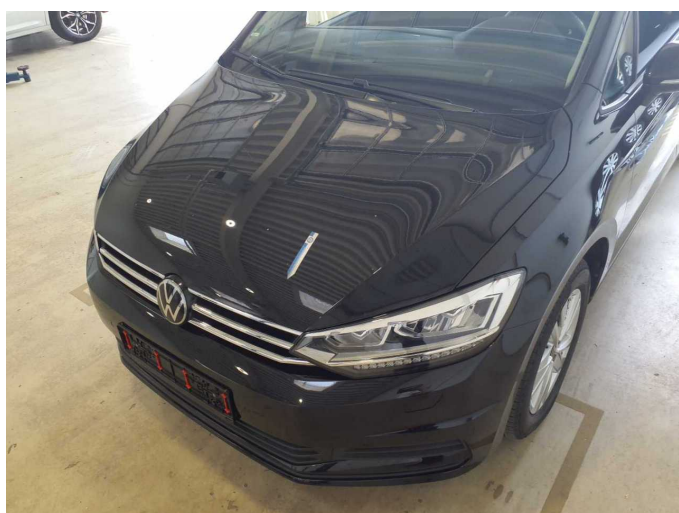
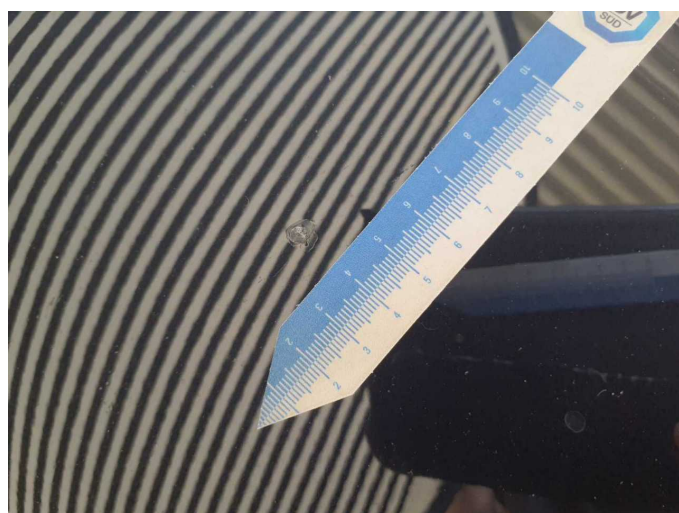
| No. | Component group | Description |
|---|---|---|
| 8 | Bonnet | Bonnet (Anätzung) - Paint defect - Repair and paint |

**Damage 8:** Bonnet: Bonnet (Anätzung) - Paint defect - Repair and paint

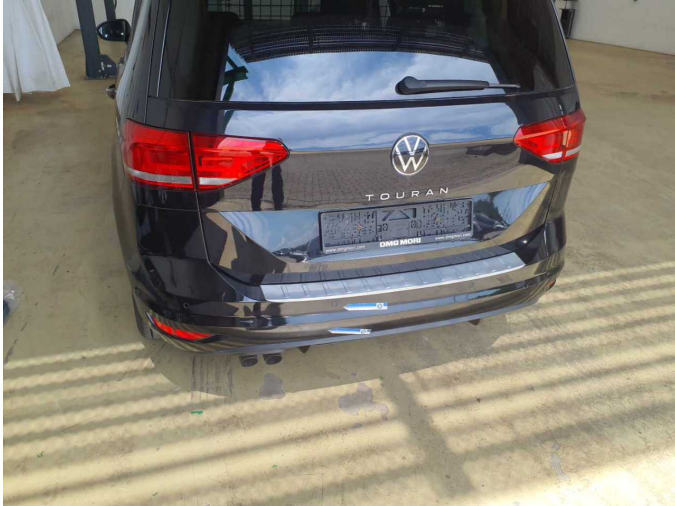
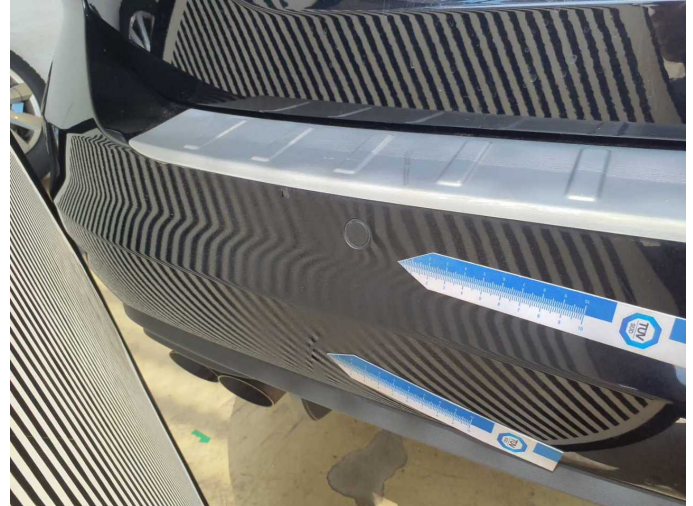
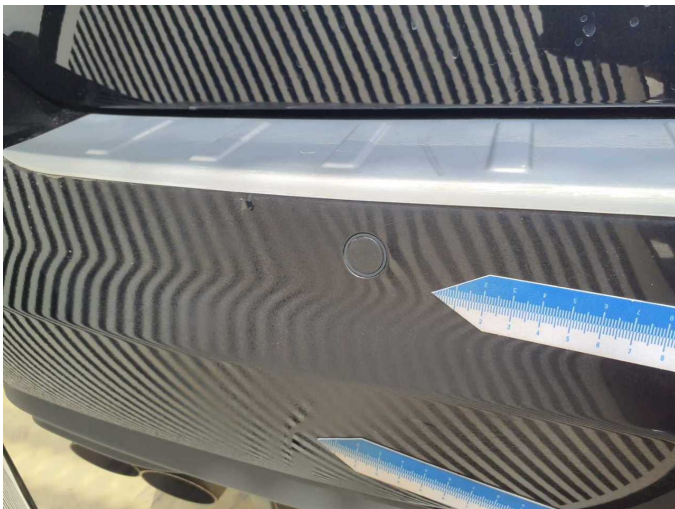
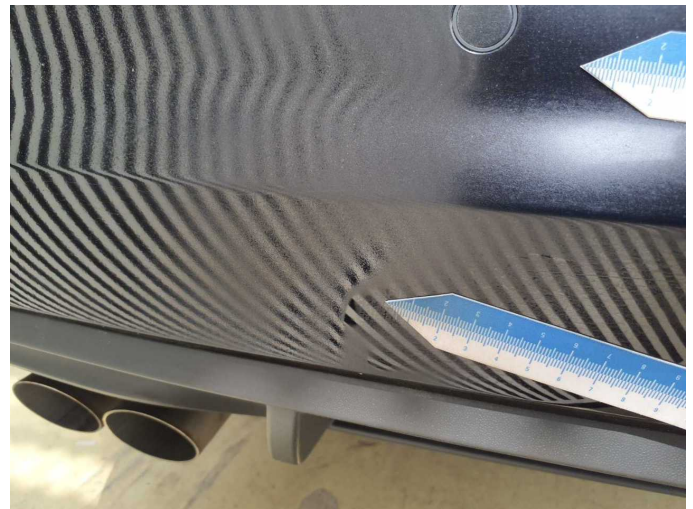
| No. | Component group | Description |
|---|---|---|
| 9 | Rear bumper | Rear bumper - Paint defect - Repair and paint |

**Damage 9:** Rear bumper: Rear bumper - Paint defect - Repair and paint

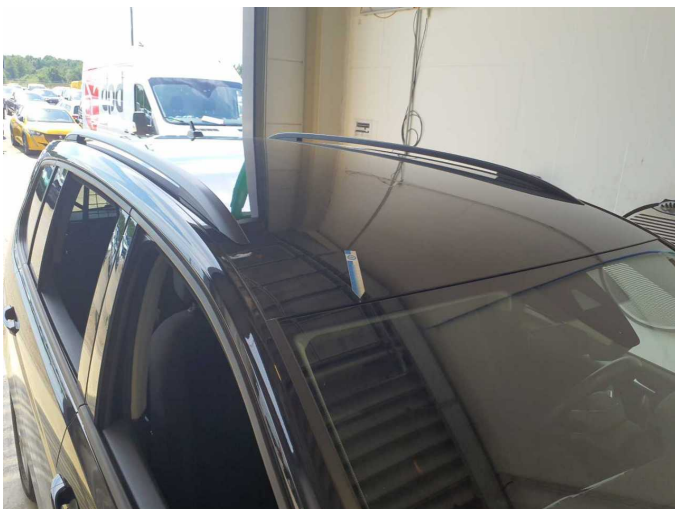
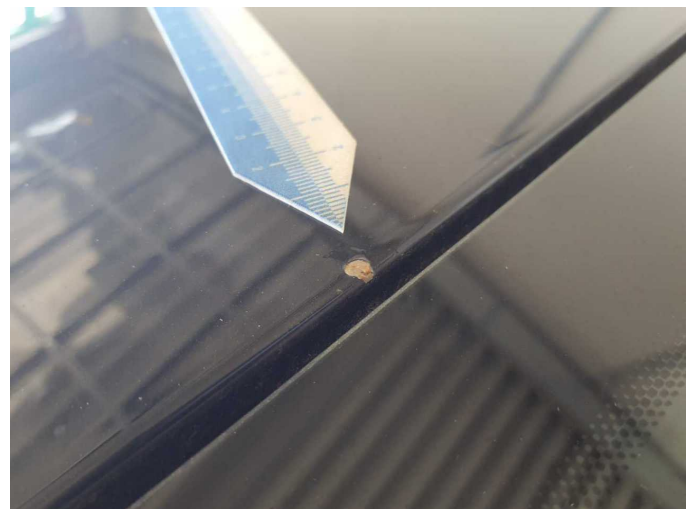
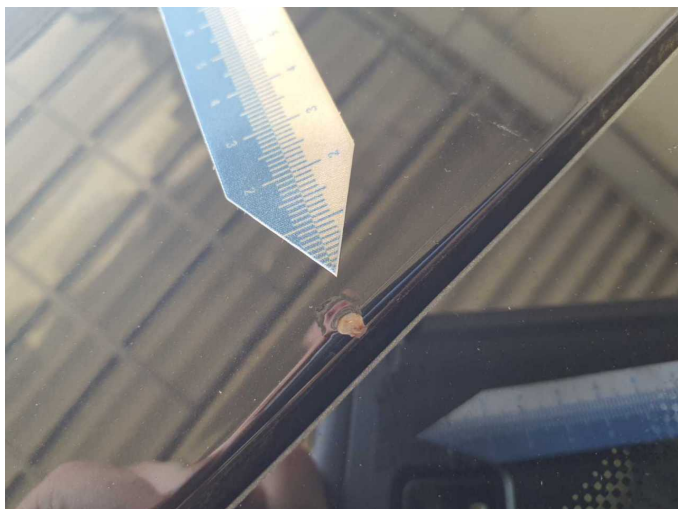
| No. | Component group | Description |
|---|---|---|
| 10 | Roof | Roof - Corrosion - Repair and paint |

**Damage 10:** Roof: Roof - Corrosion - Repair and paint

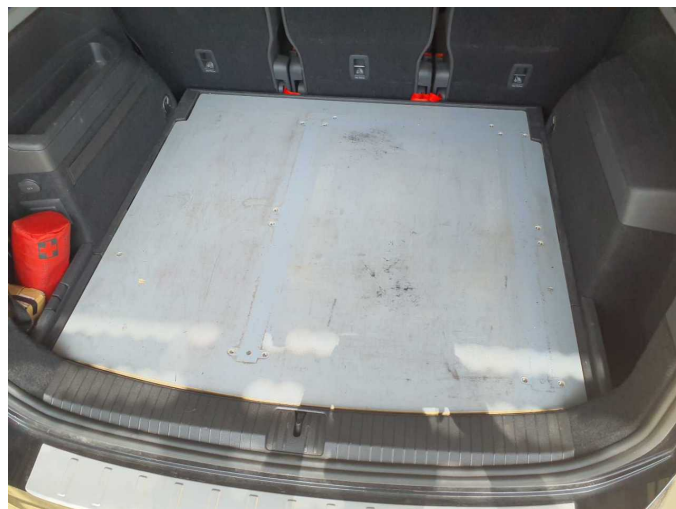
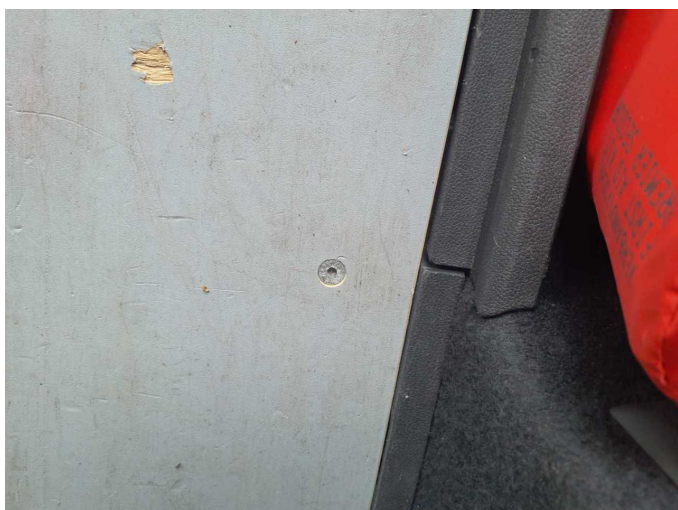
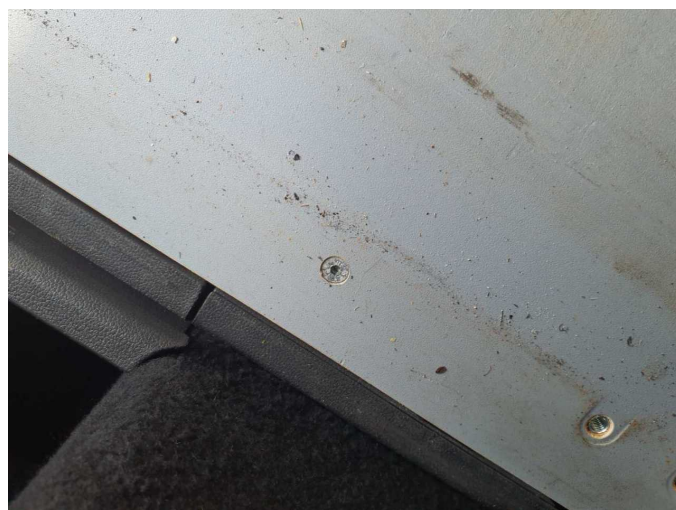
| No. | Component group | Description |
|---|---|---|
| 7 | Interior | Cargo area floor (fester Boden verbaut, Rückrüsten, Mehrkosten möglich) - Differs from the original configuration - Replace |

| No. | Component group | Description |
|---|---|---|
| 1 | Interior | Cargo area floor (Holzboden verschraubt) - No deduction |

**Wear and tear 1:** Interior: Cargo area floor (Holzboden verschraubt) - No deduction

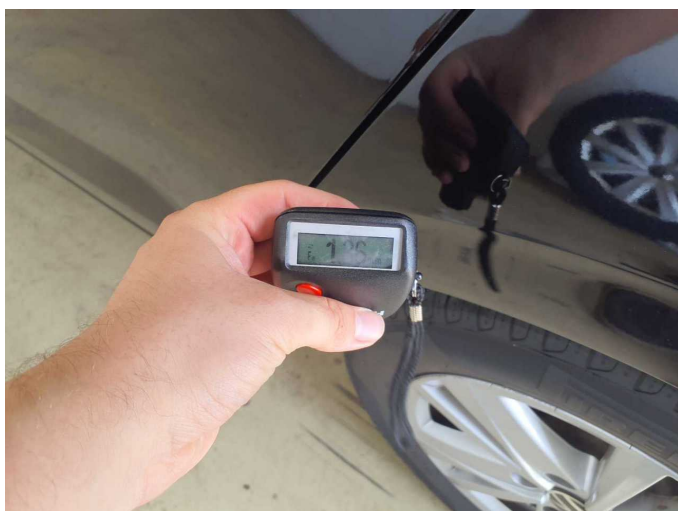
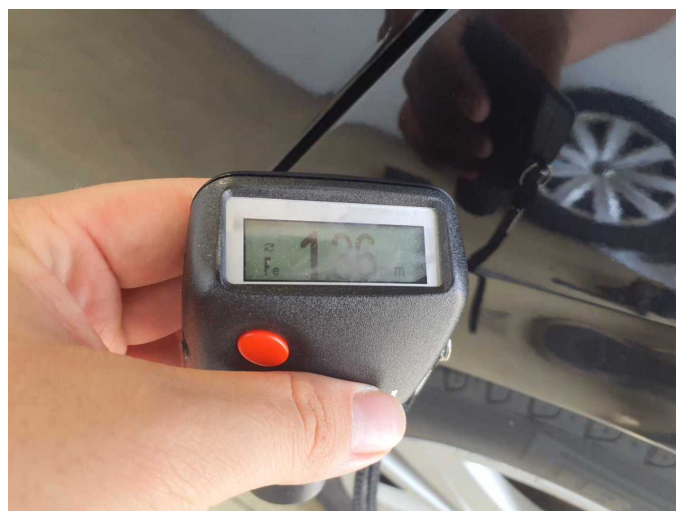
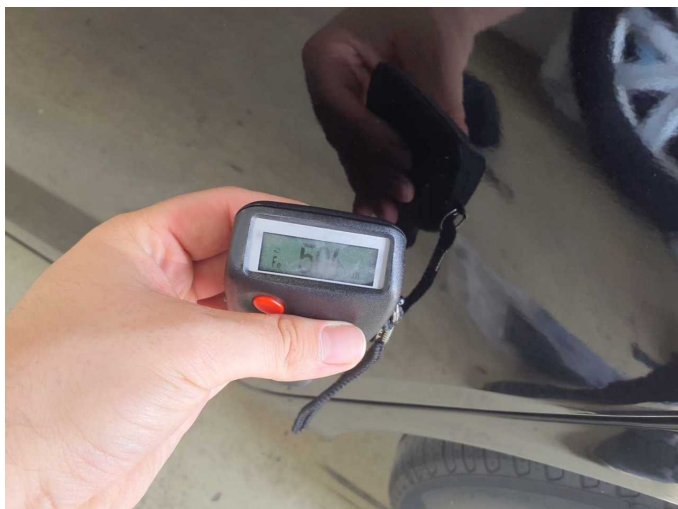
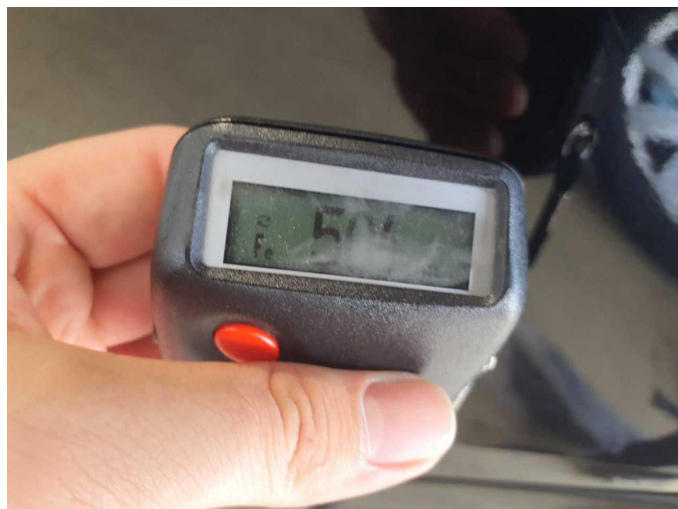
| No. | Repainting |
|---|---|
| 1 | Side panel - rear left side, Door - rear left side, Unprofessionally carried out |

**Repainting 1:** Side panel - rear left side, Door - rear left side
