Expertise

Protocol number: 44529452  
Order number / reference: 26003252  
Inspection date: 17 Mar 2026

Manufacturer: Ford

Model: Mondeo Turnier 2.0 EcoBlue Aut. Titanium

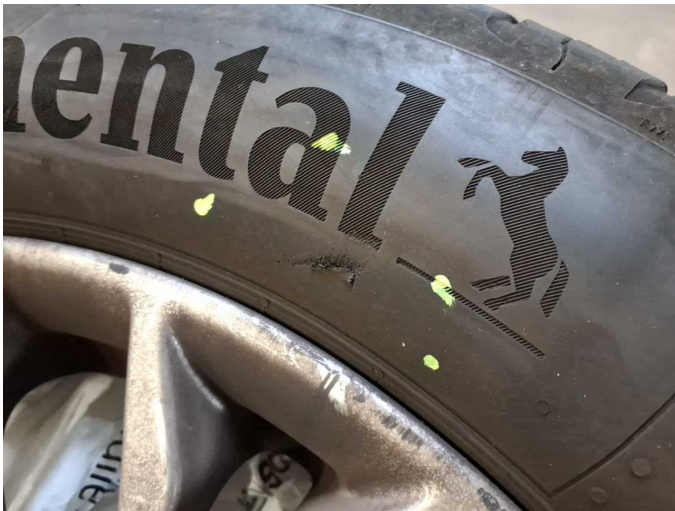
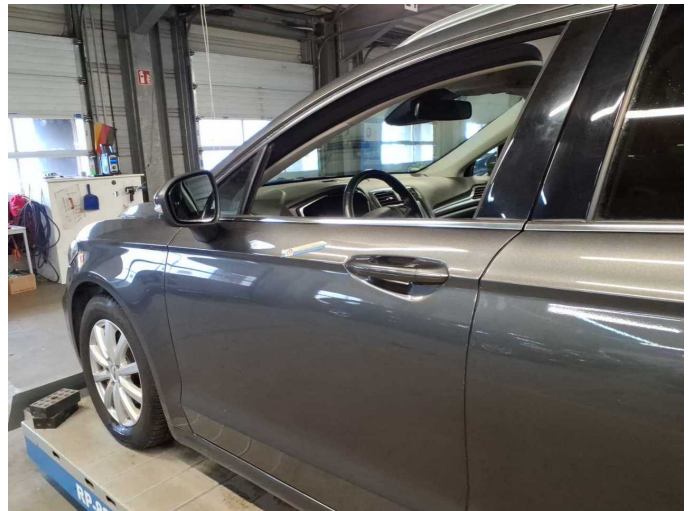
| No. | Component group | Description |
|---|---|---|
| 2 | 2nd wheel set | 1 tyre (Flanke) - Damaged - Replace |

**Damage 2:** 2nd wheel set: 1 tyre (Flanke) - Damaged - Replace

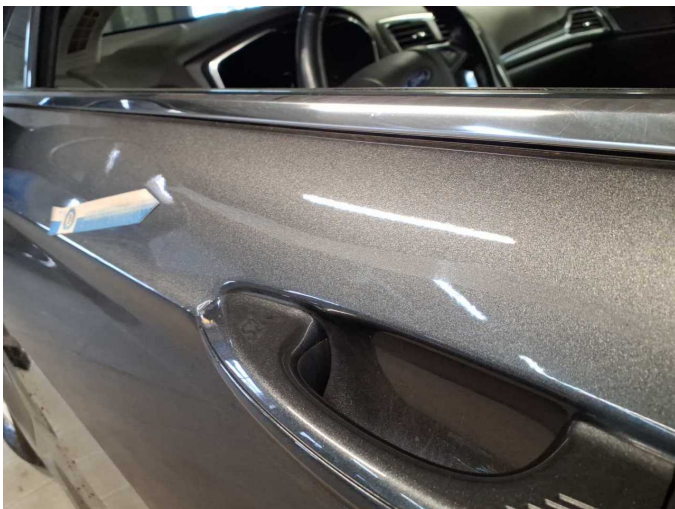
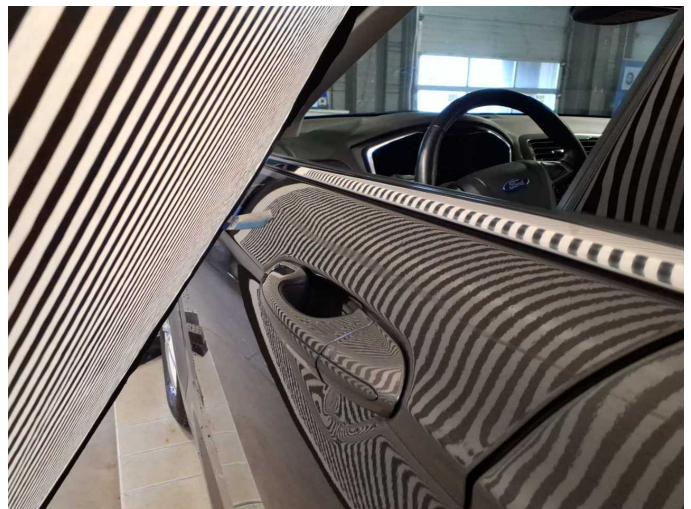
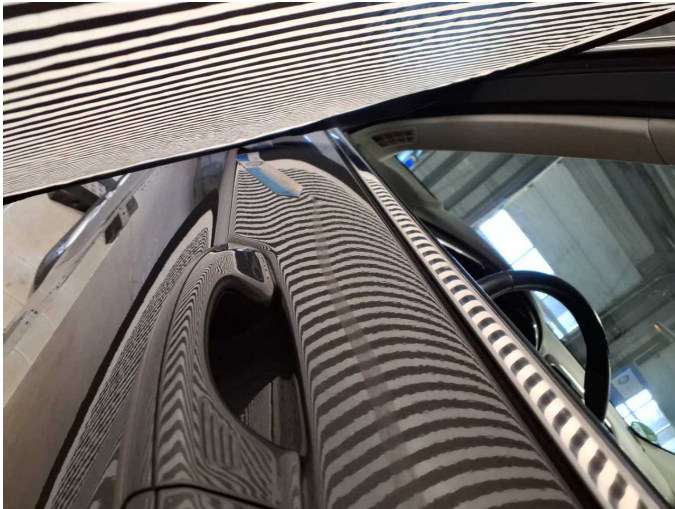
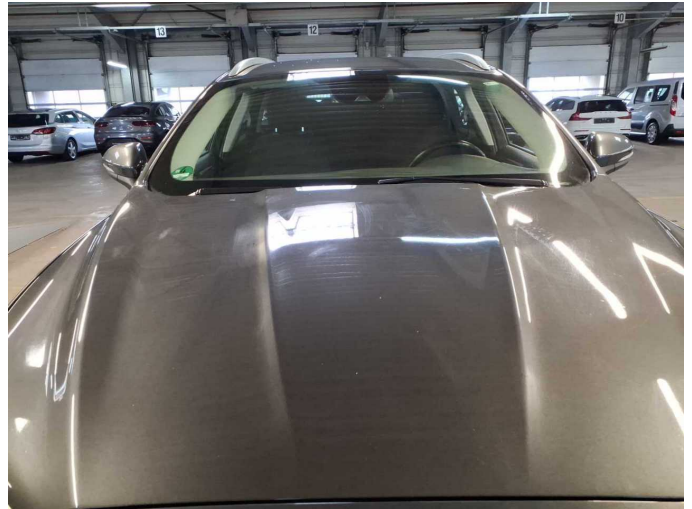
| No. | Component group | Description |
|---|---|---|
| 3 | Door - front left side | Door - Deformed - Repair and paint |

**Damage 3:** Door - front left side: Door - Deformed - Repair and paint

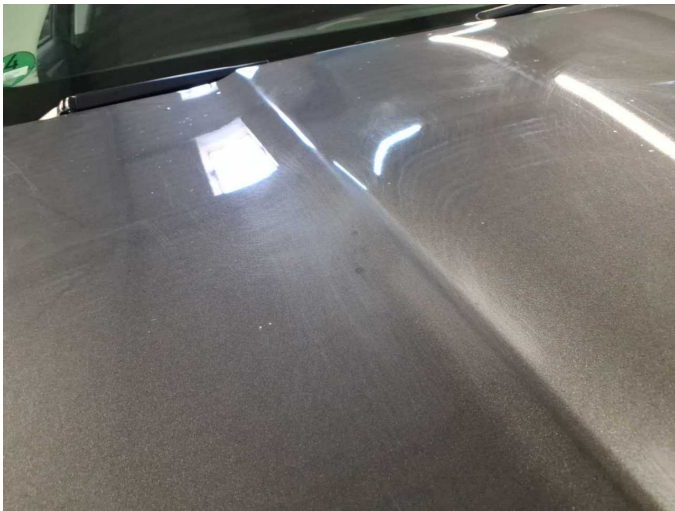
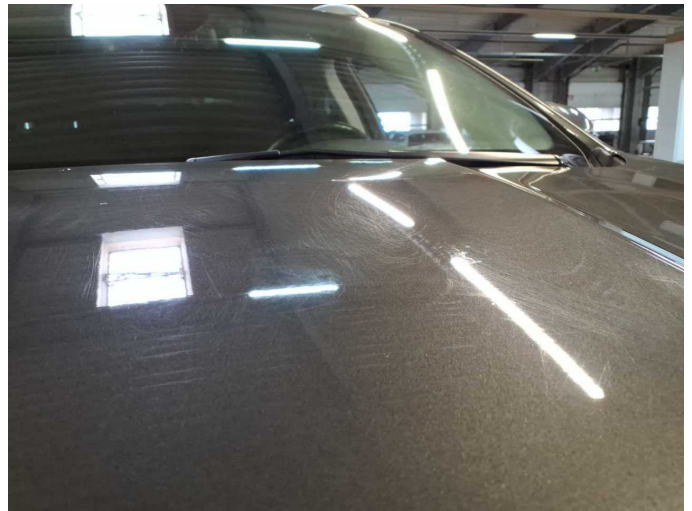
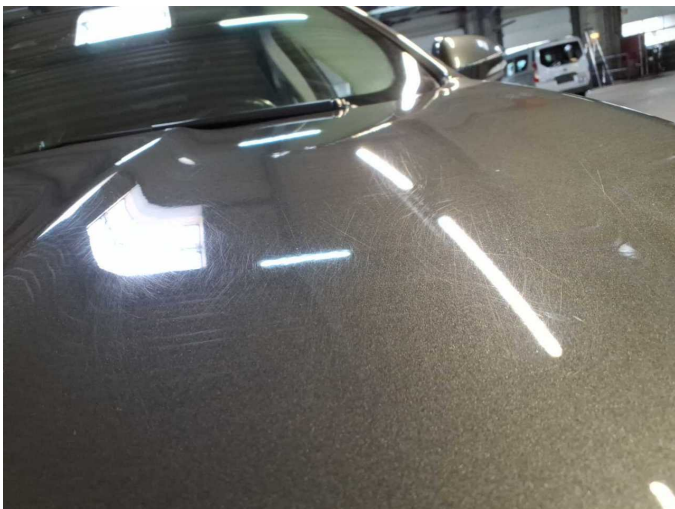
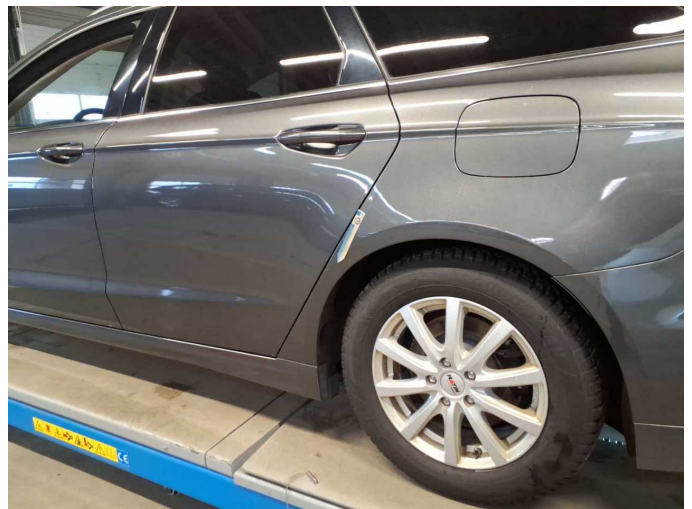
| No. | Component group | Description |
|---|---|---|
| 4 | Bonnet | Bonnet - Scratched - Paint |

**Damage 4:** Bonnet: Bonnet - Scratched - Paint

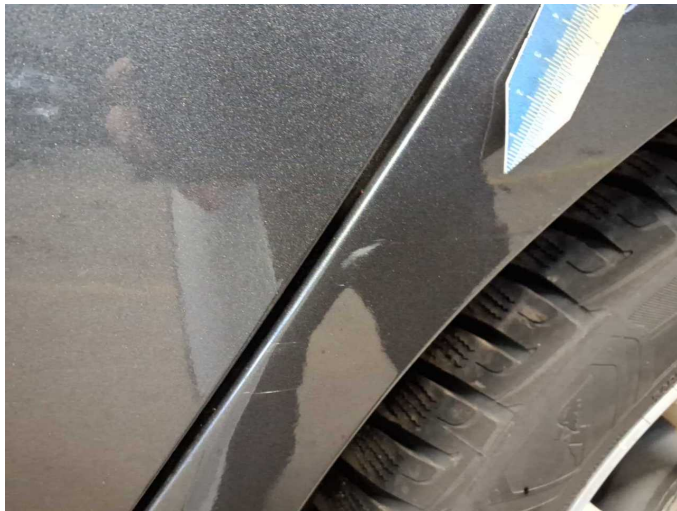
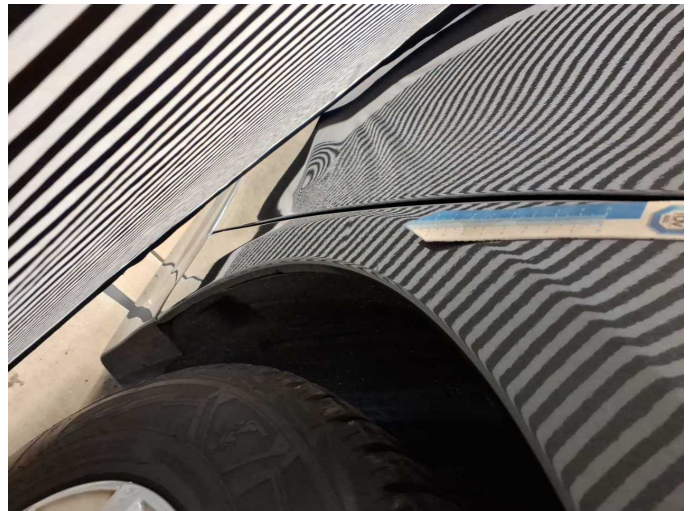
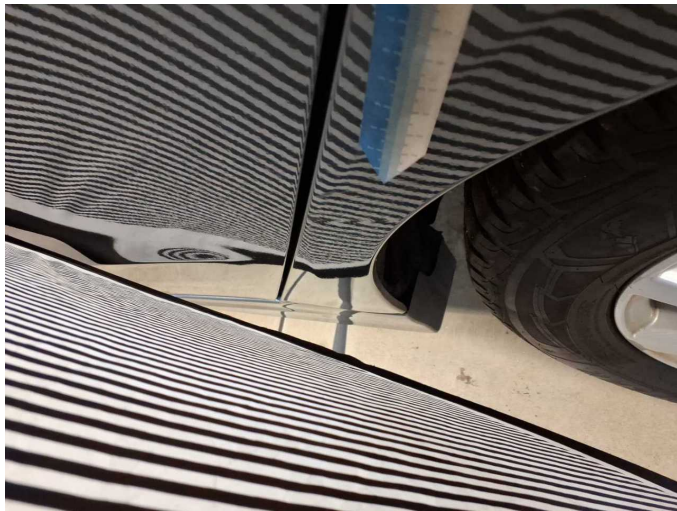
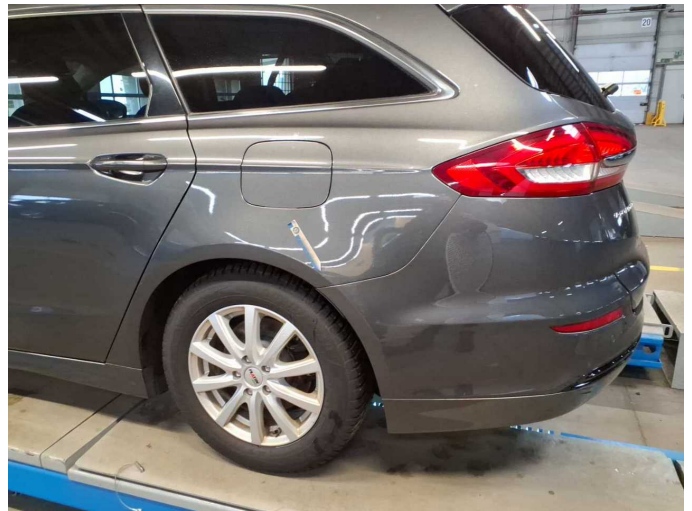
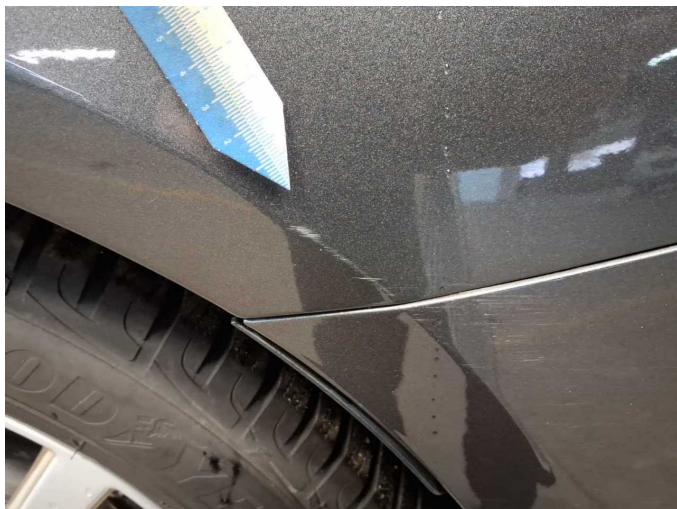
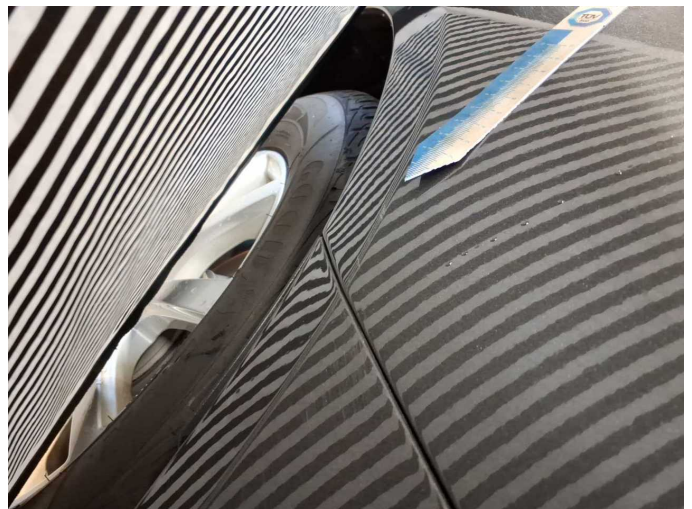
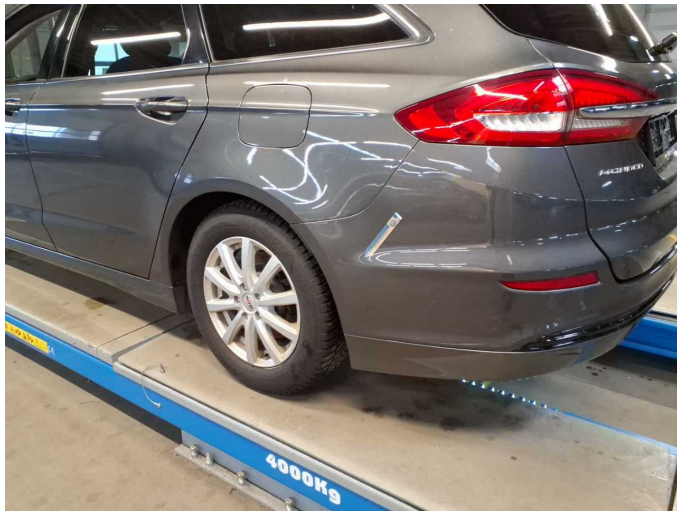
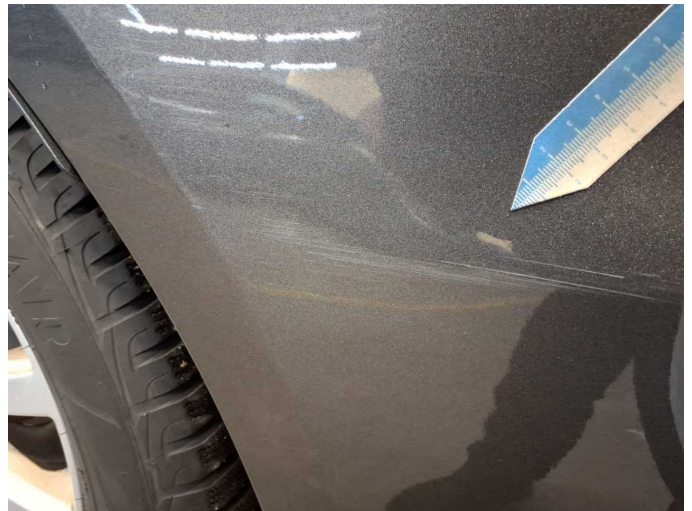
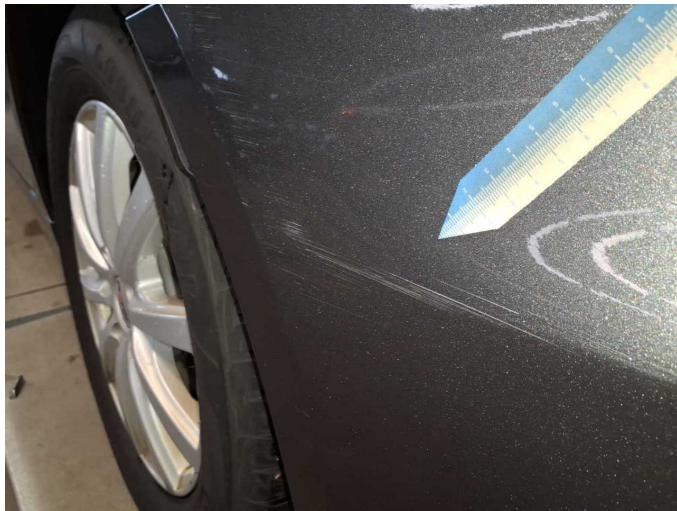
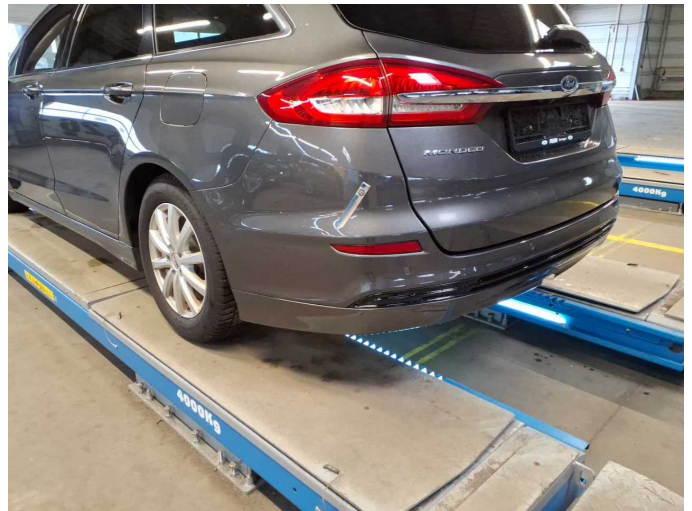
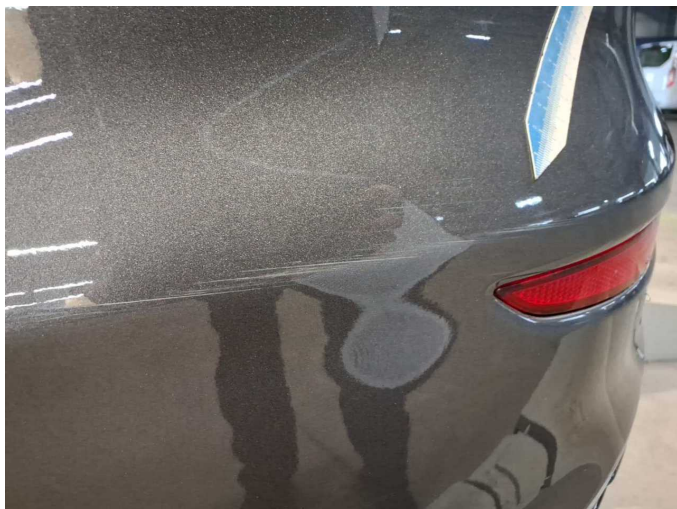
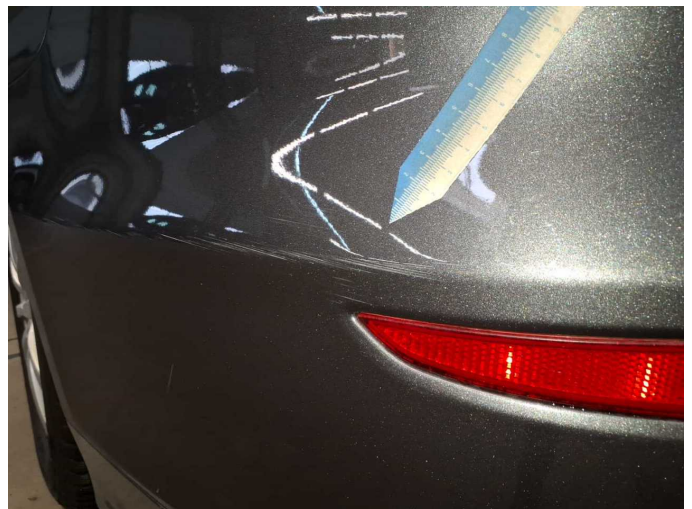
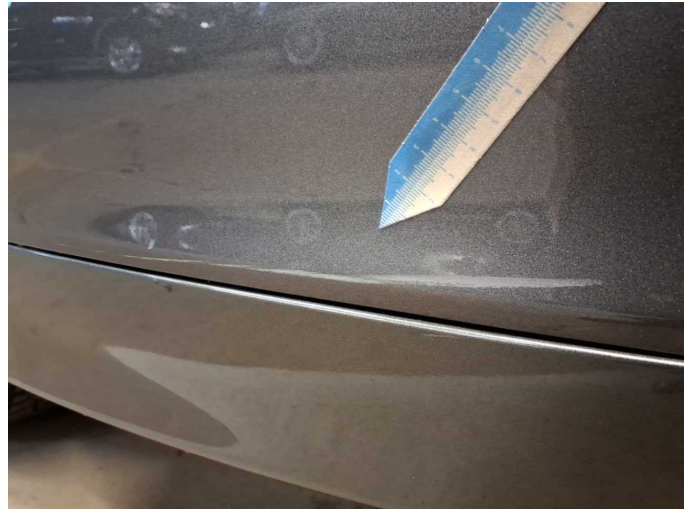
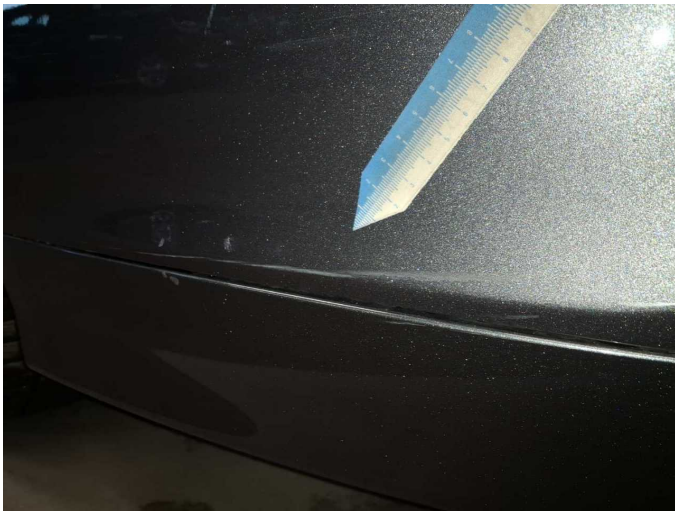
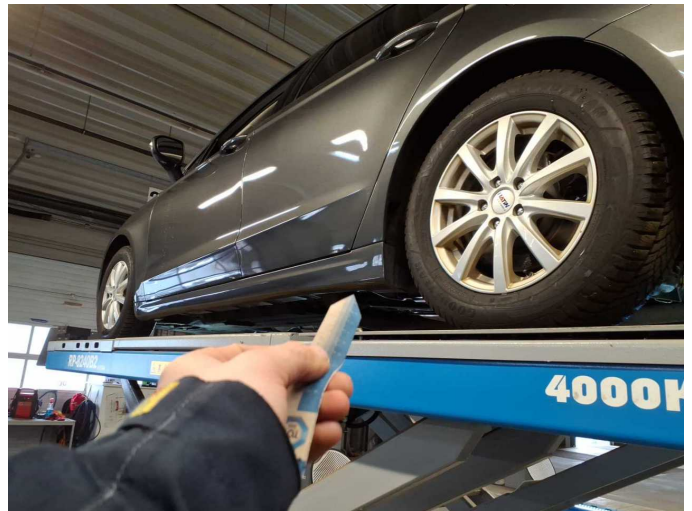
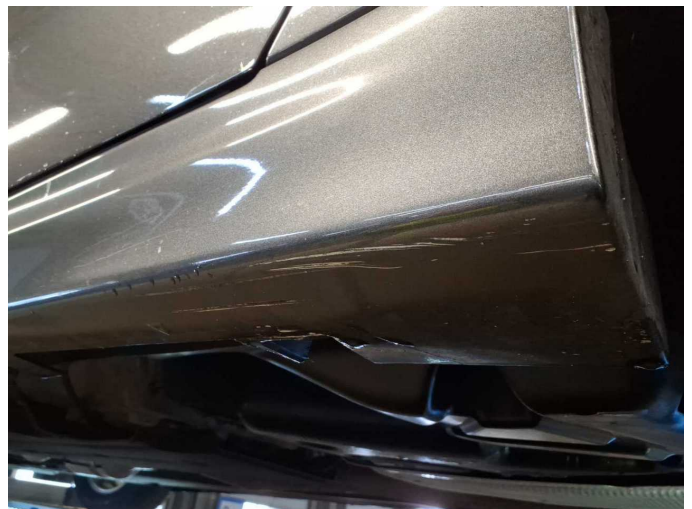
| No. | Accident |
|---|---|
| 1 | Side - left |

**Accident 1:** Side - left

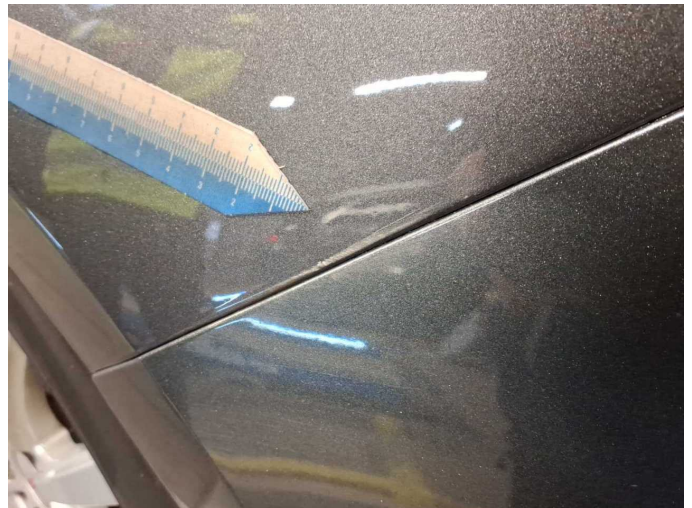
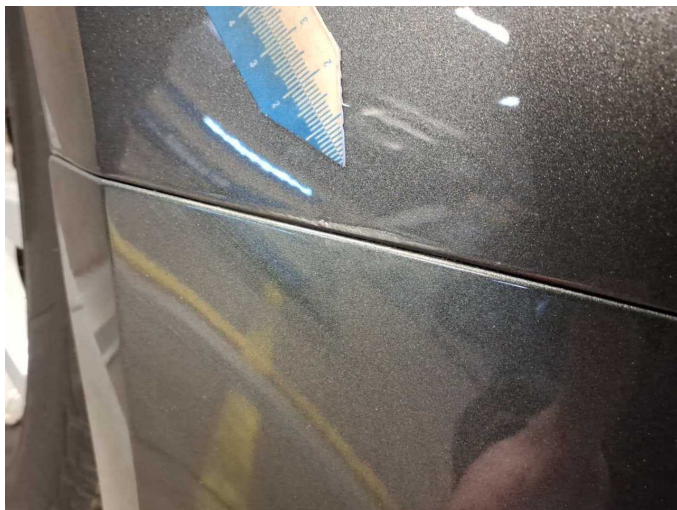
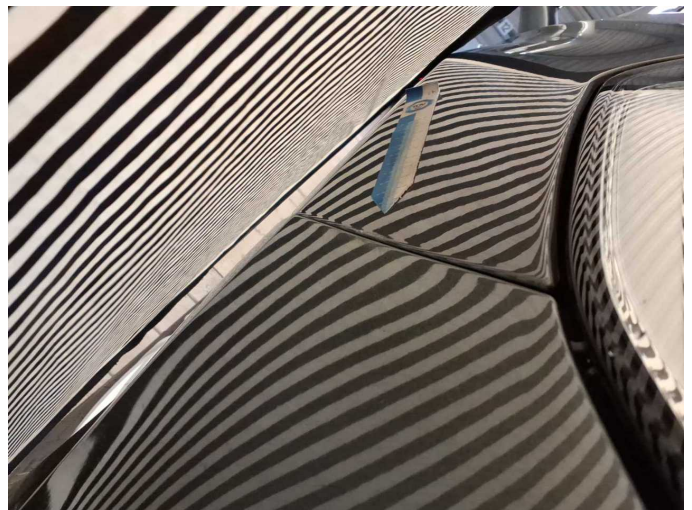
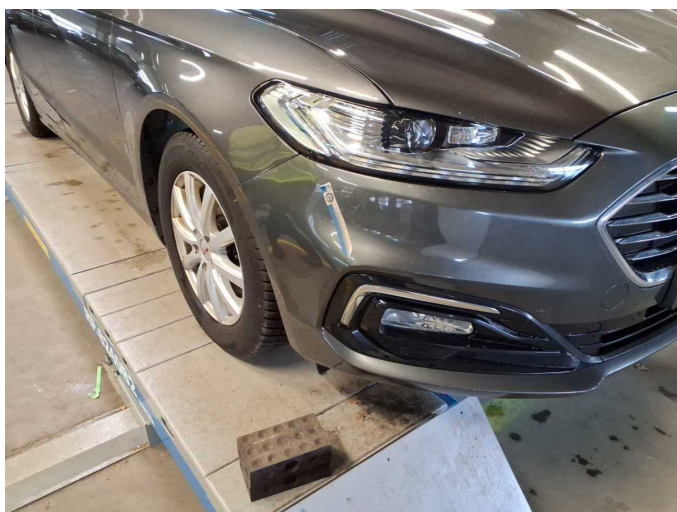
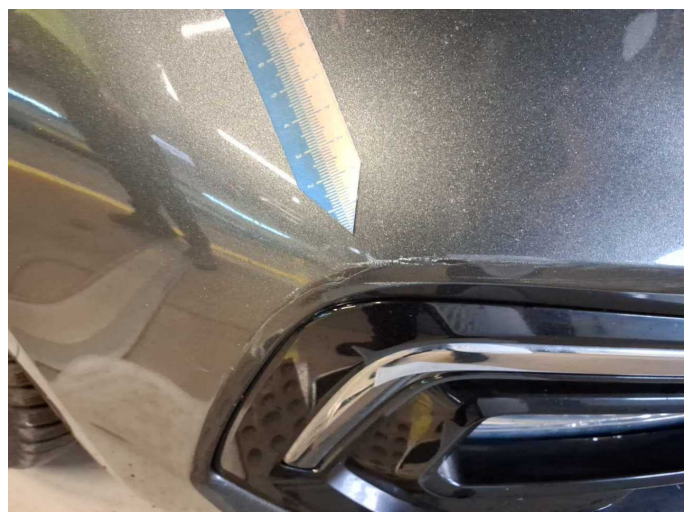
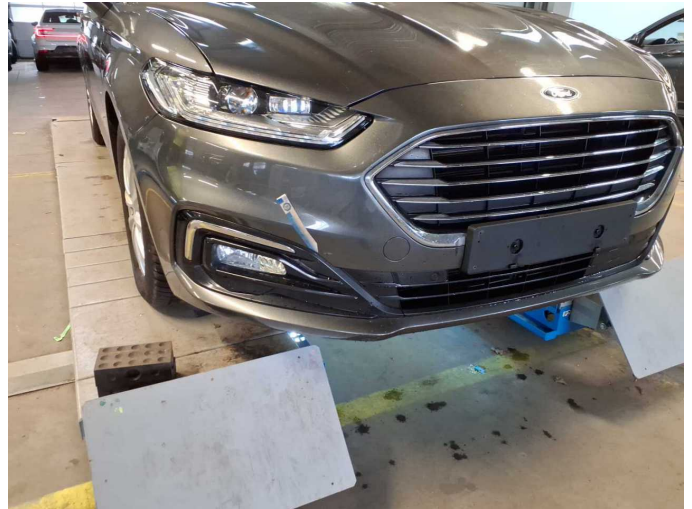
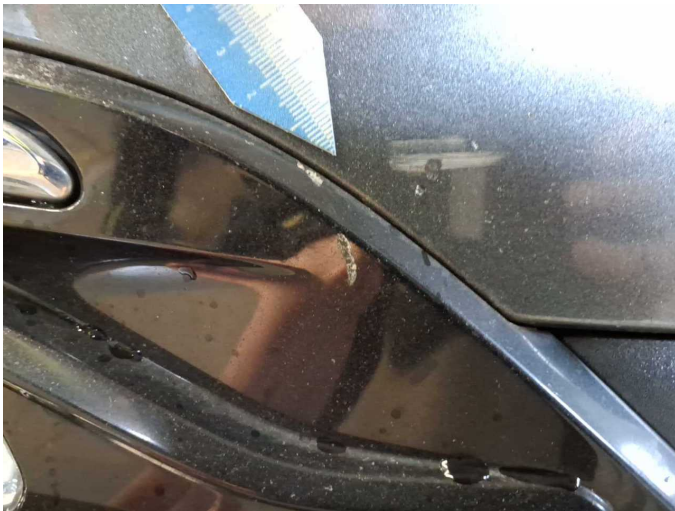
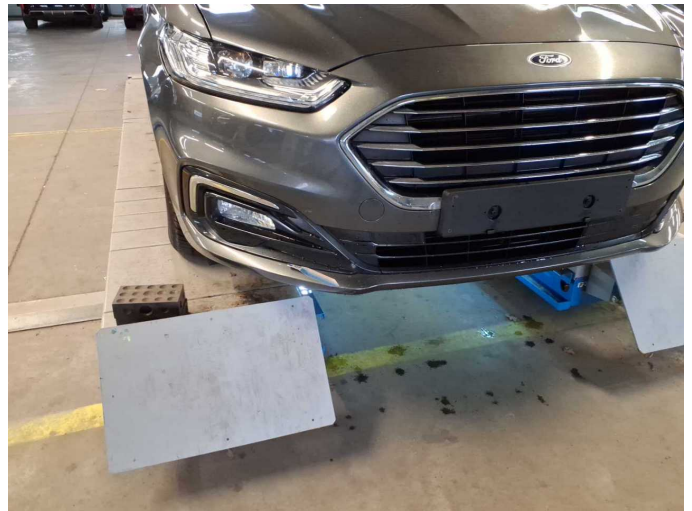
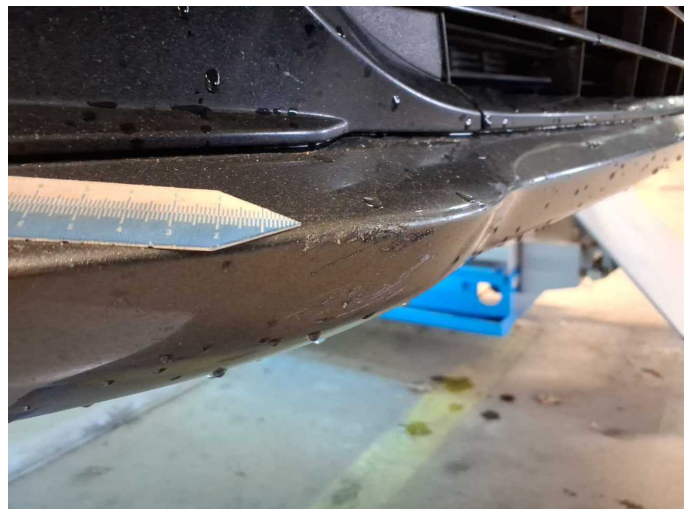
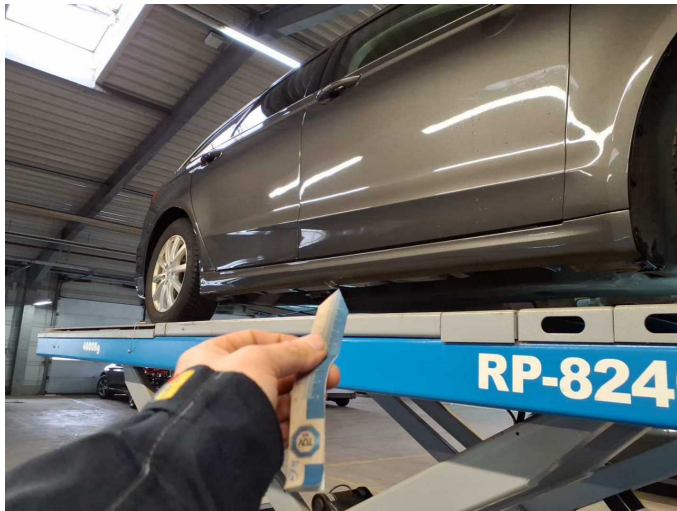
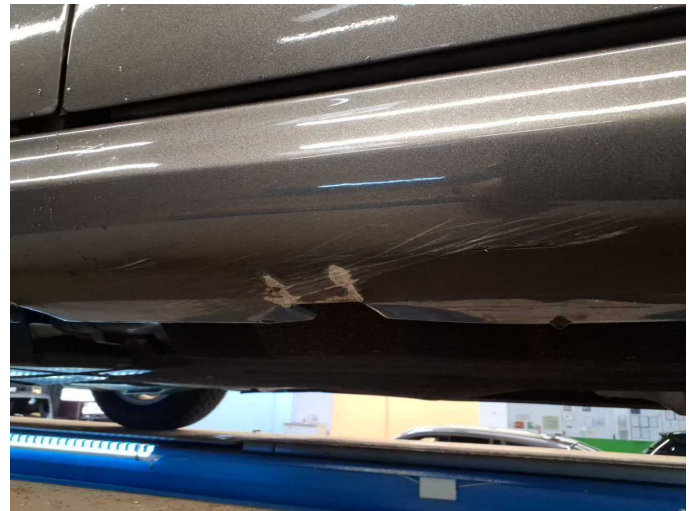
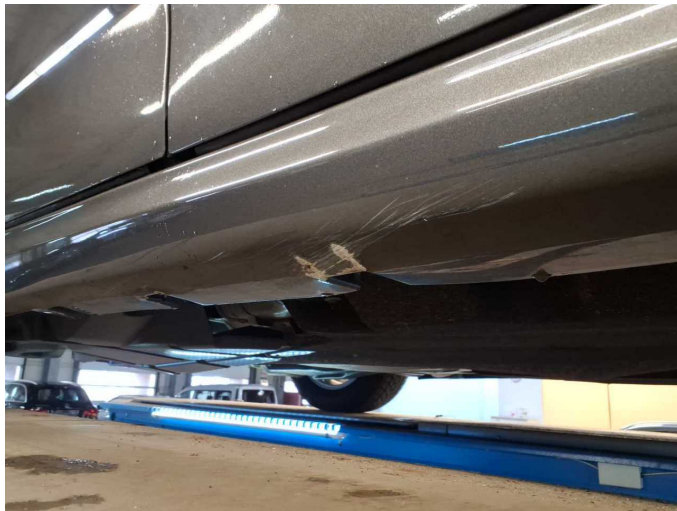
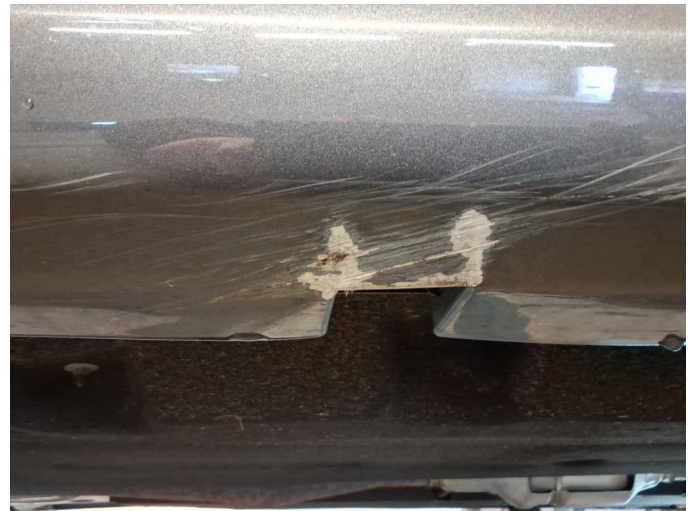
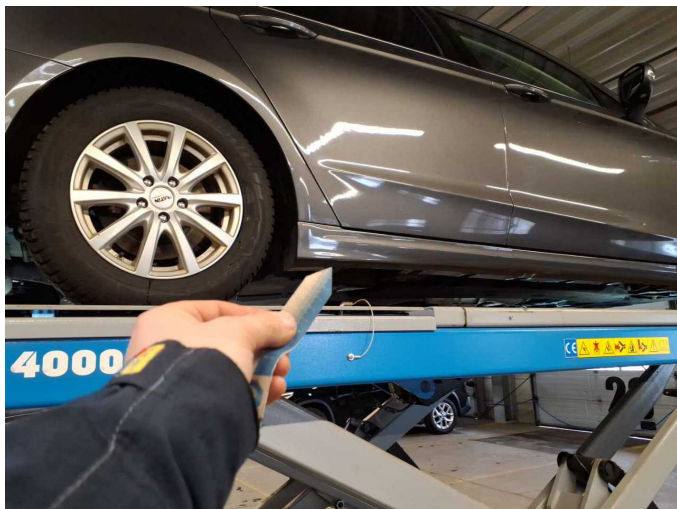
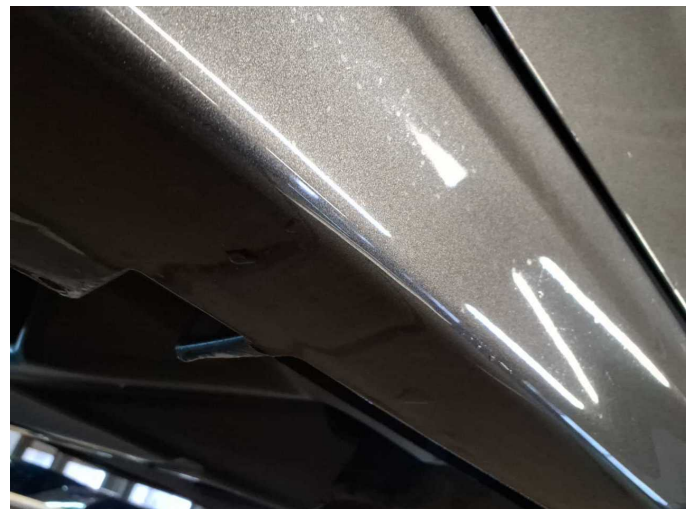
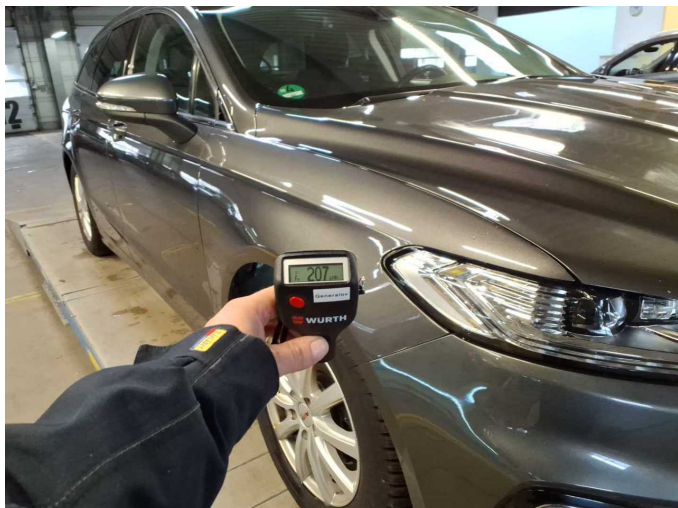
| No. | Accident |
|---|---|
| 2 | Front, Side right |

**Accident 2: Front, Side right**

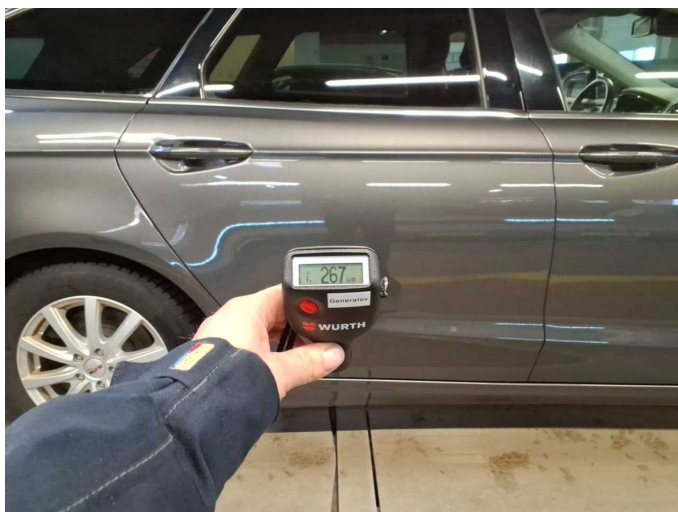
- 2 Side panel - rear right side, Professionally carried out, Invoice of repair done Non-existent
- 3 Door - rear right side, Professionally carried out, Invoice of repair done Non-existent
- 4 Door - front right side, Professionally carried out, Invoice of repair done Non-existent

| Mudguard - right side | 207 µm | Side panel - rear right side | 264 µm |

**Repainting 2:** Side panel - rear right side

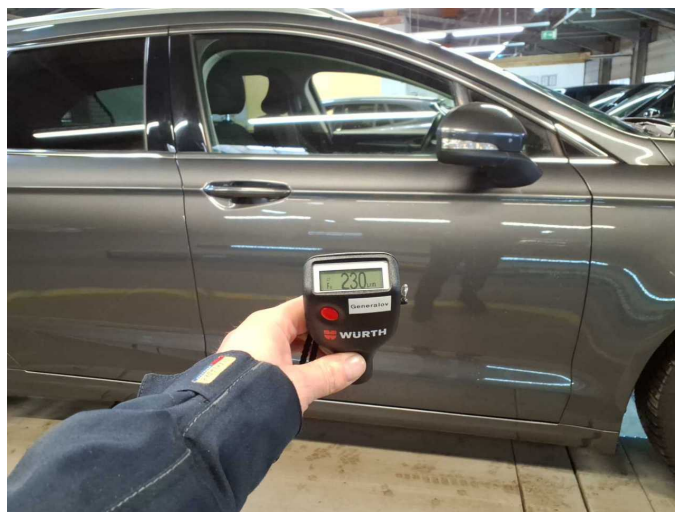
| Door - rear right side | 267 µm | Door - front right side | 230 µm |

**Repainting 3:** Door - rear right side
