Expertise

Protocol number: 46265979  
Order No. / Reference: 26598477  
Inspection date: 30 Jun 2026

Manufacturer: Skoda  
VIN: TMBJG8NX0PY008678

Model: Octavia Combi 2.0 TDI Clever

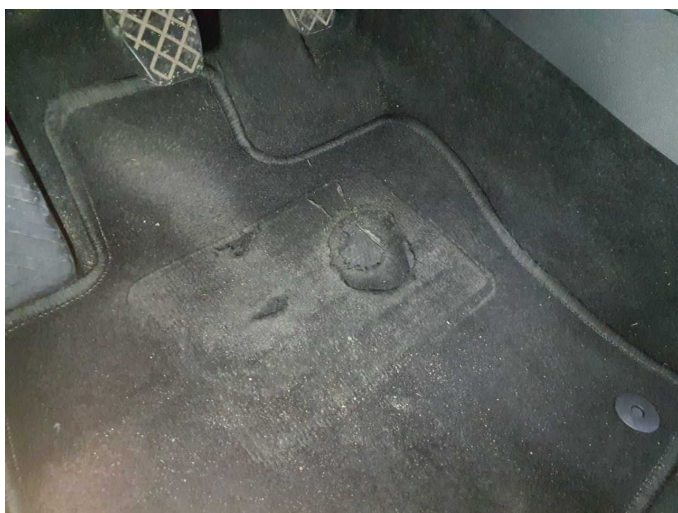
| No. | Component group | Description |
|---|---|---|
| 1 | Trim / covers | Floor mats - Broken / torn - Replace |

Damage 1: Trim / covers: Floor mats - Broken / torn - Replace

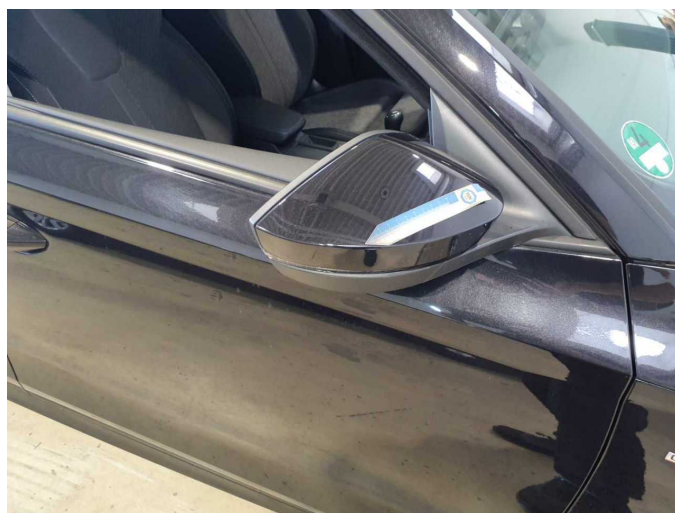
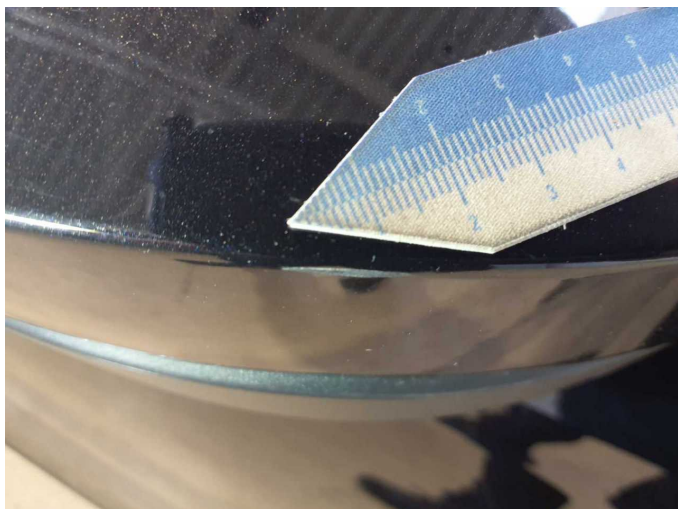
| No. | Component group | Description |
|---|---|---|
| 2 | Wing mirror - right side | Cap - Scratch(es) - Smart repair |

Damage 2: Wing mirror - right side: Cap - Scratch(es) - Smart repair

**Damage 2:** Wing mirror - right side: Cap - Scratch(es) - Smart repair

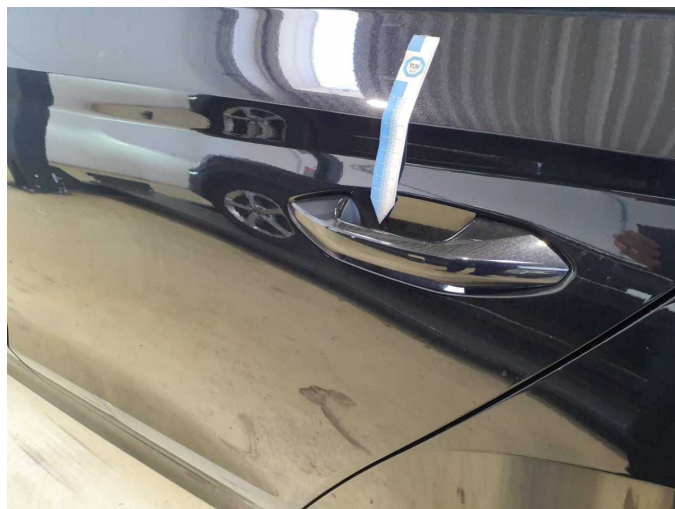
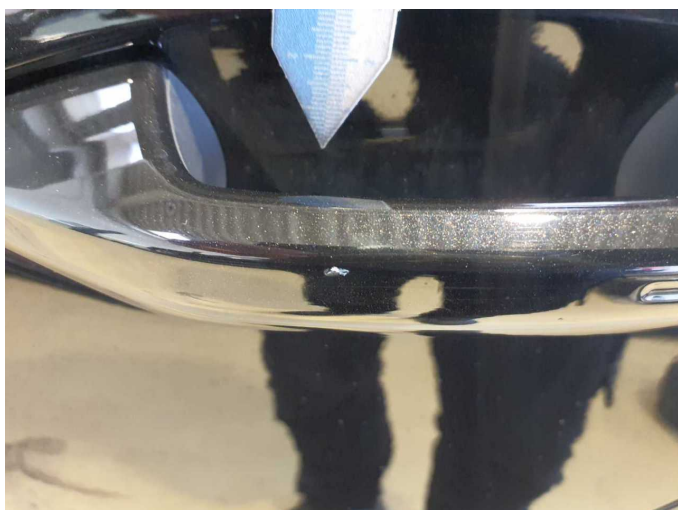
| No. | Component group | Description |
|---|---|---|
| 3 | Door - rear left side | Door handle - outside - Scratch(es) - Smart repair |

**Damage 3:** Door - rear left side: Door handle - outside - Scratch(es) - Smart repair

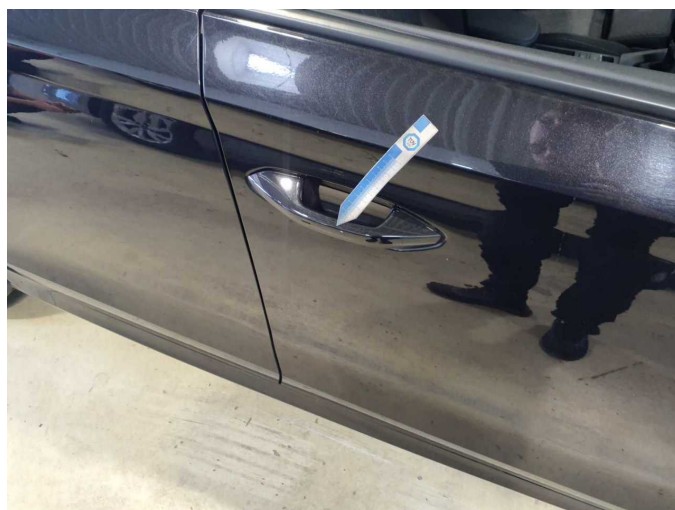
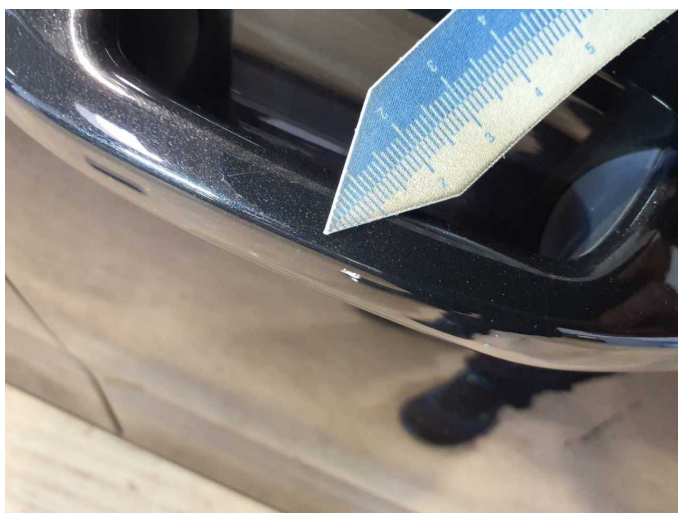
| No. | Component group | Description |
|---|---|---|
| 4 | Door - front right side | Door handle - outside - Scratch(es) - Smart repair |

**Damage 4:** Door - front right side: Door handle - outside - Scratch(es) - Smart repair

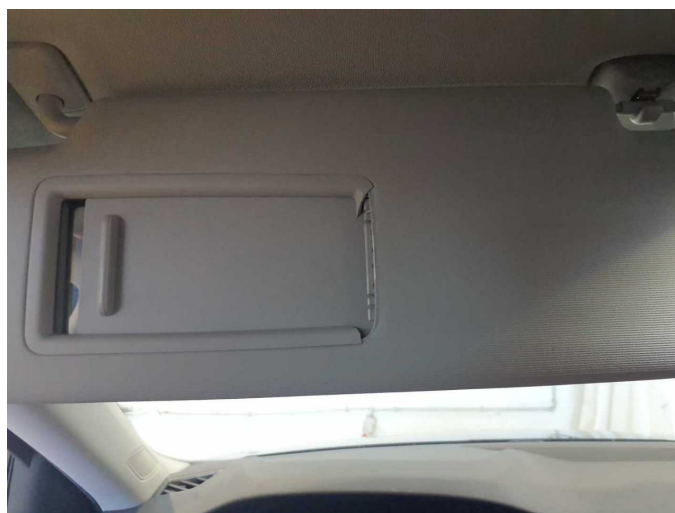
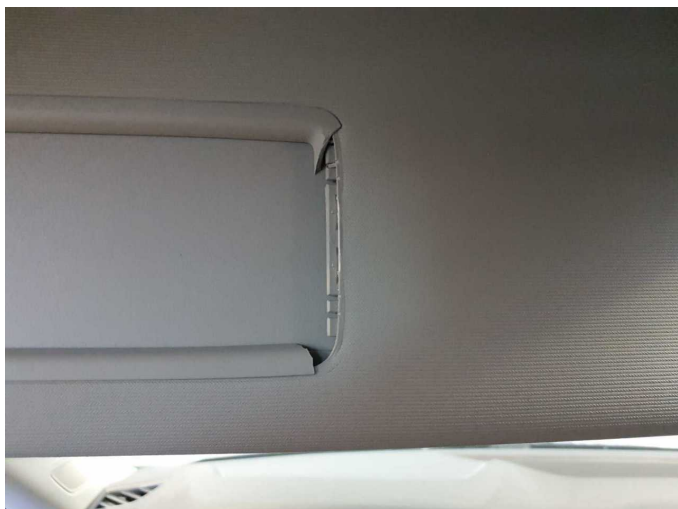
| No. | Component group | Description |
|---|---|---|
| 5 | Interior | Sun visor - left side - Broken / torn - Replace |

**Damage 5:** Interior: Sun visor - left side - Broken / torn - Replace

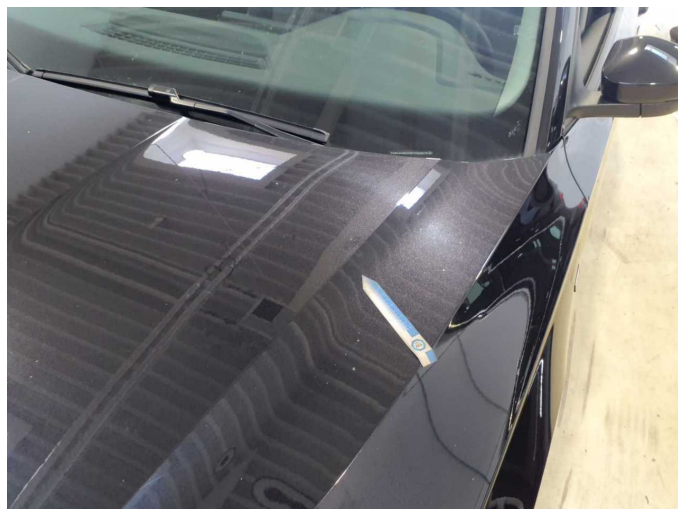
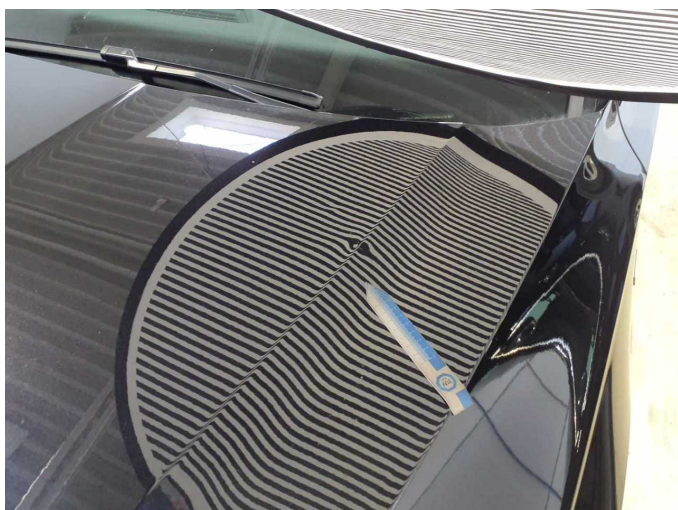
| No. | Component group | Description |
|---|---|---|
| 6 | Bonnet | Bonnet - dent(s) - Smart repair |

**Damage 6:** Bonnet: Bonnet - dent(s) - Smart repair

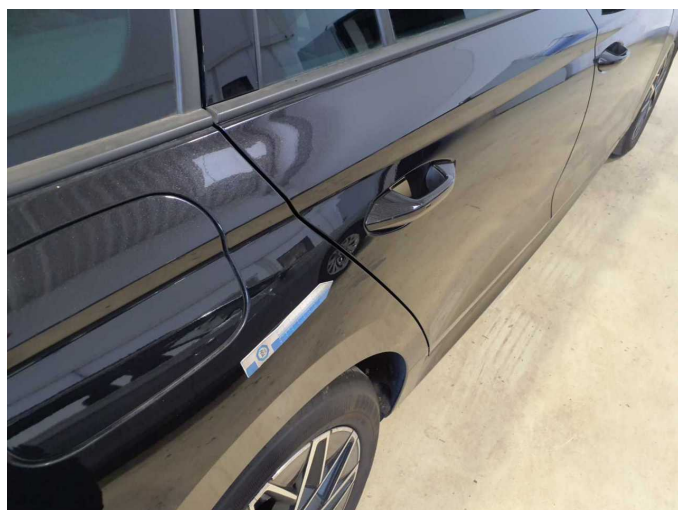
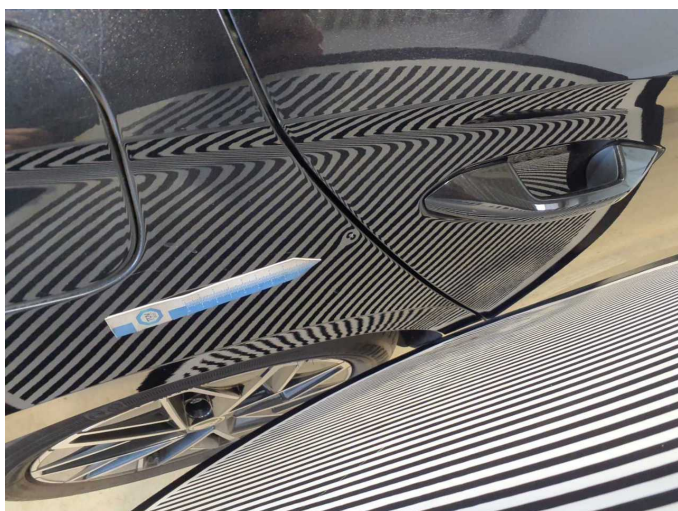
| No. | Component group | Description |
|---|---|---|
| 7 | Side panel - rear right side | Side panel - Dent / paintcoat damage - Smart repair |

**Damage 7:** Side panel - rear right side: Side panel - Dent / paintcoat damage - Smart repair

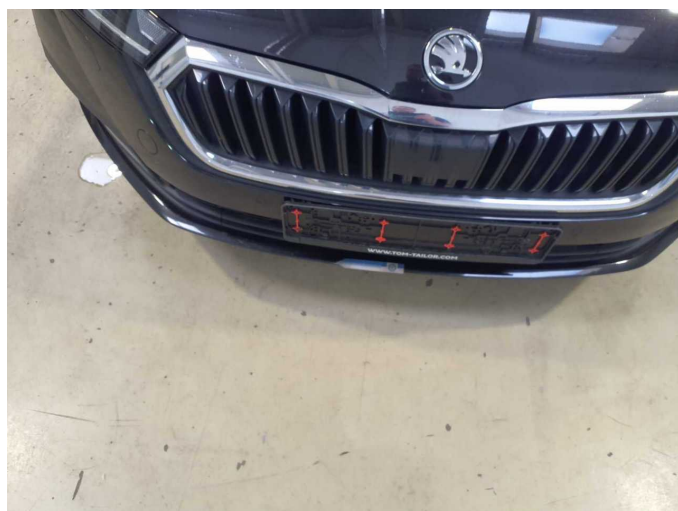
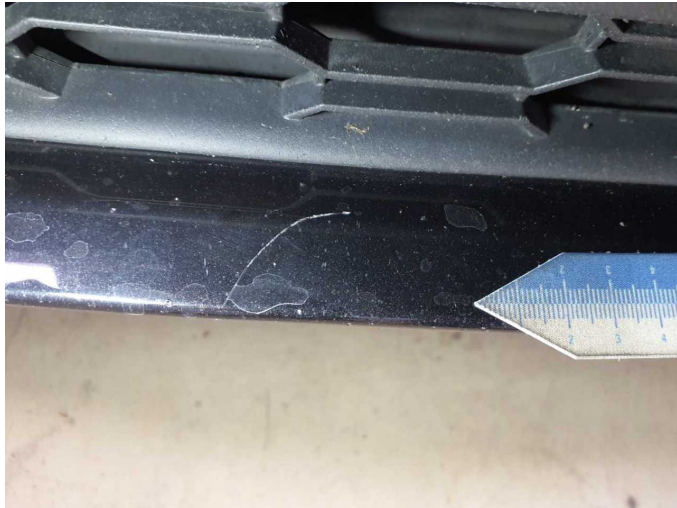
| No. | Component group | Description |
|---|---|---|
| 8 | Front bumper | Front bumper - Scratch(es) - Smart repair |

**Damage 8:** Front bumper: Front bumper - Scratch(es) - Smart repair

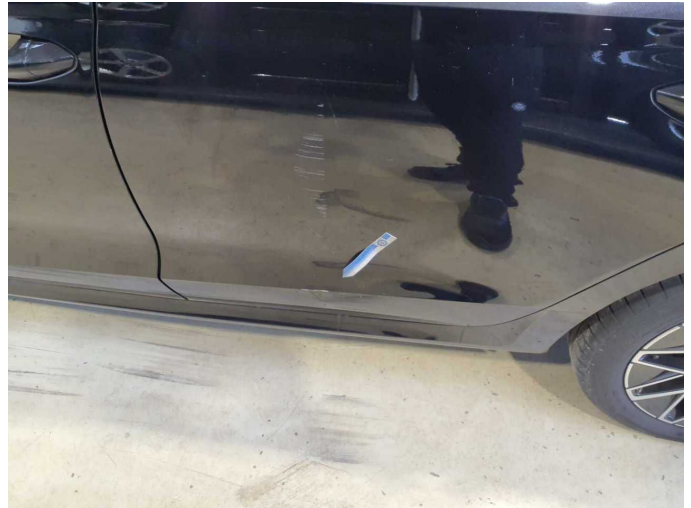
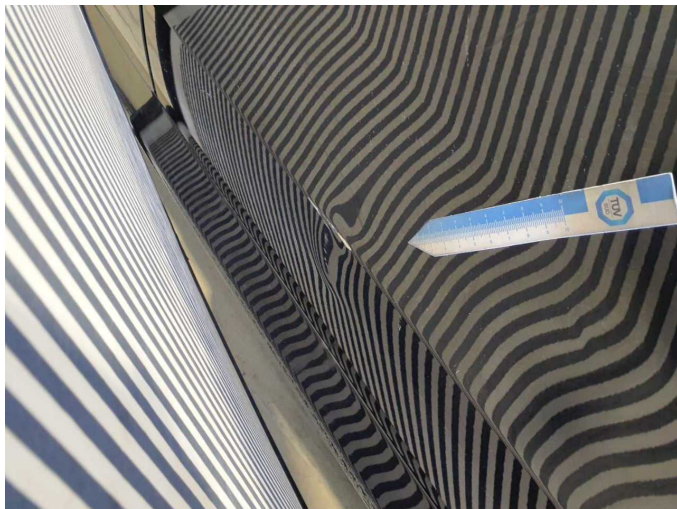
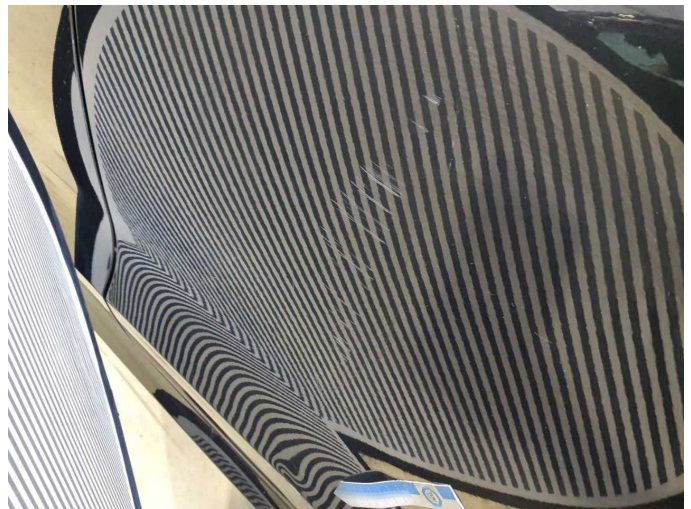
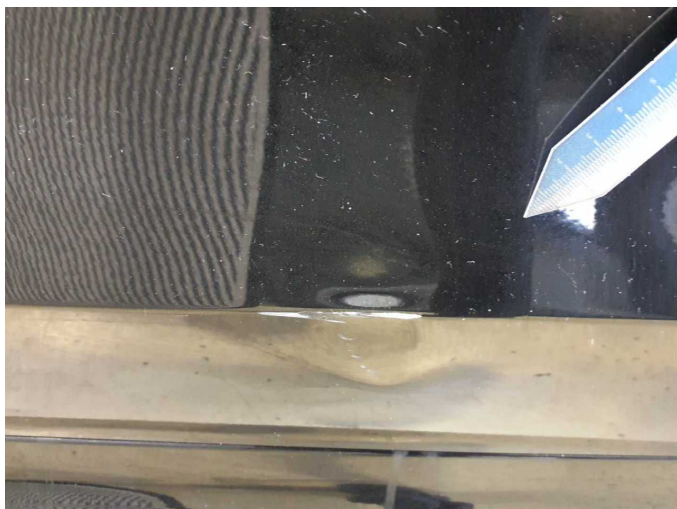
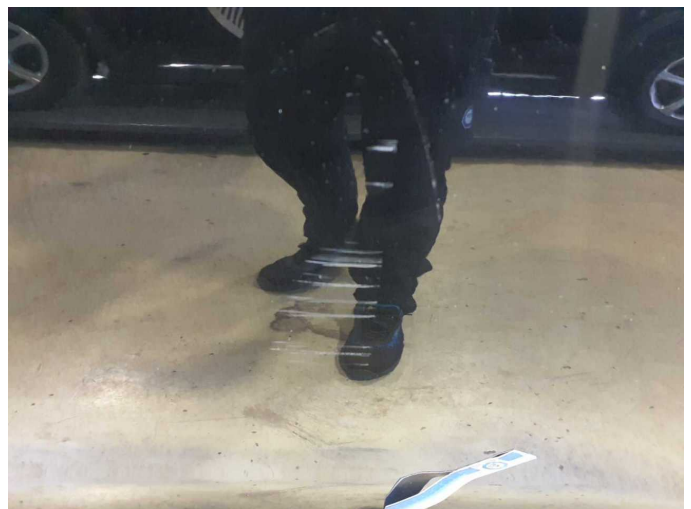
| No. | Component group | Description |
|---|---|---|
| 9 | Door - rear left side | Door - Dent / paintcoat damage - Repair and paint |

**Damage 9:** Door - rear left side: Door - Dent / paintcoat damage - Repair and paint

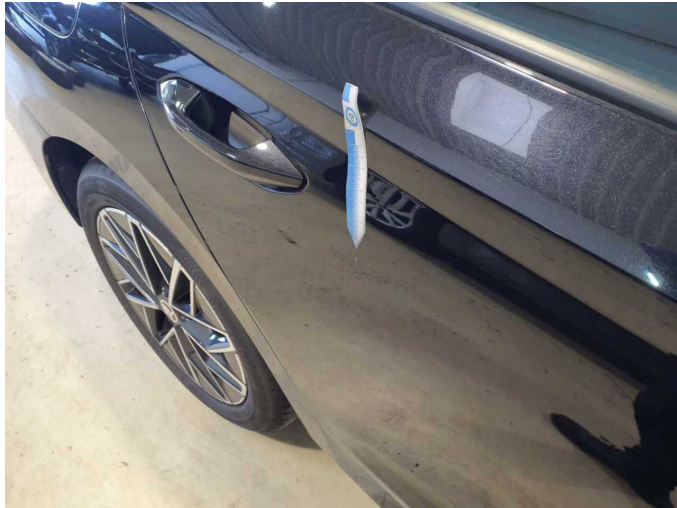
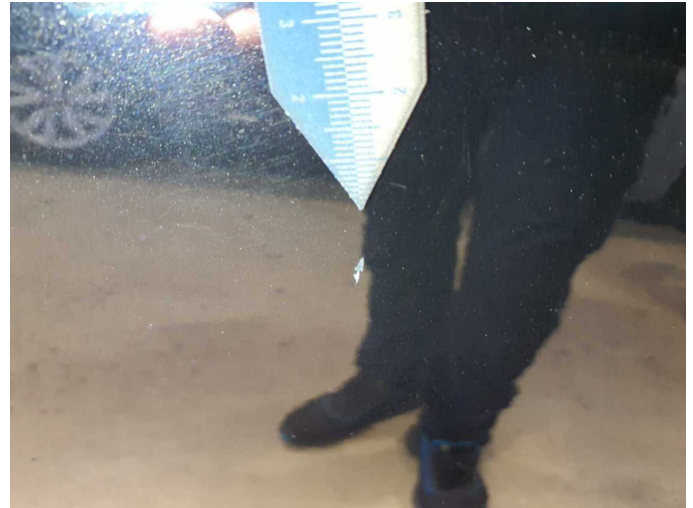
| No. | Component group | Description |
|---|---|---|
| 10 | Door - rear right side | Door - Scratch(es) - Paint |

**Damage 10:** Door - rear right side: Door - Scratch(es) - Paint

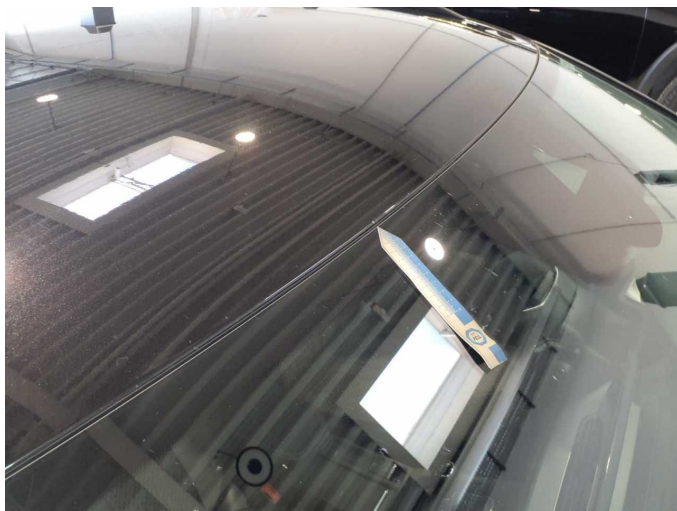
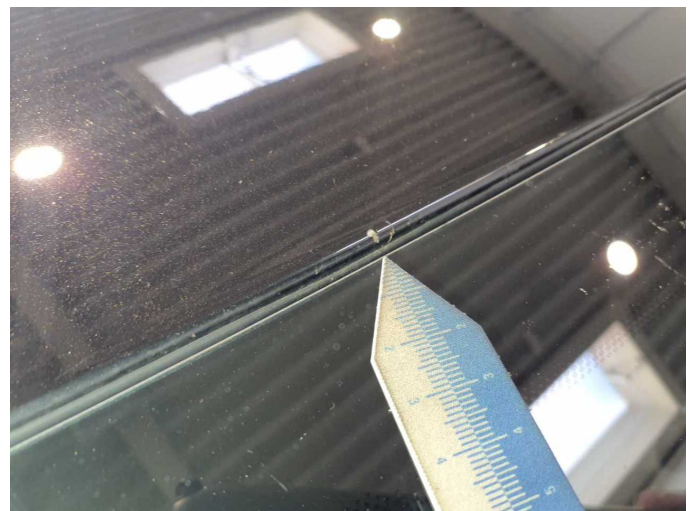
| No. | Component group | Description |
|---|---|---|
| 11 | Roof | Roof (Beginnende Korrosion) - Corrosion - Paint |

**Damage 11:** Roof: Roof (Beginnende Korrosion) - Corrosion - Paint
