## Toyota Corolla (UKL): 2ACV030

| Vinnumber: | SB1Z93BE90E196826 | Versionname: | Corolla Touring Sports Plus 1.8i Hybrid 122pk/cv 5p eCVT |

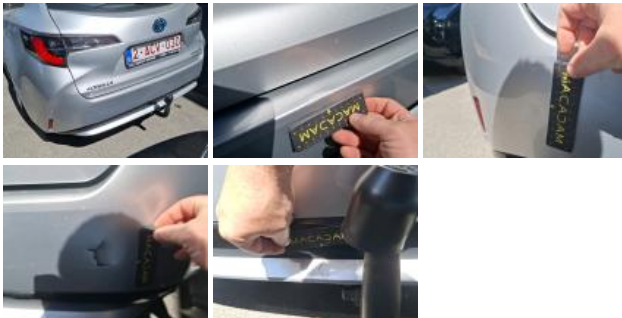
Bumper R, Deformed / Strained, Replace and paint
