## Expertise

Protocol number: 46080258  
Order No. / Reference: 26438208  
Inspection date: 22 Jun 2026

Model: 308 SW BlueHDi 130 EAT8 Stop & Start Allure

VIN: VF3LCYHZKLS308705

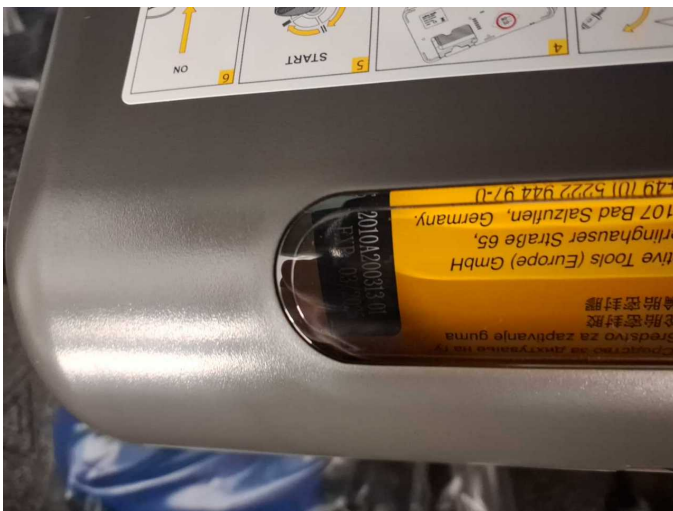
Damage 1: Equipment: Tirefit filler - Expired - Replace

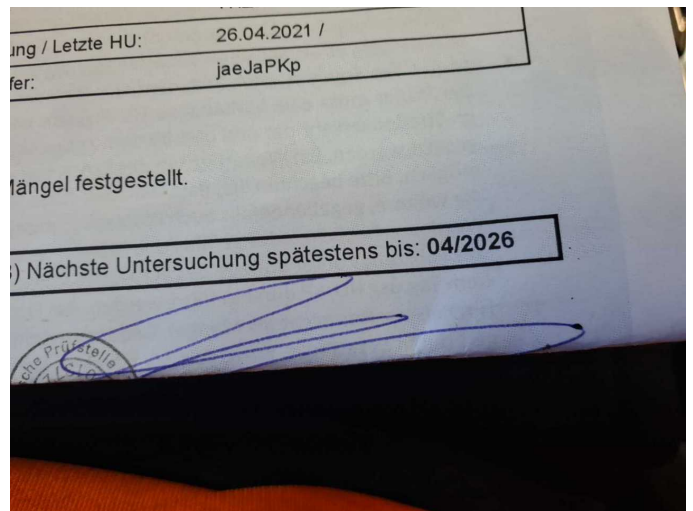
Damage 2: Misc.: Main inspection - Expired - Perform

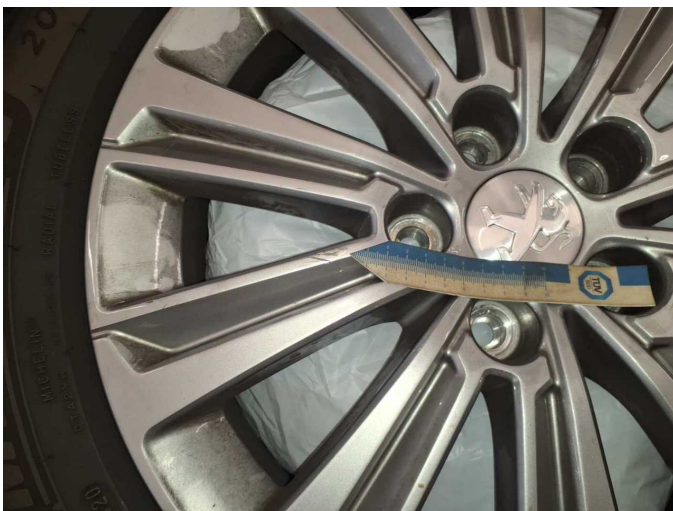
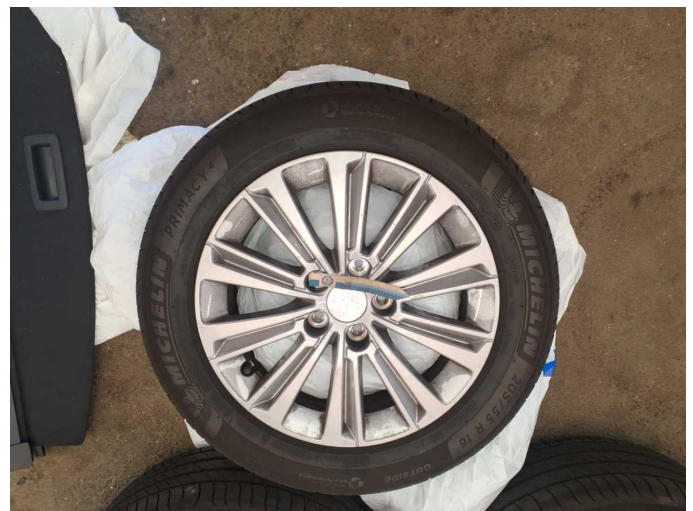
Damage 3: 2nd wheel set: 1 alloy rim - Scratch(es) - Loss in value

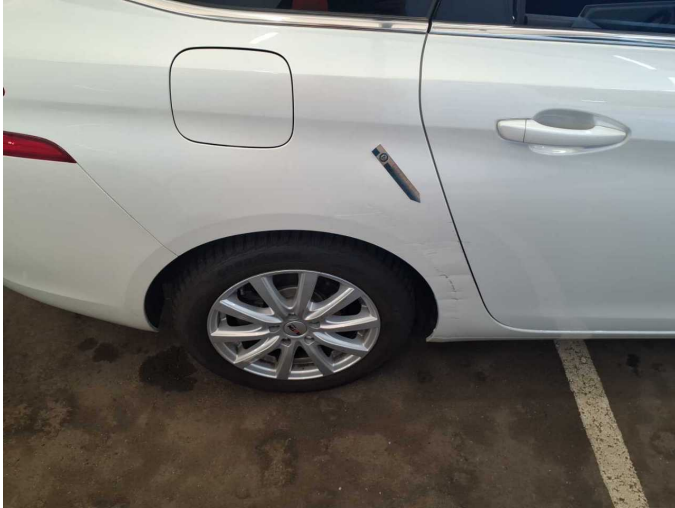
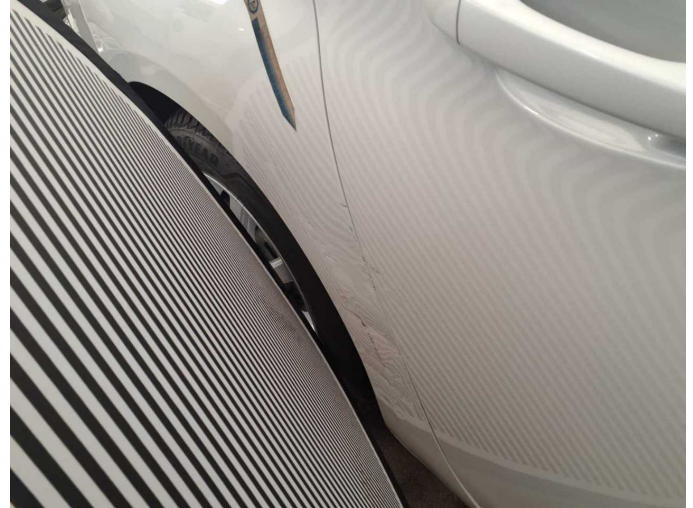
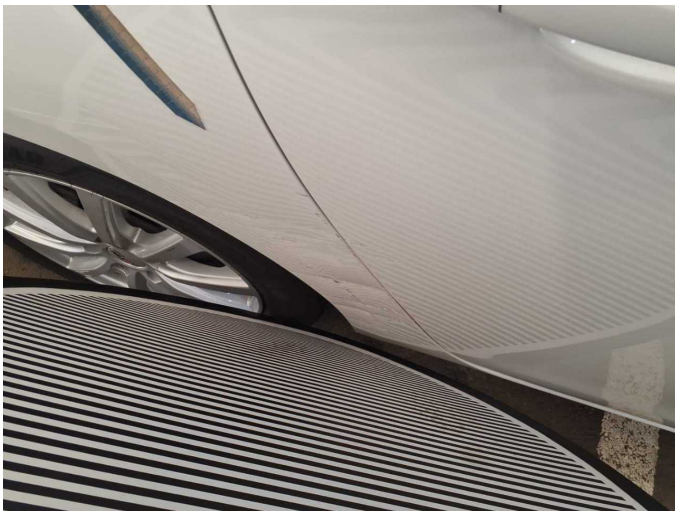
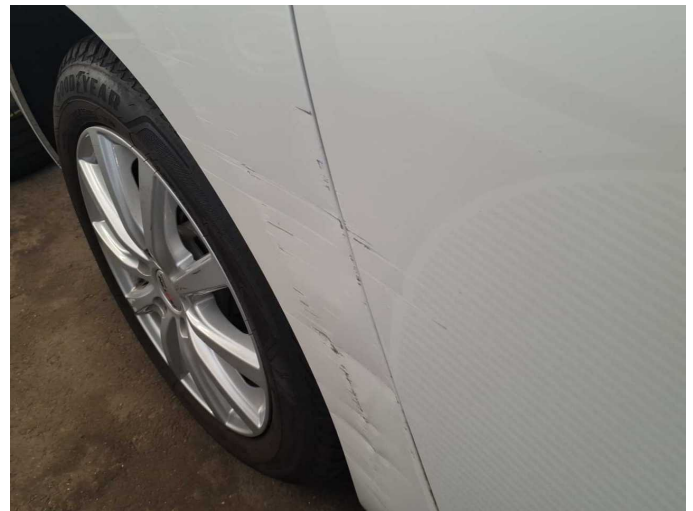
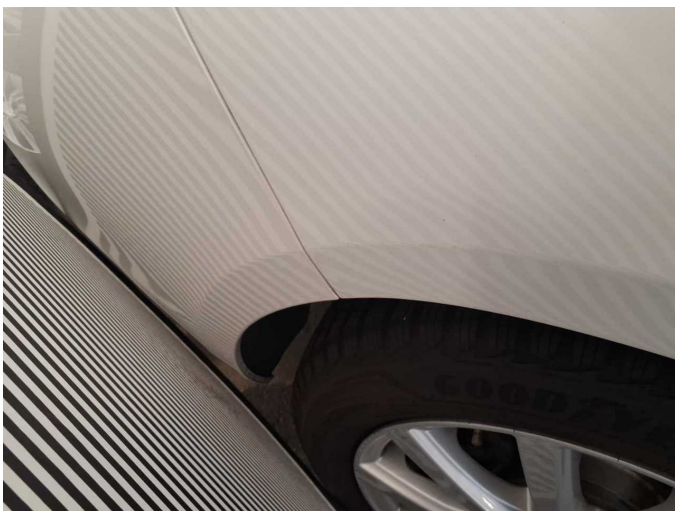
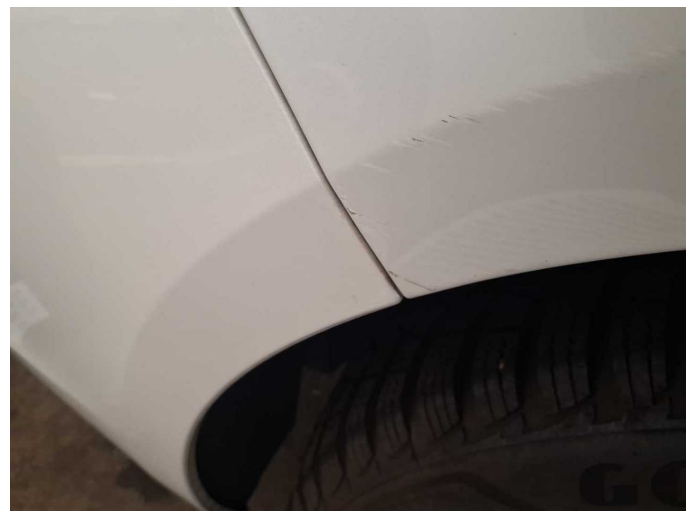
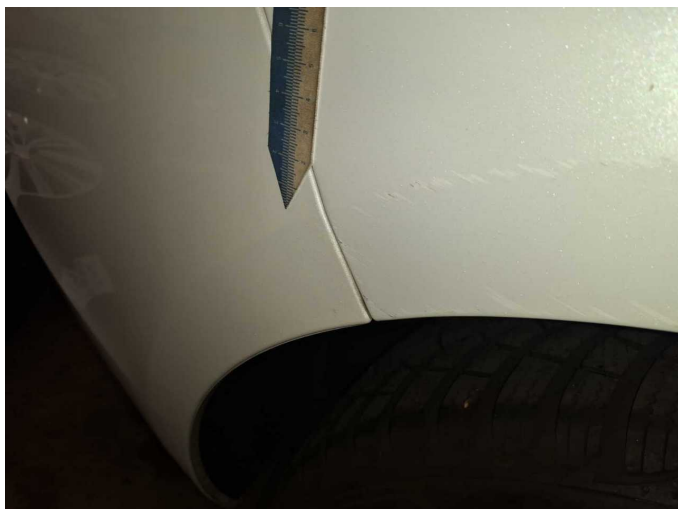
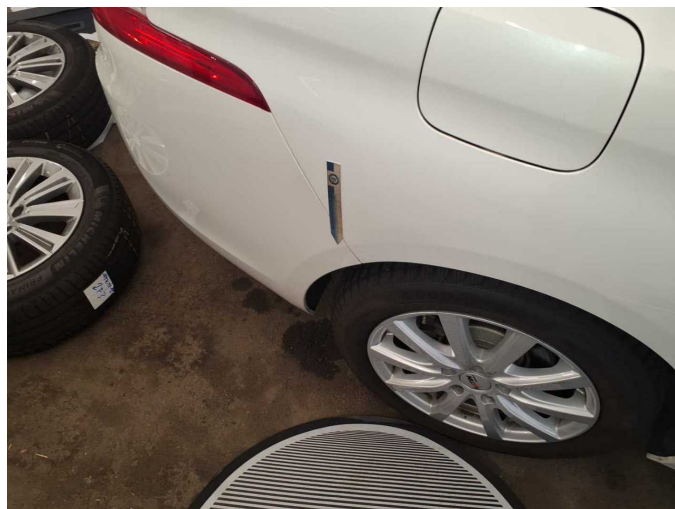
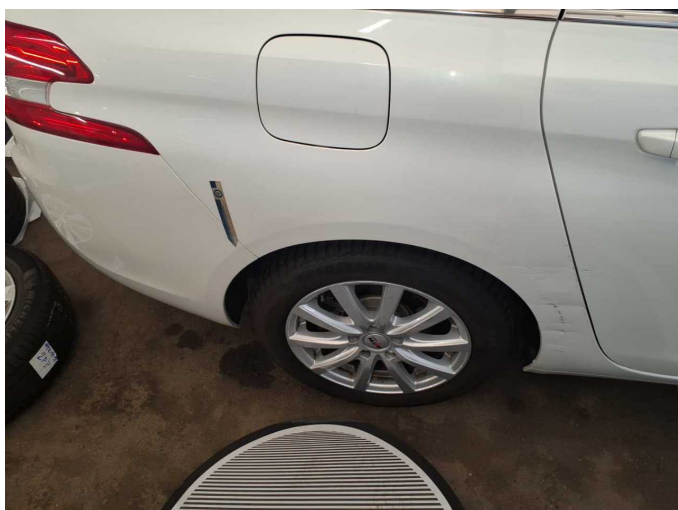
No.	Accident
1	Side right

Non-repaired previous damages were found at the vehicle. The necessary repair costs are listed in the expert report or if necessary, are listed in detail in a separately enclosed repair cost calculation.

Accident 1: Side right
