Expertise

Protocol number: 46566119  
Order No. / Reference: 26652716  
Inspection date: 16 Jul 2026

Manufacturer: Skoda  
VIN: TMBLR7NP0R7026412

Model: Superb Combi 2.0 TDI 4x4 DSG Style

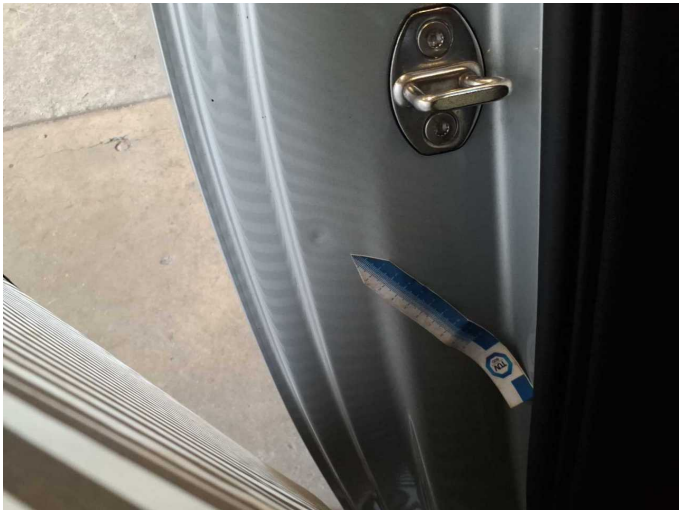
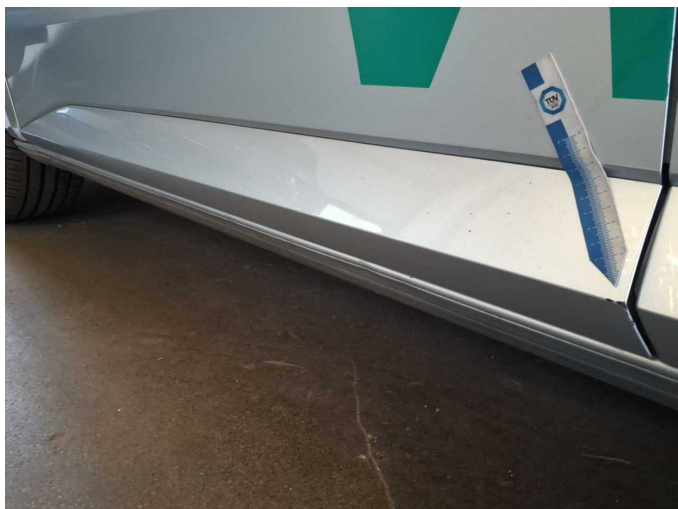
| No. | Component group | Description |
|---|---|---|
| 1 | Side panel - rear right side | Sill - dent(s) - Smooth repair work |

Damage 1: Side panel - rear right side: Sill - dent(s) - Smooth repair work

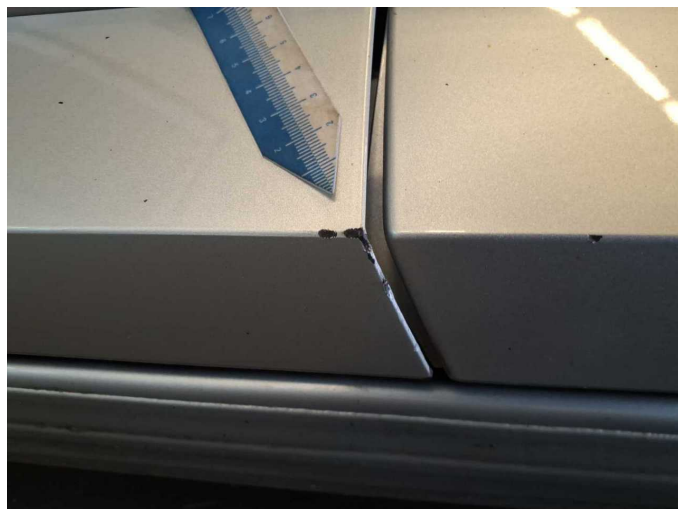
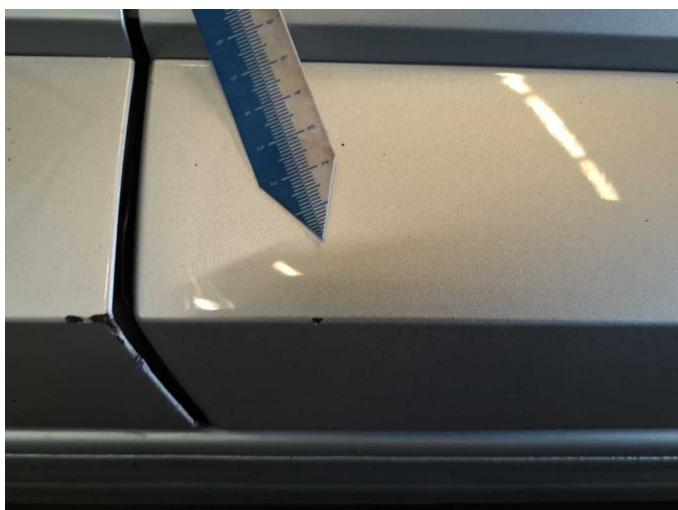
| No. | Component group | Description |
|---|---|---|
| 2 | Door - front left side | Brightware - lower - Scratched - Smart repair |

**Damage 2:** Door - front left side: Brightware - lower - Scratched - Smart repair

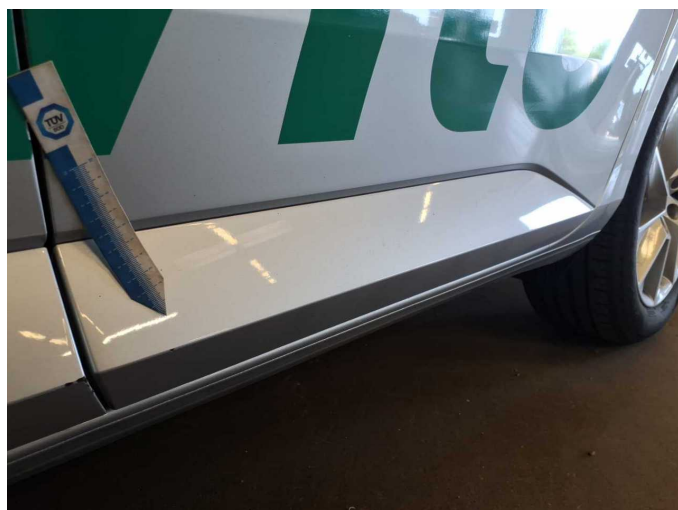
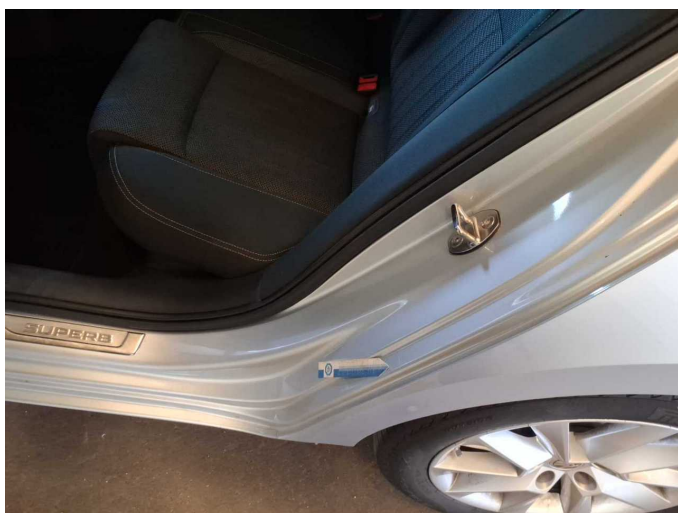
| No. | Component group | Description |
|---|---|---|
| 3 | Door - rear right side | Brightware - lower - Scratched - Smart repair |

**Damage 3:** Door - rear right side: Brightware - lower - Scratched - Smart repair

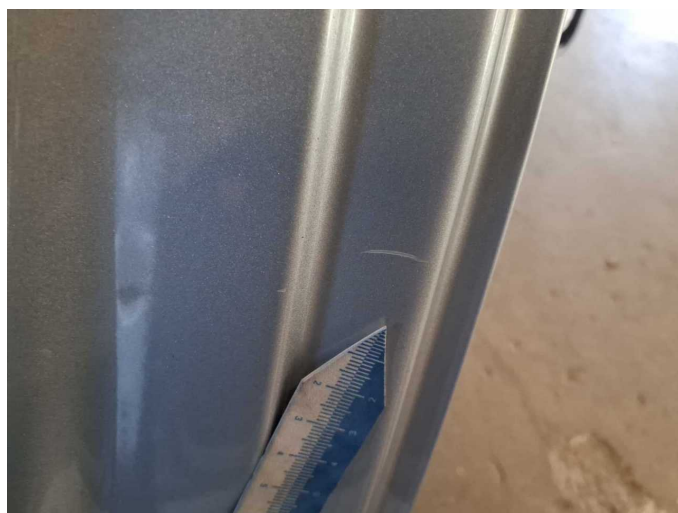
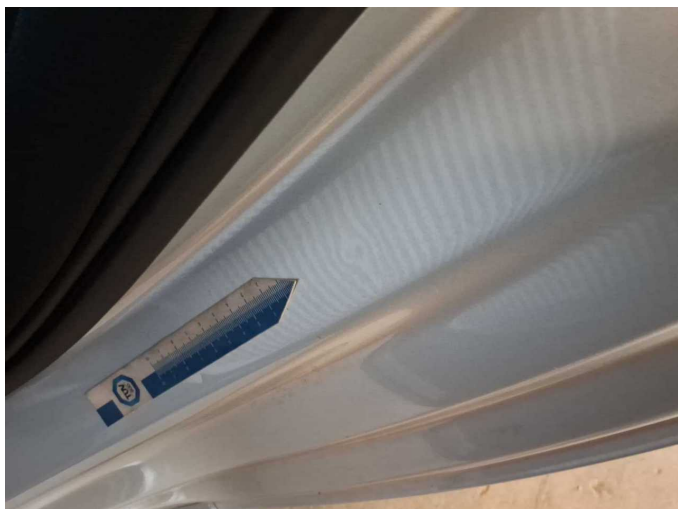
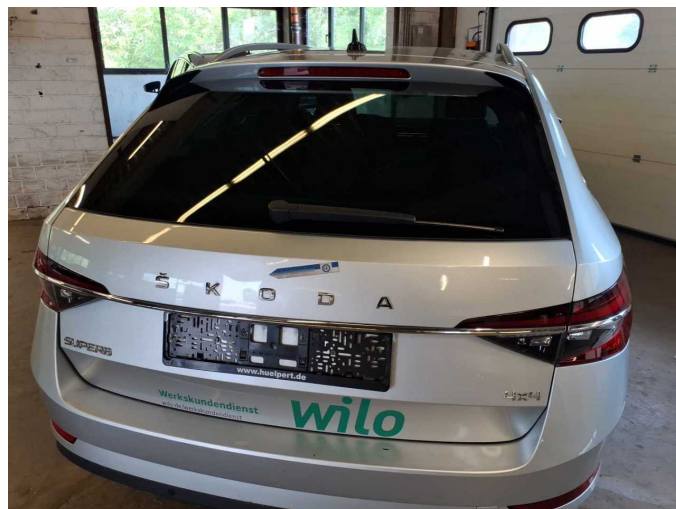
| No. | Component group | Description |
|---|---|---|
| 4 | Side panel - rear left side | Sill - Dent / paintcoat damage - Smart repair |

**Damage 4:** Side panel - rear left side: Sill - Dent / paintcoat damage - Smart repair

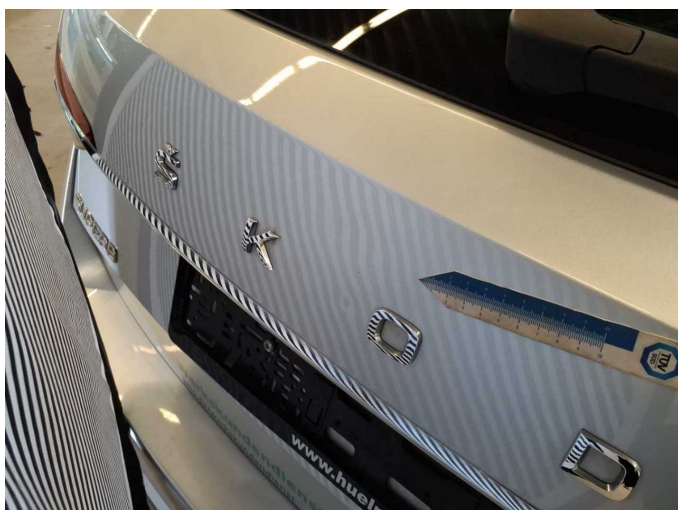
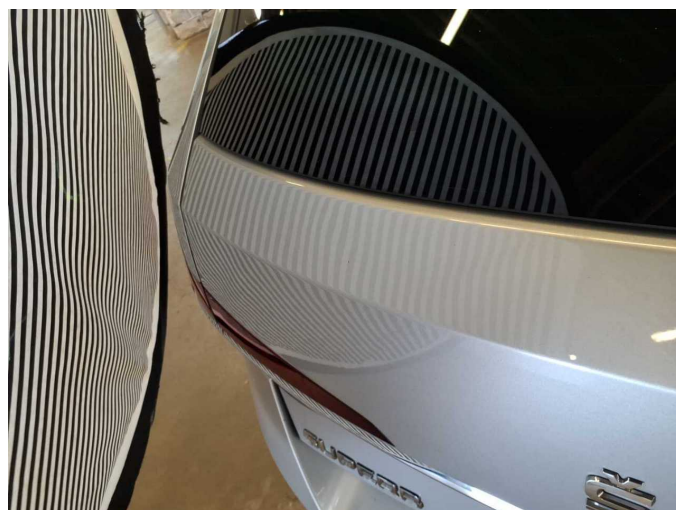
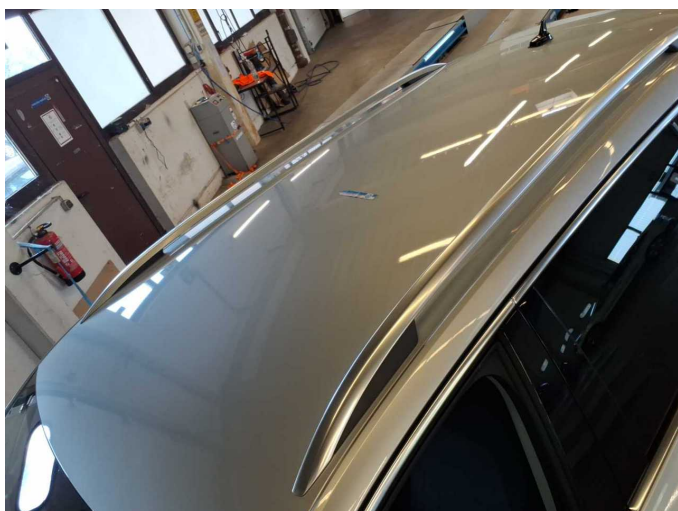
| No. | Component group | Description |
|---|---|---|
| 5 | Boot lid / rear door | Boot lid - dent(s) - Smooth repair work |

**Damage 5:** Boot lid / rear door: Boot lid - dent(s) - Smooth repair work

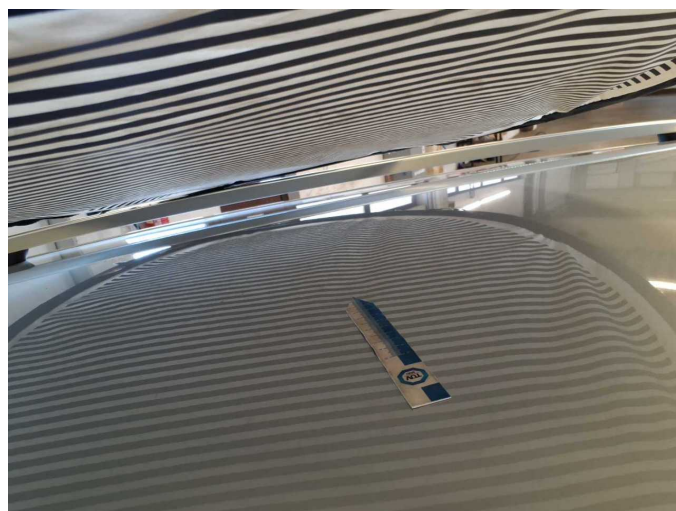
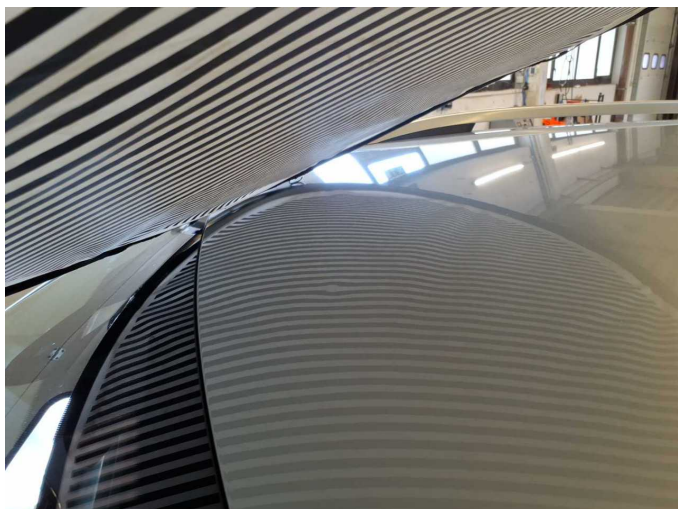
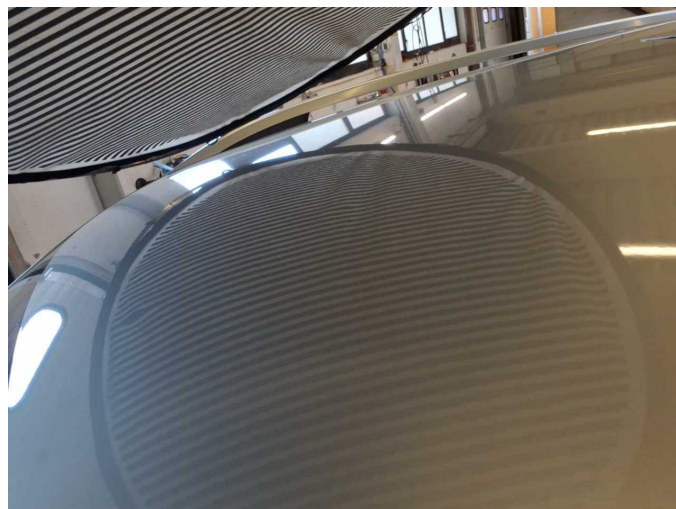
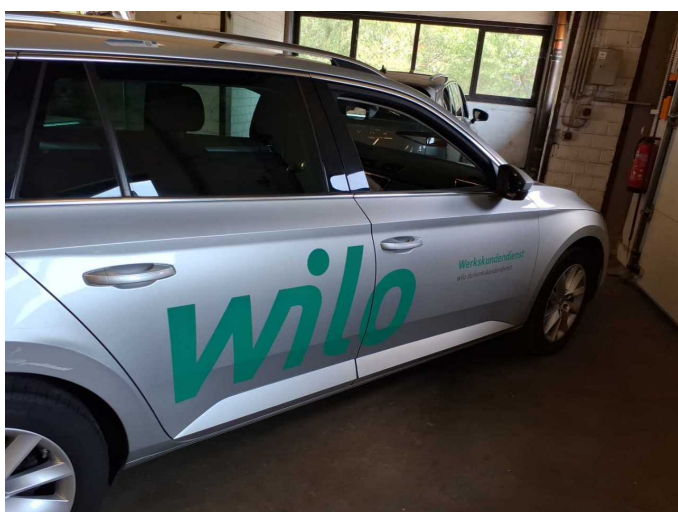
| No. | Component group | Description |
|---|---|---|
| 6 | Roof | Roof - dent(s) - Smooth repair work |

**Damage 6:** Roof: Roof - dent(s) - Smooth repair work

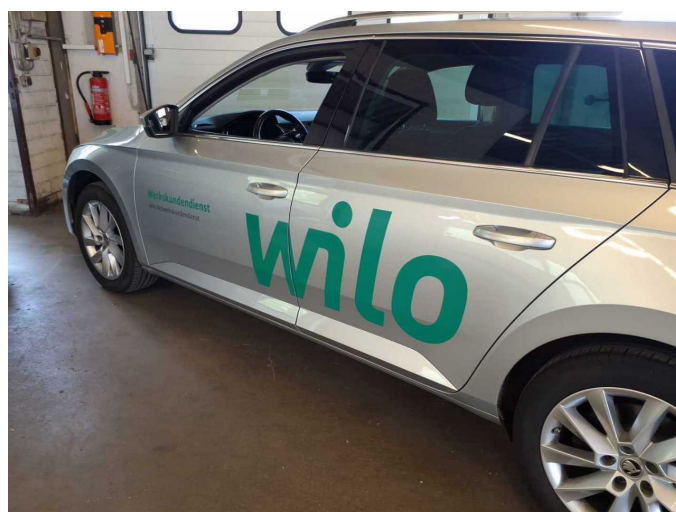
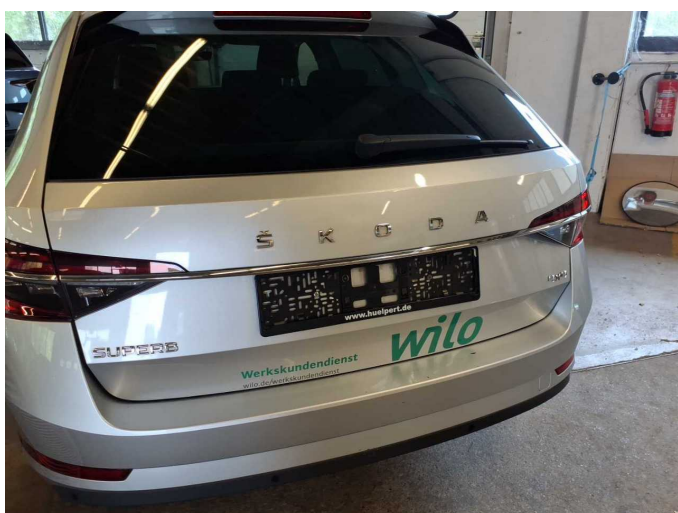
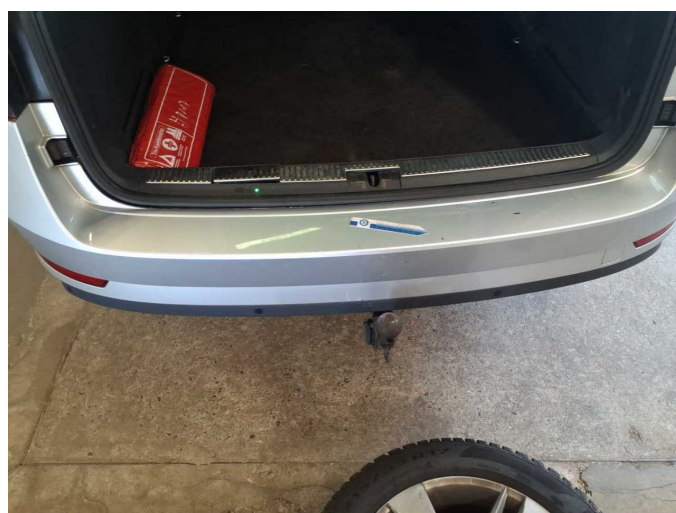
| No. | Component group | Description |
|---|---|---|
| 7 | Body | Body - Glued / labelled - De-glue / neutralise |

**Damage 7:** Body: Body - Glued / labelled - De-glue / neutralise

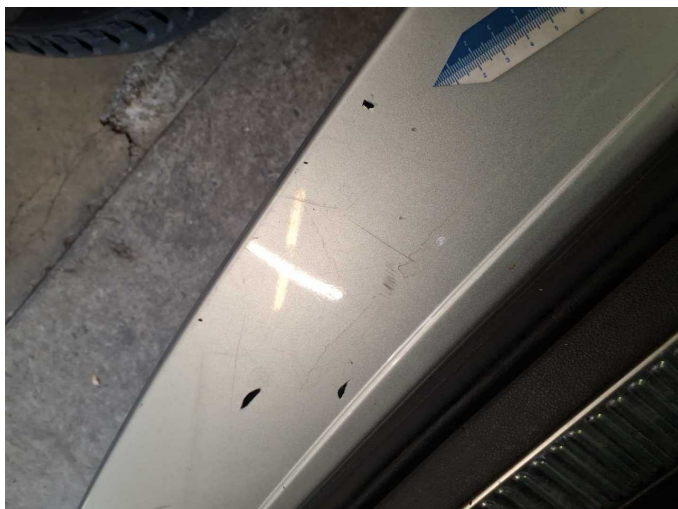
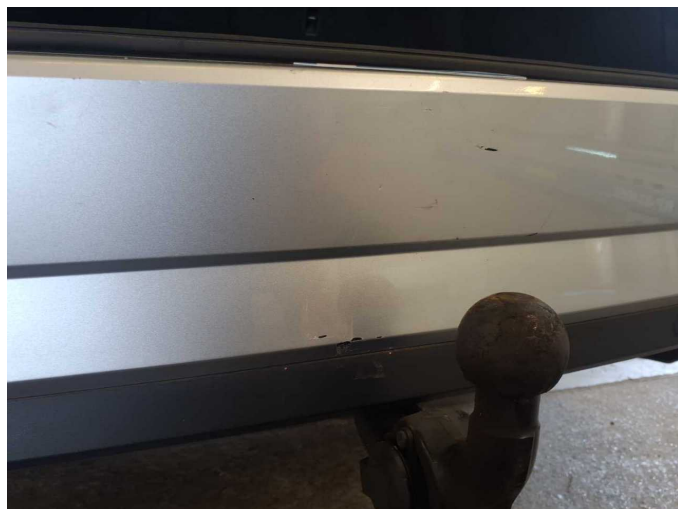
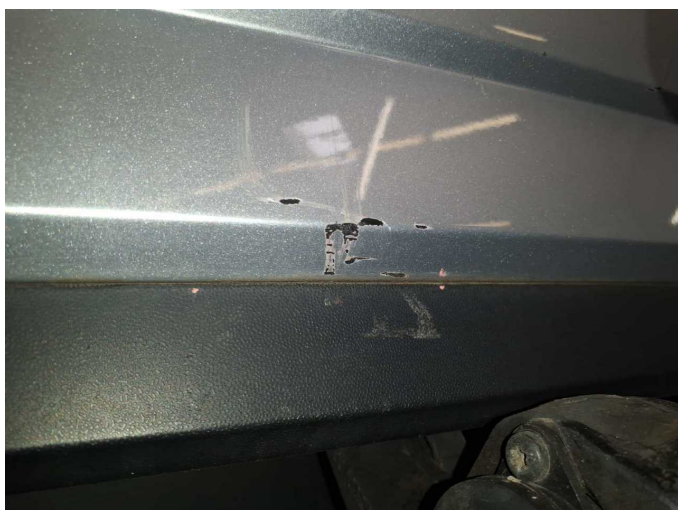
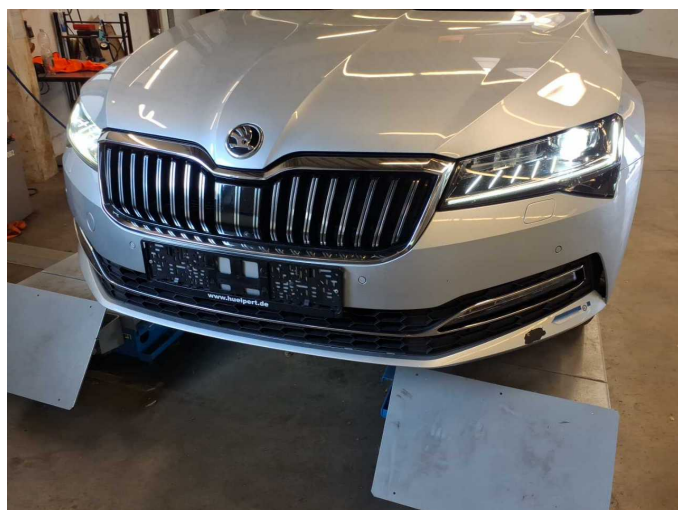
| No. | Component group | Description |
|---|---|---|
| 8 | Rear bumper | Rear bumper - Scratched - Paint |

**Damage 8:** Rear bumper: Rear bumper - Scratched - Paint

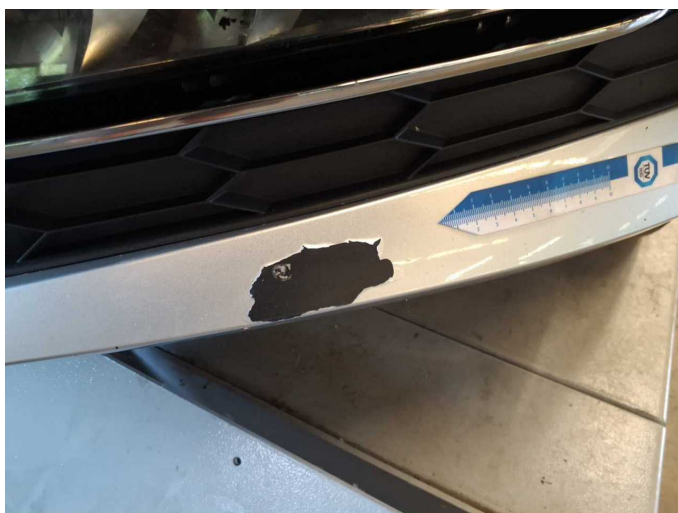
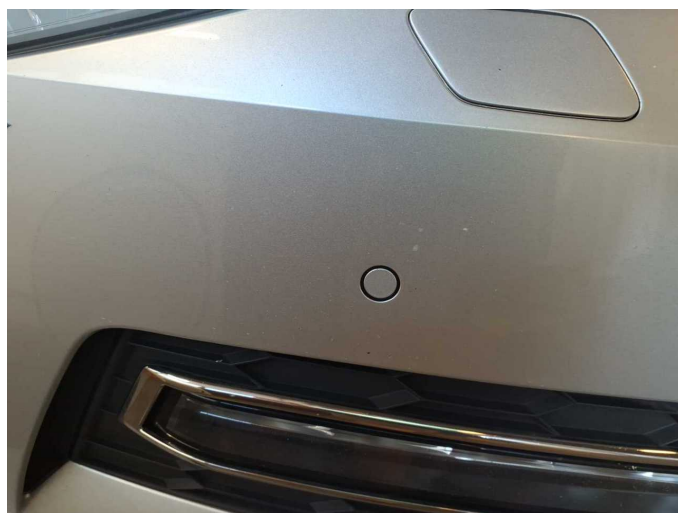
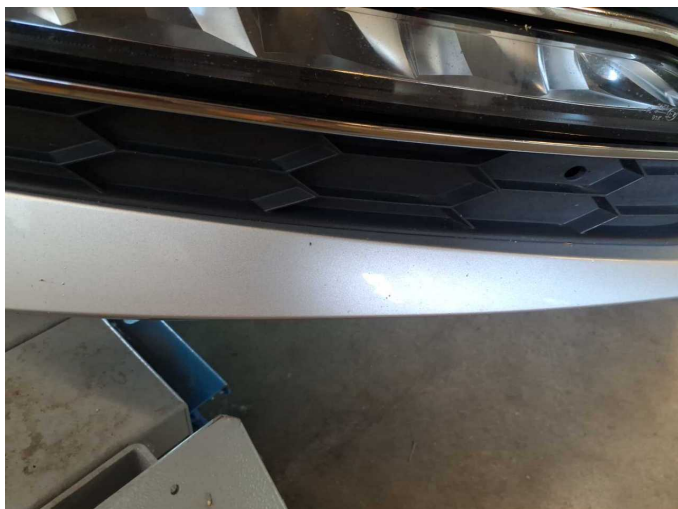
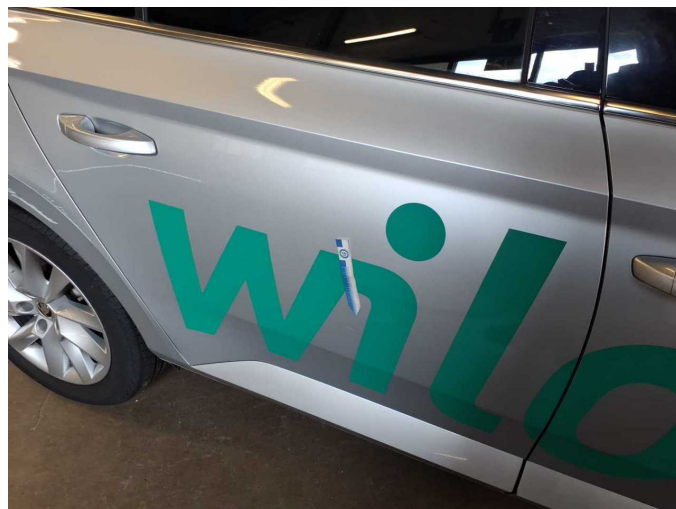
| No. | Component group | Description |
|---|---|---|
| 9 | Front bumper | Front bumper (Lackplatzer) - Paint defect - Paint |

**Damage 9:** Front bumper: Front bumper (Lackplatzer) - Paint defect - Paint

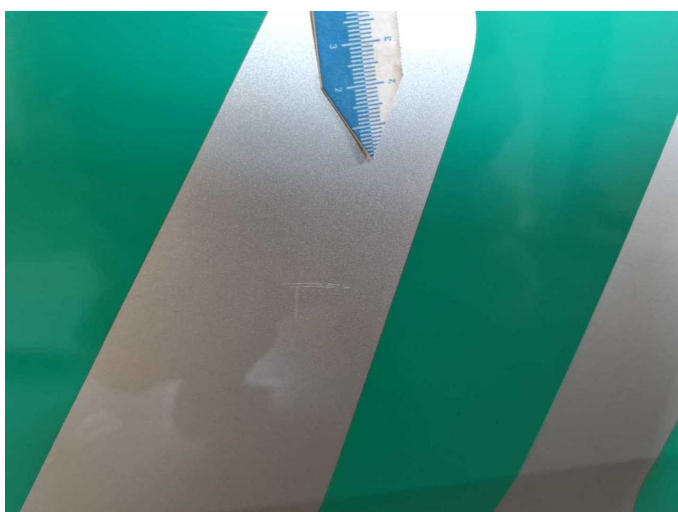
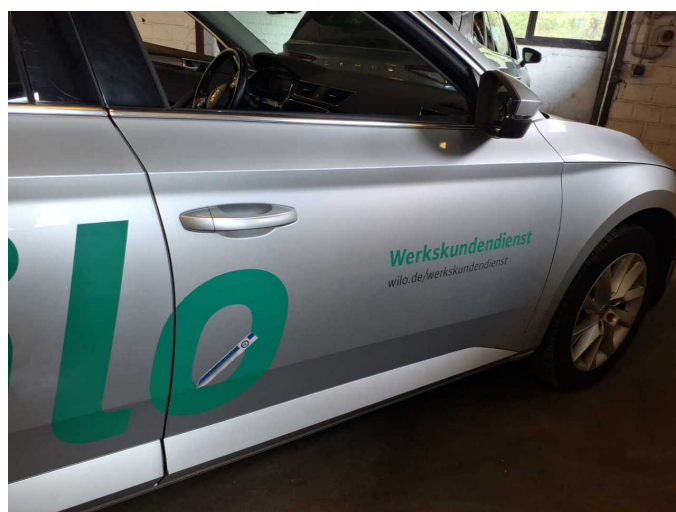
| No. | Component group | Description |
|---|---|---|
| 10 | Door - rear right side | Door - Scratched - Paint |

**Damage 10:** Door - rear right side: Door - Scratched - Paint

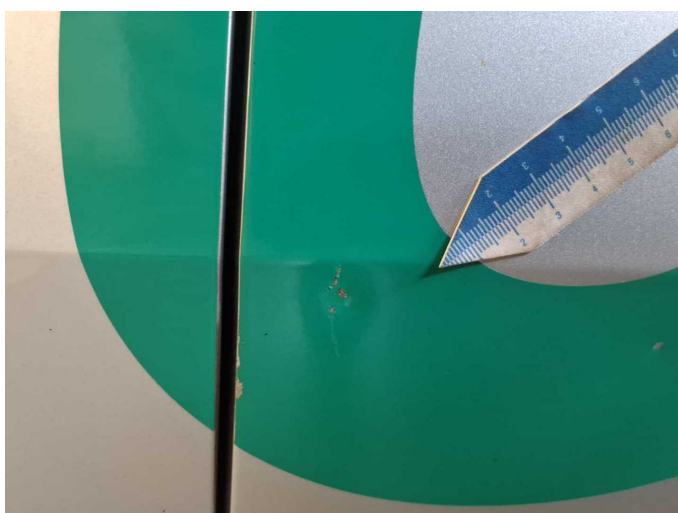
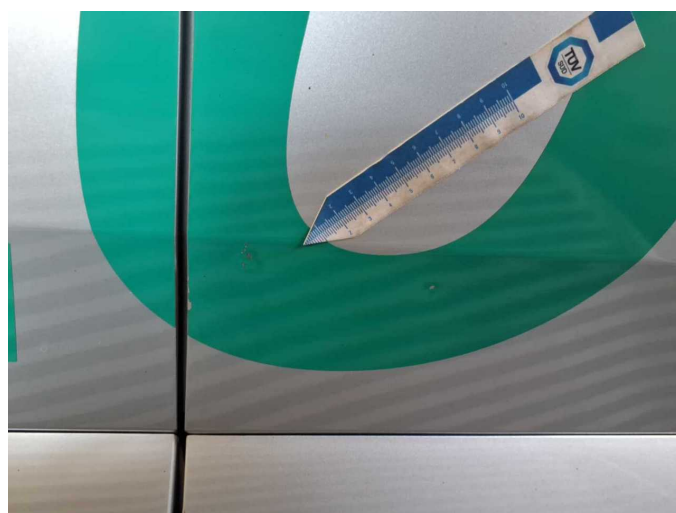
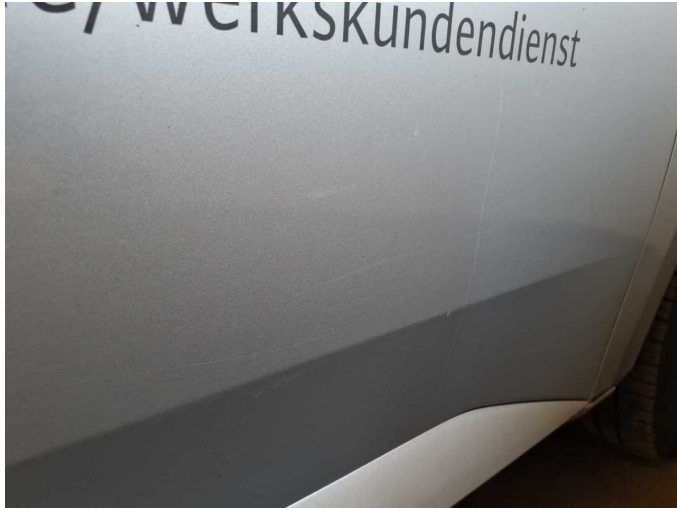
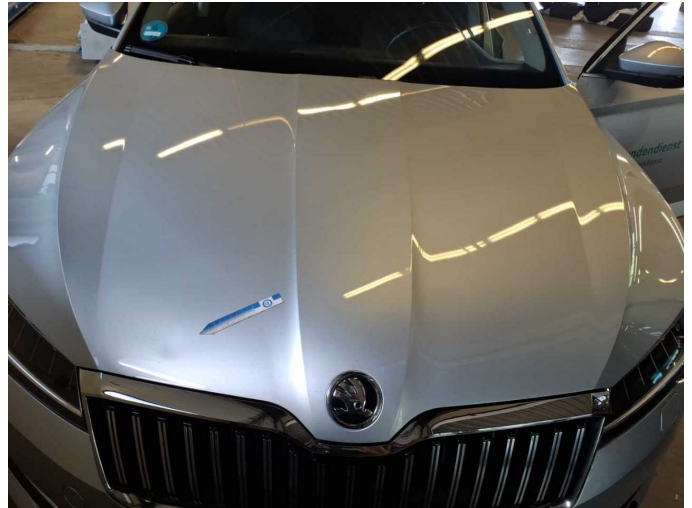
| No. | Component group | Description |
|---|---|---|
| 11 | Door - front right side | Door - Dent / paintcoat damage - Repair and paint |

**Damage 11:** Door - front right side: Door - Dent / paintcoat damage - Repair and paint

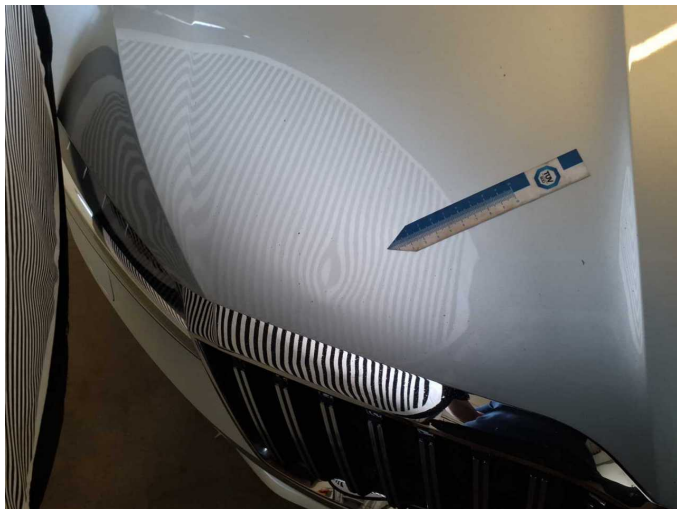
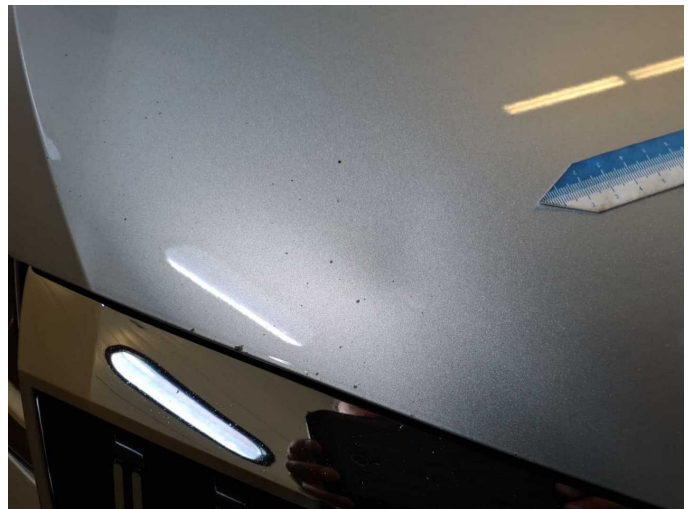
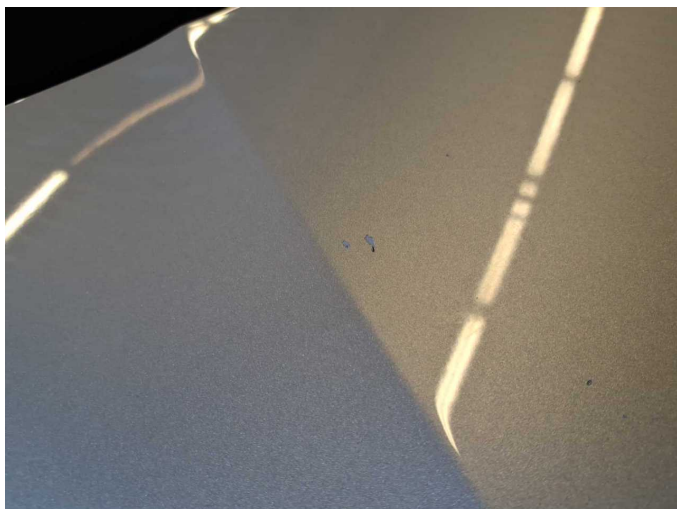
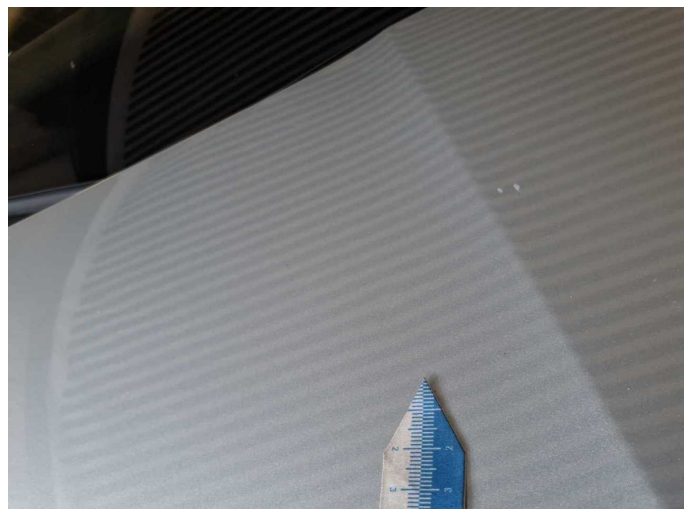
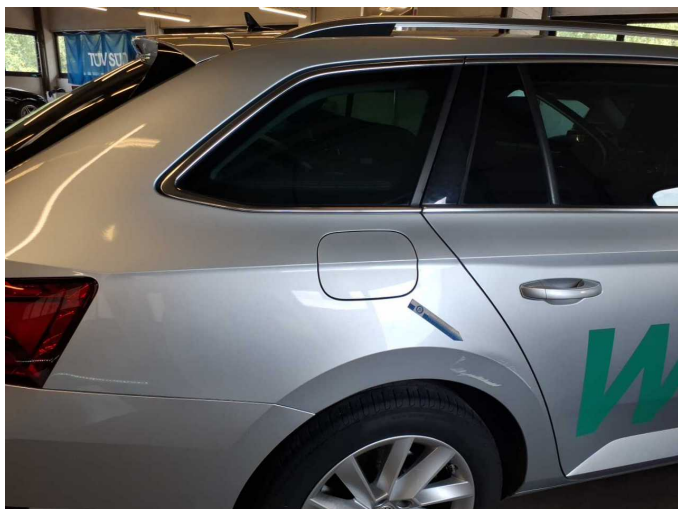
| No. | Component group | Description |
|---|---|---|
| 12 | Bonnet | Bonnet - Dent / paintcoat damage - Repair and paint |

**Damage 12:** Bonnet: Bonnet - Dent / paintcoat damage - Repair and paint

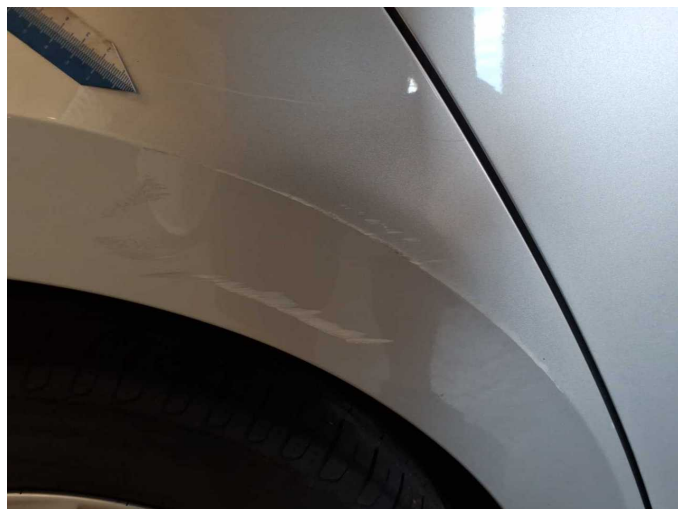
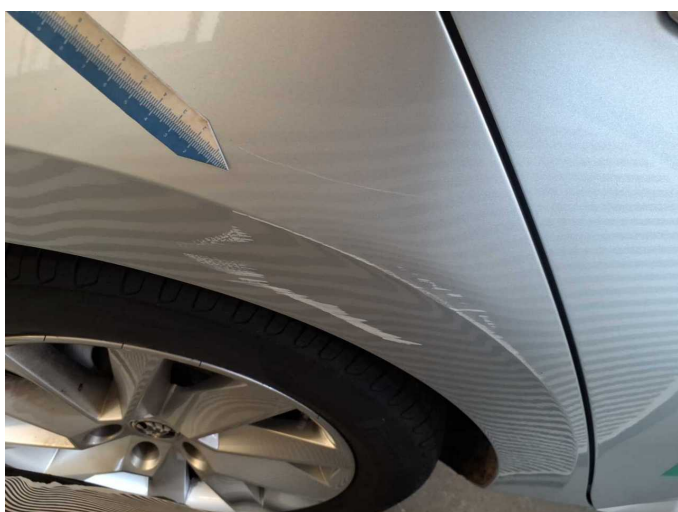
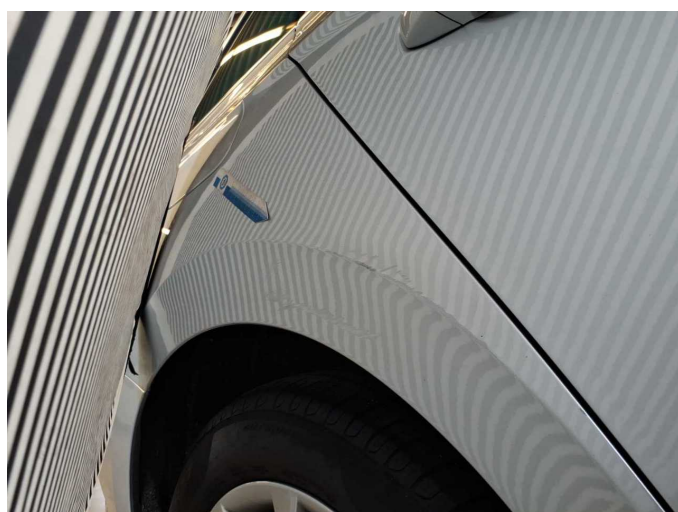
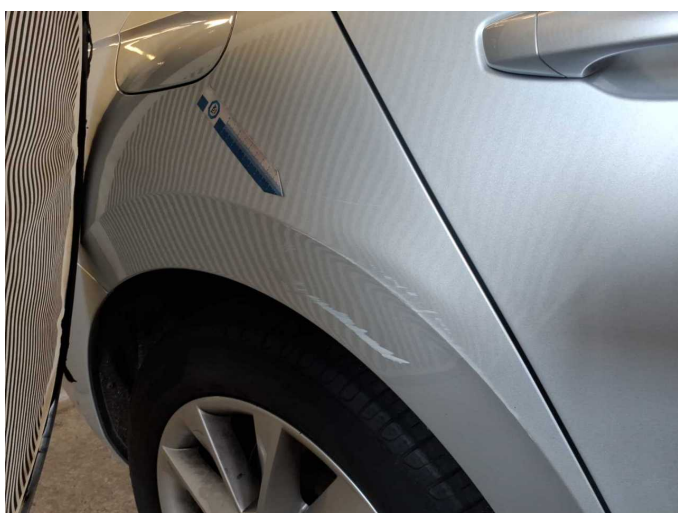
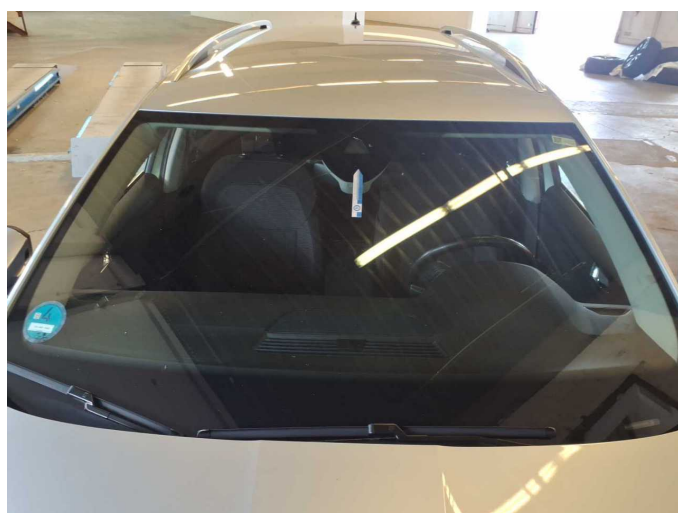
| No. | Component group | Description |
|---|---|---|
| 13 | Side panel - rear right side | Side panel - Dent / paintcoat damage - Repair and paint |

**Damage 13:** Side panel - rear right side: Side panel - Dent / paintcoat damage - Repair and paint

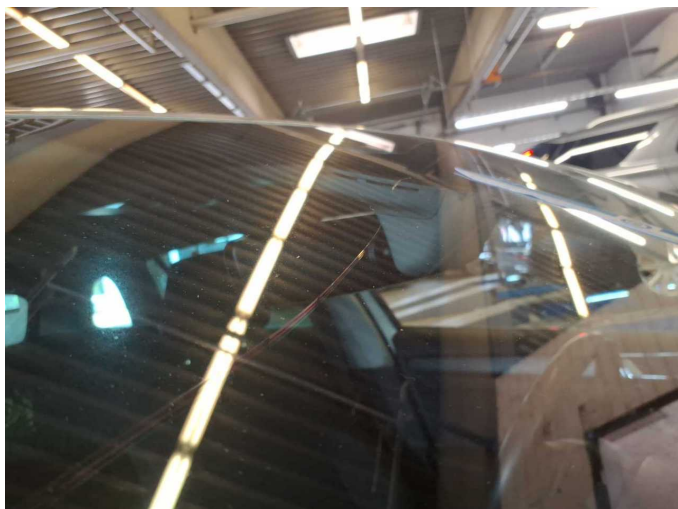
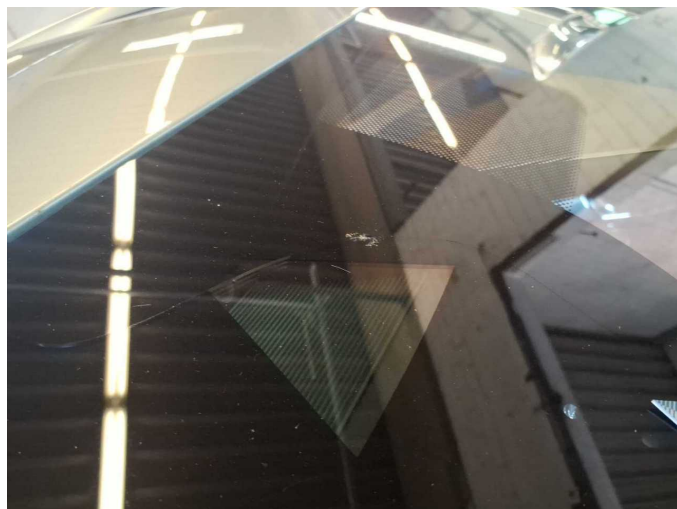
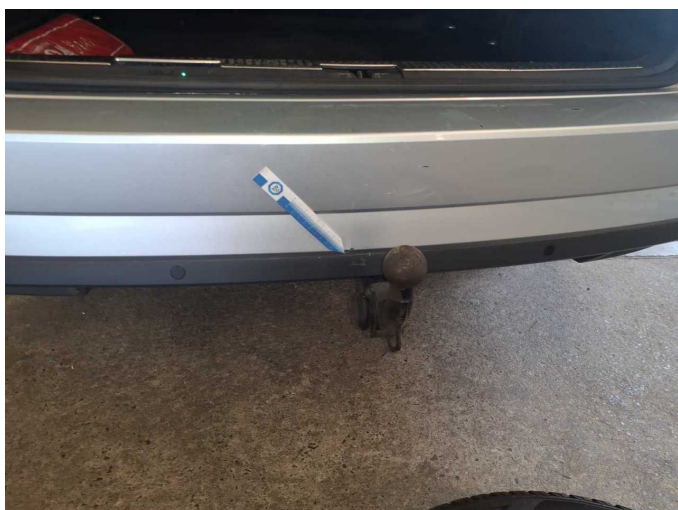
| No. | Component group | Description |
|---|---|---|
| 14 | Vehicle glazing | Windscreen - Broken / torn - Replace |

**Damage 14:** Vehicle glazing: Windscreen - Broken / torn - Replace

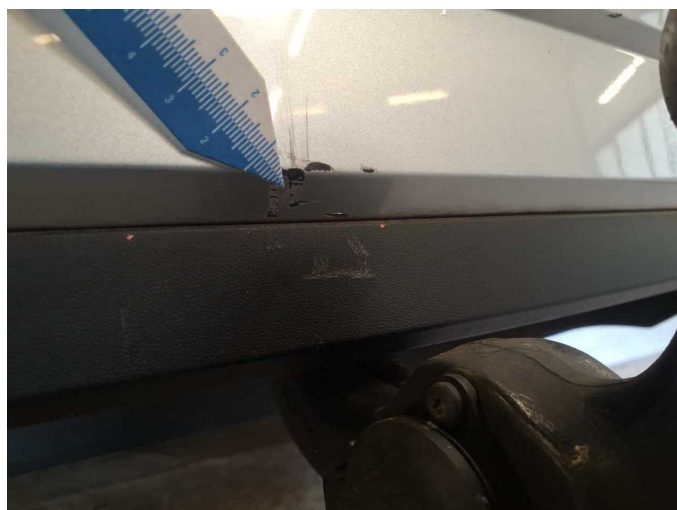
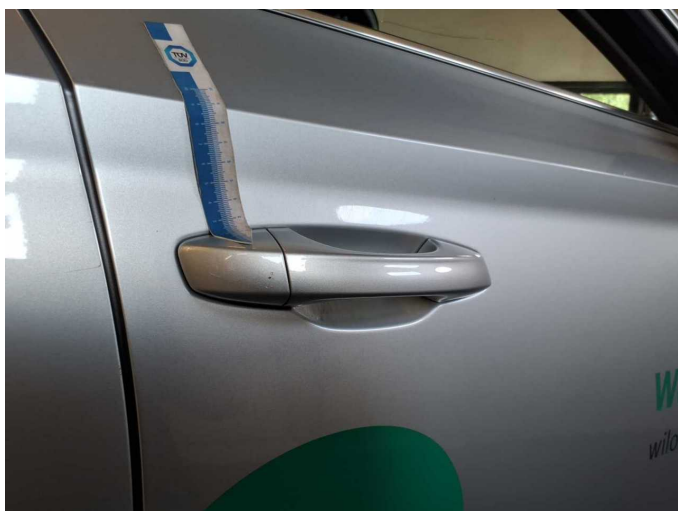
| No. | Component group | Description |
|---|---|---|
| 1 | Rear bumper | Spoiler - Scratched - No deduction |

**Wear and tear 1:** Rear bumper: Spoiler - Scratched - No deduction

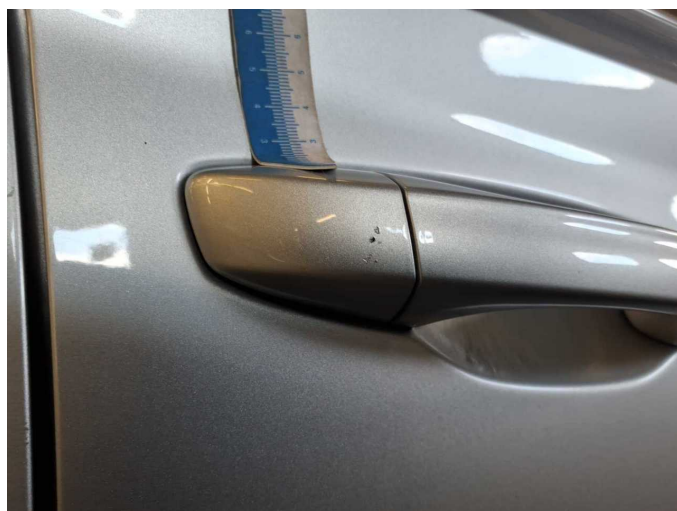
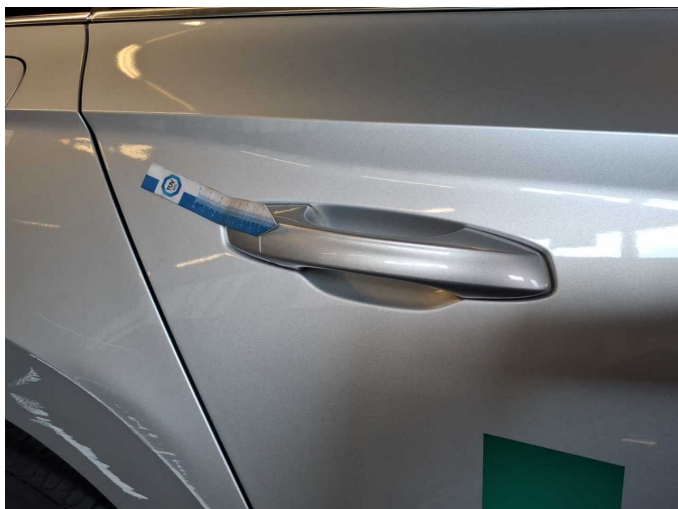
| No. | Component group | Description |
|---|---|---|
| 2 | Door - front right side | Door handle - outside (Schlosskappe) - Scratched - No deduction |

**Wear and tear 2:** Door - front right side: Door handle - outside (Schlosskappe) - Scratched - No deduction

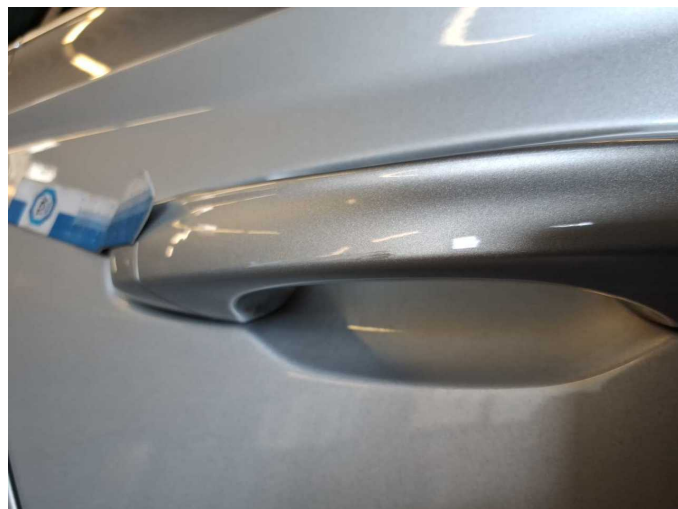
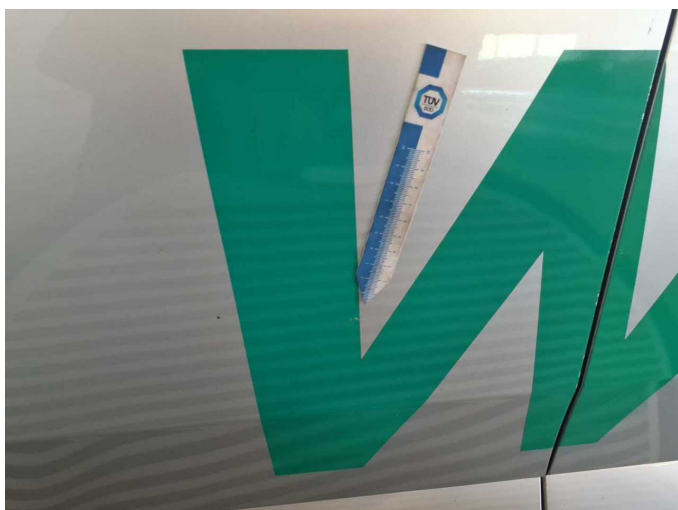
| No. | Component group | Description |
|---|---|---|
| 3 | Door - rear right side | Door handle - outside - Scratched - No deduction |

**Wear and tear 3:** Door - rear right side: Door handle - outside - Scratched - No deduction

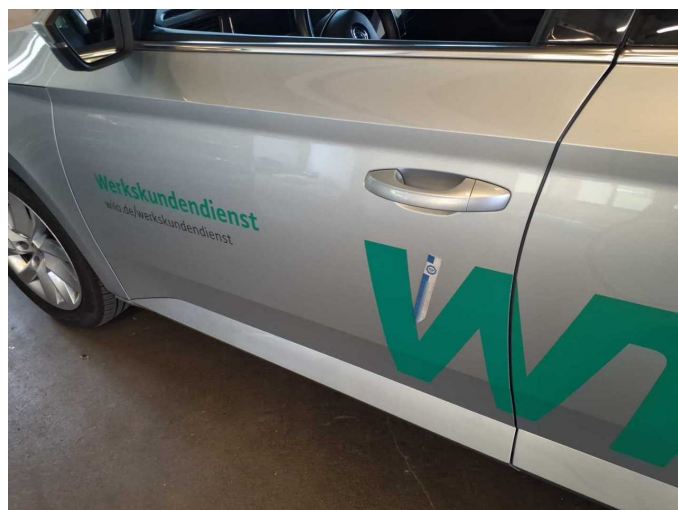
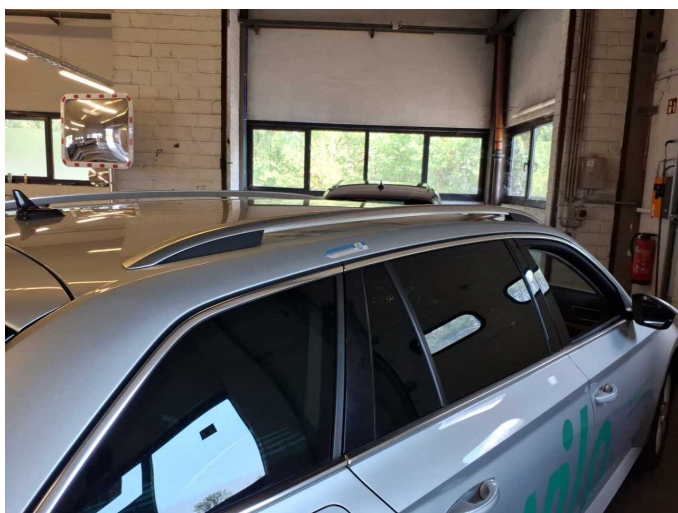
| No. | Component group | Description |
|---|---|---|
| 4 | Door - front left side | Door - dent(s) - No deduction |

**Wear and tear 4:** Door - front left side: Door - dent(s) - No deduction

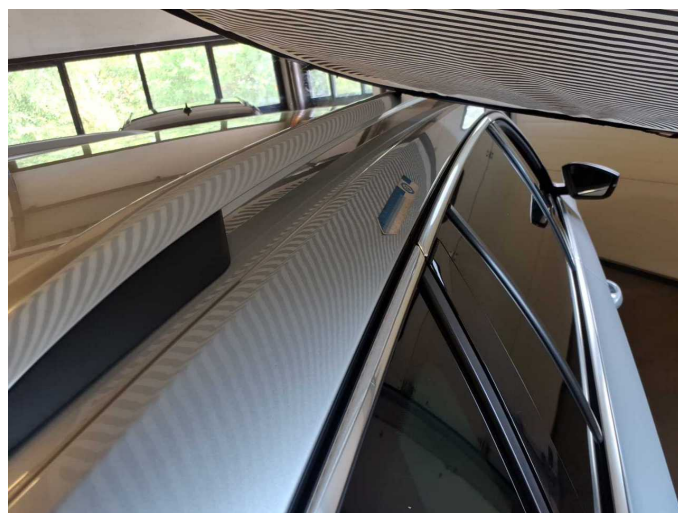
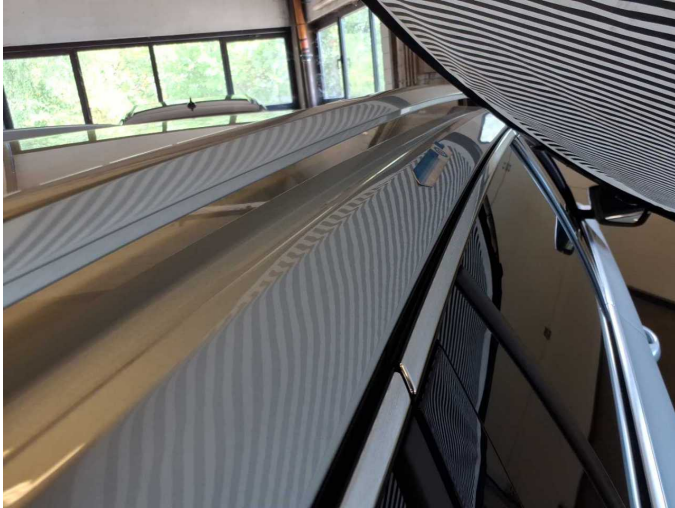
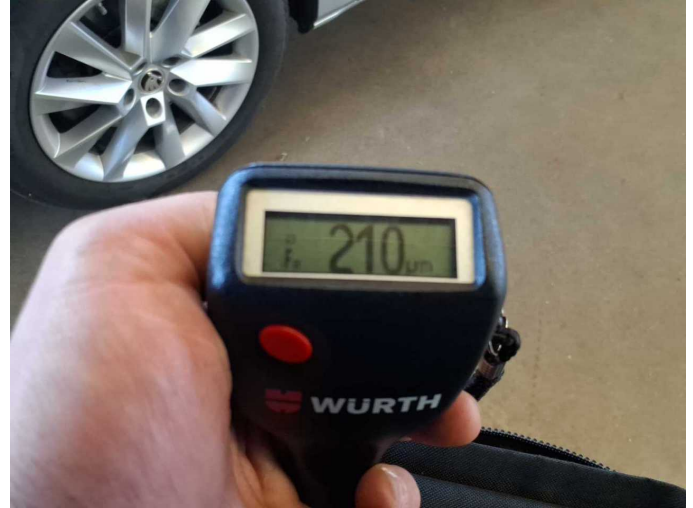
| No. | Component group | Description |
|---|---|---|
| 5 | Roof | Roof rail - right side - dent(s) - No deduction |

**Wear and tear 5:** Roof: Roof rail - right side - dent(s) - No deduction
