Expertise

Protocol number: 46631080  
Order No. / Reference: 26652104  
Inspection date: 30 Jun 2026

Manufacturer: Volkswagen

Model: Caddy Cargo 2.0 TDI BMT

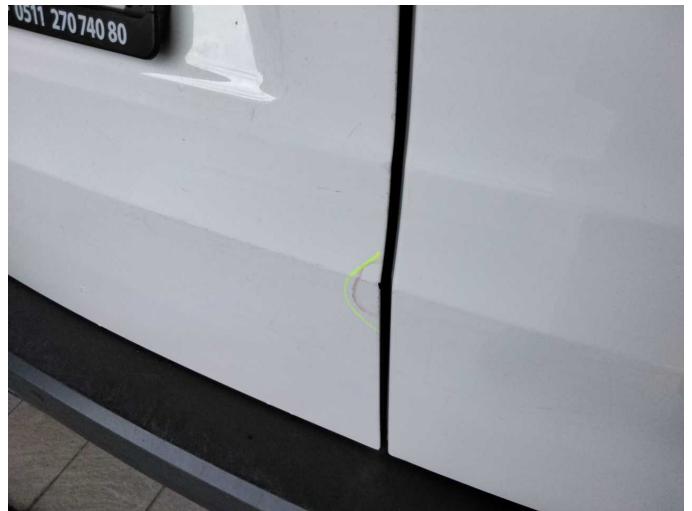
| No. | Component group | Description |
|---|---|---|
| 1 | Boot lid / rear door | Rear door - left side - Scratch(es) - Smart repair |

Damage 1: Boot lid / rear door: Rear door - left side - Scratch(es) - Smart repair

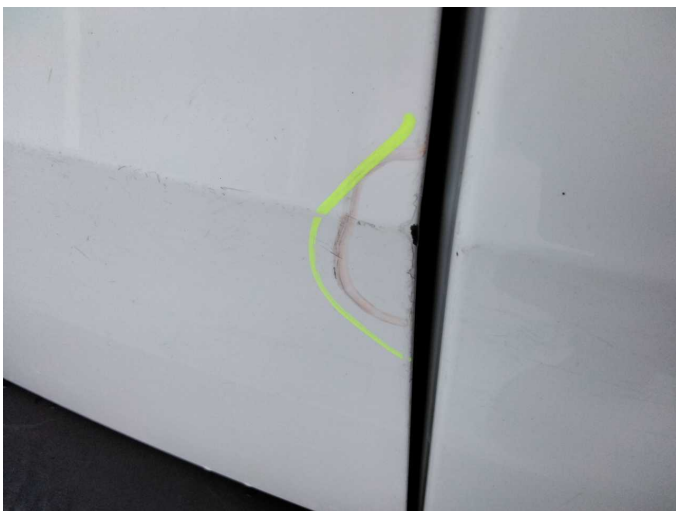
Damage 1: Boot lid / rear door: Rear door - left side - Scratch(es) - Smart repair

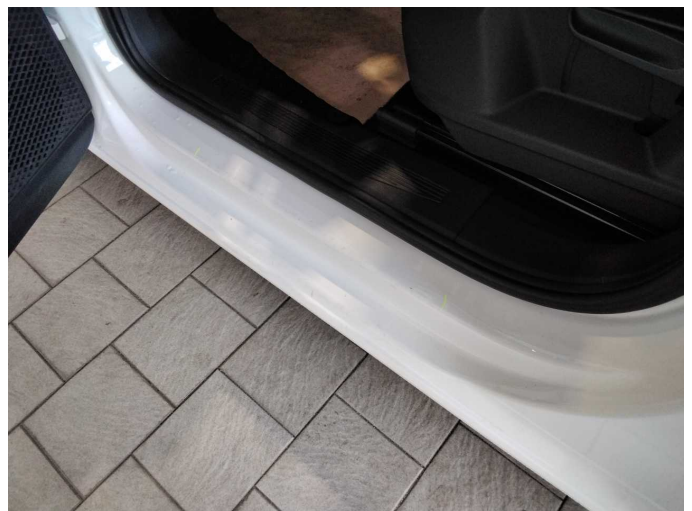
| No. | Component group | Description |
|---|---|---|
| 2 | Sill - left side | Sill - Scratch(es) - Smart repair |

Damage 2: Sill - left side: Sill - Scratch(es) - Smart repair

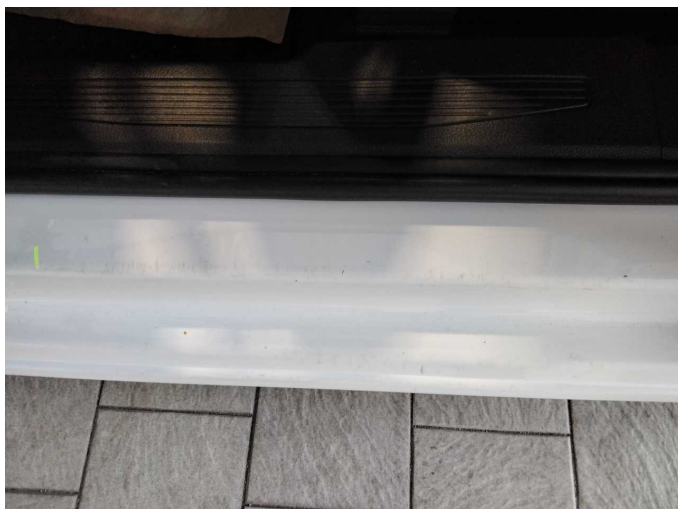
**Damage 2:** Sill - left side: Sill - Scratch(es) - Smart repair

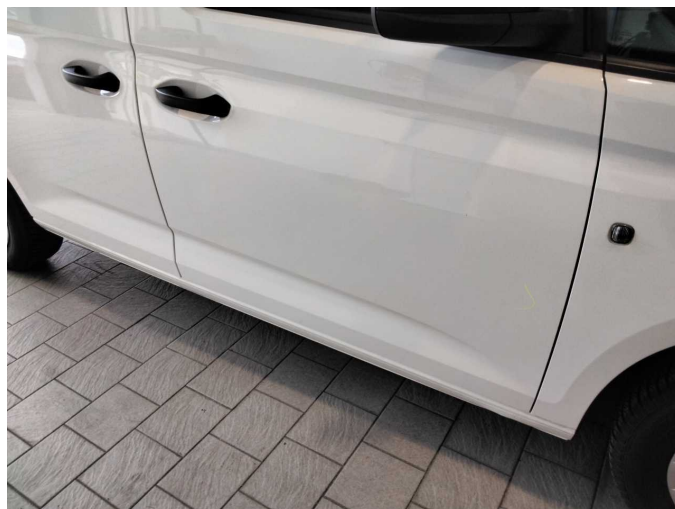
| No. | Component group | Description |
|---|---|---|
| 3 | Door - front right side | Door - Dent / paintcoat damage - Repair and paint |

**Damage 3:** Door - front right side: Door - Dent / paintcoat damage - Repair and paint

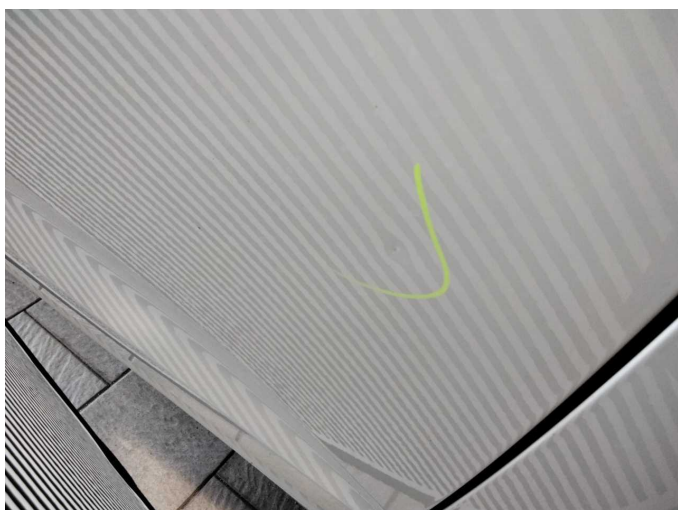
**Damage 3:** Door - front right side: Door - Dent / paintcoat damage - Repair and paint

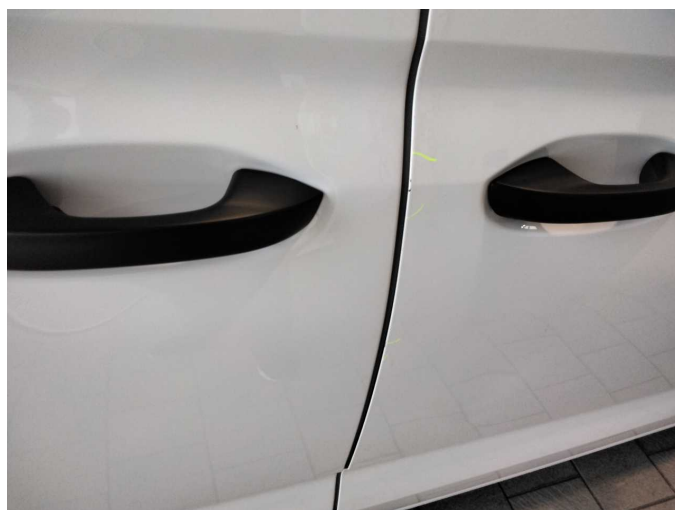
**Damage 3:** Door - front right side: Door - Dent / paintcoat damage - Repair and paint

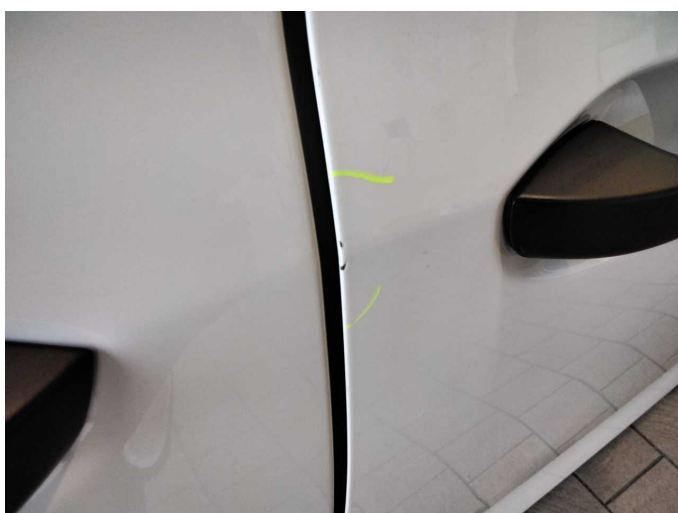
**Damage 3:** Door - front right side: Door - Dent / paintcoat damage - Repair and paint

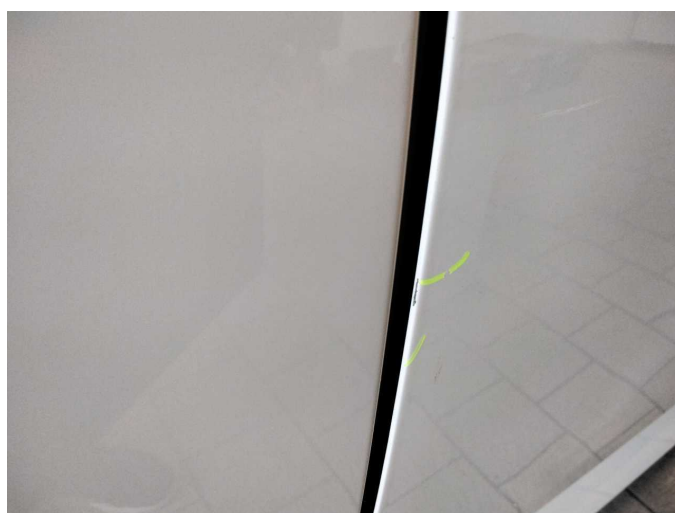
**Damage 3:** Door - front right side: Door - Dent / paintcoat damage - Repair and paint

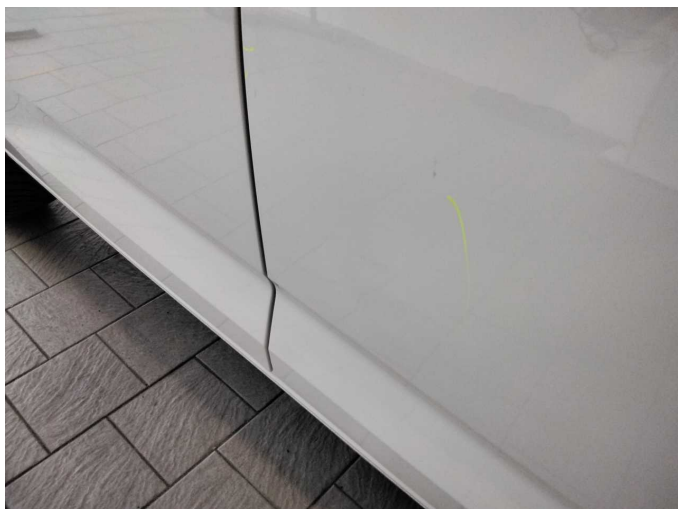
**Damage 3:** Door - front right side: Door - Dent / paintcoat damage - Repair and paint

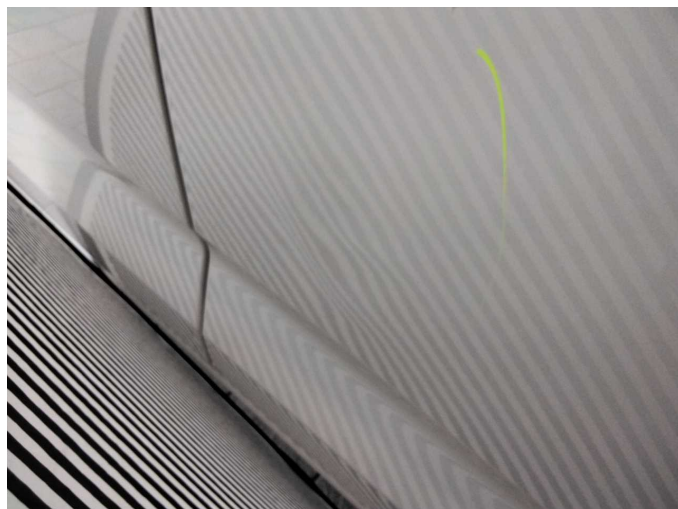
**Damage 3:** Door - front right side: Door - Dent / paintcoat damage - Repair and paint

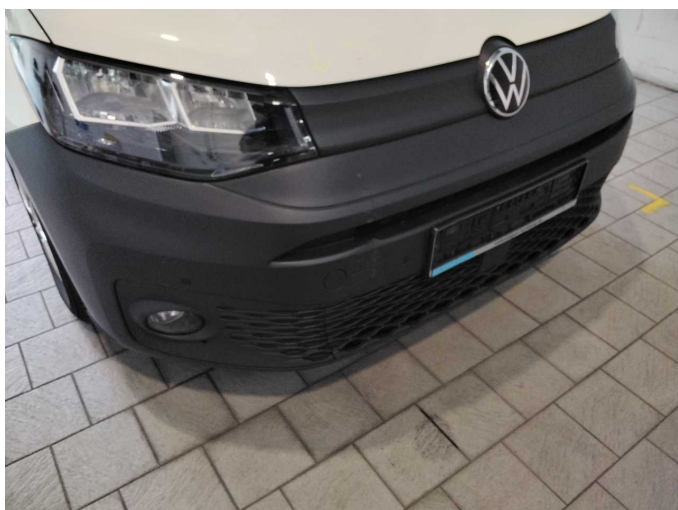
| No. | Component group | Description |
|---|---|---|
| 4 | Front bumper | Front bumper - Damaged - Replace |

**Damage 4:** Front bumper: Front bumper - Damaged - Replace

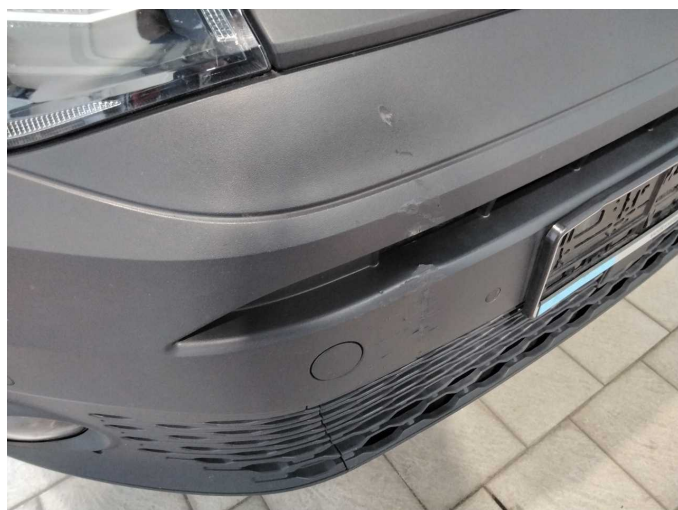
**Damage 4:** Front bumper: Front bumper - Damaged - Replace

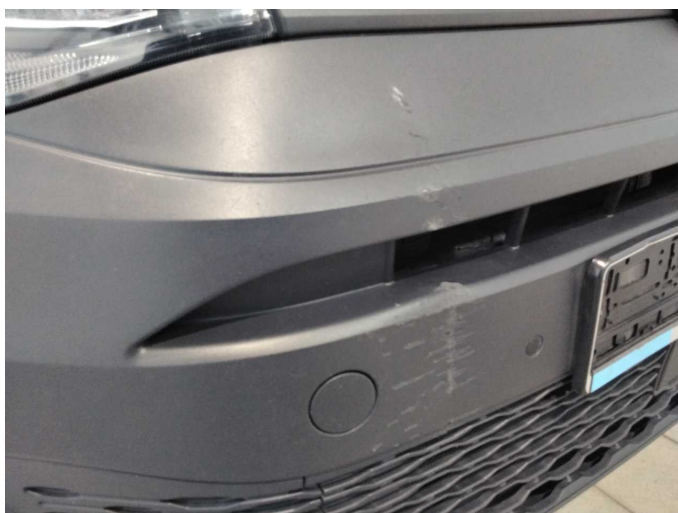
**Damage 4:** Front bumper: Front bumper - Damaged - Replace

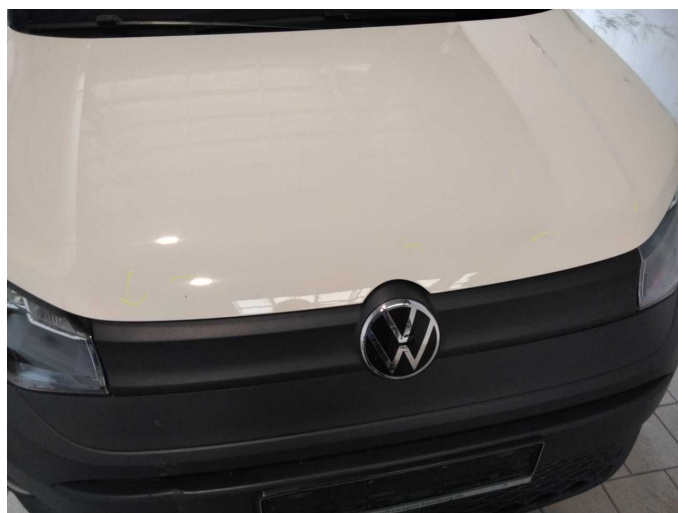
| No. | Component group | Description |
|---|---|---|
| 5 | Bonnet | Bonnet - Stone chips - Paint |

**Damage 5:** Bonnet: Bonnet - Stone chips - Paint

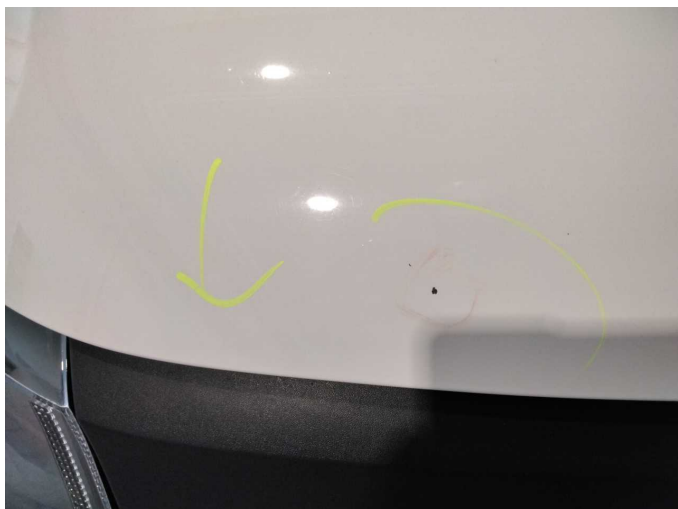
**Damage 5:** Bonnet: Bonnet - Stone chips - Paint

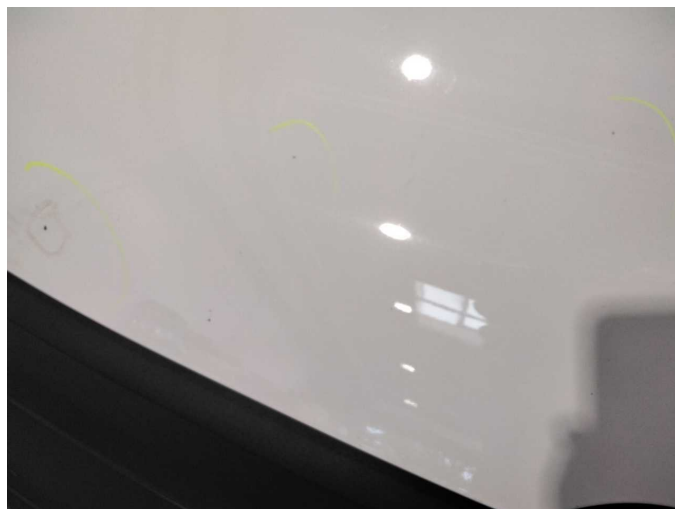
**Damage 5:** Bonnet: Bonnet - Stone chips - Paint

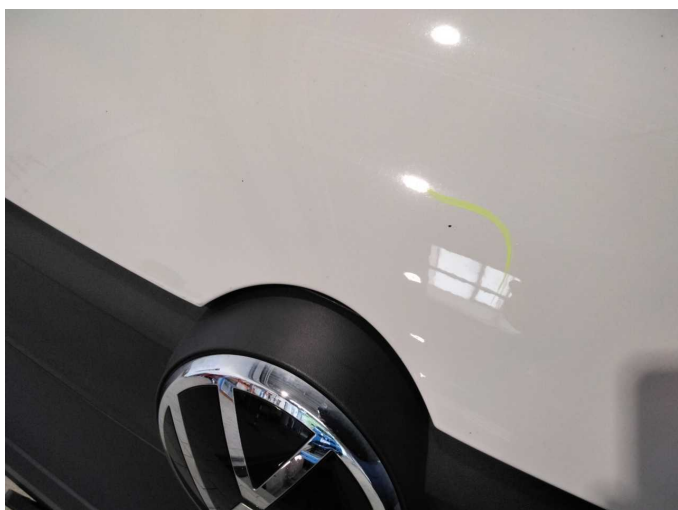
**Damage 5:** Bonnet: Bonnet - Stone chips - Paint

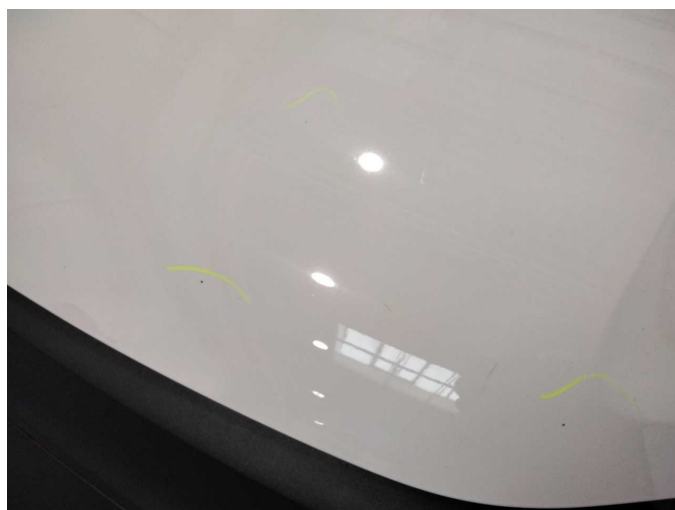
**Damage 5:** Bonnet: Bonnet - Stone chips - Paint

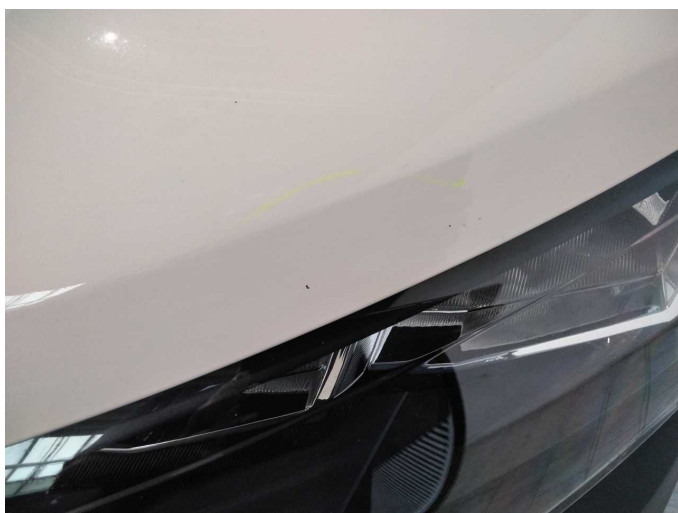
**Damage 5:** Bonnet: Bonnet - Stone chips - Paint

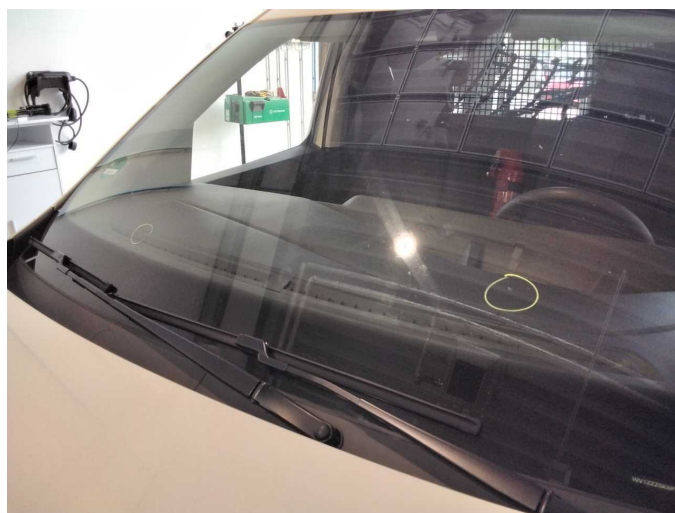
| No. | Component group | Description |
|---|---|---|
| 6 | Vehicle glazing | Windscreen - Stone chips - Replace |

**Damage 6:** Vehicle glazing: Windscreen - Stone chips - Replace

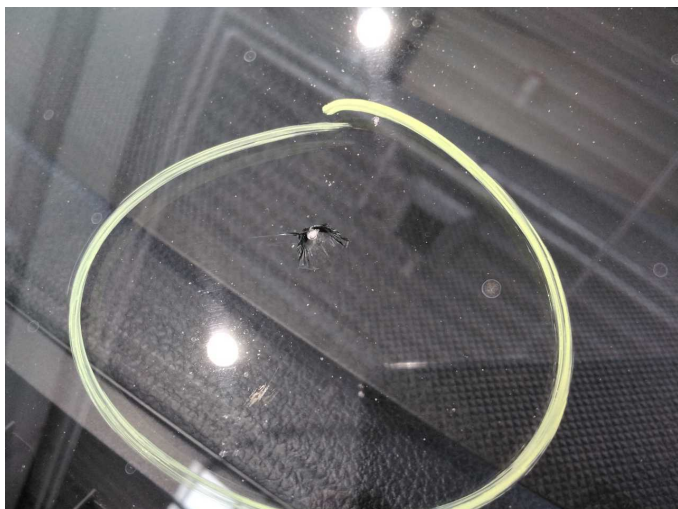
**Damage 6:** Vehicle glazing: Windscreen - Stone chips - Replace

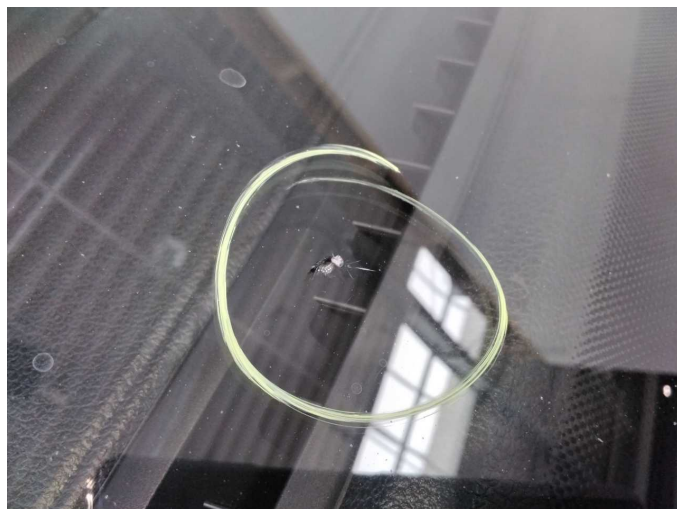
**Damage 6:** Vehicle glazing: Windscreen - Stone chips - Replace

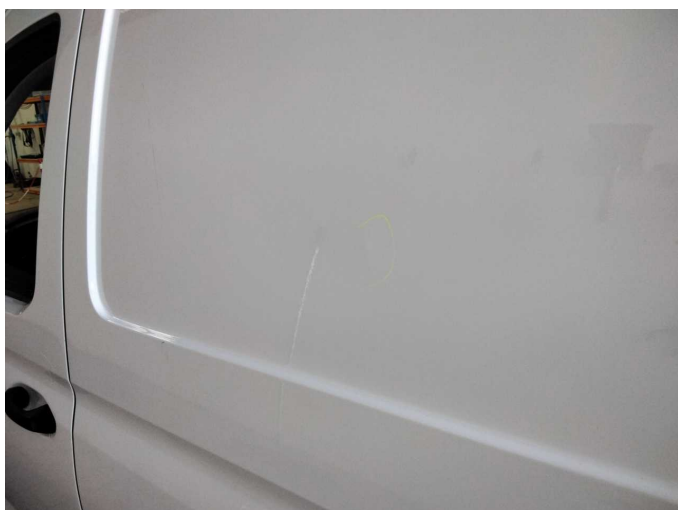
| No. | Component group | Description |
|---|---|---|
| 1 | Side panel - rear left side | Side panel - dent(s) - No deduction |

**Wear and tear 1:** Side panel - rear left side: Side panel - dent(s) - No deduction

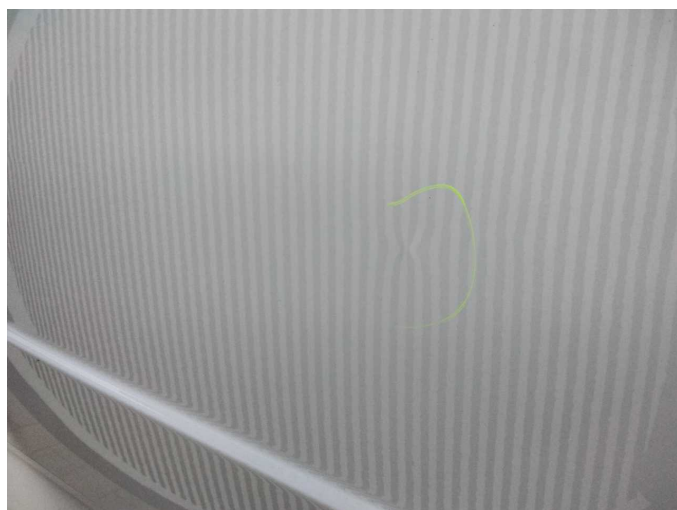
**Wear and tear 1:** Side panel - rear left side: Side panel - dent(s) - No deduction

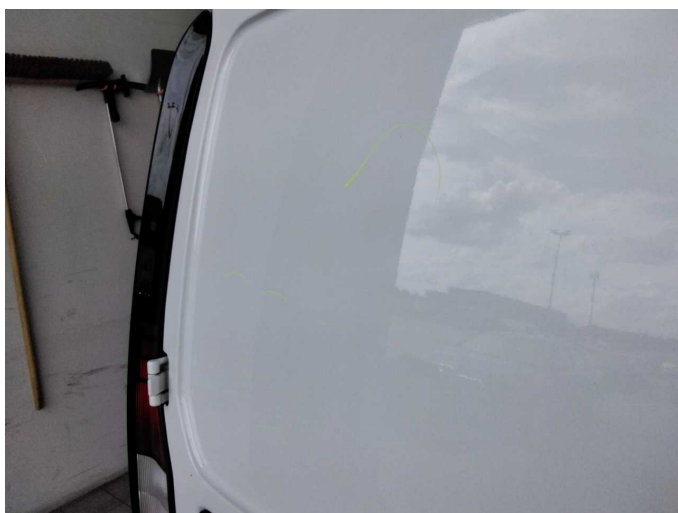
| No. | Component group | Description |
|---|---|---|
| 2 | Boot lid / rear door | Rear door - left side - dent(s) - No deduction |

**Wear and tear 2:** Boot lid / rear door: Rear door - left side - dent(s) - No deduction

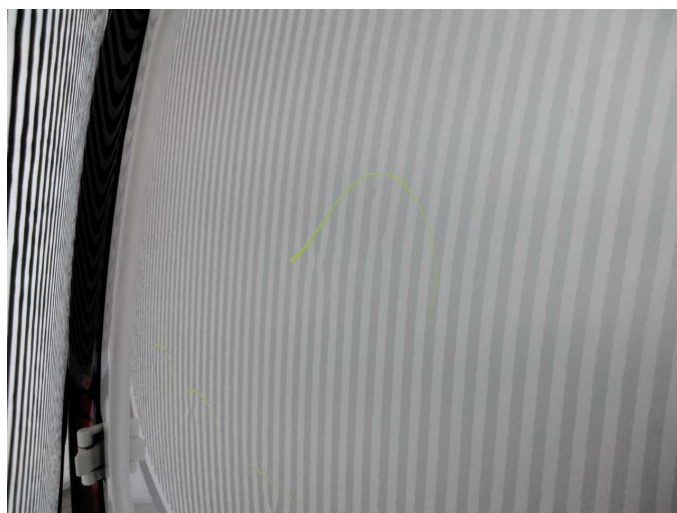
**Wear and tear 2:** Boot lid / rear door: Rear door - left side - dent(s) - No deduction

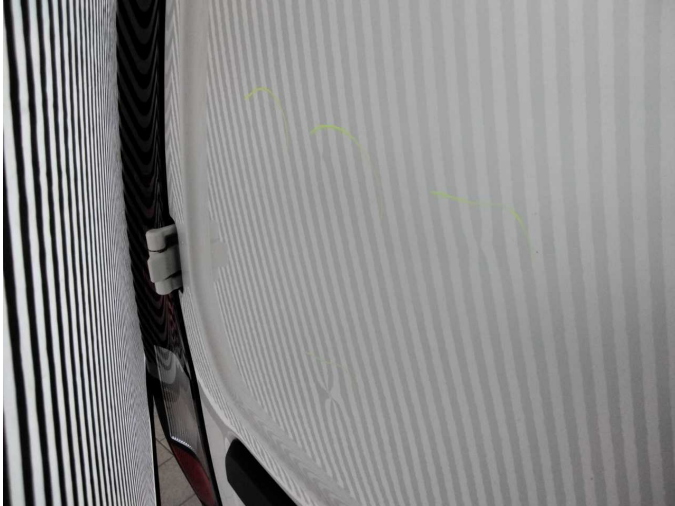
**Wear and tear 2:** Boot lid / rear door: Rear door - left side - dent(s) - No deduction

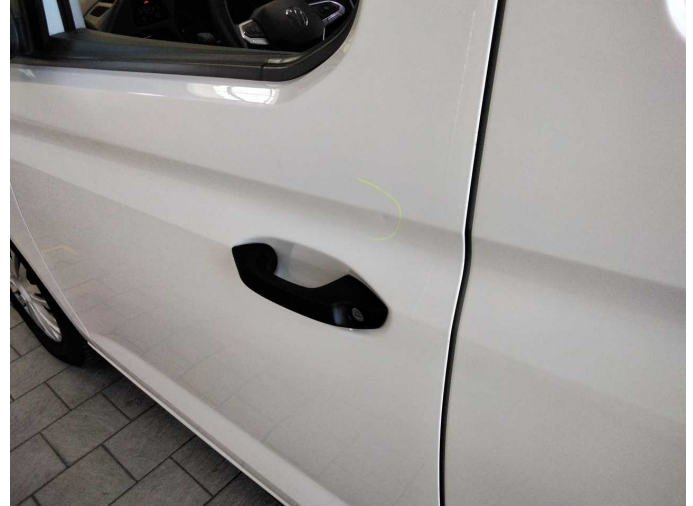
| No. | Component group | Description |
|---|---|---|
| 3 | Door - front left side | Door - dent(s) - No deduction |

**Wear and tear 3:** Door - front left side: Door - dent(s) - No deduction

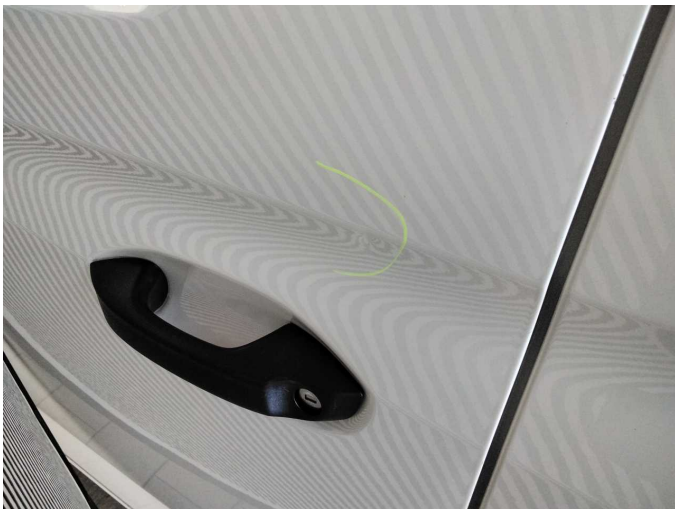
**Wear and tear 3:** Door - front left side: Door - dent(s) - No deduction

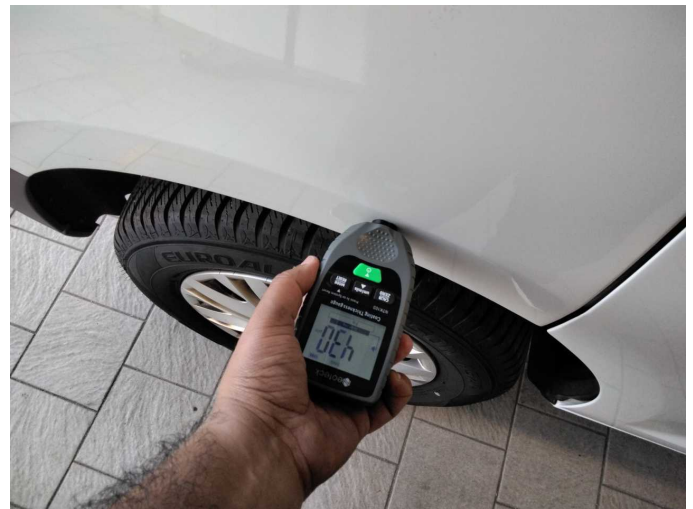
| No. | Repainting |
|---|---|
| 1 | Side panel - rear right side, Door - rear right side |

**Side panel - rear right side:** 430 µm

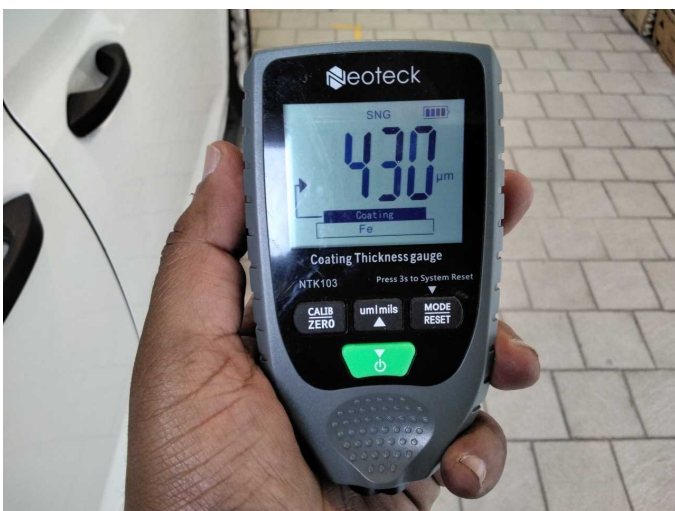
**Side panel - rear right side:** 430 µm

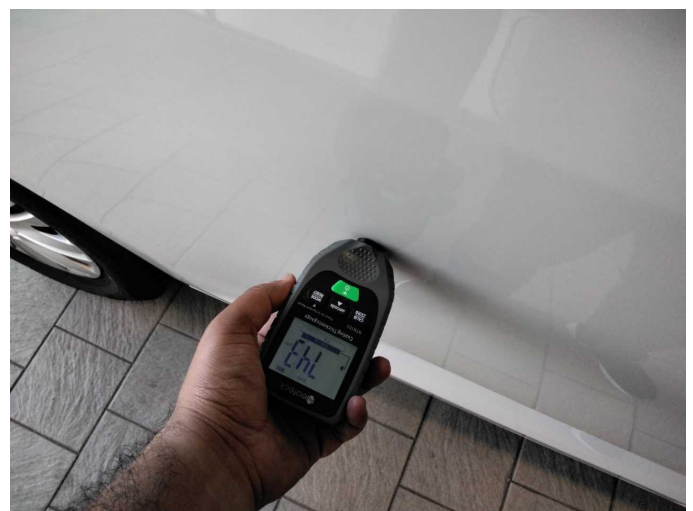
**Door - rear right side:** 743 µm

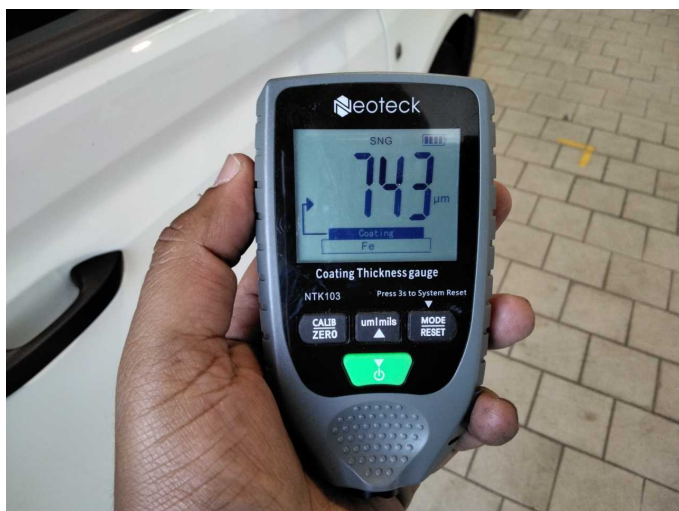
Door - rear right side: 743 µm
