Expertise

Protocol number: 45919793
Order No. / Reference: 26489950
Inspection date: 12 Jun 2026

Manufacturer: Seat

Model: Tarraco 2.0 TDI SCR DSG Style

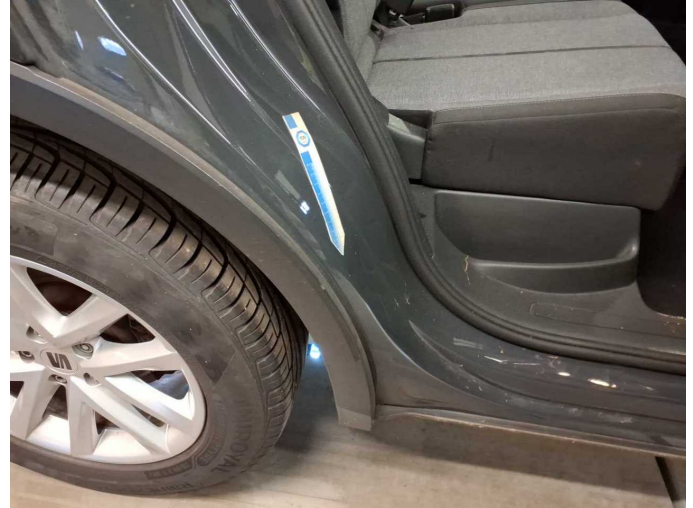
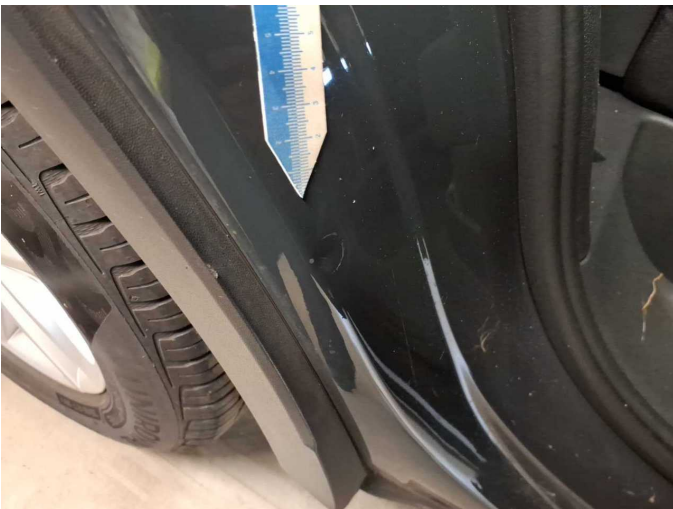
Damage 1: Side panel - rear right side: Sill - dent(s) - Smooth repair work

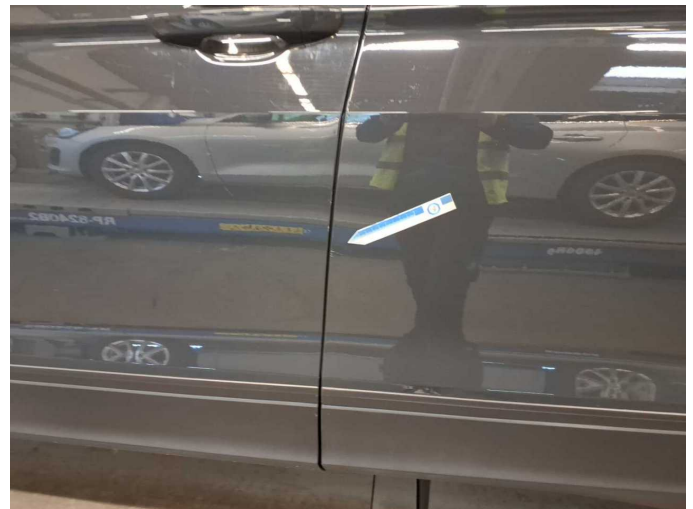
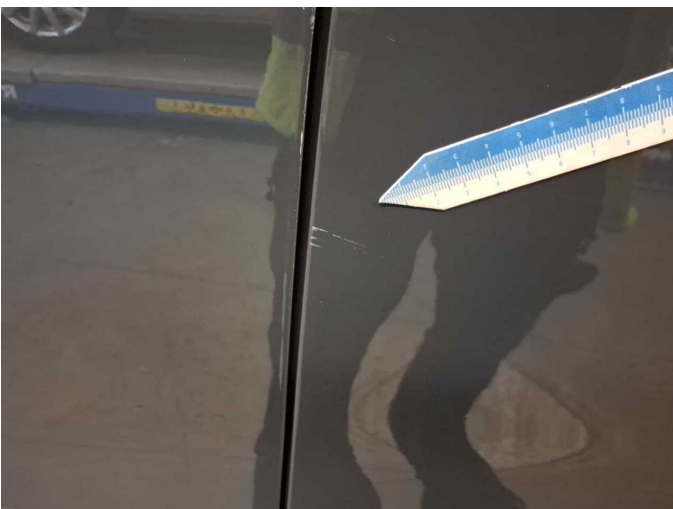
Damage 2: Door - rear left side: Door - Scratch(es) - Smart repair

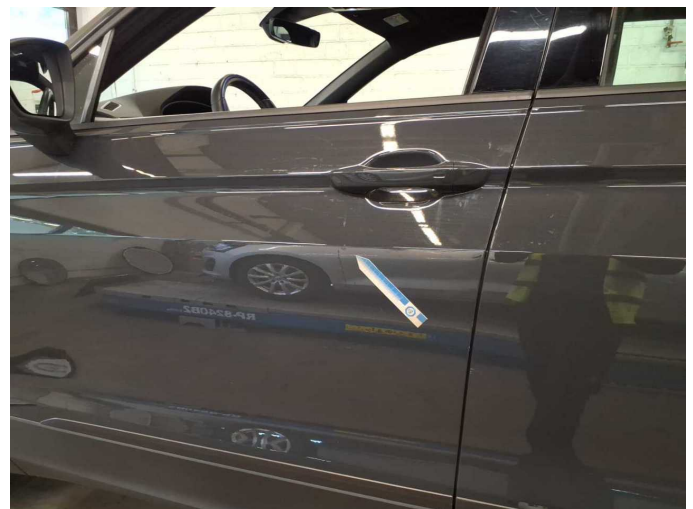
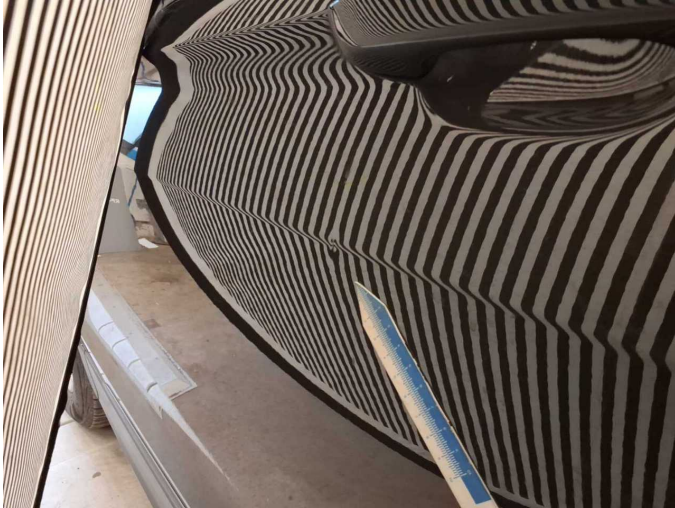
Damage 3: Door - front left side: Door - dent(s) - Smooth repair work

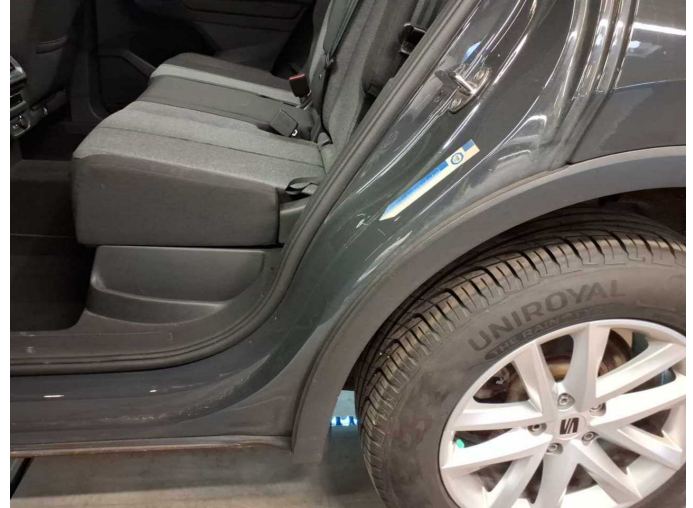
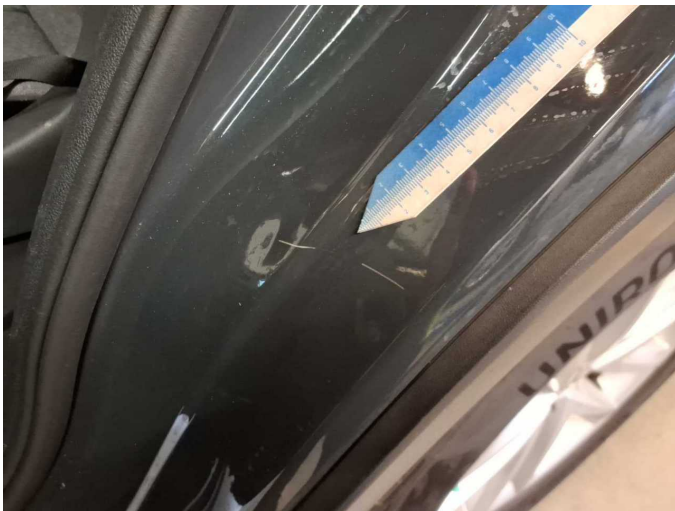
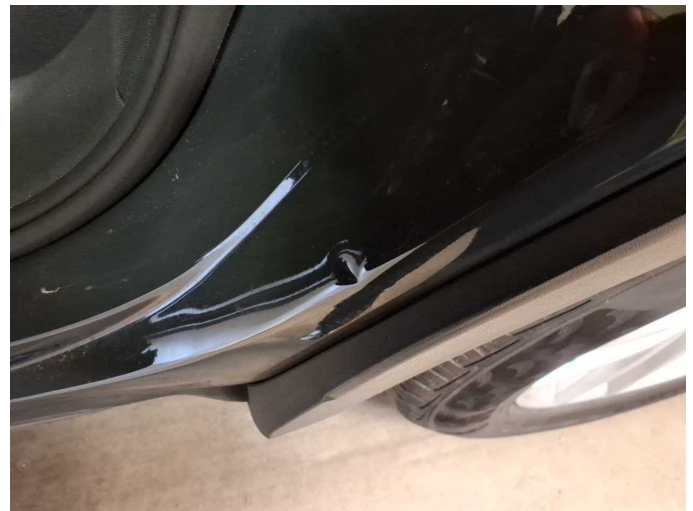
Damage 4: Side panel - rear left side: Sill - Dent / paintcoat damage - Smart repair
