## Expertise

Protocol number: 45128328  
Order No. / Reference: 26272698  
Inspection date: 22 Apr 2026

Model: Kuga 2.5 Duratec PHEV VIGNALE

VIN: WF0FXXWPMHNS87568

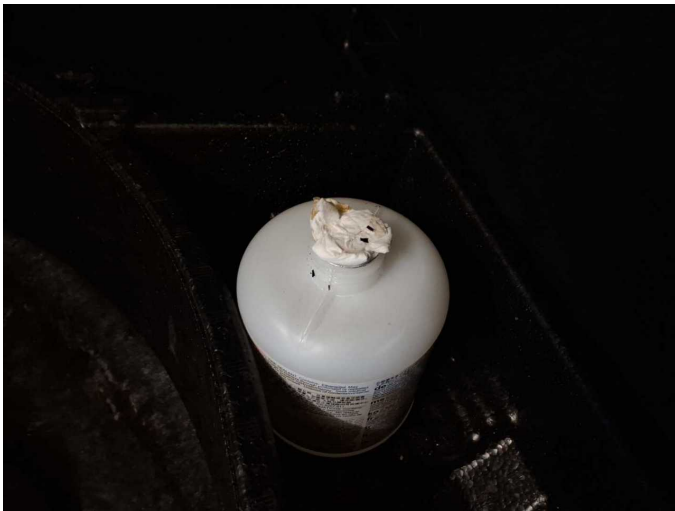
Damage 2: Equipment: Tirefit filler - Empty - Replace

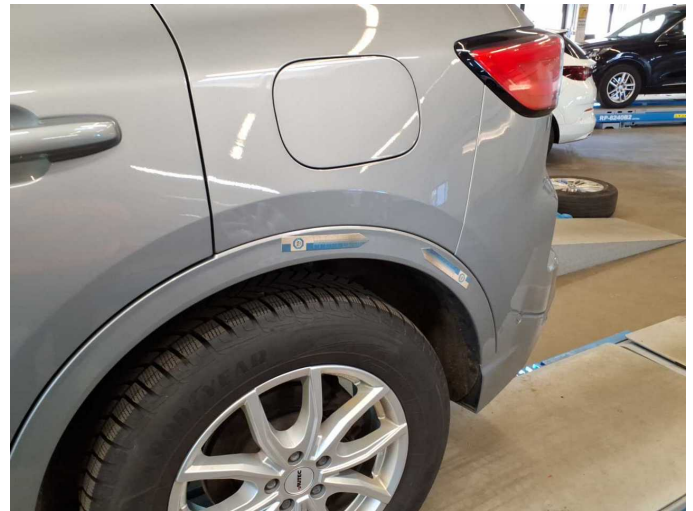
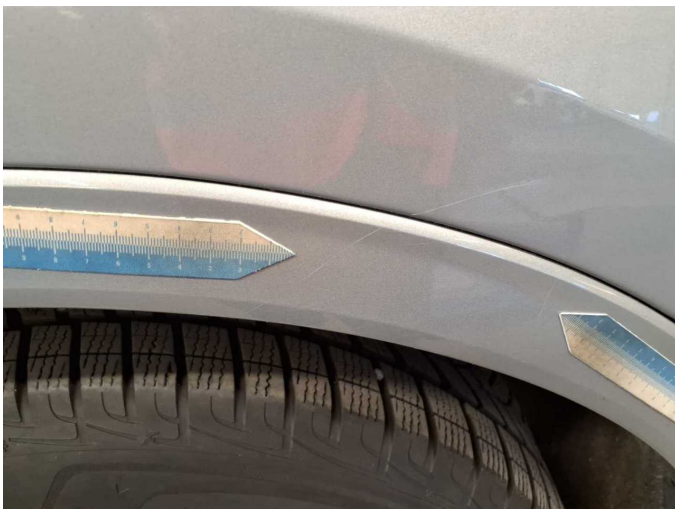
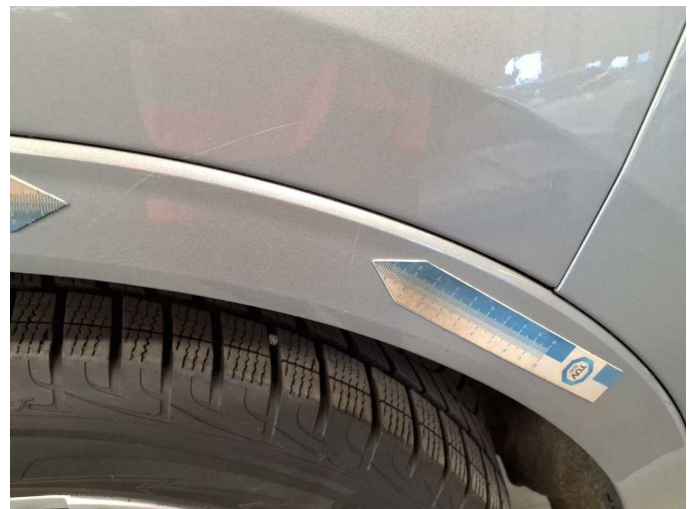
No.	Component group	Description
1	Documents	Service book (sporadische Durchführung) - Incomplete - No deduction
2	Equipment	Tirefit filler - Empty - Replace
3	Side panel - rear left side	Wheel well extension - Scratch(es) - Smart repair
4	Mudguard - right side	Wheel well extension - Scratch(es) - Smart repair
5	Side panel - rear left side	Side panel - Scratch(es) - Smart repair

Damage 3: Side panel - rear left side: Wheel well extension - Scratch(es) - Smart repair

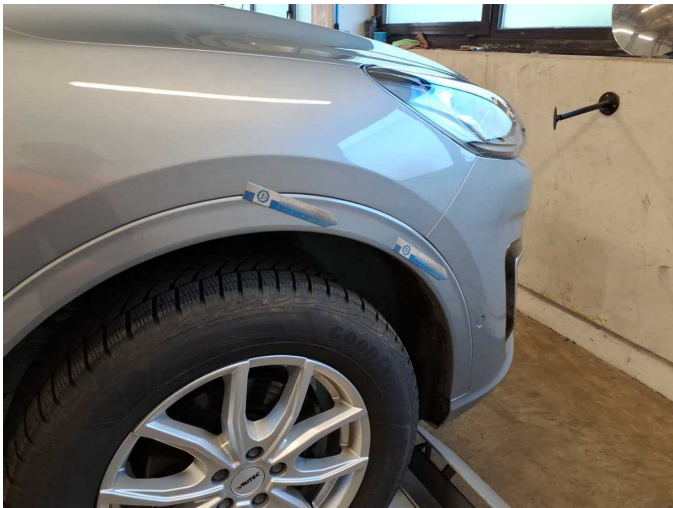
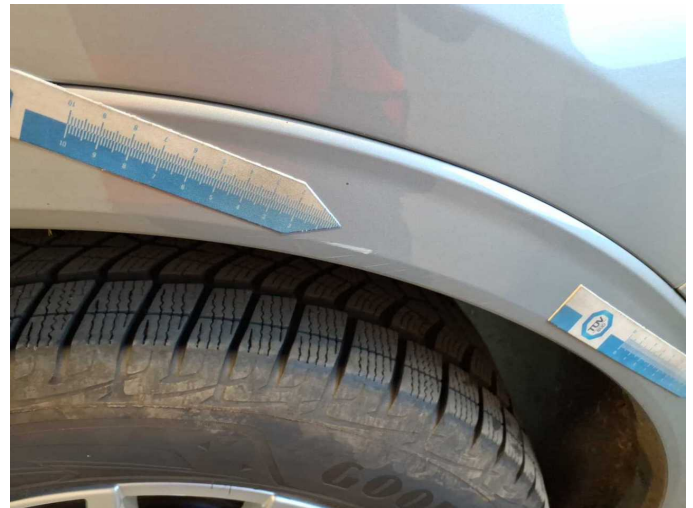
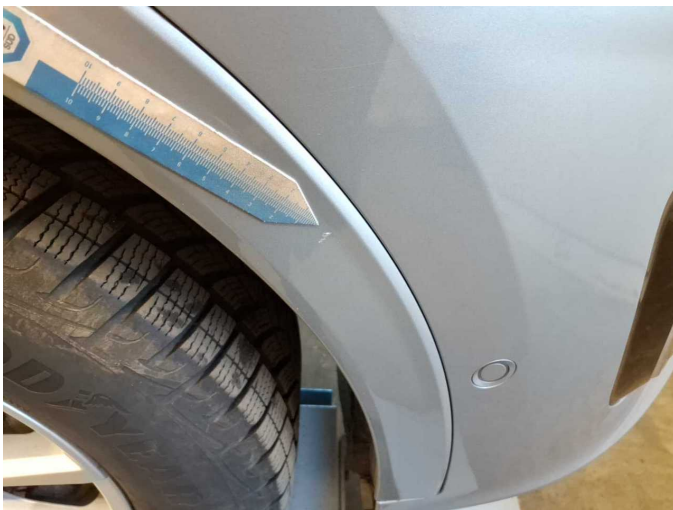
**Damage 4:** Mudguard - right side: Wheel well extension - Scratch(es) - Smart repair

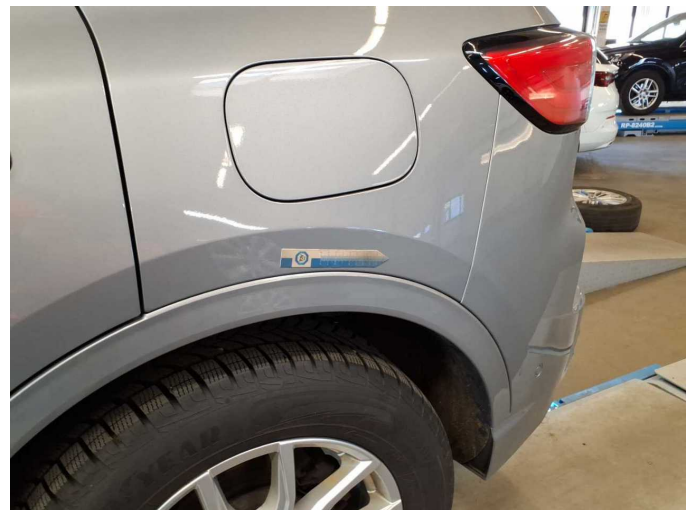
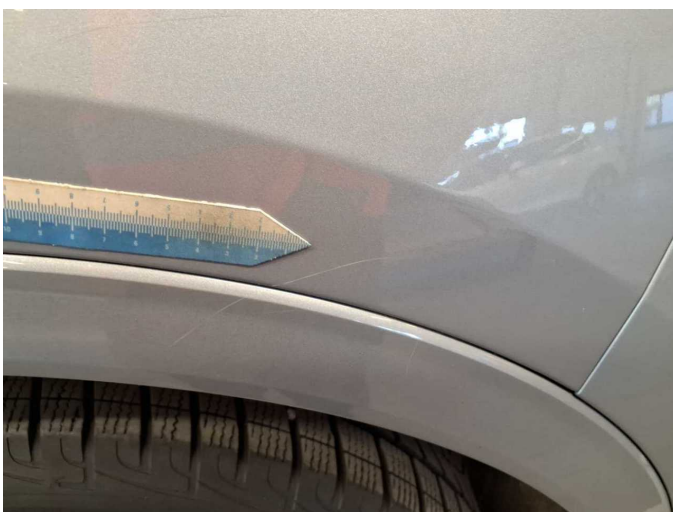
**Damage 5:** Side panel - rear left side: Side panel - Scratch(es) - Smart repair

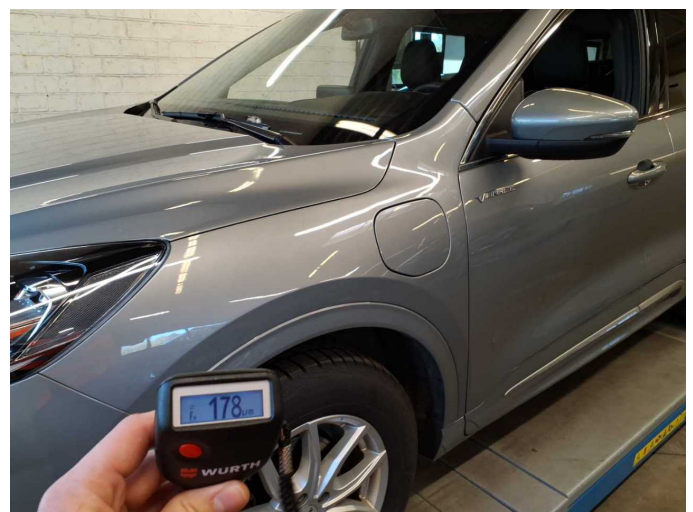
**Repainting 1:** Mudguard - left side

No.	Repainting
1	Mudguard - left side, Professionally carried out, Invoice of repair done Non-existent
2	Mudguard - right side, Professionally carried out, Invoice of repair done Non-existent

Mudguard - left side	178 µm	Mudguard - right side	166 µm
Bonnet	166 µm	Door - front left side	196 µm
Door - front right side	189 µm

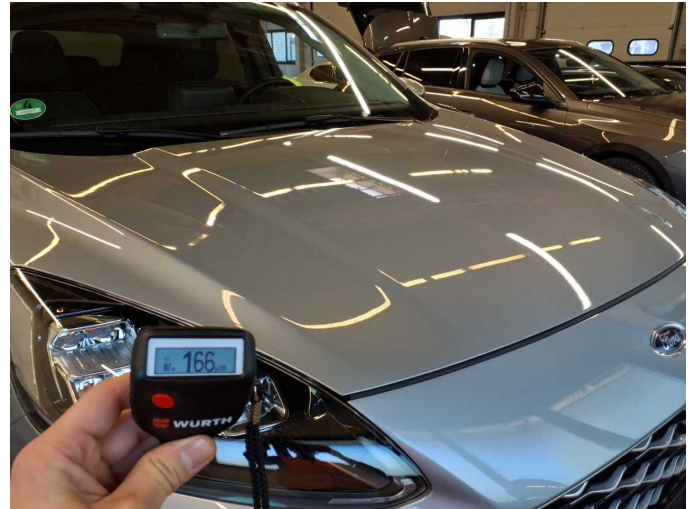
**Repainting 3:** Bonnet

- 3 Bonnet, Professionally carried out, Invoice of repair done Non-existent
- 4 Door - front left side, Professionally carried out, Invoice of repair done Non-existent
- 5 Door - front right side, Professionally carried out, Invoice of repair done Non-existent
