Expertise

Protocol number: 46275334  
Order No. / Reference: 26584352  
Inspection date: 30 Jun 2026

| Manufacturer: Volvo | Model: XC60 T6 AWD Recharge Core |
| VIN: LYVUZH1V9PB342673 | |

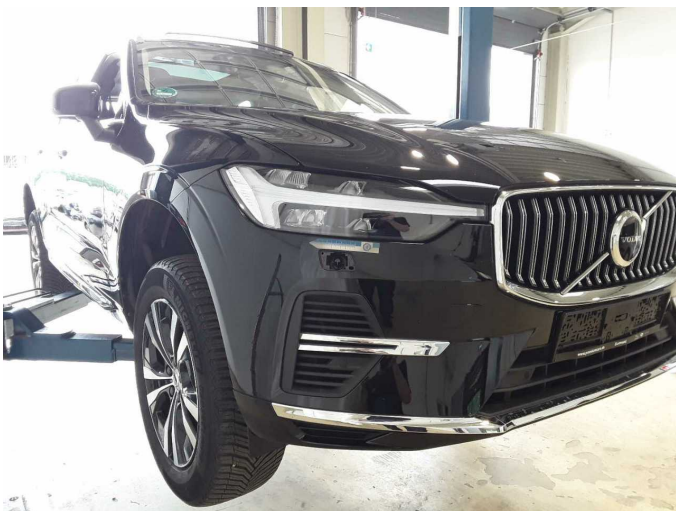
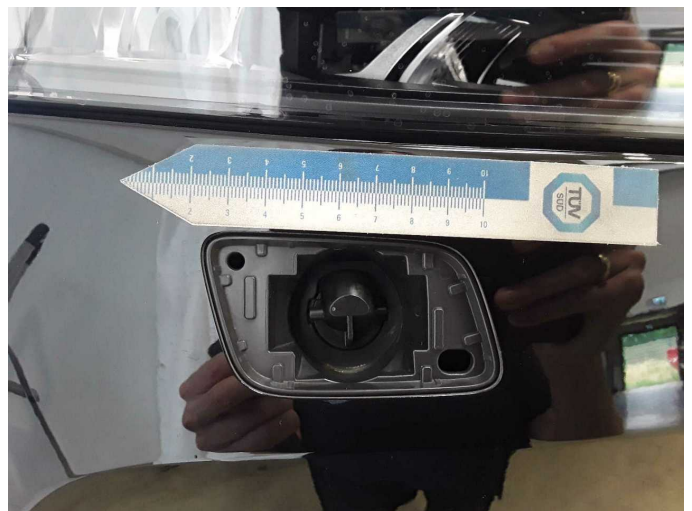
**Damage 1:** Headlight: Headlight cleaning nozzle - right side (Kappe fehlt)  
- Missing - Replace

| No. | Component group | Description |
|---|---|---|
| 1 | Headlight | Headlight cleaning nozzle - right side (Kappe fehlt) - Missing - Replace |

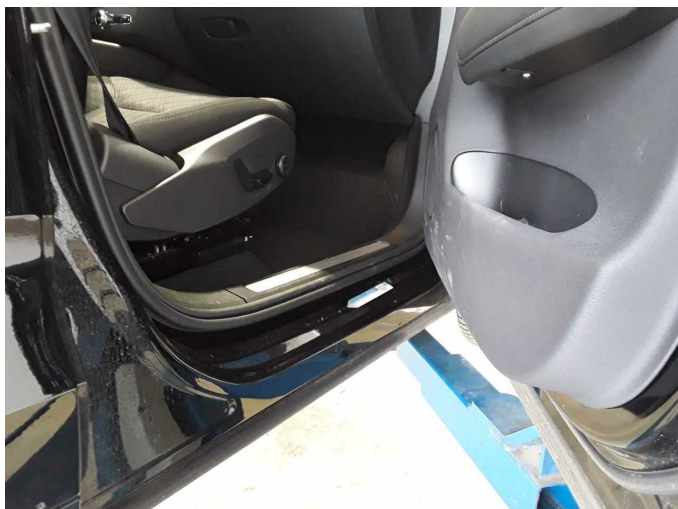
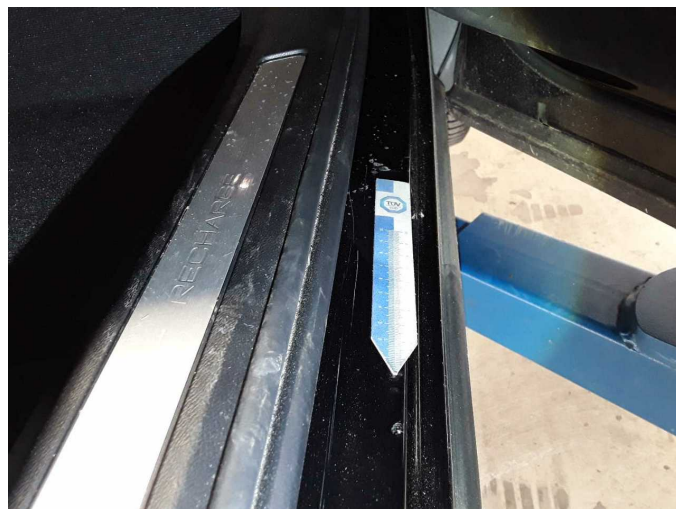
**Damage 2:** Sill - right side: Sill - Scratch(es) - Smart repair

| No. | Component group | Description |
|---|---|---|
| 2 | Sill - right side | Sill - Scratch(es) - Smart repair |

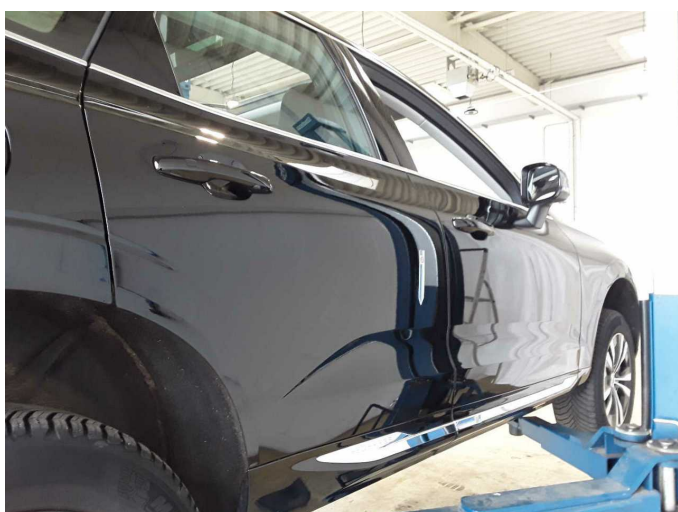
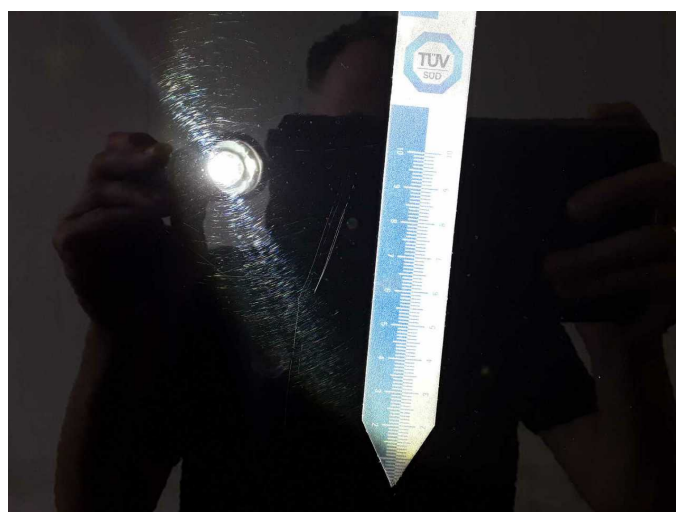
**Damage 4:** Door - rear right side: Door - Scratch(es) - Paint

| No. | Component group | Description |
|---|---|---|
| 4 | Door - rear right side | Door - Scratch(es) - Paint |

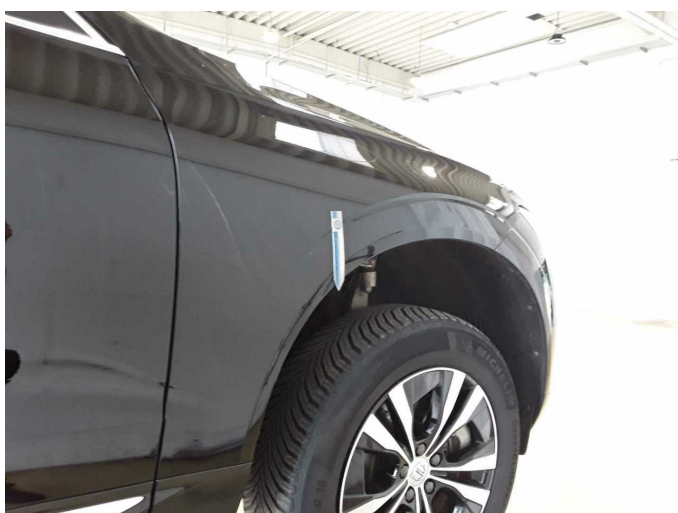
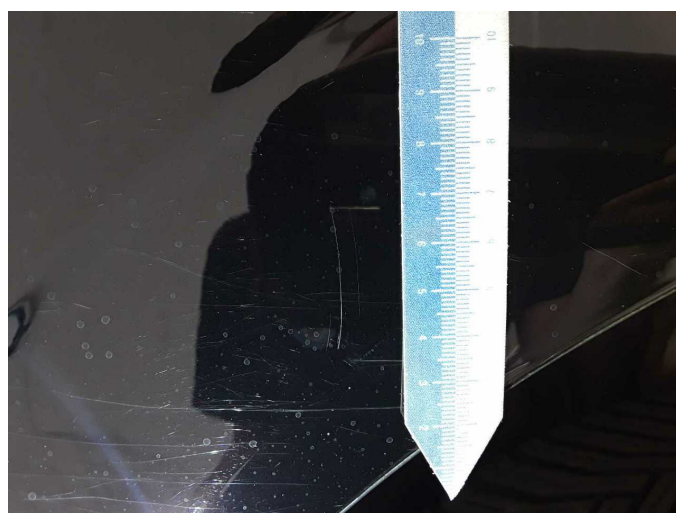
**Damage 5:** Mudguard - right side: Mudguard - right side - Scratch(es) - Paint

| No. | Component group | Description |
|---|---|---|
| 5 | Mudguard - right side | Mudguard - right side - Scratch(es) - Paint |

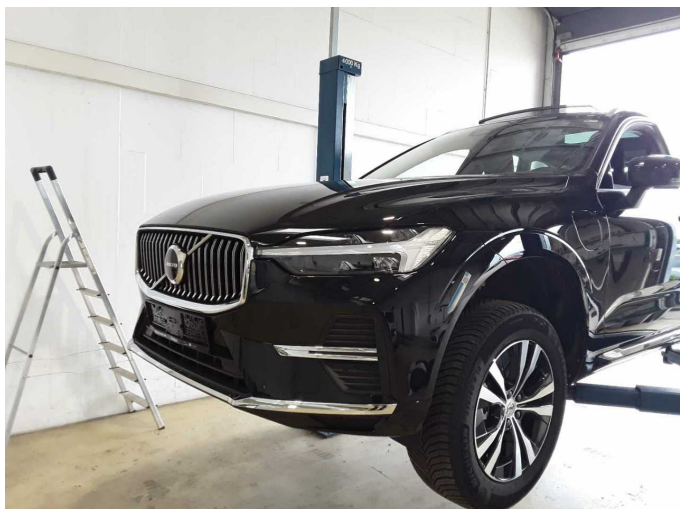
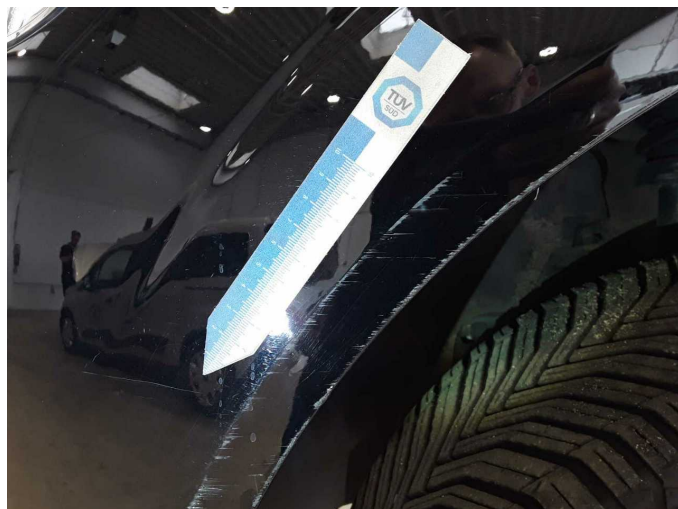
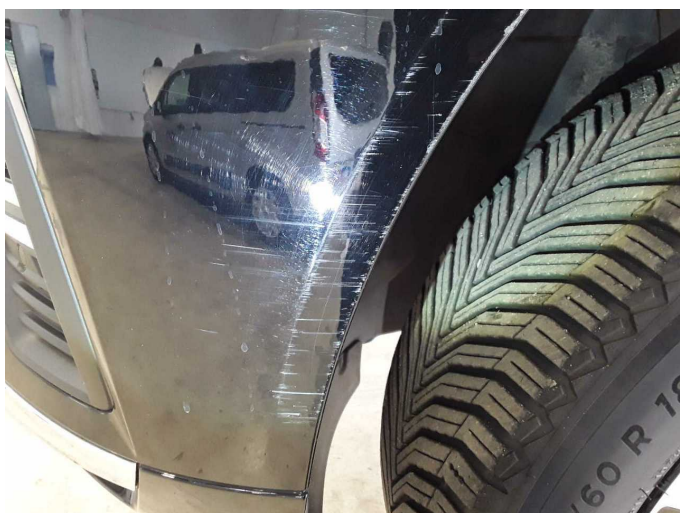
**Damage 6:** Front bumper: Front bumper - Scratch(es) - Paint

| No. | Component group | Description |
|---|---|---|
| 6 | Front bumper | Front bumper - Scratch(es) - Paint |

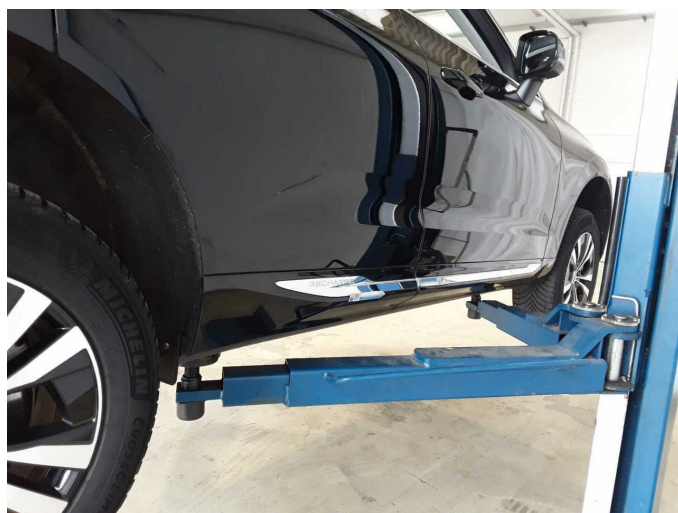
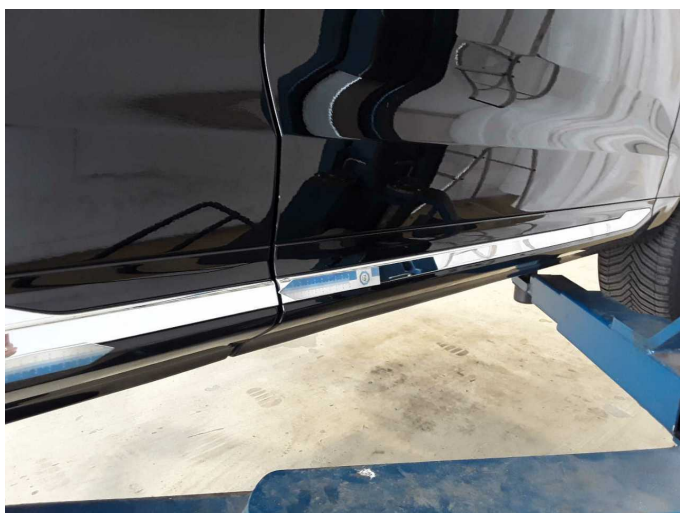
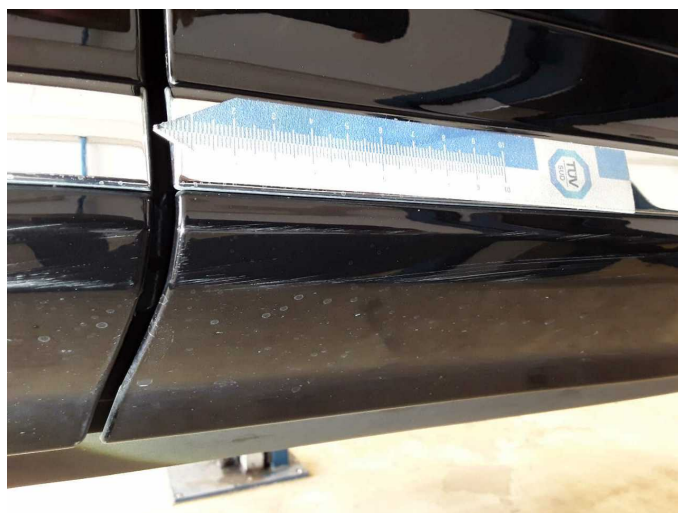
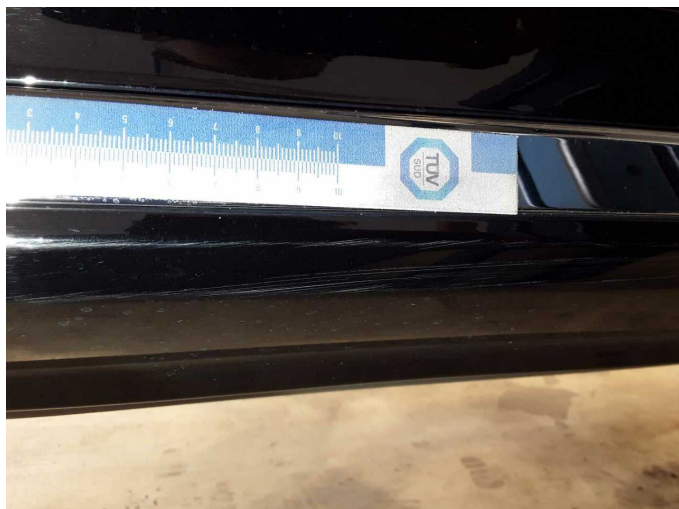
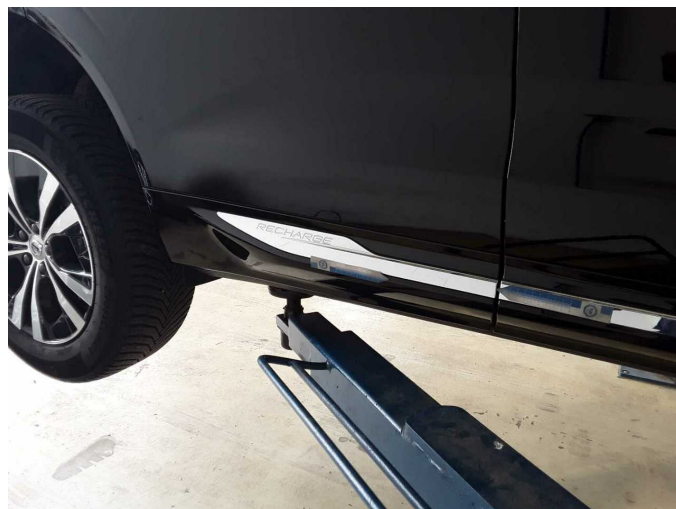
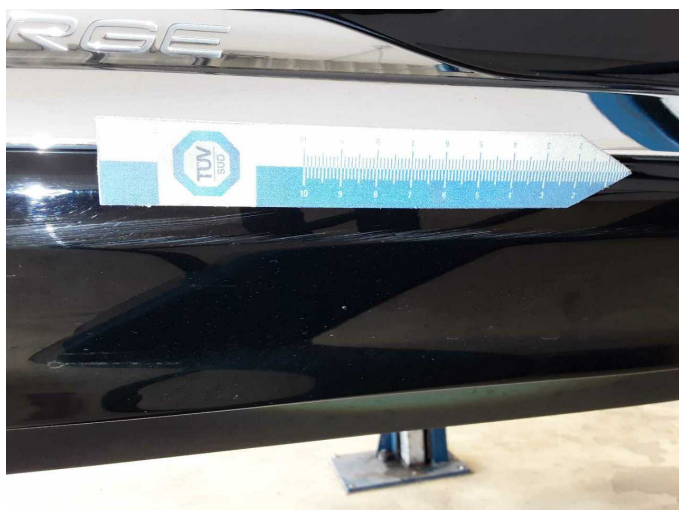
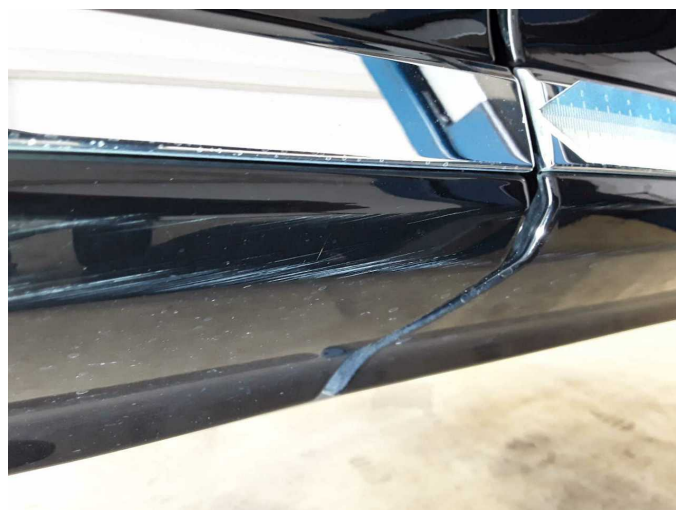
- 1 Side right

**Accident 1:** Side right

**Accident 1: Side right**
